Preservation Department – Item 2, LPC-25-12470

118 Rutland Road – Crown Heights North Historic District Borough of Brooklyn

This is part of an application to legalize the removal of a low ironwork railing that was installed atop the property's areaway curb

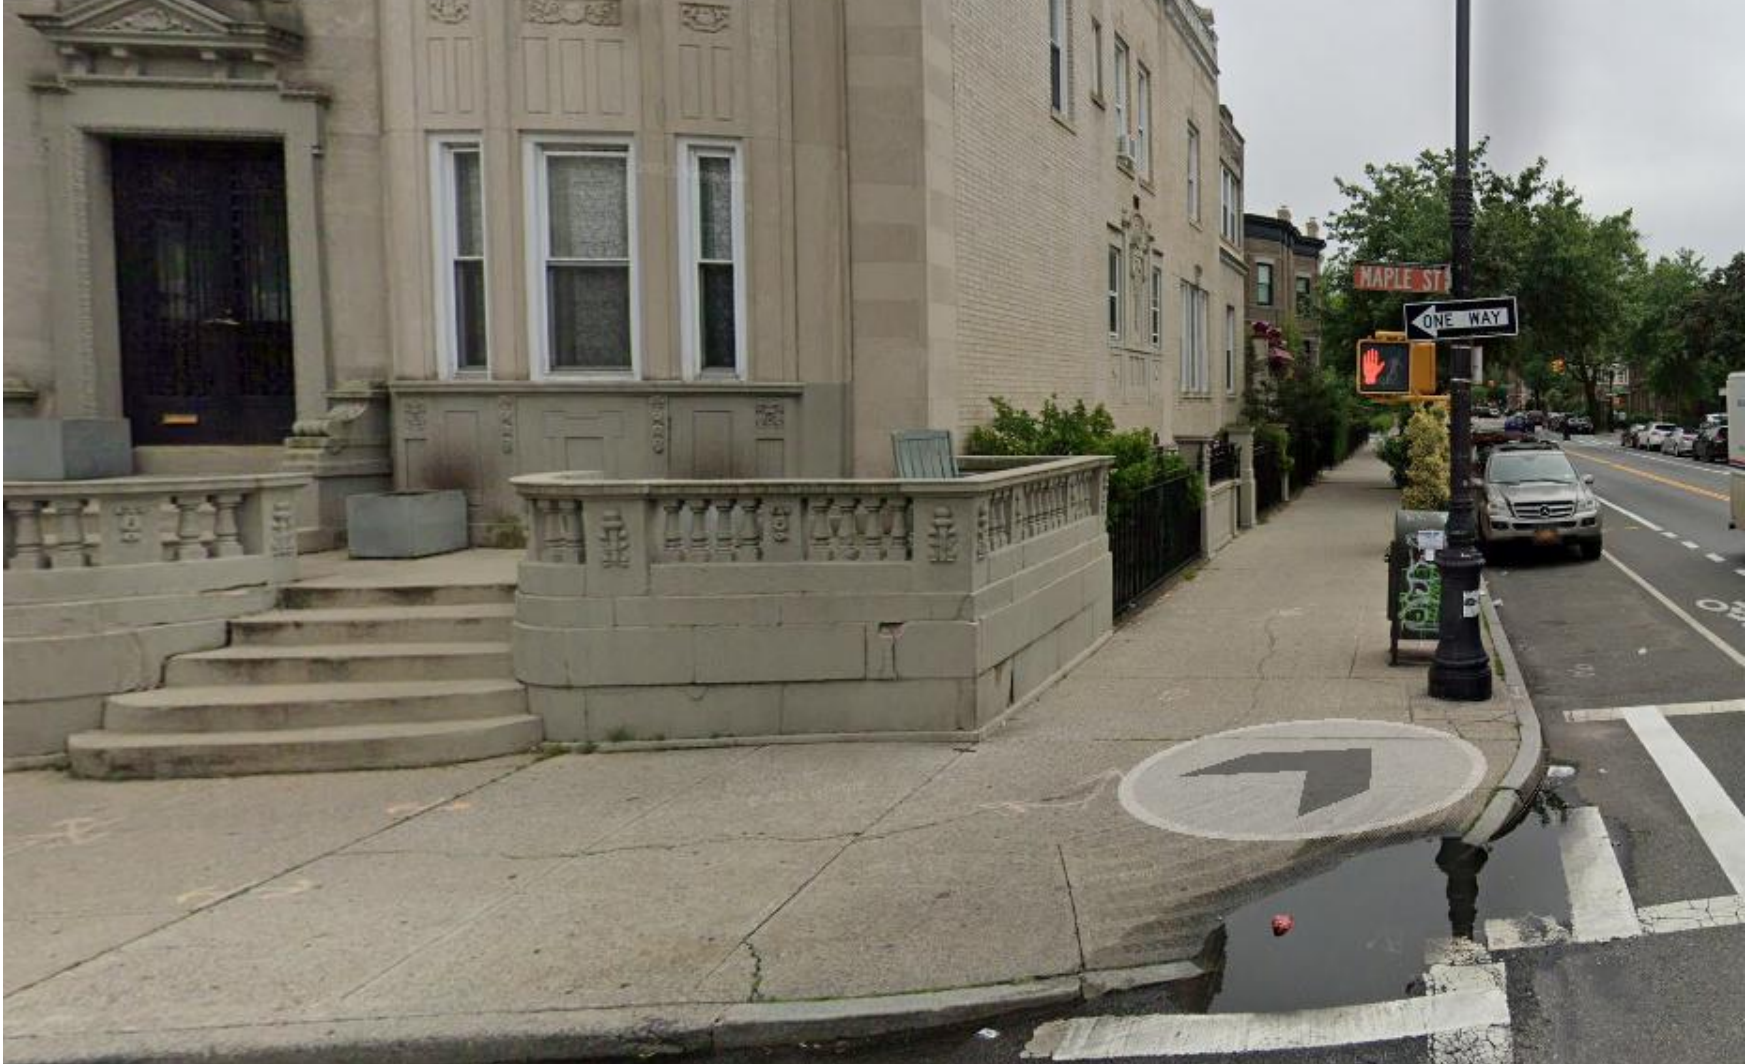
A-34

126 Maple Street at Bedford Avenue – SE corner

Two blocks north on Bedford Avenue: Type F – Mixed partial high fence on low curb & wall

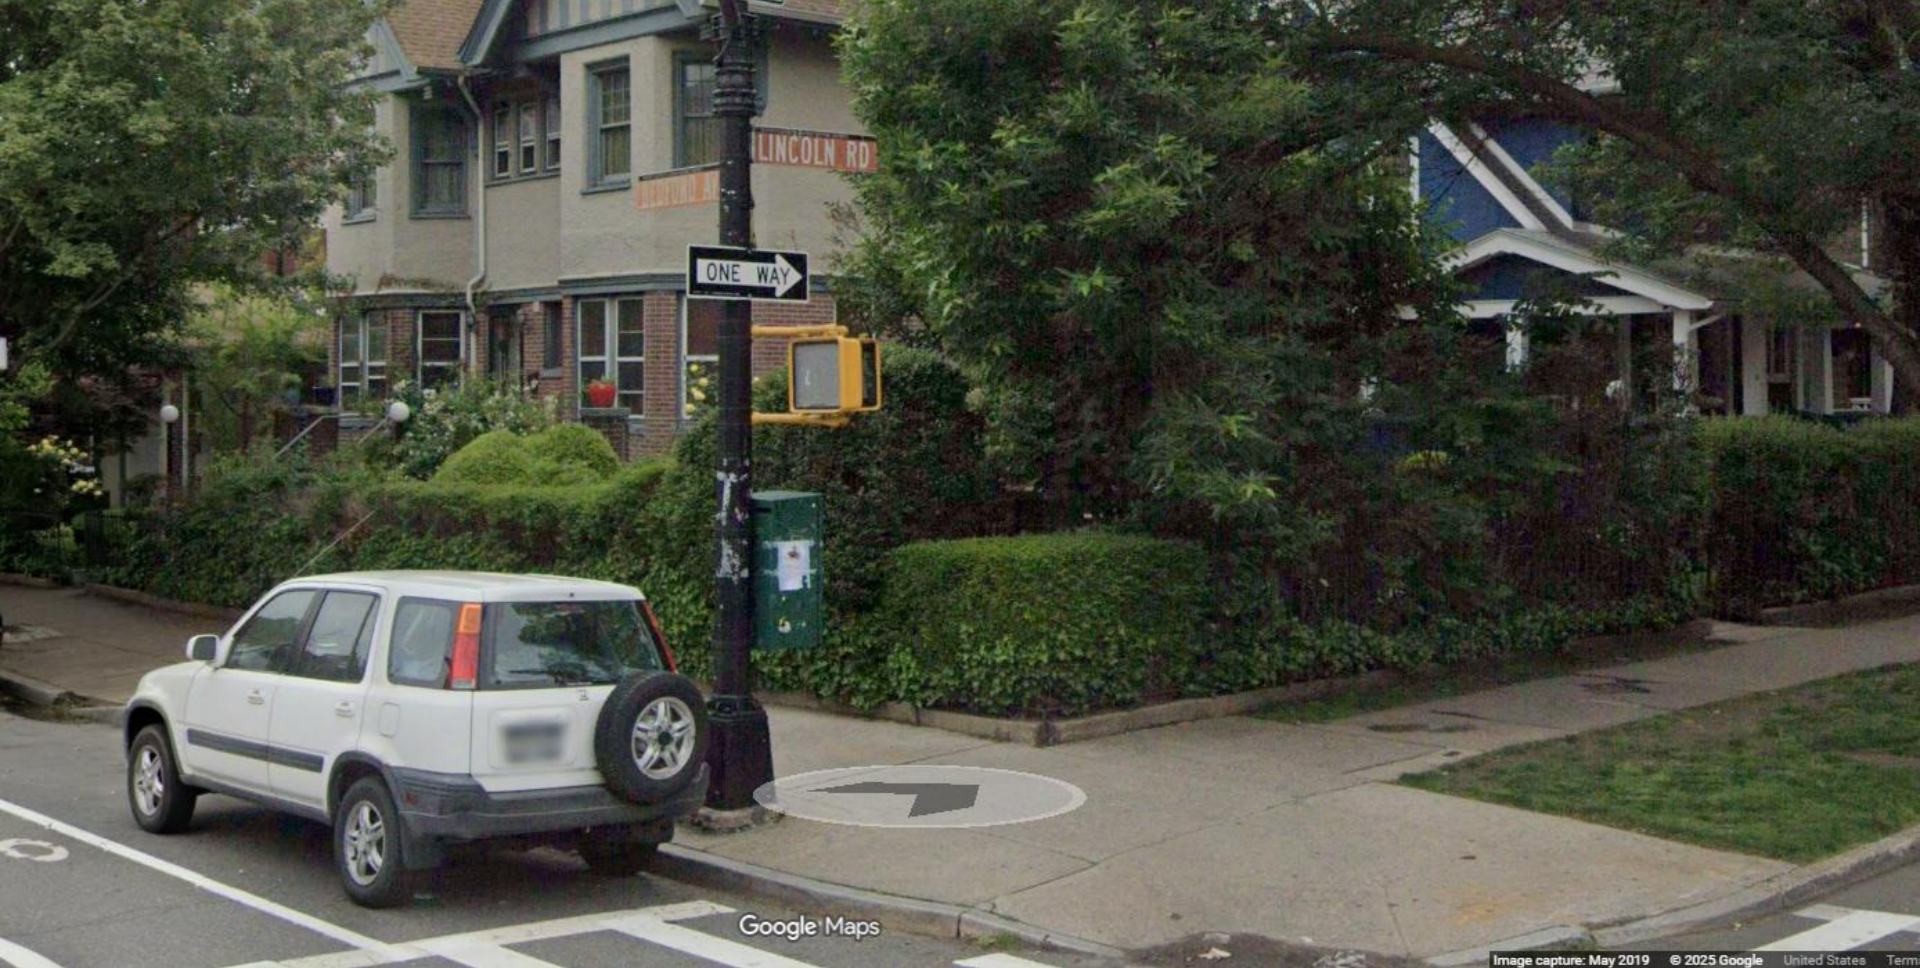
170 Lincoln Road at Bedford Avenue – SW corner

Three blocks north on Bedford Avenue: Type F – Mixed partial high fence on low curb

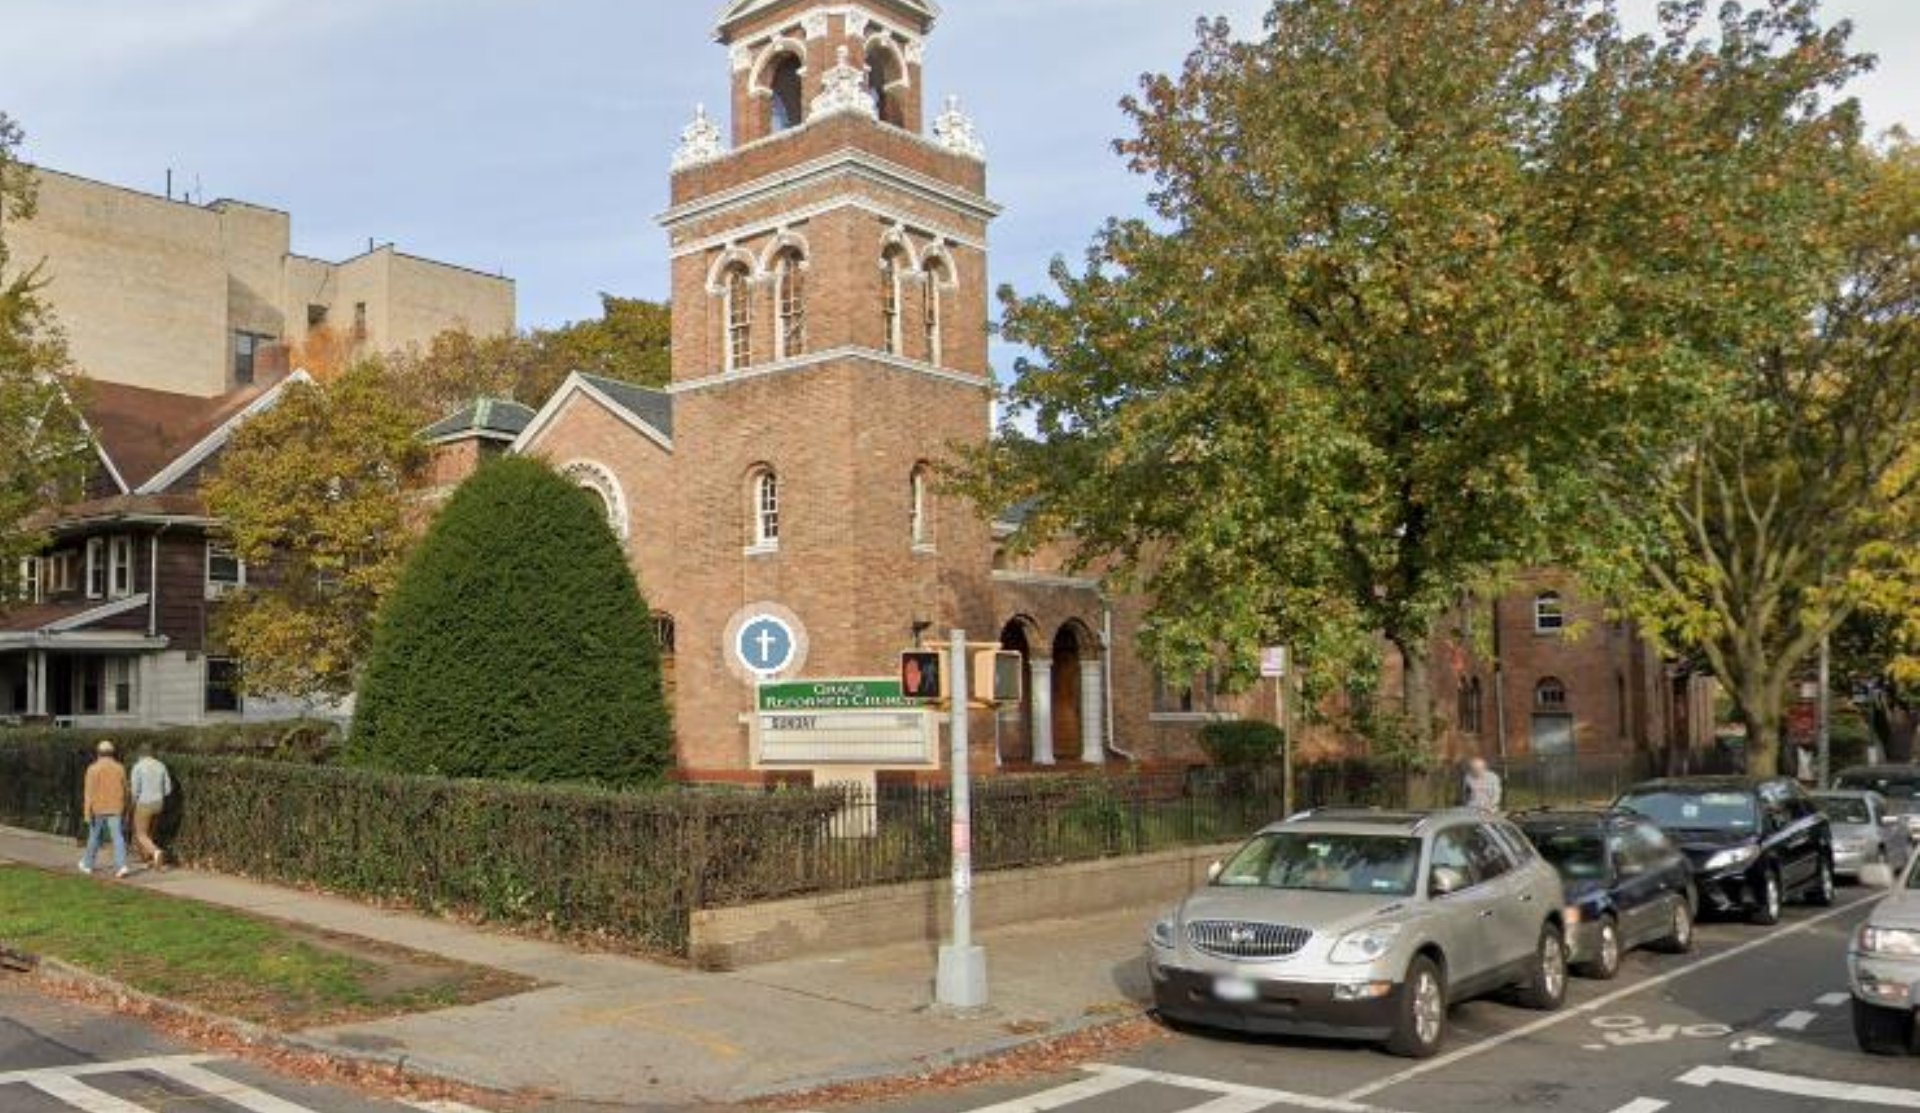
A-36

159 Lincoln Road at Bedford Avenue – NW corner

Three blocks north on Bedford Avenue: Type F – Mixed Fence on curb and fence w/o curb

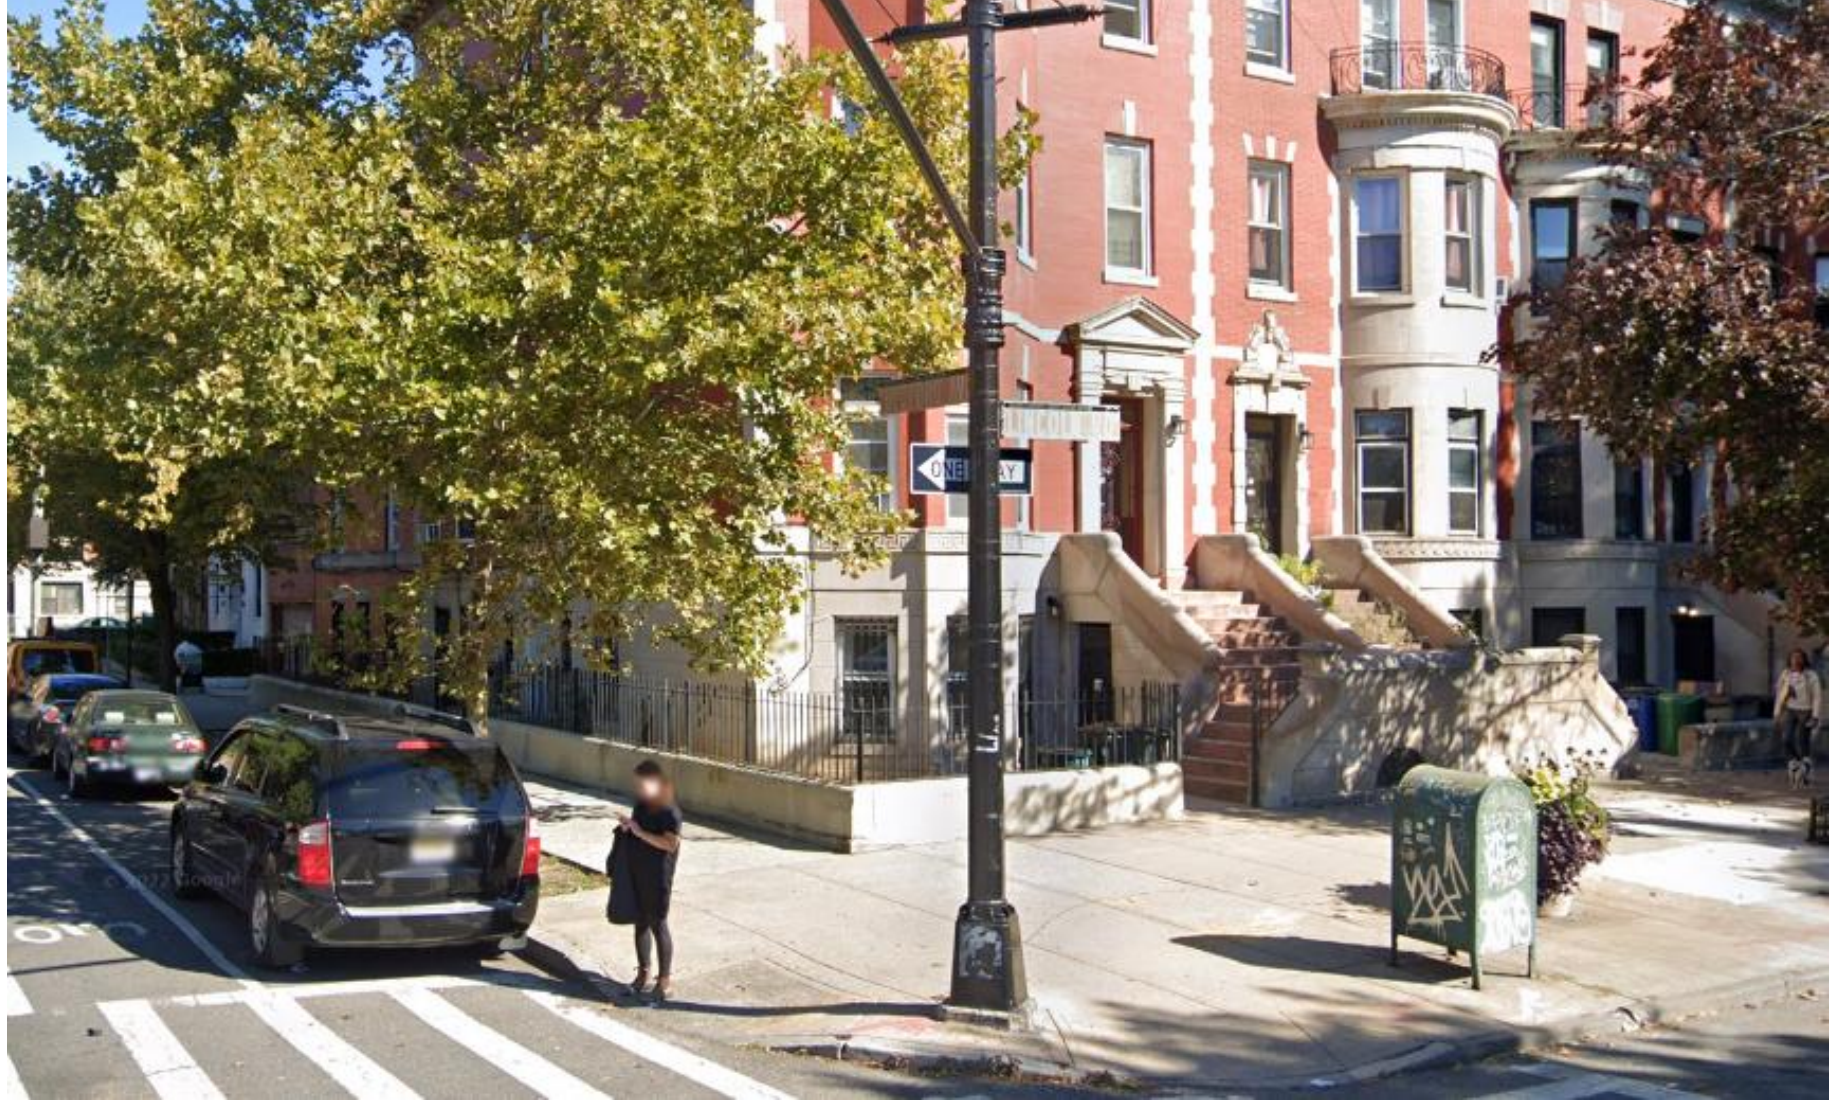
A-37

177 Lincoln Road at Bedford Avenue – NE corner

Three blocks north on Bedford Avenue: Type E – Fence on curb

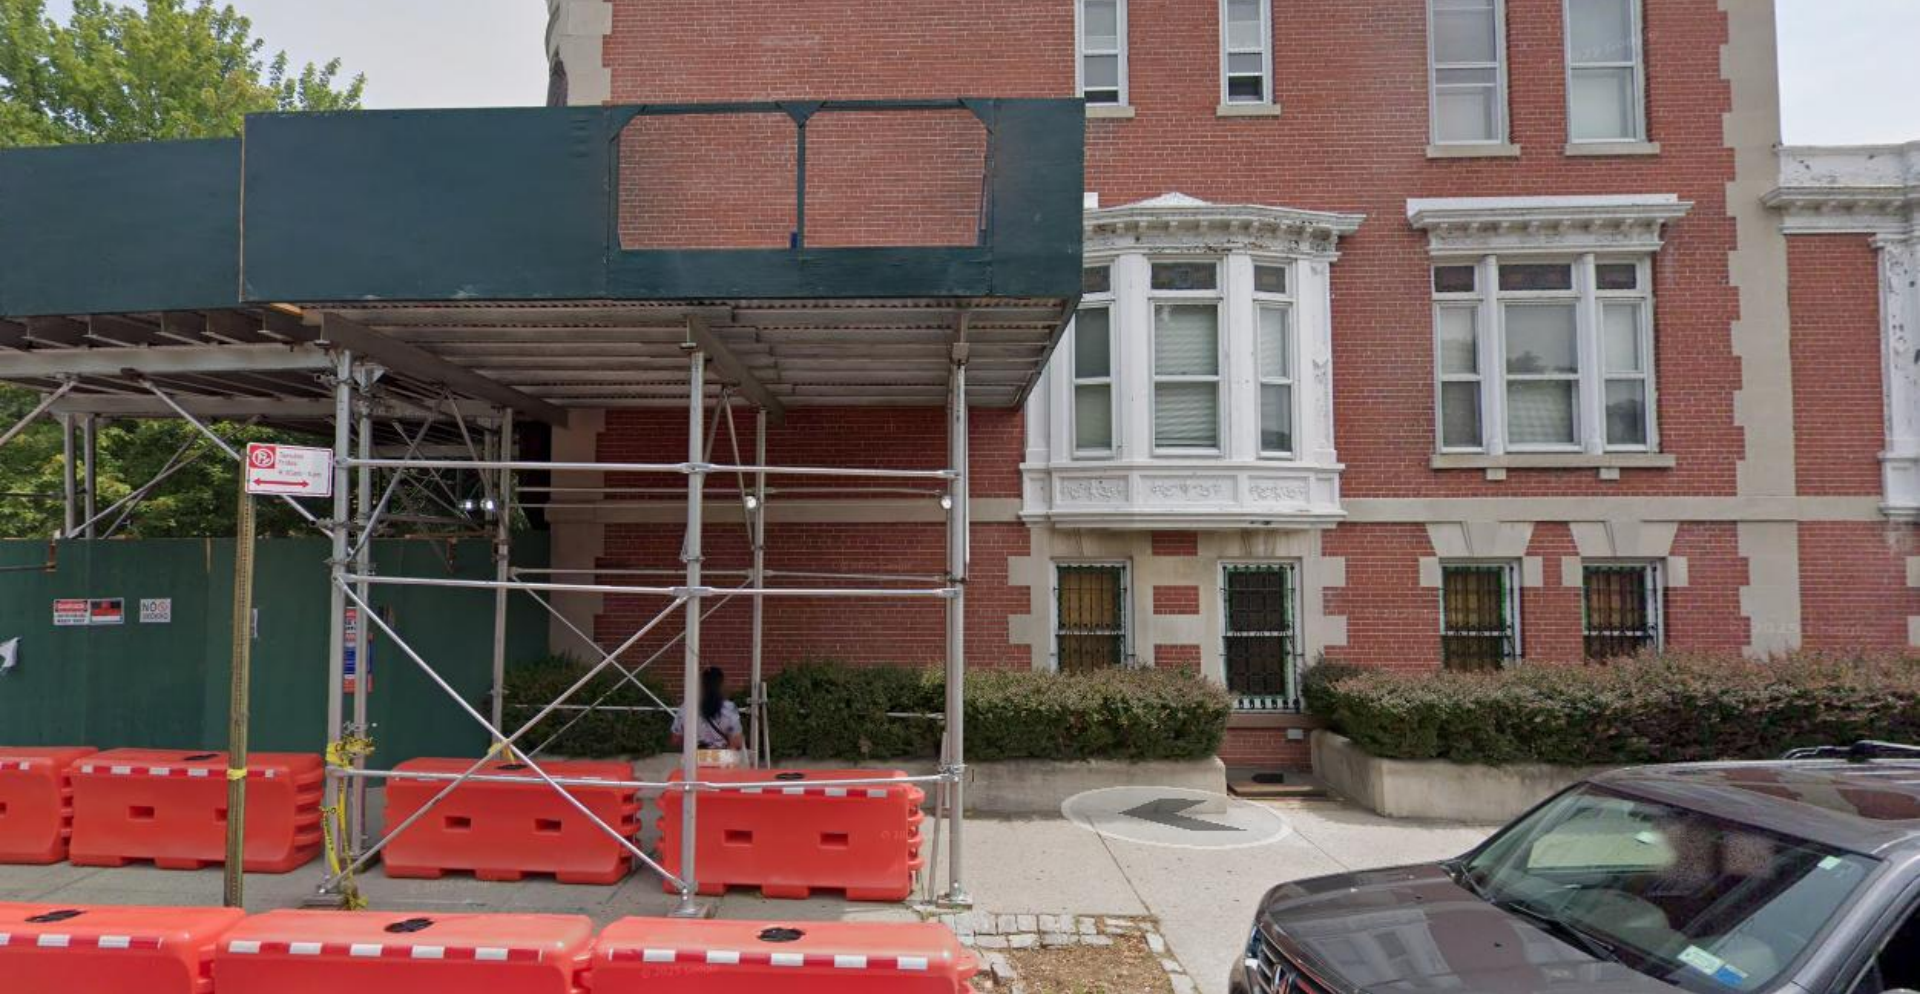
A-38

174 Lincoln Road at Bedford Avenue – SE corner

Three blocks north on Bedford Avenue: Type B – Curb, no Fence
