**Preservation Department – Item 2, LPC-26-02845**

**158 Remsen Street (aka 158-182 Remsen Street) – Brooklyn  
Union Gas Company Building – Individual Landmark  
Borough of Brooklyn**

# 176 REMSEN STREET

### Window Replacement Presentation

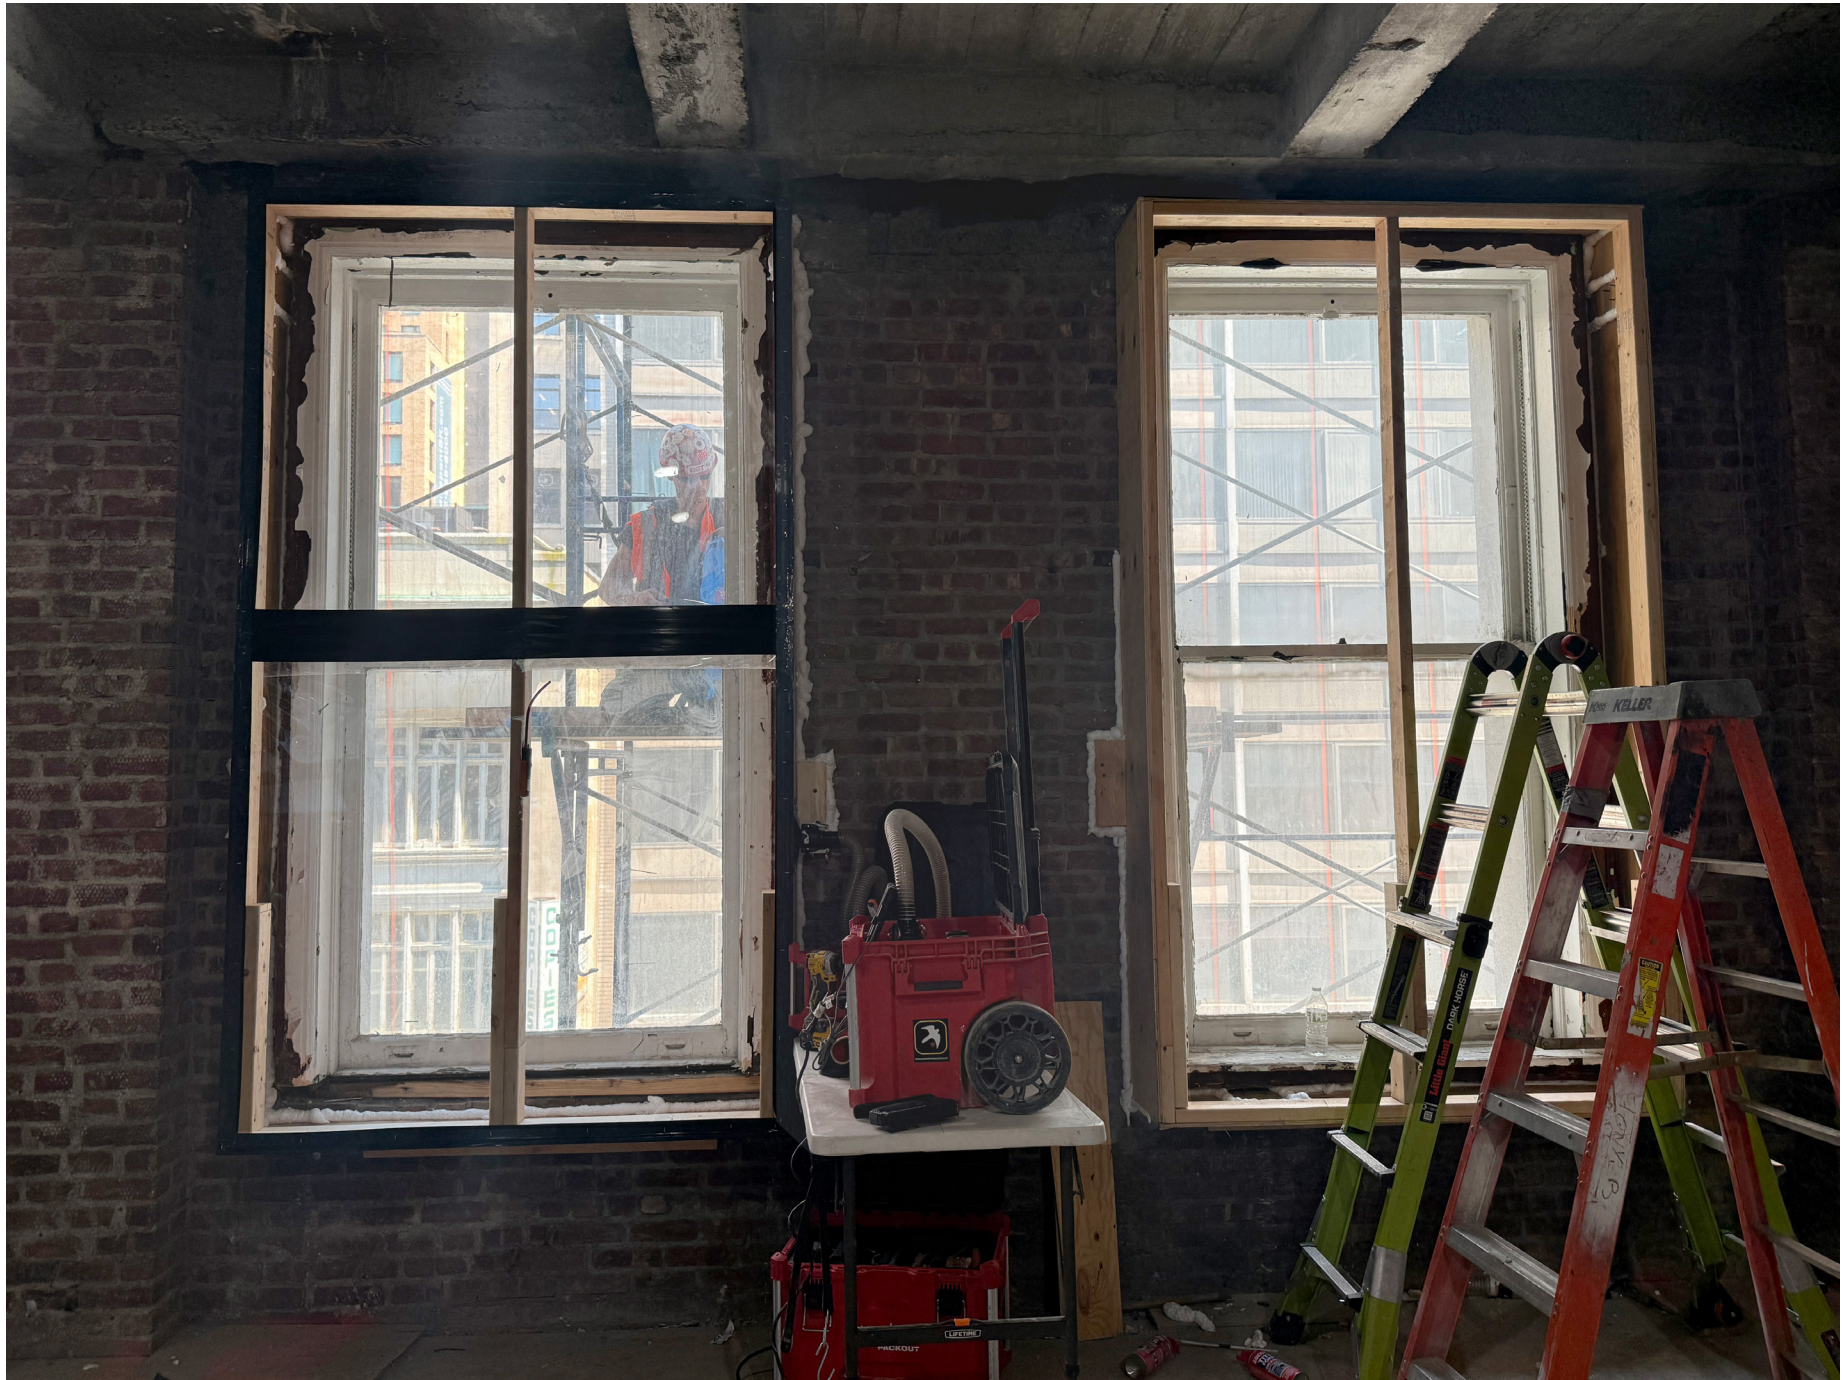
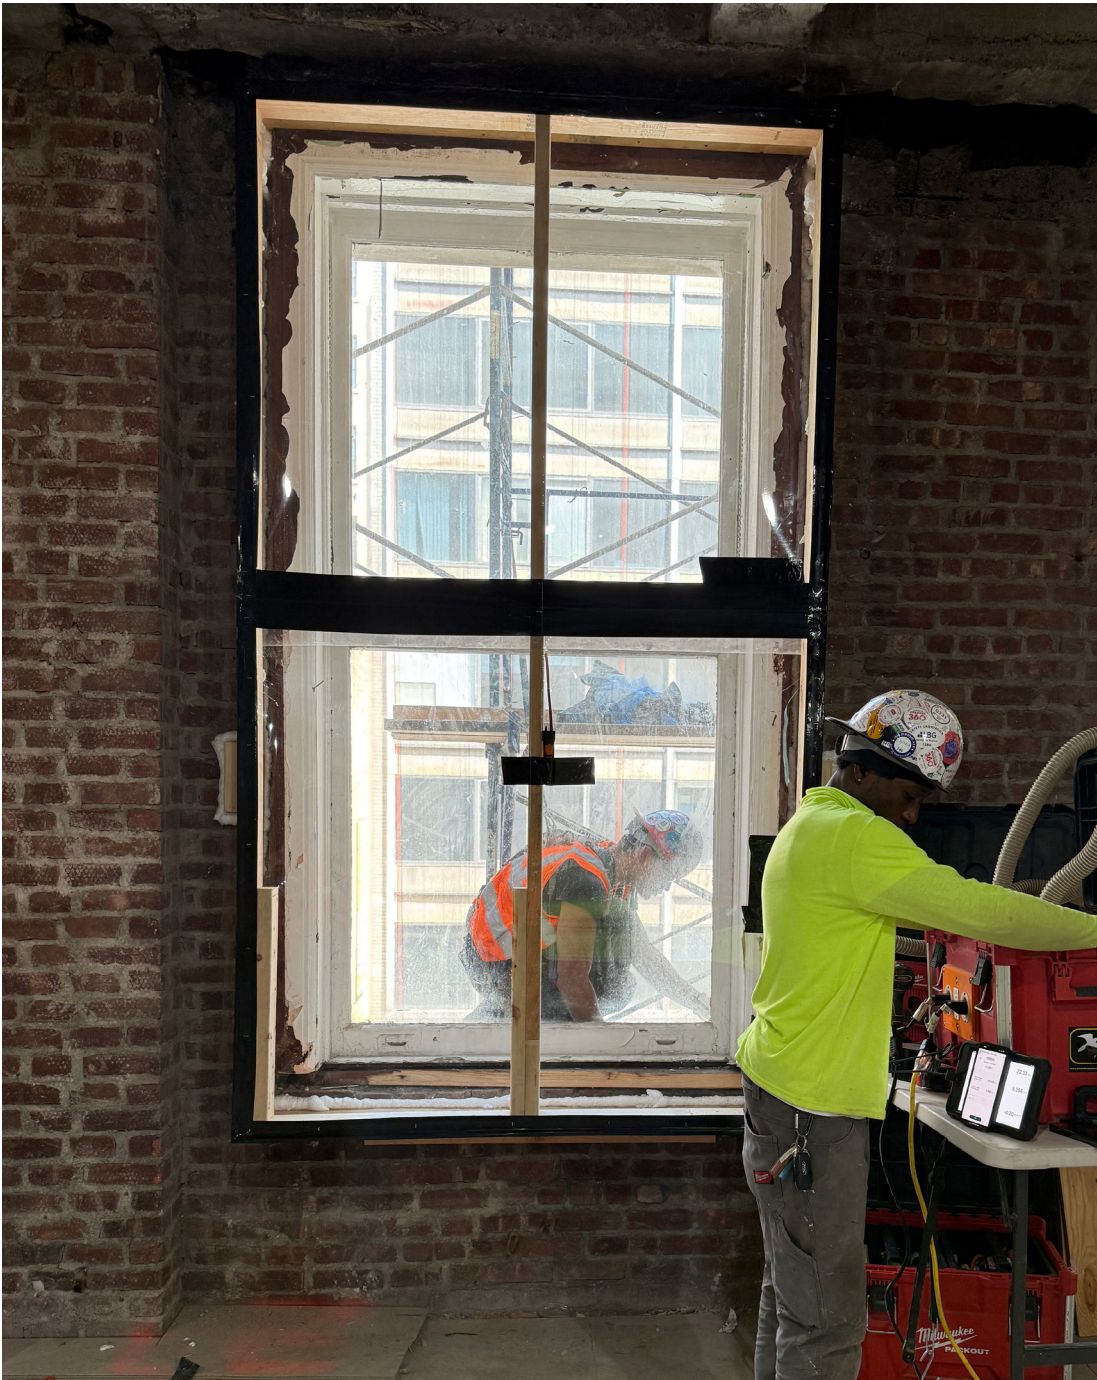
Two Typical Windows Tested

Air Infiltration Testing  
(Building Envelope Testing LLC, ASTM E783 Field Test, 7/25/25)

- Both windows failed to meet minimum requirements for residential construction:
- First window: air leakage reading was 93.68 CFM (acceptable reference for a new window of this size is 14.28 CFM)
  - Second window: air leakage was so significant that the chamber could not meet minimum required pressure to perform the test.
