Preservation Department – Item 9, LPC-25-09313

768 Fifth Avenue – The Plaza Hotel – Individual and Interior Landmark Borough of Manhattan

The Plaza Private Residences

Canopy & Lobby Renovations

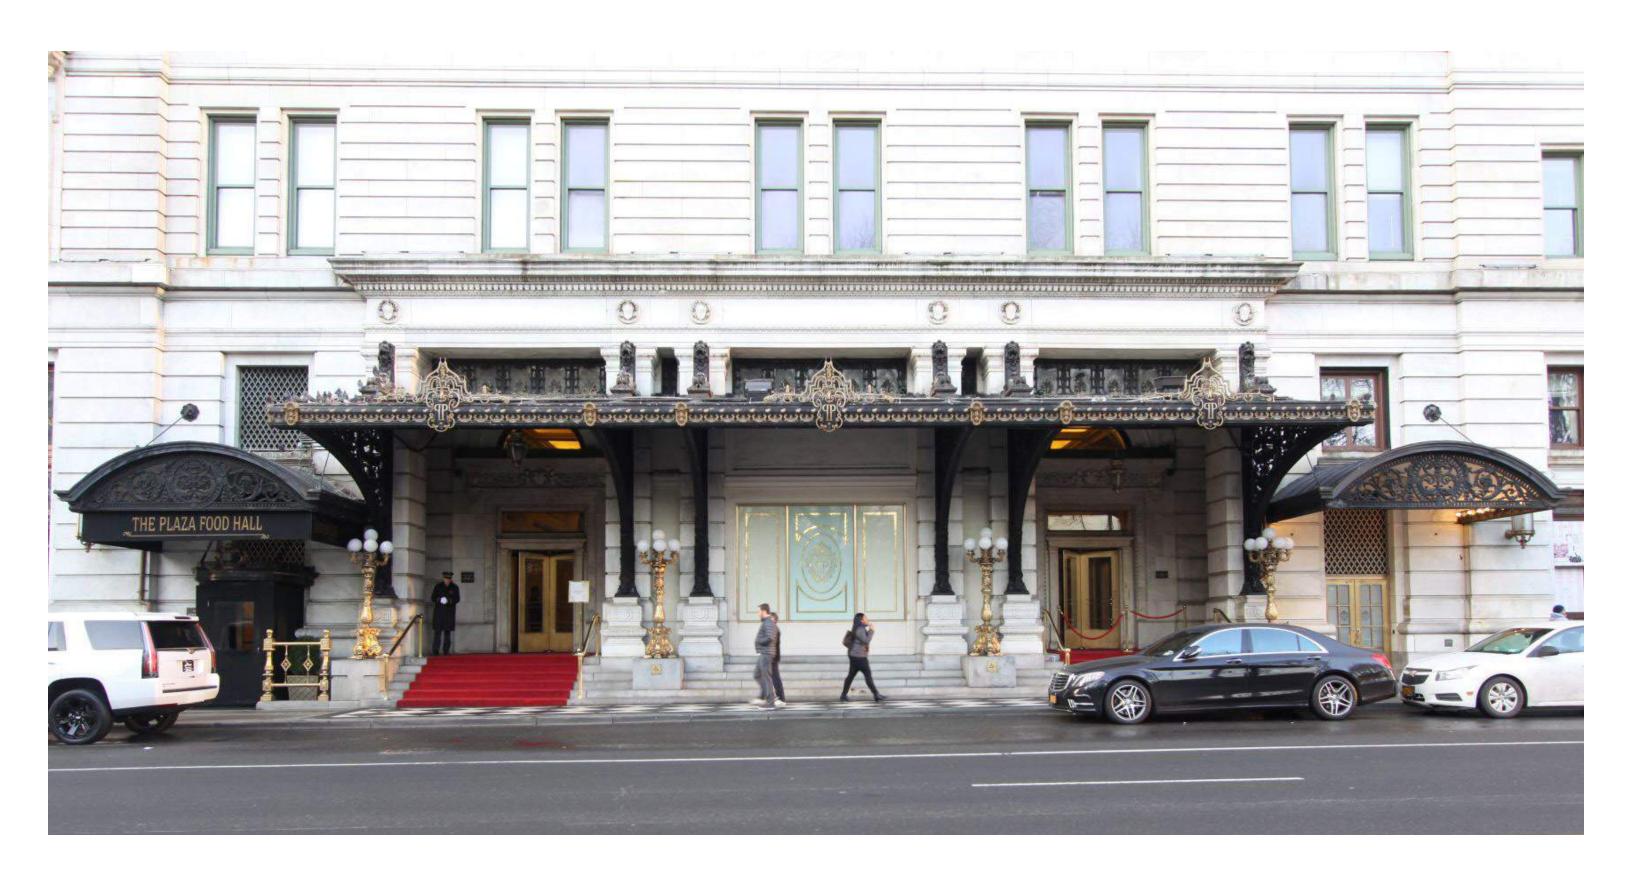
Existing Conditions - Entry & Canopy (2025)

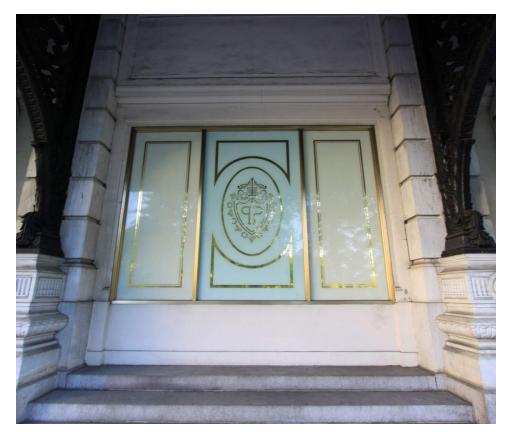
Mail Room Enclosure

- Remove non-historic mailroom enclosure
- Remove non-historic stair railings

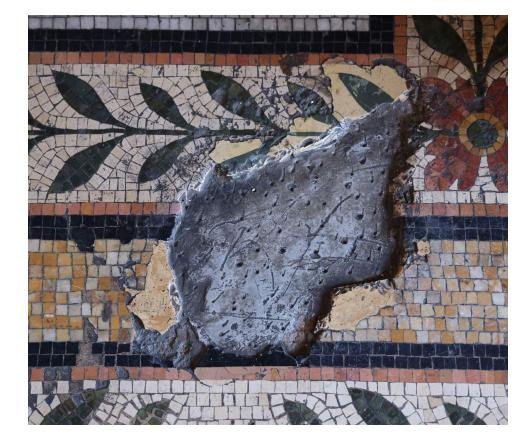
Damaged Exterior Mosaic

- New wood entry door and vestibule
- New bronze handrails
- Restore stone door surround
- Restore mosaic floor tile at entry

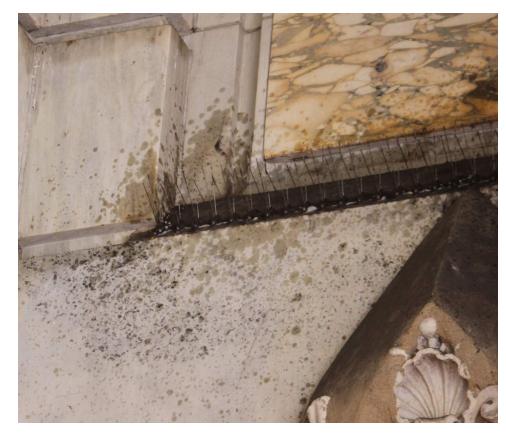
Stone Staining

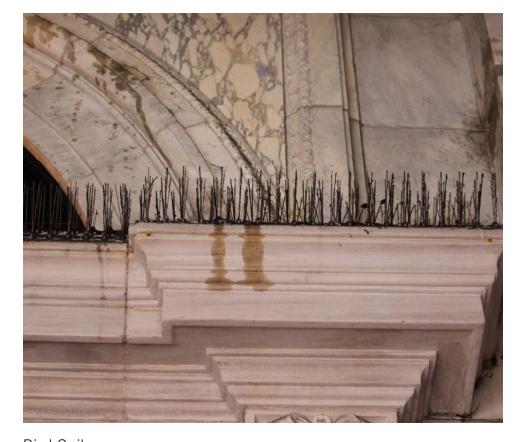
Bird Spikes

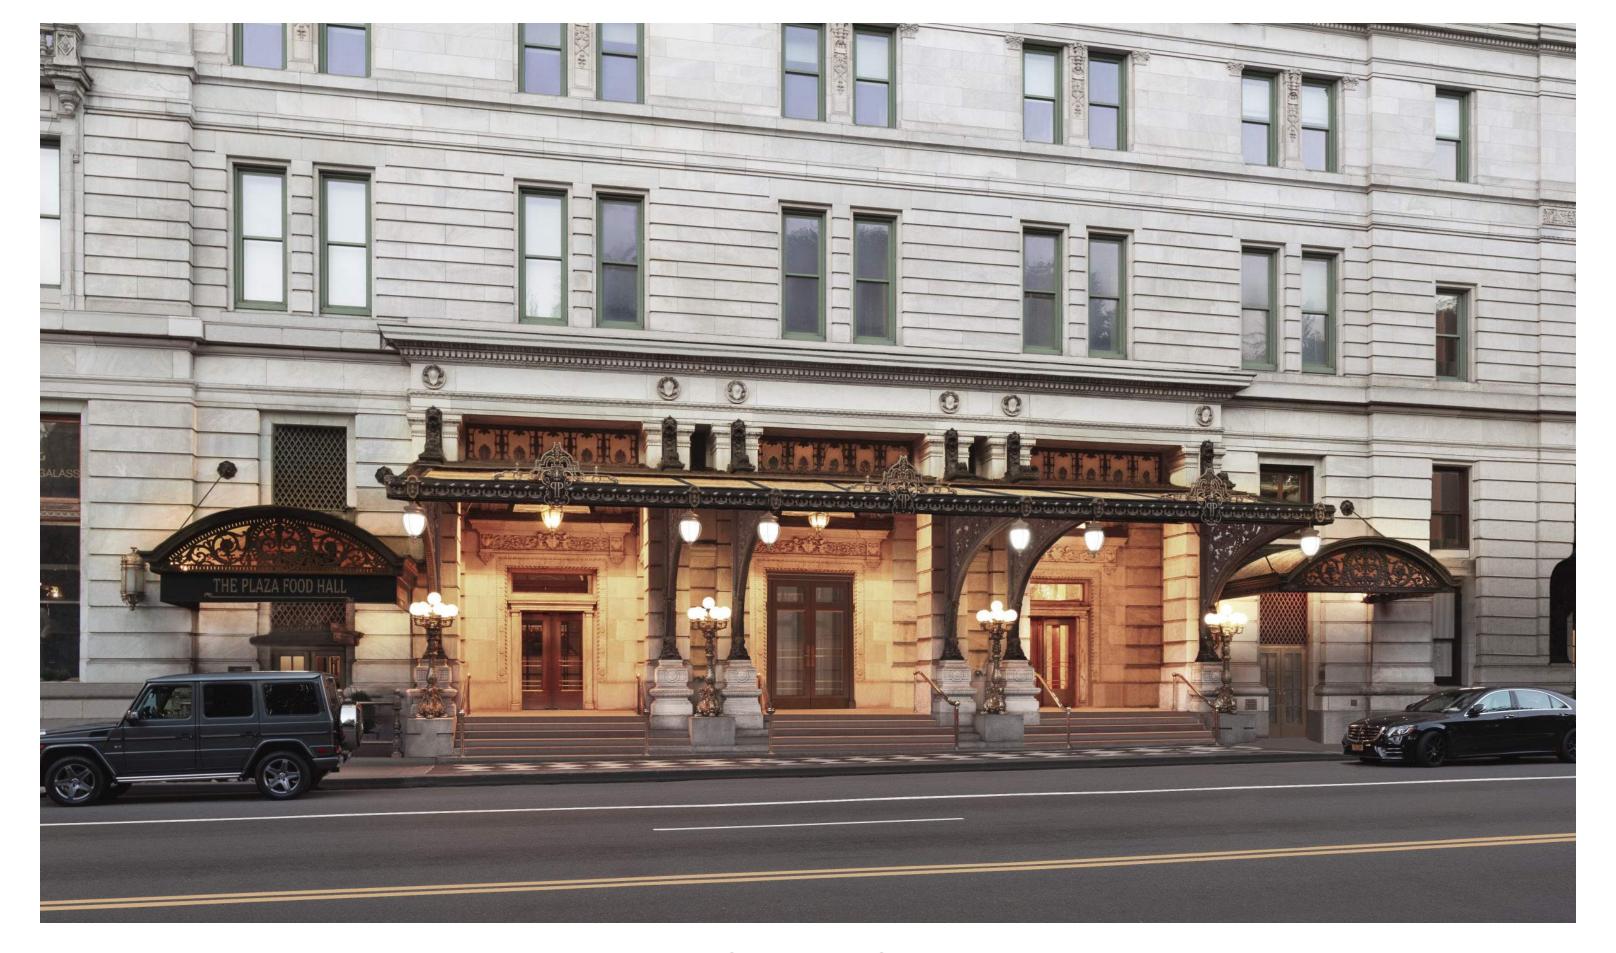
Proposed Central Park South Entry

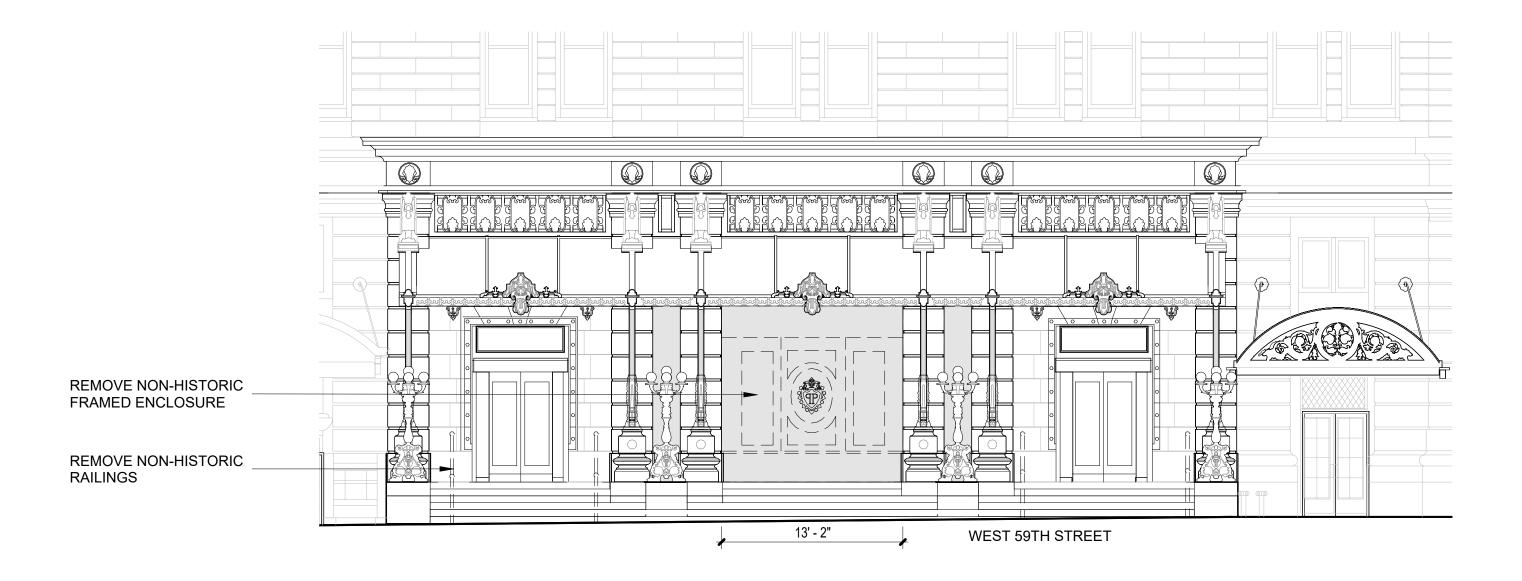
Demolition Central Park South Entry

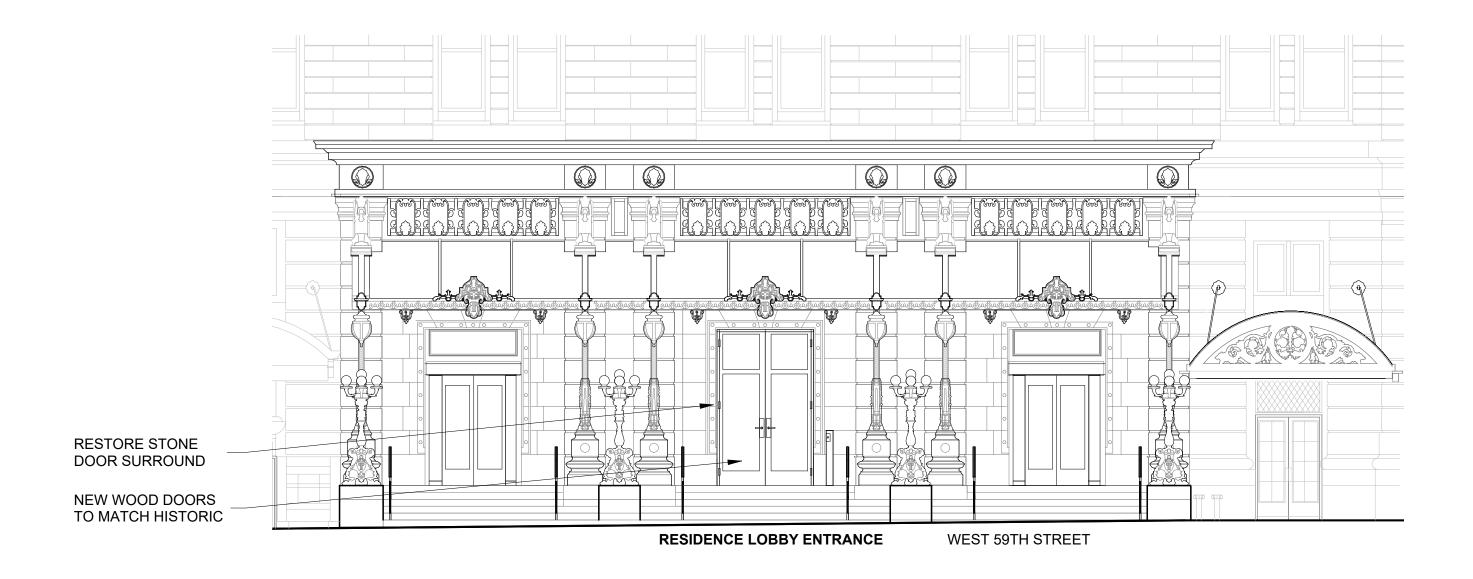
Proposed Central Park South Entry

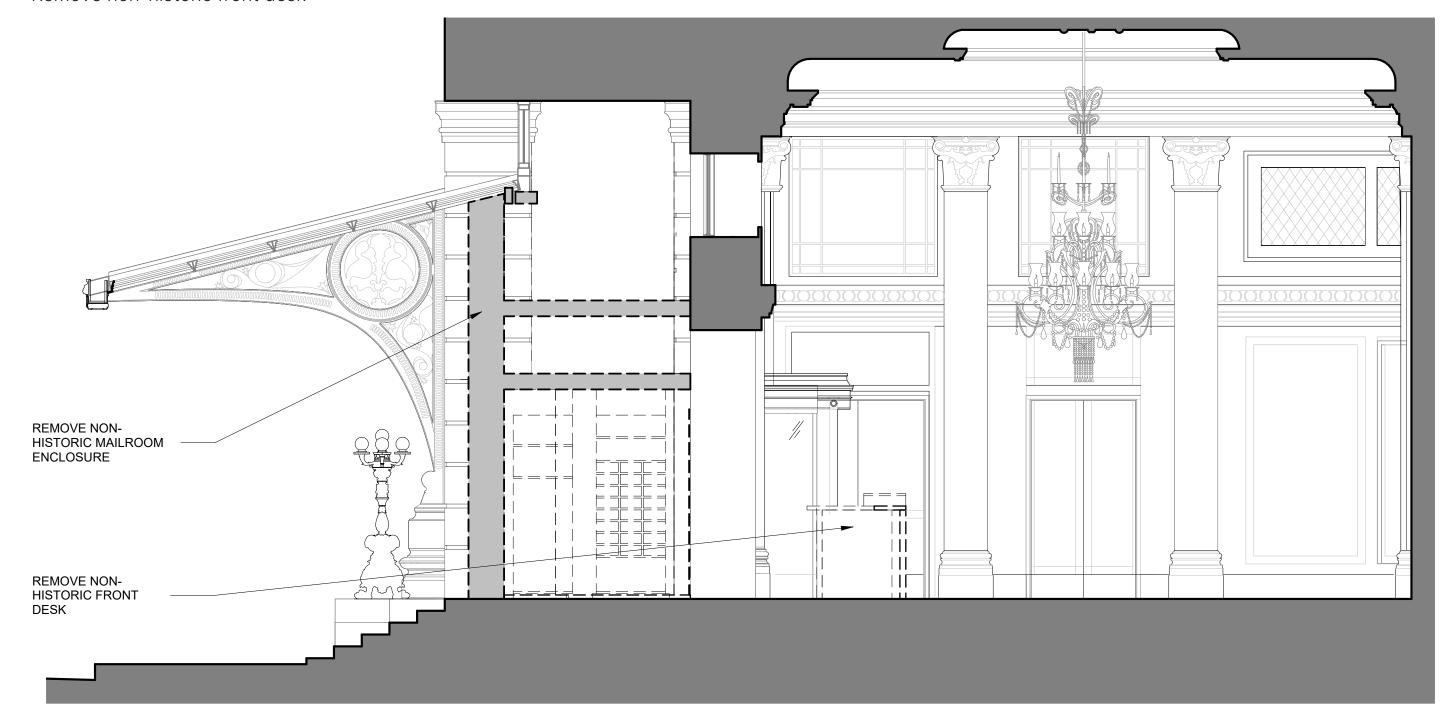
- Remove non-historic mailroom enclosure
- Remove non-historic stair railings
- Remove non-historic front desk

Demolition Cross Section

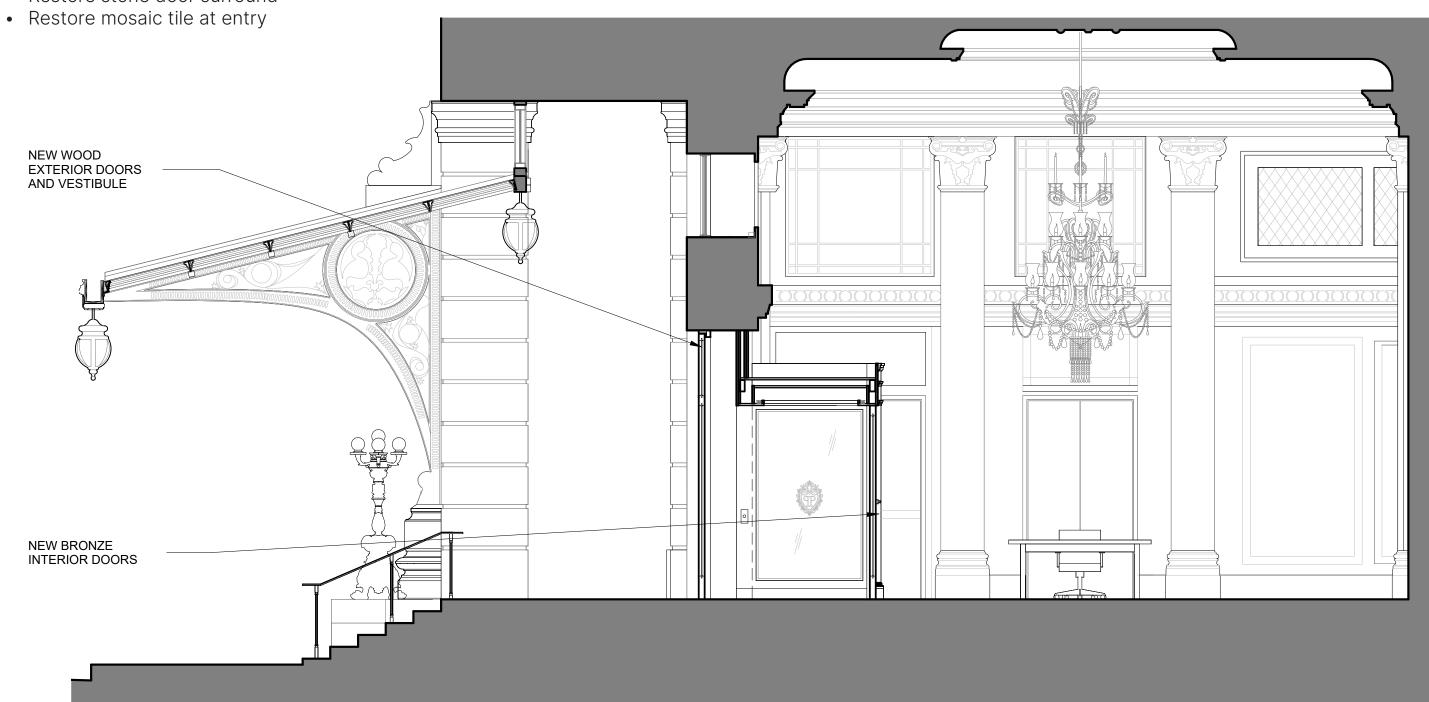
- New wood entry door and vestibule
- New bronze handrails
- Restore stone door surround

Proposed Cross Section

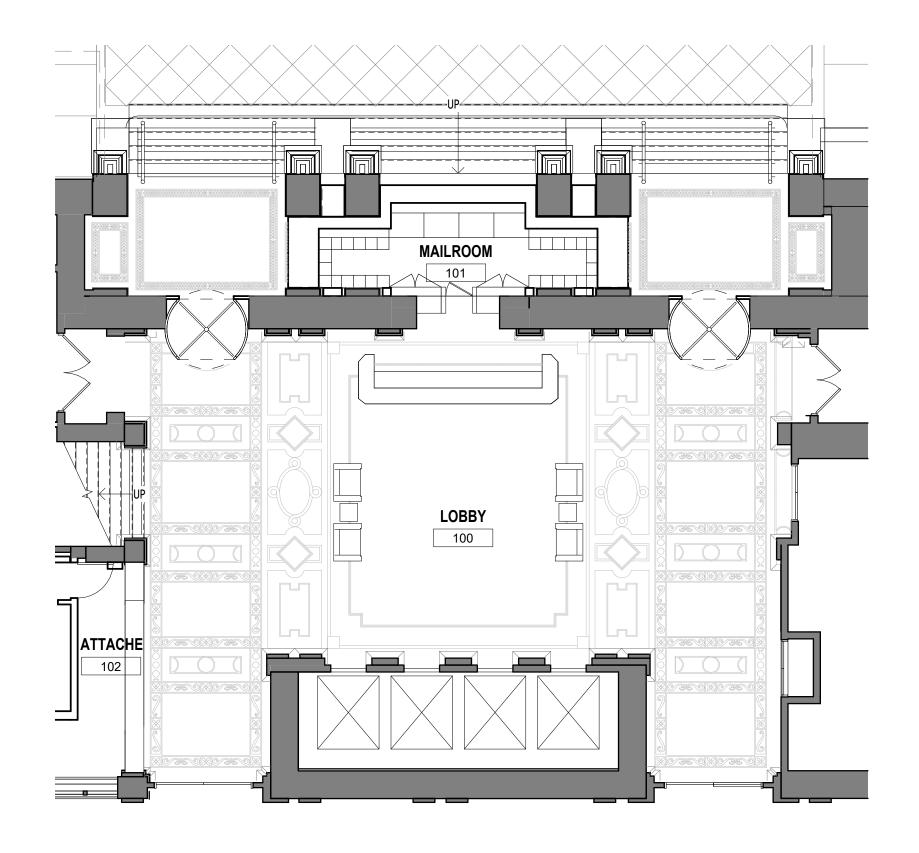
Existing Floor Plan

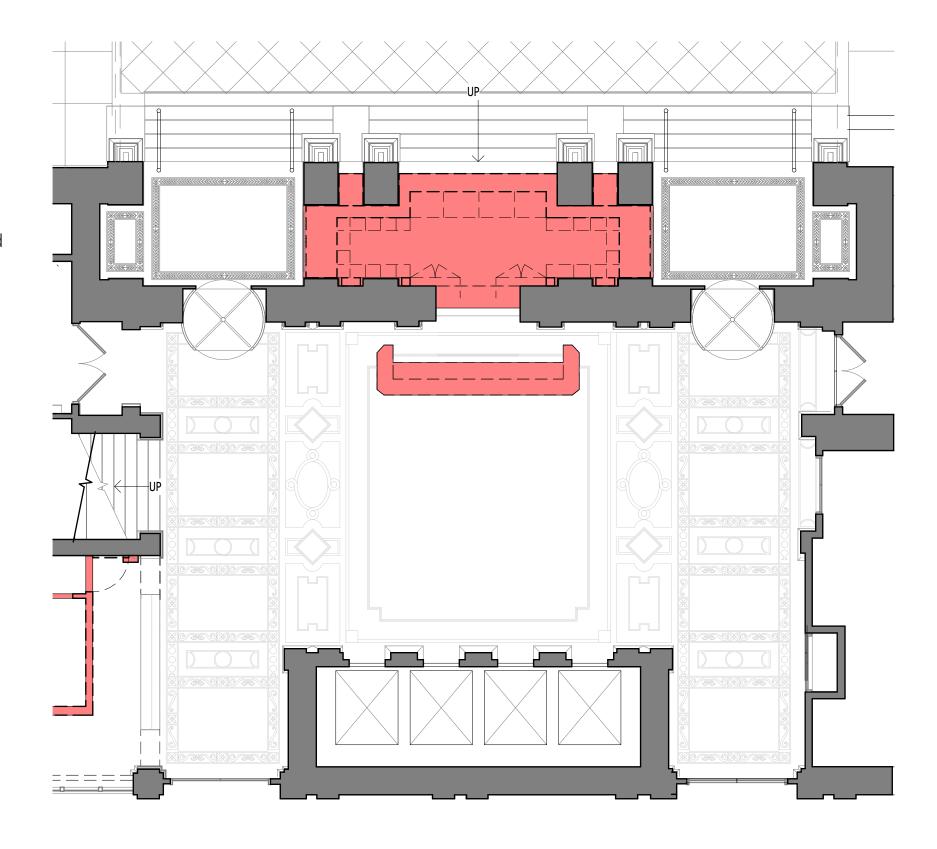
- Remove and dispose of non-historic mailroom enclosure
- Remove and dispose of non-historic front desk

- Selective removal and salvaging of stone desk paneling for modification and re-installation
- Removal of non-historic faux painted panel wall

Residential Lobby - Selective Demolition

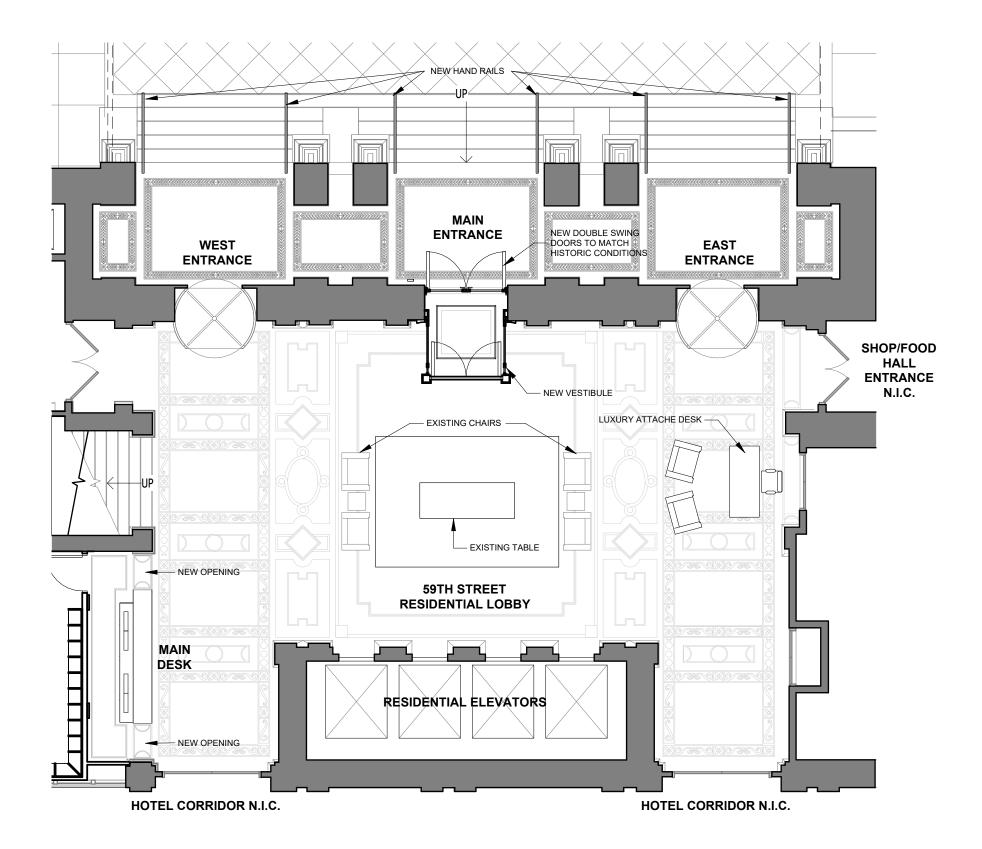
- New exterior wood and glass double doors (to match historic)
- New wood and glass vestibule with bronze clad interior doors
- Restore mosaic flooring at entry

- Modify desk using salvaged historic stone
- New stone wall paneling behind and above desk
- New mosaic flooring behind desk

Residential Lobby - Proposed Plan

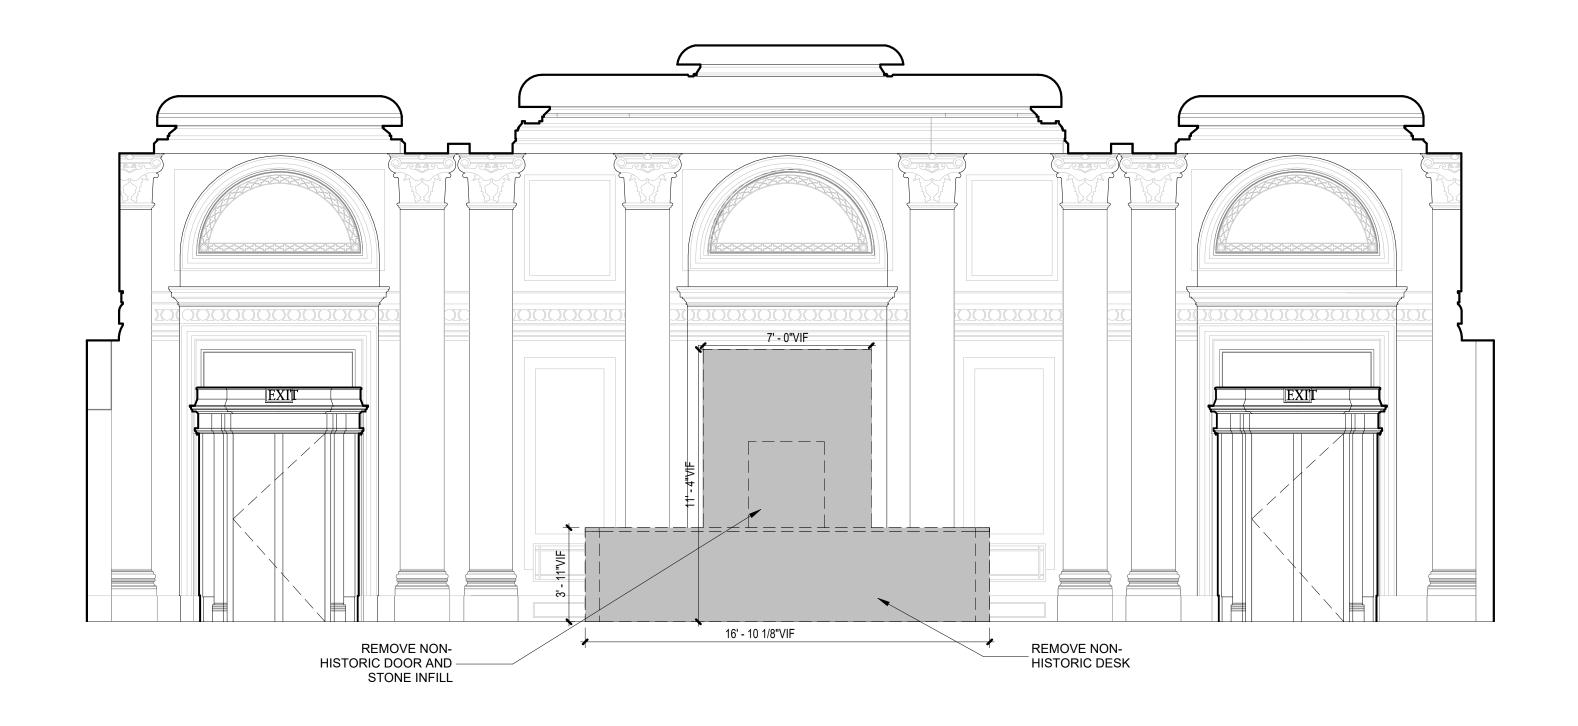
Demolition Entry Interior Elevation

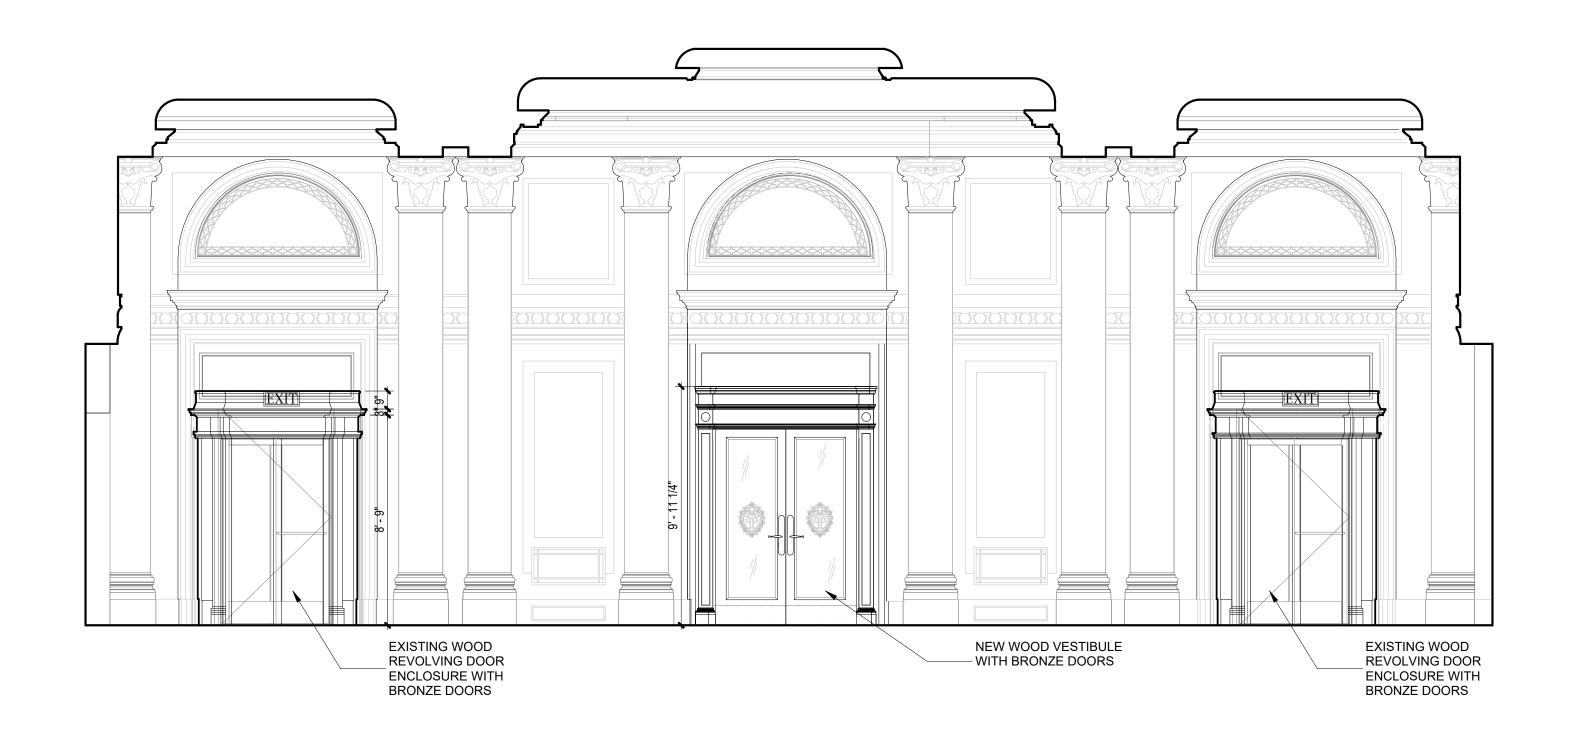
Proposed Entry Interior Elevation

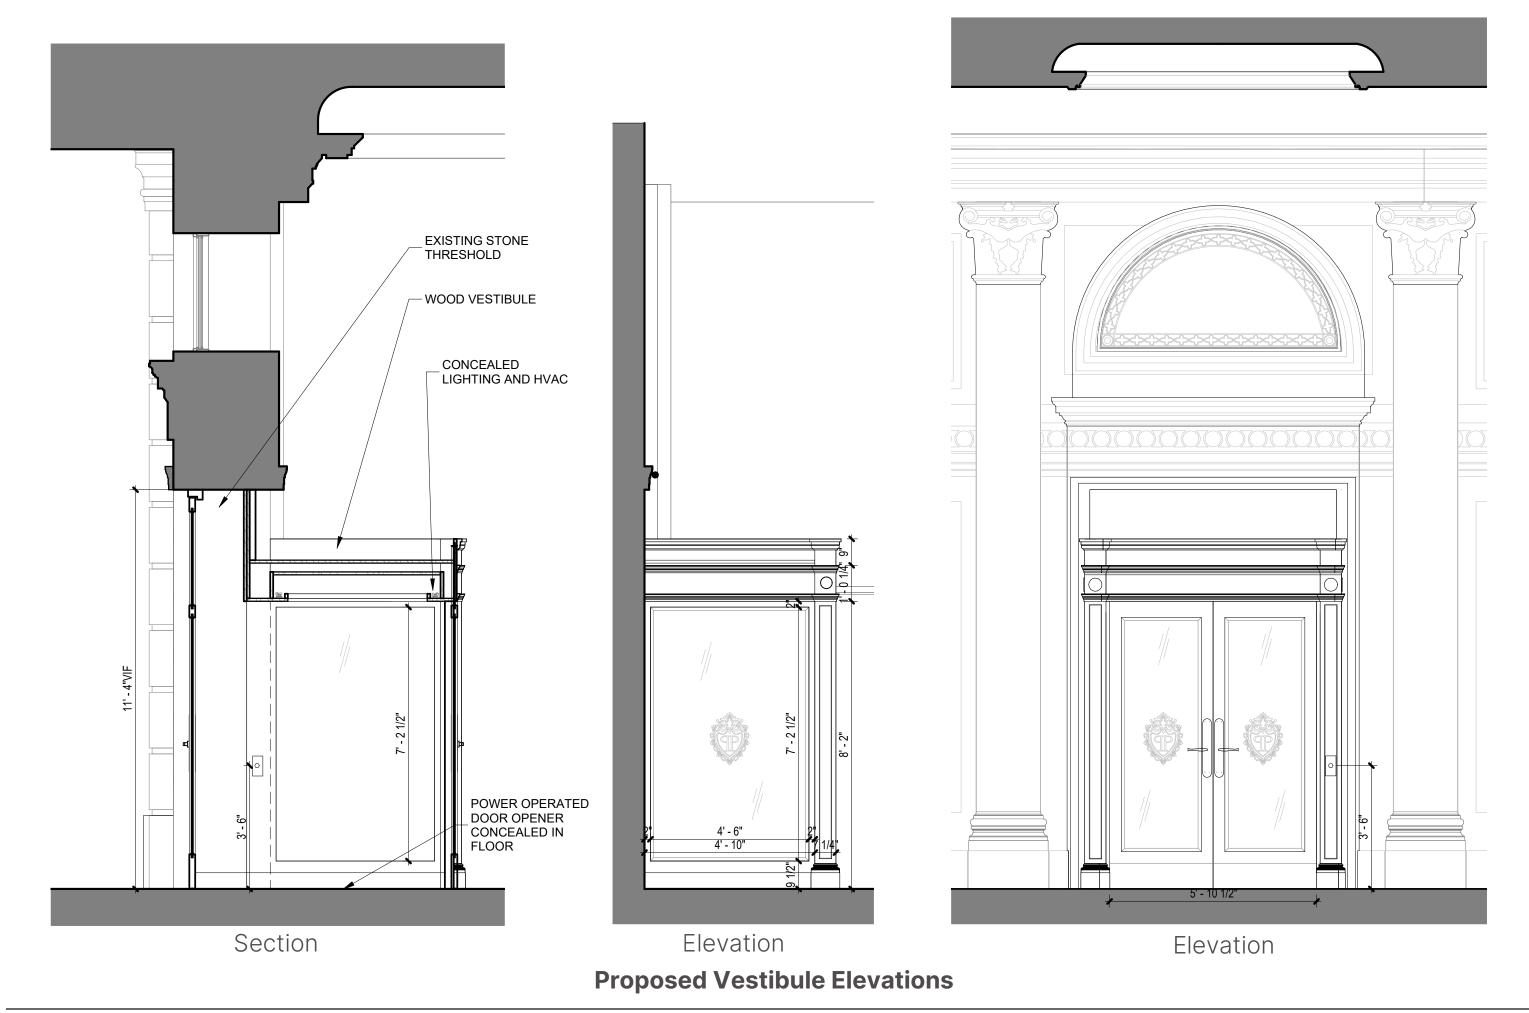
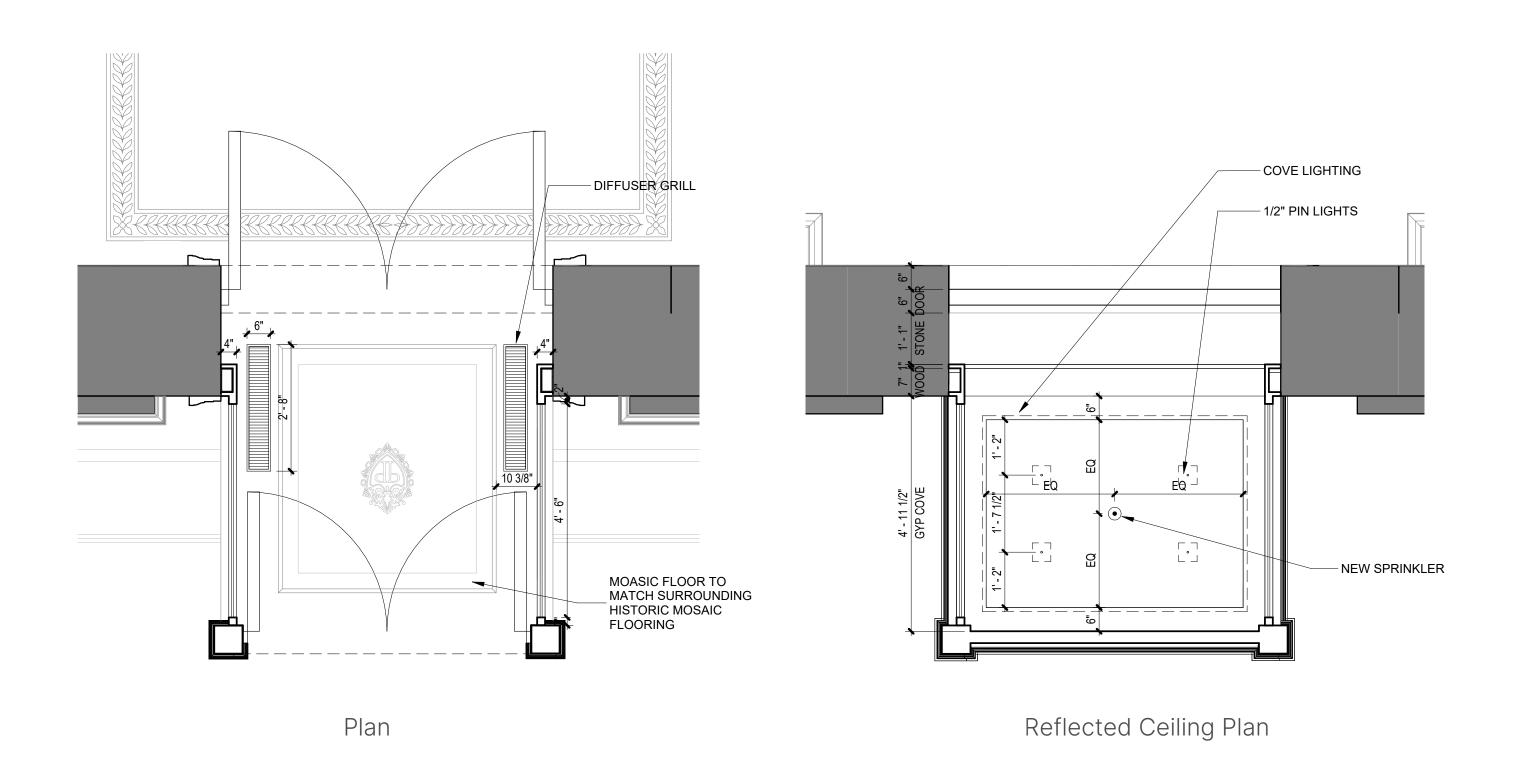
Proposed Vestibule Plan & RCP

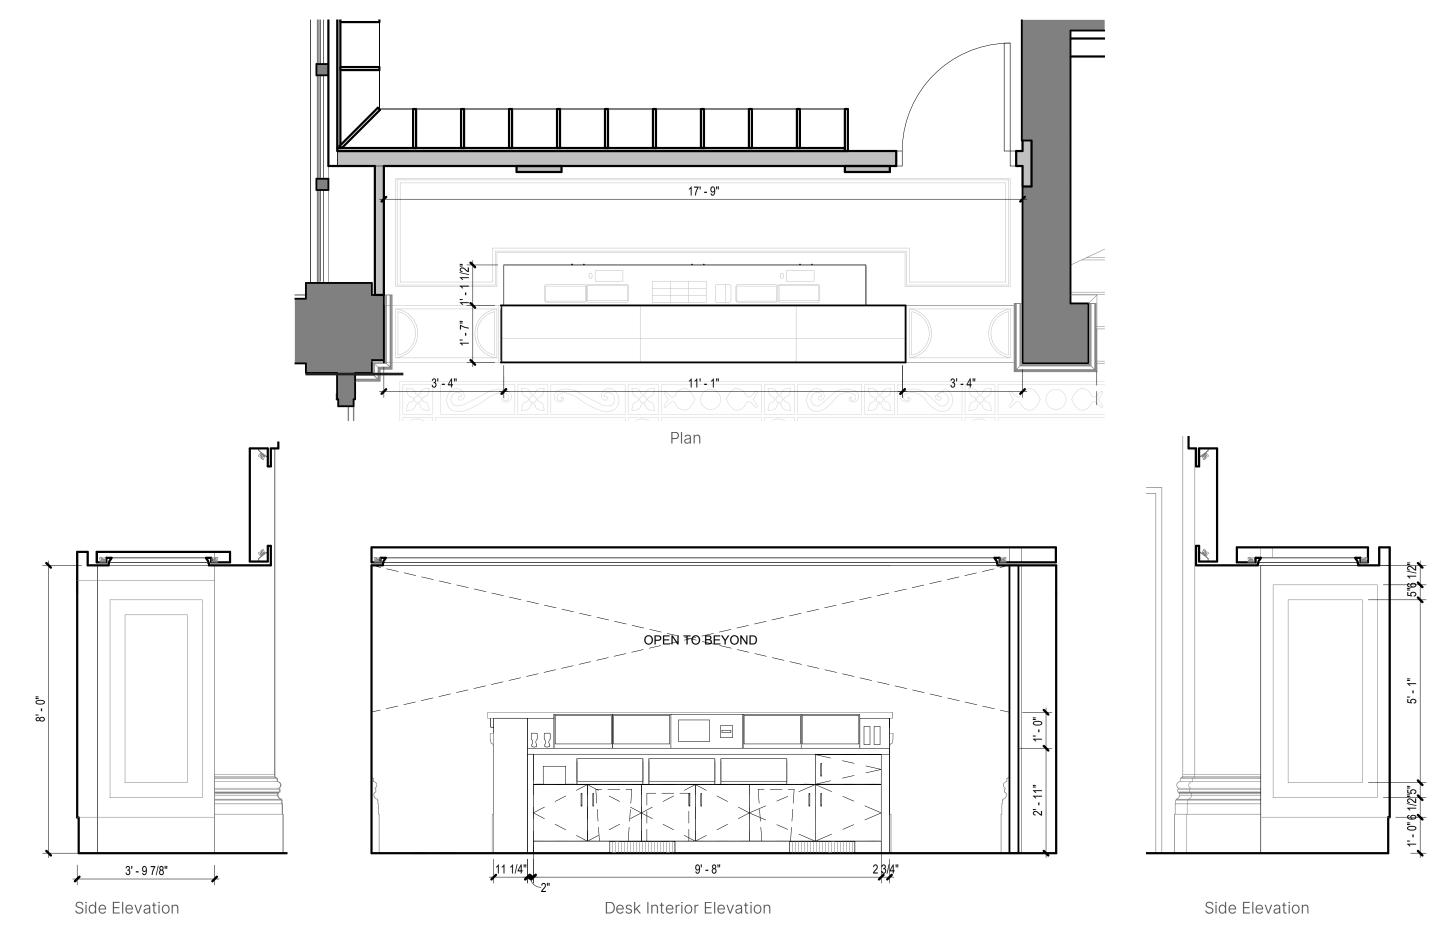
Proposed Front Desk Area Plan & Elevations

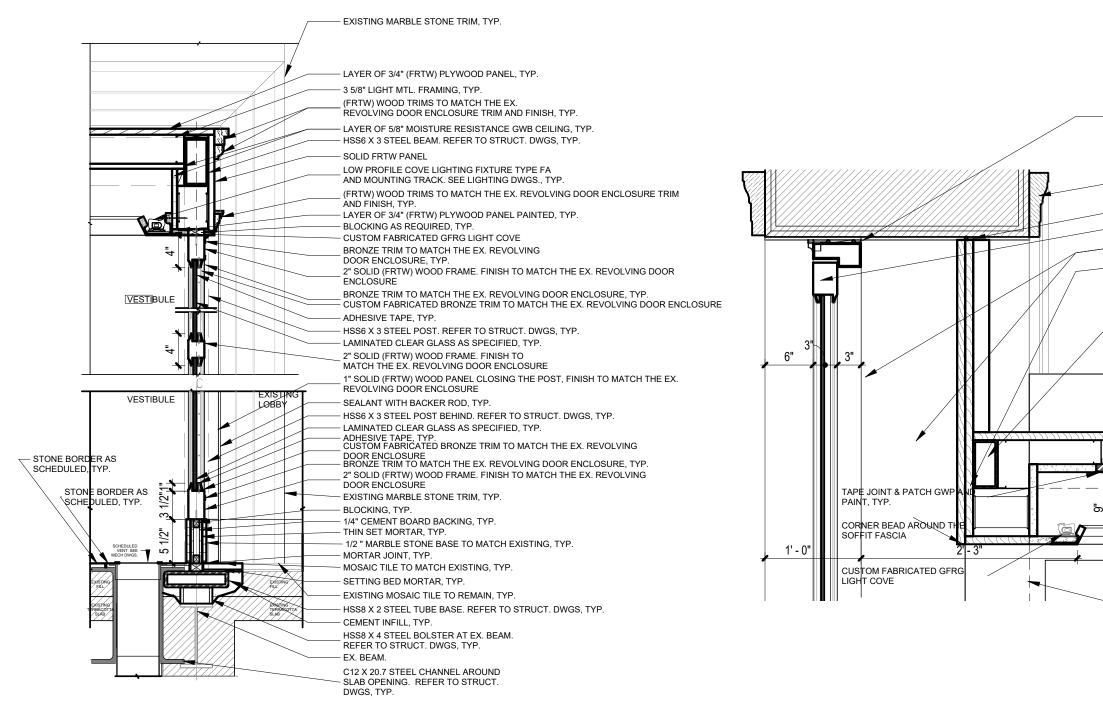
EXISTING MARBLE STONE TRIM, TYP. SEALANT AND BACKER ROD, TYP. DOOR & FRAME (WOOD, FINISH TO MATCH REVOLOVING DOORS) AS SCHEDULED. PROVIDE DUTCHMAN REPAIRS AT EXISTING STONE HEADER & SURROUND AS REQUIRED (2) LAYERS OF 3/4" MARBLE PANEL HSS6 X 3 STEEL BEAM REFER TO STRUCT. DWGS, TYP. LIGHTING FIXTURE TYPE FB, TYP. LIGHTING MOUNTING BOARD/BRACKET, TYP. 3 5/8" LIGHT MTL. FRAMING, TYP. LAYER OF 3/4" (FRTW) PLYWOOD PANEL, TYP. LAYER OF 5/8" MOISTURE RESISTANCE GWB CEILING, TYP. (FRTW) WOOD TRIMS TO MATCH THE EX. REVOLVING DOOR ENCLOSURE TRIM AND HSS6 X 3 STEEL BEAM. REFER TO STRUCT. LAYER OF 3/4" (FRTW) PLYWOOD PANEL, TYP. LOW PROFILE COVE LIGHTING FIXTURE TYPE FA AND MOUNTING TRACK. SEE LIGHTING DWGS., TYP. (FRTW) WOOD TRIMS TO MATCH THE EX. REVOLVING DOOR ENCLOSURE TRIM AND FINISH, TYP. LAYER OF 3/4" (FRTW) PLYWOOD PANEL PAINTED, TYP. 3" SOLID (FRTW) BRONZE CLADDED WOOD DOOR, BRONZE FACING INTERIOR LOBBY, FINISH TO MATCH THE EX. REVOLVING DOOR. REFER TO DOOR SCHEDULE POST BEHIND. SEE STRUCT. DWGS., TYP. LAMINATED CLEAR GLASS AS SPECIFIED, TYP. HSS6 X 3 STEEL POST BEHIND. REFER TO

Vestibule Frame Base & Ceiling

Vestibule Proposed Section Callout

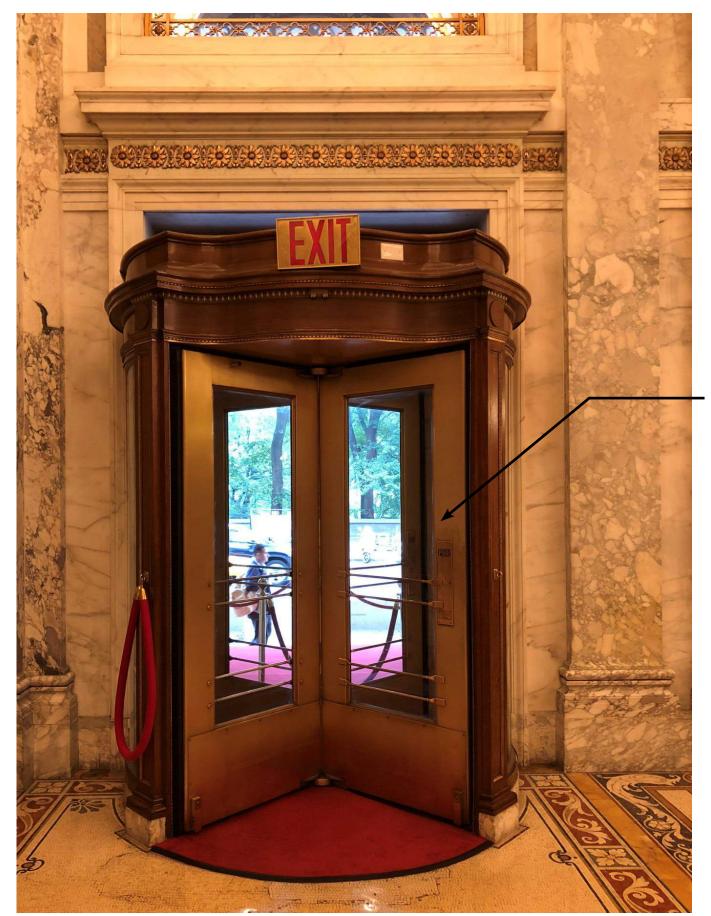
Bronze revolving doors -

Bronze doors with wood frame

Wood frieze detail

Revolving Door Details

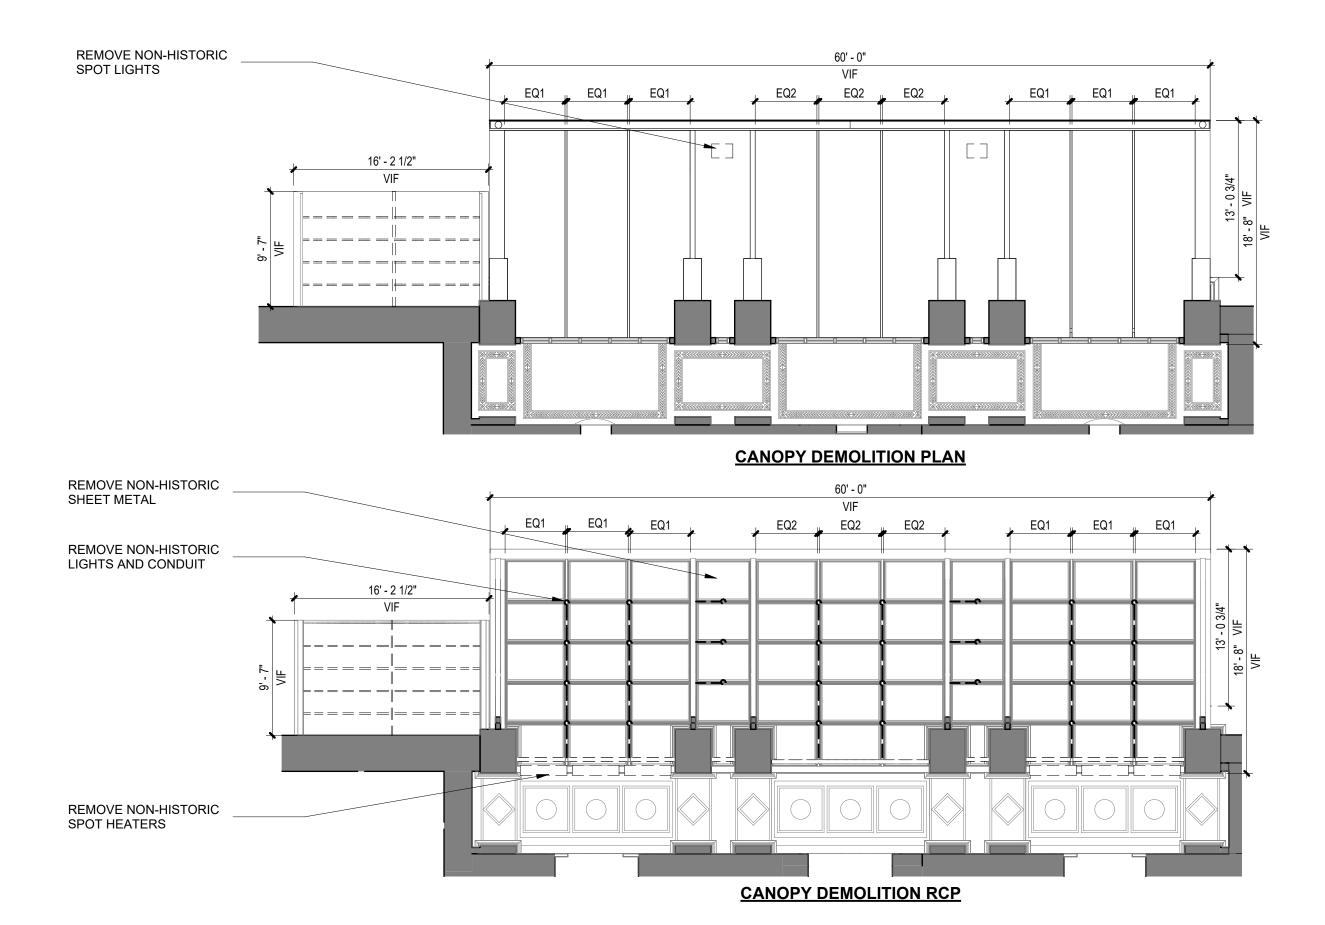
Demolition Canopy Design

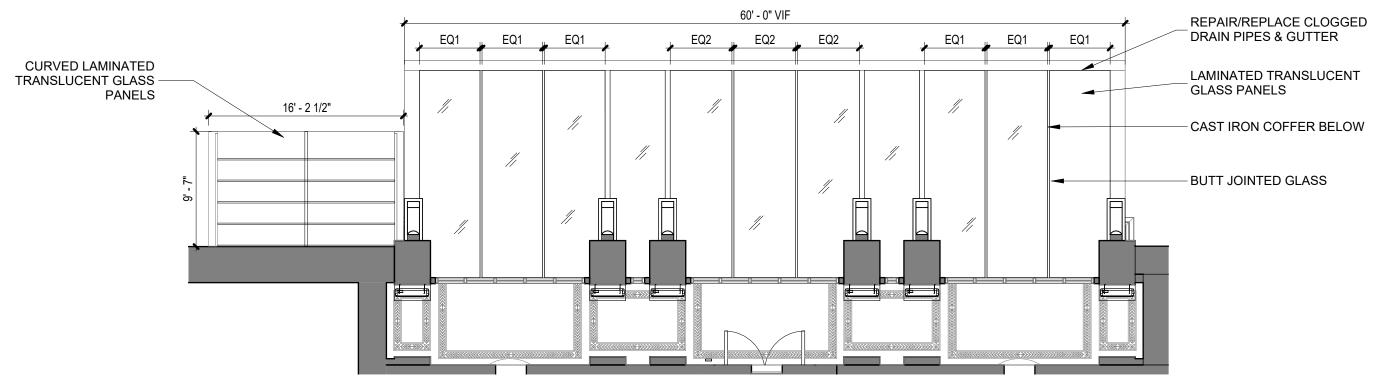
CANOPY ROOF PLAN

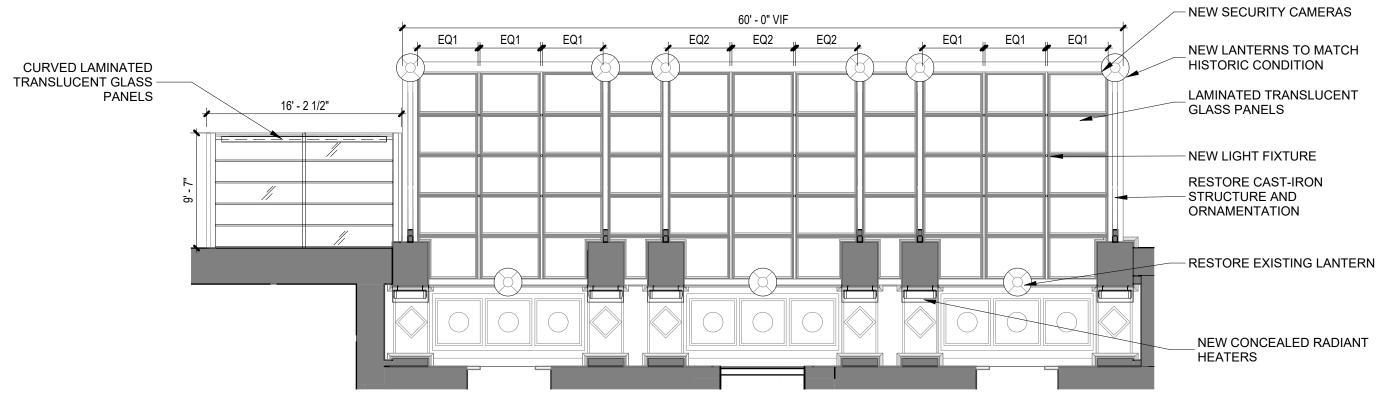
CANOPY REFLECTED CEILING PLAN
