Preservation Department – Item 3, LPC-26-03584

# **83-85 Sullivan Street – 83 Sullivan Street Individual Landmark and 85 Sullivan Street Individual Landmark Borough of Manhattan**

# 83-85 SULLIVAN STREET

PRESENTATION TO:  
LANDMARKS PRESERVATION COMMISSION

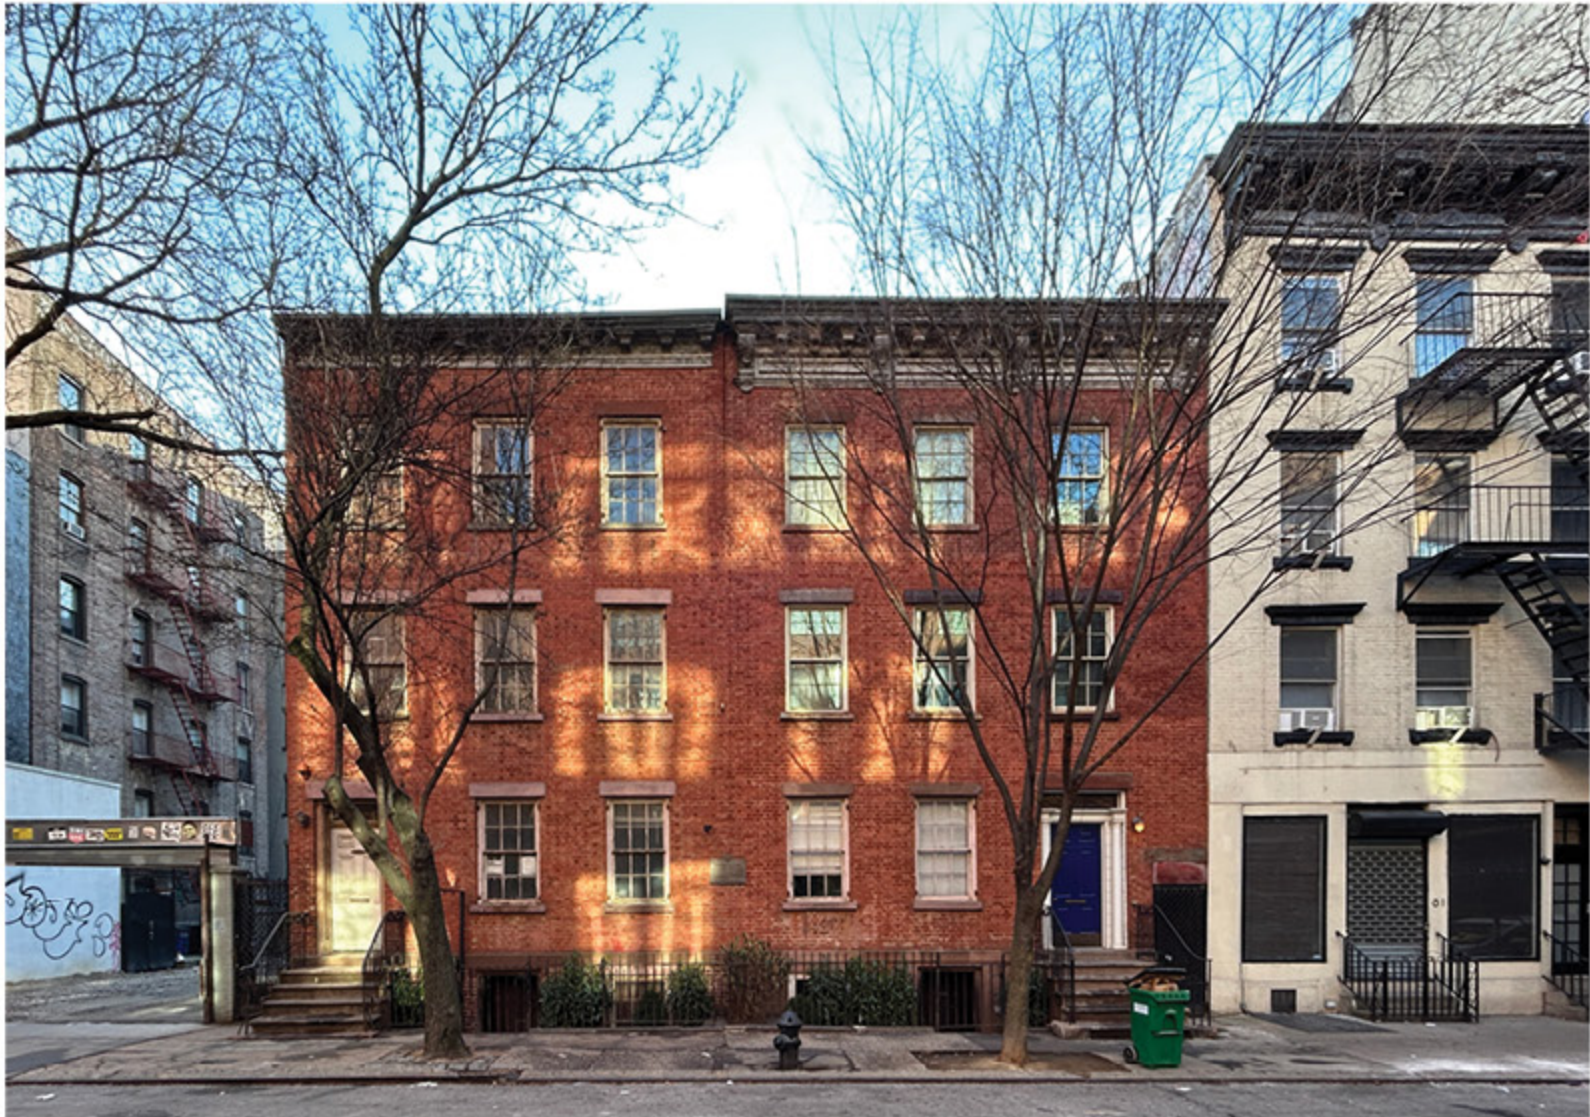
# Existing Conditions: Sullivan Street Facade

85 Sullivan

83 Sullivan

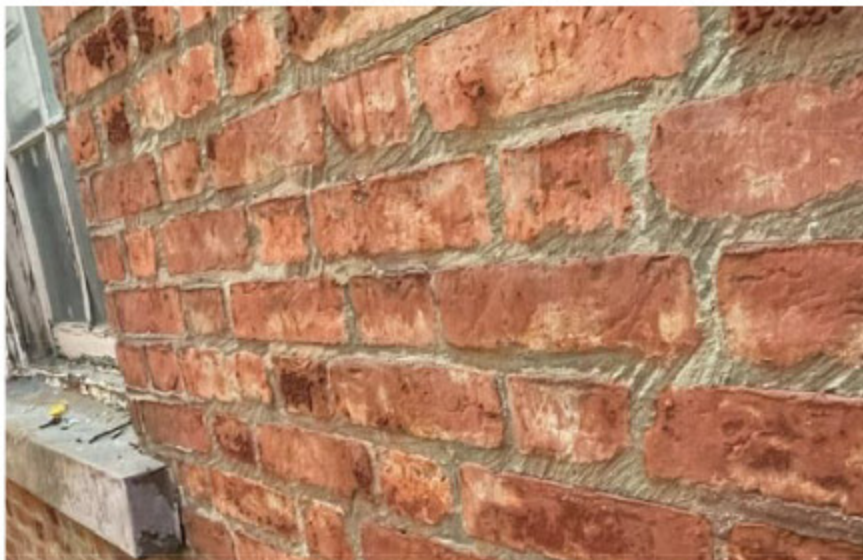
Mechanically Scraped Bricks

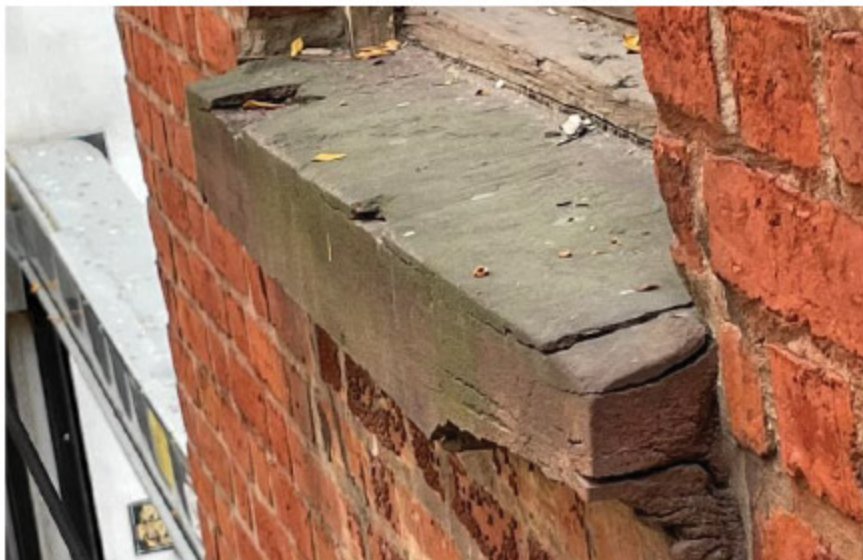
Stone Sill Deterioration

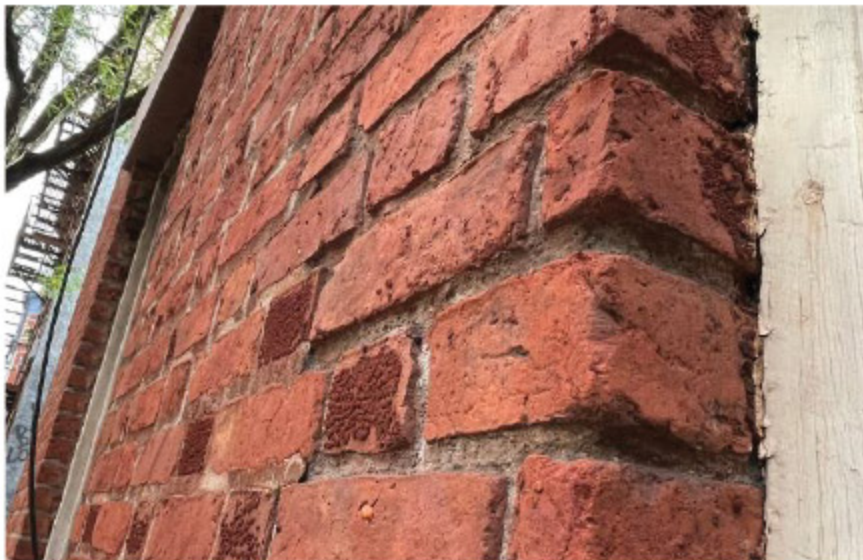
Mortar Erosion

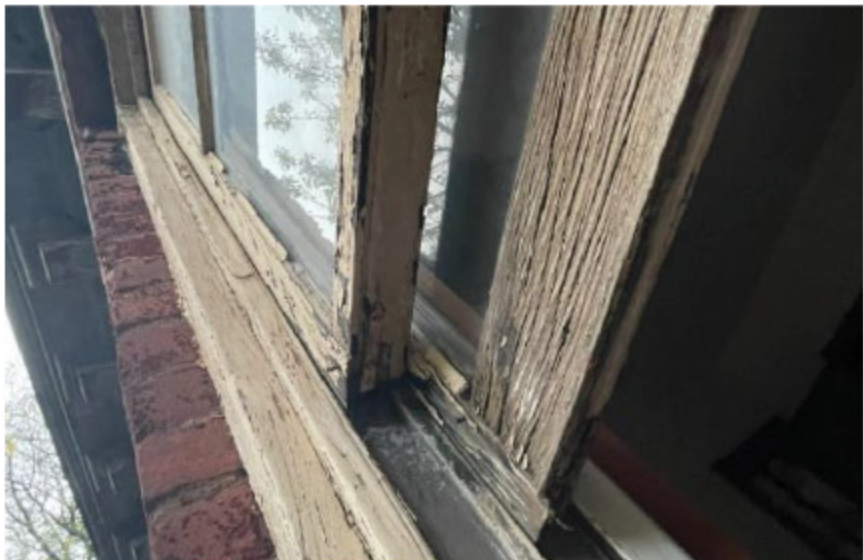
Severe Window Frame Deterioration

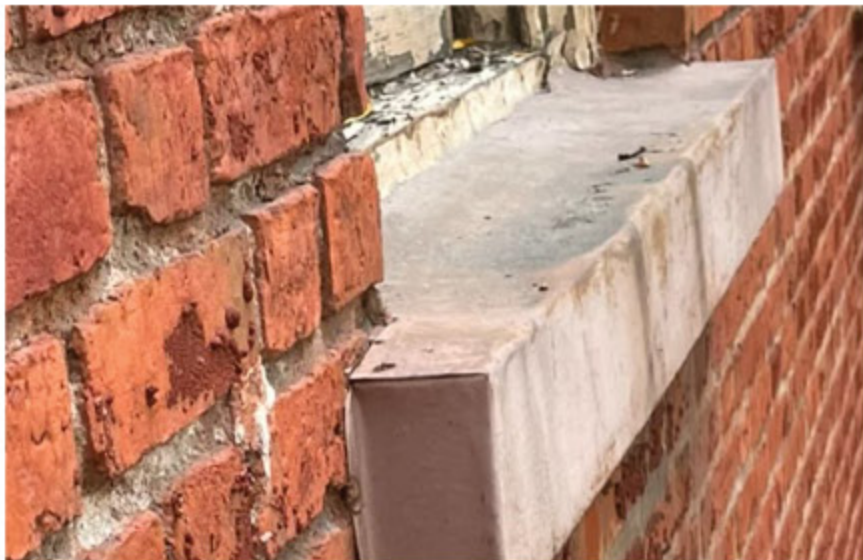
Sill Covered in Break Metal

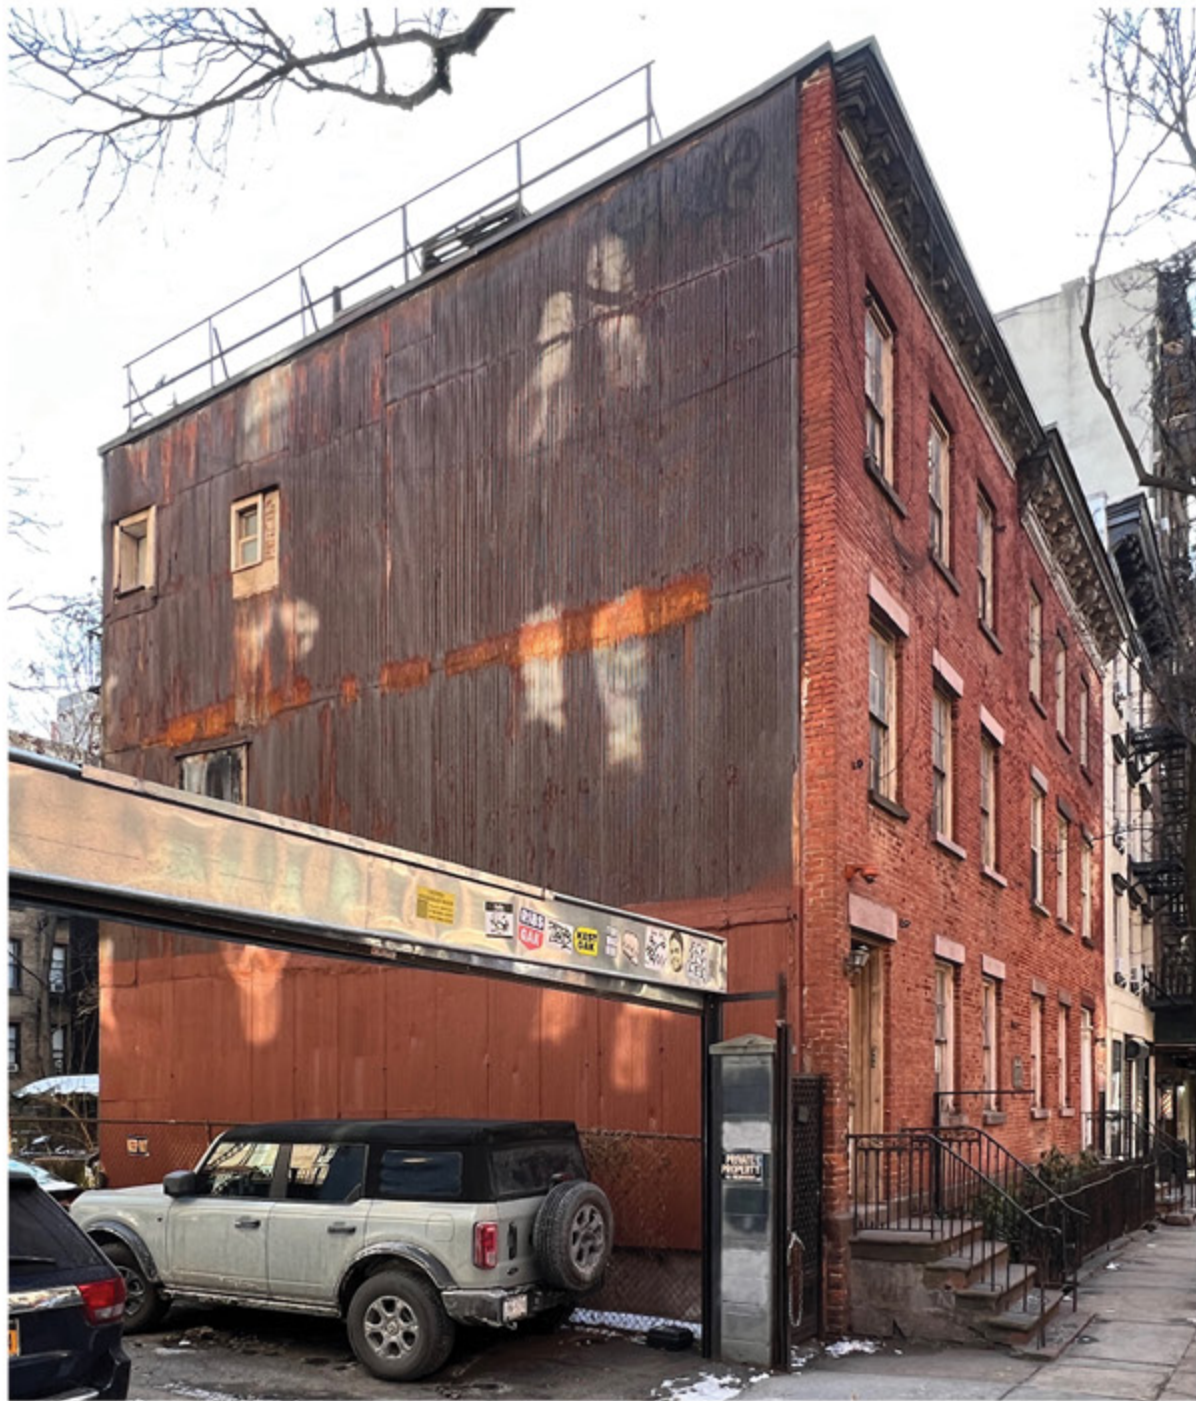
85 Sullivan Street North Facade  
Current photograph, deteriorated metal cladding, installed in 1930s

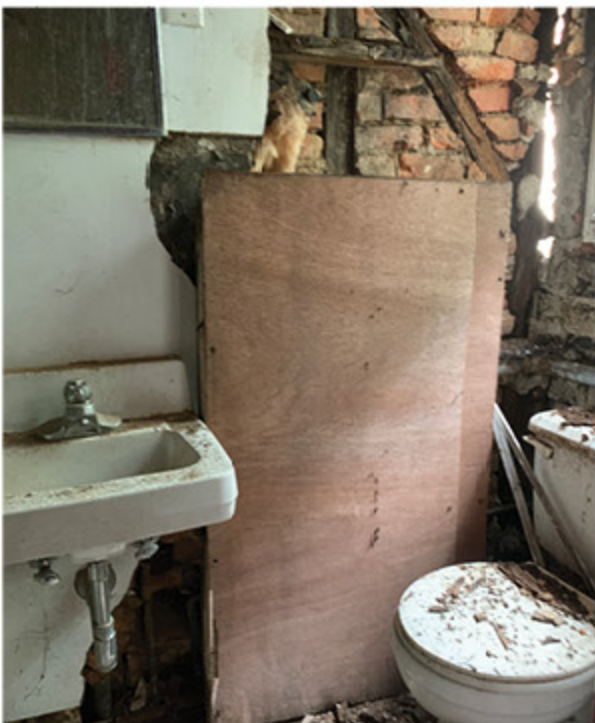
Interior deterioration due to weather infiltration at open exterior corner

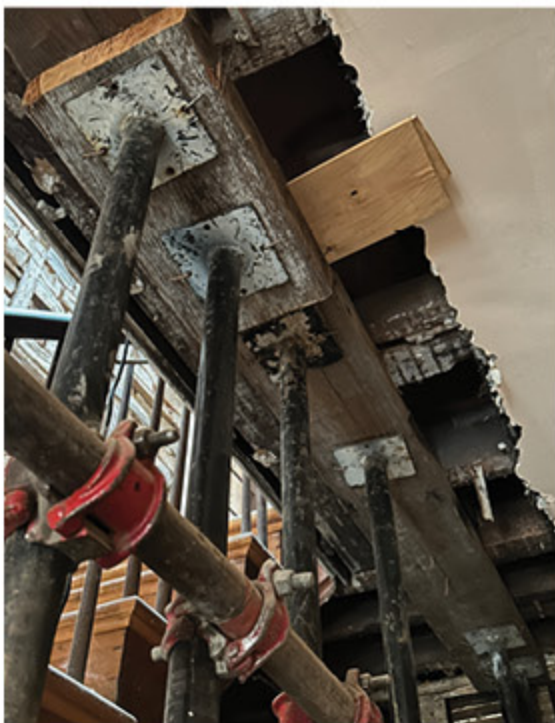
Structural shoring, installed in 2009 to prevent building collapse

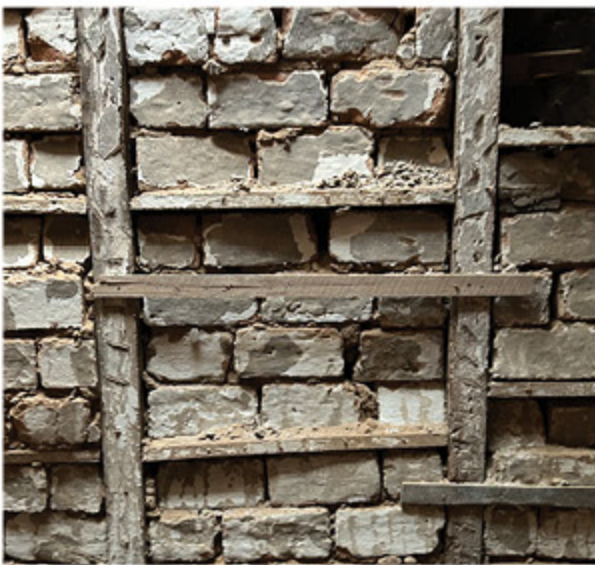
Decay of brick nogging wall,  
including loose brick and rot at  
original structural timbers

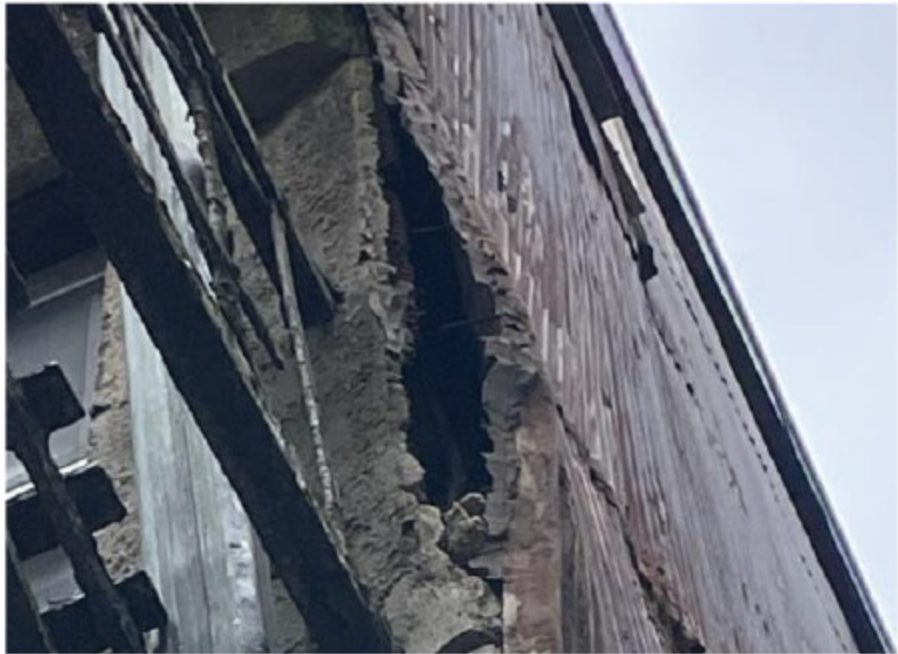
**Buckling Wall**  
Separation of the north and east wall,  
source of considerable water infiltration

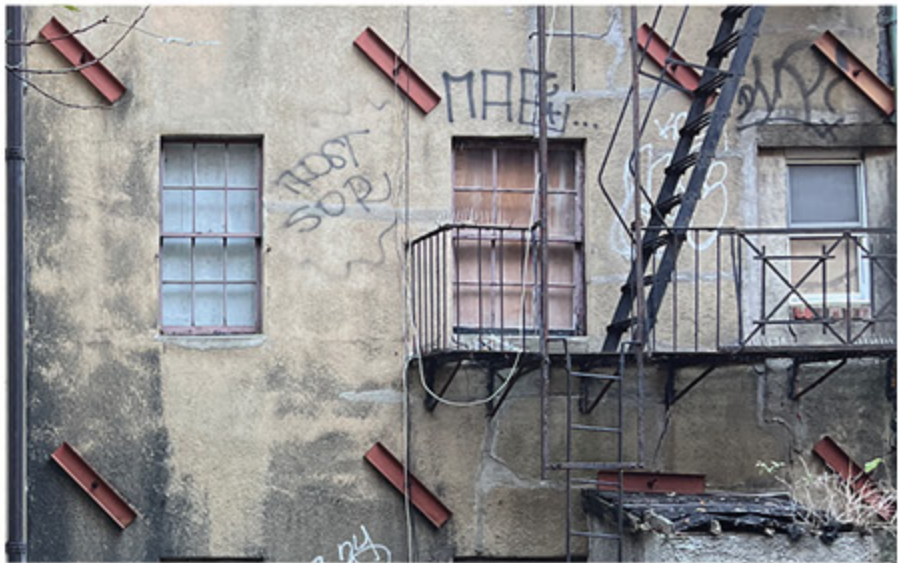
**Exposed Structural Tie-Backs**  
Installed in 2009 to help stabilize the building  
and prevent further separation of the facade
