246 Henry Street
Brooklyn Heights Historic District

Project: Replace a garden level, under-stoop
gate, with a door
January 12, 2026

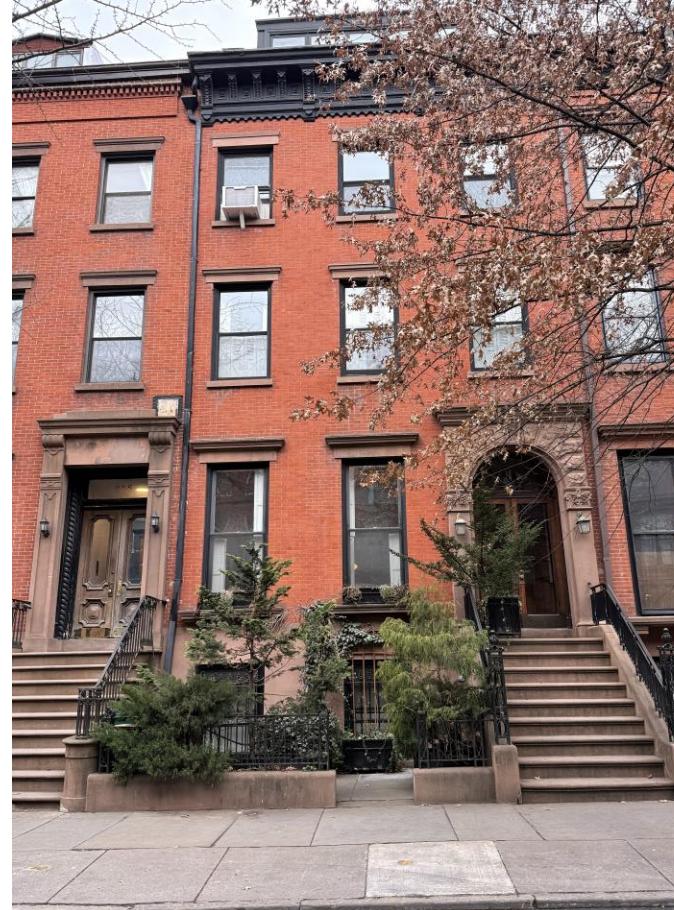
Façade of 246 Henry from across street; 4 family building; upper 3 apartments enter up the stoop

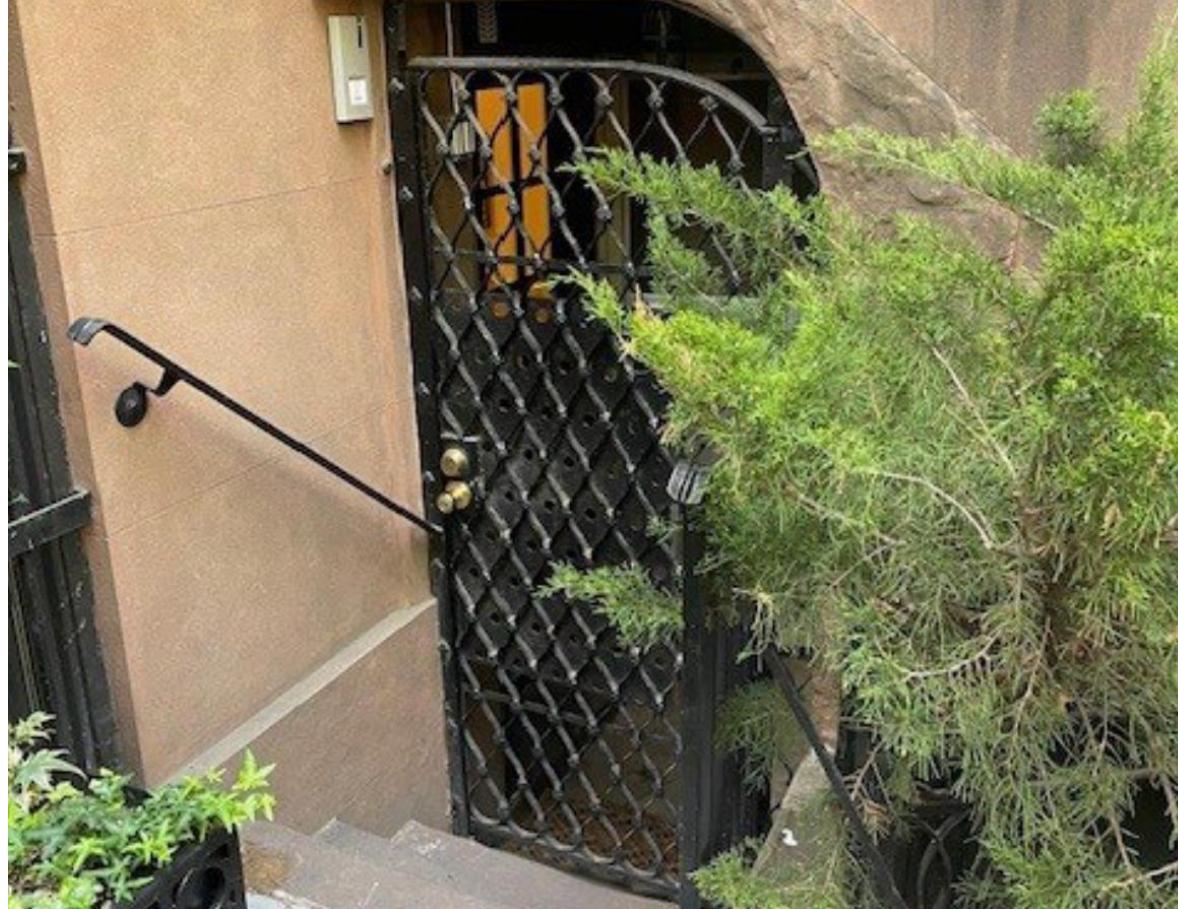
Current Gate is the entrance to lower duplex. Lower third of gate is below ground level. Gate is not front-facing.

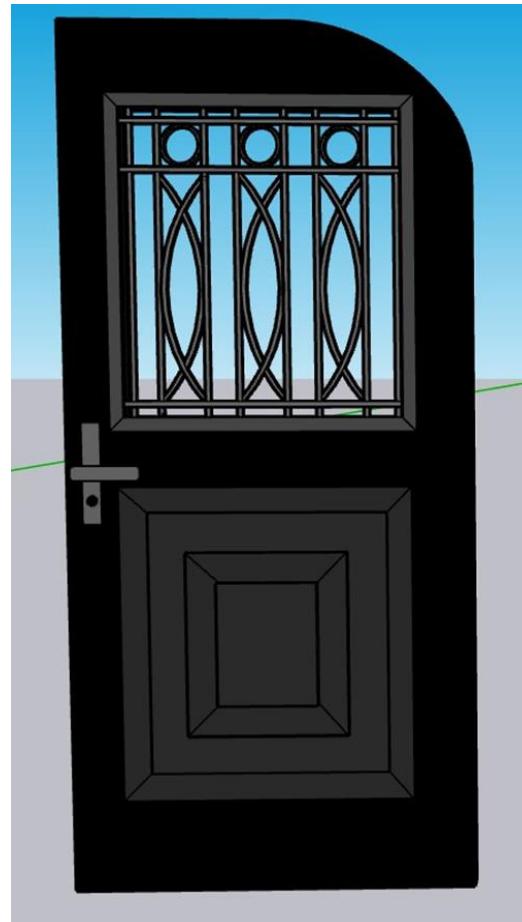
Proposed door – all black, transparent glass with wrought iron detail to match existing fencing. Would be at same below grade level or one step lower still. Door frame will be black wood, around the existing opening.

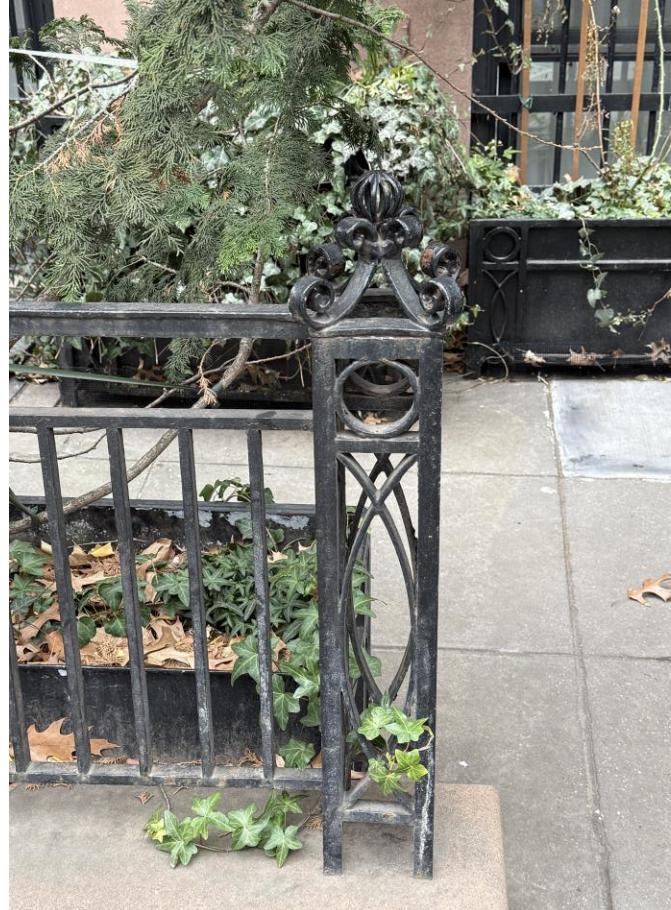
Detail of fencing deployed for door wrought iron design

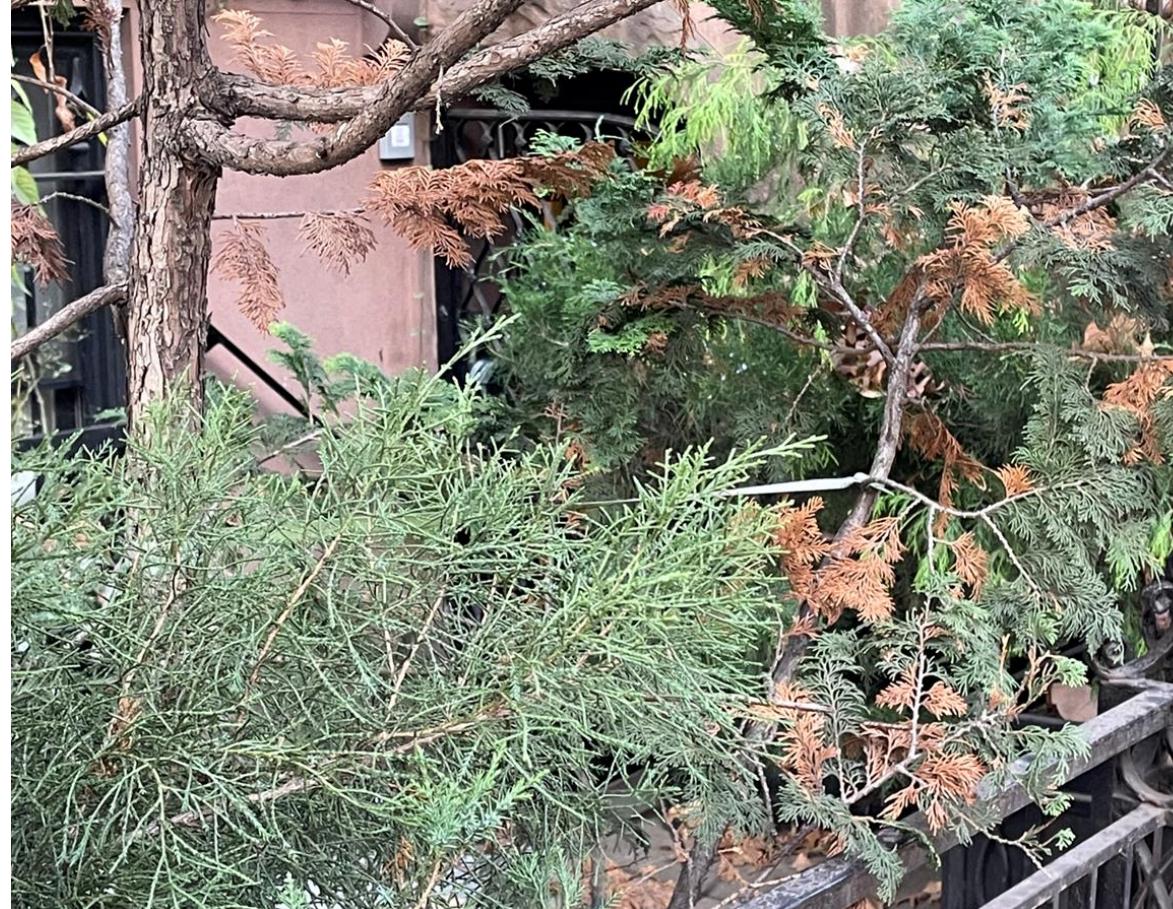
Visibility of Existing Gate/Proposed Door – Because of stoops on either side, only peripherally visible. Also screened by planters and plantings (and trash cans)

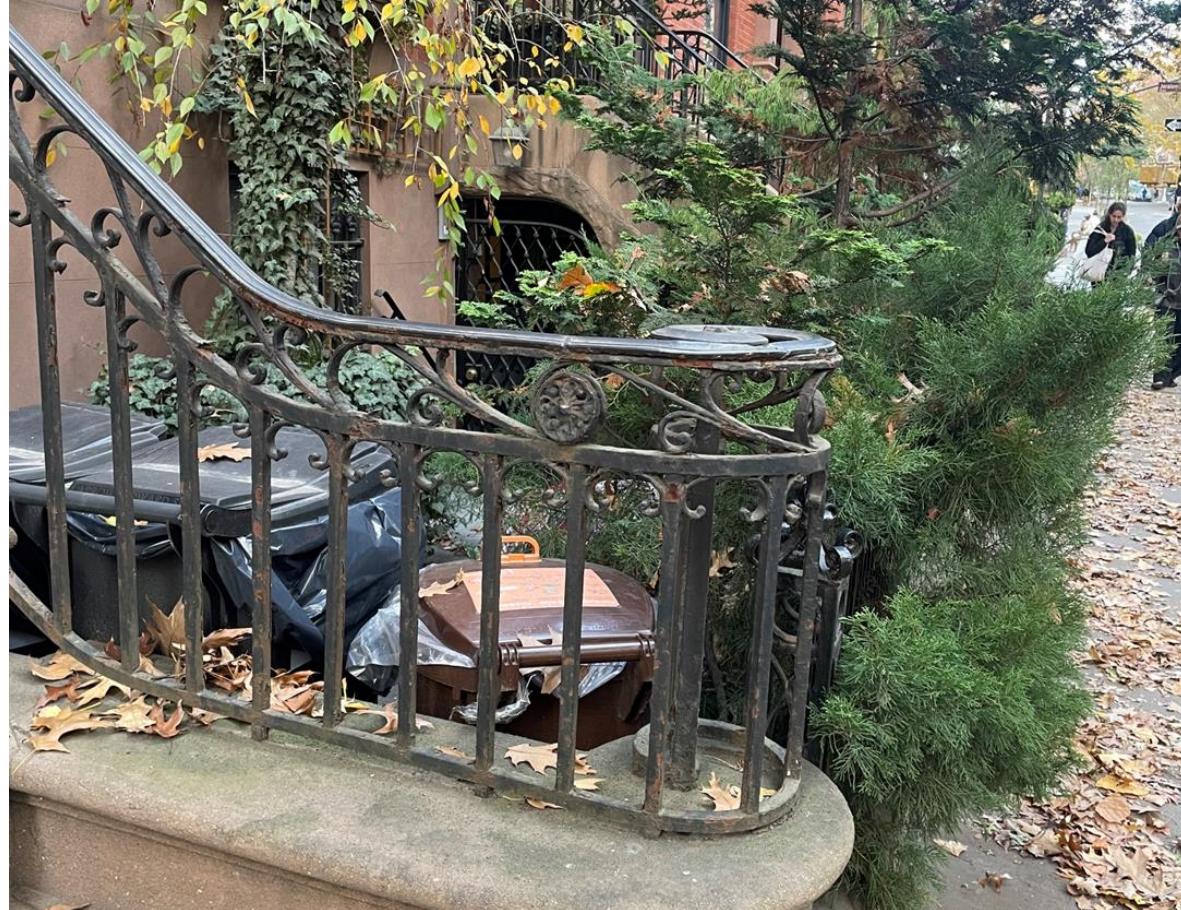
Visibility of Existing Gate/Proposed Door – Because of stoops on either side, only peripherally visible. Also screened by planters and plantings (and trash bins)

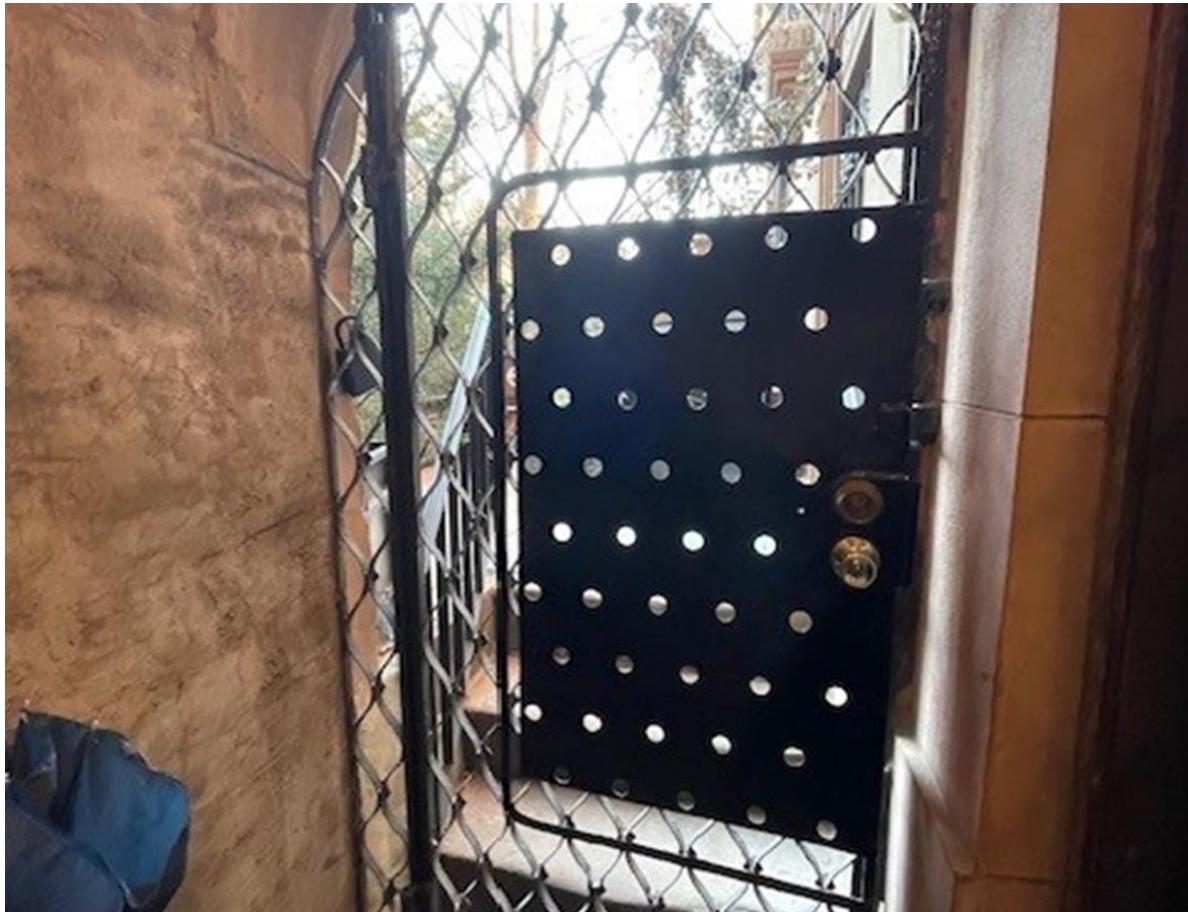
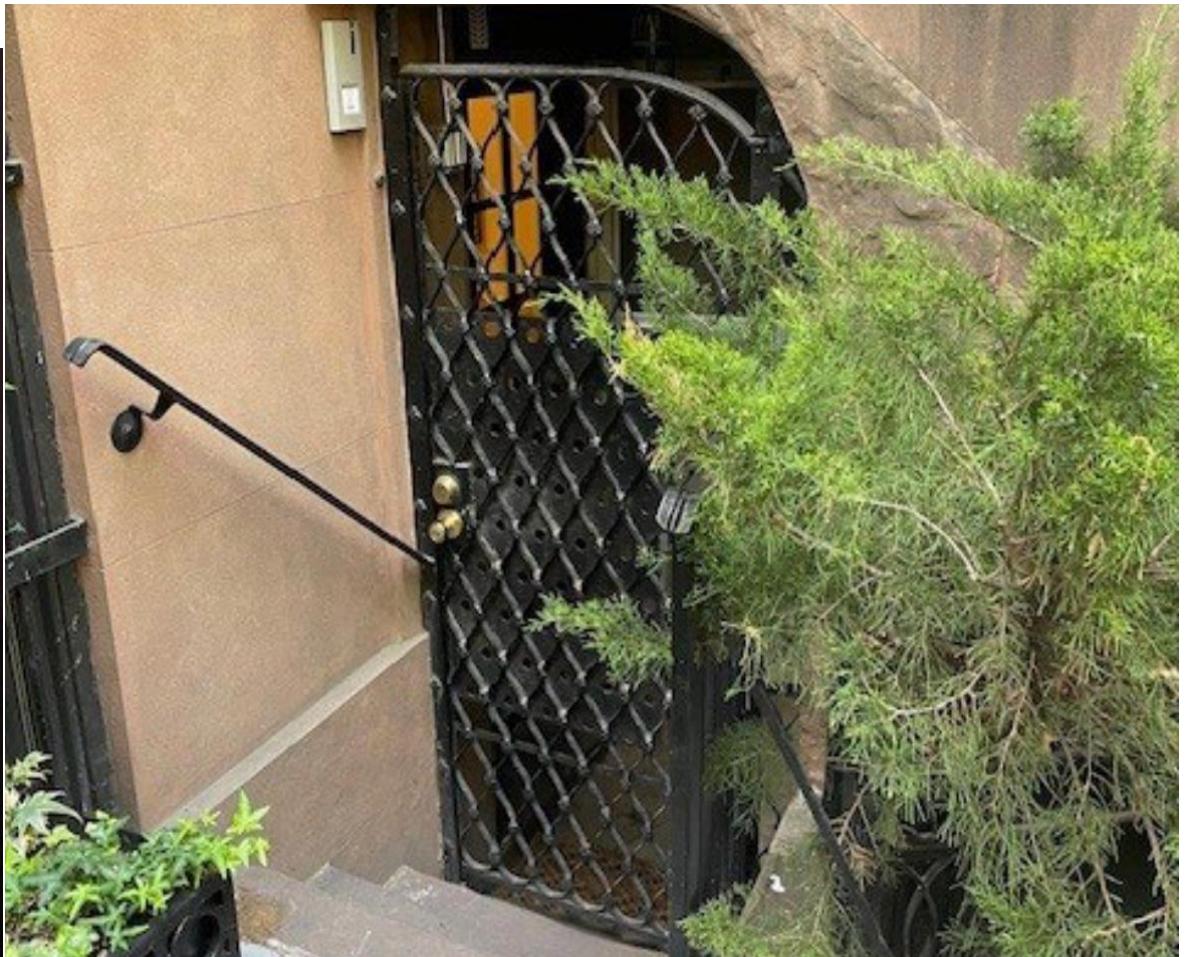
Current Conditions Include mostly solid, substantial iron plate on the existing gate
