Preservation Department – Item 9, LPC-26-06412

**595 Madison Avenue (aka 593-599 Madison Avenue, 41 East
57th Street) – Fuller Building – Individual and Interior Landmark
Borough of Manhattan**

FULLER BUILDING 595 MADISON AVENUE GROUND FLOOR NEW LOADING DOCK DOOR

LANDMARKS PRESENTATION

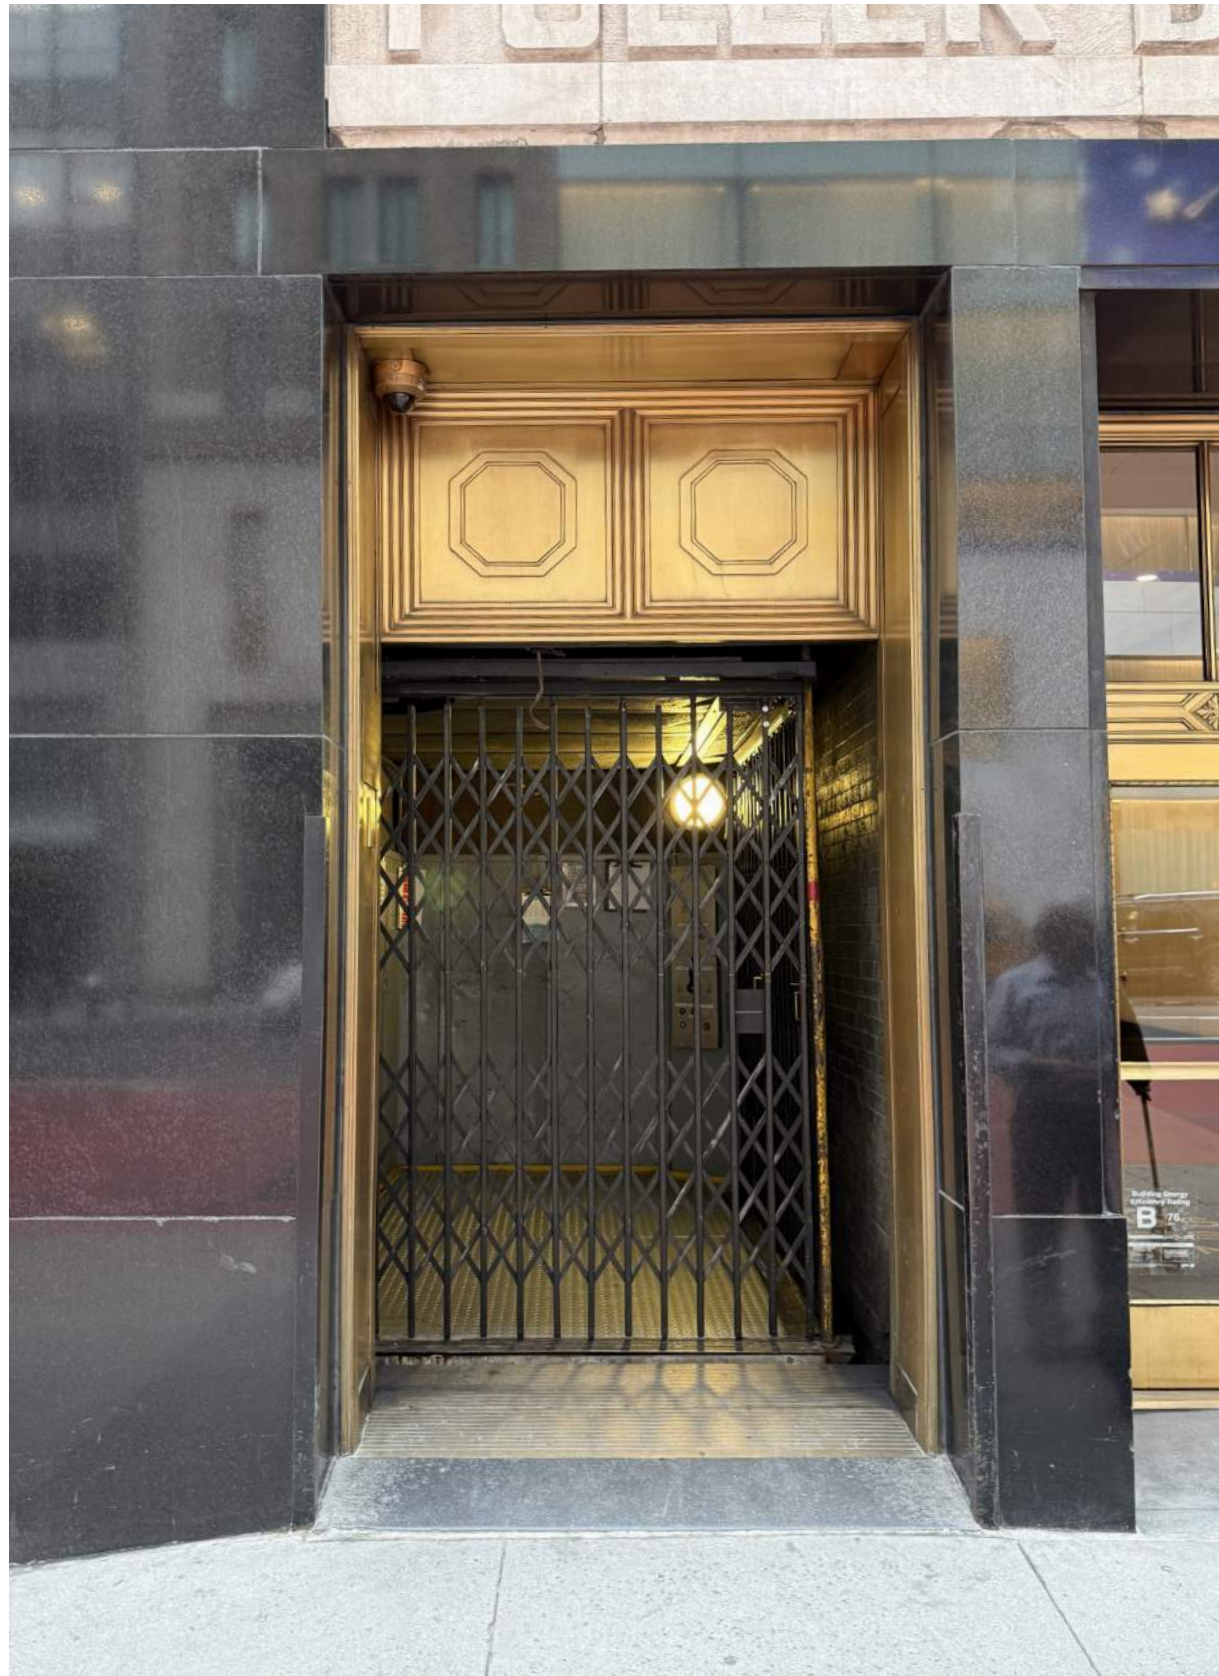
EXISTING LOADING DOCK RAISED DOOR

Our goal with this application is to rehabilitate and upgrade the existing service elevator door on the Madison Avenue side of the building. The door currently opens directly onto the sidewalk and is accessed from Madison Avenue. At present, it is equipped with an outdated electromechanical pulldown system that is difficult to maintain and poses a life safety concern. We propose replacing this system with a manual swing door to improve reliability and ease of use, while remaining sensitive to the building’s unique historic character.
