Re: West Park Presbyterian Church
165 West 86th Street, Manhattan (Block 1217, Lot 1) (the "Building")
Application pursuant to NYC Administrative Code § 25-309 (2)
Response to LPC Comments July 28, 2022

This letter is submitted in support of the above-referenced hardship application by the West-Park Presbyterian Church (the "Church") in response to the questions from the Commissioners sent to us in a memorandum from Mark Silberman dated July 28, 2022.

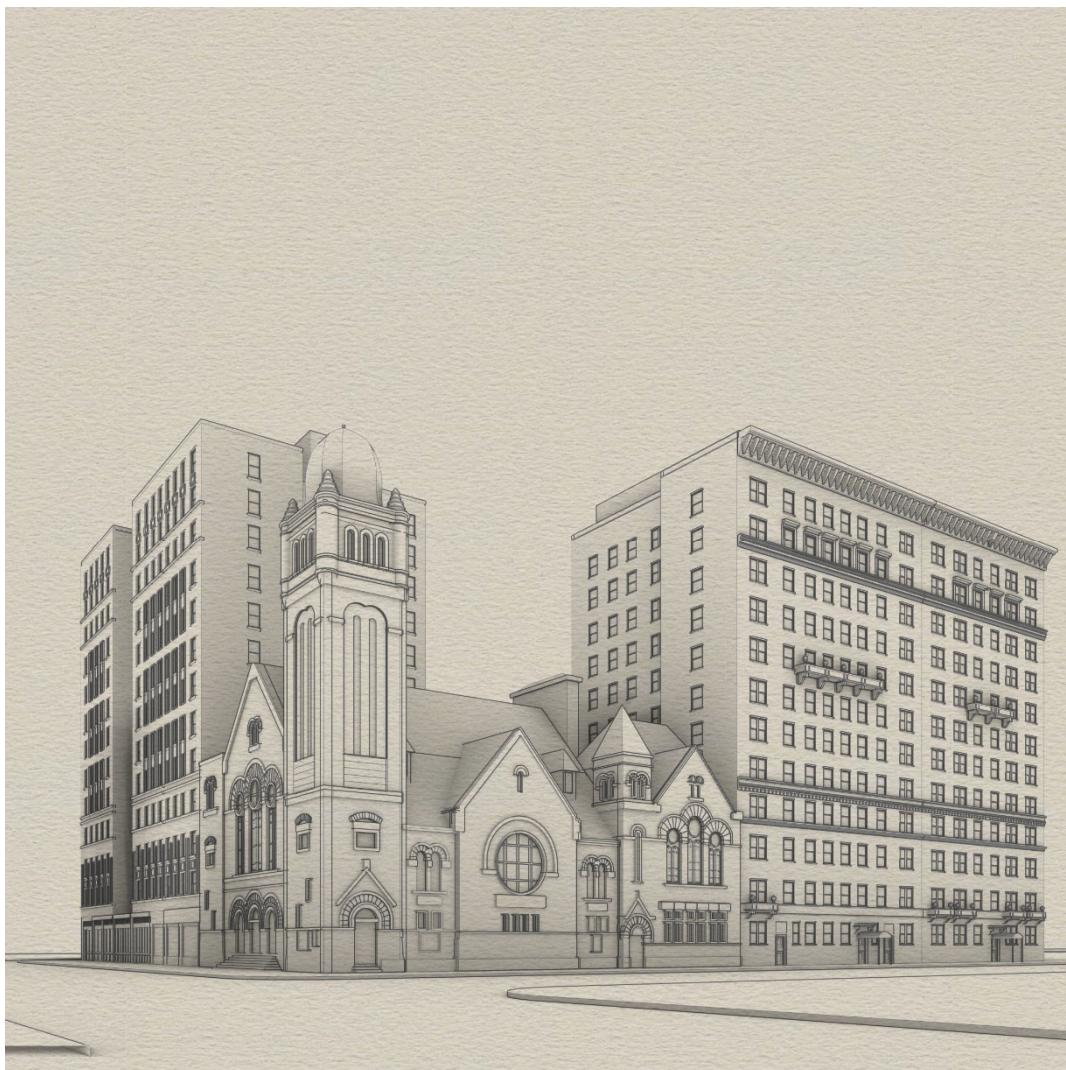
Study B: Convert existing buildings to residential use

Area Summary:

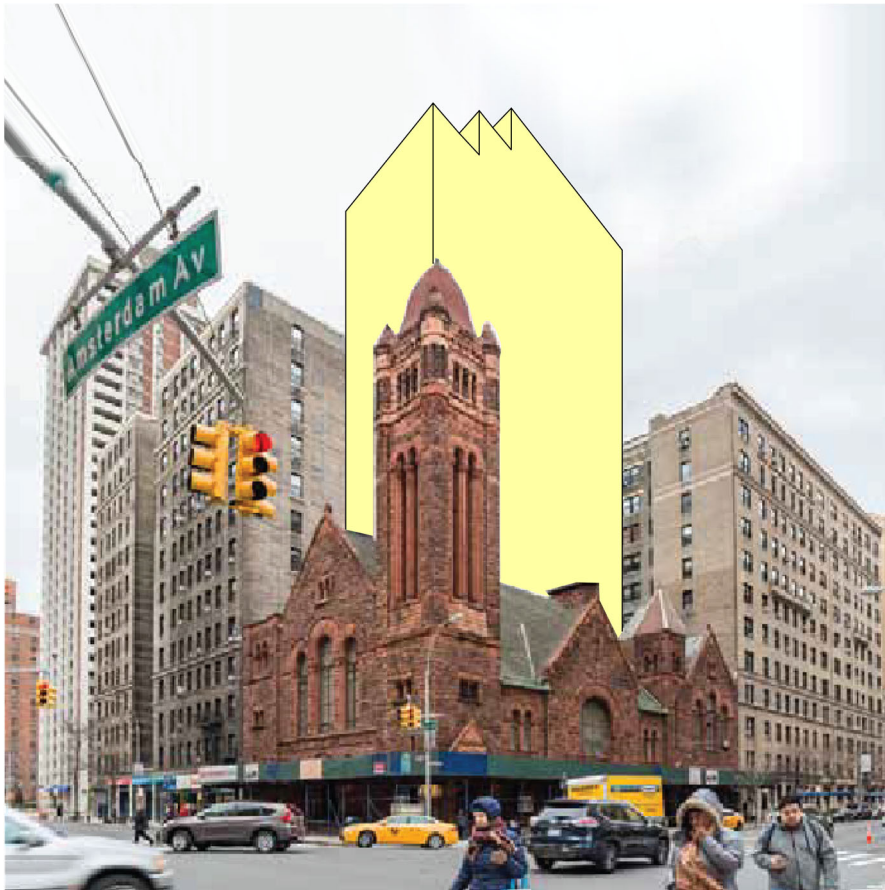
Above grade Gross SF:	68,900 sf
Zoning SF used:	65,400 sf
Unused ZSF:	30,170 sf
Net Residential Rentable / Sellable :	47,900 sf
Community Facility SF:	5,500 sf

- Requires BSA Variance for rear yard / legal windows
- Requires Landmarks approval for demolition, alterations and overbuilds to buildings
- Requires expensive façade repair and stabilization.
- Requires extensive underpinning, structural complexities and protection of the existing church façade during construction of new building.
- Yields limited, floor area
- Yields compromised Community Facility space

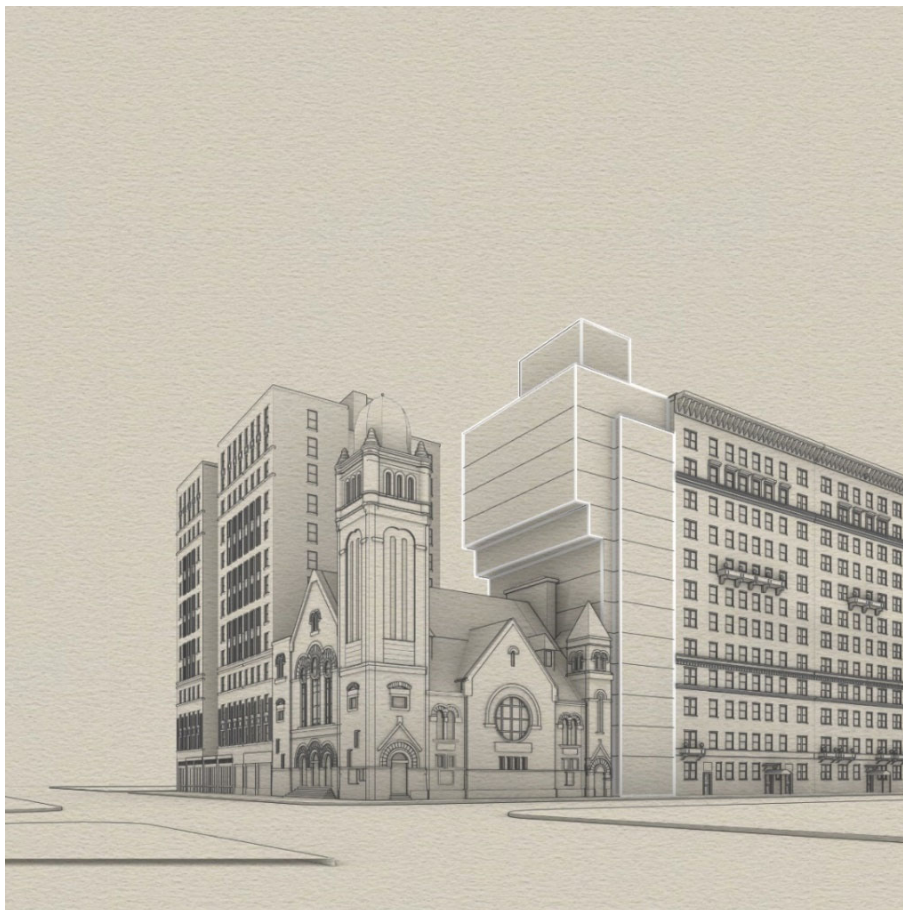
Study F: Repair and restore Sanctuary façade; repair Sanctuary structure and interior, bring up to code for use as Community Facility; demolish Parish house in its entirety; construct new 150' tall, cantilevered-form Residential tower on eastern portion of site

Above grade Gross SF:	46,253 sf
Zoning SF used:	43,028 sf
Unused ZSF:	58,542 sf
Net Residential Rentable/Sellable:	31,434 sf
Community Facility Area:	6,500 sf

- As of Right
- Requires Landmarks approval for repair, alteration and demolition of to buildings
- Requires expensive façade repair and stabilization.
- Requires extensive underpinning, structural complexities (separating the two buildings) and protection of the existing church façade during construction of new building.
- Yields very inefficient, limited, compromised floor area
- Awkward / ungainly building form

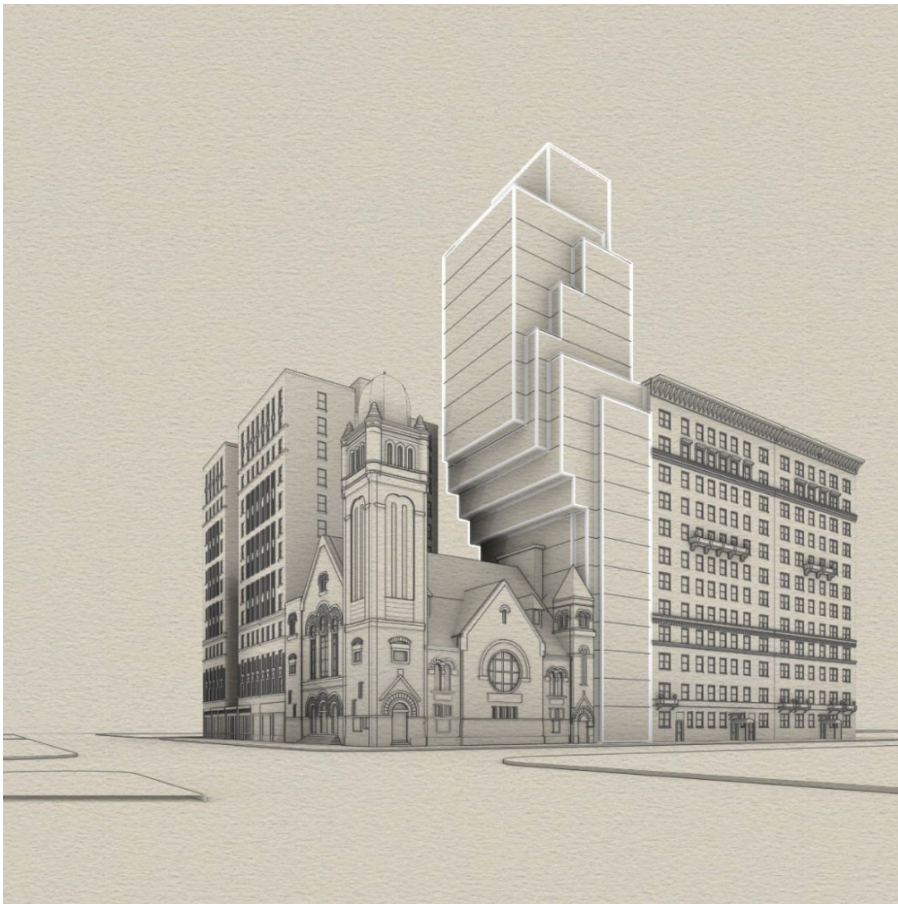
Study G: Repair and restore Sanctuary façade; repair Sanctuary structure and interior, bring to code for use as Community Facility; demolish Parish house in its entirety; construct new 210' tall, cantilevered-form Residential tower on eastern portion of site (requiring BSA Approval)

Above grade Gross SF:	66,476 sf
Zoning SF used:	62,038 sf
Unused ZSF:	39,532 sf
Net Residential Rentable/Sellable:	46,424 sf
Community Facility Area:	6,500 sf

- Requires BSA discretionary approval for "Sliver Law" height waiver
- Requires Landmarks approval for alterations to buildings
- Requires expensive façade repair and stabilization.
- Requires extensive underpinning, structural complexities (separating the two buildings) and protection of the existing church façade during construction of new building.
- Yields very inefficient, limited, compromised floor area
- Awkward / ungainly building form

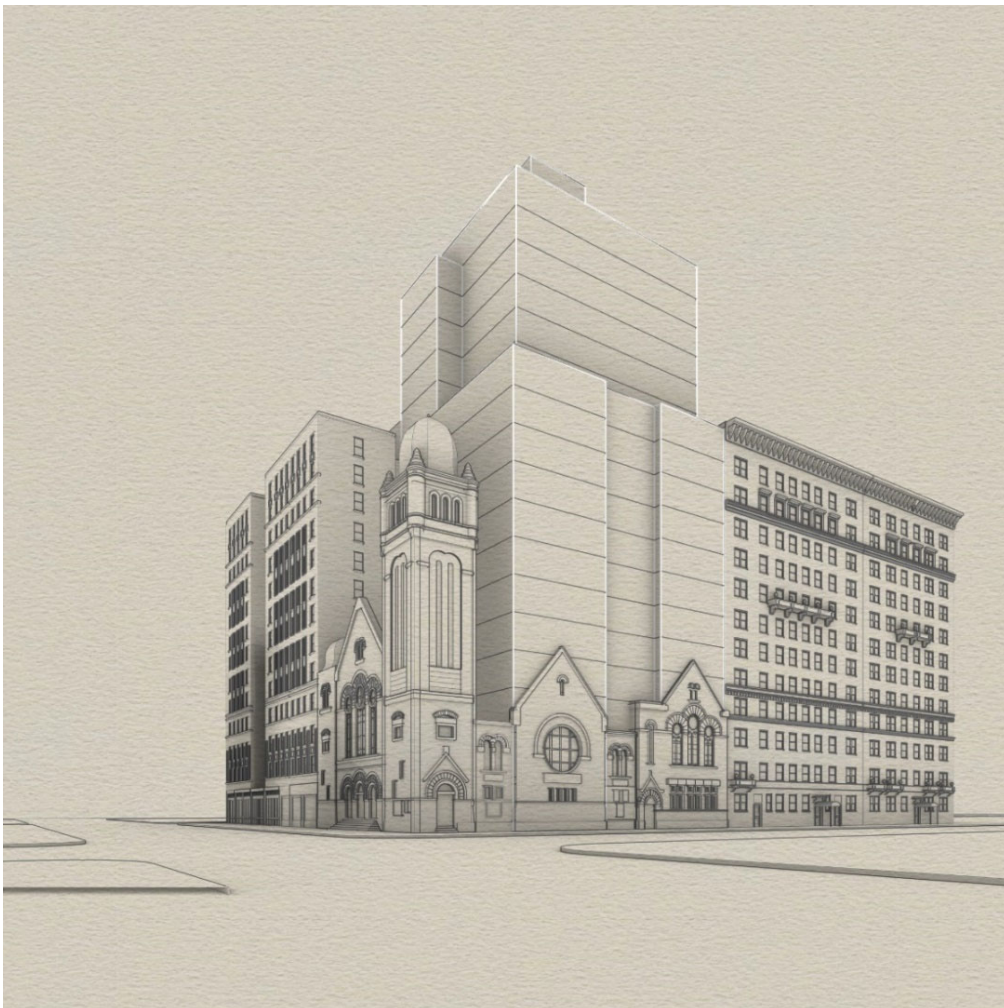
Study H: Repair and restore façade; demolish Sanctuary and Parish house structures and interiors; construct new 210' tall Residential tower on majority of site, behind and above existing façade avoiding belltower on western portion of site

Above grade Gross SF:	103,147 sf
Zoning SF used:	93,600 sf
Unused ZSF:	7,970 sf
Net Residential Rentable /Sellable:	76,800 sf
Community Facility Area:	6,000 sf

- Requires BSA Waiver for non-complying streetwall
- Requires Landmarks approval for demolition and alterations to buildings
- Requires expensive façade repair and stabilization.
- Requires extensive underpinning, structural complexities and protection of the existing church façade during construction of new building.
- Inappropriate treatment of existing historic fabric / "facadism"

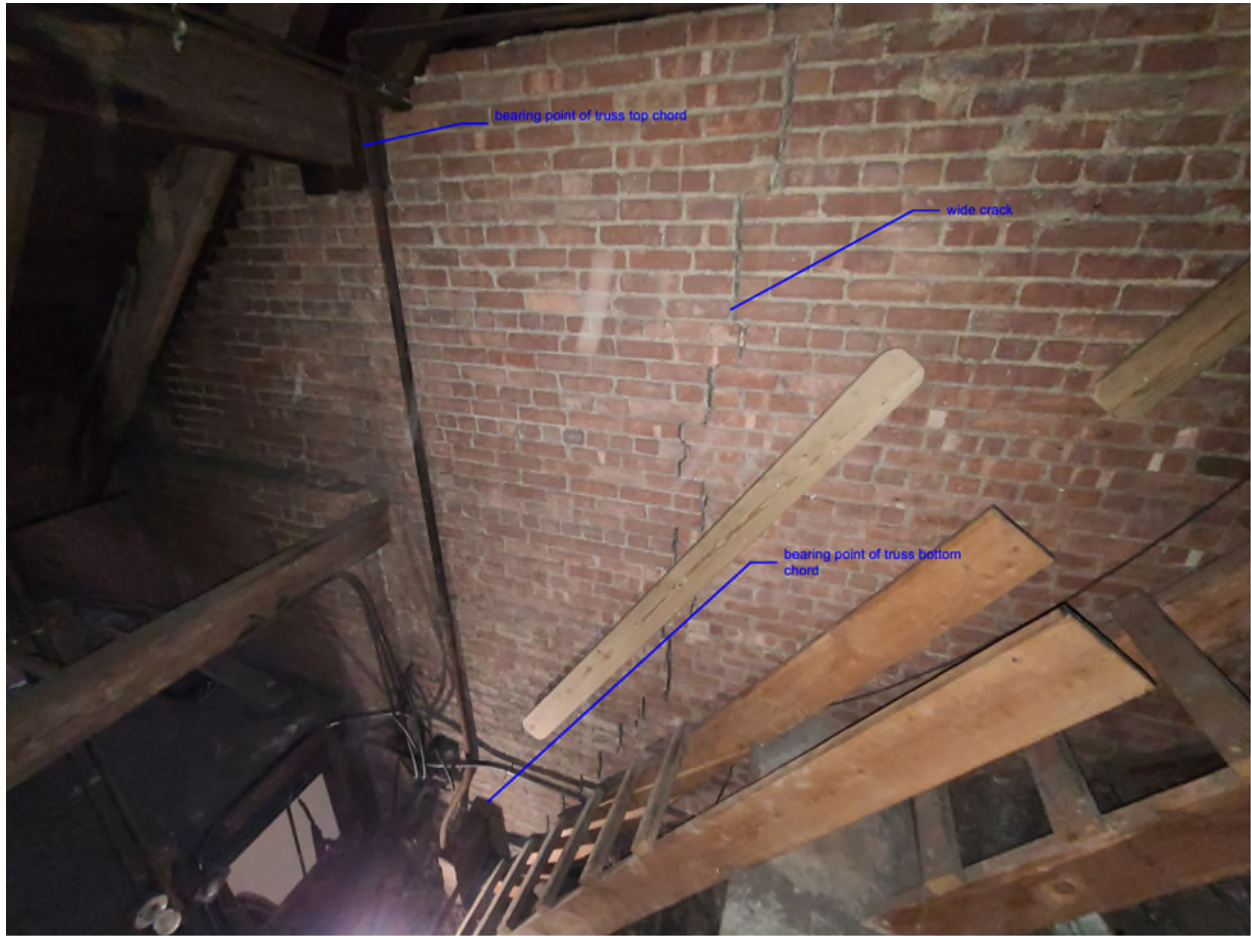
Our response to the findings was appropriate given the information that was known at the time. We engaged with a licensed surveyor, and they mapped the facade and installed tilt beams to monitor them. The leaning condition of the south wall is partially ameliorated by the emergency work done, and perhaps it helps to keep the condition from being an outright emergency at this point. However, the design intent of the emergency repair was to brace the wall and safely support the sanctuary ceiling adjacent to the wall, not to reinforce and stabilize the wall against excessive lean. The current conceptual repair scheme is intended to do just that – to reinforce the walls so that when snow falls on the roof, and wind hits the wall, there is not an excessive amount of compressive stress in the wall due to its lean, in order to ensure that the north and south walls are stabilized with no possibility of leaning out further.

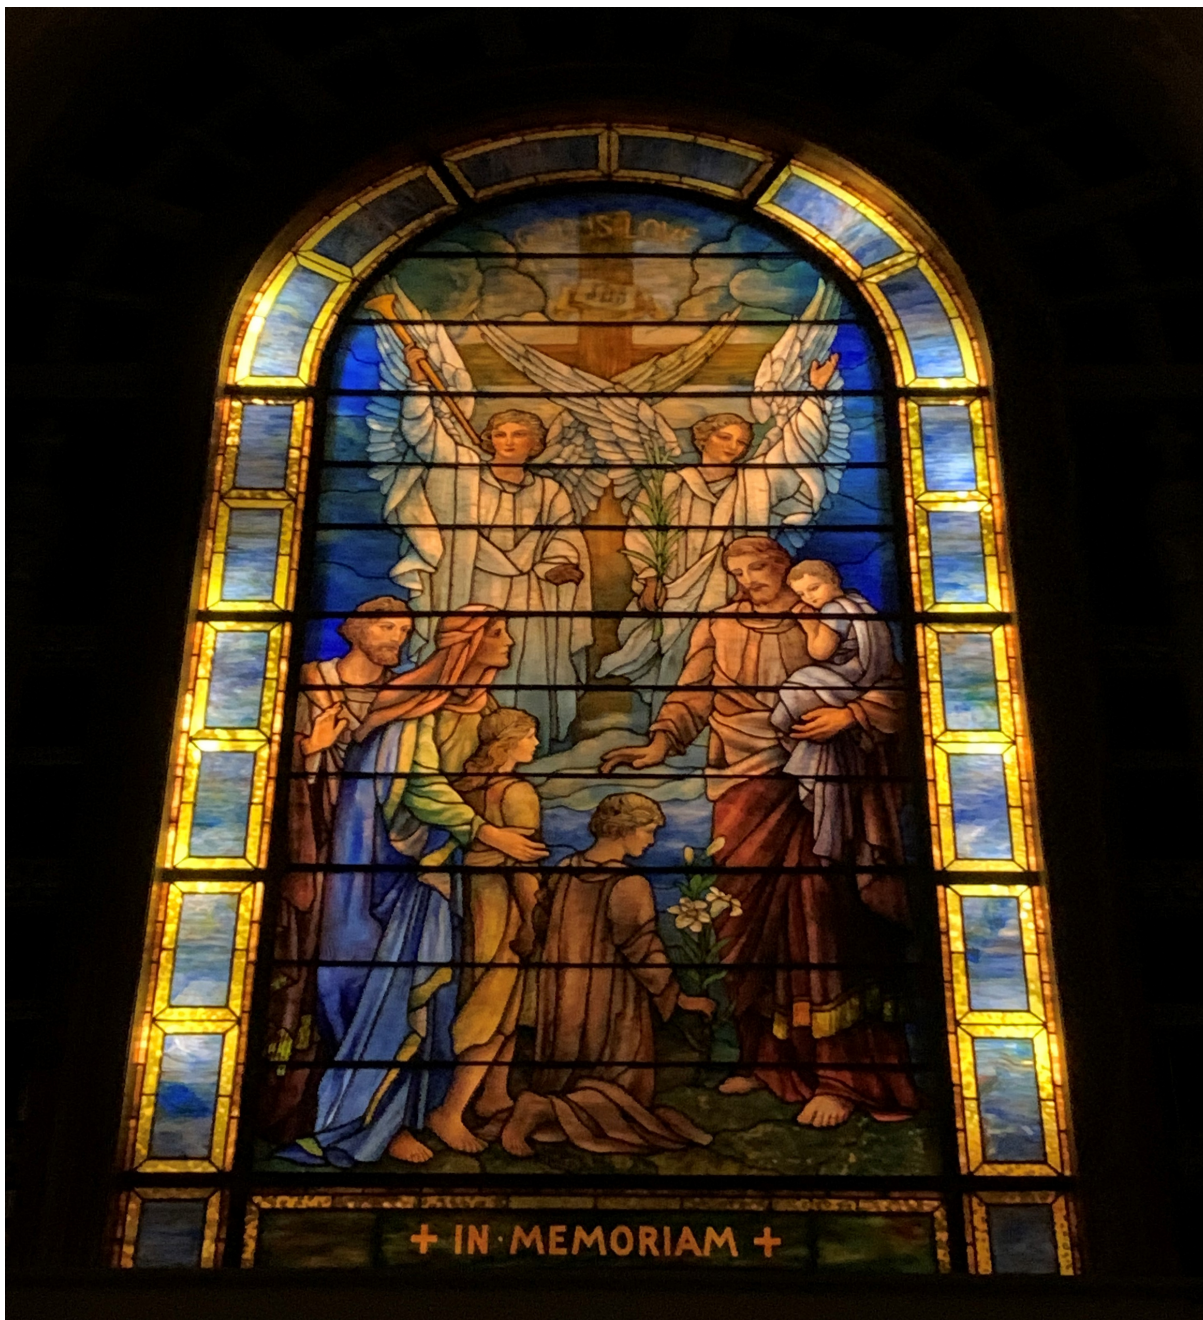
Organ Screen Window: Tiffany Studios

The War Memorial Window, depicting Christ Blessing the Children, was executed by Tiffany Studios in 1929. The window is dedicated to the sons of the church who sacrificed their lives in WWI (New York Times [27 May 1929, p. 25]).

The window was viewed from the back only. It is heavily plated and has a steel subframe to support it. The exterior side of the window did not show bowing or breakage. An up-close inspection of the window is needed.

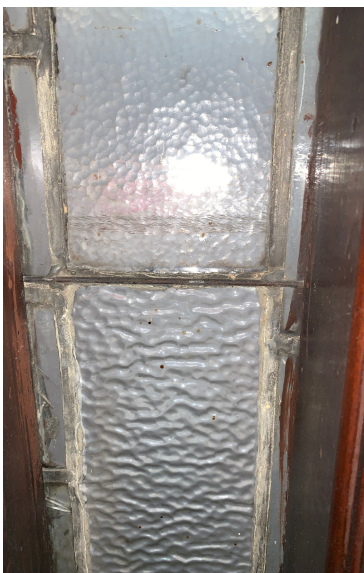
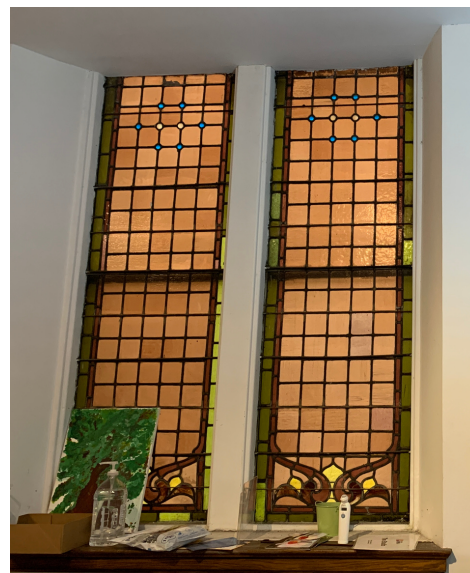
The windows at West Park Presbyterian Church and Parish House use various colors of opalescent (left), cathedral (center) and antique glasses (right). The clouded exterior Lexan coverings create a semi-opaque appearance, even in the transparent glasses. All of the windows were made with lead matrices.

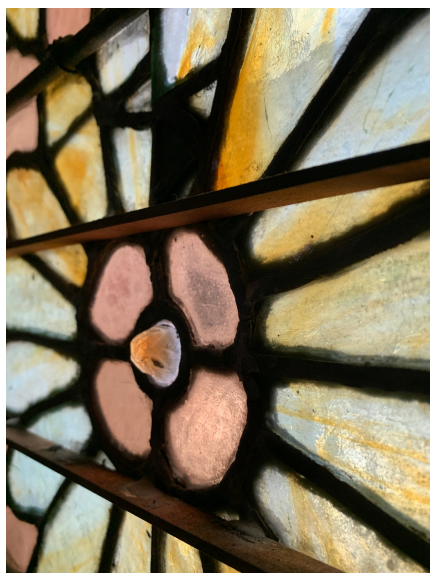
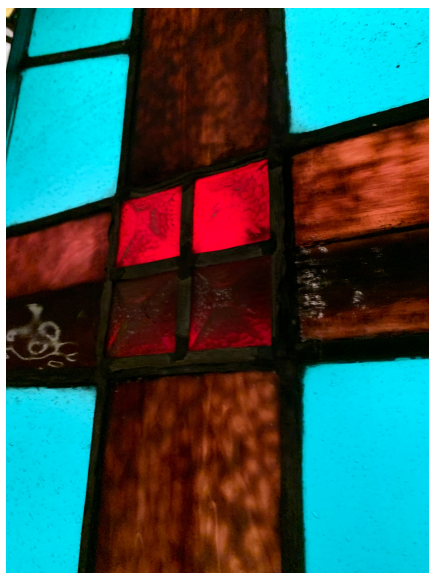
Detail from windows S9, PHS 9, and PHS 10. The window scheme uses chipped jewels in the sanctuary (left), cast jewels (center), and spun roundels (right) in the Parish House. Jewels and roundels were often seen in 19th-century windows and were a notable inclusion. They were more expensive than glass.

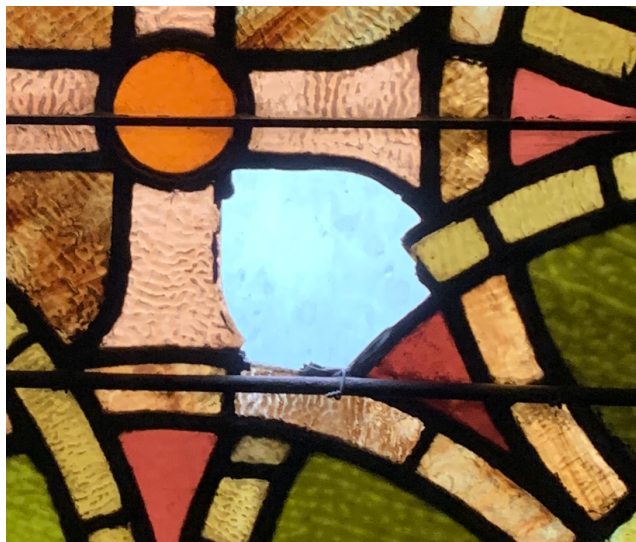
There are many untreated breaks, broken pieces that have been totally or partially lost and evidence of previous repairs.

Detail from window S 12 where a piece of glass and the surrounding matrix have been lost. The pieces are unstable.

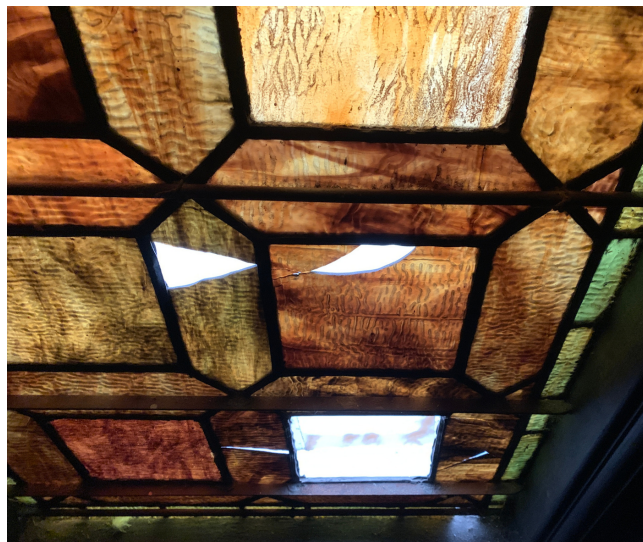
Detail illustrating several lost and unstable glass pieces in window S 13.

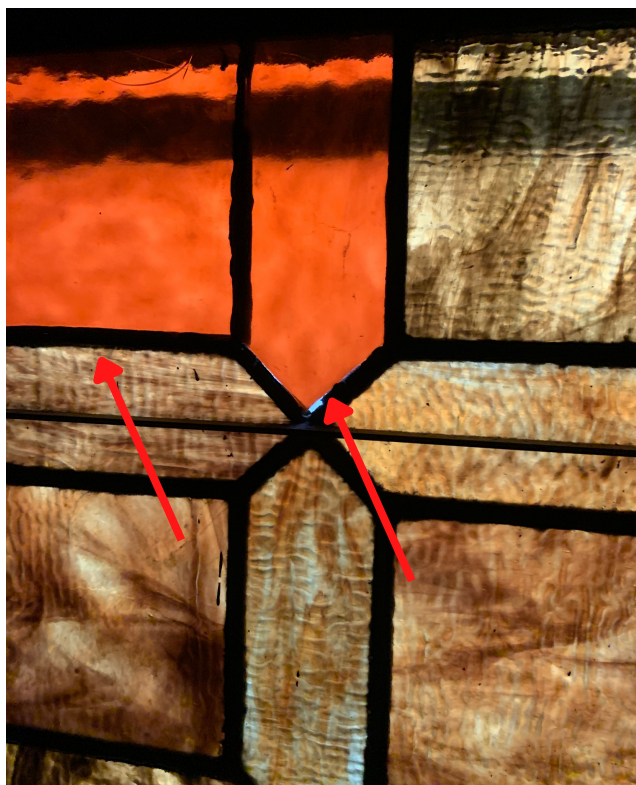
Detail of a poor repair in window S 13. The replacement glass is not a good match to the surrounding material.

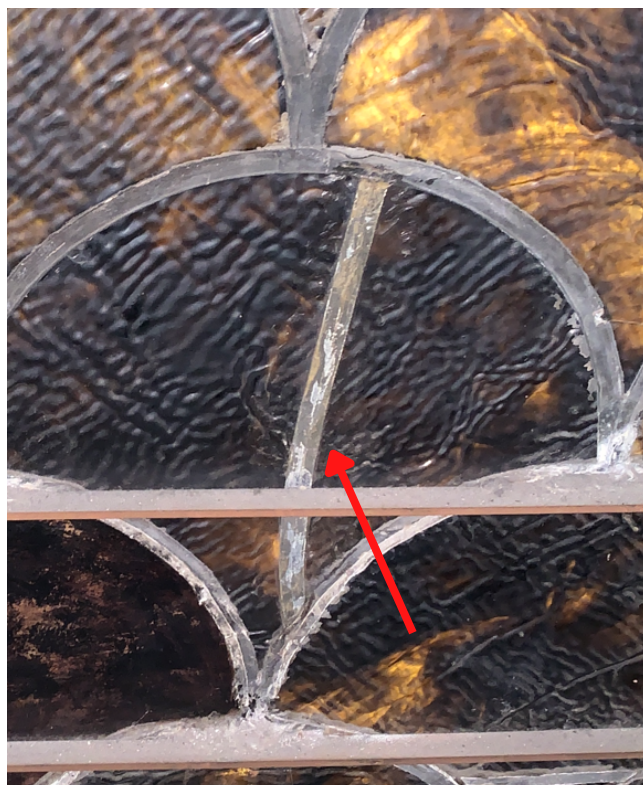
Detail of typical strap lead in window W 15. Strap leads are not true repairs, they merely cover the break.

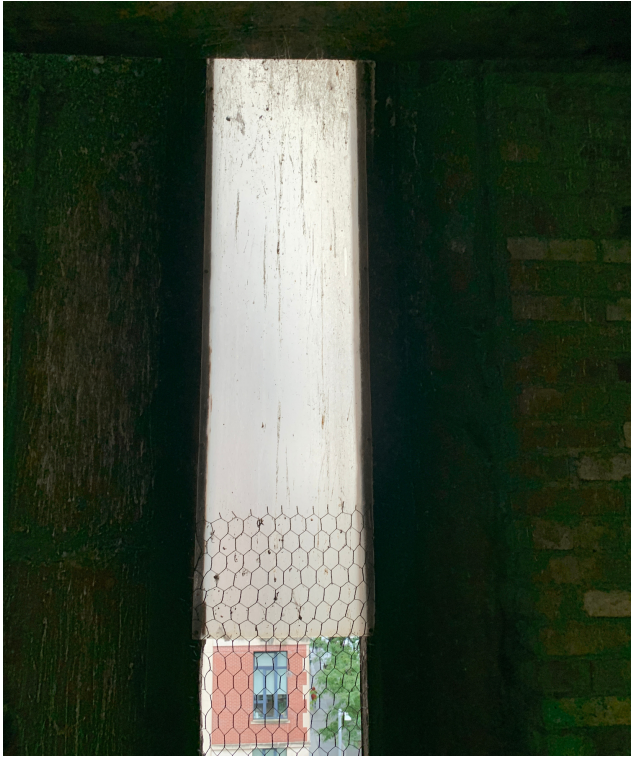
An opening with missing leaded glass that has been secured with plastic and chicken wire. This is not weather tight, and water is infiltrating the tower.

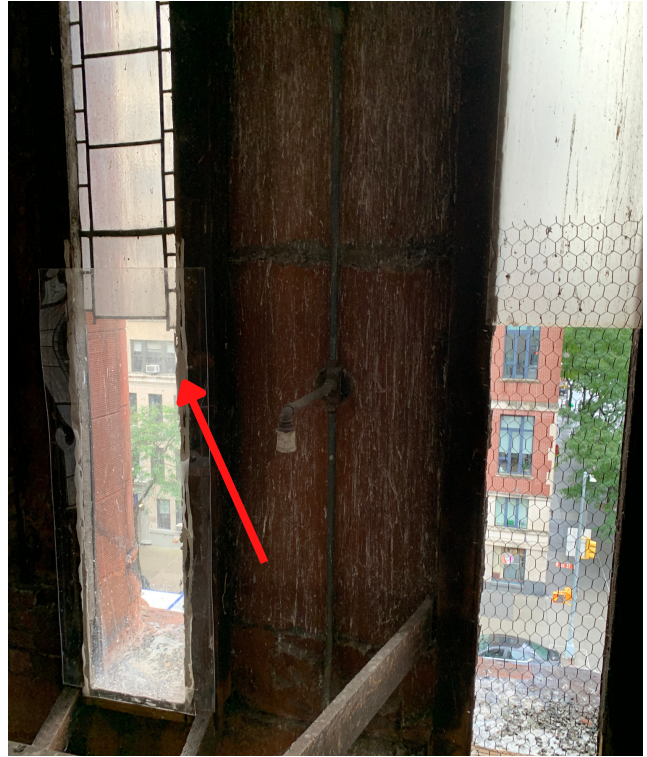
This remaining panel in danger of falling out. There is nothing supporting it from the bottom.

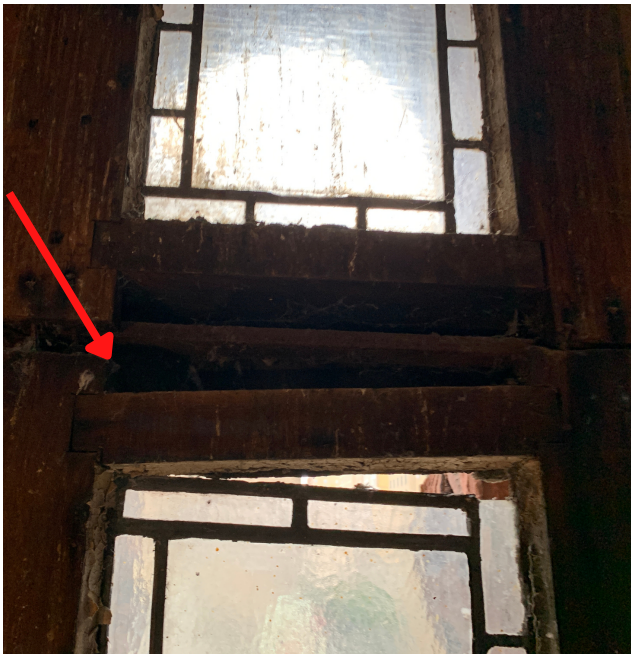
Detail of frame slippage. The top of the frame is no longer holding in the window.

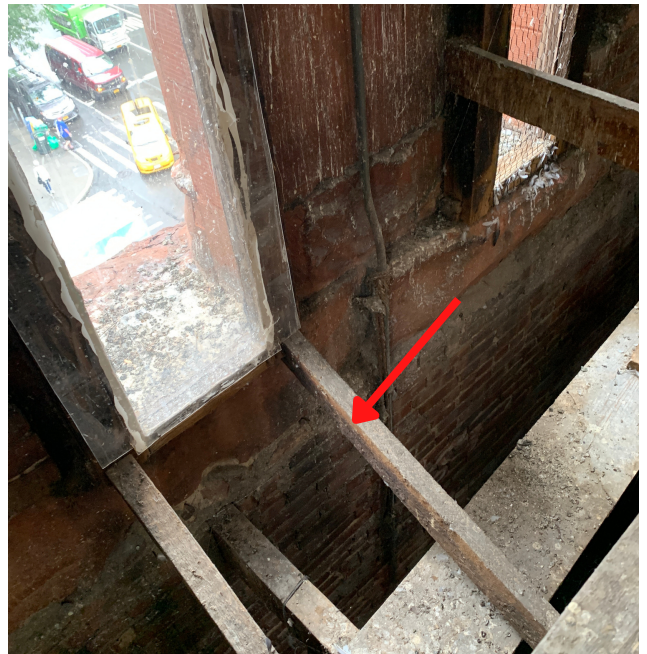
The frame appears to be shored by 2x2 lumber. The stone stool has been lost on the interior. The window frame is in danger of falling out of the setting.

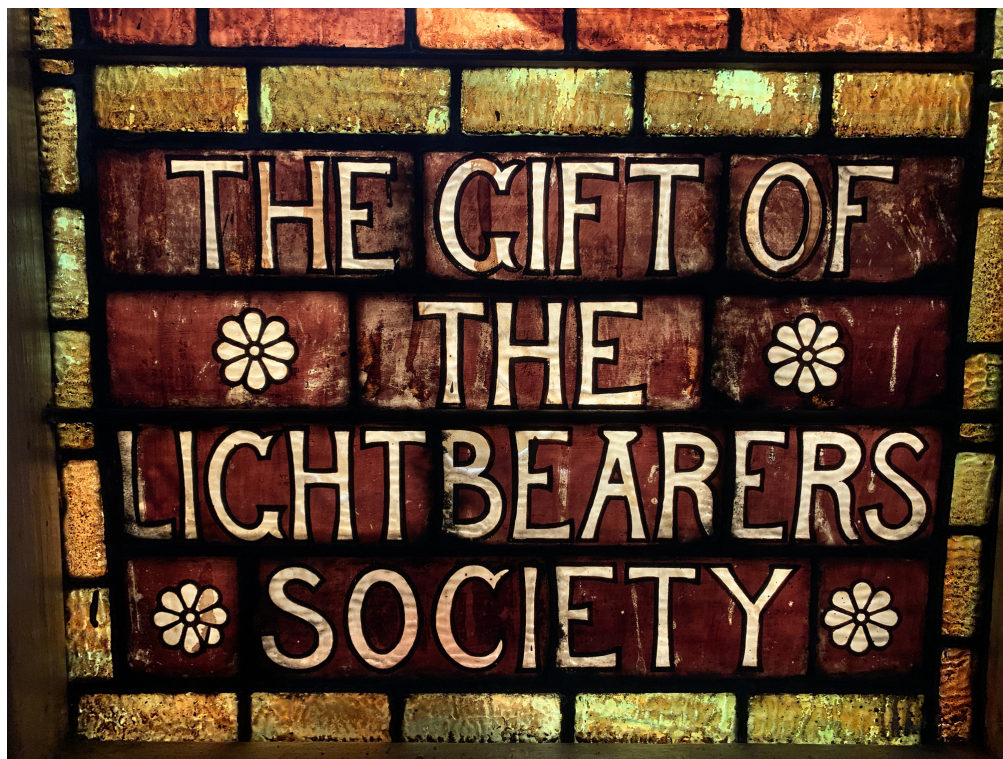
Detail from window S 11. The grisaille (glass paint) shows scratch marks and speckled losses. Cold paint (unfired paint) was applied to the inscription pieces, likely to camouflage the failures of the glass paint. The glass paint should be assumed fragile and handled with care until further testing is conducted.

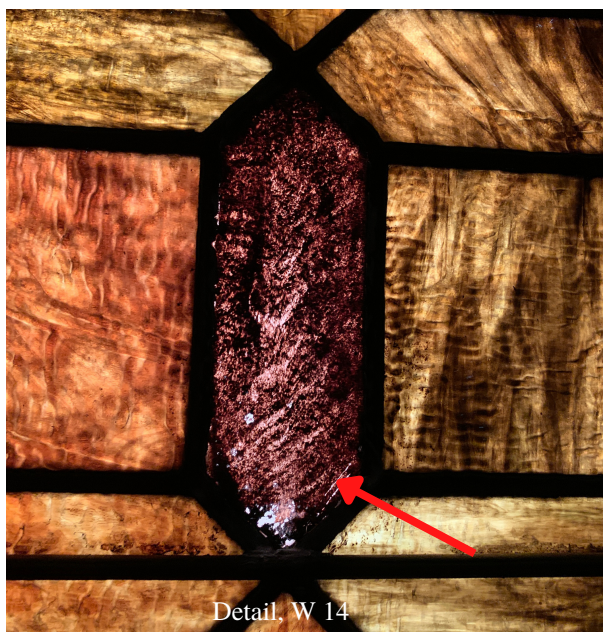
Detail, W 14

Nearly all of the sanctuary windows have been treated with cold paint. It was likely used as a darkening agent to mask bright light and to darken the extensive replacement pieces to blend in with the historic glass. Cold paint, like all material, degrades over time. The cold paint is patchy and has been affected by age and condensation.

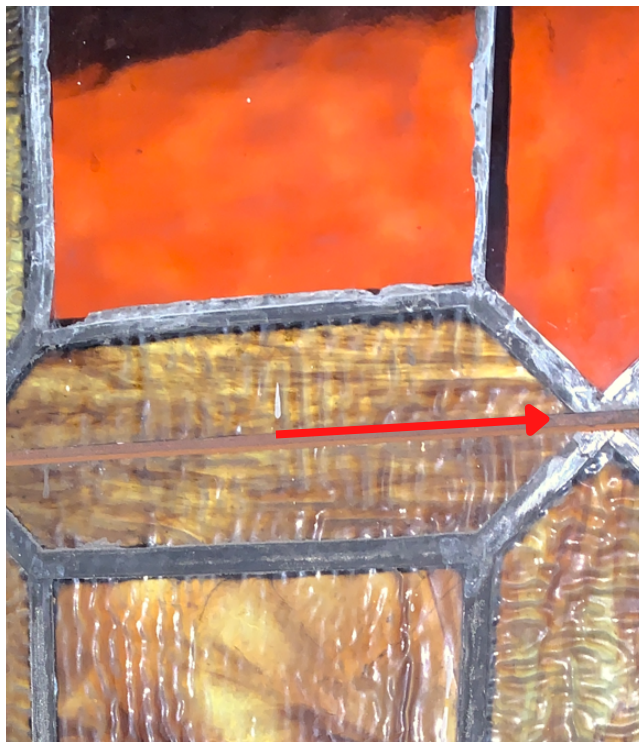
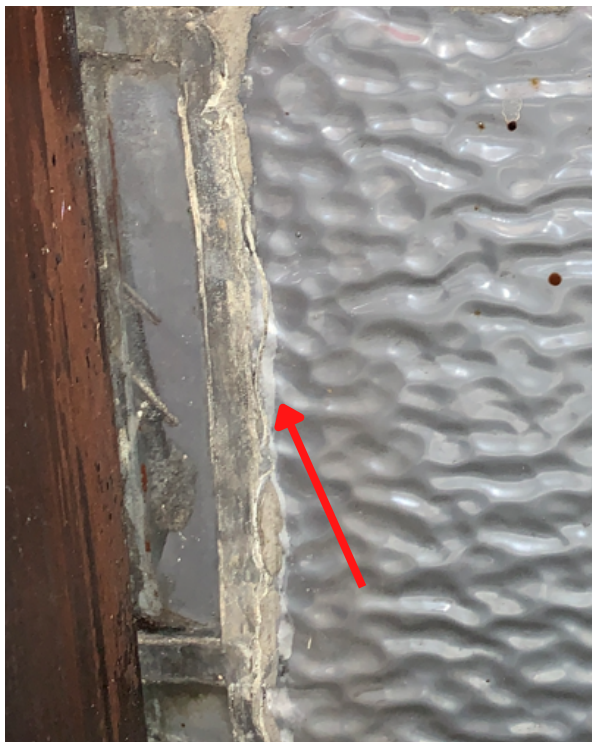
Details of windows S 13 (left) and W 11 (right) showing lead carbonate, a white powdery substance, on the interior lead matrix. Lead carbonate is a by-product of advanced oxidation. It can become friable and should be considered dangerous. The lead has become brittle and is breaking in areas. This condition occurs in 40% of the interiors of the windows.

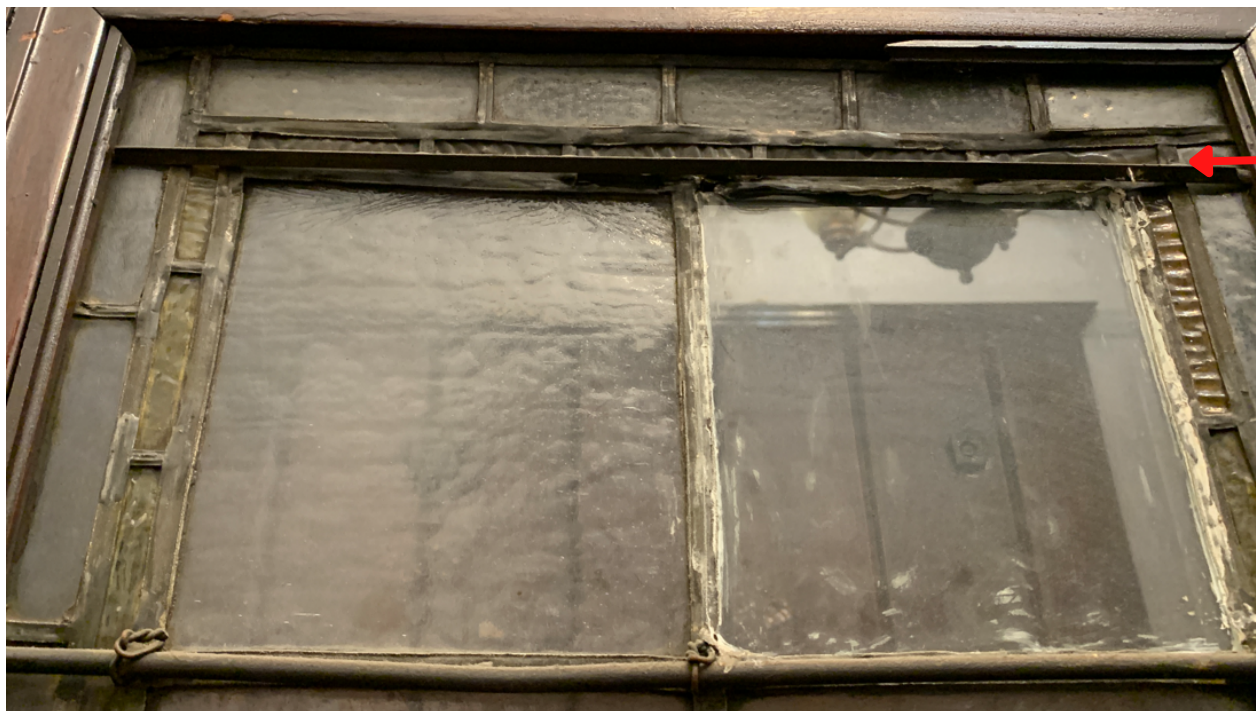
Details of window W 10. Note the lead carbonate, brittle lead came and bowing of the matrix.

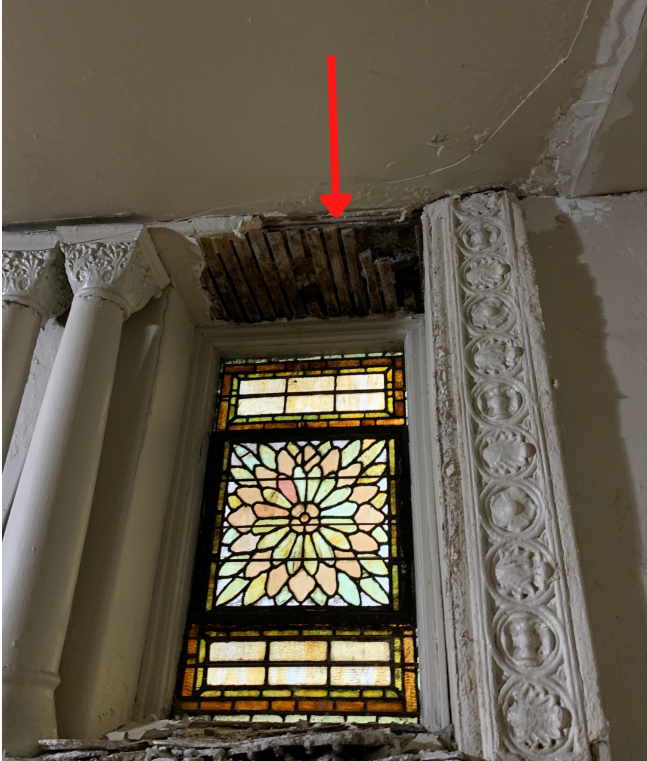
Detail of lost, cracked and damaged plaster in window N 1.

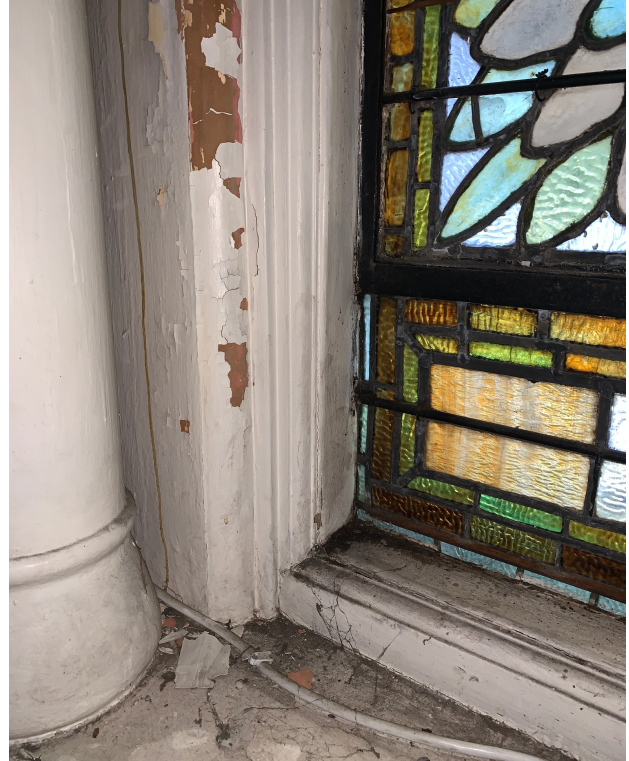
Detail of window S 9 showing chipping interior paint which is typical across the building.

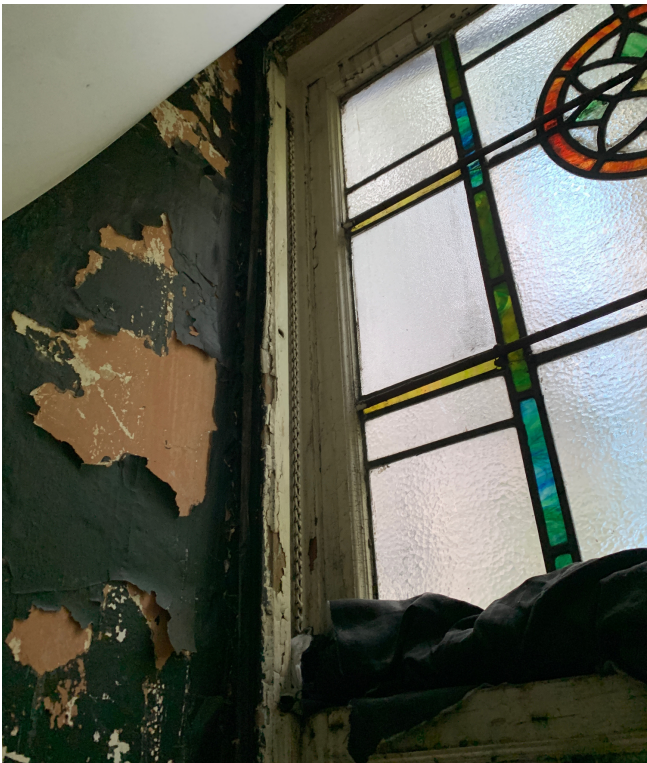
Detail of PHN (Register 1) showing watermarks on the interior of the sash and chipping paint.

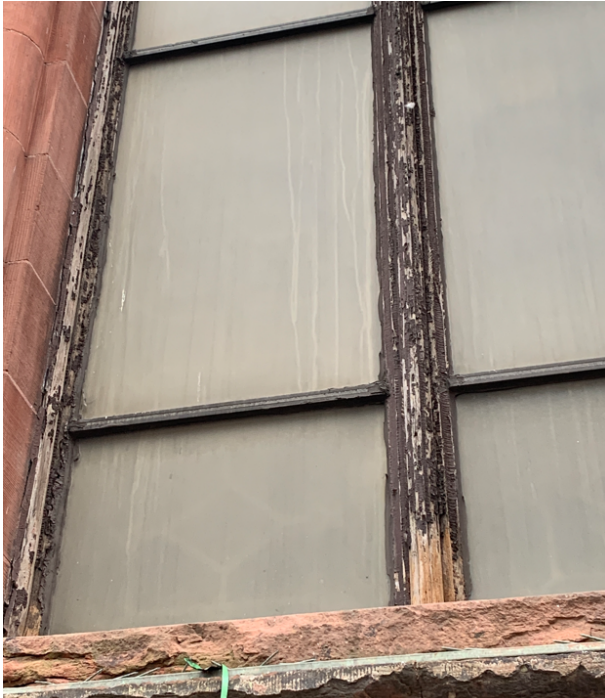
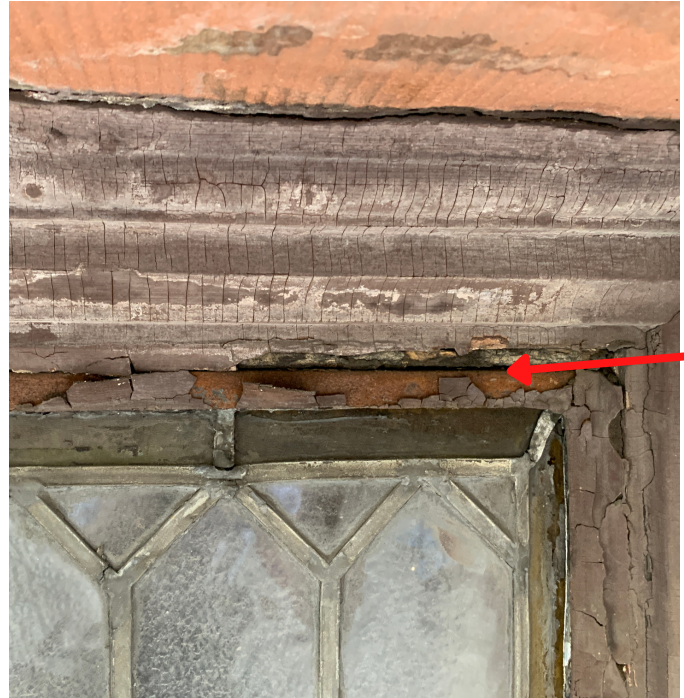
Details illustrating typical exterior wood and steel conditions. The paint has chipped away exposing bare wood and steel. The steel ventilators have rusted.

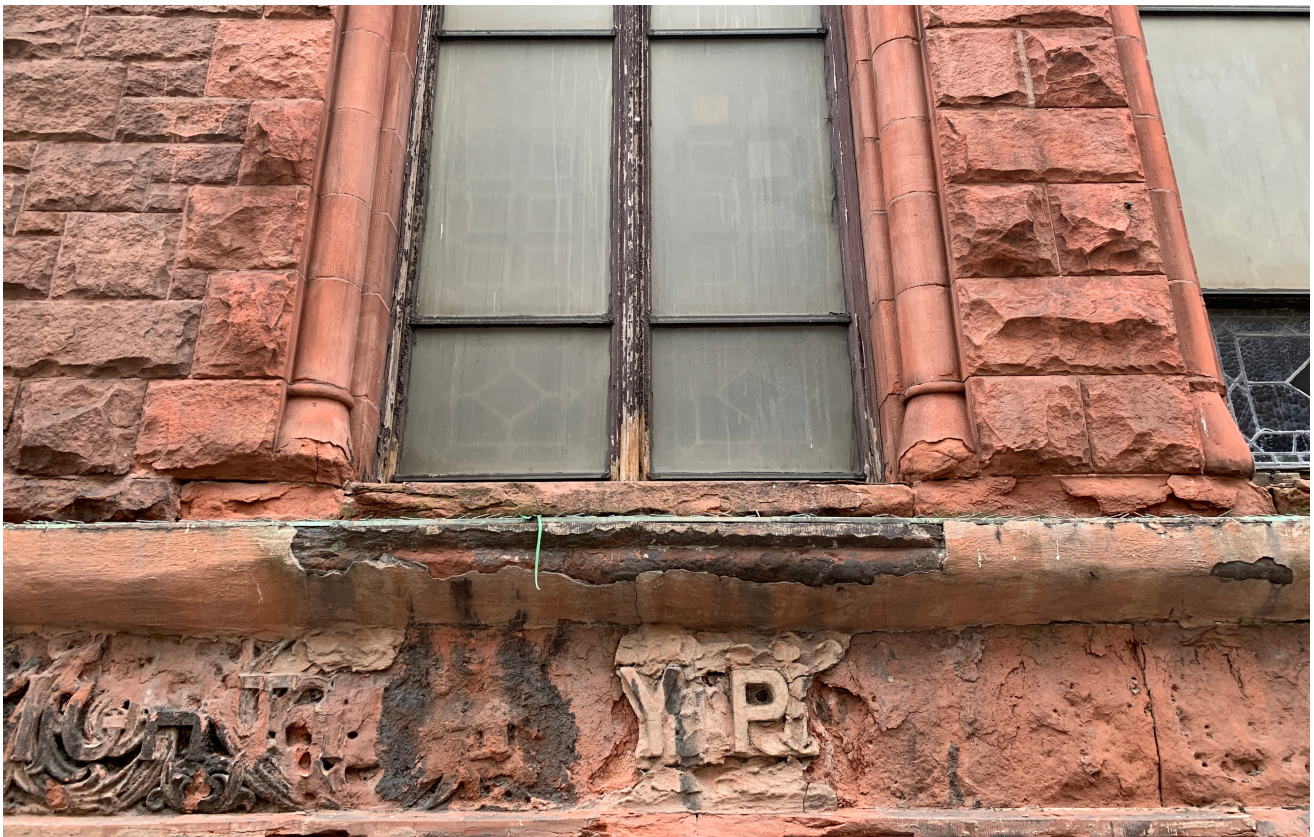
Stone spalling and delamination on the exterior of the West facade. The window sills have eroded.

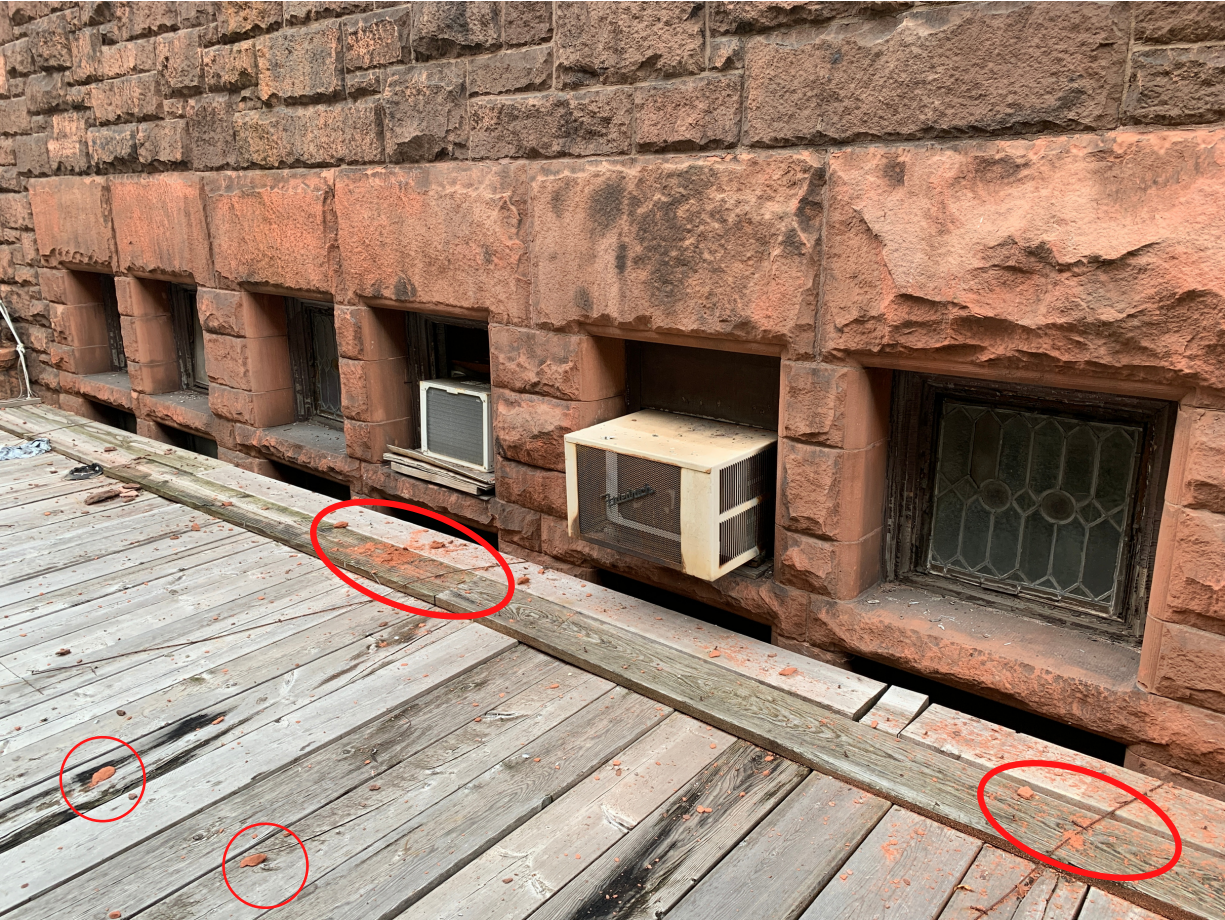
Many panels have been removed to accommodate air condition units across the building. Note the pieces of stone which have fallen on the sidewalk bridge.

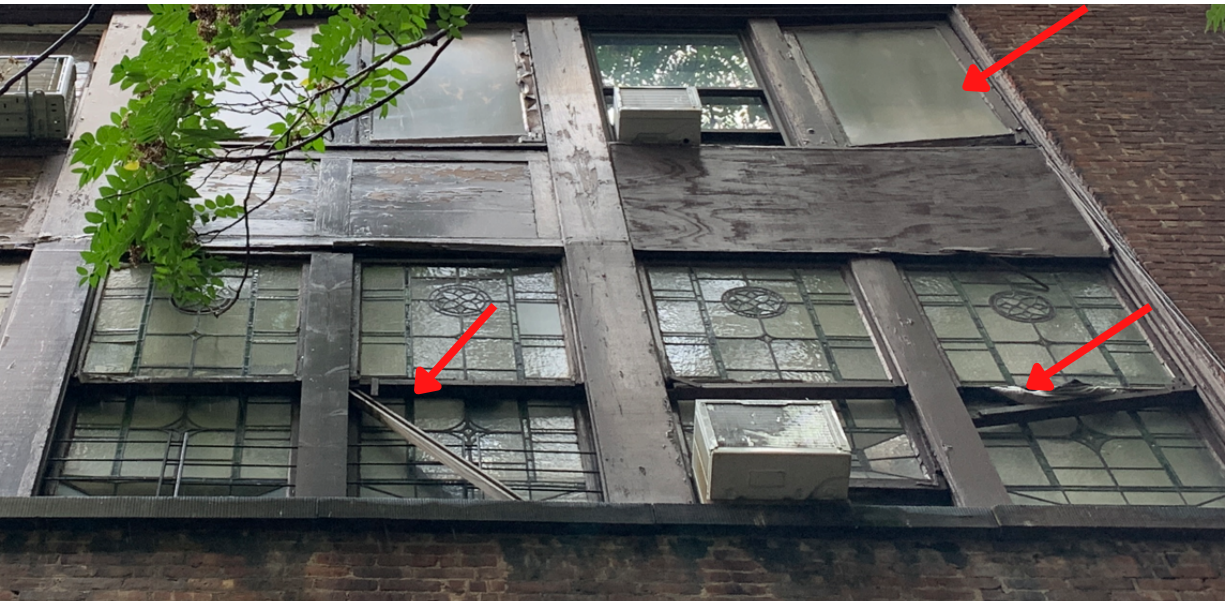
Pieces of the wood sashes and Lexan framing are in danger of falling on the northern side of the parish house. The caulk adhering the Lexan has failed and the Lexan is unstable.

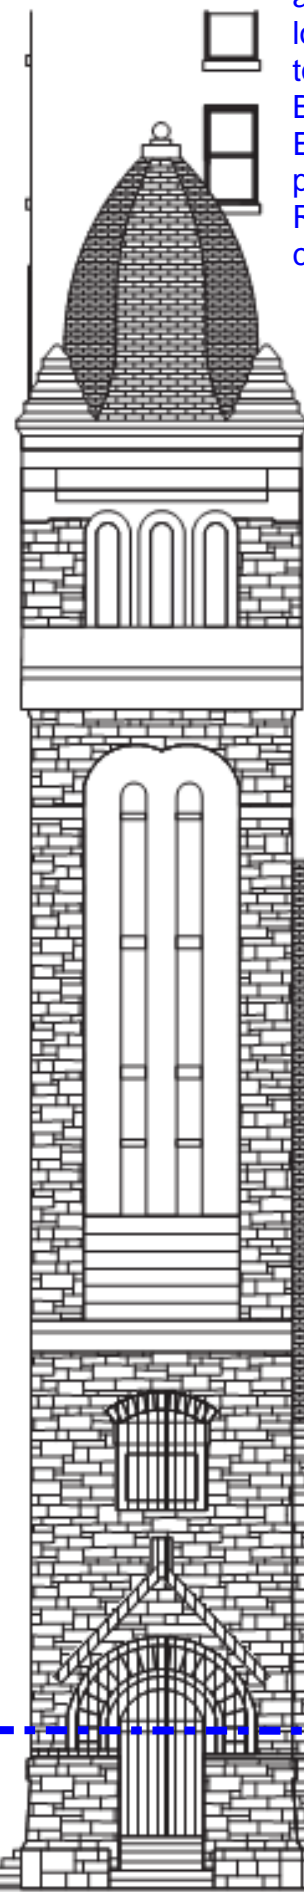
Facade Probe 1-4 - Prior to the removal of brownstone, each area was sounded and scanned with a metal detector, infrared camera and ultrasound. The only pretest that yielded useful information was the ultrasound, which were able to identify some anchor locations, but when stones were removed nearly every anchor had not been installed properly engaged with the stone or deteriorated to the point of being ineffective.
