2023 Report on NYCHA's Mold and Leak Response Efforts: Progress, Challenges and Next Steps

Presented by: NYCHA's Office of Mold Assessment and Remediation

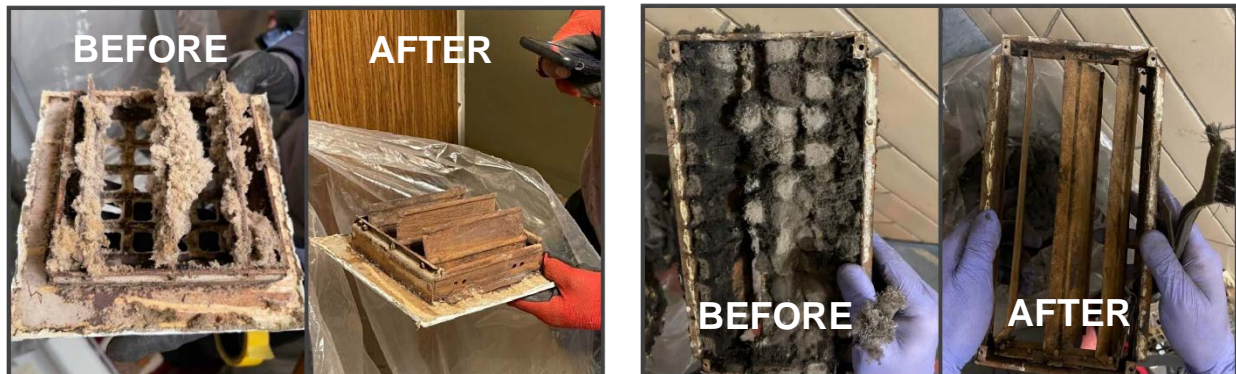
Clean Vent Initiative (CVI)

NYCHA launched its CVI in December 2020 to clean in-unit lateral vents to improve air circulation and air quality in units with mechanical ventilation. As of January 2023, the CVI is 79% complete (vents were cleaned in 68,395 out of 87,268 units). In January 2022, NYCHA started making third attempts to access approximately 30,000 units to clean vents. These units were originally inaccessible because the residents were not home during the first two attempts or because the residents refused cleaning services. NYCHA will continue the third attempt effort for the remaining units, which will be completed in April 2023.

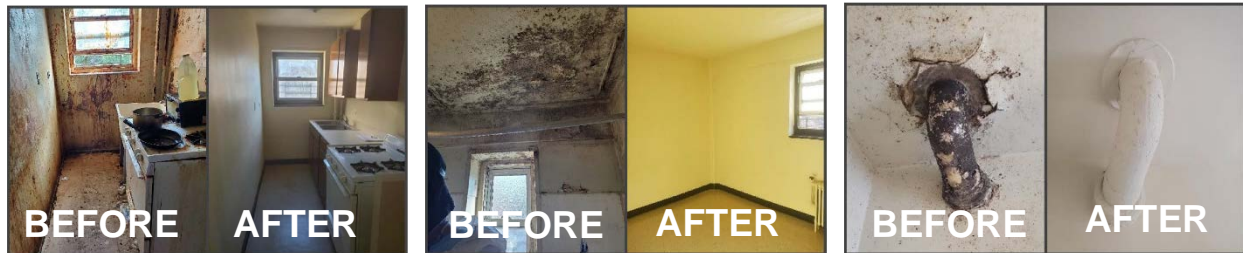
Brownsville – 251 Osborn Street:

For challenging mold and moisture issues, OMAR utilizes specialized vendors for comprehensive mold remediation projects. OMAR restores apartments to safe and sanitary conditions with full-scale mold remediation and the use of mold-resistant paint and paperless sheetrock. Below are photos of improvements from several complex remediation projects.

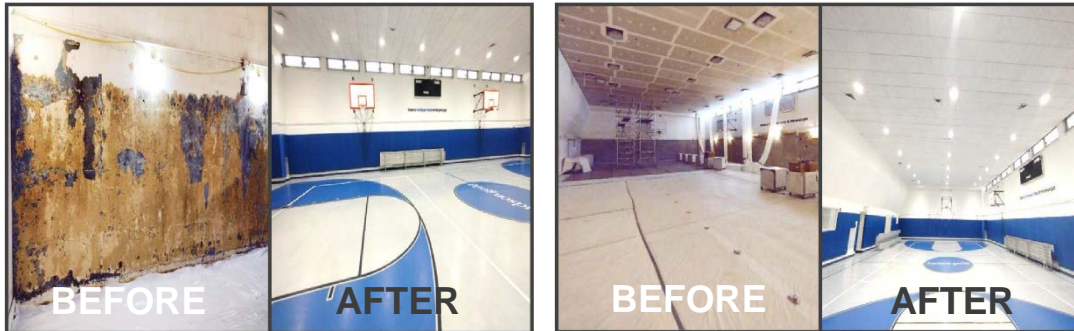
Chelsea Addition – Chelsea Gymnasium – 441 West 26th Street:

OMAR has completed nine complex remediation repairs at several community centers across the five boroughs. Renovating and re-opening these community centers gave access to important youth and senior services and created a safe space for community events. The following three community centers showcase large-scale mold remediation renovations carried out by OMAR:

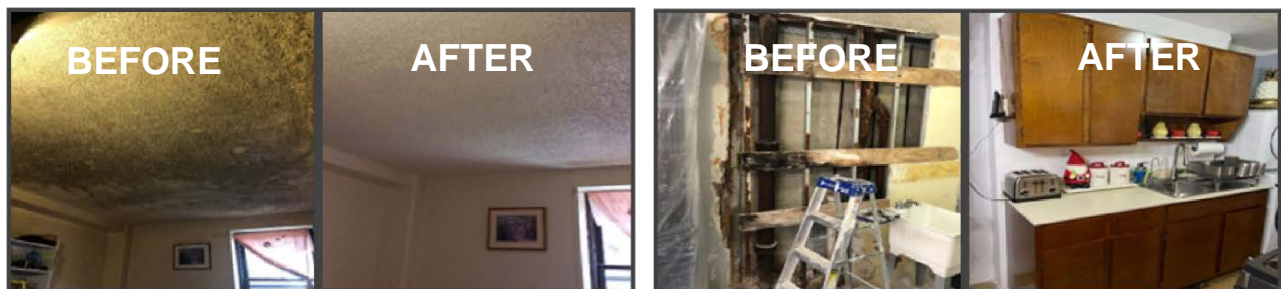
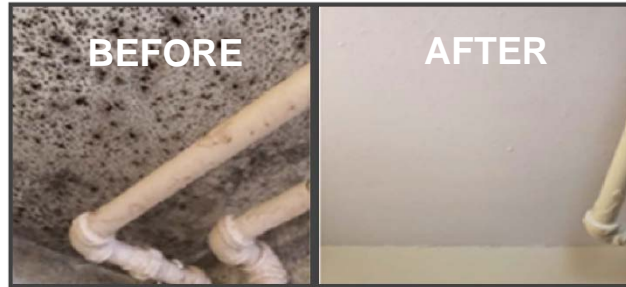
Residents who reach out to the OCC often live with severe conditions that may negatively impact physical and mental health like ongoing leaks or severe mold that result in deteriorated walls, pest infestations, and unhealthy air quality. Resident-reported complaints often involve broken or missing fixtures such as sinks, cabinets, toilets, showers, or exposed holes in the wall from wall breaks made to attempt leak repairs. Some are forced to relocate while units are in disrepair, as some WOs take months or years to be resolved. See below for examples of the conditions originally reported by residents to the OCC and photos after repairs were completed.

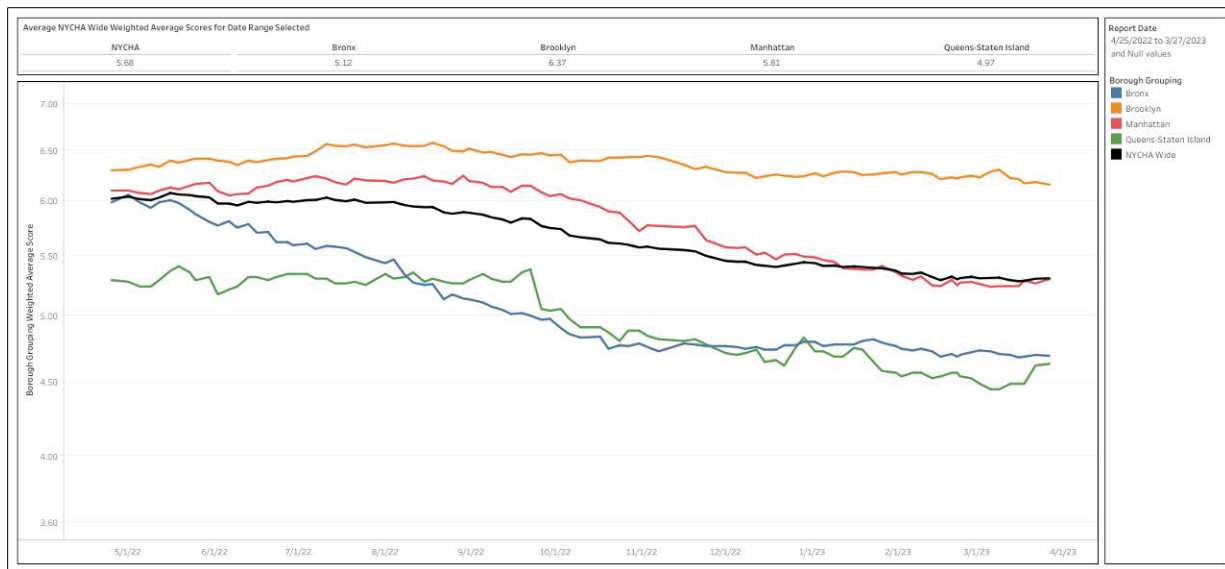
Chart 9: Overall Score Trend⁴⁰

Chart 9 outlines each borough’s performance from March 24, 2022, through March 27, 2023.

⁴⁰ This chart and view display the overall score trend and weighed average score from a selected date range, which in this case is March 24, 2022, to March 27, 2023. The weighted average score of a date range will differ from the weighted average score of a select date. The borough weighted average scores displayed in this view are different from the borough weighted average scores mentioned in this section.

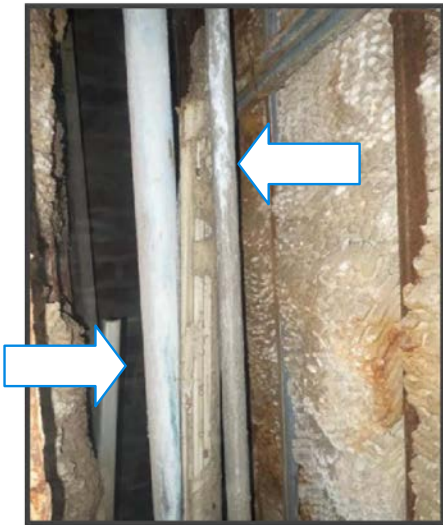
Domestic water risers at Queensbridge North displaying possible chemical reaction or de-zincification of the brass, suggesting that the pipes are at the end of their service life and may be subject to failure in the near term

The findings from the first 21 assessments of this Project (conducted in seven EOP developments) indicate that the domestic water risers (composed of copper/brass) were in good to fair condition. However, in the two units assessed at Queensbridge North⁵⁶, the domestic water risers (and all other pipes within the wall cavity) appear to be approaching the end-of-service life and may be subject to failure in the near term. Further invasive inspection work is necessary to evaluate the interior condition of various types of plumbing pipes and assess the correlation between exterior and interior appearances. During the invasive inspection work at Howard Houses, significant sediment/debris accumulation was observed on the interior of the waste branch line (>90% obstructed), which can be expected to substantially impede water flow and may have other considerations with respect to pipe health over time (e.g., residents using corrosive drainpipe cleaning products). Other observations from the first 21 assessments include evidence of kitchen waste riser leaks in multiple units at Saint Mary's Park and previous waste riser repairs in two units at the development, suggesting that in some instances, local plumbing repairs of waste risers can be effective in situations in which the problem areas can be isolated. In the two units in which previous waste riser repairs were observed, the affected sections had been cut/spliced with new sections of cast iron and without hub fittings. These repairs appear to have been made from the adjacent bedrooms that adjoin the kitchens and could be completed without the need for resident relocation.

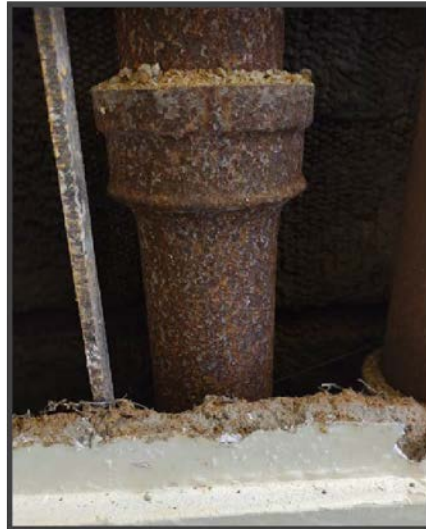
Waste riser at Howard considered to be in poor condition based on exterior physical appearance (excessive exterior corrosion)

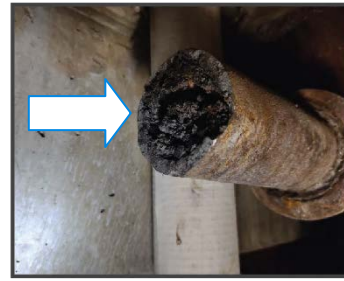
Interior surface of waste branch line (cast iron section) at Howard with significant sediment/debris accumulation
