## A. INTRODUCTION

This chapter assesses the potential of the Proposed Project to affect historic and cultural resources. The Project Site, located in Staten Island’s Tottenville neighborhood, is bounded by the Outerbridge Crossing to the north, Arthur Kill Road to the east, Richmond Valley Road to the south, and the Arthur Kill waterway to the west. As described in greater detail in Chapter 1, “Projection Description,” the Proposed Project is a commercial center with the associated parking, open space, and street and infrastructure improvements.

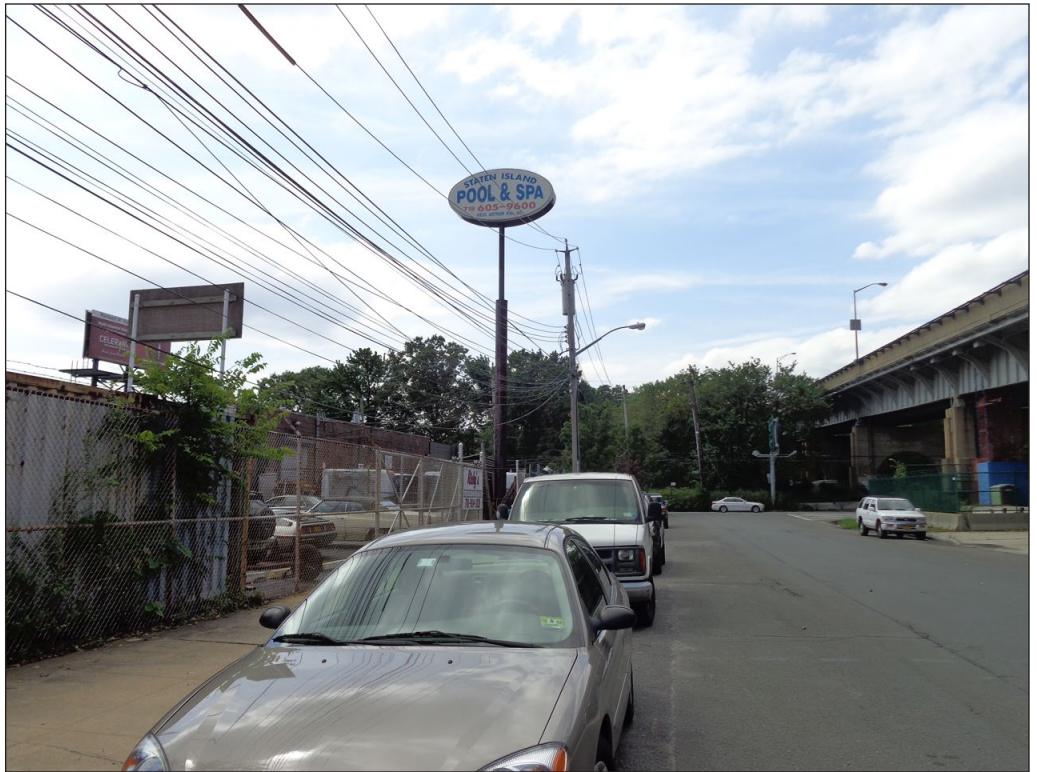
View west of the ramp and bridge supports of the Outerbridge Crossing from South Bridge Street

There is one known architectural resource in the study area: the Outerbridge Crossing (S/NR-eligible). The ramp, bridge supports, and approximately 250 feet of the easternmost portion of the truss of the Outerbridge Crossing are located within the study area (see photos 2 and 3 of **Figures 6-2 and 6-3**). The Outerbridge Crossing is a steel cantilever bridge that connects Tottenville, Staten Island with Perth Amboy, New Jersey. The bridge, built by PANYNJ, was designed by John Alexander Low Waddell and opened simultaneously with the Goethals Bridge on June 29, 1928. Originally called the Arthur Kill Bridge, the bridge was later renamed in honor of Eugenius H. Outerbridge, the first chairman of PANYNJ after it was created in 1921. Completion of the bridge marked the success of PANYNJ’s first bi-state development project. The ramp and bridge supports of the Outerbridge Crossing are located adjacent to the Project Site to the north. The portion of the truss within the study area is located approximately 200 feet west of the Project Site.

With the Proposed Project, public views of the truss, ramp, and bridge supports of the Outerbridge Crossing would remain visible from Arthur Kill Road and from the proposed new waterfront open space. Maintenance of the existing vegetated buffer south of the Outerbridge Crossing would help preserve views of the bridge from Arthur Kill Road. The Proposed Project would also not isolate this architectural resource from its setting, or alter its relationship to the streetscape nor would it introduce an incompatible visual, audible, or atmospheric element to this architectural resource's setting, and would not introduce shadows over a historic landscape or an architectural resource with sun-sensitive features that contribute to that resource's significance. Finally, the proposed project would introduce new waterfront public views of the bridge from the proposed publically accessibly open spaces, which is a benefit of the proposed project. For these reasons, it is concluded that the Proposed Project would not result in any significant adverse indirect impacts on historic architectural resources in the study area. \*

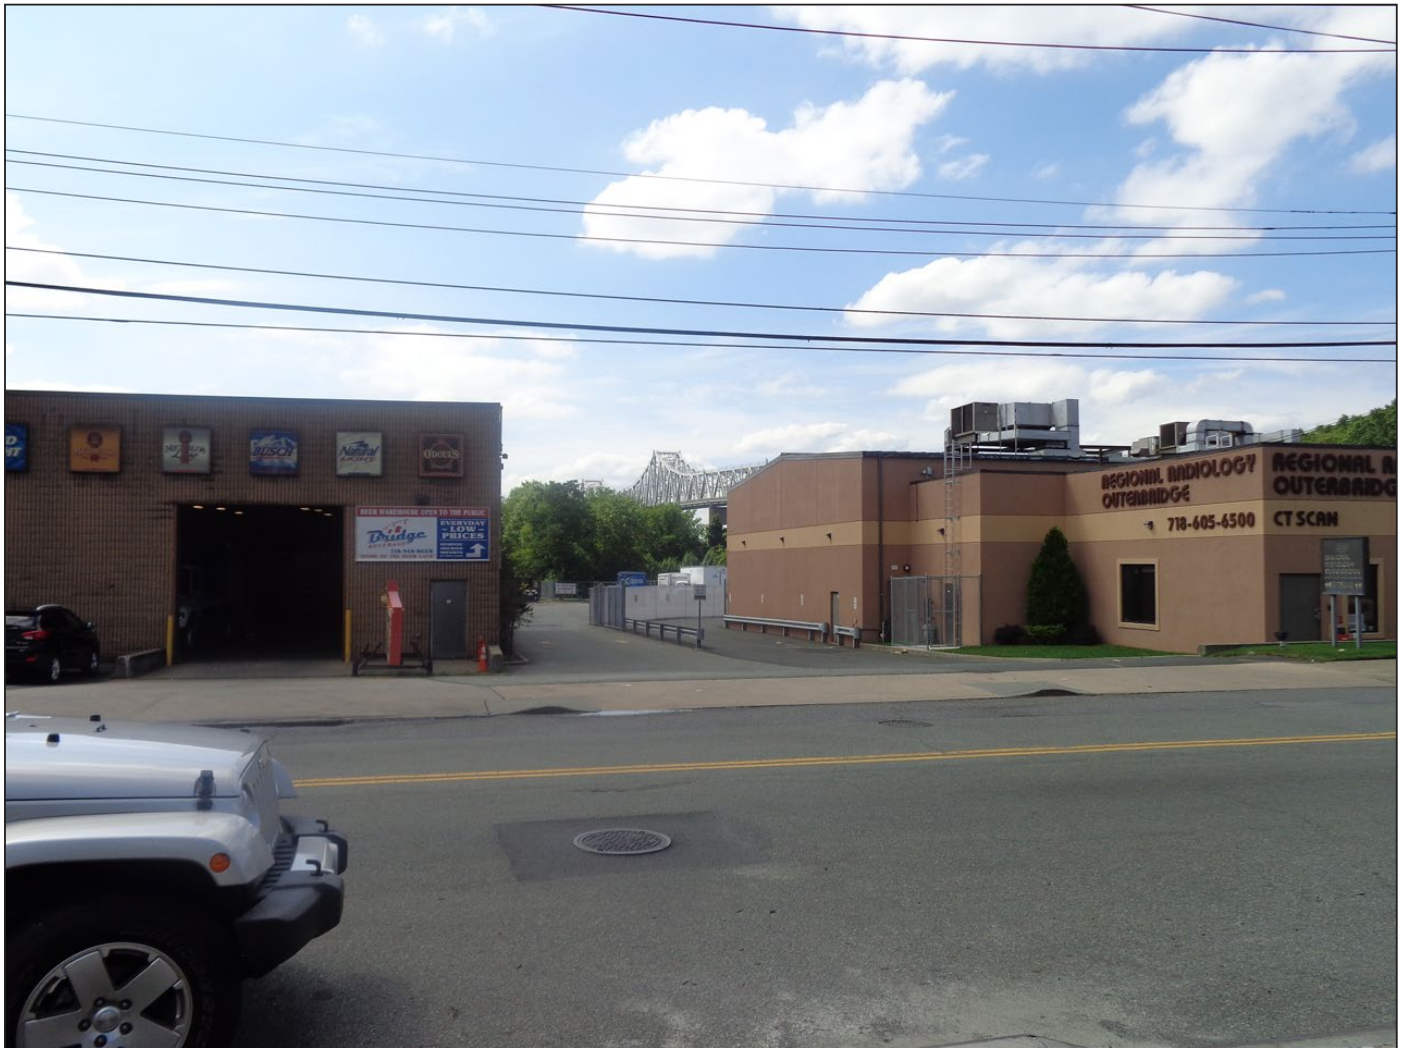
View west of the easternmost portion of the truss of the Outerbridge Crossing from Arthur Kill Road 3
