# Safe Streets for Seniors

## Stuyvesant, Manhattan

**FINAL REPORT**

**November 16, 2010**

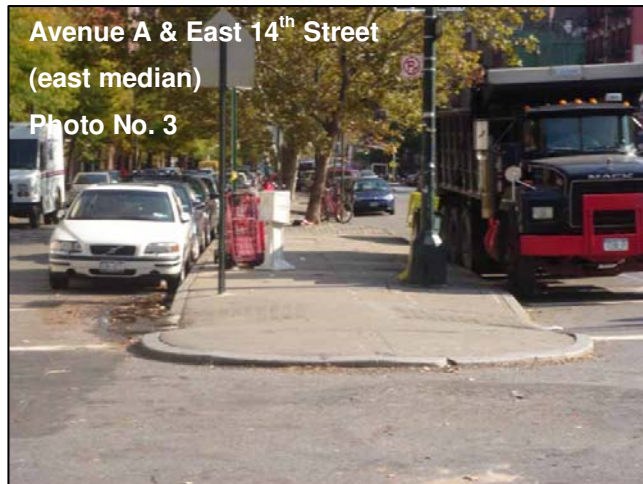
There is an entrance to Stuyvesant Town at Avenue A and East 14<sup>th</sup> Street and bus stops along East 14<sup>th</sup> Street. At this intersection, there are heavy pedestrian volumes, including a significant number of seniors. Many seniors indicated they do not feel safe crossing the street at this intersection. The east median along East 14<sup>th</sup> Street does not have at-grade cut through for pedestrians, making it more difficult for seniors to cross East 14<sup>th</sup> Street (Photo No. 3). It is recommended that the median have an at-grade cut through with an ADA safety surface installed. It is also recommended that pedestrian signals be installed on the west and east median islands. Sight lines to the current signals are not direct and the signals can be difficult to detect.

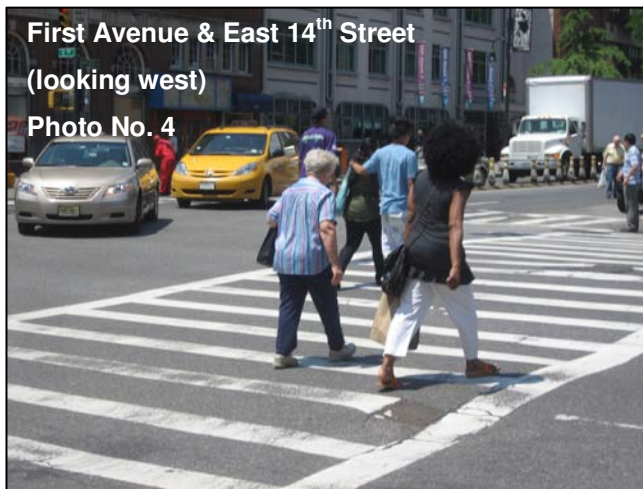
The intersection of First Avenue and East 14<sup>th</sup> Street has heavy vehicular and pedestrian volumes with an exclusive left turn signal for eastbound to northbound traffic (Photo No. 4). The exclusive left turn shortens the crossing time and many seniors raised concerns about this particular intersection. Additional pedestrian traffic is generated from the 'L' Train entrances/exits at this intersection and the three bus stops. The pedestrian ramp

along the north side of the median should be replaced with a NYCDOT standard pedestrian curb configuration and ADA safety surface. A new East 14<sup>th</sup> Street sign is recommended to be hung over First Avenue. The oversized sign will allow motorists to determine their location so they can concentrate on the traffic/pedestrian conditions.

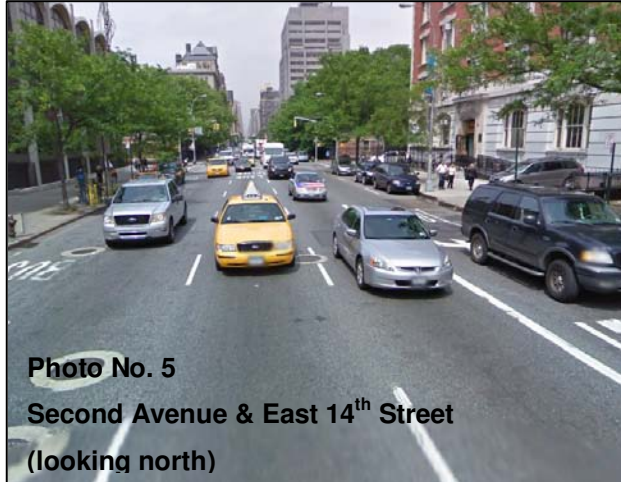
Second Avenue is a 57-foot wide southbound corridor with 3 moving lanes and parking on both sides (Photo No. 5). As discussed under First Avenue, New York City Transit in conjunction with the New York City Department of

A pedestrian ramp is missing on the northwest corner of East 13<sup>th</sup> Street and Second Avenue. A new NYCDOT standard pedestrian ramp and ADA safety surface is recommended. High-visibility crosswalks are recommended for all four legs of East 13<sup>th</sup> Street and East 14<sup>th</sup> Street.

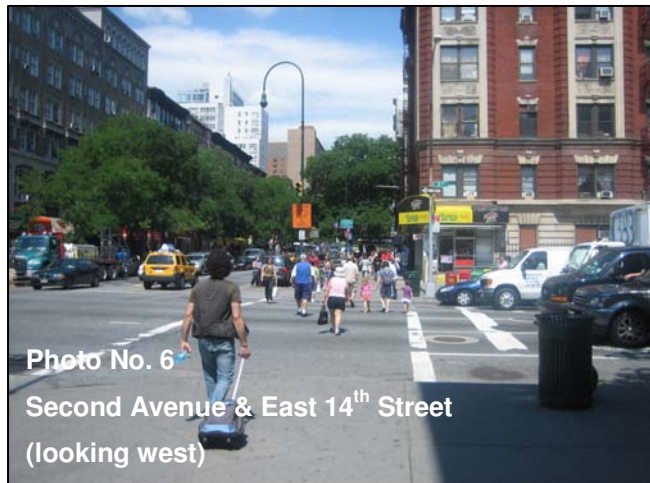
Many of the senior residents interviewed, indicated that there was not enough time to cross Second Avenue. It was observed that vehicles speed to the intersection to make both left and right turns from Second Avenue onto East 14<sup>th</sup> Street, before pedestrians could cross. This further shortens the crossing time, as pedestrians need to wait for vehicles to clear the intersection (Photo No. 6). Turning movement counts for the AM and PM peak periods were performed on 06/09/08. For southbound traffic turning right, the PM peak counts indicated that

491 pedestrians conflict with 85 vehicles turning per hour. For southbound traffic turning left, the AM peak counts indicated that 294 pedestrians conflict with 197 vehicles turning per hour (see Appendix C for complete traffic count). A Leading Pedestrian Interval (LPI) was evaluated at this intersection but the existing volume did not meet NYCDOT guidelines to warrant an LPI. The existing dedicated left turn signal for westbound traffic along

East 14<sup>th</sup> Street will be eliminated and the westbound to southbound turn will be banned at this intersection. Pedestrians often ignore the DON'T WALK signal when westbound East 14<sup>th</sup> Street has the dedicated left arrow, and this modification could help to eliminate pedestrian/vehicle conflict and also process more traffic.

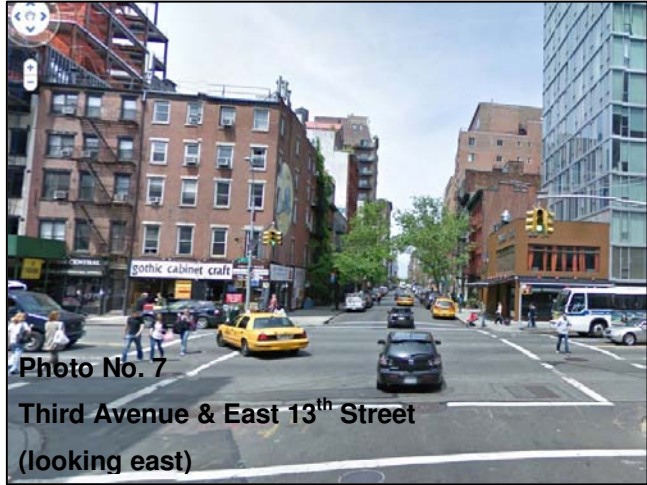
**Photo No. 7**  
**Third Avenue & East 13<sup>th</sup> Street**  
**(looking east)**

Third Avenue is a 70-foot wide corridor with two moving lanes in each direction with parking on both sides. High-visibility crosswalks are recommended for all four legs of Third Avenue and East 13<sup>th</sup> Street (Photo No. 7).

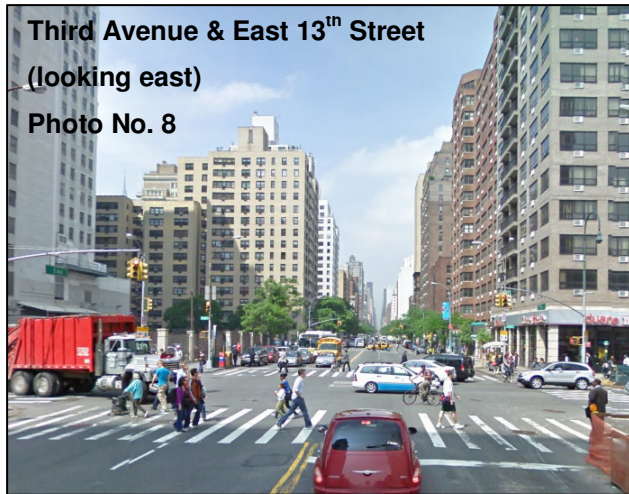
**Third Avenue & East 13<sup>th</sup> Street**  
**(looking east)**  
**Photo No. 8**

Third Avenue and East 14<sup>th</sup> Street is a congested intersection with heavy truck, bus and pedestrian volumes (Photo No. 8). It was observed that westbound and eastbound traffic on East 14<sup>th</sup> Street turning onto Third Avenue were not yielding to pedestrians crossing the north leg of the intersection.

Turning movement counts for the AM and PM peak periods were performed on 06/10/08. The PM peak counts indicated that 1298 pedestrians conflict with 174 vehicles (68 westbound + 106 eastbound) turning per hour (see Appendix C for complete traffic count). In order to lengthen the pedestrian crossing time, A Leading Pedestrian Interval (LPI) was evaluated at this intersection; however, the existing volume did not meet NYCDOT guidelines to warrant an LPI.

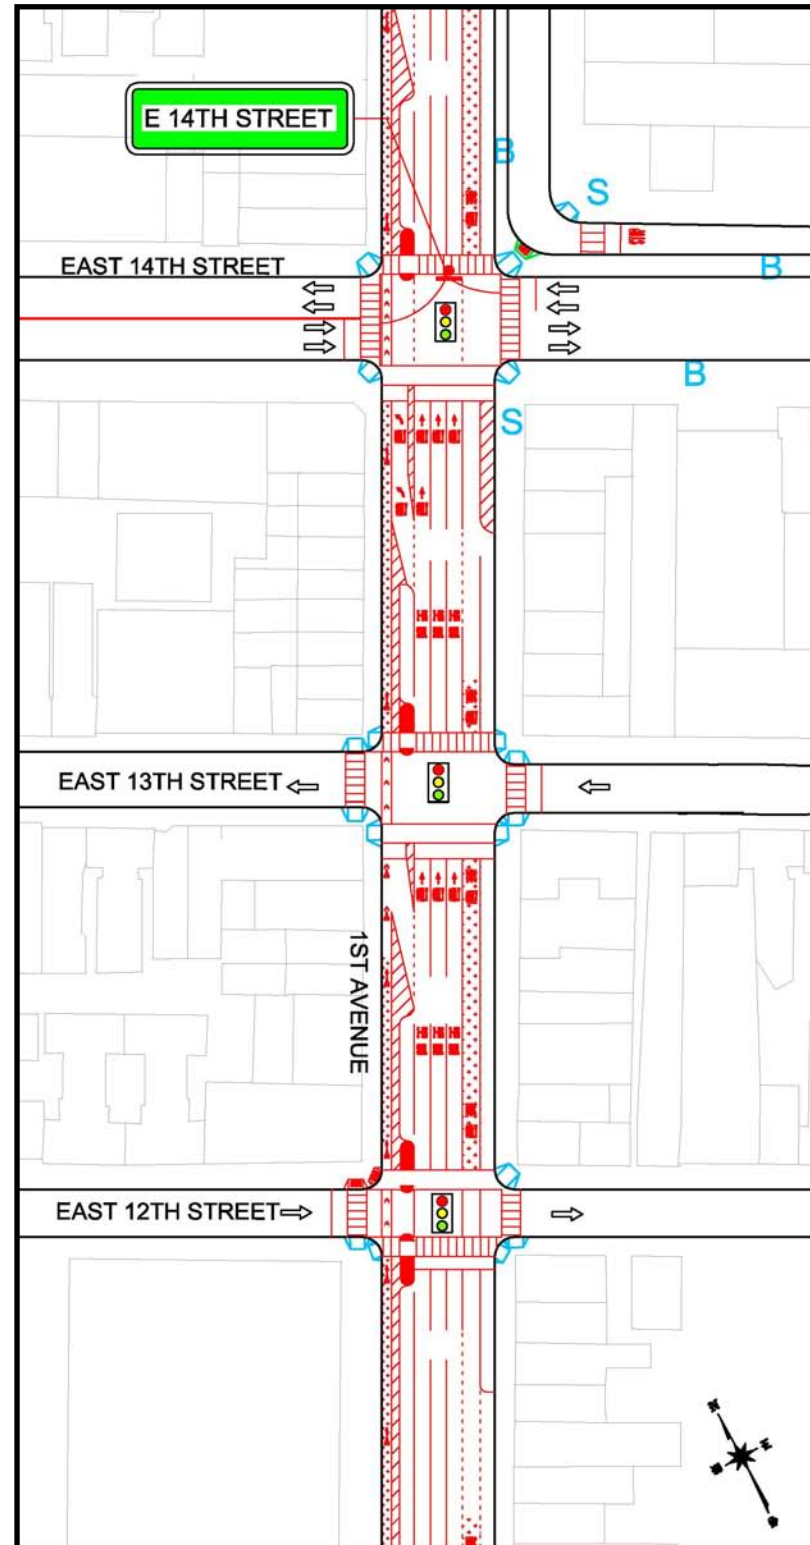
# SITE 2: FIRST AVENUE (FROM EAST 12<sup>TH</sup> STREET TO EAST 14<sup>TH</sup> STREET)

- Speeding vehicles
- Turning vehicles not yielding to pedestrians
- Signal timing (insufficient crossing time)
- Missing or inadequate pedestrian ramps

**Traffic Analysis:**  
Speed study on East 12<sup>th</sup> Street between 1<sup>st</sup> & 2<sup>nd</sup> Avenue

- 85<sup>th</sup> Percentile = 23.0 mph

- Time all signals for seniors and where feasible, the crossing time will be extended
- Install new advanced stop bars
- Install Bus Rapid Transit (BRT) along First Avenue
- Install new sign  
-oversized E 14<sup>th</sup> Street sign to be hung over First Avenue

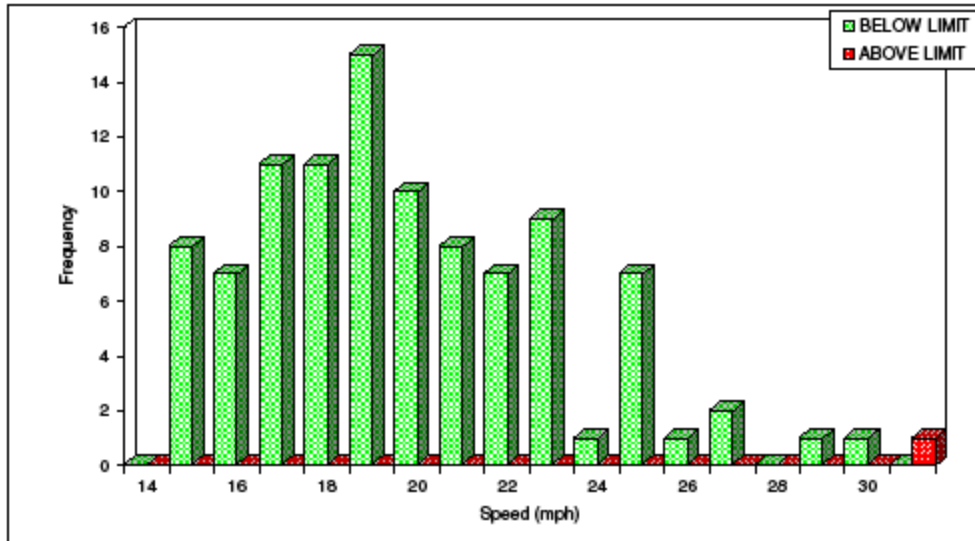
**APPENDIX D – SPEED STUDY  
EAST 12<sup>TH</sup> STREET BETWEEN FIRST AVENUE & SECOND AVENUE**

Boro:	Manhattan	Average Speed:	20.0 mph
Date:	07/21/08	15th Percentile:	16.9 mph
Day:	Mon.	50th Percentile:	19.0 mph
Weather:	Clear	85th Percentile:	23.0 mph
Time:	12:45PM-1:45PM		
Speed Limit:	30 mph	Above Speed Limit:	1.0 %
Sample Size:	100	Minimum Speed	15.0 mph
		Maximum Speed	31.0 mph
Type of Roadway:	One-Way	Pace:	15.0 - 25.0 mph
Width of Road by Direction:	30'	In Pace:	94.0 %
Number of Moving Lanes:	1	Below Pace:	0.0 %
Number of Parking Lanes:	2	Above Pace:	6.0 %
Observer:	B. Patel	Standard Deviation:	3.5 mph
