West Side Transportation Study (Began 2007)

West Side Manhattan Transportation Study Technical Memorandum No. 2

Existing Conditions – W72nd St

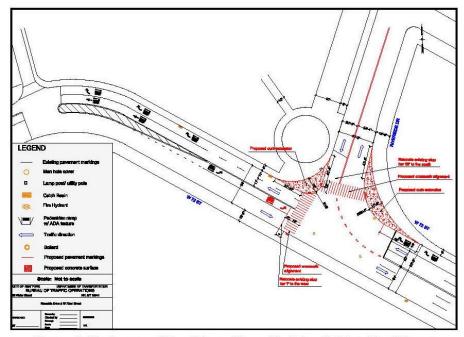
Figure 3-2b: Proposed Condition - Riverside Drive & West 72nd Street

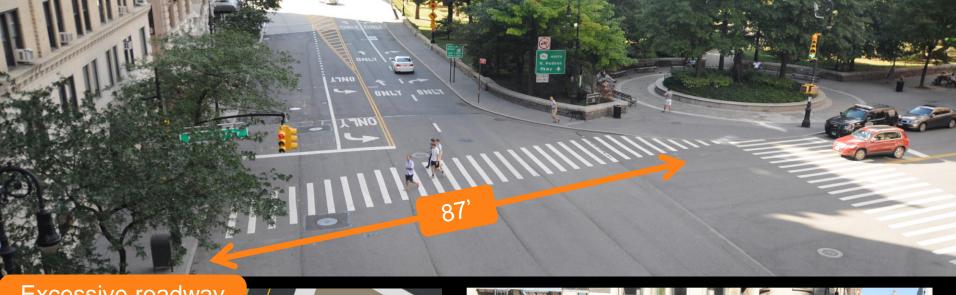
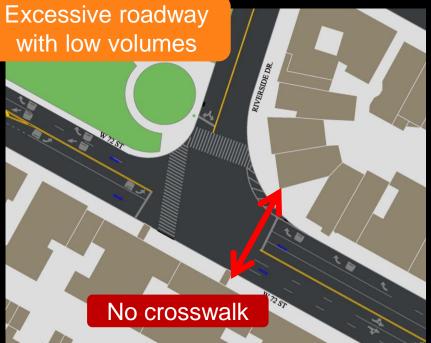
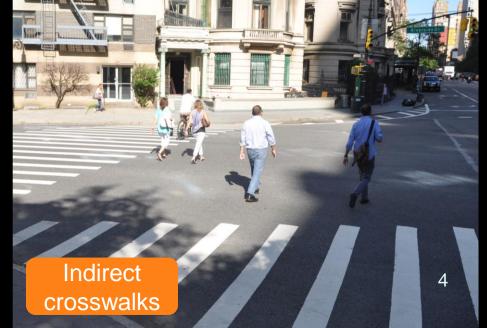
Overly wide intersection

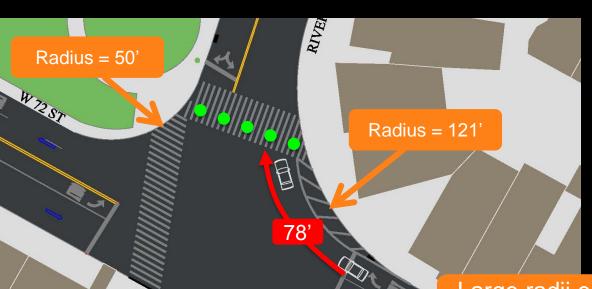
Typical Radius = 12'

Large radii encourages high speeds

Long distance allows cars to accelerate as they approach crosswalk

Poor sight lines due to wide intersection

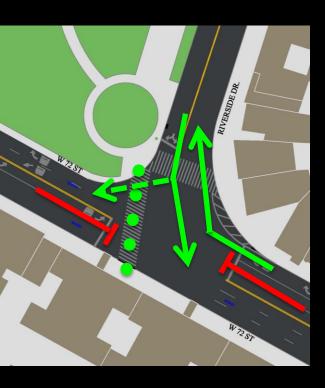
Phase A: Riverside Dr 44 secs

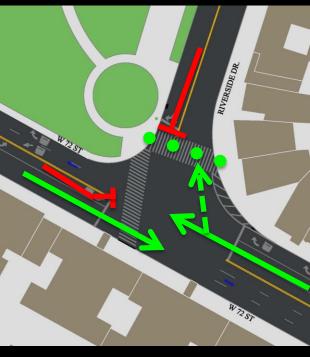
Phase B: W72nd St 35 secs

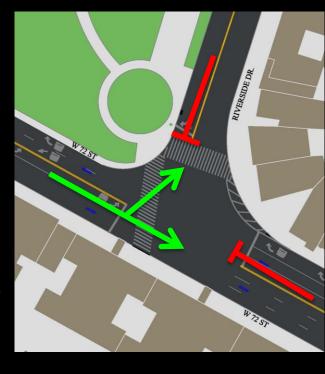
Phase C: W72nd Left Turn 11 secs

Separate phase for 35 left turns in the peak hour

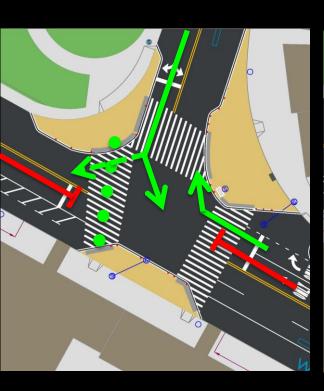
Phase A: Riverside Dr 35 secs

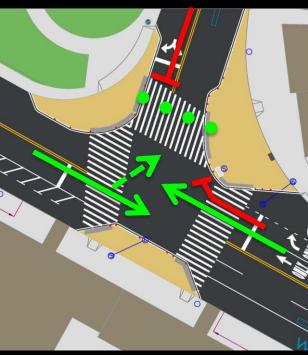
Phase B: W72nd St 30 secs

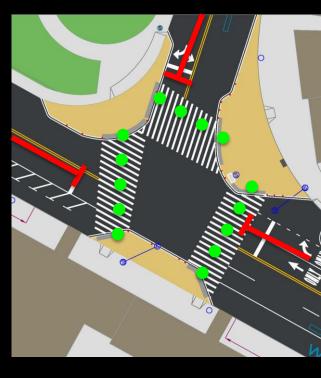
Phase C: All Pedestrian 25 secs
