Astoria Boulevard – 105th St to Ditmars Blvd

2016

Project Extents

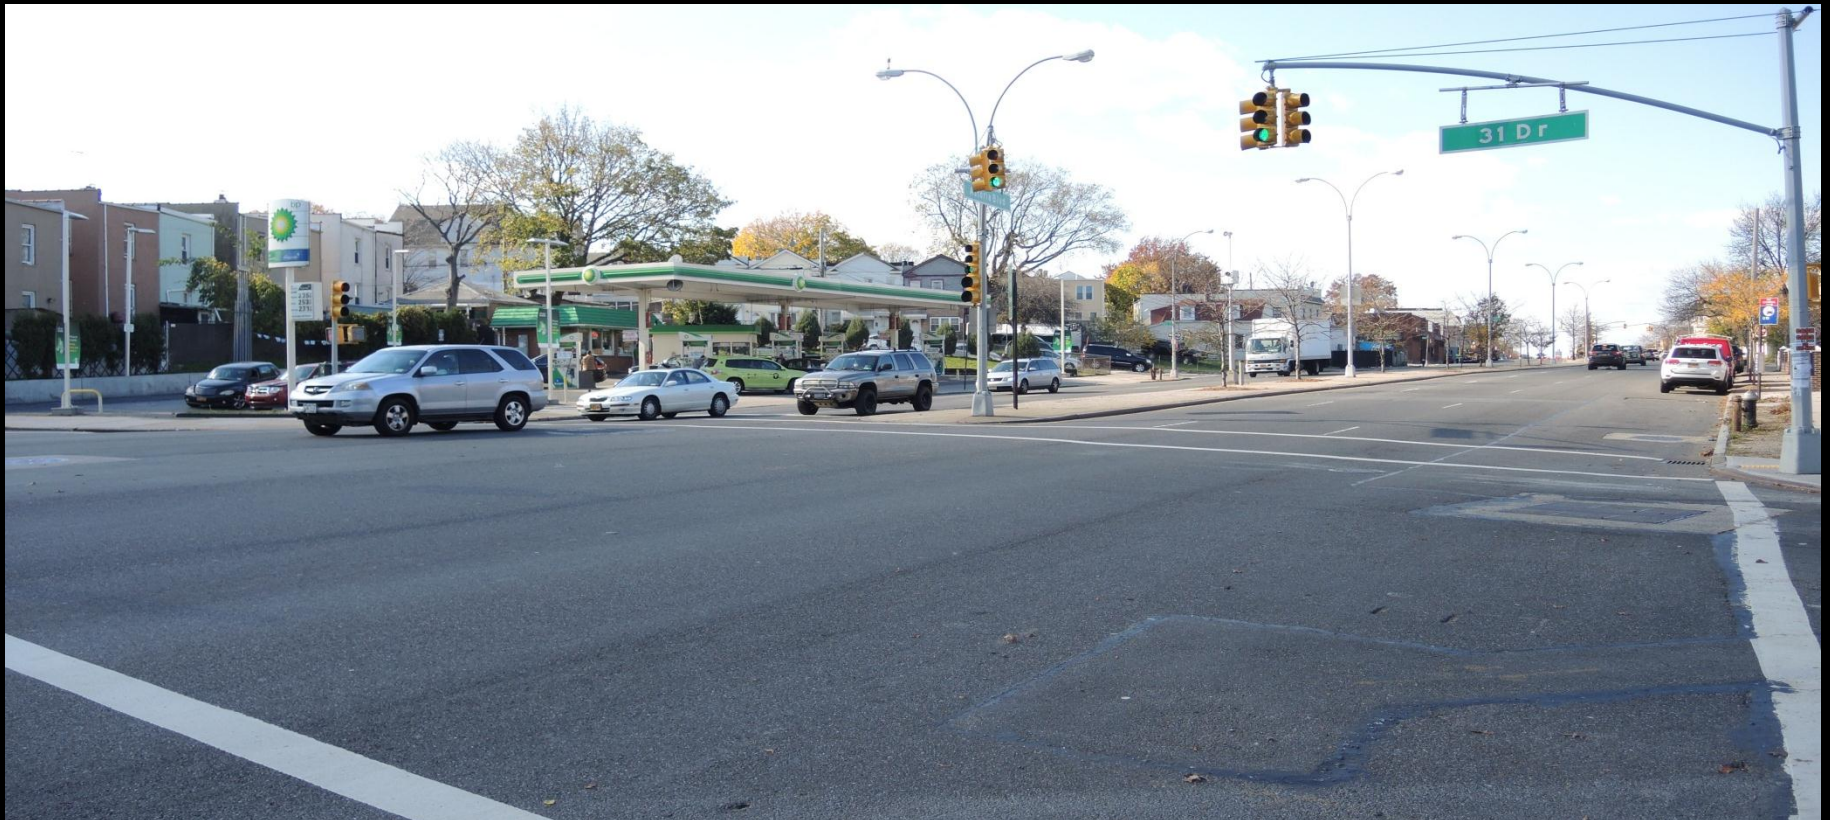
Phase I – Astoria Blvd between
99th St and 105th St
Approved by Board in May 2015

Phase II – Astoria Blvd between
105th St and Ditmars Blvd

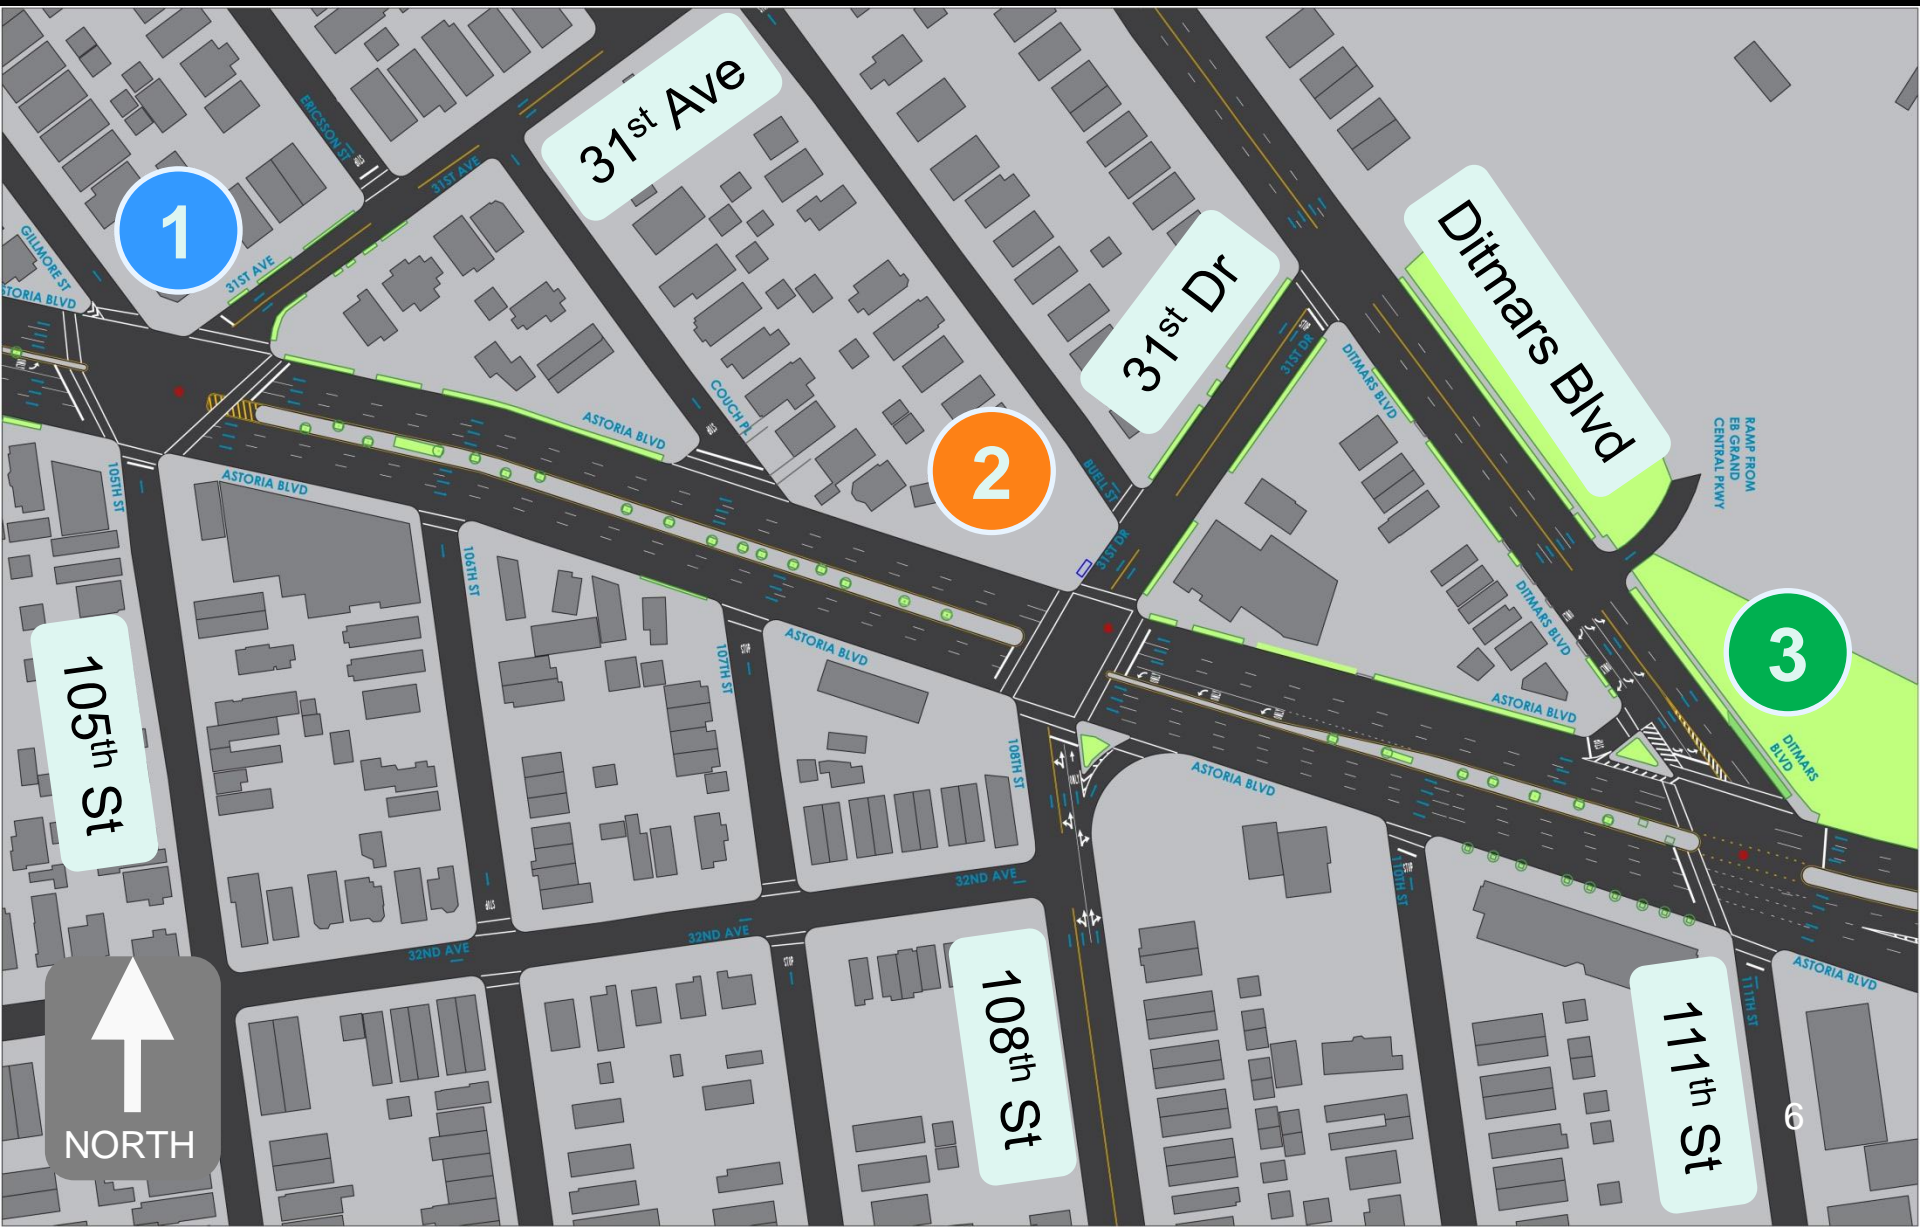
Project Intersection Locations

Astoria Blvd and 105th St

1

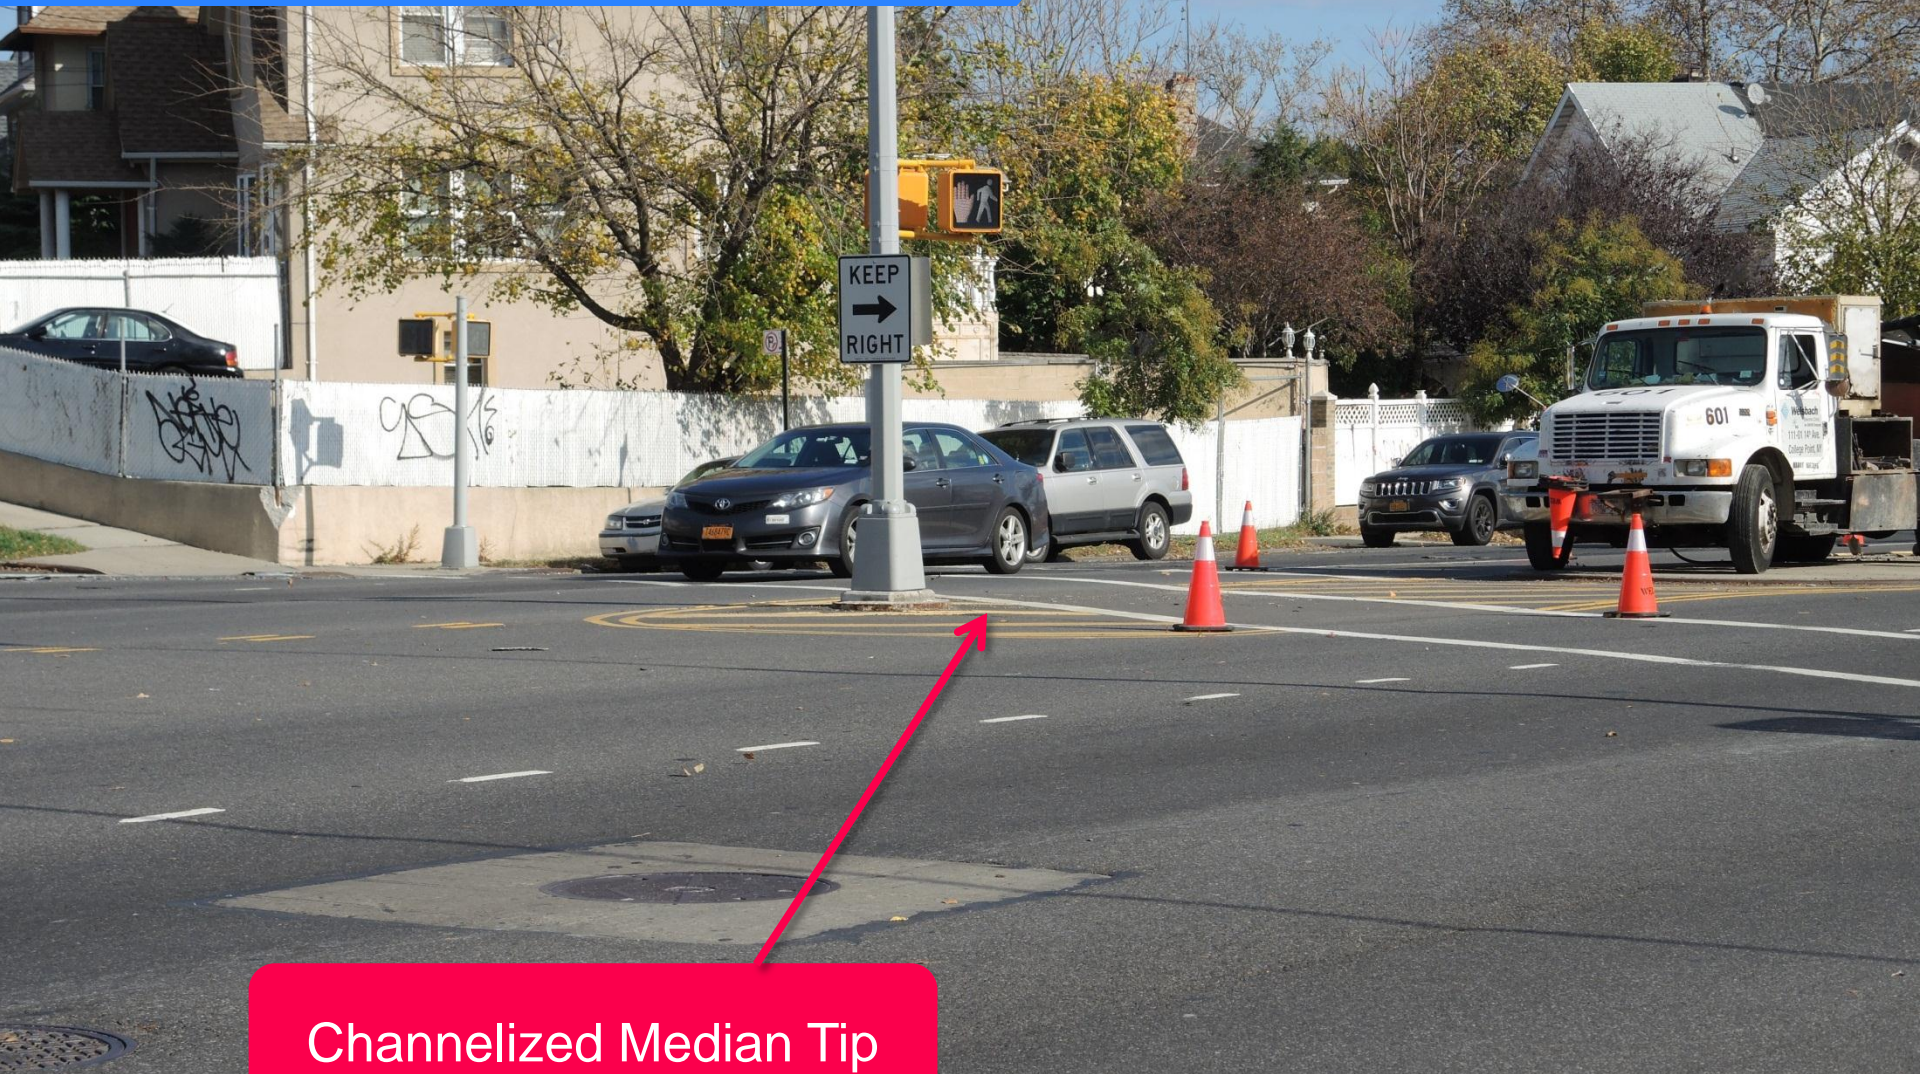
Channelized Median Tip

View looking Northeast

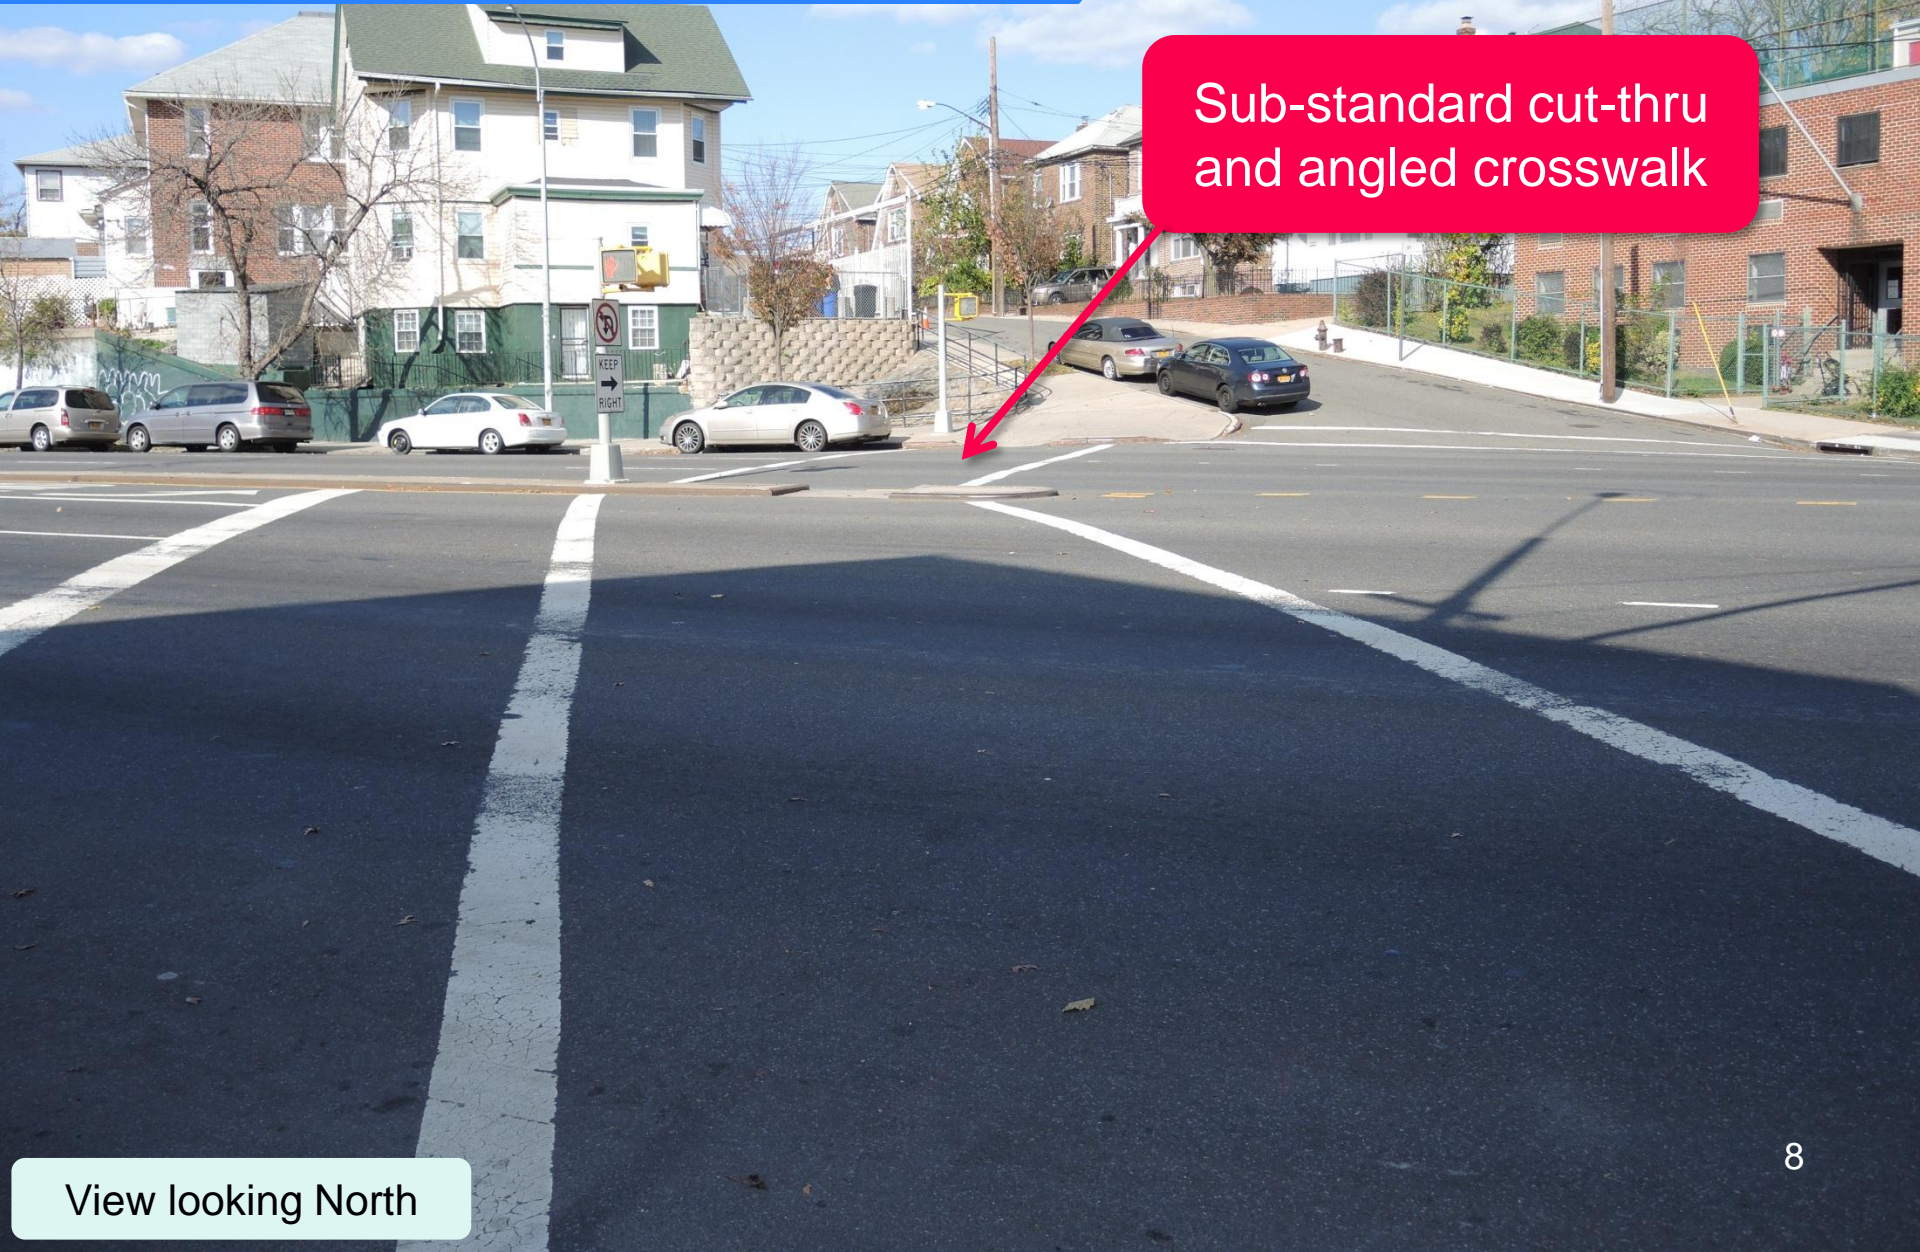
Astoria Blvd and 105th St

Sub-standard cut-thru
and angled crosswalk

View looking North

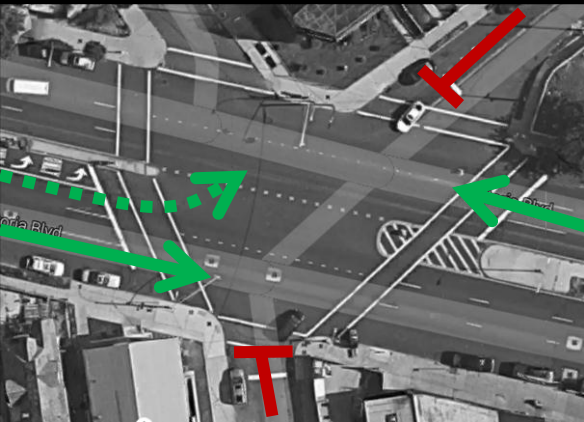
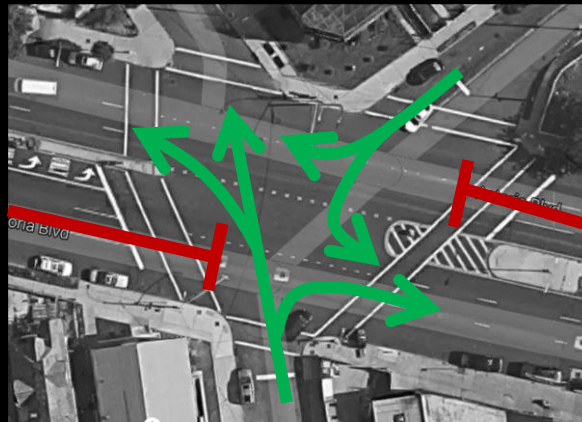
EXISTING

North/South goes at same time

- Create three phase signal to separate north/south movements and reduce vehicular conflicts

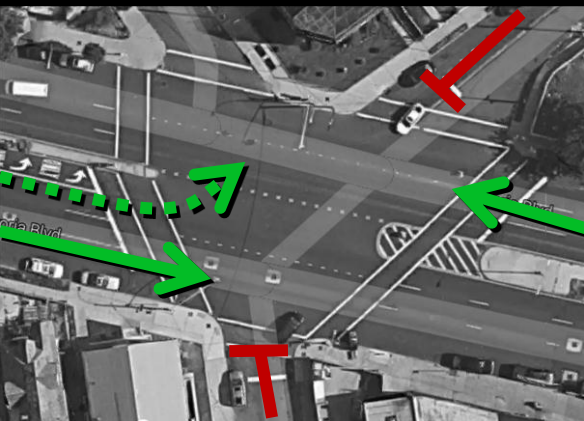
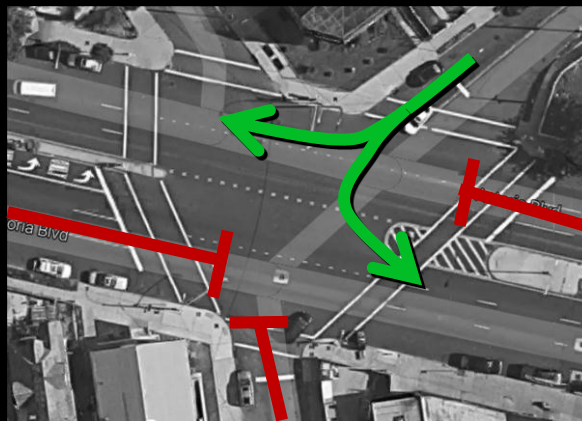
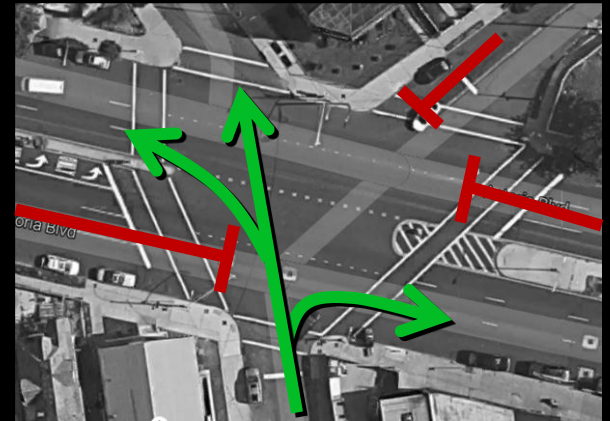
PROPOSED

Southbound Phase

Northbound Phase

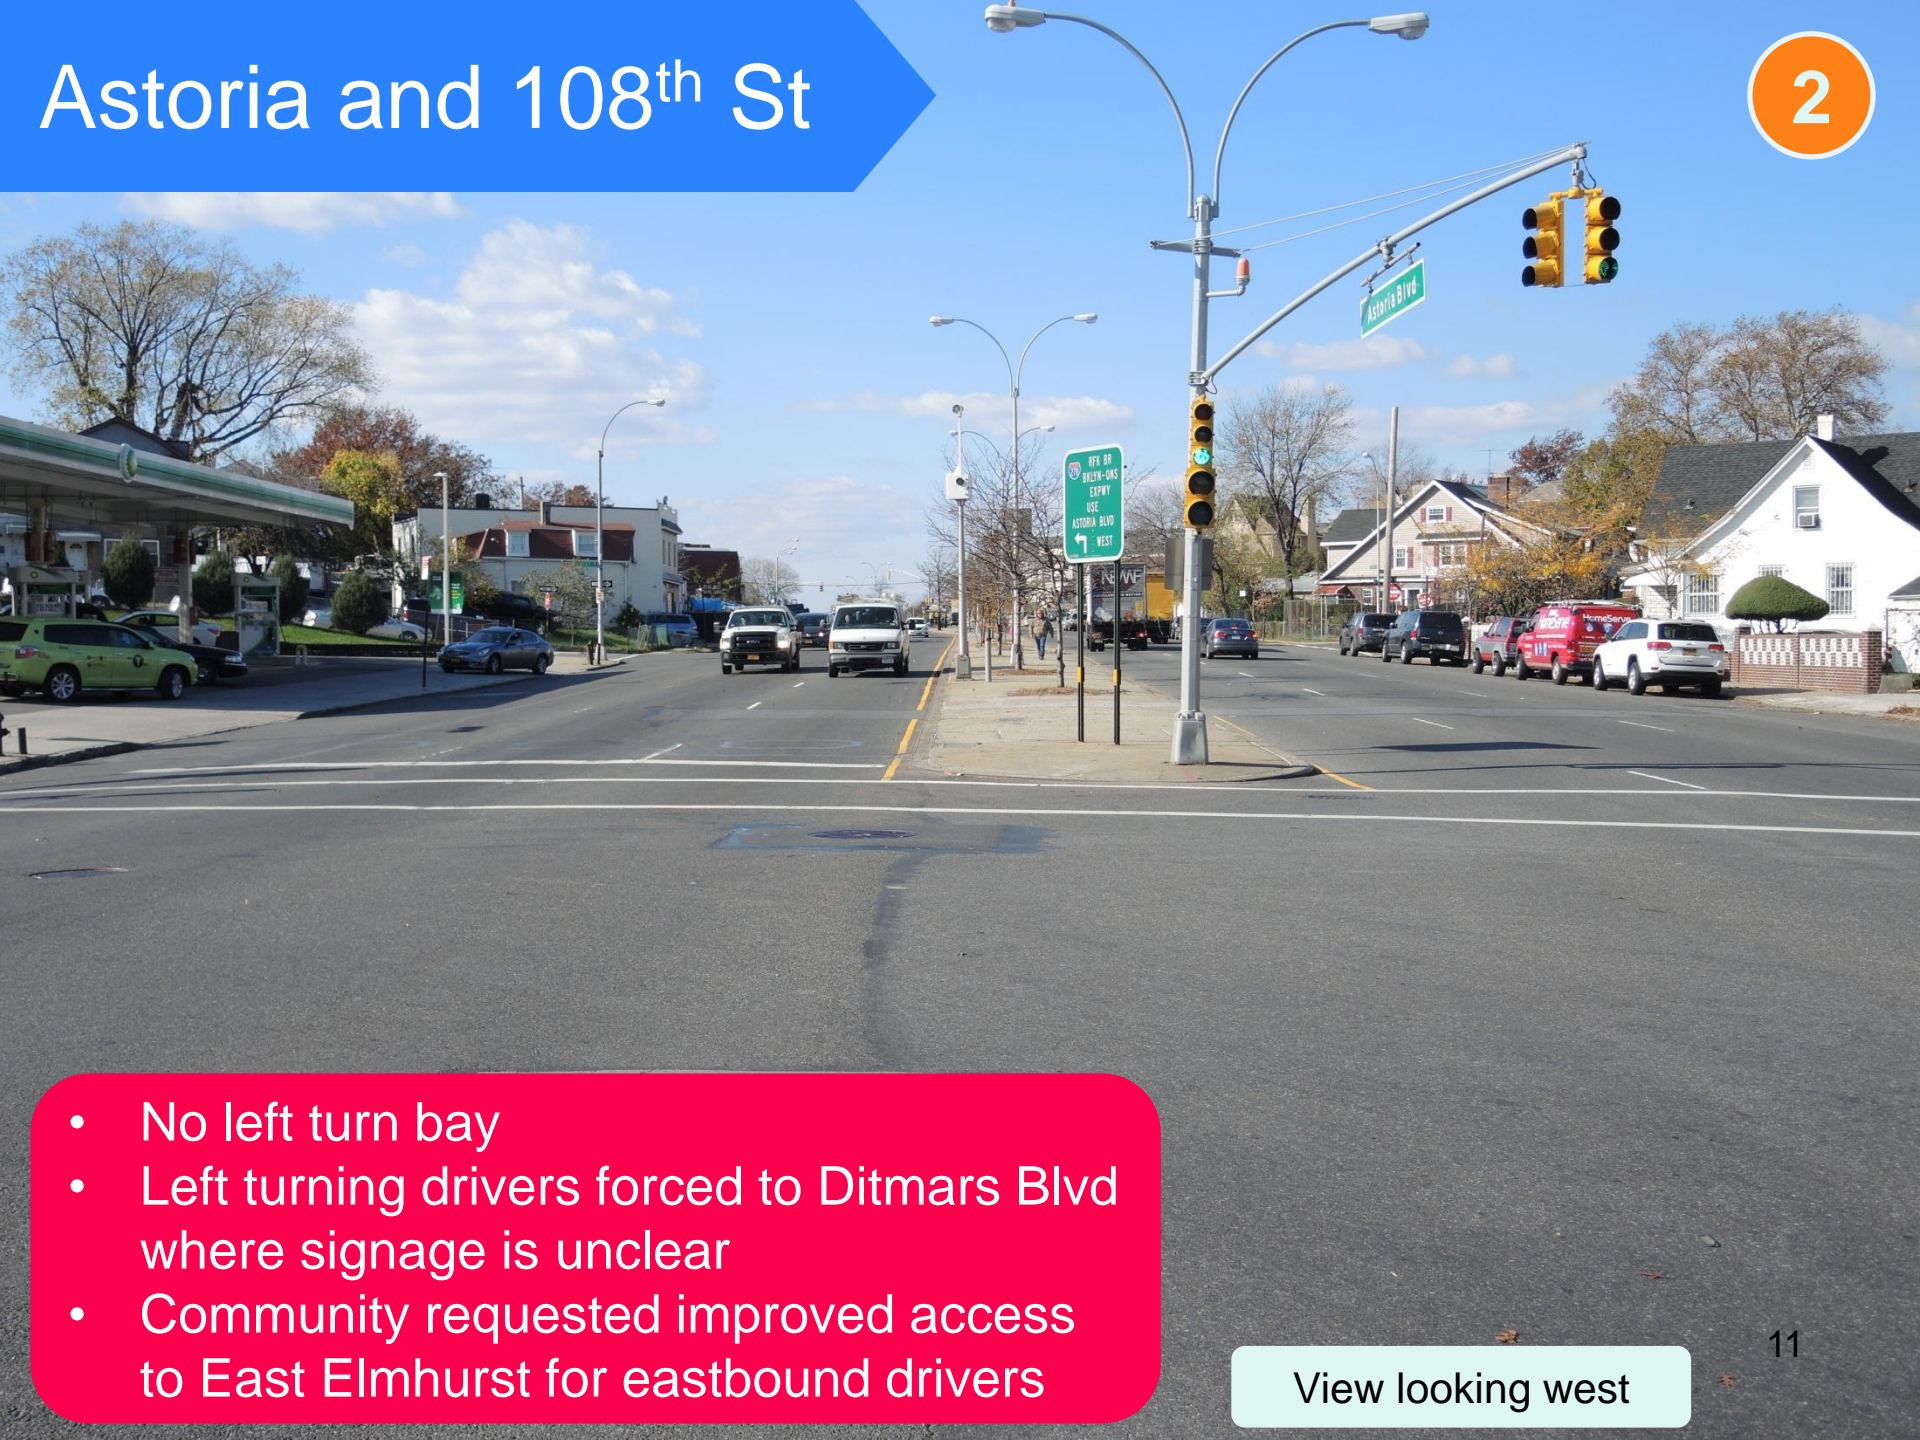
Astoria and 108th St

- No left turn bay
- Left turning drivers forced to Ditmars Blvd where signage is unclear
- Community requested improved access to East Elmhurst for eastbound drivers

View looking west

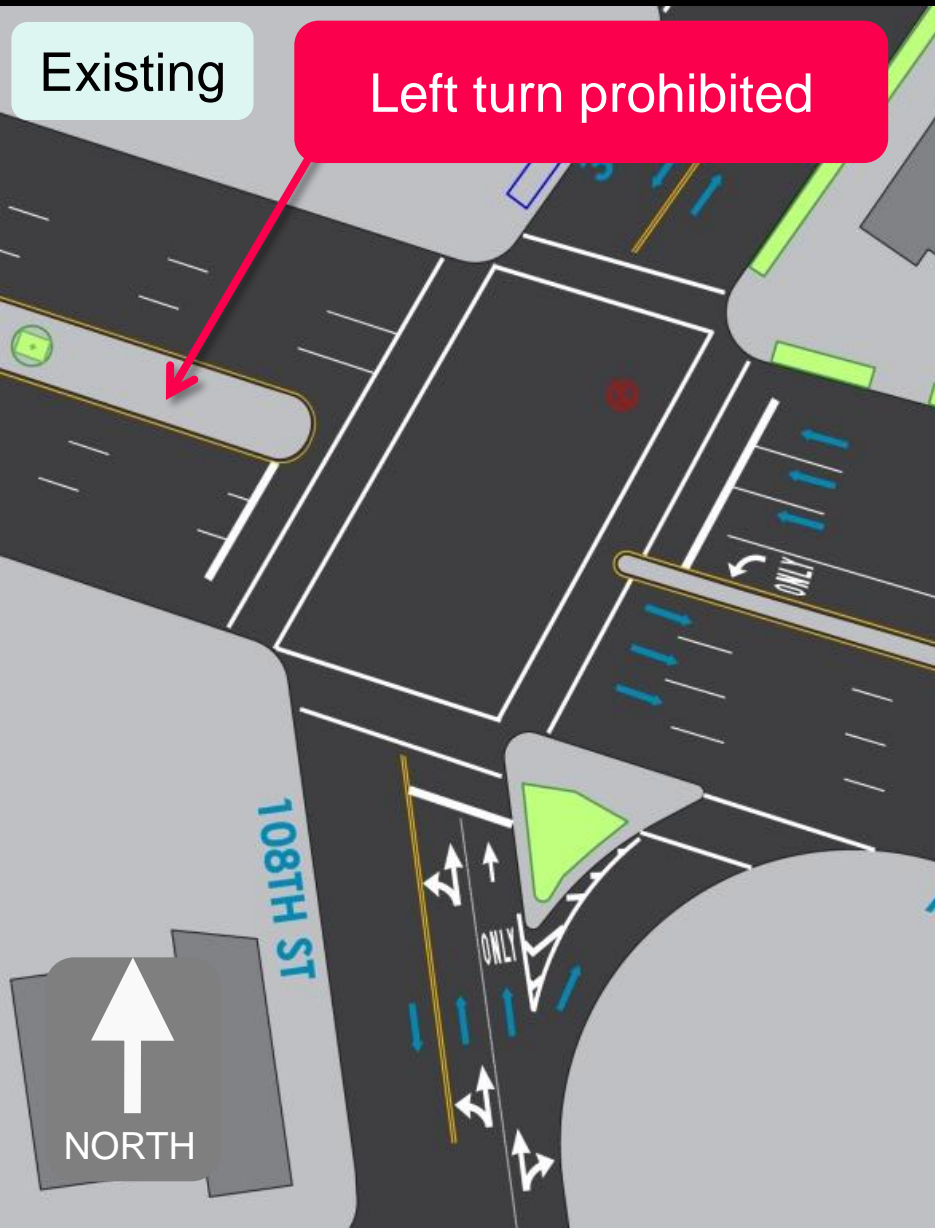
Existing

Left turn prohibited

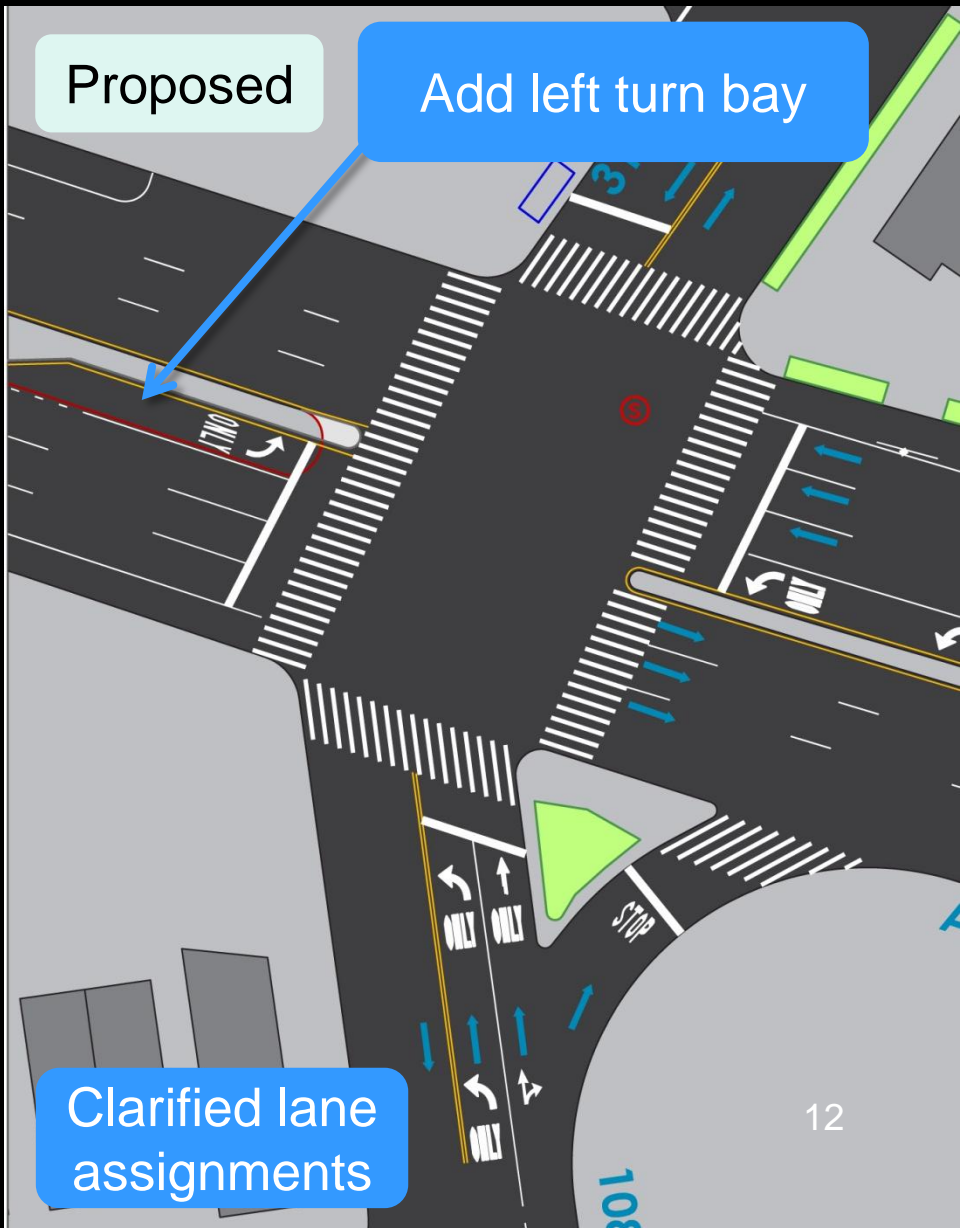
Proposed

Add left turn bay

Clarified lane assignments

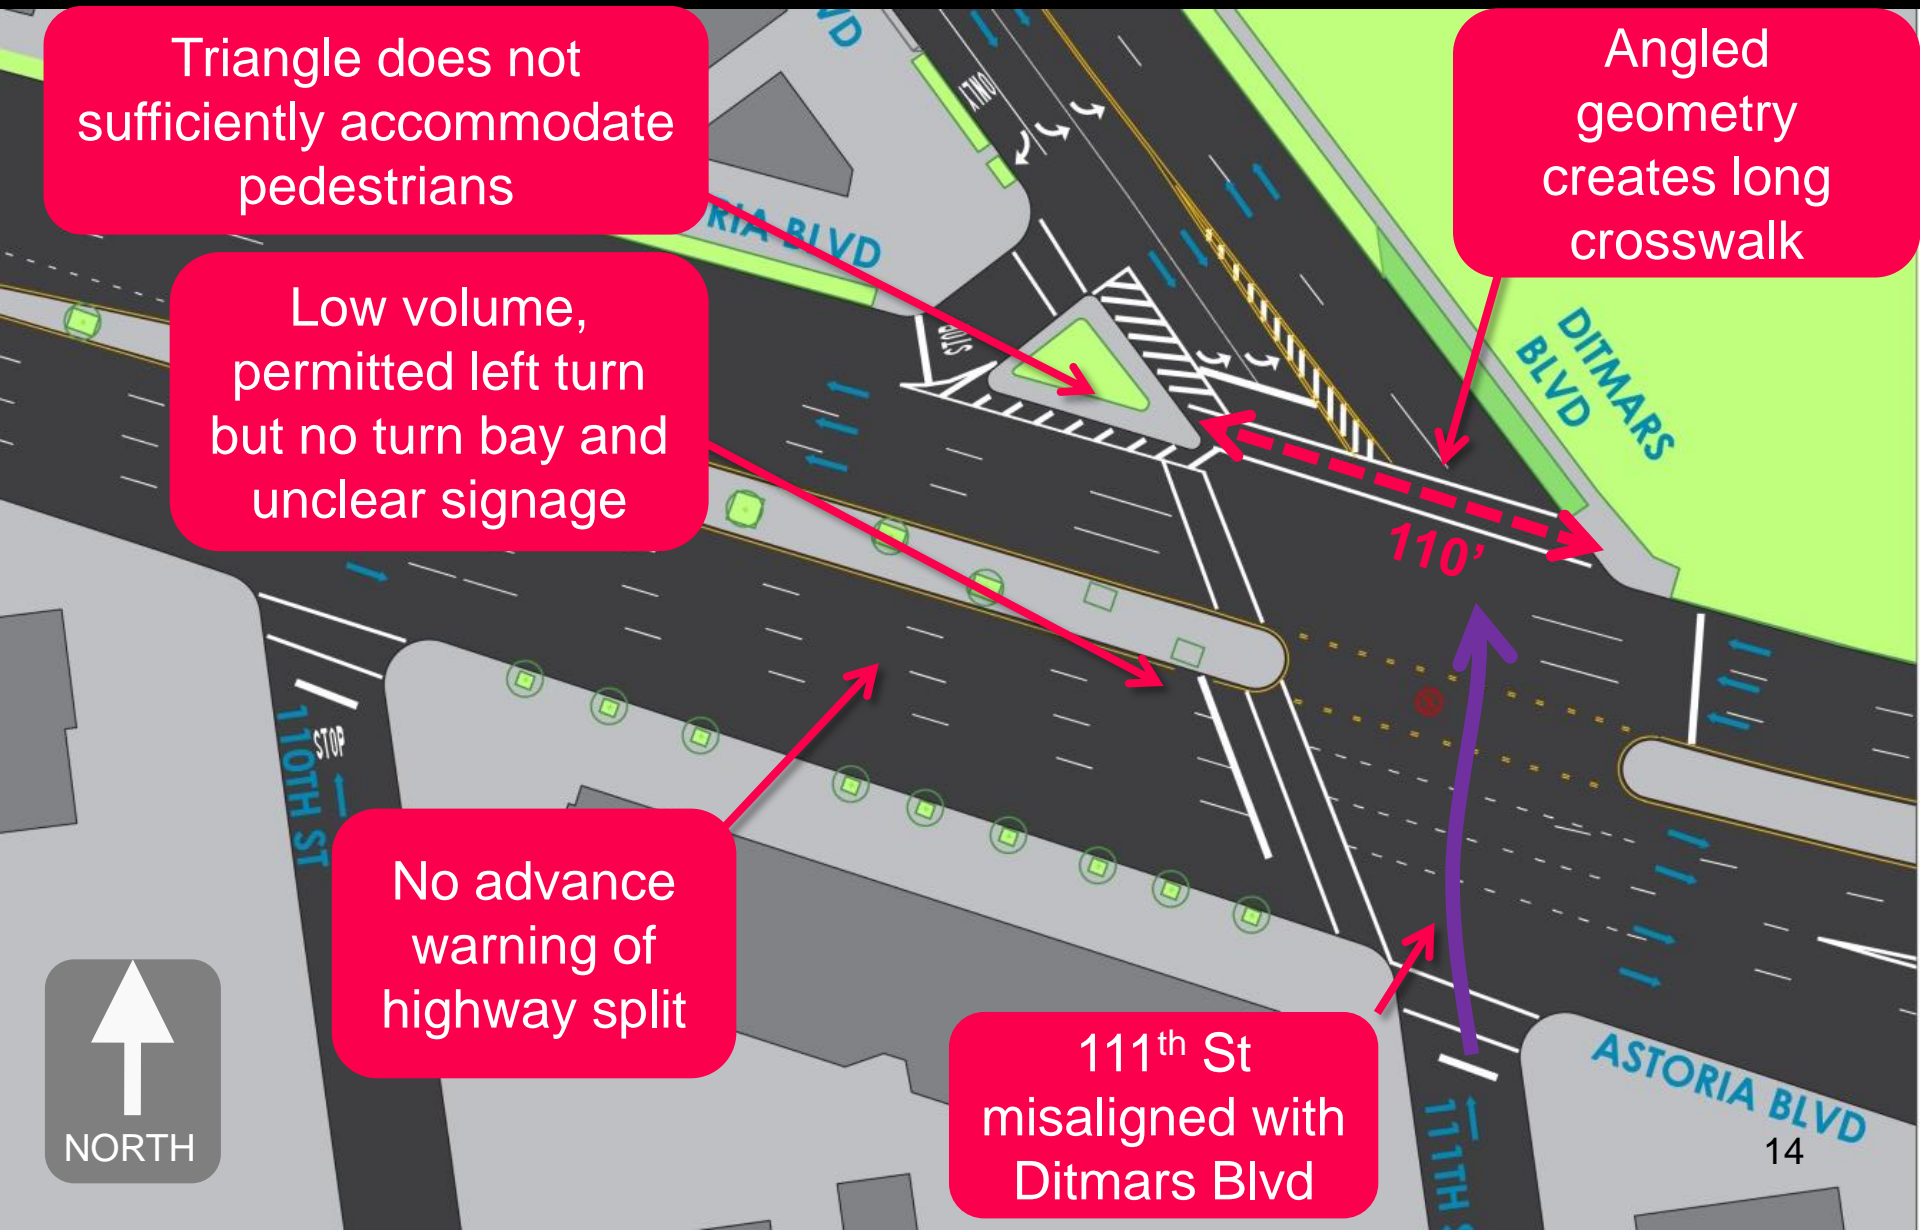
Existing Conditions at Ditmars Blvd

Triangle does not sufficiently accommodate pedestrians

Low volume, permitted left turn but no turn bay and unclear signage

No advance warning of highway split

Angled geometry creates long crosswalk

111th St misaligned with Ditmars Blvd

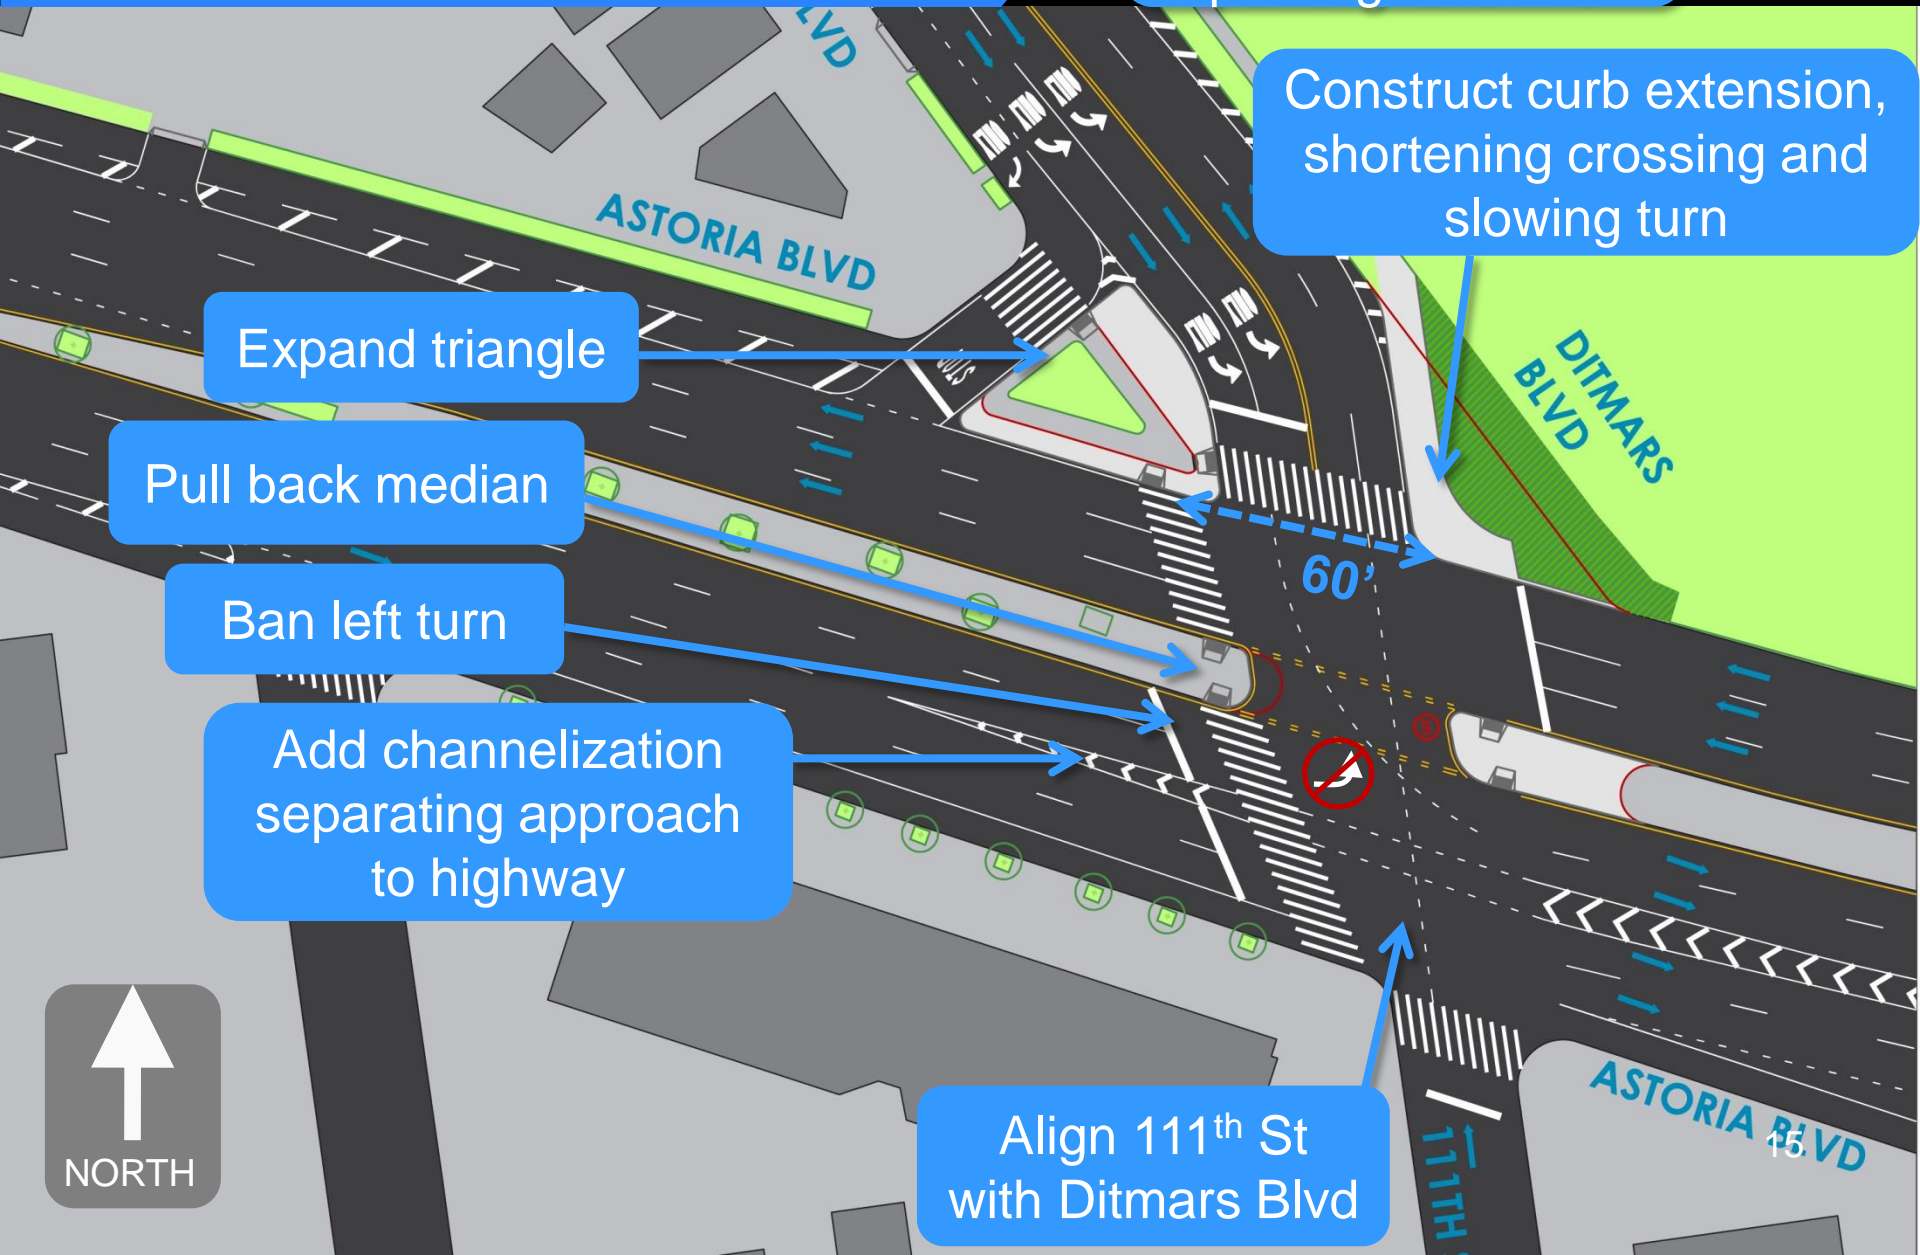
Proposal – Ditmars Blvd

Construct curb extension,
shortening crossing and
slowing turn

Expand triangle

Pull back median

Ban left turn

Add channelization
separating approach
to highway

Align 111th St
with Ditmars Blvd

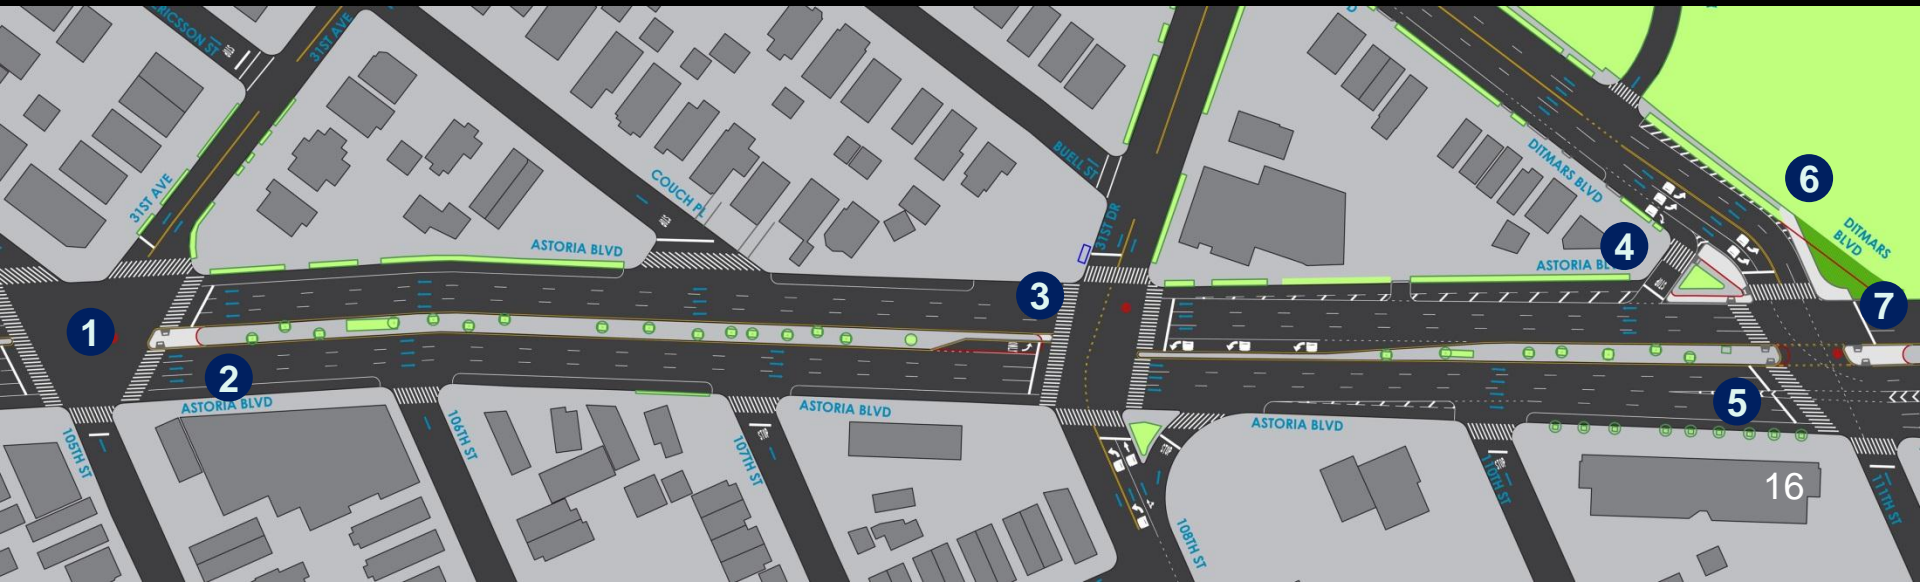
Improvements Summary

1. Create three phase signal at 105th St
2. Extend east median tip at 105th St and realign west crosswalk
3. Add left turn bay for eastbound Astoria Blvd at 108th St
4. Expand northwest triangle at Ditmars Blvd
5. Pull back west median at Ditmars Blvd and ban eastbound left turn
6. Construct curb extension on northeast corner of Ditmars Blvd and Astoria Blvd
7. Extend eastern median at Astoria Blvd
8. Add parking lane line and upgrade to Hi-Vis crosswalks throughout
