# Barnes Ave (E 233<sup>rd</sup> St & E 236<sup>th</sup> St)

Safety Improvements

Bronx Community Board 12

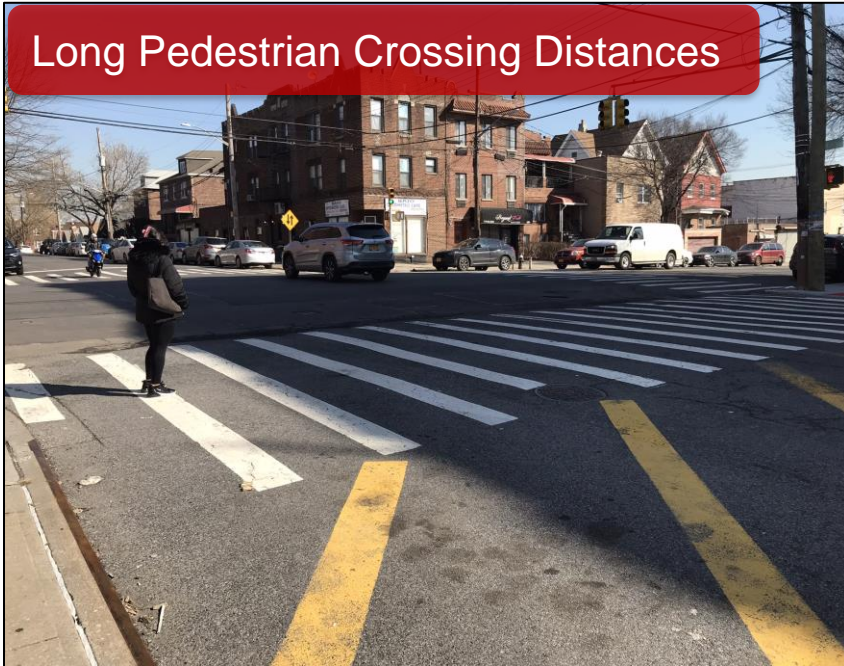
Long Pedestrian Crossing Distances

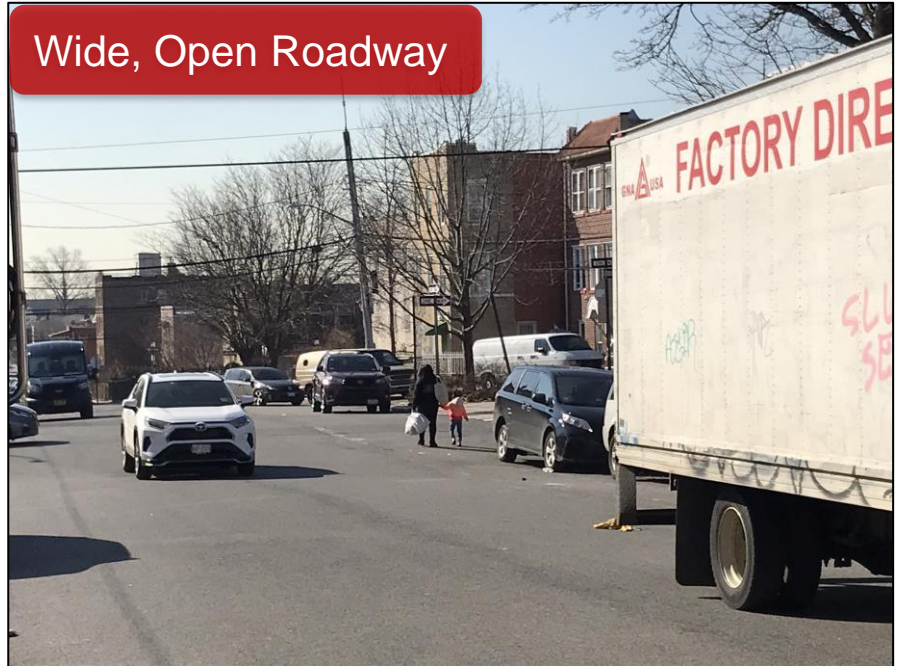
Wide, Open Roadway

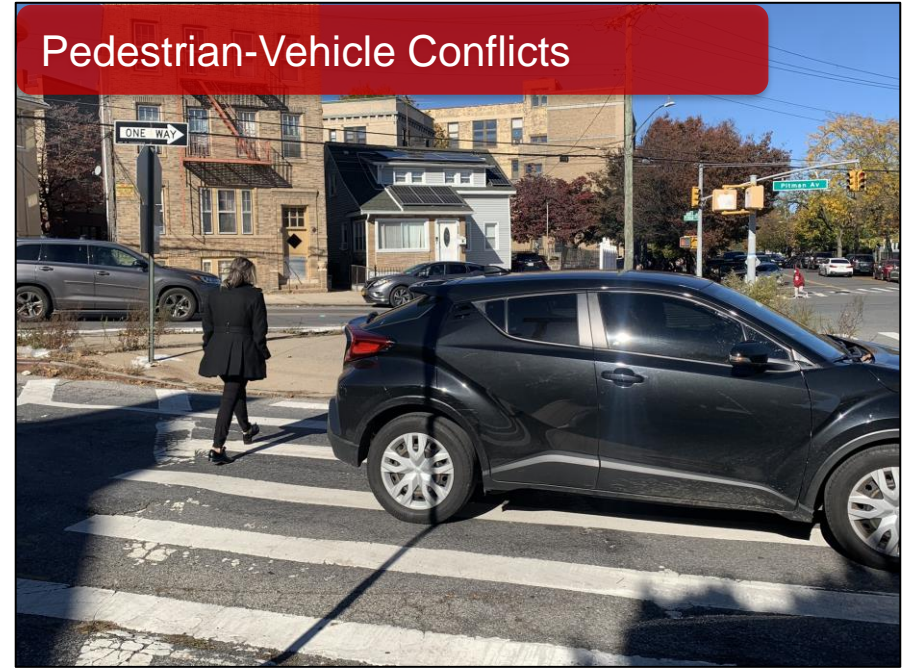
## Pedestrian-Vehicle Conflicts

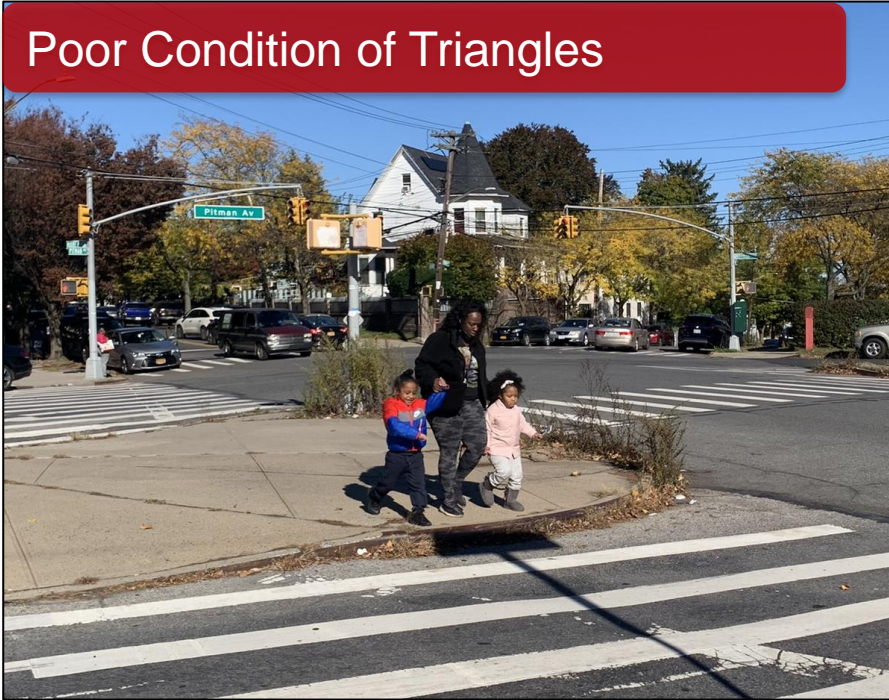
Poor Condition of Triangles

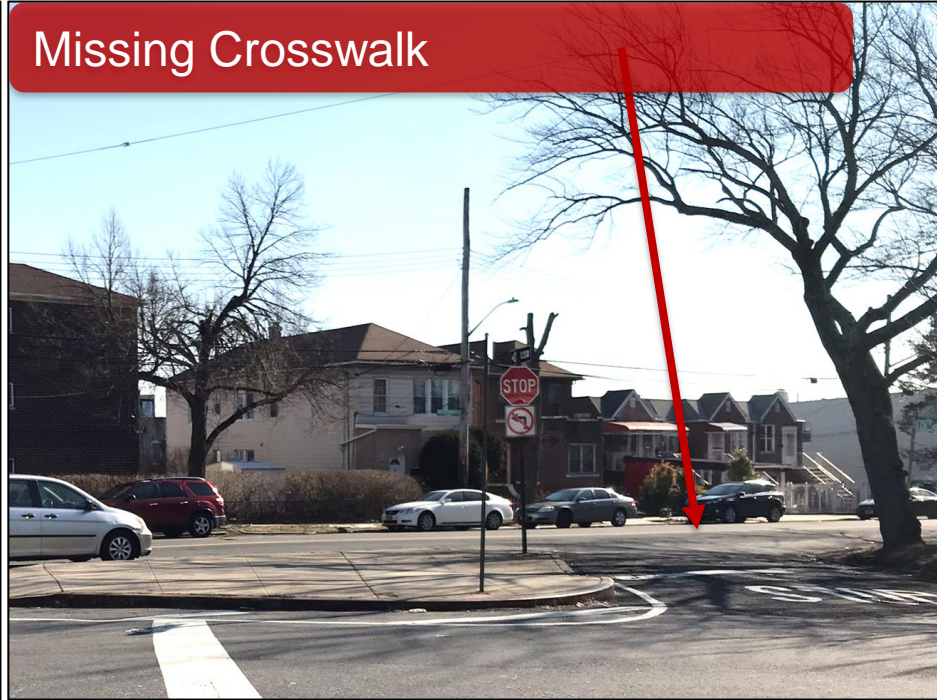
Missing Crosswalk
