BEDFORD AVE – NASSAU AVE

Post Implementation – Brooklyn CB 1

November 19, 2018

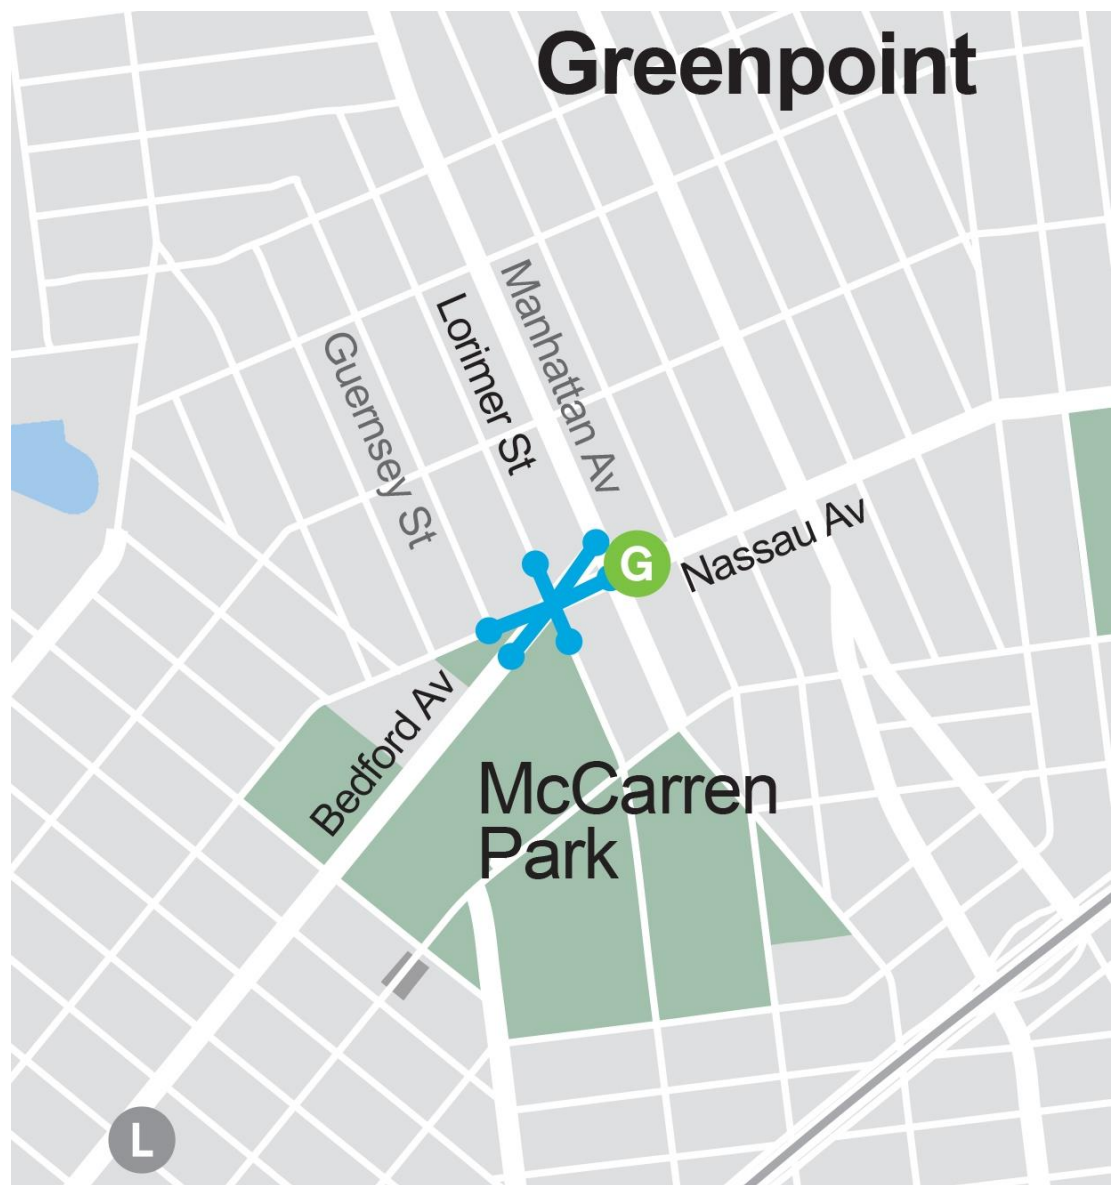
PROJECT AREA AND SAFETY DATA

- 6 legged intersection of Bedford Ave - Lorimer St - Nassau Ave
- Northern border of McCarren Park
- Close proximity to Nassau Ave G Train Station
- Neighborhood commercial destinations

Bedford Ave and Nassau Ave, BK

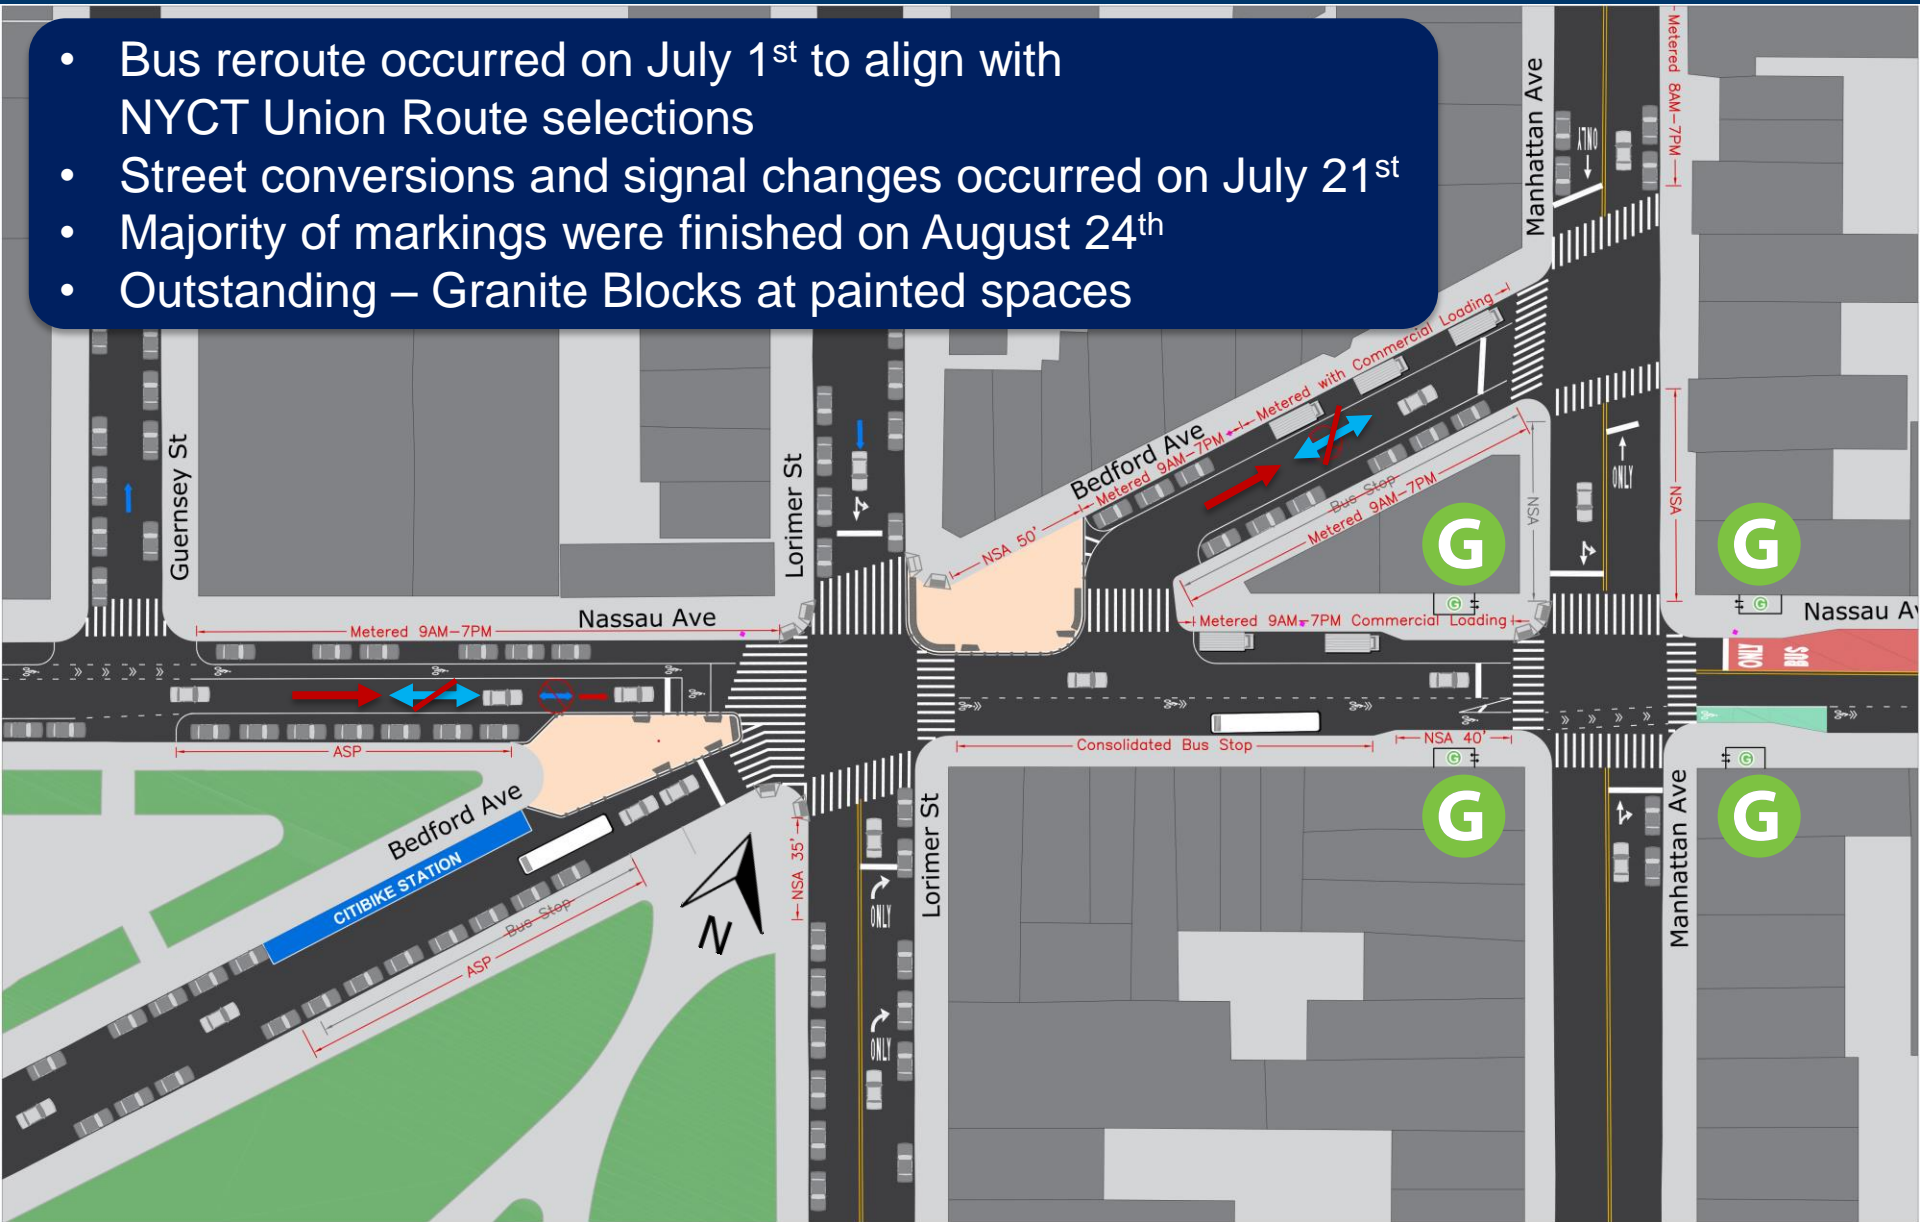
IMPLEMENTED PLAN

- Bus reroute occurred on July 1st to align with NYCT Union Route selections
- Street conversions and signal changes occurred on July 21st
- Majority of markings were finished on August 24th
- Outstanding – Granite Blocks at painted spaces

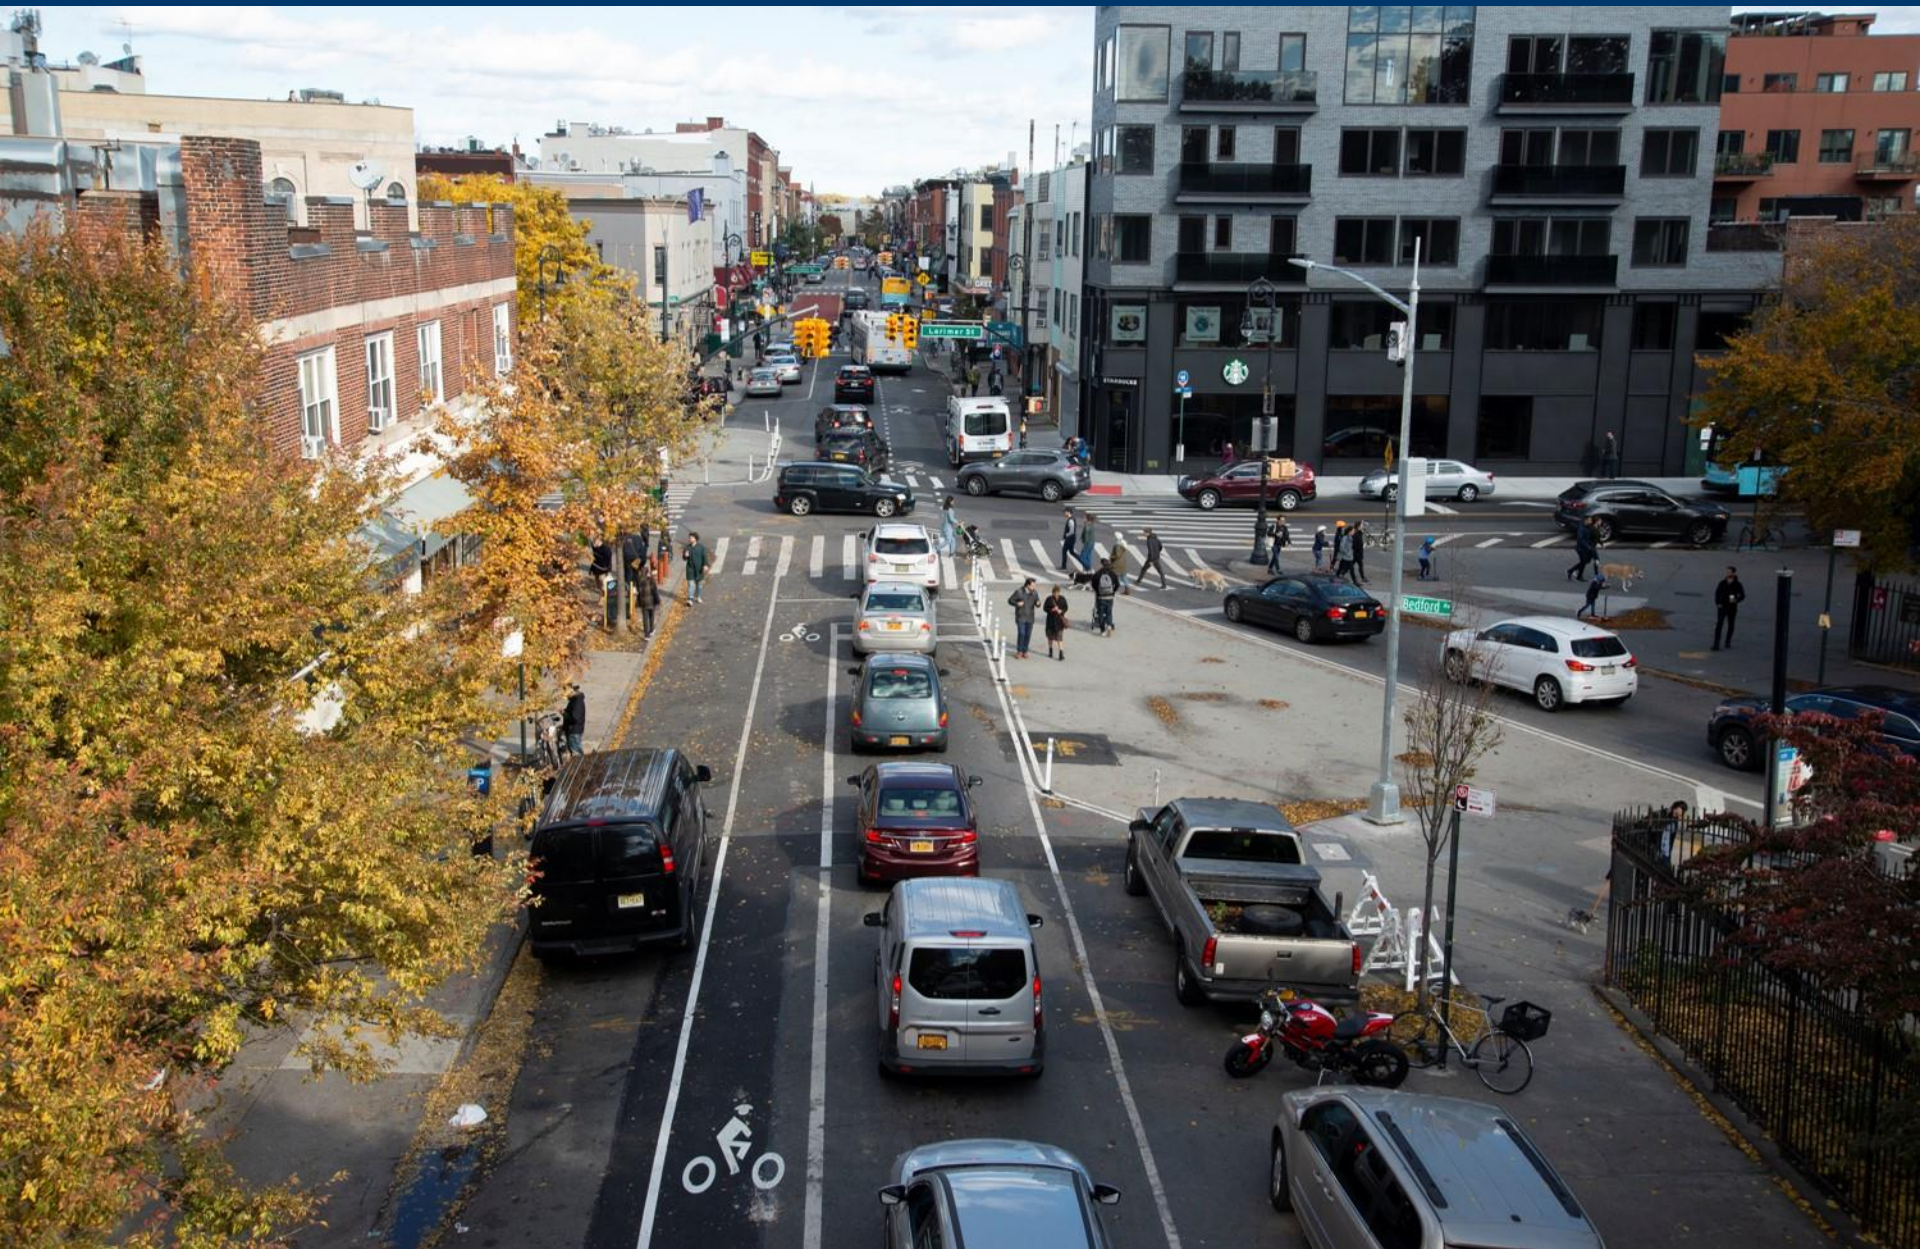
AFTER

An aerial photograph of a city street intersection. The street is paved with asphalt and has white painted crosswalks and a large white 'X' marking. A black SUV is stopped at the intersection, facing away from the camera. A black pickup truck is parked on the left side of the street. Pedestrians are crossing the street. A green sign on the left building reads "NORTHVILLE MEDICAL CLINIC". The street is lined with trees and buildings. A green sign on the left building reads "NORTHVILLE MEDICAL CLINIC". The street is lined with trees and buildings. A green sign on the left building reads "NORTHVILLE MEDICAL CLINIC".

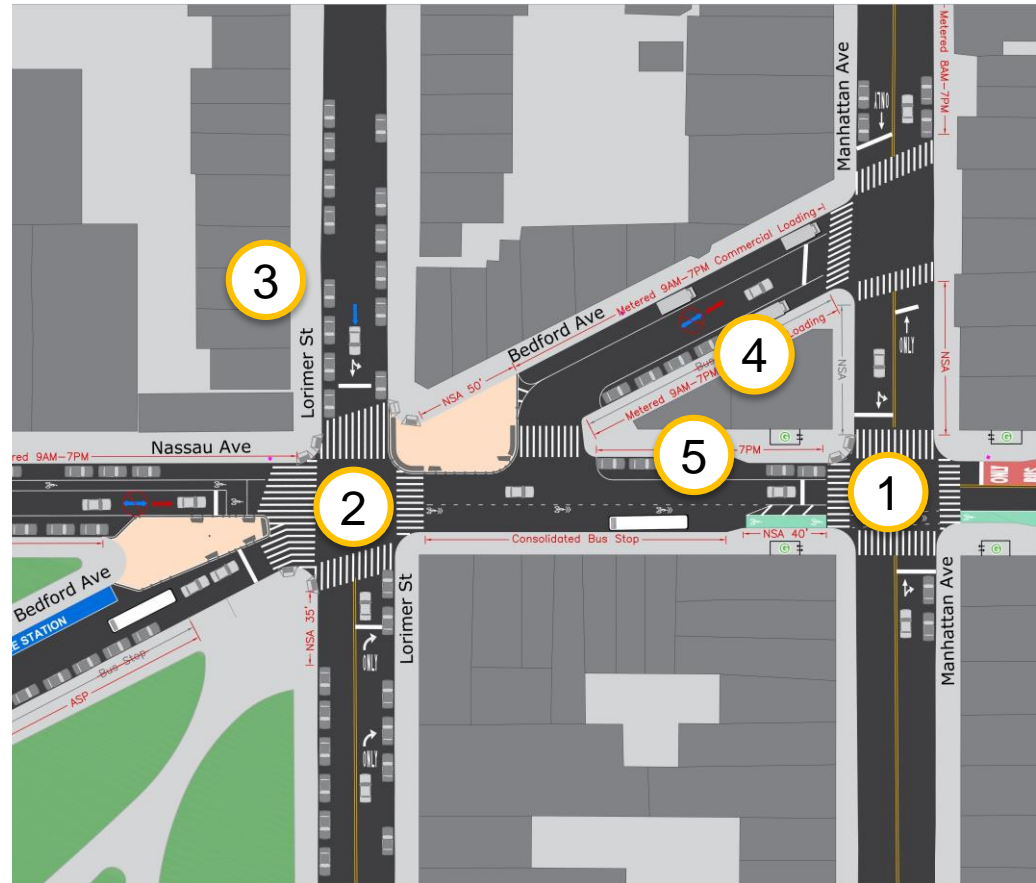
CRASH REPORTS – JULY TO NOVEMBER

- 1 8/4/18 – Eastbound MVO* collides with southbound bicyclist (no injuries)
- 2 8/10/18 – Southbound MVO collides with westbound bicyclist
- 3 8/16/18 – MVO changing radio station rear ends MVO (no injuries)
- 4 8/20/18 – MVO collides with MVO existing parking space (no injuries)
- 5 9/5/18 – MVO rear ends parked car while parallel parking (no injuries)

94th Precinct reported no further crashes at this location.

*MVO: Motor Vehicle Operator

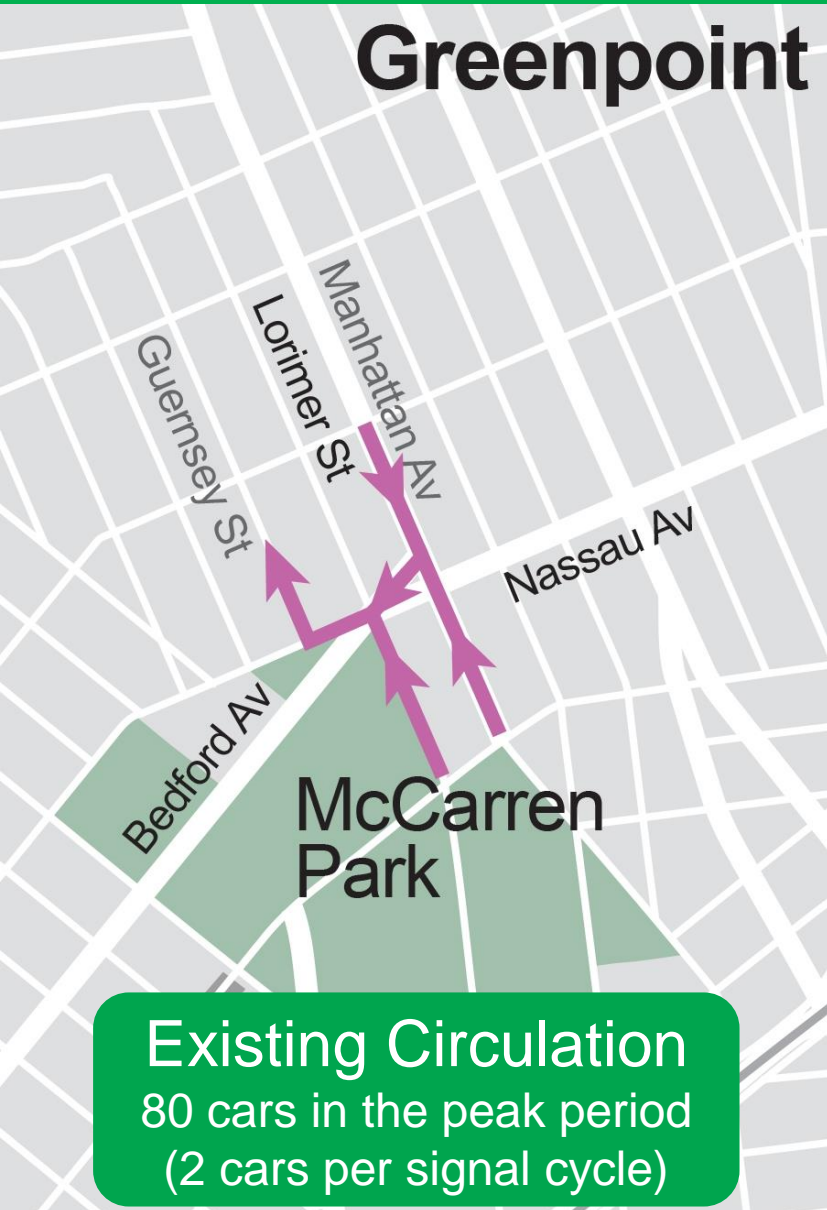
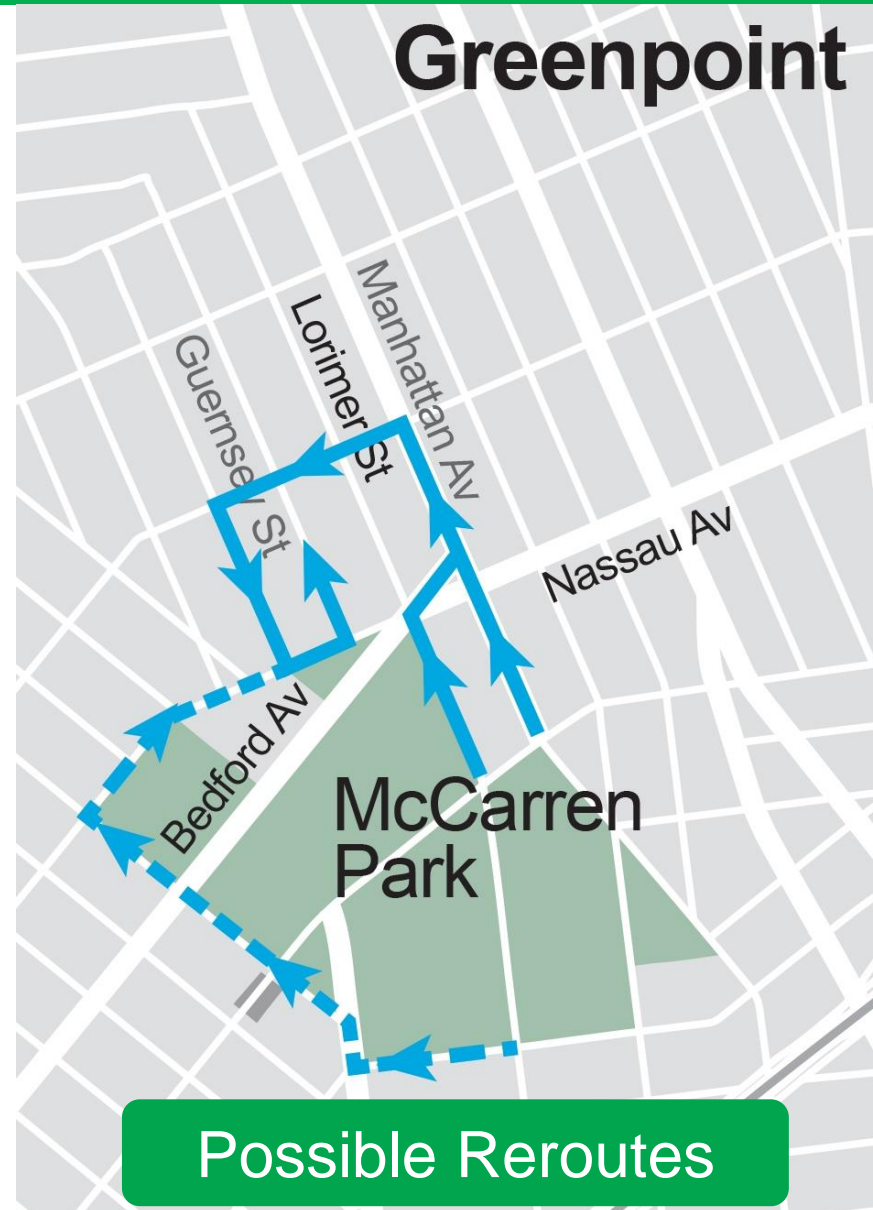
STREET CONVERSION DIVERSION

VOLUMES TO BE DIVERTED

80 cars in the peak period
use Nassau Ave Westbound
(2 cars per signal cycle)

Represents 12% of traffic in
the intersection in the AM
and 9% in the PM
