Broadway

Marcus Garvey Blvd to Howard Ave

Brooklyn Community Board 3

June 2025

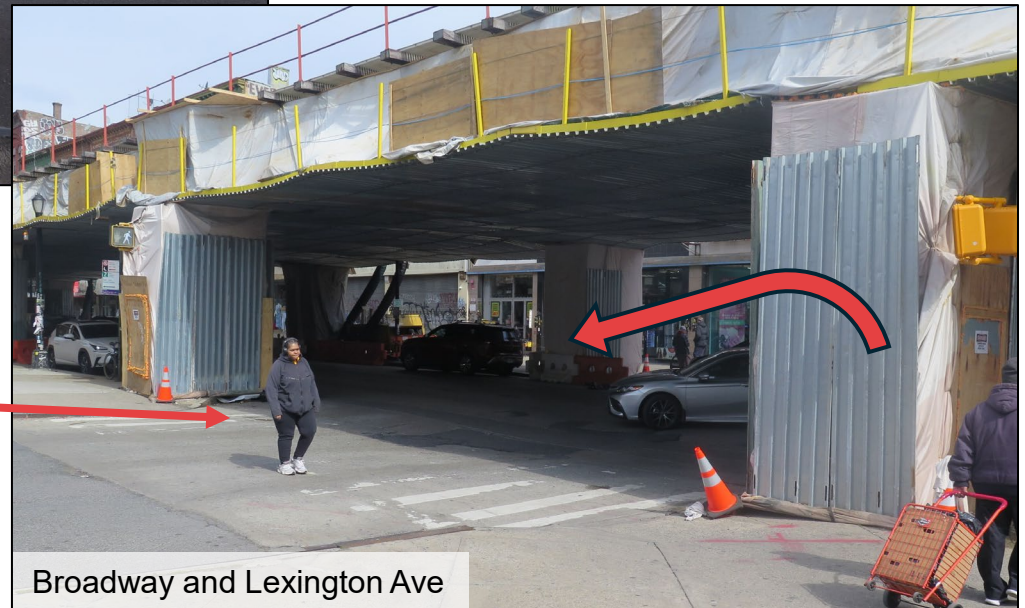
41% of the time pedestrians are hit in the crosswalk crossing with the signal, the vehicle is making a left turn. Each of these crashes are due to the driver failing to yield to the pedestrian.

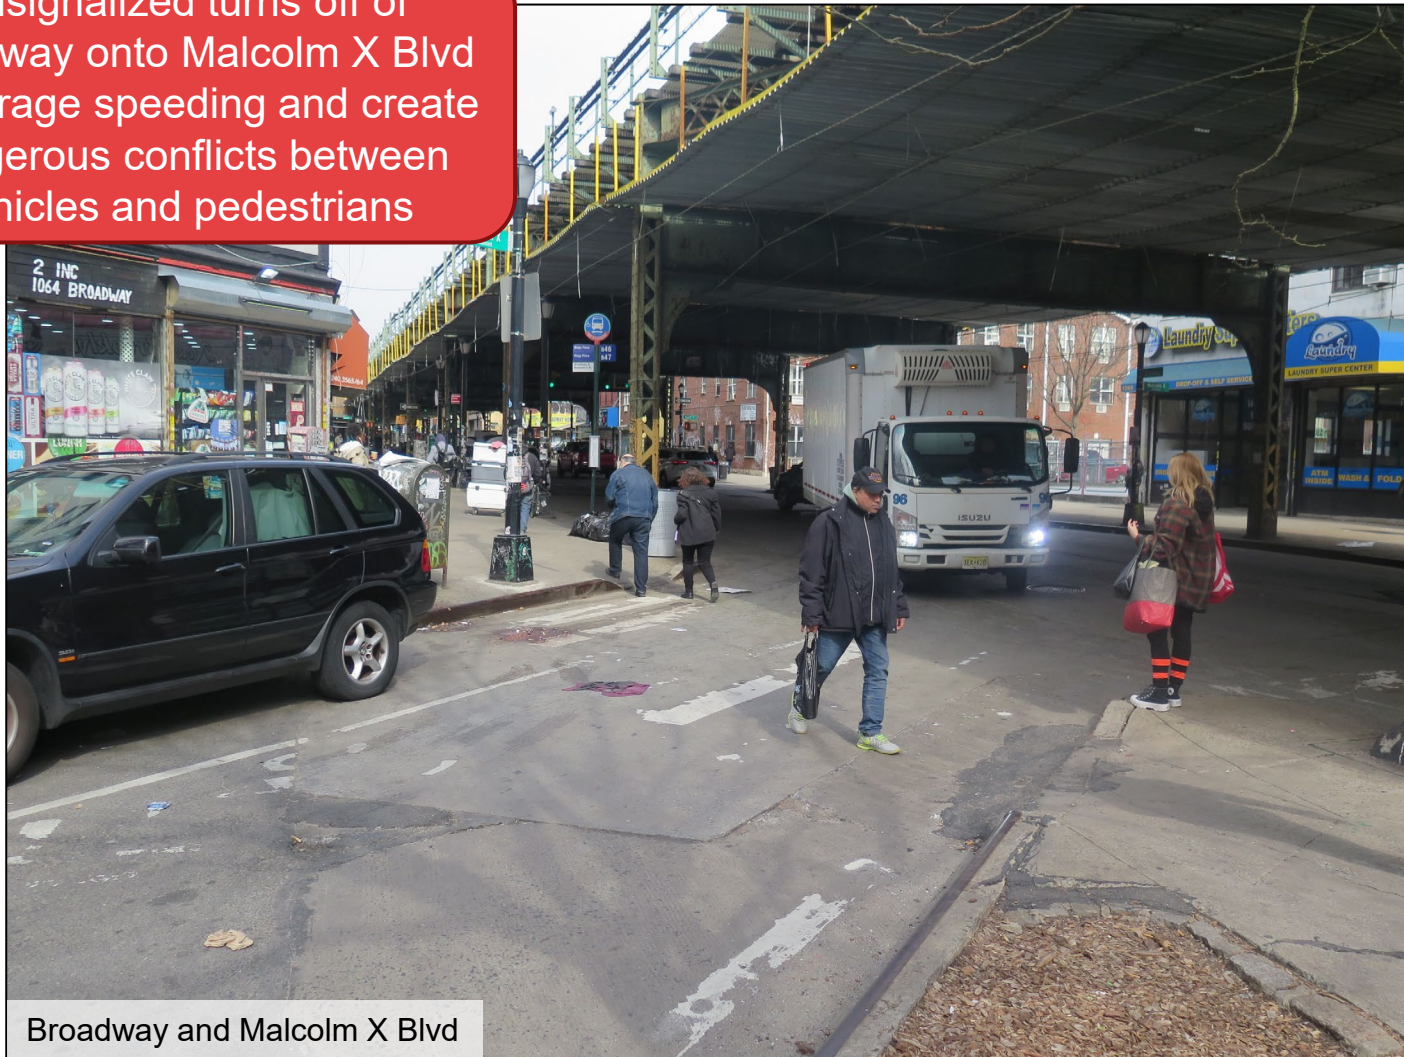
Broadway and Malcolm X Blvd

Unsignalized turns off of Broadway onto Malcolm X Blvd encourage speeding and create dangerous conflicts between vehicles and pedestrians

- **Closure of Malcolm X Blvd slip lane in concrete:**

- Removes conflicts between vehicles and pedestrians
- Expands existing pedestrian space
- Encourage slower, safer turns for drivers
