Cropsey Avenue & Bay 53 St

Intersection Safety Improvements

2023 Street Improvement Project

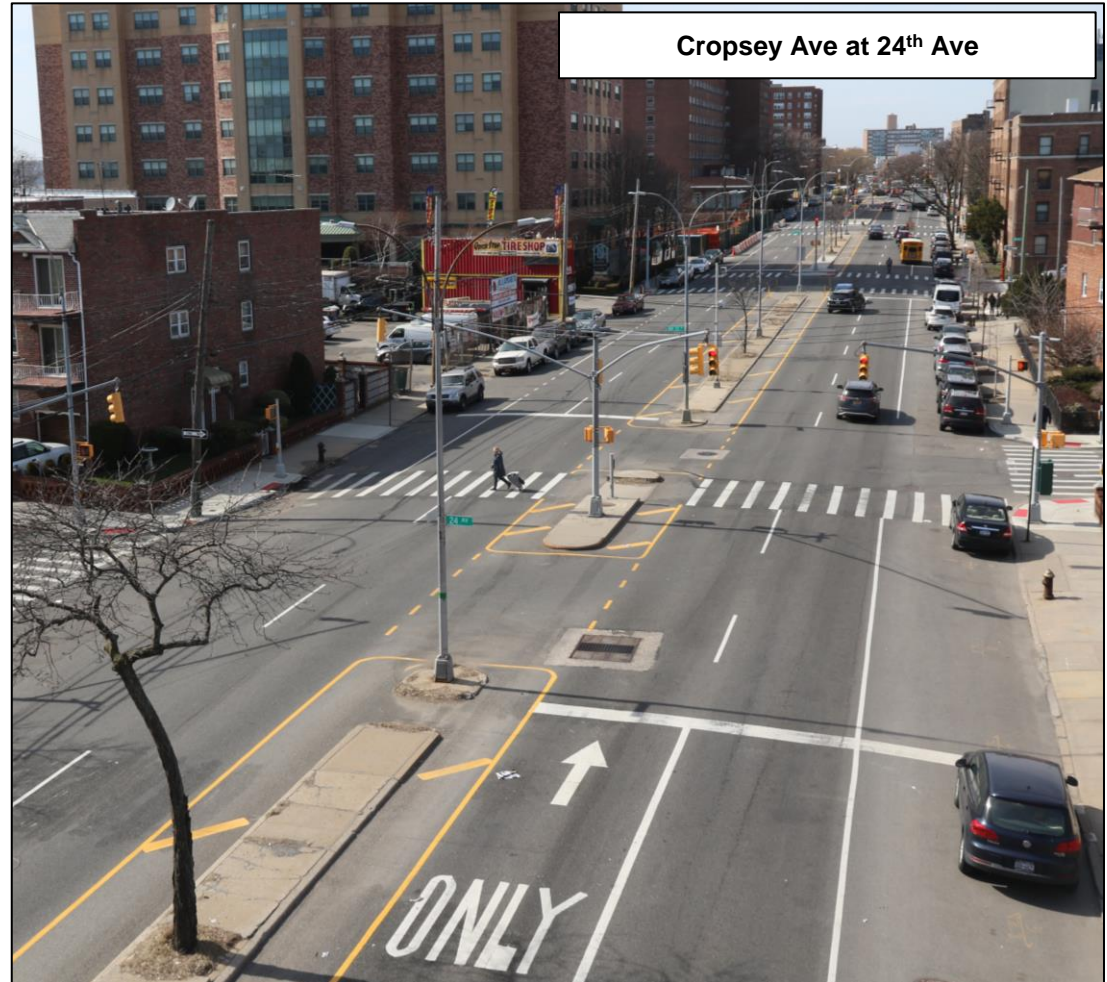
Previous Improvements

- Expanded median tips and concrete islands shorten crossing distances and provide refuge for pedestrians
- Expanded median tips encourage slower, safer turns by vehicles
- Improved markings clarify roadway and discourage speeding on Cropsey Ave

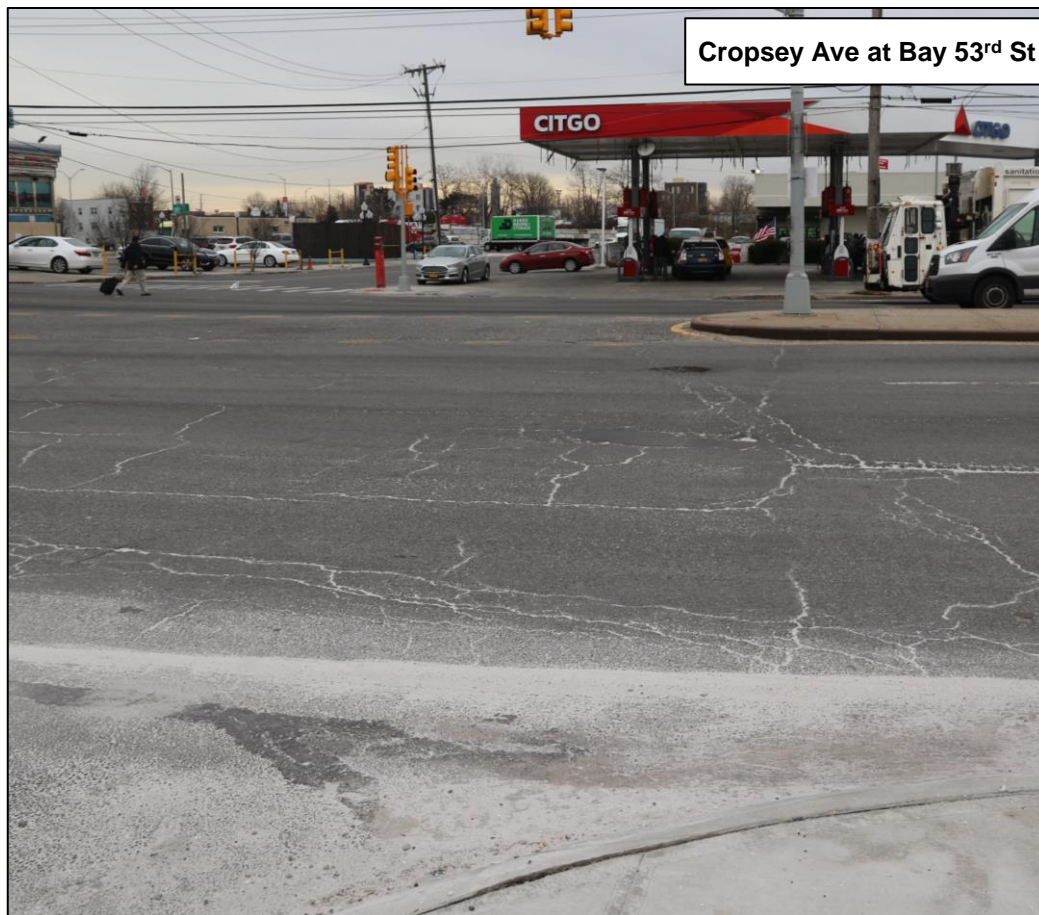
Existing Conditions

- No safe pedestrian crossing at the south leg of the intersection
 - Existing demand for safe crossing
 - Existing concrete median has no accessible pedestrian cut-through and does not provide safe refuge
- Existing pedestrian ramps at corners below ADA legal standards
