As an integral part of New York City's Department of Transportation, the Division of Bridges has a two-fold mission: to maintain an optimal transportation network by ensuring smooth mobility on the city's bridges, and to ensure the safety of the public.

ACCOMPLISHMENTS & PLANNED PROJECTS

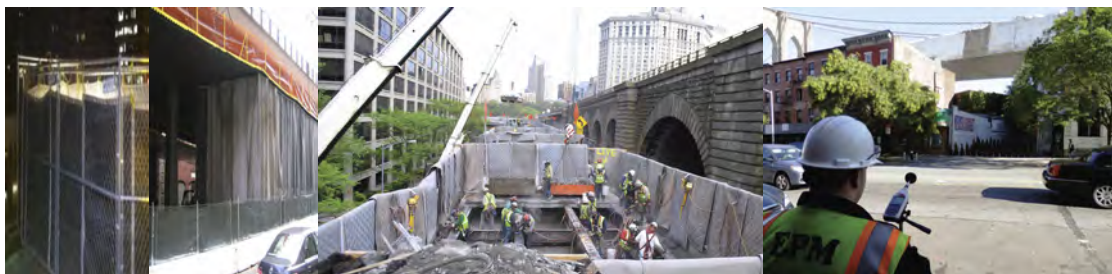
Noise Reduction Along the Sound Pathway – Acoustical Barriers on the Bridge During Night Construction Activities. Acoustical Curtains Along Frankfort Street. Two Crews Work Along Frankfort Street in April 2012. Cranes (On Left) Lift Material In And Out of Walled Enclosures of Sound Blankets. Inspector Taking Noise Measurements.

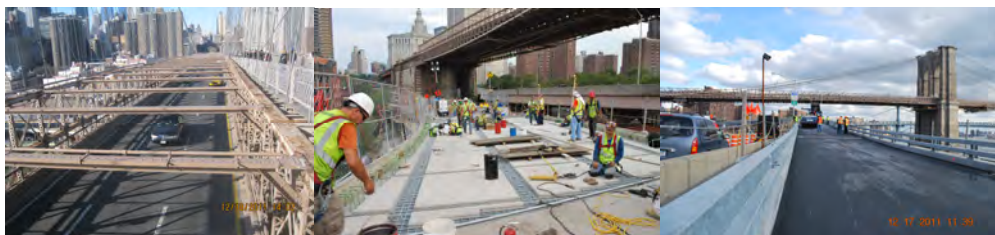
December 2011: Painted Top Struts of the Brooklyn-Bound Manhattan Side Span. Summer 2011: Manhattan Approach - Ramp C Deck Replacement. December 2011: Ramp C.

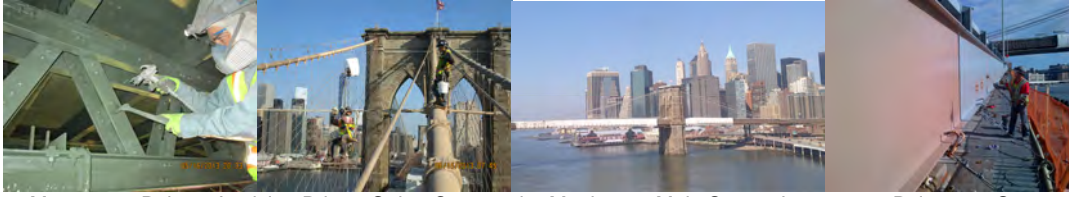
May 2013: Painter Applying Primer Stripe Coat on the Manhattan Main Span. June 2013: Painter on Sway Bracing on the Brooklyn Side Span. (View Credit: Earlene Powell) November 2013: Painting Fascia Steel on Ramp C.

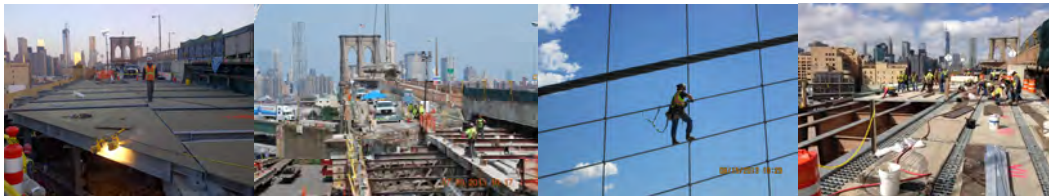
April 2013: Installation of Temporary Deck Units at the York Street Structure Over Brooklyn-Queens Expressway. July 2013: Removal of the Existing Concrete Slab on the Eastbound Main Street Structure. August 2013: Ironworker Replacing Cable Clamp Assemblies on the Suspended Span. October 2013: Grid Deck Panel Installation at the Eastbound Park Row Structure.

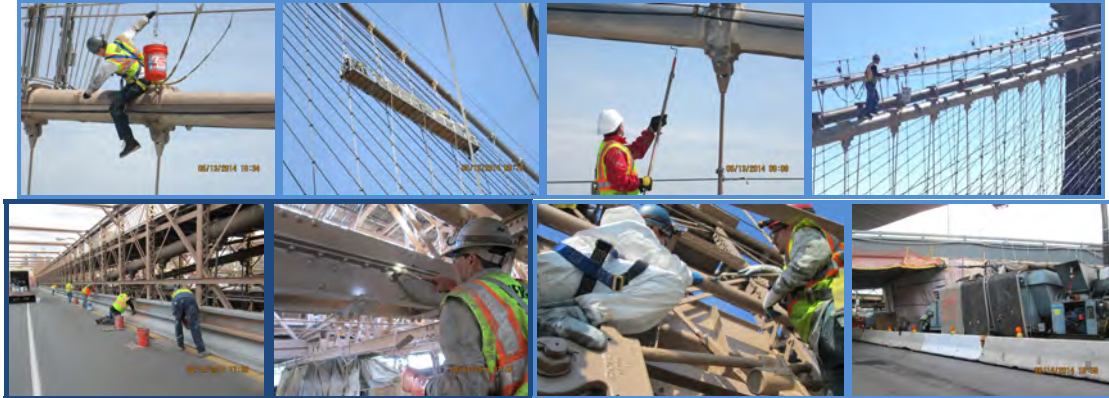
May 2014: Painting Main Cables and Suspension Ropes. June 2014: Painting at Main Bridge – Safety Barrier and Touchup. Containment at Ramp A, Span 4.

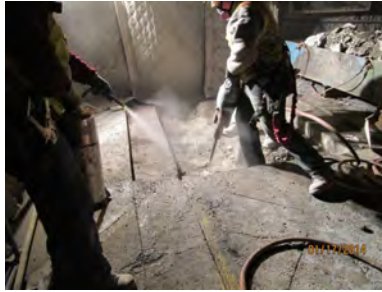
Respirable Dust & Airborne Silica Monitoring.

In response to residents' concerns about airborne silica, a type of dust that is emitted during concrete demolition operations, the project team conducted a series of tests to monitor the levels of this substance in the air in January 2014. In addition to three types of silica, the tests also monitored for general respirable dust. Monitors were placed in four locations near concrete demolition operations occurring at the Main Street and York Street structures on the Brooklyn approach. Two monitors were placed within 50 feet of the construction activities themselves, one was placed at ground level north of the activity, and another placed directly in front of a residential building just south of the work. Analysis was undertaken by the project's environmental experts using procedures established by the Occupational Safety and Health Administration (OSHA) and the National Institute for Occupational Safety & Health (NIOSH). All results were well below the permissible exposure levels as established by the NYS Department of Labor Public Employee Safety and Health and threshold limit values established by the American Conference of Governmental Industrial Hygienists.

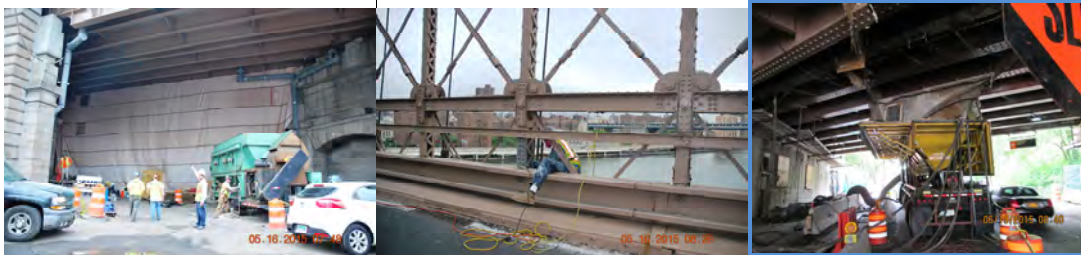
May 2015: Class 1A Abrasive Blast Containment System for the Main Street Structure Promenade Steel. Power-Tool Cleaning on Steel Repairs at the Suspended Spans. June 2015: Brooklyn Approach Structures.

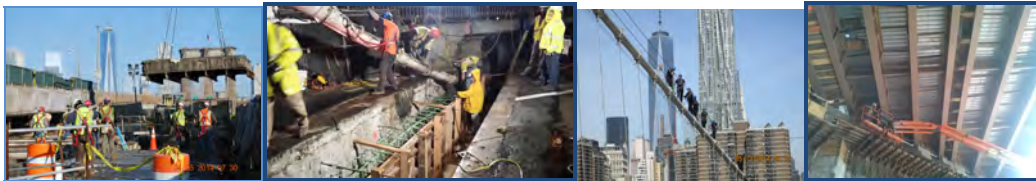
April 2014: York Street Structure Deck Replacement During Full Weekend Closure. May 2014: Main Street Structure – Abutment Concrete Placement. May 2014: Ascending the Cable. July 2014: Preparation for Closure Pour at Main Street Structure.

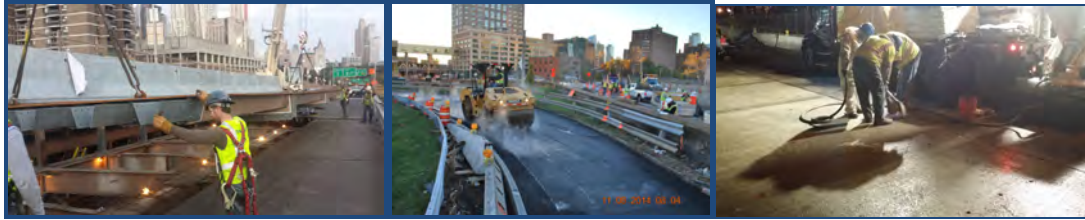
September 2014: Franklin Square Structure – New Orthotropic Deck. November 2014: Manhattan-Bound Brooklyn Approach Paving. December 2014: Super Slab Installation in Manhattan-Bound Lanes.

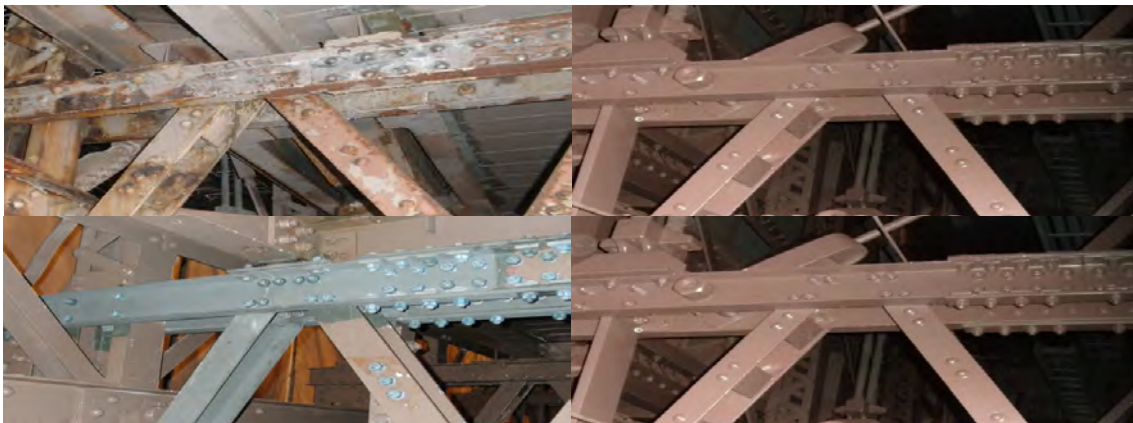
Steel Repair Process: Although Deteriorated Steel is Often Apparent Right Away, Many More Instances are Encountered Only After Removing the Paint. In Some Cases the Location of Deterioration is Painted Along With the Healthy Steel and its Location is Documented for Later Repair. Iron Workers Then Return to Those Locations and Replace the Deteriorated Sections With New Steel. The New Steel is Then Painted Over Again for the Final Protective Coating.

Structural repairs continued to be identified by biennial inspections and the construction consultants. Repair work is nearly complete and removal of the underdeck shield system commenced in 2016. Over 5,000 incidental steel defects were identified that could not be anticipated prior to the removal of the existing paint. Approximately 4,050 of them have been corrected to date. Not all of the identified steel repairs will be completed in this contract. Multiple unforeseen factors have served as major obstacles, including the discovery of additional deterioration of bridge elements, discovery of a former trolley structure thought to be removed over 50 years ago, the cancellation of full weekend closures due to additional citywide events, and the Superstorm Sandy construction embargo.

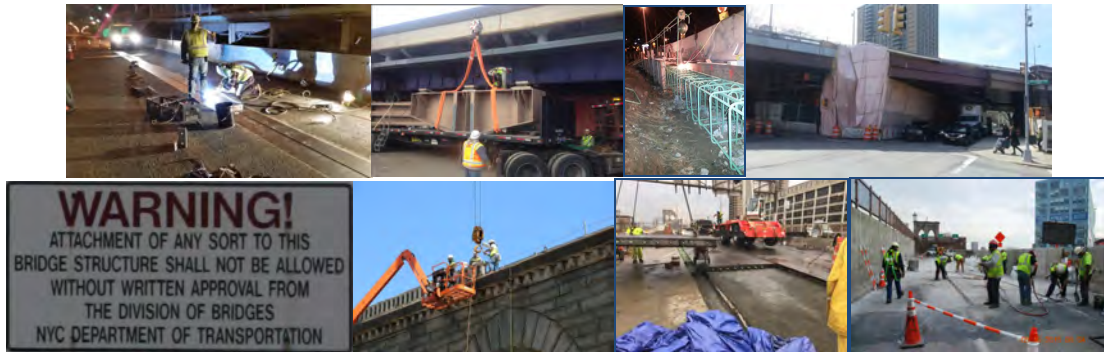
January 2015: Welding on the Bridge above Pearl Street (Franklin Square Structure). Ramp C Steel Column Erection. Cast-in-Place Concrete Barrier Installation. April 2015: Containment System at Prospect Street. (Warning Sign Credit: Eugene Parker). Working on the Stone Balustrade at Arch Block II. After Removing it in Sections, the Granite was Either Repaired and Reinstalled or Replaced With Completely New Granite. May 2015: Manhattan-Bound Approach SuperSlabs. Brooklyn Approach Concrete Headers.

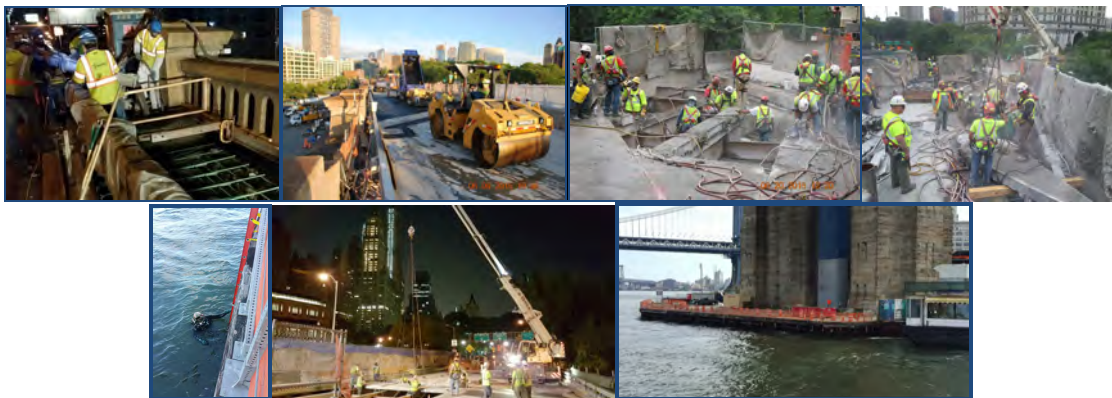
May 2015: Brooklyn Arch Blocks Steel-Faced Curb. June 2015: Asphalt Paving of Brooklyn Approach. Manhattan-Bound Approach North Cantilever. Demolition at Ramp D in Manhattan During the Full Weekend Closure in June. August 2015: Diver Inspects the Fender System at the Brooklyn Tower. September 2015: Park Row Bridge – Westbound Stage II Deck Replacement. October 2015: Brooklyn Tower Fender System.

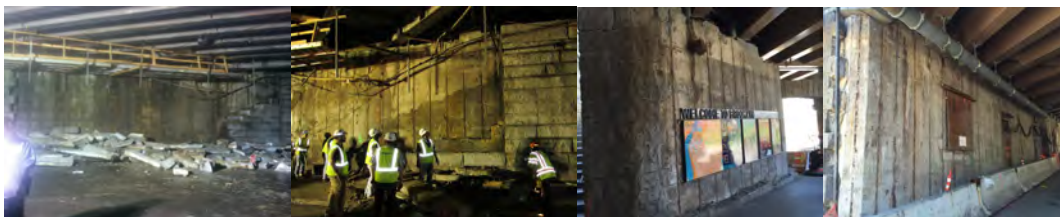
Prospect Street East Abutment Collapse in July 2014. Washington Street East Abutment.

The masonry façade at the east abutment of Prospect Street under the Brooklyn approach suddenly collapsed in July of 2014. Immediate measures were taken to inspect and evaluate the collapse. All additional loose masonry cladding was removed from the abutment wall, including a portion of the wingwall. The remainder of the east wingwalls were found to be in good condition, but based on the condition of the east wall, the decision was made to secure the masonry to the existing walls. The condition of the Washington Street abutment façade was assumed to be similar to Prospect Street and a decision was made to remove the portions of the masonry cladded walls below the bridge seat and along the sidewalks. All of the loose and unsecured stone was removed to a staging area for possible reinstallation.

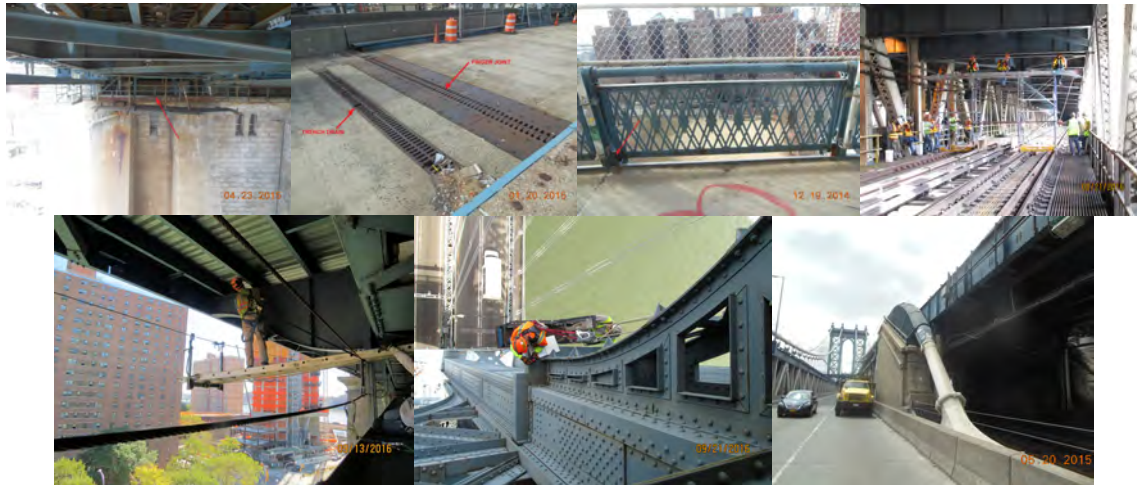
Manhattan Anchorage Maintenance Platform. Looking Northeast at a Trench Drain and Finger Joint on the Parking Deck. First South Rail at South Walkway. 2016: Inspecting the Bridge Using a Rolling Platform, Scaffold, and Sky Climber. (2016 Credit: NYSDOT) Bridge Saddle.

The scope of work for the upcoming structural and component rehabilitation will include: replacement of the south fascia railing and fencing; replacement of the finger joints in the south upper roadway with modular joints; rehabilitation of the drainage troughs and grating in the south upper roadway; rehabilitation of the masonry and cable housing at the anchorage; rehabilitation of the truss gusset plates at the approach and suspended spans to improve the load rating to HS20; replacement of the work platform at the anchorages; rehabilitation of the joints in the south upper roadway approach spans; refurbishing the existing fire standpipe system; and strengthening of the subway floorbeam connections in the approach spans.

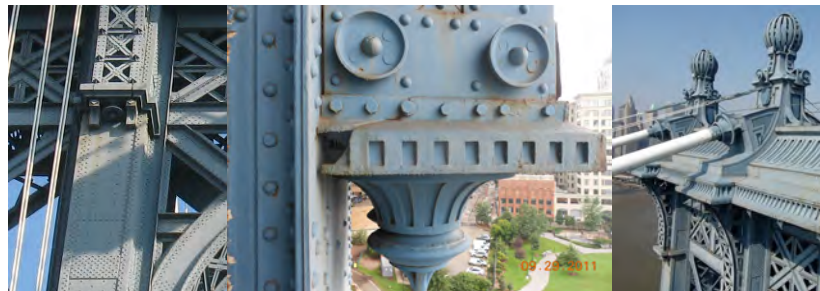
Ornamental Brackets, Rosette, Ball, and Cable Band.

The scope also includes the removal and replacement of the tower ornamental cornices, globes, cable collars and brackets. These features of the bridge are constructed from cast iron and are quite heavy. They are installed at the top of the towers and are exhibiting severe structural and connection problems. These elements are cracking and the connection bolts are severely corroded and/or missing. They have been red flagged under the biennial inspection program and need to be replaced. The Notice to Proceed for construction is expected in early 2018.

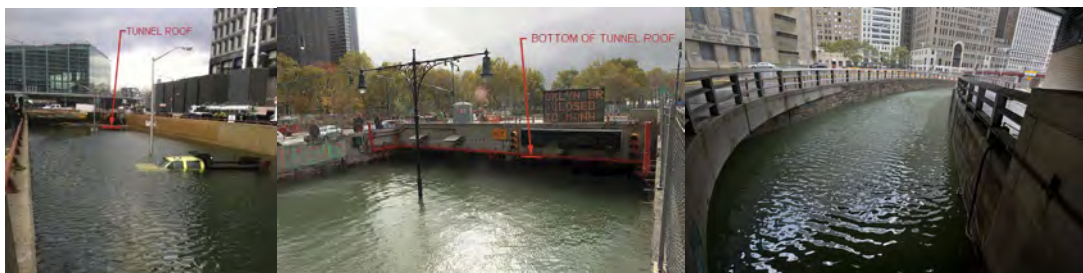
October 2012 - Battery Park Underpass - View Looking West at the South Portal Entrance Near the FDR Drive. View Looking South at the North Portal Entrance Near West Street. West Street Underpass – Approach at South Portal Looking Southeast. Both Tunnels Were Flooded to Their Roofs, Which Means That all Tunnel Ventilation, Electrical, and Mechanical Systems Were Entirely Submerged in Saltwater.

On October 29, 2012, the New York Metropolitan area was impacted by Hurricane Sandy, causing flooding, loss of power and damage to many components of New York City's infrastructure. On October 30, 2012, a site inspection by the Department revealed major damage to both underpasses. Specifically, certain electrical, mechanical and structural issues with regard to the tunnels had to be addressed.

Salt water penetrated the electrical and mechanical equipment in both underpasses, including but not limited to, motors, lighting and pumps. It is therefore, necessary to solicit the services of a specialty contractor to perform all necessary repairs.

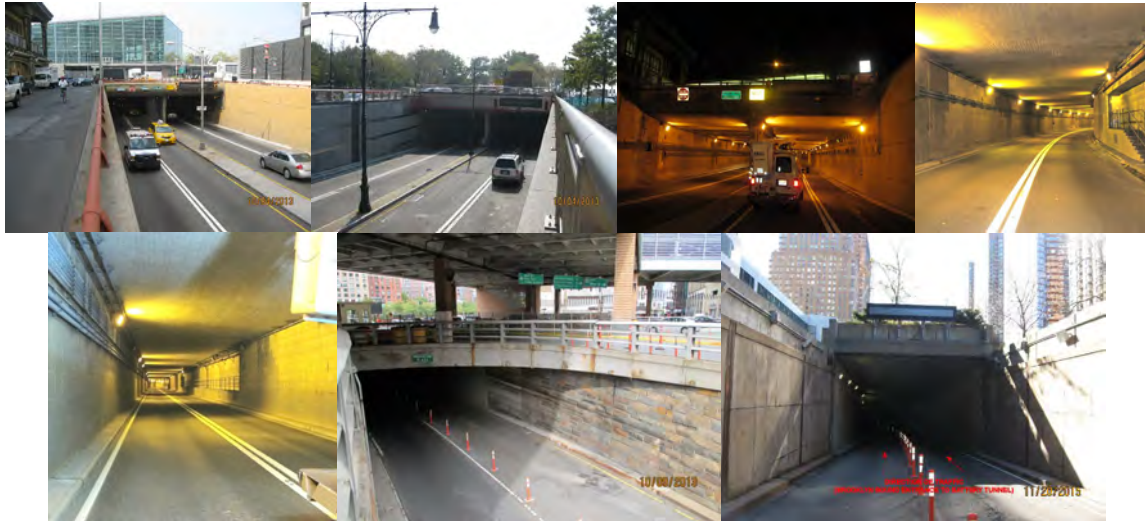
October 2013 – Battery Park Underpass – Elevation Right Span 1 and Left Span 1. (Credit: NYSDOT) September 2013 - Span 2 Looking Westbound (FDR Drive to West Street). June 2014 – The Underside of the Tunnel is Completely Covered With Tiles. October 2013 - West Street Underpass - Elevation Right Span. November 2015 – Left Fascia. (Credit: NYSDOT)

A Letter of Intent for the emergency repairs of these underpasses was issued to the contractor with a start date of February 17, 2015. The scope of work includes replacement of all of the exhaust fans, motors, sump pumps, traffic signals/VMS, heating and ventilation units, fire and CO monitoring control systems, and the street lighting and emergency response systems. The project will be constructed in four phases and was in the second phase in Fall 2016. The scope of work also includes the installation of a SCADA system (Supervisory Control and Data Acquisition) for the remote monitoring and control of all systems. Construction is expected to be complete in July 2018.

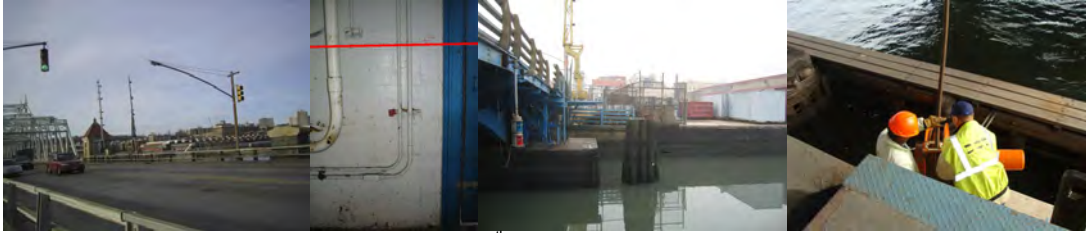
Inspection in Late 2012: East End of the West 207th Street Bridge - Missing Traffic Signal was Knocked Down by the Hurricane Winds. Borden Avenue Bridge Operator's House Basement Level – Depicted Flood Line was Approximately 5 Feet Above the Floor. Third Street Bridge – Northwest Channel Light Missing. Ninth Street Bridge – Manually Pulling the Cable Reel Because the Motor Failed.

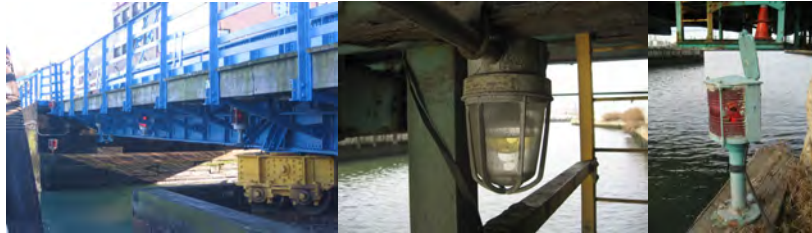
Inspection in Late 2012: Carroll Street Bridge - Navigational Fixtures on North Side of Span – Only the Center Span Fixture was Operational. Grand Street Bridge – Standing Water in the Access Light Fixture at the East Wedge Walkway. Typical Impact Damage to Pier Light.

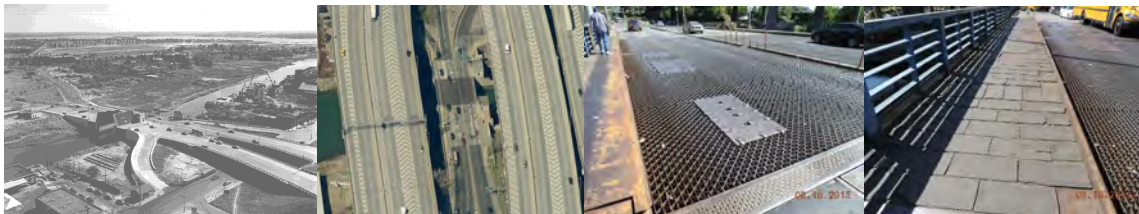
Unionport Bridge in 1953 and 2009. 2015: Span #9, Open Deck Grating at Westbound Roadway, Looking Ahead and Right. Loose and Bouncing Plates. Plastic Delineator Posts Mounted to the Concrete Median are Missing the Majority of Posts Due to Vehicular Impacts. Span #9 Right Sidewalk, Looking Back. Asphalt Tiles Over the Bascule Span are Severely Deteriorated and Exhibit Several Missing Tiles. (Credit: NYSDOT)

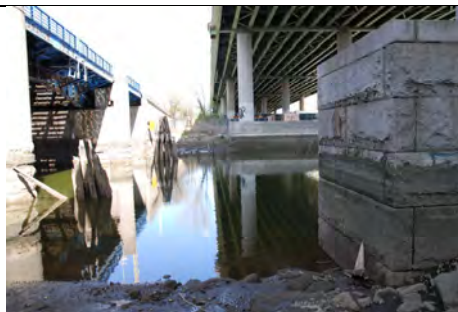
Proposed Bridge Cross Section. Area of Bridge Widening.

The project's scope of work includes: a complete replacement of the bascule, flanking, and approach substructures and superstructures, providing six 12-foot travel lanes with shoulders on both sides of the bridge; a new 12-foot bicycle/pedestrian path and a 8-foot sidewalk, separated from traffic with a barrier; replacement of the existing mechanical and electrical systems for the bascule span; reconstruction of the bridge operator and control houses, and replacement of the existing fender system, sheeting, dolphin clusters, drainage system, street lighting, traffic signal facilities, and gates. All asbestos containing materials, contaminated soils, lead paint, and other regulated materials will be removed and discarded. The new west and east approaches and ramps will be constructed with new modular retaining walls and filled with soil at grade. The new protected bicycle/pedestrian path will close a gap between the Hutchinson River Greenway east of the bridge and the existing bikeway network west of the bridge. Additional improvement measures will be implemented at the Brush Avenue intersection to enhance safety and operation. Construction is anticipated to start in summer 2017, and to be completed in summer 2021.

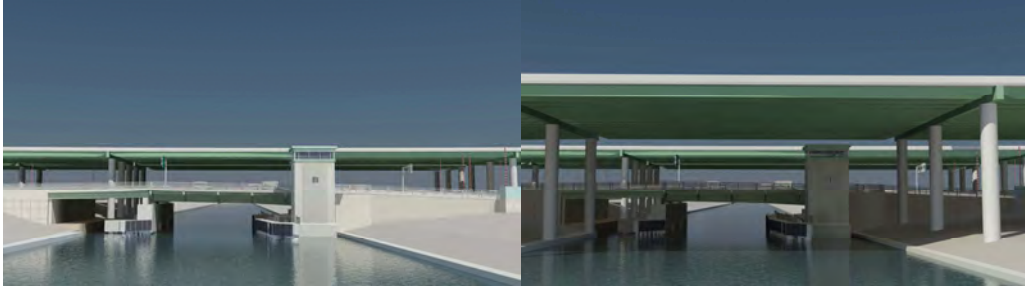
Proposed Twin Single Leaf Bascule (Looking North).

The project is in its final design phase for the replacement of the existing bridge with a new wider bridge. Due to overhead and lateral site constraints, other movable bridge types such as swing spans or vertical lift bridges were not deemed feasible. The new, wider roadway maximizes use of the space between the elevated structures. The single leaf bascule built in the open position, offset from and behind the existing bascule, will allow traffic to continue on a skewed alignment across the existing bridge as the new span is built. The resulting twin bascules will allow one span to be taken out of service if required for future maintenance or reconstruction while providing ample room for traffic on the remaining span.

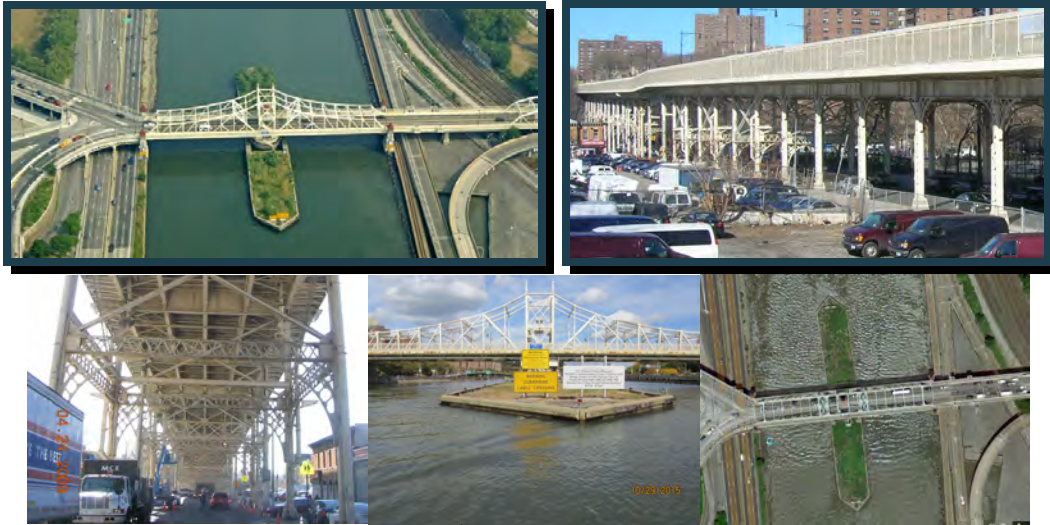
Aerial View. West 155th Street Viaduct. The Timber Fender.

The existing swing span fender is misaligned with the swing span in open position, and the timber cribbing is under attack by marine borers which could lead to the failure of the timber cribbing and

the collapse of the stone fill. In 2016, the contractor installed formwork around the perimeter of the existing fender, filled the voids in the fender with sand-cement grout, and bonded the existing timber and rock into one solid mass. Remaining work includes the construction of a fender extension on the northeast corner. In addition, in connection with the fender repair, the work activities will include removal of debris located on the river bottom in the channels adjacent to the swing spans. A Notice to Proceed for this rehabilitation project was issued to the contractor with a start date of July 27, 2015. Construction is anticipated to be substantially complete in January 2018.

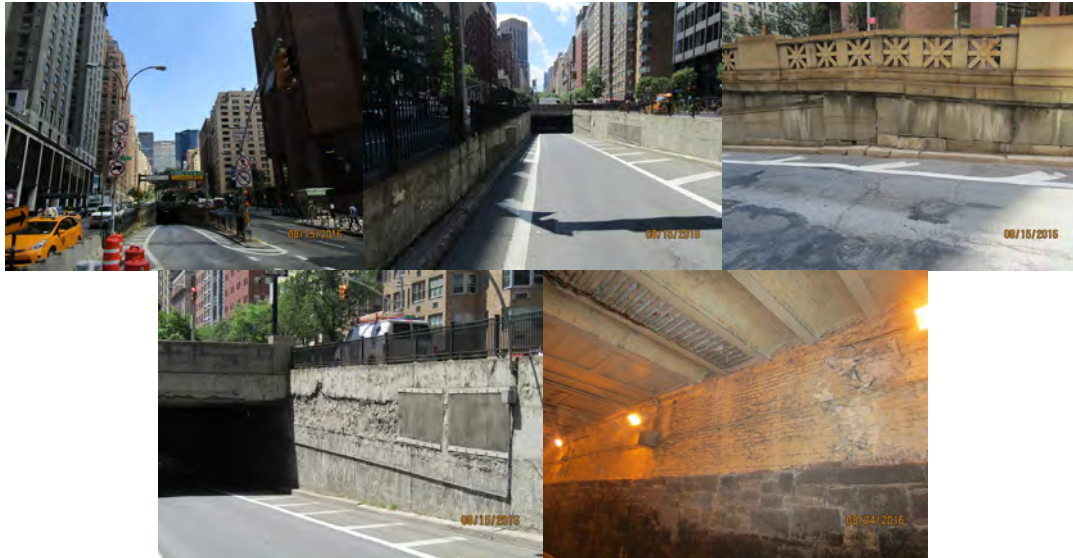
Park Avenue Tunnel – Left and Right Elevations in 2016. Begin Left Wingwall - Stones are Partially Dislodged, Cracked and With Missing Mortar. End Right Wingwall - Wall is Spalled and Exhibits Hollow Concrete Areas That are Shielded With Wire Mesh. End Abutment (Near South Portal) – Bricks Exhibit Deteriorated Mortar. (Credit: NYSDOT)

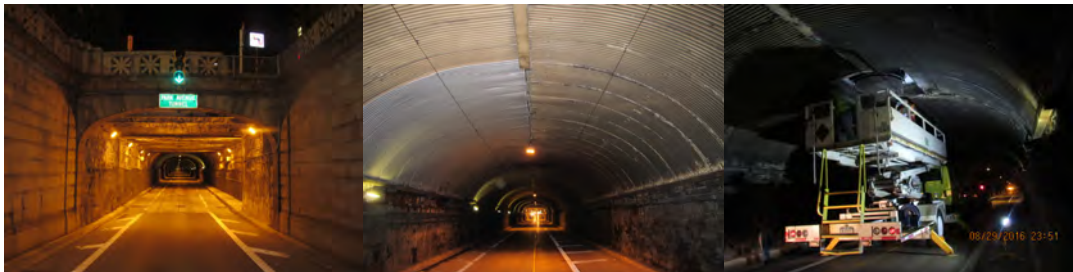
March 2016: 34th Street Entrance, Looking Northeast. March 2016: Missing Joint Plates at Tunnel Crown. August 2016: Performing Overnight Preventive Maintenance.

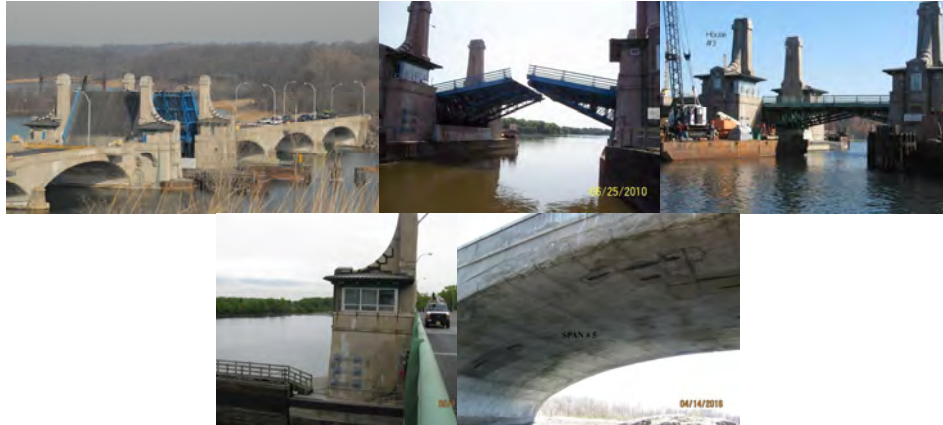
Bridge Closing in 2010. (Credit: NYSDOT) General View of Bridge Operator House #3 in 2011. Bridge Operator House #3 Exterior Wall in 2016, Looking Northwest. Underside of Arch Span # 5 - Spalled Concrete With Exposed Rebar is Secured With Netting.

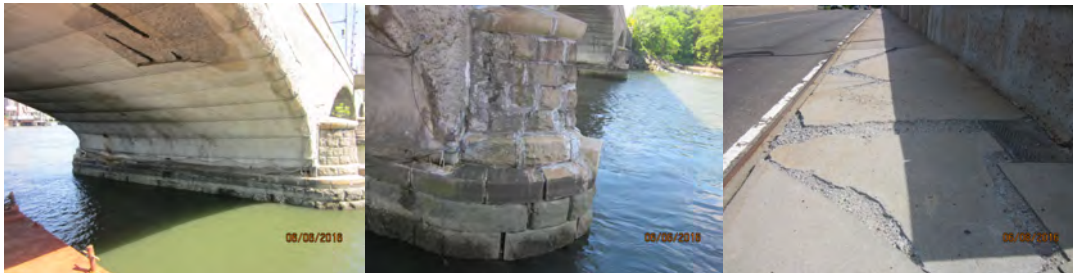
2016: Pier 1 Begin Face. Pier 2, Left End of Pier Nose - Typical Mortar Loss Between Stones. Span 6 Right Sidewalk Exhibits Full Width Shallow Spalls. (Credit: NYSDOT)

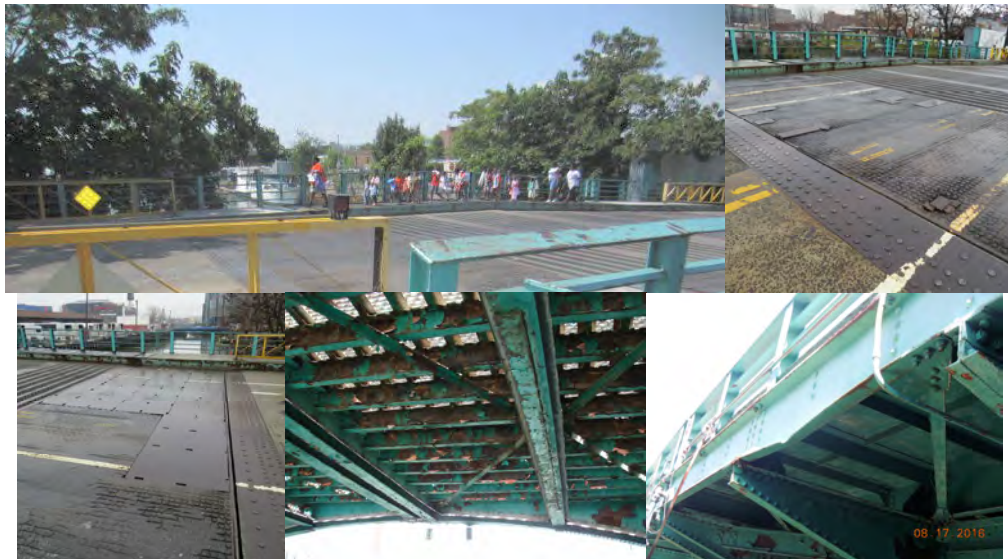
Union Street Bridge - Schoolchildren Crossing in 2012. (Credit: NYSDOT) Steel Plates Covering the Steel Grid Deck. 2016: Severe Corrosion and Peeling Off Paint Under Deck of Span #3. Span 3 - The Left Fascia Stringer Exhibits Impact Damage. (Impact Credit: NYSDOT)

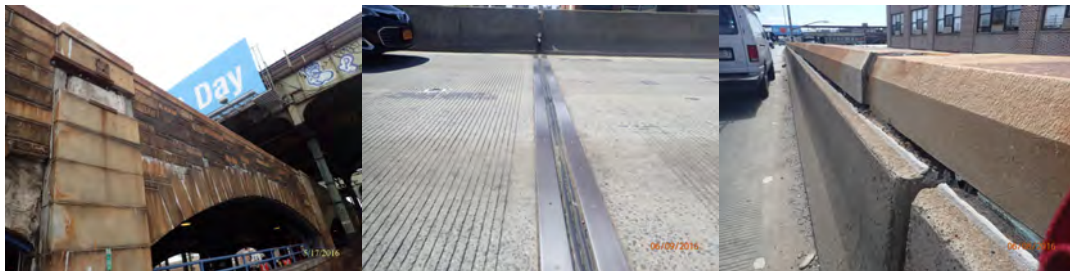
May 2016: Span 43, Right Side Fascia - the Stone Masonry Curtain Wall Exhibits Localized Moderate to Heavy Efflorescence Formation at Several Mortar Joints at the Outside Face and at the Underside of the Arch. Pier 19 Joint, Atlantic Avenue Westbound - Approximately 40% Length of Joint Compression Seal is Slightly Debonded. Spans 33 thru 35, Top of Deck, Right Fascia at Right Bridge Railing - Separation (up to 2") of the Fascia Stones From the Bridge Railing. (Credit: NYSDOT)

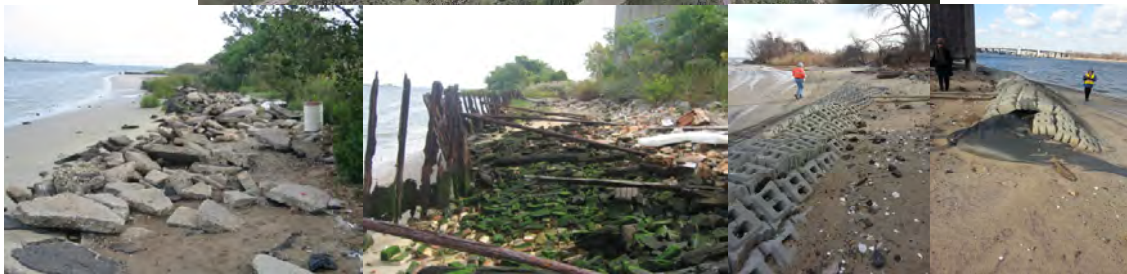
Tidal Wetland Mitigation Site. Before Mitigation – Large and Heavy Surface Debris and Deteriorated Bulkhead. Inspecting the Hurricane Sandy Damage at the Site in January 2013.

On October 29, 2012, Hurricane Sandy impacted the east coast and caused major damage. A survey after the storm discovered severe plant and revetment damage at the contract site. The established site grades were overwhelmed by the storm surge, ground protection and slope stabilization measures were displaced, and the plantings were uprooted and washed away. The National Park Service put the worksite off limits while Hurricane Sandy cleanup operations were in progress. A site inspection was held in the winter of 2013, and again in the summer of 2014. In June 2015, approximately 22,000 intertidal wetland plants (*Spartina Alterniflora*) were re-established. In addition goose fence and overhead protection were installed. The location of the planting was also adjusted to better fit the tidal contours. The plants were watered in June and July, and the site was monitored in September. The area will continue to be monitored through 2017.

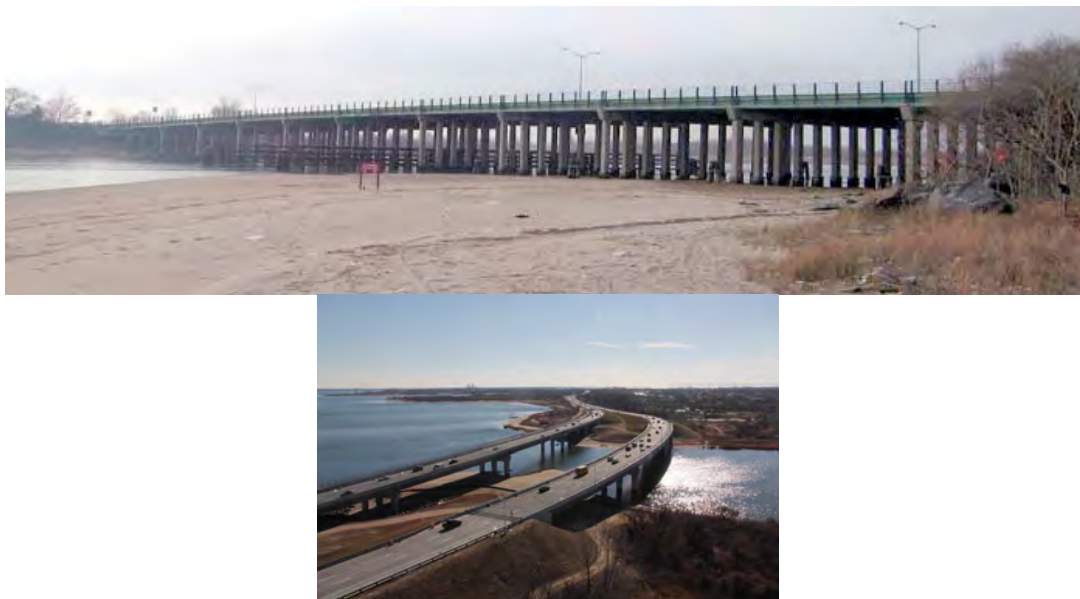
Old Paerdegat Basin Bridge. New Bridges in November 2013.

The old Paerdegat Basin Bridge was a 692-foot long, 13 span, multi-girder, simple supported steel superstructure, supported on reinforced concrete pier cap beams and abutments supported on reinforced concrete piles. The bridge had two 34-foot wide roadways carrying three lanes of traffic in each direction, with a 3-foot safety walk on the north side, a 4-foot wide center median/barrier, and an 8-foot wide south pedestrian/bicycle sidewalk. The existing structure and immediate approaches were demolished and replaced by two new bridges and new approach roadways on split alignments. The existing structure was permanently closed to traffic on December 20, 2012, upon opening of the new westbound structure. Demolition of the existing structure was completed in May 2013.

The two replacement bridges consist of trapezoidal steel box girder structures: the 825-foot, 3 span westbound bridge, north of the existing structure, and the 1,227-foot, 5-span eastbound bridge, south of the existing structure, remaining at 28 feet over the navigable channel. Both bridges have a 36-foot wide roadway with a 12-foot wide right shoulder. The eastbound bridge

has a 4-foot wide left shoulder, while the westbound bridge has a 10-foot wide left shoulder. The southern structure carries eastbound traffic while the northern structure accommodates westbound traffic. Both the horizontal and vertical alignments changed, resulting in improved sight distances on the bridges and their approach roadways. The bridge carrying eastbound traffic also has a dedicated pedestrian/ bicycle path along the south side. The pedestrian/bicycle path is separated from traffic lanes by a concrete barrier on the bridge, and by a 15-foot wide grass mall on the approach roadways.

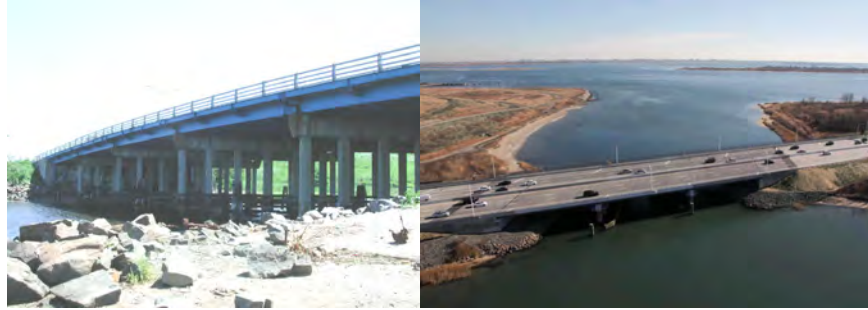
Old Fresh Creek Bridge. New Bridge in November 2013. (2002 Credit: NYSDOT)

The Fresh Creek Bridge was a 264.5 foot, 5-span, multi-girder, simple supported steel superstructure, supported on pre-cast concrete columns founded on four reinforced concrete piers on concrete piles with concrete gravity abutment walls on timber piles. One navigation channel passed under the bridge. The bridge had two 34'-2" wide roadways, a 5-foot wide center median/barrier, and a 10-foot wide south sidewalk. The parkway, east and west of the bridge, has a 10-foot wide bicycle/pedestrian path on the south side. The existing structure and immediate approaches were demolished in spring 2012, and the replacement structure was fully opened in August 2013.

The replacement bridge is a 316-foot, 3-span structure; the new structure has only two support piers, resulting in a wider channel. The bridge deck and approaches were widened to 126 feet from the former 86 feet to accommodate three 12-foot lanes in each direction, 12-foot wide right shoulders, and a 12-foot wide bicycle/pedestrian path, separated from the traffic lanes by a barrier system. The profiles of the approach roadways and bridge structure accommodate stopping sight distances for a design speed of 60 miles per hour. The remainder of the construction resulted in improved landscaping on the bridge approaches. The existing pedestrian and bicycle pathway were maintained and open at all times during construction.

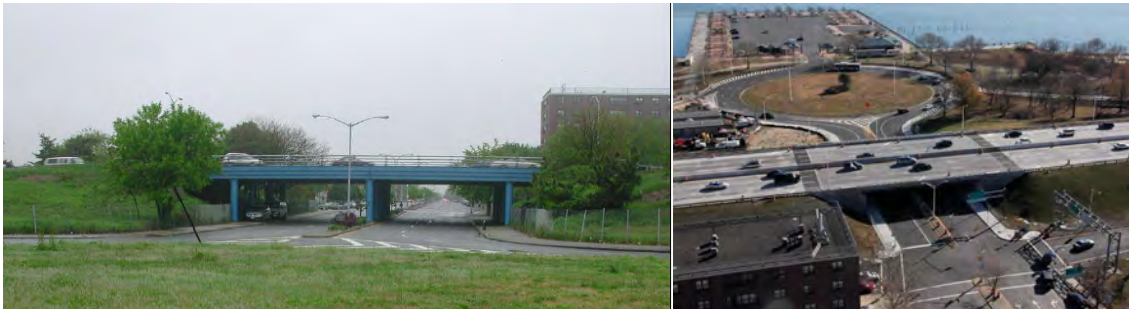
Old Rockaway Parkway Bridge. New Bridge in November 2013. (2002 Credit: NYSDOT)

The Rockaway Parkway Bridge was a 150-foot, 4-span, multi-stringer, simple supported steel superstructure, supported on steel cap beams on concrete filled steel pipe columns, and reinforced concrete abutment walls supported by concrete pile foundations. The bridge had two 34'-2" wide roadways, a 5-foot wide center median/barrier, and a 10-foot wide south sidewalk. The existing structure and immediate approaches were demolished in fall 2012, and the replacement structure was fully opened in August 2013.

The replacement bridge is a single span structure to improve visibility along Rockaway Parkway. The new structure was built in the same alignment as the existing bridge. The bridge deck was widened to 109 ½ feet from the former 84 feet to accommodate three 12-foot lanes with a 12-foot wide right shoulder and 4-foot left shoulder in each direction, including 5 ½ feet for median and parapet width. The right shoulder on each approach is 10 feet wide (while the width of the right shoulders on the bridge structure are 12 feet), with the other dimensions the same width as those on the bridge. In addition to reconstruction of the bridge, four access ramps were also reconstructed, as was Rockaway Parkway in the vicinity of the Belt Parkway.

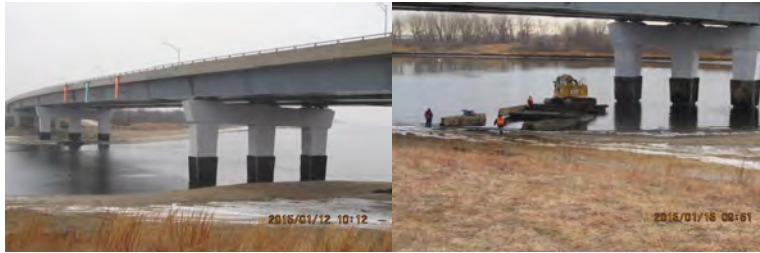
January 2015: Paerdegat Basin Bridges. Eastbound Belt Parkway Bridge over Paerdegat Basin. Newly installed Pier Bumpers at Low tide Facing East. Navigation Lights Over Center of Channel. Barge-Mounted Back Hoe used to Complete Installation of Pier Bumpers.

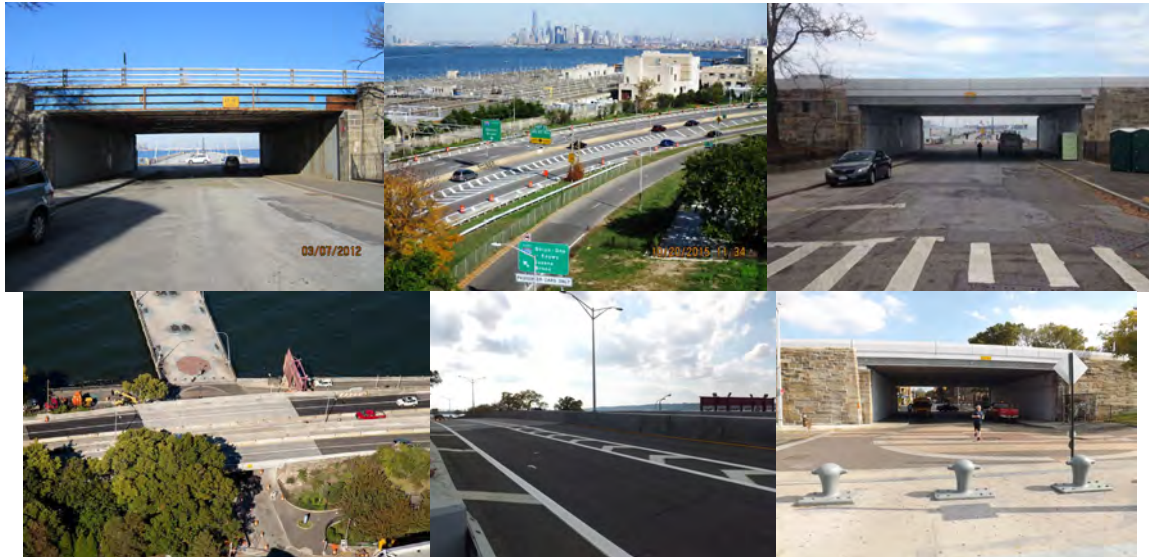
Old Bay Ridge Avenue Bridge in 2012. (Credit: NYSDOT) October 2015: Belt Parkway Roadway at West Side of Bridge. NYCDEP Owl's Head Waste Water Treatment Plant at Top. New Bridge in November 2015. October 2016.

The Bay Ridge Avenue Bridge was a 58-foot long, single span, reinforced concrete deck on a multi-girder system superstructure over Bay Ridge Avenue. The superstructure is supported by concrete gravity type abutments on pile foundations. There is pedestrian access under the bridge to both the American Veterans Memorial Pier and the Shore Parkway Seawall pedestrian and bicycle paths. The underpass also serves as access to the NYCDEP Owl's Head Wastewater Treatment Plant. The existing superstructure was demolished and replaced.

Permanent reconstruction of the bridge included the new concrete barriers along the median and eastbound roadway, new pre-stressed concrete box beams, superstructure slab, pavements, pressure relief joints, approach slabs, and upper abutment stem wall reconstruction for the center and eastbound segments of the new bridge and approaches. The Bay Ridge Avenue Bridge was substantially completed on November 2, 2015.

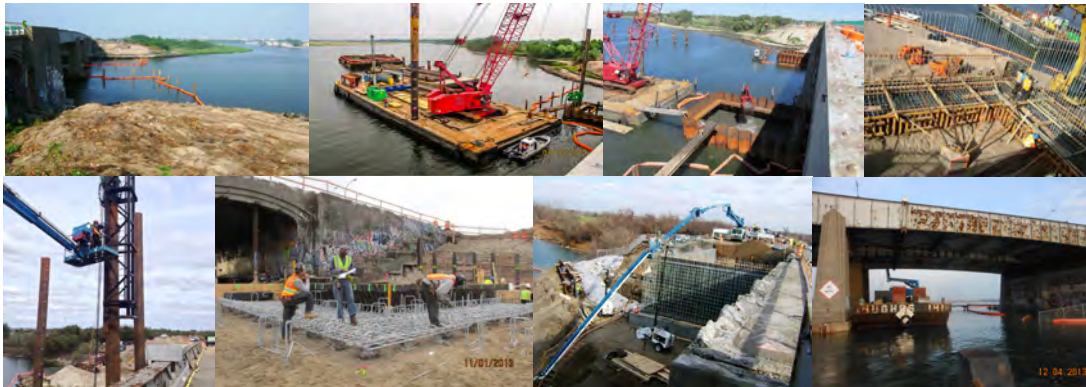
June 2013: North Side of Gerritsen Bridge - Turbidity Curtains Placed on Both Sides of Navigable Channel.

July 2013: Work Barges Driving Steel Sheet Piling for Pier #1 Cofferdam. September 2013: Rebars and Form Work for Footing and Walls at the Northwest Abutment. Stage 1 Piles. November 2013: Inspecting Rebar. December 2013: Tremie Concrete Pour at Pier #2. Inspecting Spans 7 & 8 of the Existing Bridge From a Barge. (Inspection Credit: NYSDOT)

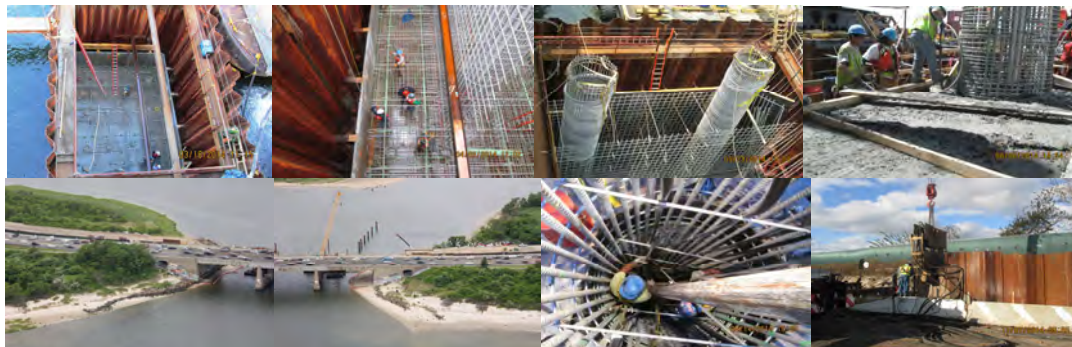
Gerritsen March 2014: Setting Footing Rebars Prior to Placing Pier Rebars and Concrete at Pier No. 2. April

2014: Setting Rebars for Footing and Pier Inside Cofferdam at Pier #1. May 2014: Plinth and Column Reinforcement Inside the Cofferdam for Pier 2. June 2014: Placing and Vibrating Concrete for Plinth at Pier #1. Rebars for Column in Place. West Abutment of Bridge. New Roadway Under Construction at top Next to Westbound Lanes. East Abutment of Bridge. Crane on Barge at Cofferdam for New Pier #2. August 2014: Workers Inside Rebar Cage During Operation of Pumping Concrete Into Pier #2 Column. November 2014: Steel Sheet Piling in Place for the East Approach Temporary Access Roadway.

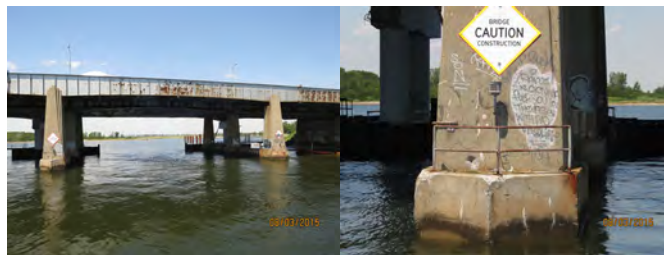
Current Gerritsen Inlet Bridge in August 2015 - Span 6, Right Fascia, Looking Left. Span 6, Pier 5, Column 3 – Construction Sign and Non-Functioning Light. (Credit: NYSDOT)

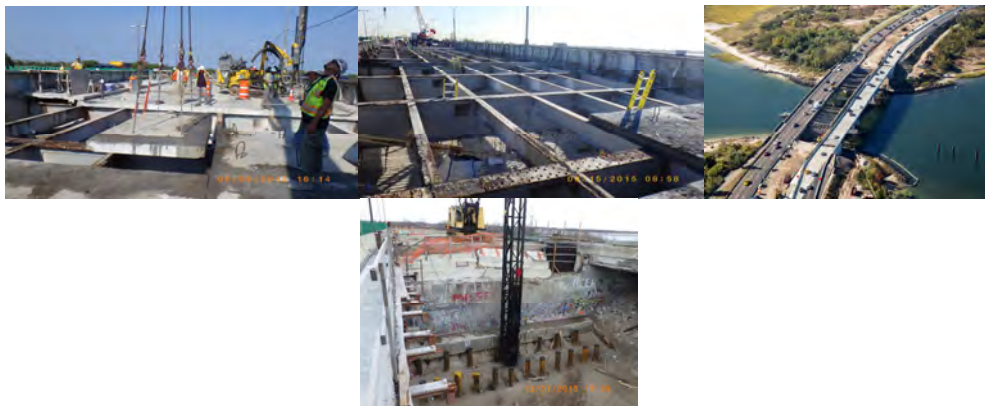
September 2015: Removing Saw-Cut Deck Panels. Deck Removed Prior to Steel Removal. October 2015: Stage 2 Traffic Pattern. Westbound Traffic at Right on New Bridge. Eastbound Traffic at Left on Existing Bridge. December 2015: Driving 14-Inch Diameter Steel Shell Piles at East Abutment - Facing East.

On August 14, 2015, the contractor transitioned to Stage 2, through the movement of all traffic to the new northern (westbound) section of the bridge. Stage 2 work completed in 2015 included the demolition of the northern portion of the existing bridge, placement of embankment material for the Stage 2 approach roadway, and installation of the Stage 2 drainage facilities. Installation of the Stage 2 cofferdams began in late 2015, and were followed by all foundation operations in early 2016.

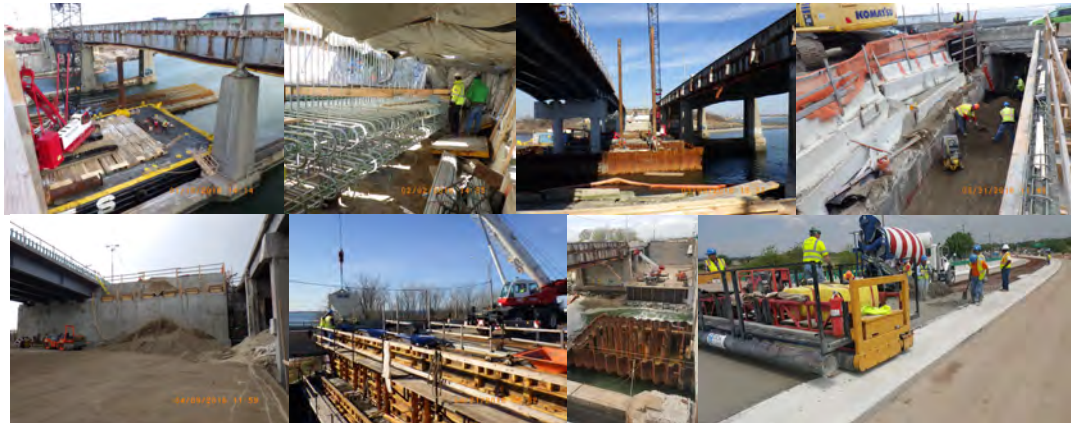
Gerritsen Inlet January 2016: Work Barges Setting up to Drive Steel Shell Piles at Pier #1. Existing Bridge at Right (Partially Demolished) Carrying Eastbound Traffic. February 2016: Galvanized Rebars in Place for East Abutment Footing. March 2016: Driving 24" Diameter Steel Shell Piles at Extension of Pier #1 Cofferdam. New Westbound Bridge at Left. Existing Eastbound Bridge at Right. Backfill Between Old East Abutment of Bridge at Left and New East Abutment Wall for Stage # 2 Bridge Construction. April 2016: Completed Portion of New East Abutment of the Bridge. New Bridge at Left. Placing Concrete at West Abutment Back Wall With a Crane and Bucket. May 2016: Stage 2 Pier #1 Cofferdam With Steel Pipe Piles. Bottom - Existing Footing to be Removed. Top - West Abutment and Existing Eastbound Roadway at Upper Left. Placing and Finishing On-Grade Pavement at Approach.

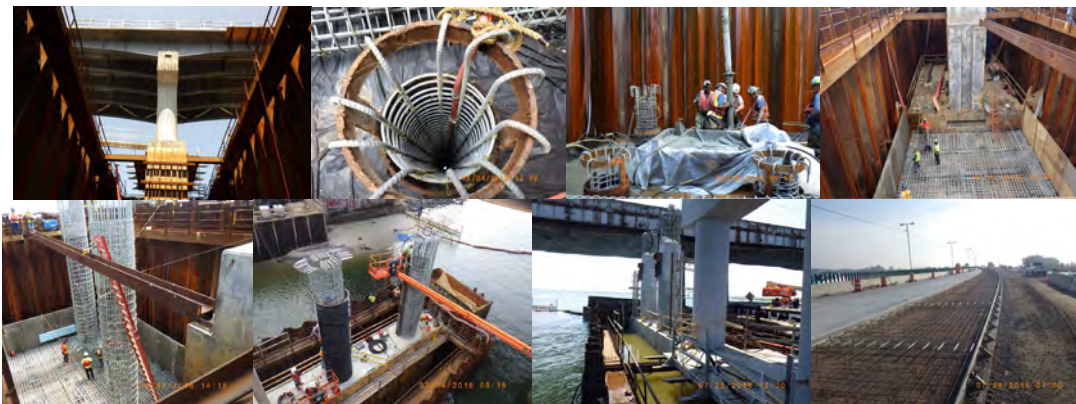
Gerritsen Inlet May 2016: Cofferdam at Pier at Pier #2. Column, Pier Cap and Structural Steel Placed in Stage 1. June 2016: Rebar Cage Placed Inside Steel Pipe Pile Prior to Concrete Operation. Filling Steel Pipe Piles With Pumped Concrete. Pier # 2 Setting Rebar for Footing to Extend Footing Placed During Stage 1. Lowering Column Rebar Cage

Onto Footing Rebars at Pier # 2. July 2016: Pier #2. Placing Pier Column Forms Around Galvanized Steel Rebar Cages on Top of Plinth. Pier # 2. Pier Columns With Cap Beam Form Supports. Old Eastbound Bridge at Top. On Grade Pavement Forms, Joints, and Pavement Mesh at Bridge Approach.

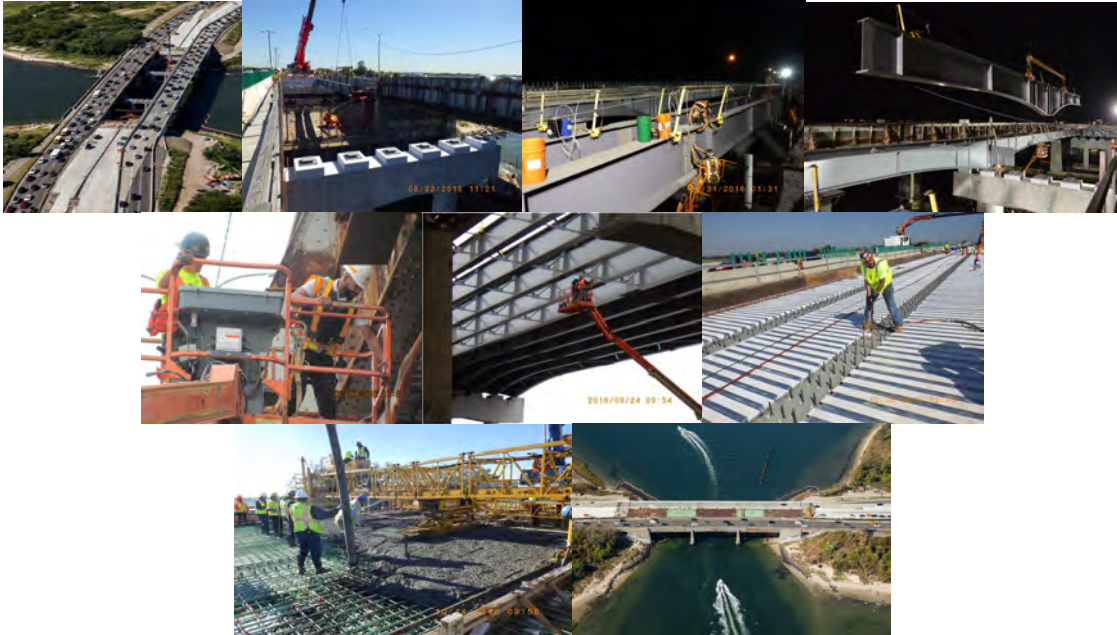
Gerritsen Inlet August 2016: New Westbound Bridge at Right. Existing Eastbound Bridge at Left. Completed Piers #1 and #2. Approach Pavement in Place for New Eastbound Bridge. Setting Girder Sections Between East Abutment and Temporary Falsework. Pier #2 at Bottom. Placing High-Strength Bolts Through Girder Splice Plates. Lowering Girder Section Onto Pier #2 for the Eastbound Bridge at Night. Civil Engineering Intern Juan Medina-Yan Examines the Existing Structure. (Credit: Eric Callender) September 2016: Torqueing Girder Web Splice Plate Bolts. October 2016: Welder Attaching Shear Studs to the Top Flange of the Eastbound Bridge During Stage 2. Placing and Finishing Deck Concrete. Construction of Stage 2 Deck at Center of the Bridge.
