As an integral part of New York City's Department of Transportation, the Division of Bridges has a two-fold mission: to maintain an optimal transportation network by ensuring smooth mobility on the city's bridges, and to ensure the safety of the public.

ACCOMPLISHMENTS & PLANNED PROJECTS

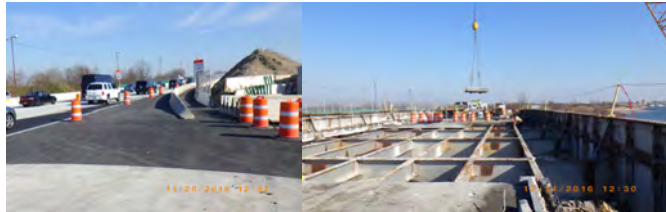
Gerritsen Inlet November 2016: West Approach to New Eastbound Bridge. Stage 3 Temporary Bicycle/Pedestrian Path Entrance at Right. December 2016: Removing Saw-Cut Deck Panels From Eastbound Bridge During Stage 3.

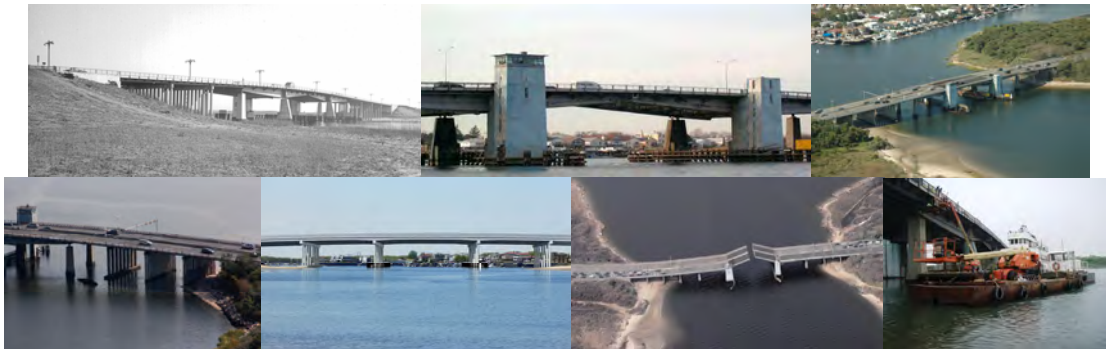
Mill Basin Bridge in 1946. Aerial Views. Proposed Bridge. Open Bridge. May 2013 – Inspecting the Bridge From a Barge.

The existing Mill Basin Bridge is 864-feet long and 14 spans, including double movable leaf bascule spans and a steel superstructure, supported on reinforced concrete piers on timber piles, and abutments supported on pre-cast concrete piles. The existing structure and immediate approaches will be demolished and replaced.

The replacement will be a 2,645-foot long, 17-span, 60-foot high fixed bridge. It will consist of a steel composite superstructure and reinforced concrete substructure on piled footings, and will be constructed on a new alignment set on the north side of the existing bridge and partially overlapping with the existing bridge. The new bridge and approach roadways will have three 12-foot wide traffic lanes, a 12-foot wide right shoulder on the bridge, a 10-foot wide right shoulder on the approaches, and a minimum left shoulder in each direction. The eastbound side will carry a dedicated pedestrian/bicycle path along the south fascia. The new bridge will be a fixed structure with a 60-foot vertical clearance over Mean High Water, obviating the need for opening and closing the structure to accommodate tall vessels. The channel will remain navigable during construction, and the clear channel width will remain the same after the new structure is in place. A new fender system will be installed to protect the bridge substructure from marine traffic. The contract will be completed in four stages of work (including two additional sub-stages) and will maintain three lanes of vehicular traffic in each direction, as well as pedestrian and bicycle traffic during all construction stages. Construction began in the summer of 2015 and is scheduled to last for 5 ½ years, including demolition of the existing bridge.

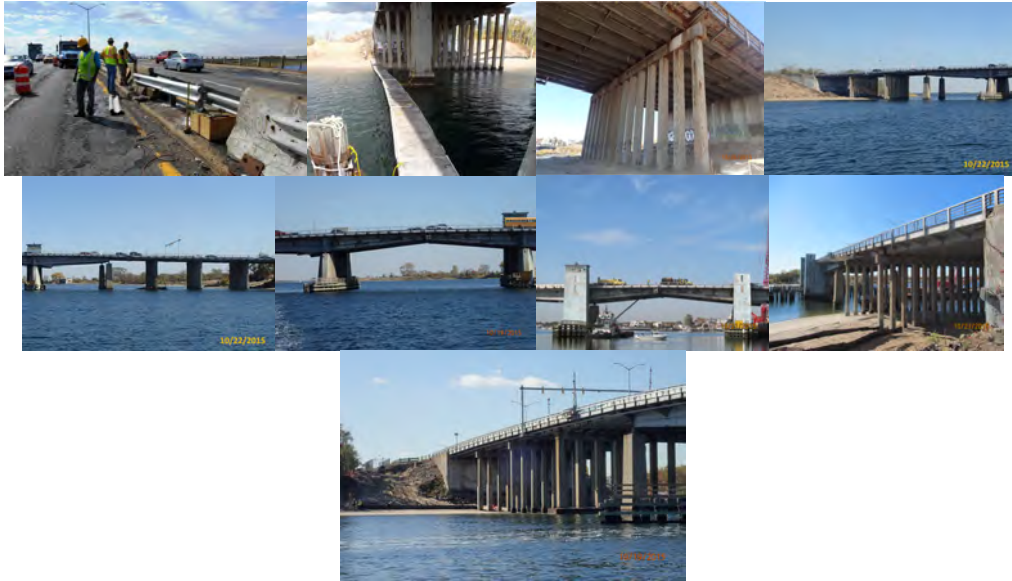
Mill Basin September 2015: Median Guide Rail Repair Operations on East Side of Bridge. October 2015: Temporary Walkway on North Side of Bridge for Access to Pier #9. Current Mill Basin Bridge in October 2015 - Span 11 Pier 11 - Columns with Cracks, Hollow and Spalls. Elevation Left Span 1-7, 7-14. Span 8. Elevation Right Span 8, 9-14, 1-7. (Inspection Credit: NYSDOT)

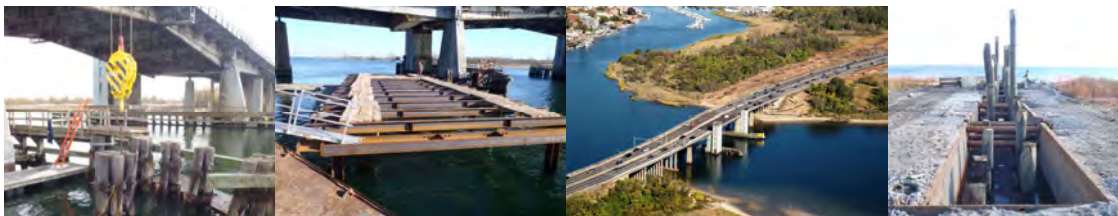
November 2015: Extracting Wood Piles From the Existing Bridge Fender System at New Pier #9 Site. Pier #9 Steel Framing for the Cofferdam on the West Side of the Existing Bridge. December 2015: Outfall #2. Pressure Treated Wood Piles – Facing East.

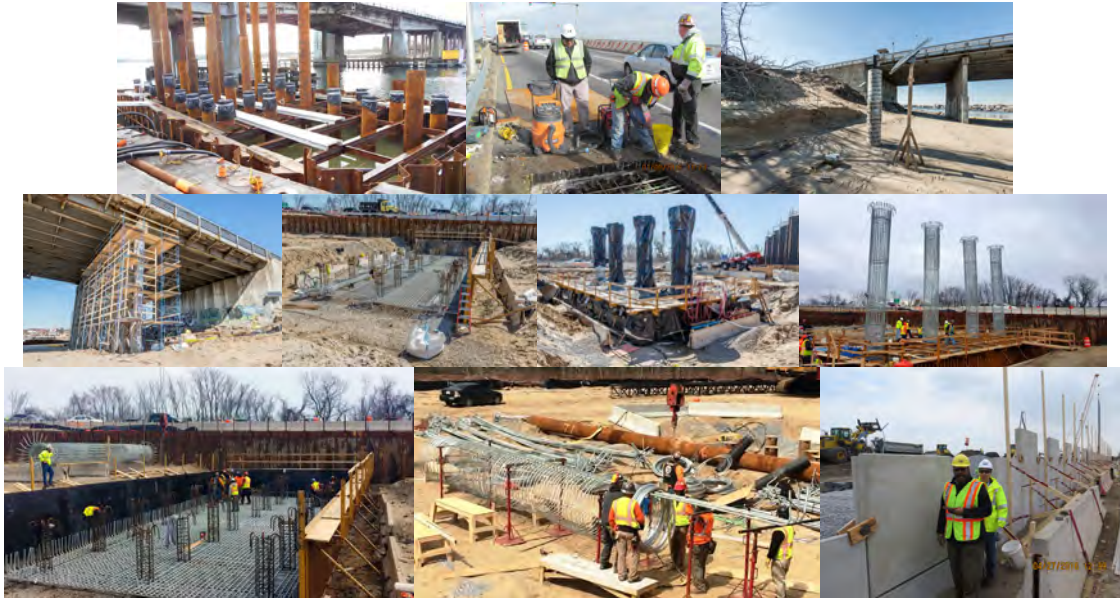
Mill Basin January 2016: New Pier #9. Cofferdam With 24-Inch Steel Shell Pipe Piles. Existing Moveable Span at Upper Right. Assistant Civil Engineer Khalid Mohammed (White Helmet) Inspecting Repairs on the Existing Bridge. (Credit: Eric Callender) February 2016: Vibration Monitoring Equipment Located at the South Abutment. March 2016: Scaffolding in Place at Pier #11 for Flag Repairs of Existing Bridge. North Abutment at Right. Setting Rebar Footing Mat at Bridge Pier #3. Tops of Concrete-Filled Steel Piles. Westbound Belt Parkway Traffic in Background. Pier #1 at Southwest Quadrant of Bridge. Cooling Tubes for Mass Concrete Placement of Footing and Piers. April 2016: Rebar Cages in Place at Pier #3 Columns. Pier #3 of New Bridge. Footing, Rebars, and Top of Pile Rebars in Place. Galvanized Rebar Columns Cage at Left Prior to Setting on Footing. On-Site Fabrication of Pier Column Galvanized Steel Reinforcement Bar Cages. Associate Project Manager Sobner Saint Dic and Administrative Engineer Daniel Hom Inspecting the Abutment. (Credit: Eric Callender)

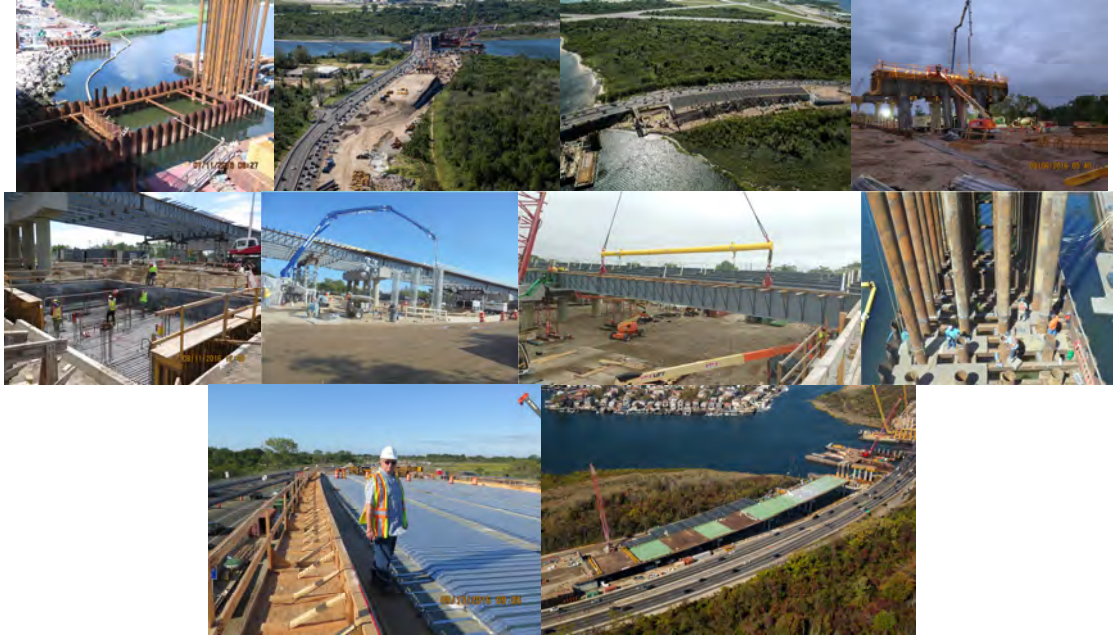
Mill Basin July 2016: Pier # 7 Cofferdam Prior to Driving Steel Pipe Piles to Final Depth. August 2016: North Abutment and Completed Columns, and Pier Caps at Piers #16 – #12. Jamaica Bay Riding Academy at Left Center. South Abutment With Structural Steel on Piers #1-#5. Floyd Bennett Field at Top. Concrete Pour for Pier 14 Cap at Sunrise. Southwest Quadrant Pier Footing. September 2016: Pumping Concrete for Columns at Pier # 15 for the Westbound Bridge. Erecting Steel Girders Using Lifting Frame. Pier #7 cofferdam. Steel Pipe Piles Driven to Grade Being Cut for Final Grade Prior to Concrete Placement. Assistant Civil Engineer Yuriy Kheyman Examining the South Side of the New Eastbound Deck. (Credit: Eric Callender) October 2016: Between the South Abutment and the Waterway. Stay-in-Place Forms, Epoxy-Coated Rebars and West Deck Curing in Progress. North Abutment at the Top.

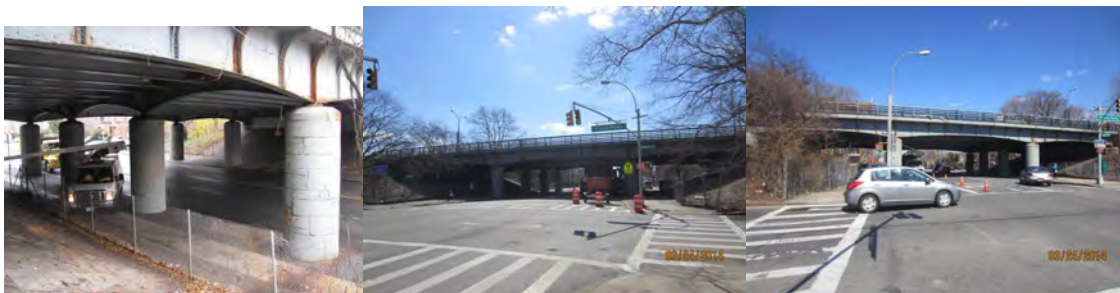
Nostrand Avenue Bridge Pier 1 and 2 Columns in December 2014. Left and Right Elevations in 2014
(Credit: NYSDOT)

The existing Nostrand Avenue Bridge is a 140-foot long, 3-span, multi-girder superstructure, consisting of a concrete deck with an asphalt overlay over Nostrand Avenue. The superstructure is supported by concrete pier columns with a steel cap beam, and abutments on concrete filled steel pile foundations. The existing structure and immediate approaches were to be demolished and replaced. This bridge was removed from the current Belt Parkway Project, and its design was terminated. It will be added to another Belt Parkway bridge project in the future. The condition rating of this bridge is better than the other remaining bridges in this program; rescheduling will not negatively impact the bridge users.

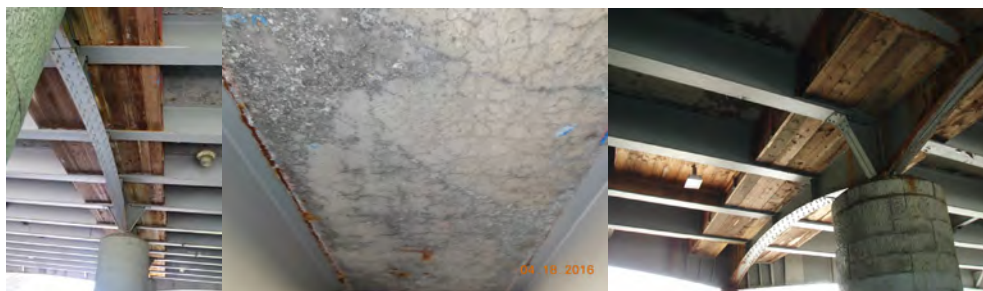
Span 1 Deck – Hollow Sounding Concrete Areas are Covered by Timber Planks That are in Good Condition. April 2016: Span 2, Underside of Deck, Bay 3 - Exhibits Scaling, Mapcracking with Localized Efflorescence, and Dampness Over Approximately 50%-60% of its Surface. (Credit: NYSDOT) July 2016: Span 2 Timber Shielding.

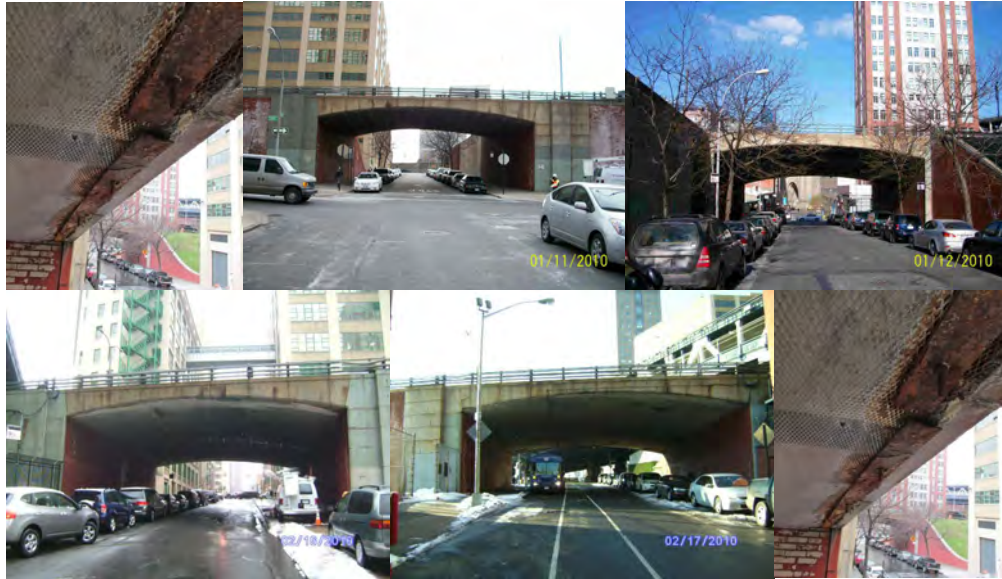
In general, the arch bridges have an adequate load-carrying capacity, however, there are areas of map cracking and visible leakage through the joints. Mesh has been installed at the underside of the deck to prevent debris from falling on vehicles or pedestrians below.

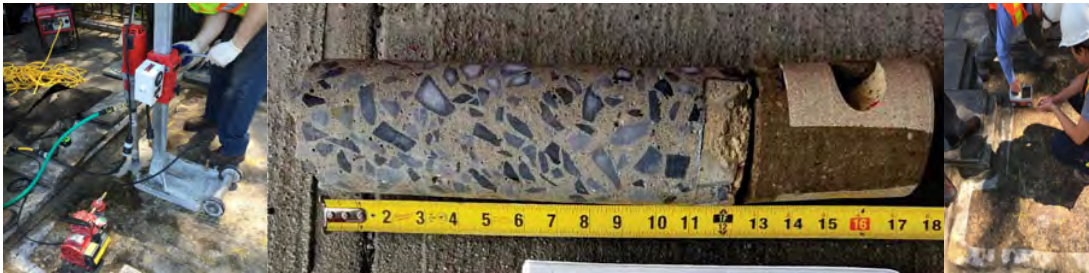
Utilizing a Coring Machine to Obtain a Concrete Core for Testing. June 2016: Core Sample from the Westbound BQE over Adams Street. Ground Penetrating Radar Utilized to Locate Rebars.

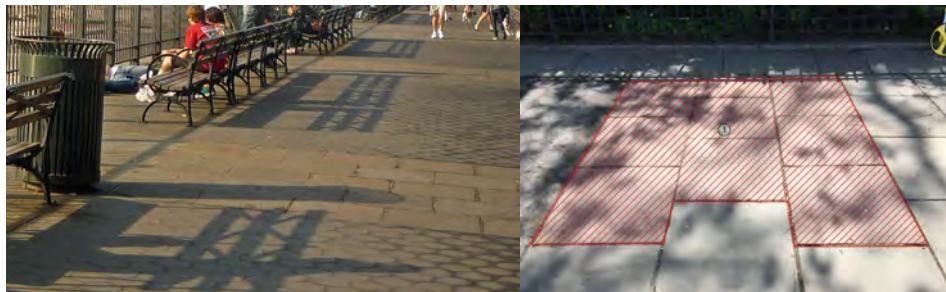
Brooklyn Heights Promenade Pavement - The deck slab of the Brooklyn Heights Promenade is paved with hexagonal pervious pavement interspersed with areas of large rectangular stone pavers. Pavers were removed for testing on the Promenade then replaced once completed. Hands-on inspection of the promenade revealed that the overall condition of the pavement is good, with the exception of a few areas of heaved or sunken pavement, missing pavement, and scaling paver stones. Heaved pavement was observed specifically at the bridge joints.

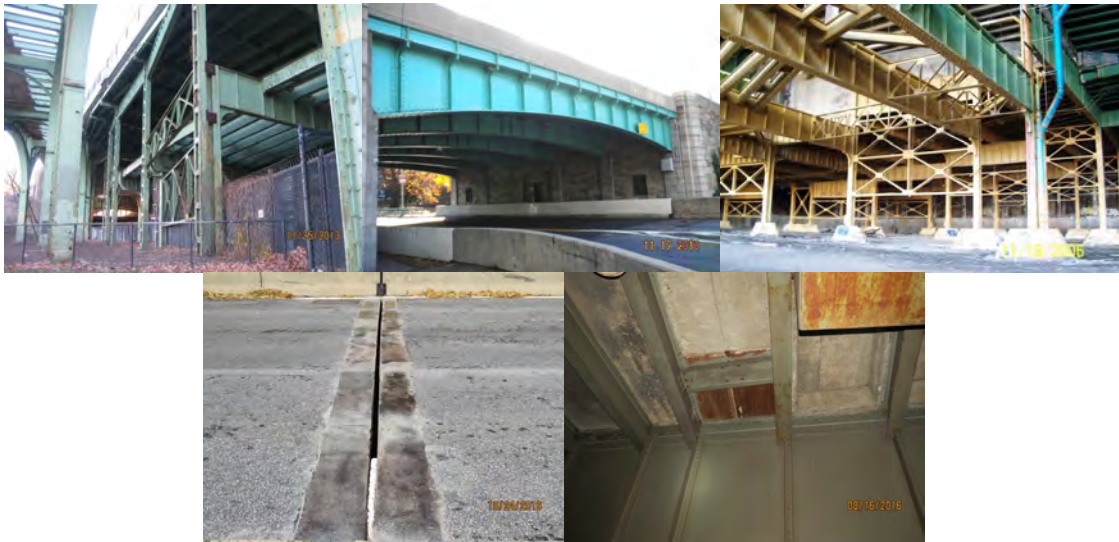
West 72nd Street Viaduct Left Elevation Spans #1 -5, and Span #107. Piers #3 – 10. 2016: Pier 102, Deck Joint at Southbound Roadway – Missing Joint Sealer Material. Span 143, Underside of Deck – Deep Spall.
(Credit: NYSDOT)

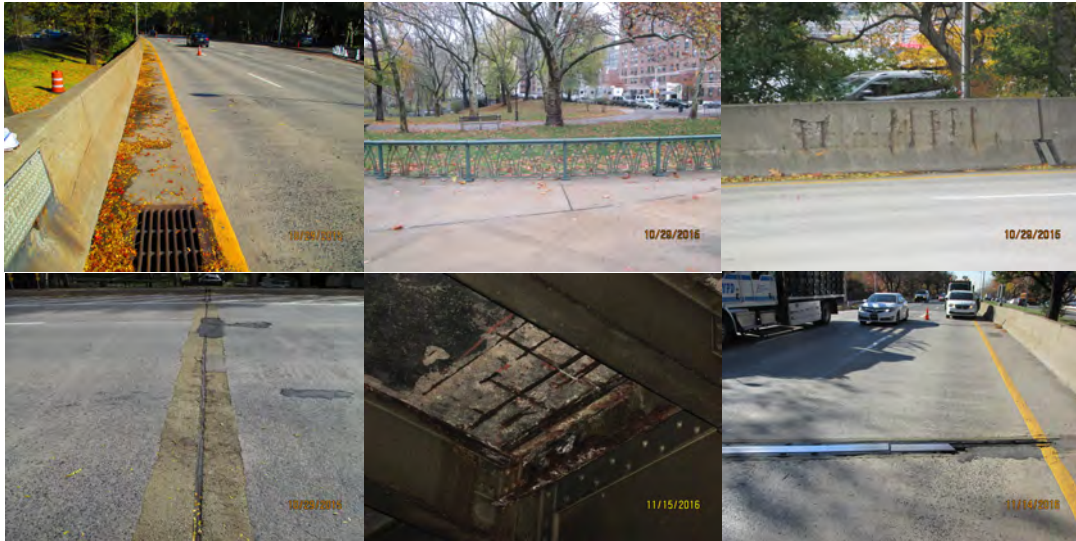
West 94th Street Viaduct – 2015: Span 34 Left Lane. Span 12 Right Railing and Left Side Concrete Parapet. Span 31 Top of Deck. 2016: Span 4 – Spall With Exposed Rebar. Pier # 3, Deck Joint, Northbound Henry Hudson Parkway, Left Lane – Joint Missing Metal Plate. (Credit: NYSDOT)

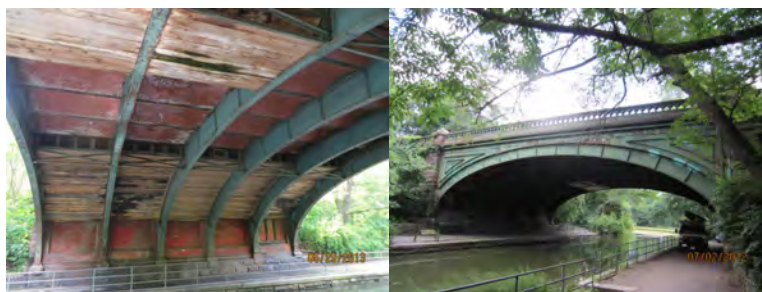
Hill Drive Bridge Span 2 Pier 1 End Face in 2013. View of Bridge in 2012. (Credit: NYSDOT)

The landmark Hill Drive Bridge was built in 1890, and was designed by Calveart Vaux. It was previously known as the Breeze Hill Bridge. The existing Parks bridge is a three span simply supported steel girder/beam structure, with the center arch span crossing Prospect Park Lake, and the other two spans consisting of underground masonry cellular structures with multiple interior masonry-bearing walls and non-composite concrete deck and concrete sidewalk. The substructure of the bridge consists of solid gravity masonry abutments with U-type wing walls.

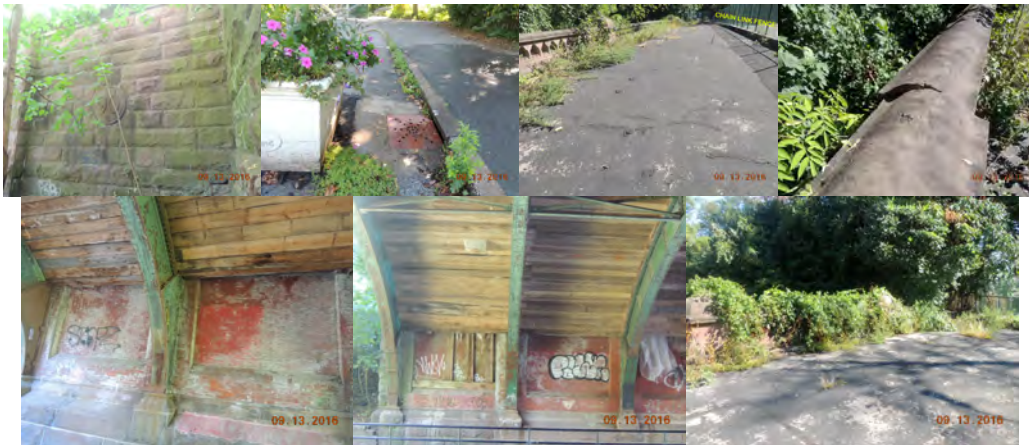
Hill Drive Bridge in 2016: Span 1, Left Exterior Enclosure Wall. End Approach at Right Curb Line. Spans 1 Through 3 Wearing Surface - Exhibits Partially Sealed Asphalt Cracks and Vegetation Growth on the Left Side. Span 1 Left Railing- Shifted but Stable Stone Railing Coping. Pier 1 Between Bays 4 and 5 - Exhibits Efflorescence and Water Stains Through the Brick. Span 2 Brick Arch - View of Installed Timber Shielding. Span 3 Left Parapet and Railing - Heavy Vegetation Growth. (Credit: NYSDOT)

This project will include the replacement of the existing masonry cellular abutments with new reinforced concrete abutments clad with existing stone and new brick masonry; the removal, storage, and reinstallation of the existing stone wing walls with a new reinforced concrete core; the replacement of the existing stringers and floor beams with new steel stringers; the reinforcement of the existing arch girders with new cover plates; the reinstallation of the steel arch girders at their current locations to replicate original construction; and the replacement of the existing masonry arches spanning between floor beams by masonry cladding on the underside of the new arched concrete deck. The concrete deck, approaches, sidewalk, and roadway will be replaced within the project limits.

The ornamental cast iron and stones will be rehabilitated and reinstalled, replicating all the historic features and aesthetics of the original bridge. New bridge lighting and drainage systems will be installed. The park landscape will be restored, and trees identified by the Prospect Park Alliance as rare and/or historic shall remain undisturbed during construction.

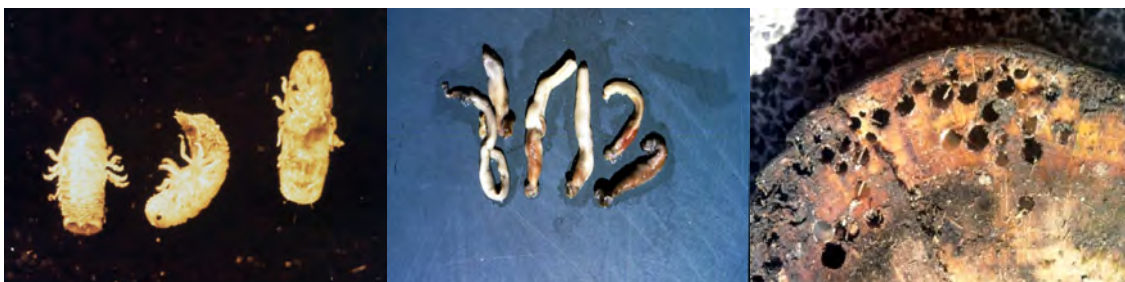
Marine Borer – Limnoria Species (the Common “Gribble,” a Genus of Crustacea Borers). Marine Borer – Teredo Species (a Genus of Molluscan Borers, Commonly Called the “Shipworm”). Teredo Damage (Holes up to ¼” Diameter).

Marine borers pose an immediate and serious danger to the thousands of piles and other structures of timber built in the marine environment. In New York Harbor, as the water quality improved due to many years of clean-up efforts, marine borer (limnoria, teredo, etc.) activity has increased significantly in recent years. The recent inspections of timber structures by various local agencies (such as The Port Authority of NY & NJ, NYS Department of Transportation, NYC Department of Sanitation, and NYC Economic Development Corporation) indicate increasing damage to their structures resulting from marine borer activity. These agencies are implementing measures to protect the structures against marine borers.

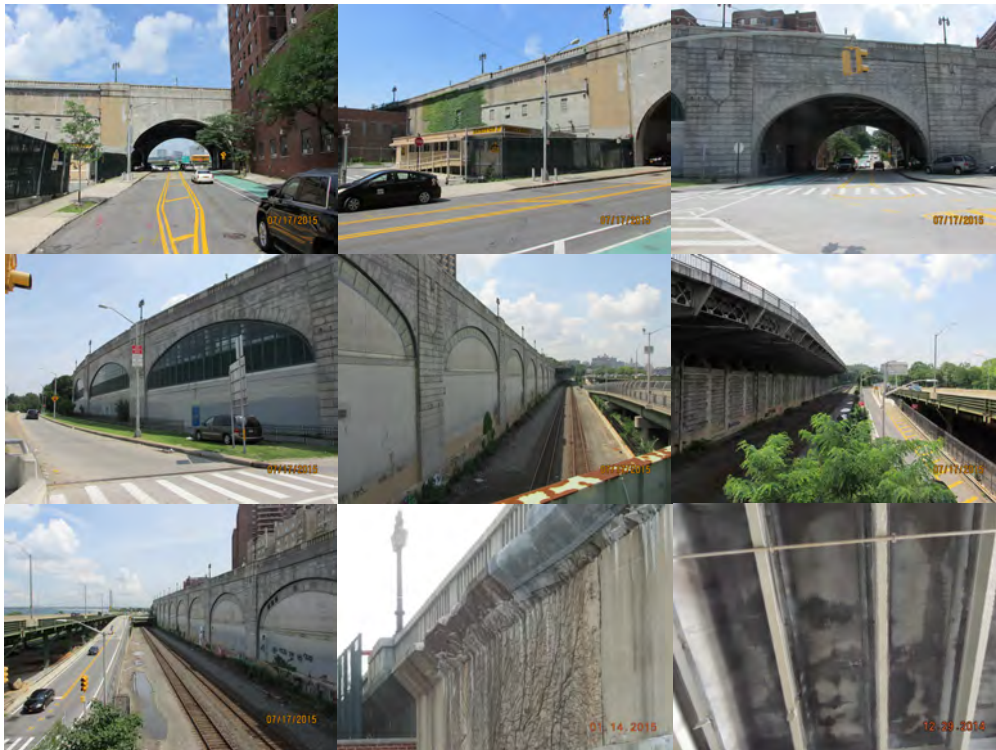
2015: Left Elevation Span 14, Spans 15 – 20. Right Elevation Span 14, Spans 13 – 1, 15 – 77, 41 – 77, and 43 – 13 (Section over NYCDOT Maintenance Garage Area). (Credit: NYSDOT) Spans 19-21, East Fascia Overhang, Looking Southwest - Large Edge Spalls with Numerous Cracks and Heavy Efflorescence Throughout Overhang. Span 52 Looking South - General View of Underside of Deck Showing Extensive Dampness and Cracks with Efflorescence.

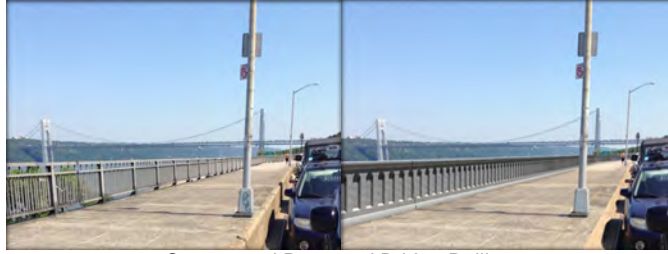
Current and Proposed Bridge Railing.

Project work will include the repair of deteriorated structural steel members; replacement of the existing deck; abutment and retaining wall repair; repairs and replacement of concrete barriers and bridge rails; complete expansion joint replacement; approach slabs and pavement replacement; cleaning and necessary repairs of drainage system, as well as encasement removal, paint removal, lead abatement and recoating of steel. The scope also includes the replacement in-kind of the existing period lighting and the restoration of the historic parapet at deck level. The project will neither change the roadway configuration nor impact the Viaduct facades. The bridge will remain open to traffic throughout field work and construction. The superstructure rehabilitation will be performed in four primary stages with a minimum of three travel lanes open all times, two in the peak direction and one in the off-peak direction through the use of a reversible lane. Work Zone Traffic Control to maintain traffic in both directions throughout the duration of construction will be implemented to replace the existing concrete deck, one third at a time, in three main stages. The majority of construction will occur during weekday daytime hours. Some weekend work is anticipated for the intersection with West 155th Street and limited nighttime work will be required for the portion of the Viaduct between West 153rd Street and West 155th Street that cantilevers over the Amtrak tracks. Construction is expected to begin in mid-2018, and is expected to be complete by the end of 2021.

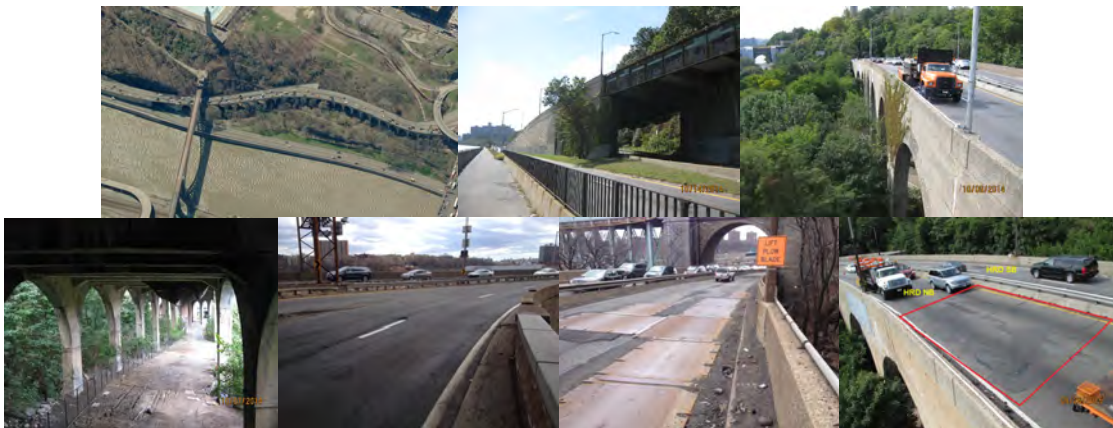
Aerial View. Trans-Manhattan Expressway Connector Ramp in 2014: Elevation Right Spans 1 – 25, 33 – 40.
Span 42, Netting at Deck Underside, Looking Ahead. (Credit: NYSDOT) March 2015 Field Inspection.
September 2015 - Span 42, Northbound Roadway, Looking Back. (Credit: NYSDOT)

The Trans-Manhattan Expressway Connector Ramp is an elevated viaduct that consists of a multi-span steel superstructure supporting a concrete deck. The ramp connects the Trans-Manhattan Expressway to the Harlem River Drive and it was built in 1939. It is a 2,080 foot long and 57 foot wide structure, consisting of 14 steel spans and 41 reinforced concrete spans, carrying two lanes of traffic in each direction, northbound and southbound. In 2008, New York State DOT completed an approximately \$4.5 million “top-side” repair project of the wearing surface, joints, median, parapets, and other above-deck elements. The scope of work includes rehabilitation of the bridge steel and concrete components; repairing outstanding structural flags on the ramp; repairing existing spalls and removing existing protective netting; and restoration of adjacent parkland including placement of a gravel base within the footprint of the bridge structure, construction of a paved access roadway, and landscape restoration including grass seeding. A Notice to Proceed for the \$10 million project was issued to the contractor with a start date of August 10, 2015.

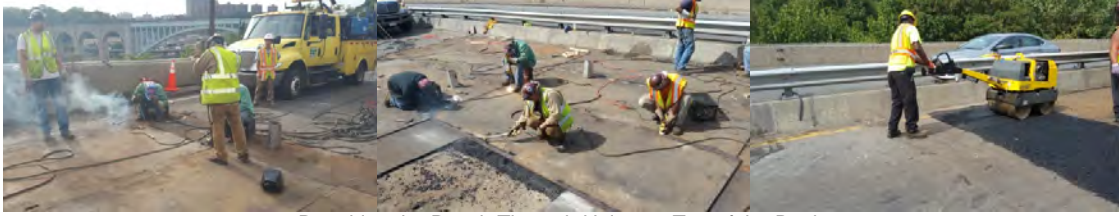
Repairing the Punch Through Holes on Top of the Deck.

During the winter of 2015, existing deck spalls developed into through holes at seven locations on both the south and north bound roadways. This situation was temporally rectified in September 2015 by Division personnel placing a number of steel road plates on the top of the holes to maintain traffic flow and keep the ramp open for the public. The repairs were then added to the contractor's work scope. The revised total contract value is approximately \$15 million.

Upon recent inspection of the holes and the anchoring steel plates, it was noted that the holes were increasing in size and the plates were exhibiting excessive movement under normal traffic. This presented a public safety hazard and emergency repair procedures were developed immediately to remedy the situation and make it safe for the public. It was decided that the emergency repairs were to be performed at the first opportunity available for full weekend closures of the ramp.

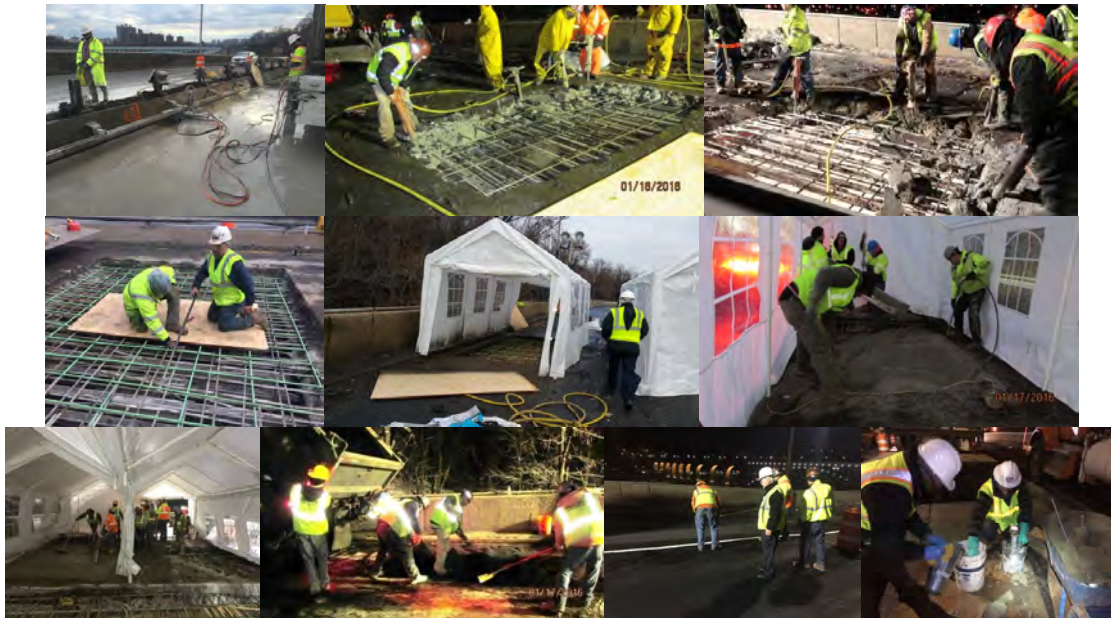
January 2016: Cold Weather Operations. Director of Manhattan and Brooklyn Roadway Bridges Mousa Nazif (White Helmet) Observing the Operations. Testing the Concrete.

Over the course of 2016, the contractor applied over 16,000 square feet of shotcrete, and erected over 80 tons of steel. In addition, repairs/replacements were made to the curtain wall along the Harlem River Drive.

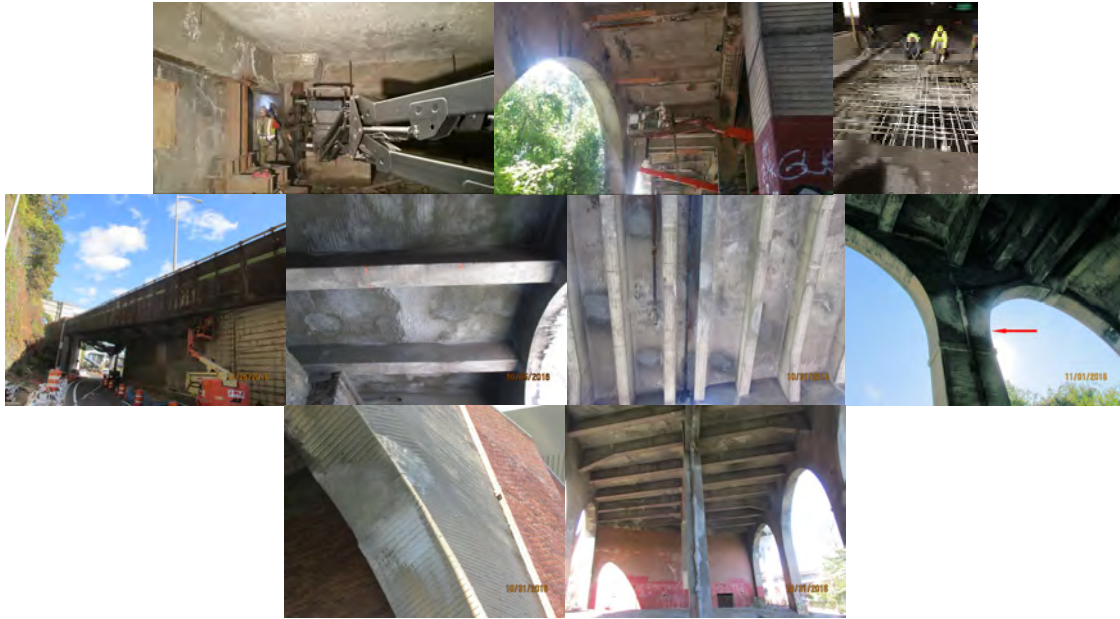
2016: Demolition of Spalled Concrete. Application of Shotcrete. Through Hole Deck Repairs. October 2016: Spans 11-18 Nylon Shielding. Span 27 Deck Repairs. Span 47 Floor Beam Repairs. Pier 43 Right Column Repairs. Span 51, Underside of Right Arch - Concrete Repairs. Pier 49, at Center Column - Concrete Repairs. (Shielding and Repair Credit: NYSDOT)

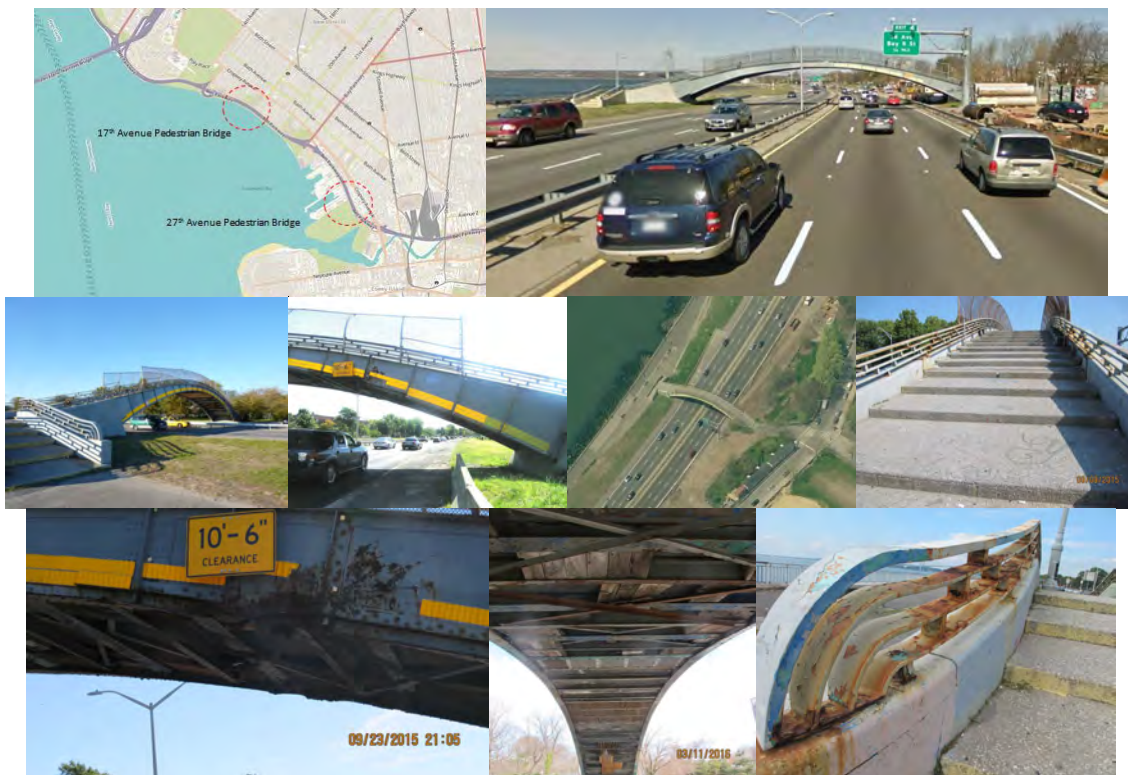
Location Map. 17th Avenue Bridge – Existing Conditions. Deteriorated Left Girder. Top of Span 1, Looking North – Wearing Surface has Extensive Scaling with Exposed Aggregates. Span 1 Left Girder over Belt Pkwy Eastbound Left Lane was Struck in September 2015. March 2016: New Bracing Under Span 1. October 2016: Beginning Approach, Left Side – Extensive Corrosion on the Guide Railing.

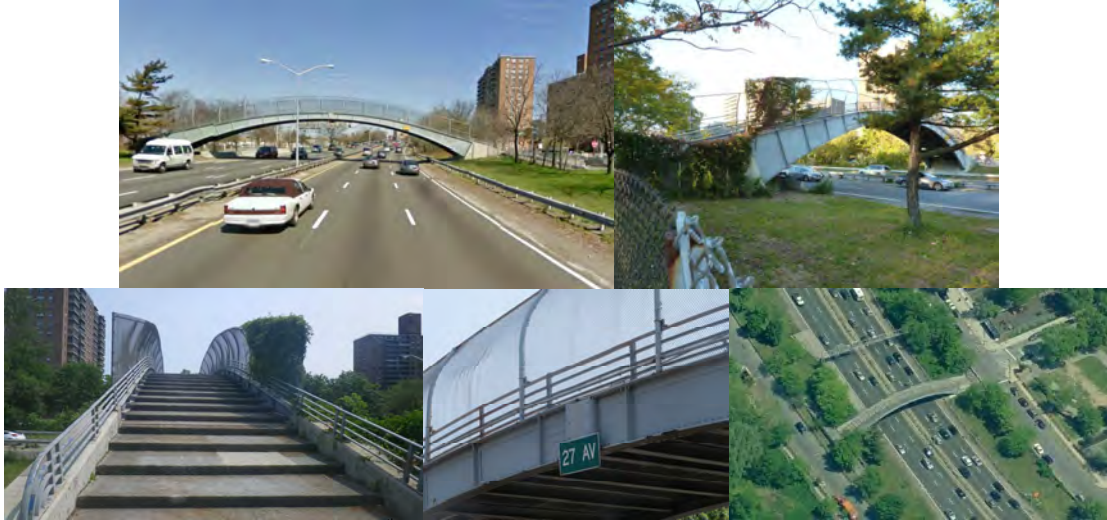
27th Avenue Bridge – Existing Conditions.

The 17th Avenue and 27th Avenue Bridges are three-hinged, steel arch girder bridges with granite-faced concrete abutments and Art Deco steel railings. These two pedestrian overpasses have deteriorated over time, and due to low vertical clearance, have suffered impact damage from oversize vehicle traffic on the Belt Parkway below. The 17th Avenue Bridge has a vertical clearance of 11'-2", at its lowest point, and the 27th Avenue Bridge a 12'-5" vertical clearance at its lowest point. Both bridges have an overall span length of approximately 130 feet, and a bridge deck width of 15 feet. In addition, these structures are not in compliance with American Disability Act (ADA) requirements.

In this project, the overpasses at 17th and 27th Avenues will be completely replaced to meet the primary goals of increasing the vertical clearance and provide ADA compliant access for the community. The structures will be designed to current codes and standards and all substandard features will be eliminated. Additionally, as the existing bridges were constructed under the Robert Moses era Master Plan for NYC, the proposed bridge designs will follow the Shore (Belt) Parkway Design Guidelines which were developed in November 2006, in order to preserve and reestablish the historic character of the parkway for drivers and pedestrians while enhancing and strengthening the visual cohesiveness of the greenspace connected to the adjacent park and recreation land. Construction is anticipated to begin in 2018, and is expected to be complete in 2020.

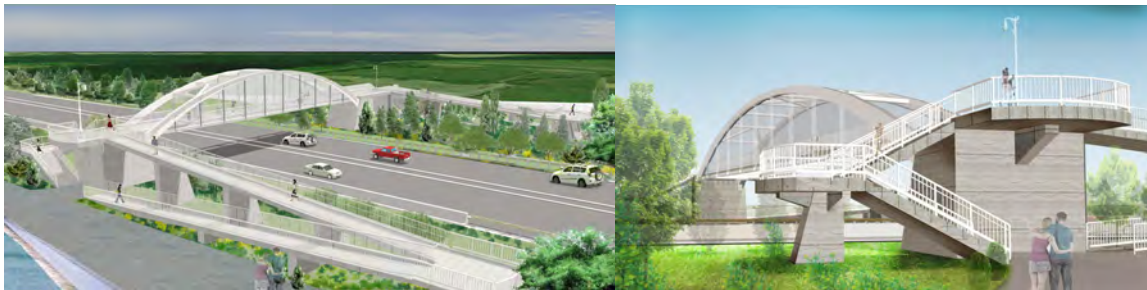
17th And 27th Avenue Bridges – Proposed Bridges.

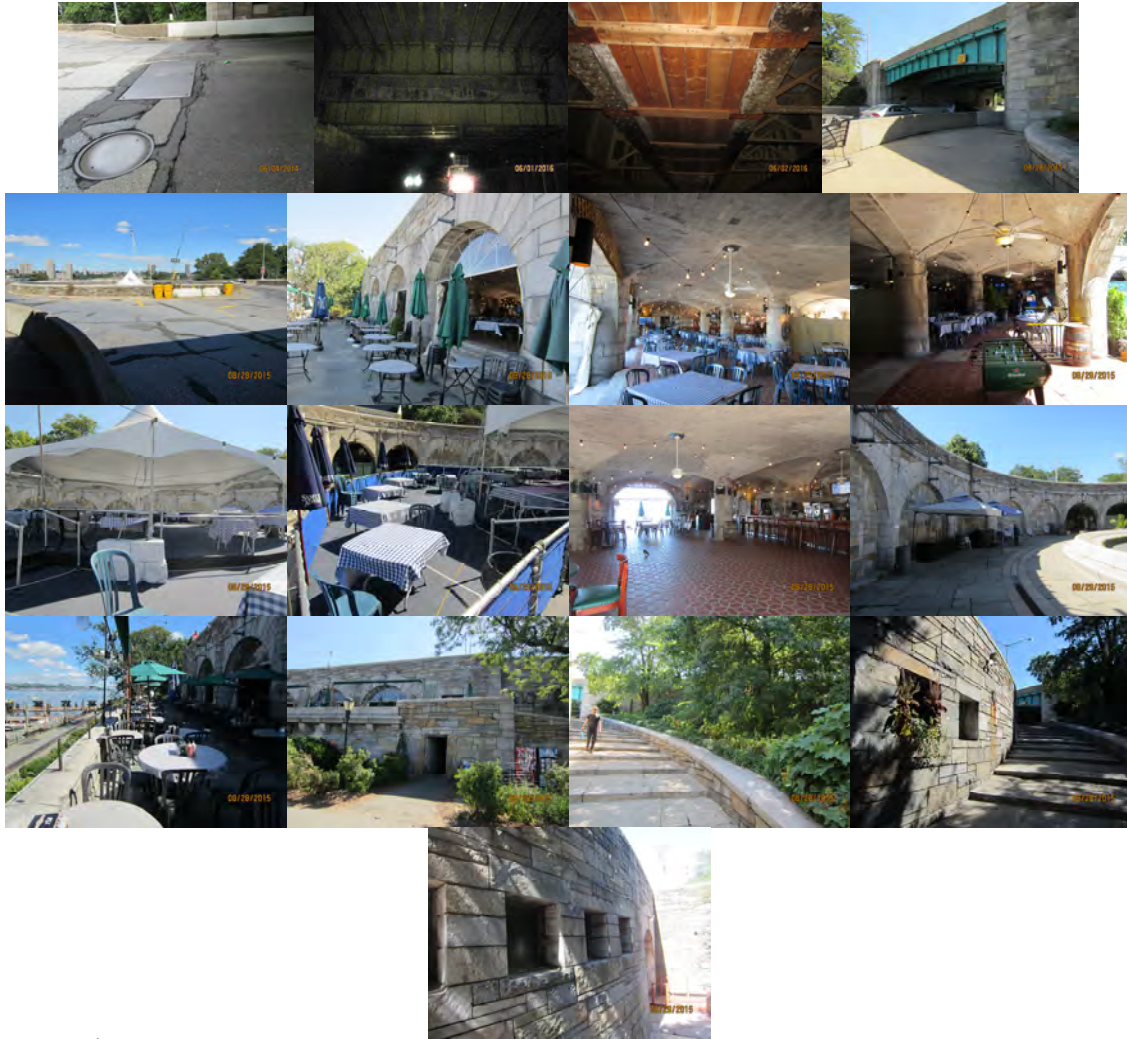
West 79th Street Bridge Over Amtrak in 2014 – Beginning Abutment Joint – Top of Deck. June 2016: Left Elevation. Underside of Deck, Bay 7 – Timber Shielding. (Credit: NYSDOT) Traffic Circle Level. Plaza Level. Ramps and Façade.

The West 79th Street Bridge over Amtrak, built in 1937, is a single span structure, with steel, non-composite girders and a reinforced concrete slab. The bridge carries two lanes of traffic in each direction and has a sidewalk on each side. The project work will include the removal of the existing concrete deck, sidewalks and the pedestrian safety barrier. The deck will be replaced with a 9.5 inch concrete slab with integral wearing surface, a new sidewalk and safety barriers on a rehabilitated superstructure.

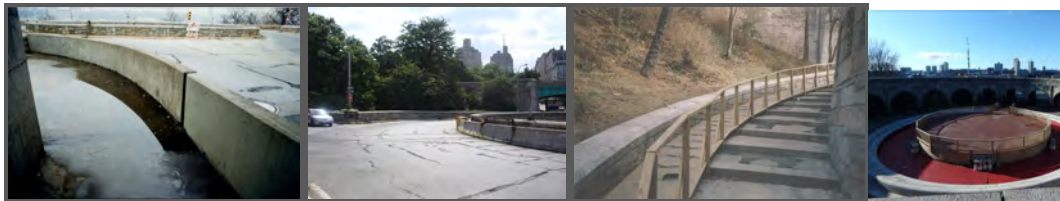
Traffic Circle Level: South Sidewalk Area - Extensive Water Ponding. Pavement - Widespread Cracking.
Pedestrian Plaza Level: North Stairway - Timber Delivery Ramp. Closed Fountain.

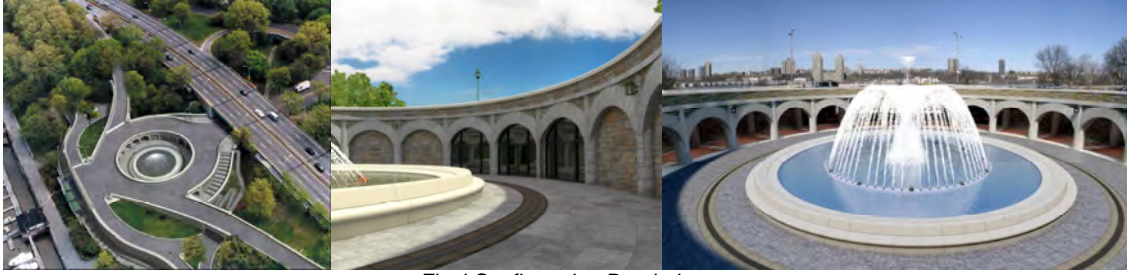
Final Configuration Rendering.

restrooms will be upgraded and restored, and a Parks Department office with public access will be incorporated into the structure. Accessibility to the facility will also be improved by the addition of four ADA-compliant ramps as a part of the rehabilitation project. At the garage level, the connector ramps will be repaired, and stone masonry restored. As with the other areas of the structure, lighting and drainage will be replaced. In addition, the Parks Department operations office will be upgraded.

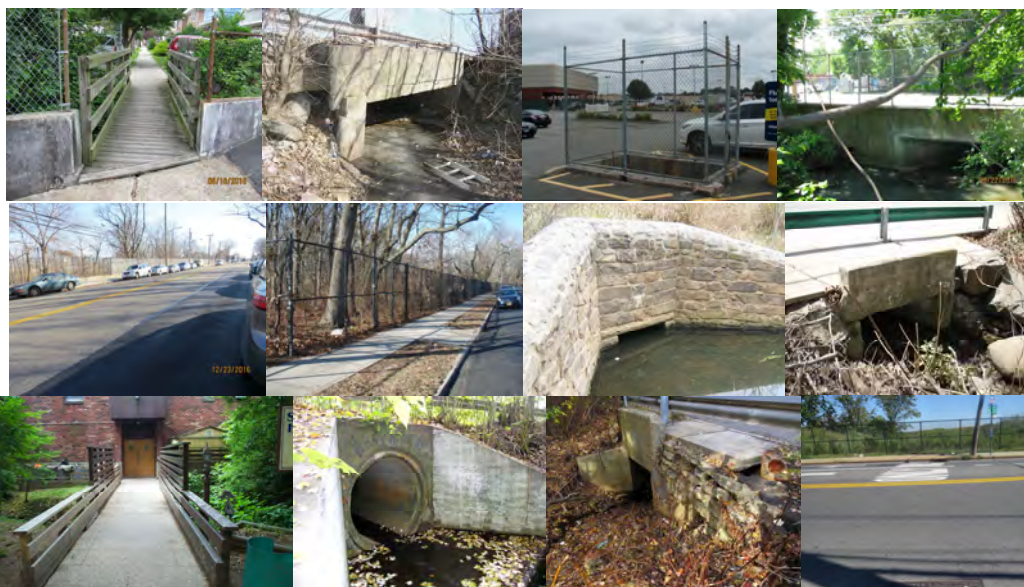
Galloway Avenue over Marianne Street – Wearing Surface, Looking Northwest. Forest Avenue over Crystal Avenue (2 Views). Midland Avenue over Hylan Boulevard (3 Views) – New Asphalt Wearing Surface. Culvert Top – Fence and Sidewalk. Rockland Avenue over Brielle Avenue. Forest Avenue over Randall Avenue. Gregg Place over Randall Avenue. Arthur Kill Road over Muldoon Avenue (2 Views). Arthur Kill Road over Ridgewood Avenue.

The Forest Avenue culvert over Crystal Avenue is a single span reinforced concrete box culvert. It is located approximately 230' east of the intersection of Forest Avenue with Crystal Avenue. The reconstruction will consist of the demolition of the existing culvert, clearance of debris from the channel, and replacement of the culvert with a concrete deck slab supported on steel beams on reinforced concrete abutment and wingwalls. The construction work is planned to be performed in four stages with proposed four traffic lanes being maintained at all times.

The Midland Avenue culvert consists of a single span reinforced concrete box, which will be replaced with a new pre-cast box culvert. It is located on Midland Avenue between Boundary Avenue and Mason Avenue. The rehabilitation will include replacing the existing concrete box structure with a new concrete box structure, new sidewalk, curb, pipe railing, chain link fence and asphalt wearing surface. The work will be performed in three stages, with one lane of traffic maintained in each direction at all times.

The Rockland Avenue reinforced concrete culvert project will include concrete repair and a lined and stabilized north embankment. It is located approximately 361' west of the intersection of Rockland and Manor Avenue. The rehabilitation work includes clearing the debris and vegetation from the channel and installing a structural lining. There are no sidewalks on this culvert. The construction is planned to be performed in one stage and no street closures will be required.

The Forest Avenue culvert over Randall Avenue is a single span concrete box culvert, located at Forest Avenue between Randall Avenue and University Place. It will be replaced with a new precast concrete box culvert with new sidewalks and asphalt pavement. The work will take place in three stages while maintaining one traffic lane in each direction during construction.

The Arthur Kill Road culvert over Muldoon Avenue consists of a reinforced concrete pipe at north and a reinforced box culvert at south. It is located on Arthur Kill Road between Muldoon Avenue and Arden Avenue. The box culvert will be replaced with a new box culvert, and a structural lining will be installed in the pipe culvert. The construction will be performed in one stage with one lane of traffic maintained in each direction.

The Arthur Kill Road culvert over Ridgewood Avenue consists of a non-reinforced concrete pipe at south and a corrugated metal pipe at north. It is located approximately 100' west of the intersection of Arthur Kill Road and Ridgewood Avenue. The rehabilitation work will include installing a structural lining inside the concrete pipe and repairing the concrete at the head walls and catch basins. There will be one stage of construction and one lane of traffic will be maintained in each direction.

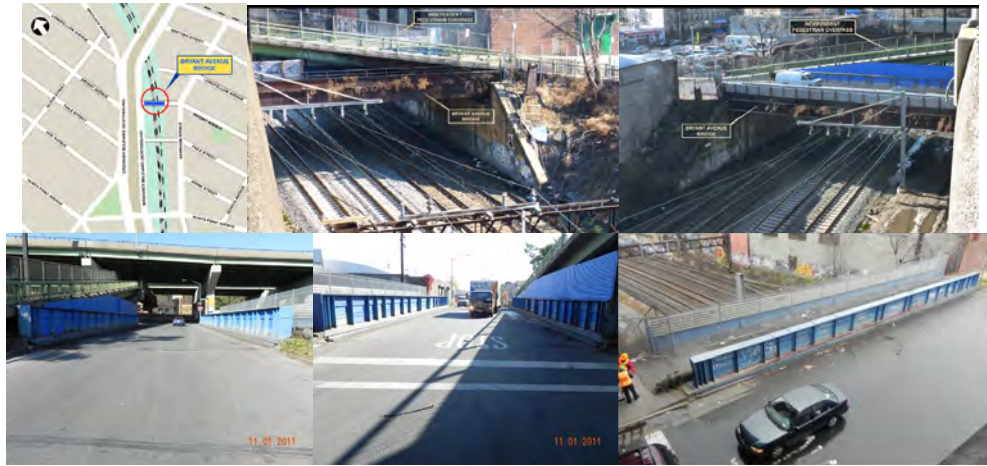
Location Map. Bridge Views Looking North and South. 11/1/11 Old Approach Begin and End. (Credit: NYSDOT) Bridge View From the Pedestrian Overpass.

This project included replacement of the steel superstructure, bearings, approaches, water mains and rehabilitation of the existing substructures by removing and replacing the top portion of the concrete abutments to accommodate the new superstructure. The abutments were retrofitted to meet seismic criteria. The new superstructure consists of a reinforced concrete deck over pre-stressed concrete box beams. The two water mains were removed and replaced. Both water mains were installed on top of the north sidewalk in a fenced-off area. The Division's in-house design staff completed the design for this project. A Notice to Proceed for the project was issued to the contractor with a start date of August 18, 2014. The bridge was completely closed to vehicles during its construction; however, pedestrian access was maintained.

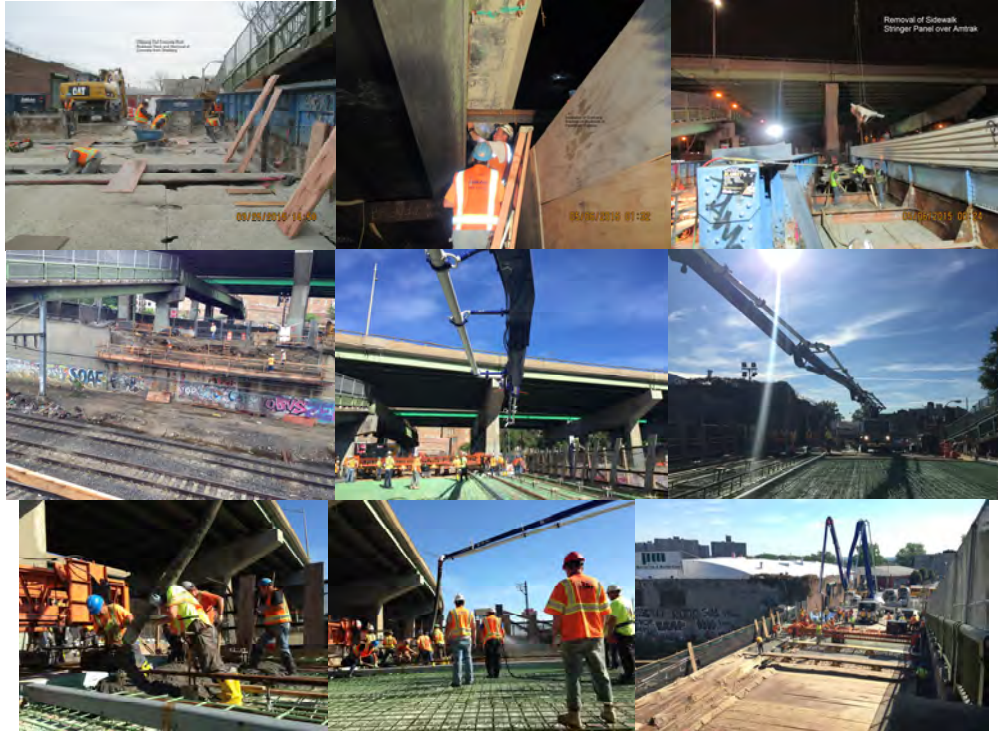
March 2015: Chipping Out Roadway Deck Concrete and Removing Shielding Concrete. May 2015: Installing Overhang Brackets on South Side of Pedestrian Walkway. Removal of Sidewalk Stringer Panel. Summer 2015: Existing Structure Removed. September 2015: Placing the Concrete for the Bridge Deck. The Concrete Pump Placed 110 Cubic Yards of Concrete Into the Deck. Covering and Protecting the Fresh Concrete with Wet Burlap.

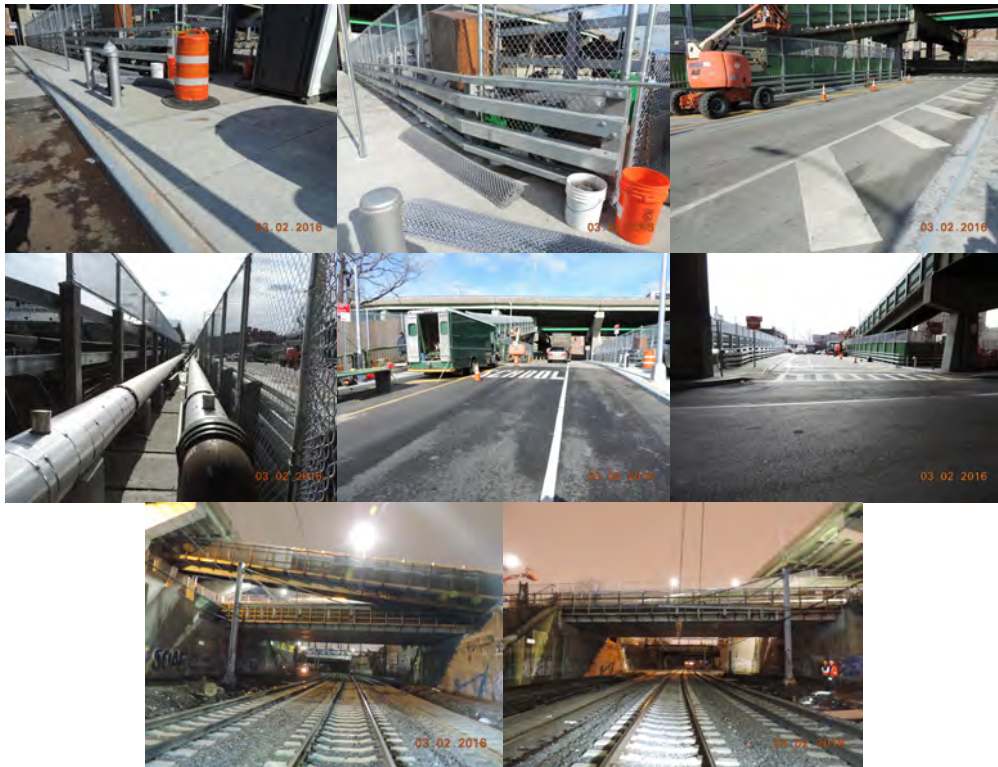
March 2016: Begin Approach, Right Sidewalk – New Concrete Sidewalk and Curb With Steel Facing. New Guide Rail. Span 1, New Concrete Overlay Wearing Surface. New Water-Mains on Top of Deck. Approach Begin and End. Left and Right Elevations. (Credit: NYSDOT)
