As an integral part of New York City's Department of Transportation, the Division of Bridges has a two-fold mission: to maintain an optimal transportation network by ensuring smooth mobility on the city's bridges, and to ensure the safety of the public.

ACCOMPLISHMENTS & PLANNED PROJECTS

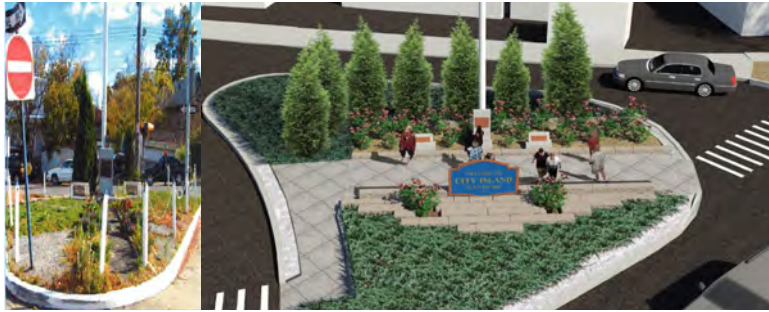
Current Legion Triangle and Rendering. The Design is Slightly Larger Than the Existing Triangle, Features a Wide Variety of Flora, and Will Provide Ample Space for Visitors who Come to Pay Homage to the Veteran's Memorial.

As part of the bridge replacement project, the Legion Triangle at the intersection of City Island Avenue, City Island Road and Bridge Street will be modified.

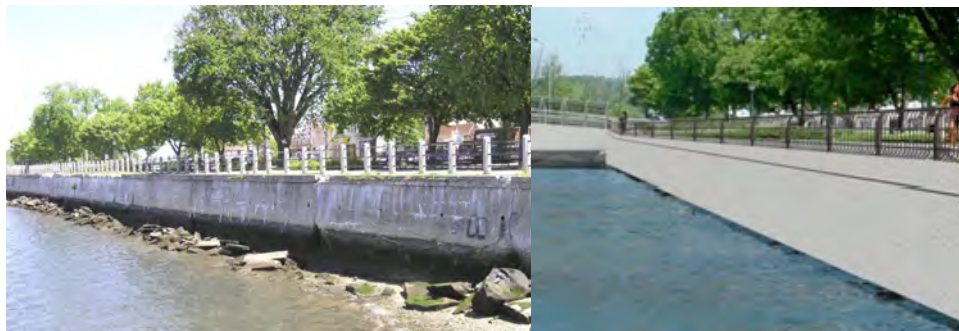
Existing Seawall. Proposed Treatment.

At the City Island side there is a seawall along the shore which is about 500 feet in length starting from the bridge and heading in a southerly direction. This seawall will be rehabilitated and turned over to the Department of Parks and Recreation along with the esplanade which it is supporting. The rehabilitation of the existing concrete seawall will include a steel rod tieback system as a precaution against loss of stability due to overturning or sliding. In addition, all unsound concrete will be removed from the face of the wall and a new reinforced concrete facing will be cast along the entire length. The esplanade will receive landscape improvements such as a new railing above the wall, new plantings, trees, grass, and paver blocks.

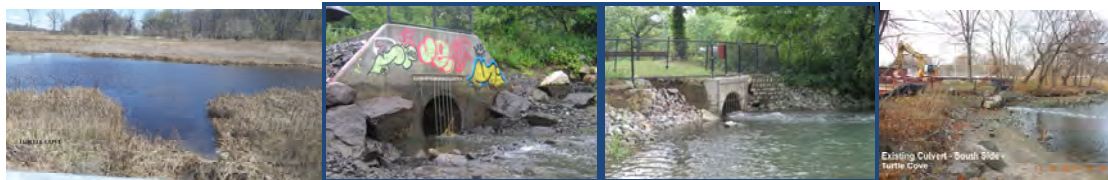
Turtle Cove. Existing Culvert – South Side.

Turtle Cove Culvert is located under City Island Road approximately half a mile west of the existing bridge. As part of the wetland impact mitigation activities for the project, this culvert will be replaced with a larger one that will allow for greater tidal flooding from Eastchester Bay to the upland portions of Turtle Cove.

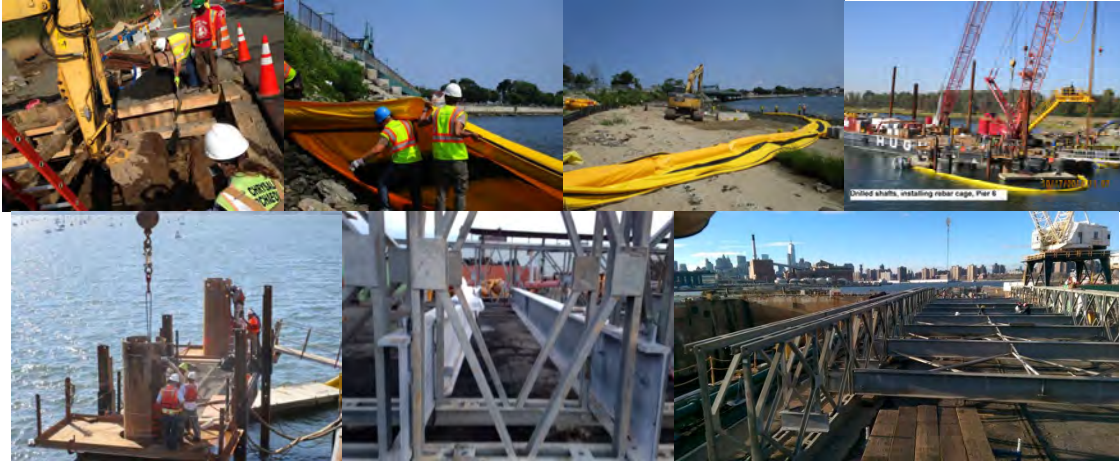
August 2014: Excavating on the West Side of the Bridge in the Presence of an Archeologist. Approximately 300 Linear Feet of a Turbidity Curtain was Installed on the Southwest Side of the Bridge to Protect the Shore During Construction. A Turbidity Curtain is a Floating Barrier Designed to Contain and Control the Dispersion of Sediment. October 2014: Drilled Shafts – Installing Rebar Cage at Pier 6. October 2014: The Contractor Airlifted Drilled Shaft Casings Into Position on a Platform Constructed Beside a Construction Barge. The Contractor Assembled the Temporary Bridge Segments at the Brooklyn Navy Yard. The Pieces Were Transported to City Island by Barge.

A Notice to Proceed for the project was issued to the contractor with a start date of September 30, 2013. At the end of 2013, the contractor started mobilizing the project activities. During 2014, the contractor surveyed the area, set up temporary work zone traffic control devices, installed temporary signals, relocated the 16 inch water main on the existing bridge, and started and installed most of the foundation work for the temporary bridge. Stage 1 of the Turtle Cove culvert replacement also began in 2014.

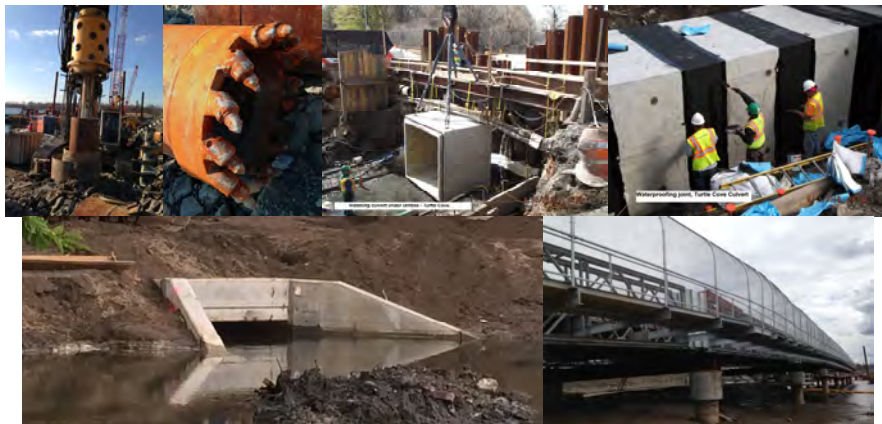
January 2015: Drilling Rig Construction Vehicle Used to Install Land-Based Drilled Shaft Casing for the Temporary Bridge. The Bucket Drills Carve Out the Casings With Teeth Capable of Tearing Through Rock. April 2015: Turtle Cove Culvert Replacement. Installing Culvert Under Utilities. May 2015: Waterproofing the

Joint. Completed Stage 1. Water Flow Inside the Culvert was Restored on May 18. The New Culvert is an 8 Foot by 7 Foot Concrete Box - About a 3x Larger Capacity. April 2015: - Installation of the Pedestrian Walkways for the Temporary Bridge. The contractor Constructed 2 Cantilevered Sidewalks - Approximately 5.5' Wide With a Chain-Link Fence.

During 2015, the contractor constructed the remainder of the substructure and superstructure for the temporary bridge. Temporary water mains, gas main and other utilities were installed on the temporary bridge. Opening of the temporary bridge to traffic and closure of the existing bridge for demolition is expected in early 2016. On December 16, the Division conducted strength testing of the temporary bridge roadway. Heavily equipped vehicles from the FDNY's Engine 70 Ladder 53 station crossed the temporary bridge to demonstrate the structural integrity of the roadway. The larger of the two vehicles weighed approximately 80,000 pounds, and the smaller vehicle weighed closer to 60,000 pounds. On December 18, all City Island Bridge traffic (vehicular and pedestrian) was transferred onto the temporary bridge. Stage I work of the Turtle Cove culvert replacement was completed and Stage II work was in progress at the end of 2015.

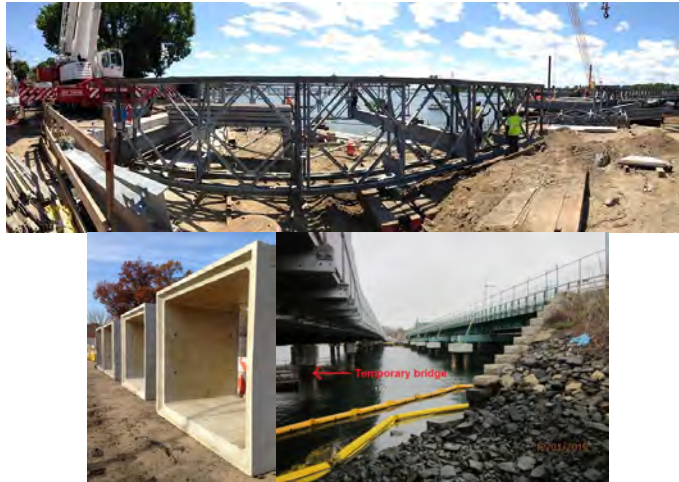
July 2015: Installing Decking for Span 15. November 2015: New Culvert Boxes to Replace the Aging Conduit that Connects the Bay with Turtle Cove, Located Beneath City Island Road. December 2015: Temporary Bridge at Left. (Temporary Bridge Credit: NYSDOT)

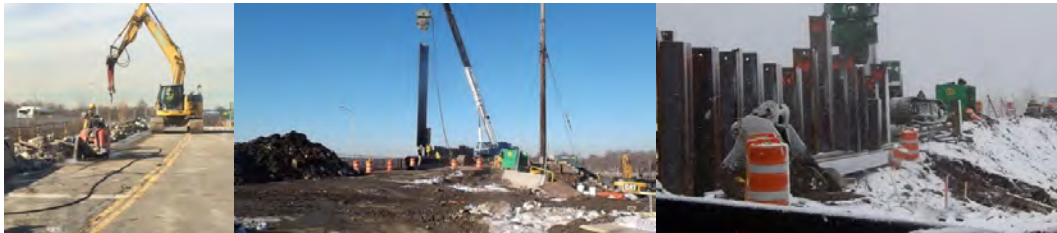
January 2016: Demolition - Removal of the Fencing and Temporary 16" Water Main From the South Side of the Bridge. Installing Metal Sheeting Plates on the East Approach. February 2016: Sheeting Operations - These Metal Sheets Will Act as a Support Brace When the Contractor Begins Ground Excavation.

In 2016, Stage II work of this contract began with the demolition of the existing spans 7, 6, 5, 4, and 1, as well as the east and west abutments. At the same time, the contractor constructed the pier 1 and 2 footing of the proposed structure. On July 6, 2016, the contractor installed the cofferdam sheeting around the east abutment and began excavating behind the sheeting. All of the excavated material was stockpiled in the southwest quadrant at the site. On July 18, 2016, the drill shaft operation started at the proposed east abutment and retaining walls and was followed by the installation of the steel cages and the pouring of the concrete for the drilled shafts. The contractor also began the demolition of the span 2 and 3 deck and then removed the truss, girders and floor beams.

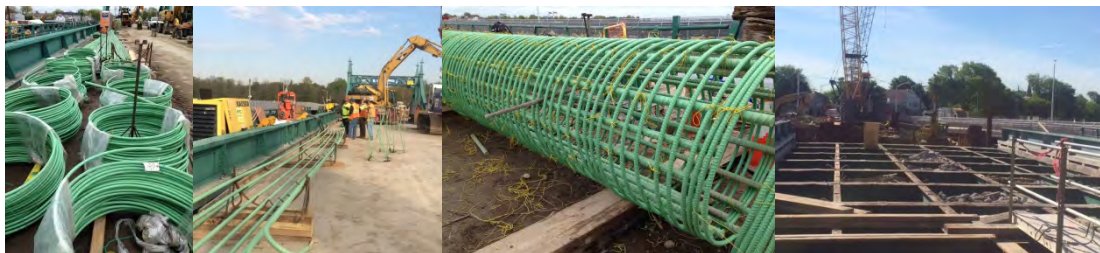
May 2016: Each Drilled Shaft Requires a Custom-Built Rebar Cage. These Steel Structures Strengthen the Concrete That is Placed Within Each Shaft Casing. Steel Bars are Laid Out on a Template to Form the Shape of the Cage, and are Then Tied Together. Once completed, the cage is Lifted by Crane and Placed Within a Corresponding Drilled Shaft. June 2016: Stripped Surface Deck of Span 6.

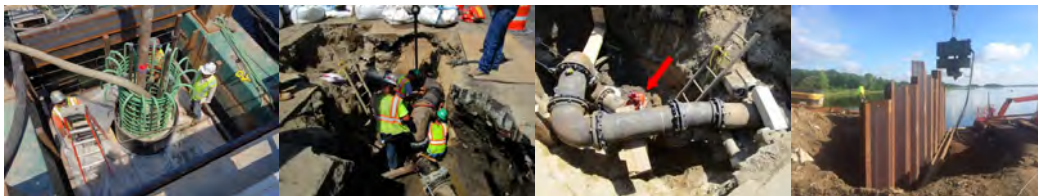
July 2016: Pier 2 Drilled Shaft Casings. August 2016: Valve Installation During the Shutdown of the Temporary 12" Subaqueous Water Main. Crew Tightening Bolts on a Section of the Water Main. The Recently Installed Valve can be Seen Nestled Below the Other Sections of the Water Main. Installing Sheet piling at the West Abutment Site.

On July 27, 2016, the contractor began installing the reinforcing steel for the pier 1 and 2 piercaps, and completed the work on August 23, 2016. Immediately after this operation, the concrete was poured. On August 3, 2016, the contractor began demolishing the existing west abutment and began installing the cofferdam sheeting around the abutment.

On August 8, 2016, the contractor installed a valve on an existing 12" subaqueous water main and reinstalled the tie-in from the temporary 12" water main to the 12" subaqueous water main, thus fulfilling the DEP request. On August 15, 2016, the contractor completed the work successfully and restored the roadway safely. Also on August 15, 2016, the contractor removed the existing signs and finials of the bridge truss and stored them at his yard as directed by the Community Board.

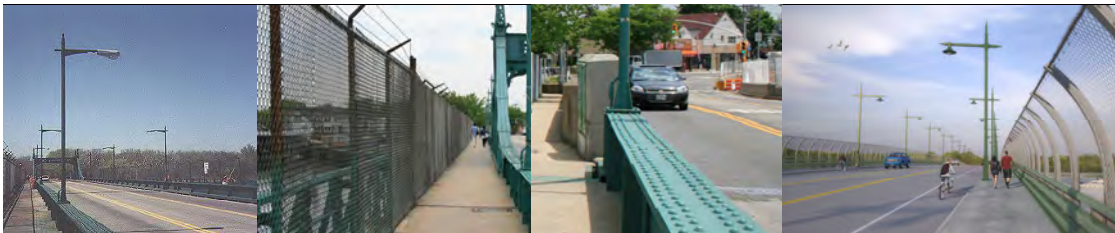
Existing and Proposed City Island Road Bridge Furnishings: Lighting, Fence, and Rail.

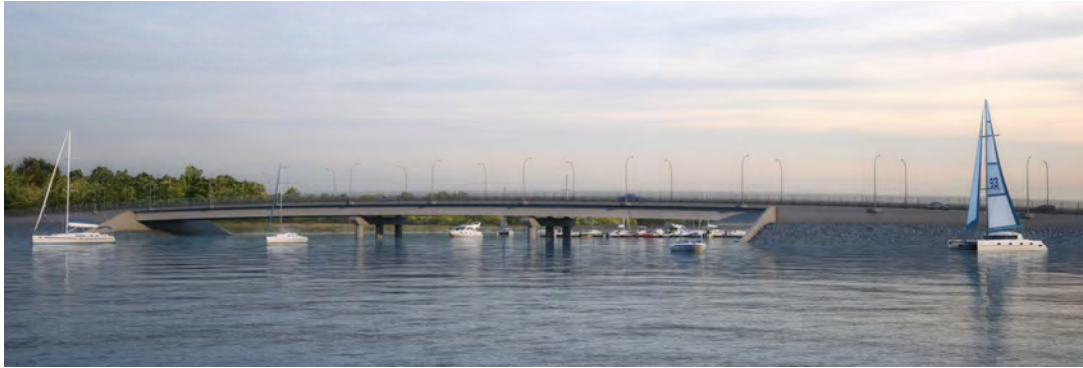
Side View Rendering of New Bridge.

The existing bridge will be replaced along the same alignment with a new three span bridge with two piers in the water. The new bridge will be approximately 17 feet wider than the existing one to accommodate three standard 12-foot wide traffic lanes, a 6-foot wide bicycle lane and a 6-foot wide pedestrian walkway on each side. The bridge will be a multi-girder continuous bridge with an integral deck. Galvanized steel stay-in-place forms will be used for the deck to both facilitate deck placement and shield the concrete from the corrosive environment of the saltwater bay below. The stainless steel rebar will also not be vulnerable to the deicing salt in the same way that epoxy coated rebar is. Therefore, the deck will have a much longer life expectancy since rebar corrosion is a primary factor in the deterioration of concrete. The new bridge will be designed to current standards and with its wider roadway width, will allow future repair and rehabilitation to be carried out while maintaining one 12-foot lane in each direction. It will also eliminate the vehicle height restriction caused by the existing overhead truss. In order to maintain traffic during the demolition of the existing bridge and construction of the new bridge, a temporary bridge will be constructed on the south side of the existing bridge. Marine traffic will remain undisturbed beneath the bridge during peak boating season.

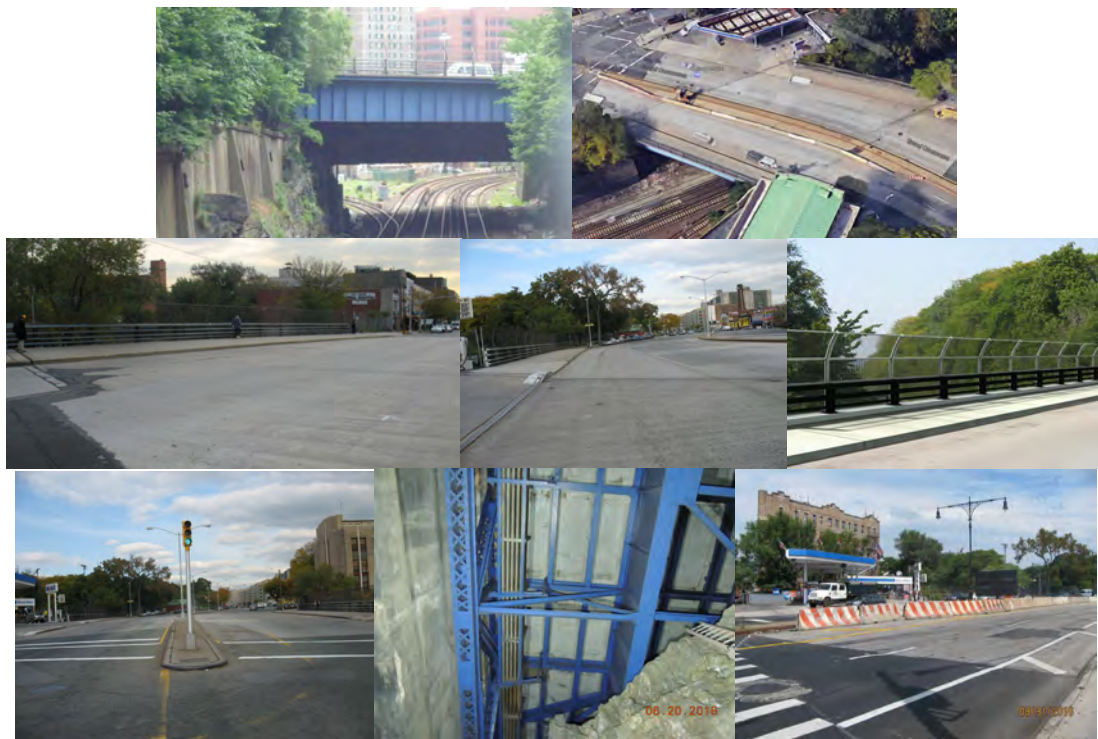
Grand Concourse Bridge over Metro North in 2010. (Credit: NYSDOT) Aerial View. East and West Sides of the Bridge. Proposed Fence and Bridge Railing. Top of Bridge. June 2016: Roadway Deck Underside of Span 1, Transverse Cracks With Efflorescence and Hollow Sections. (Credit: NYSDOT) August 2016: Jersey Barriers on Beginning Approach.

be installed. Two lanes of vehicular traffic and the pedestrian walkway will be maintained in each direction on the Grand Concourse. Deterioration was discovered during a final design inspection to assess the structural condition of the bridge, and the consultant has been instructed to prepare an interim load rating to establish the structural capacity.

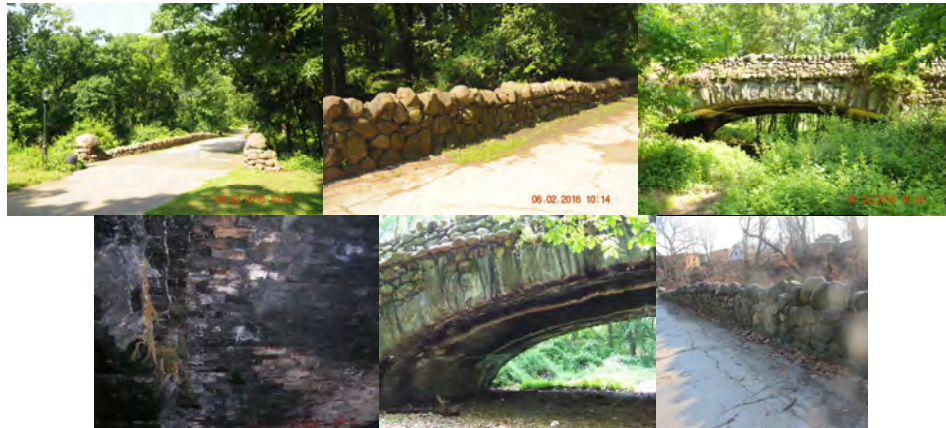
June 2016. Under-Deck Cracks and Missing Bricks - North-East Side. Under-Deck Arch Wall Showing Efflorescence Along the Cladding Stone and Brick Arch. Top of Bridge - Map Cracking, Spalled, and Patched Areas.

The bridge is under the jurisdiction of the New York City Parks Department and the DOT is conducting this rehabilitation project on their behalf. The existing stone and brick arch bridge displayed deficiencies in the form of cracking, missing mortar, spalled and missing masonry units and dissimilar grouting. The rehabilitation work will correct these defects while preserving the original elements of the structure to the greatest extent possible. The masonry will be cleaned and repointed in place. The asphalt roadway will be completely removed and the top of the arch will be excavated. This will allow for any necessary repairs on the top side of the arch and for the application of a reinforced concrete saddle with a waterproofing membrane. The arch will then be backfilled and the roadway repaved. In addition, new lamp posts and under deck lighting will be added. An eight foot wide gravel path will be installed below the bridge, and the landscape will be restored with trees and shrubs. The bridge will be completely closed to traffic during the construction which will be detoured to other parts of the park. A Notice to Proceed for the project was issued to the contractor with a start date of April 25, 2016.

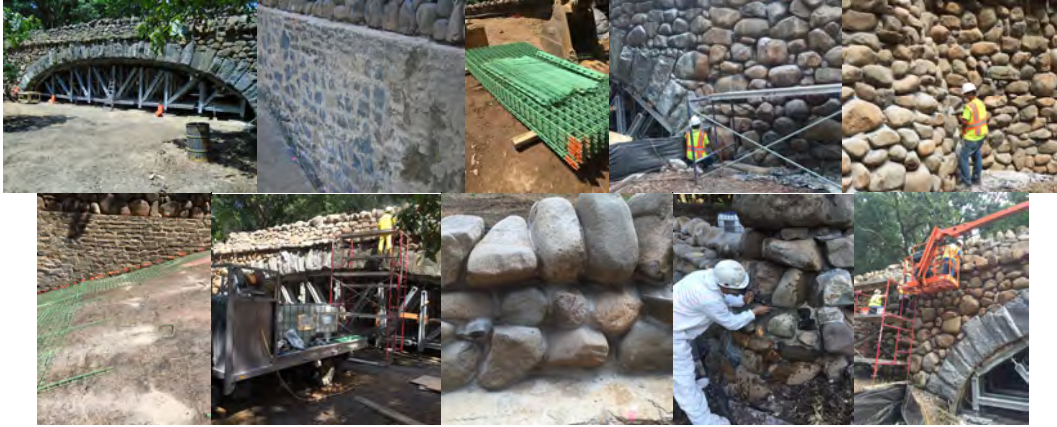
August 2016: Temporary Support Structure Under the Arch. Interior Walls After Power Washing. Epoxy-Coated Mesh Reinforcement. Chipping Out Existing Mortar. Top of Arch - Layout of Epoxy-Coated Mesh Reinforcement and Dowels. South Fascia – Cleaning the Existing Stone. South Fascia Parapet - Finished area – Cleaning, Chipping, and Repointing. North of Bridge - Cleaning and Repointing the Rubble Stone Masonry.

In 2016, the entirety of the stone masonry walls were cleared of graffiti, thoroughly cleaned, repaired, and repointed. The interior of the bridge was completely excavated to reveal the top of the arch, which was found to be in good condition. A reinforced concrete saddle was placed over the arch to bolster its strength, and a waterproofing membrane was installed over the arch and on the interior walls. The bridge was backfilled and a high performance paving material was placed for the roadway. The underside of the brick arch had all graffiti and paint removed. Final cleaning of the arch was ongoing at the end of 2016, as was the removal of old mortar.

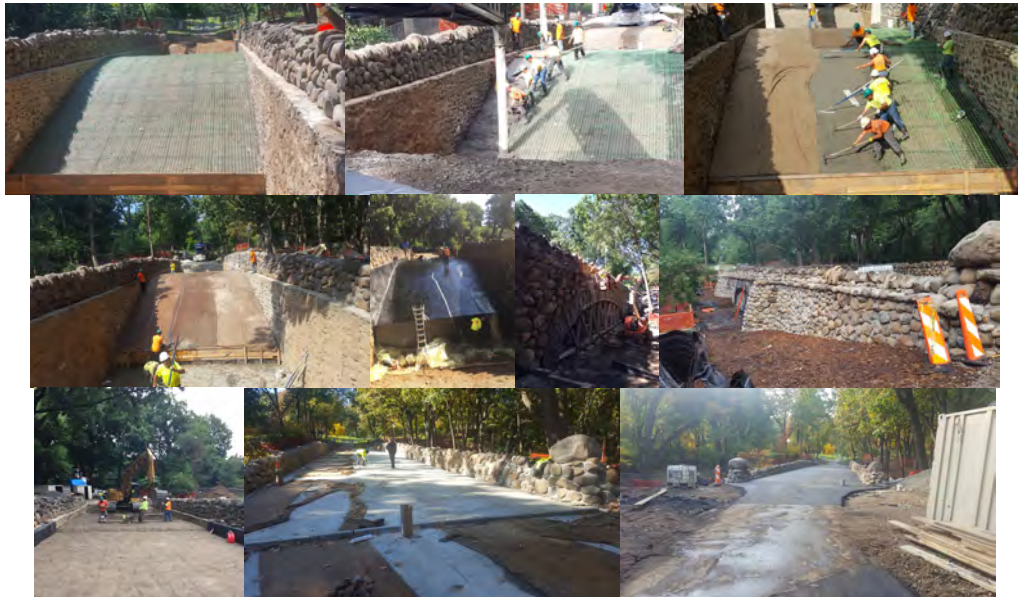
September 2016: Bridge Arch With Wire Mesh Reinforcement in Place Prior to Concrete Placement. Belt System Transporting the Concrete Into Position. Wet Burlap Placed Over Previously Finished Zones. Drip Hoses Placed to Keep Burlap Wet for the Next 7 Days. Center of the Bridge - Waterproofing Membrane Applied to Arch and Inner Walls of the Bridge. North Side of the Bridge - Cleaning the Historic Stone Masonry and Concrete Surfaces. Rubble Stone Work – the Darker Stones Have the Graffiti Protection Applied. Center of the Bridge - Backfilling and Compaction. After Backfilling, the Concrete Base for the Roadway was Placed. Following the Curing of the Concrete Base, Asphalt was Placed.

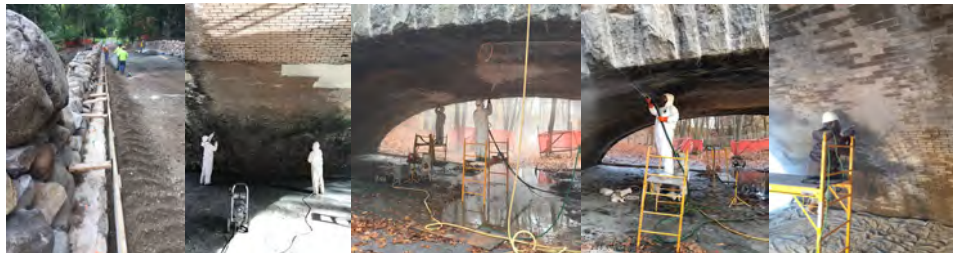
October 2016: Concrete Curb Layout. November 2016: Cleaning the Bricks Under the Bridge Arch. December 2016: Cleaning the Historic Stone Masonry and Removing Graffiti. Tuck Pointing the Bricks Under the Bridge Arch.

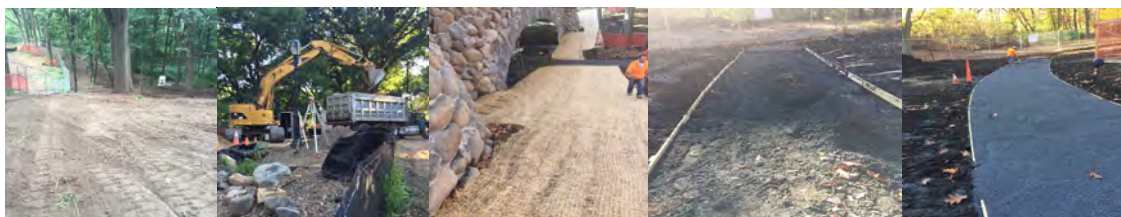
August 2016: North and South of Bridge – Clearing and Grubbing. November 2016: Placing Erosion Control Material Over the Slope Area on Both Sides of the Bridge. Placing Granular Fill Material (Crushed Stone) on the Bridge Pathway Under the Bridge Arch.

Beyond the bridge itself, much landscaping work was completed in 2016. The area directly surrounding the bridge was cleared and grubbed and the trees were pruned. A large tree near the bridge was identified as unsafe and in danger of falling and was cut down. Five lamp posts were removed (to be replaced later), and another post on the bridge was completely refurbished in place. The gravel path was installed everywhere except directly under the bridge, where work is ongoing. Subsequently, all of the landscape will be restored with trees and shrubs. Construction is expected to be complete in April 2017.

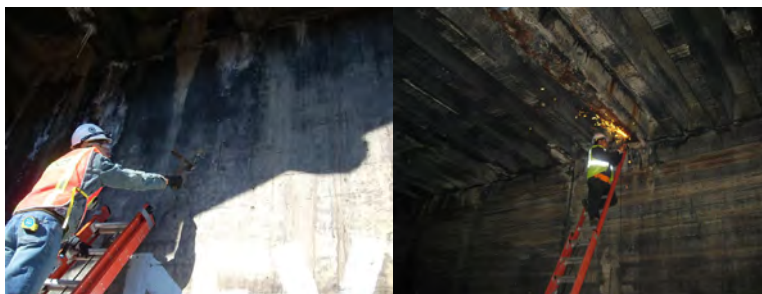
2010 Inspection - Hands-On Inspection of A Pier. Obtaining a Steel Coupon Sample From a Stringer.

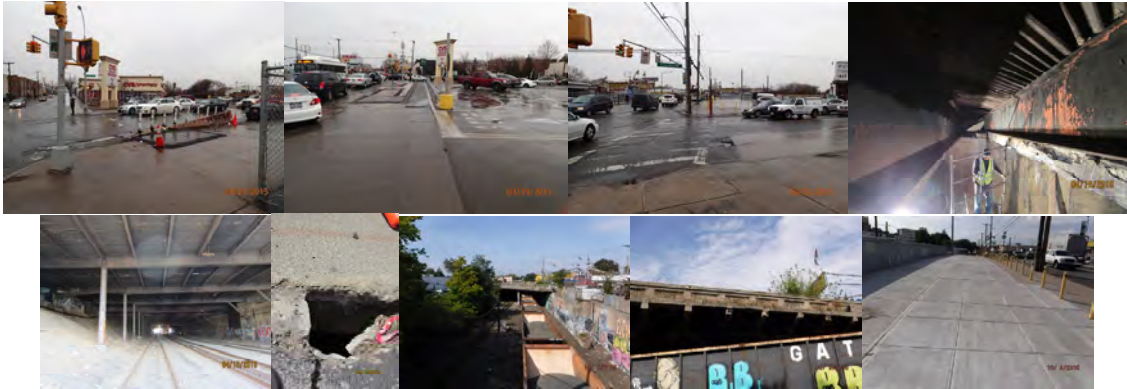
March 2015: Looking West, South, and East Across Bridge Deck. April 2015. October 2015: Elevation Right. Span 2 Right Parapet - The Outer Face Exhibits Spalls With Exposed Rebars. Spans 1 and 2 New Right Side Sidewalk. (Credit: NYSDOT)

There is a hole in the deck on the northeast sidewalk of the intersection which has been covered with a small transition barrier. The underside of the concrete deck displays typical water leakage, efflorescence and stalactites. The east fascia girder concrete encasement is severely deteriorated. There are medium to wide cracks, aggregate exposures, heavy spalls and exposed reinforcing throughout the length of the bridge. The concrete parapet of the utility bay and its west end is in poor condition. There are severe spalls in the bridge seat causing a loss of bearing area

of the east fascia girder at the north abutment. The central pier is also severely deteriorated with cracks, spalls, exposed reinforcement and water leakage.

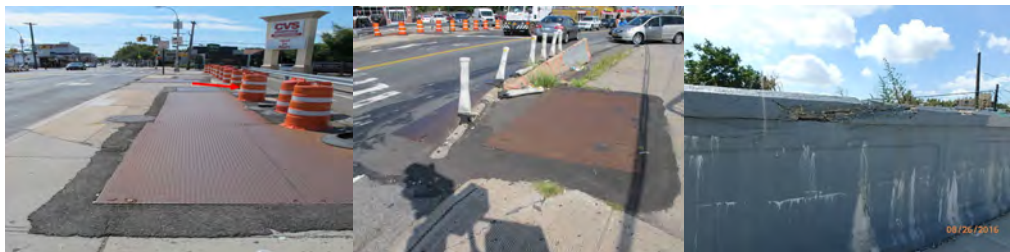
August 2016: Span 2 Left Sidewalk Looking South - Location of the Through Hole. Span 1 Right Sidewalk Looking North. Spalled and Cracked Areas on Top of Span 2 Parapet. (Parapet Credit: NYSDOT)

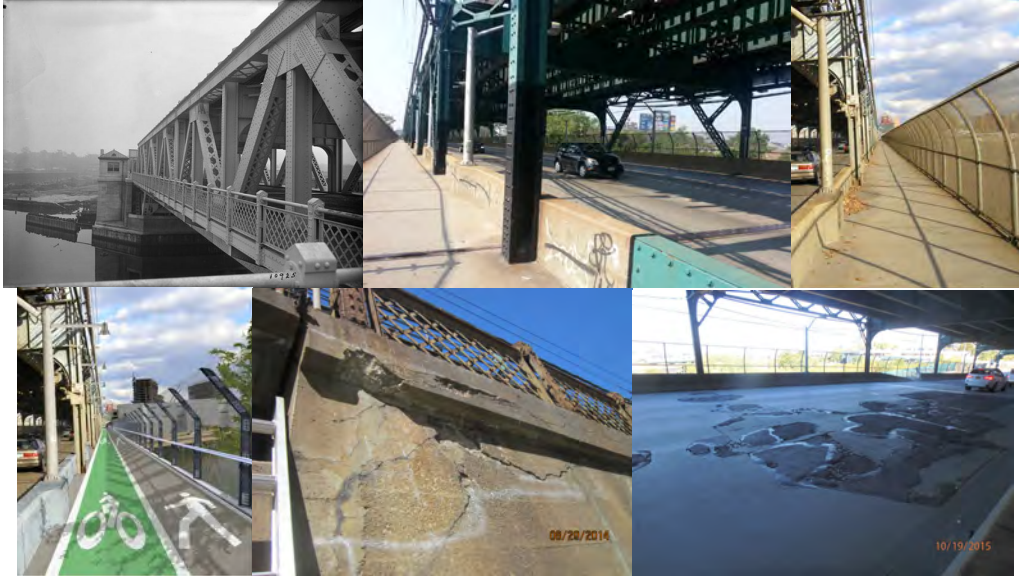
Roosevelt Avenue Bridge – In 1927. (Credit: NYC Records). Looking East. Existing and Proposed Bicycle/Pedestrian Path. 2014: Right Wingwall at the End Abutment. The Top Exhibits an area of Diagonal Cracks With Efflorescence and Spalls. The Deteriorated Concrete Areas are in Safe and Stable Condition. 2015: Spans 26 and 27 – Examples of Uneven Asphalt Patches and Broken Concrete Areas. (Credit: NYSDOT)

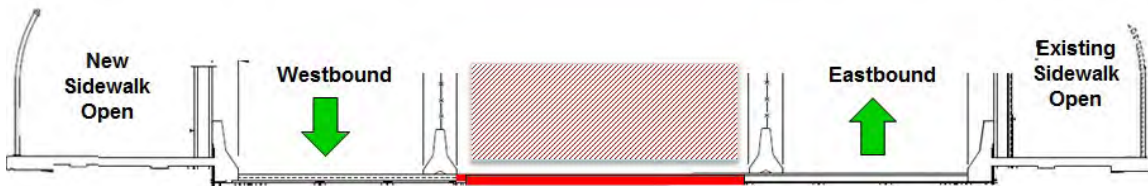
Stage 2 - Center Roadway - 12 Months. The Center Roadway will be Closed. All Traffic Shifts to One Eastbound and One Westbound Lane in Each Direction.

The lower level carrying Roosevelt Avenue will be reconstructed in three stages. Both vehicular and pedestrian traffic will be maintained throughout the construction of the bridge, with one lane in each direction.

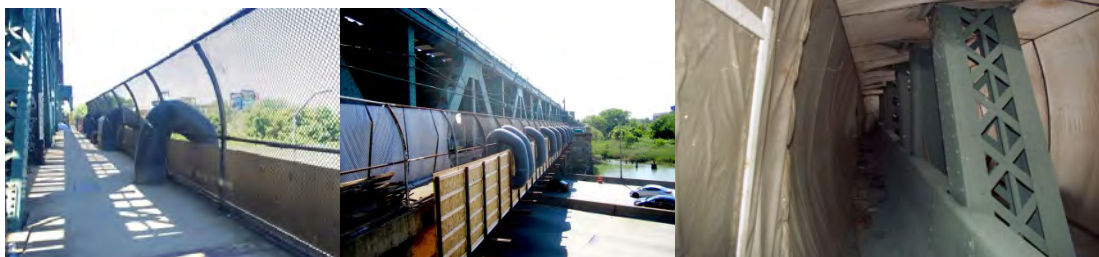
September 2016: - The Contractor Employs a Vacuum System to Capture Lead Particles During the Lead-Abatement Process. This is Done Using Negative Air Pressure to Prevent Emissions From the Abrasive Blasting Process Used to Remove Lead Paint. All Blasting is Done Within Negative Air Containment Units to Protect the Public From Emissions. View Inside the Containment – Bascule Span, Looking East.

Abrasive blasting and protective coating operations began in early 2016. The first stage of the work will consist of paint removal by abrasive blasting. Since the existing paint is expected to contain lead, the work will be performed within an entirely sealed Class 1A Containment. Abrasive blasting involves use of compressed air to propel abrasive particles against the surface to be cleaned. The area to be cleaned will be entirely contained within impermeable walls with the sealed joints. Negative pressure maintained within the containment during blasting operations will prevent paint waste dust from being released. The air in the area surrounding the containment enclosure will be monitored and tested with scientific equipment, and the abrasive blasting will be stopped if there is any indication that the containment enclosure is not working as designed. In the unlikely event of emissions, they will be cleaned utilizing high-efficiency HEPA vacuums in accordance with approved methods. All paint wastes will be packaged and shipped from the site for disposal, meeting all applicable local, state and federal guidelines, regulations and laws.

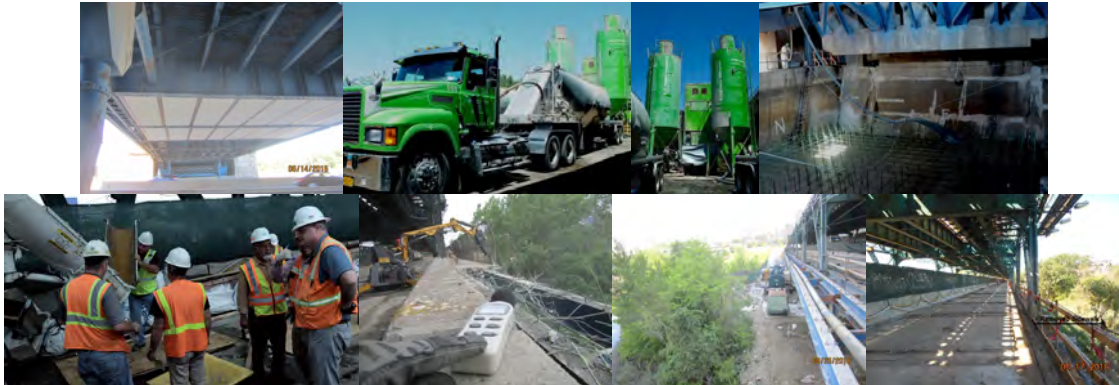
June 2016: Contractor Installs Shield Under the Bascule Span to Prevent any Debris From Falling onto the Van Wyck Expressway or Into the Flushing Creek During the Demolition Process. The Contractor Poured Lightweight Concrete on the Bridge's Counterweight Pits. These Pits, Located on the East and West Sides of the Flushing River, Were Necessary When the Bridge was a Drawbridge. Now That the Bridge is Locked in Place, the Agency Decided to Fill Them with Lightweight Concrete. This Will Prevent Them From Accumulating Water, Reducing a Potential Health Hazard. The Operation was Supervised by Construction Project Manager Syed Alam (in NYCDOT Vest). July 2016: Contractor Using a Robot to Break Through the Existing Sidewalk on the North Side of the Bridge. Using This Technology Reduces the Risk of Injury to Personnel During Demolition and Gives the Operator a Better View of the Actual Demolition. August 2016: Contractor Demolishes Existing North Sidewalk and Traffic Barrier. Span 18 Left Side of the Bridge - Wearing Surface and Sidewalk Deck Removed. (Span 18 Credit: NYSDOT)

Stage 1 construction began in early 2016. It is expected to be complete by May of 2017. During Stage 1, the lead paint removal and prime coat application will have been completed for the entire roadway section of the viaducts and bascule span. Major activities for Stage 1 include demolition and replacement of the West Viaduct right lane, traffic barrier and North sidewalk. Included in this work will be substructure concrete and steel repairs. Other work includes filling in the original bascule counterweight pits with lightweight concrete and demolition of the north operator house.

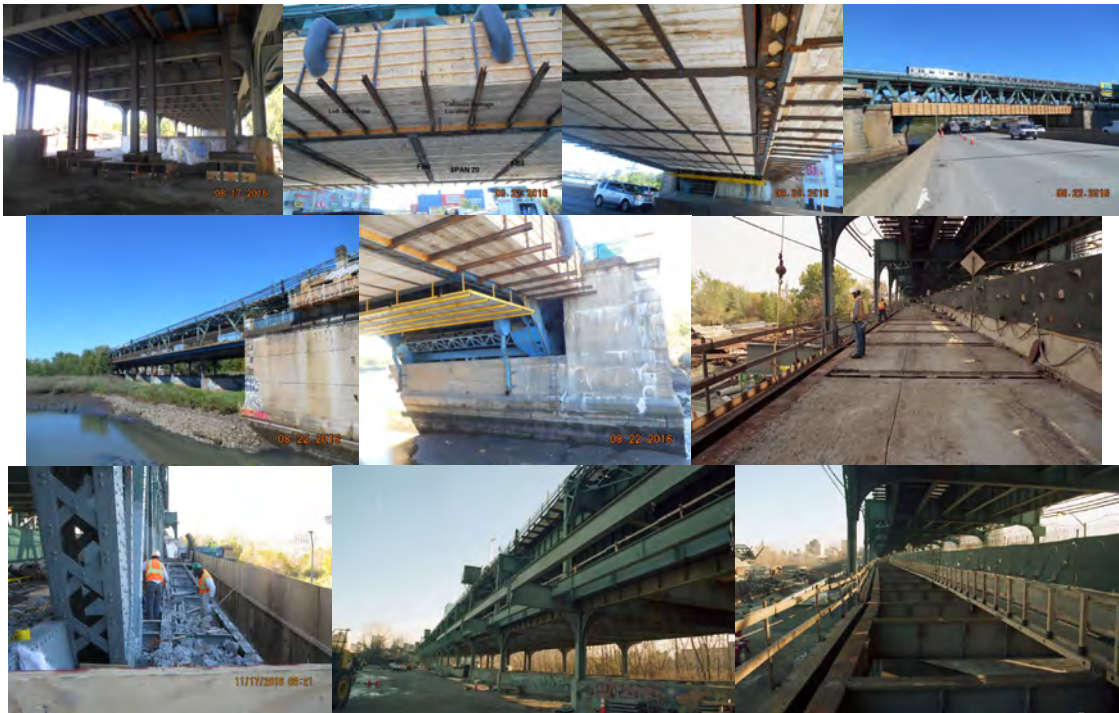
August 2016: Span 6 - Temporary Steel Shoring in Front of Pier 6. Span 20 Left Side - Encased Underside of the Span. Span 20 and Spans 11 – 19. – Elevation Right. Pier 19. (Spans 6, 20, and 11-19, and Pier 19 Credit: NYSDOT) October 2016: Installing the New North Sidewalk – West Viaduct, Looking East. November 2016: Contractor Demolishes the Sidewalk over Van Wyck Expressway. December 2016: Installed North Sidewalk Stringers. West Viaduct – Roadway Deck Removed.

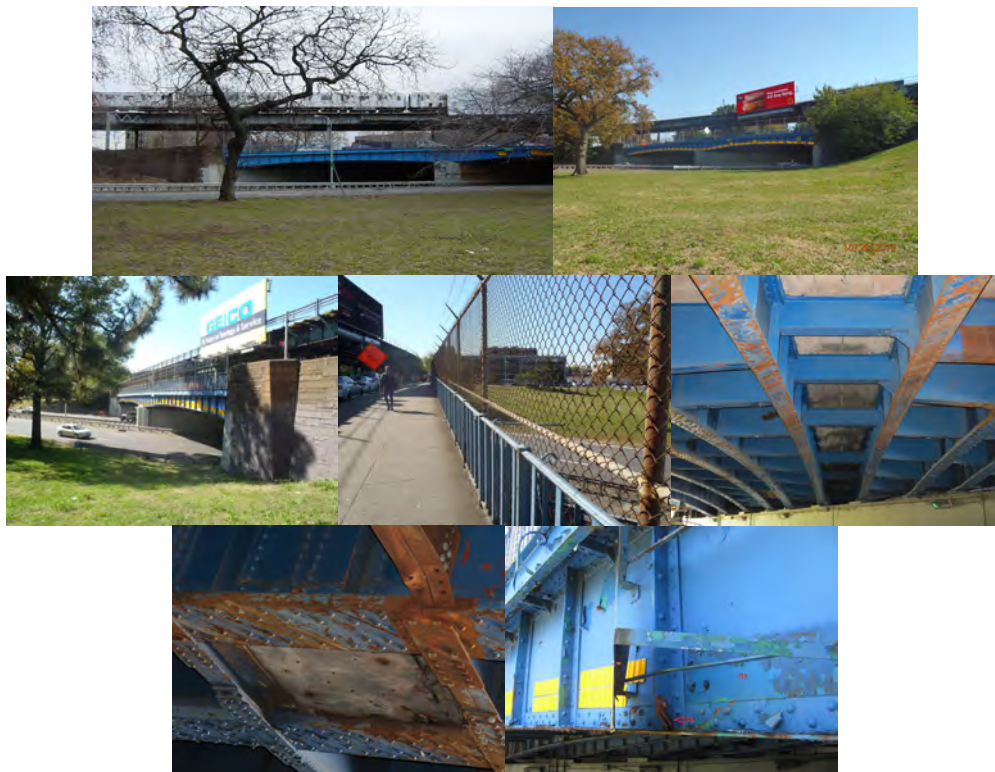
Westchester Avenue Bridge in 2015. June 2016: Underdeck of Span #1 - Deteriorated Deck is Shielded With Timber Planks and Wire Mesh. Bent Stiffener at Span #1.

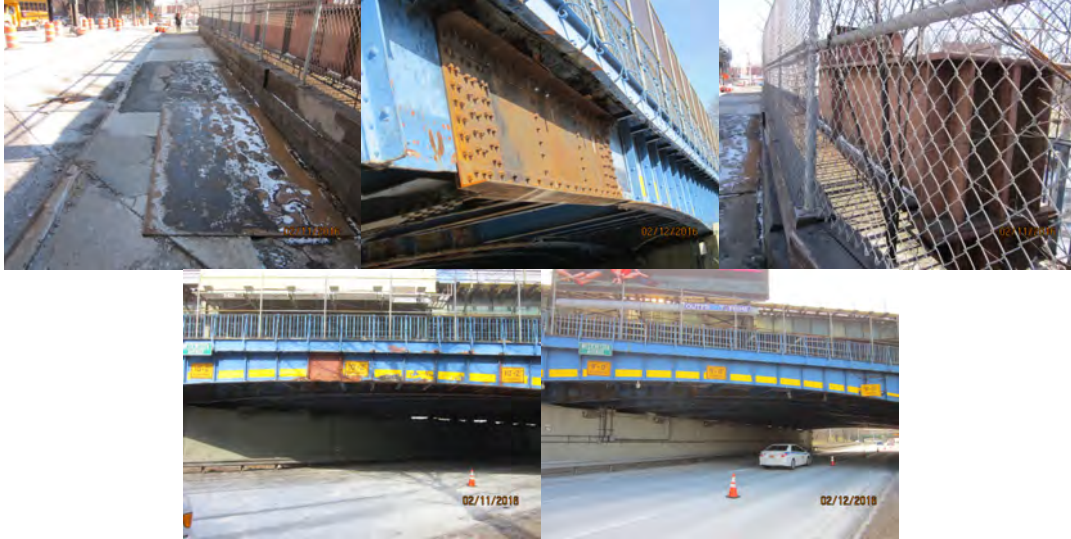
2016: Span 1 Right Sidewalk Near Beginning Abutment – Steel Plates. Girder Reinforced With New Steel Plate and Angles. Strongback Girder at Right Side of Span 1. Right and Left Fascia. (Credit: NYSDOT)

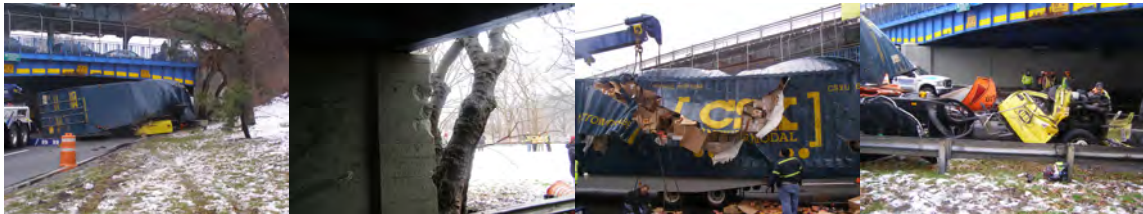
Damaged Bridge, Cargo Container, and Contractor Truck After An Over-Height Trailer Struck the Bridge in January 2012.

The Westchester Avenue Bridge's vertical clearance over the Hutchinson River Parkway is sub-standard. The existing posted vertical clearance of 10'-2" is far less than the 12'-6" minimum vertical clearance required per AASHTO standards for parkways with passenger cars only. Due to the number of truck and bus vehicles that mistakenly enter the Hutchinson River Parkway, where commercial vehicles are not allowed, the fascia steel girders of the bridge have been severely impacted and damaged numerous times. Between 2009 and October 2014, 32 freight vehicles struck this bridge at the southern approach. After a bridge strike, up to a four hour delay may occur before traffic can resume a normal pattern. Due to frequent impacts of the southwest fascia girder, a section of the respective girder was removed by Division personnel to improve the clearance at that location. A strongback girder was placed on the south sidewalk above the damaged girder to provide additional support.

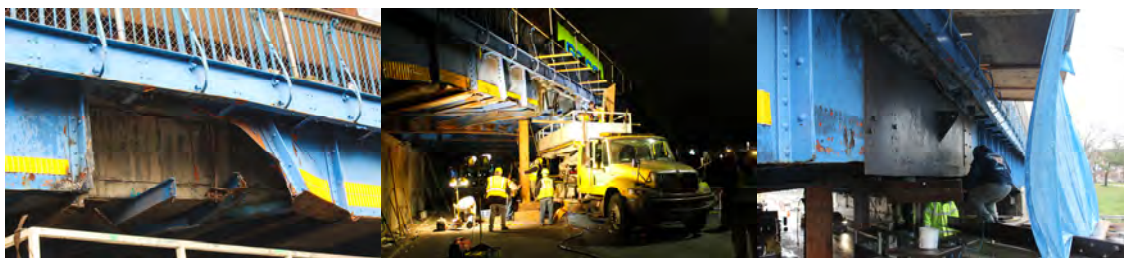
On January 9, 2016, a Truck Travelling South on the Parkway Struck the Bridge, Causing Damage to a Fascia Girder and its Preceding Girders, Stringers, and the Hanging Bars of a Strongback. Crews Responded, Cut a Portion of the Sheared Girder and Spliced it With a New Section and Installed Shoring.

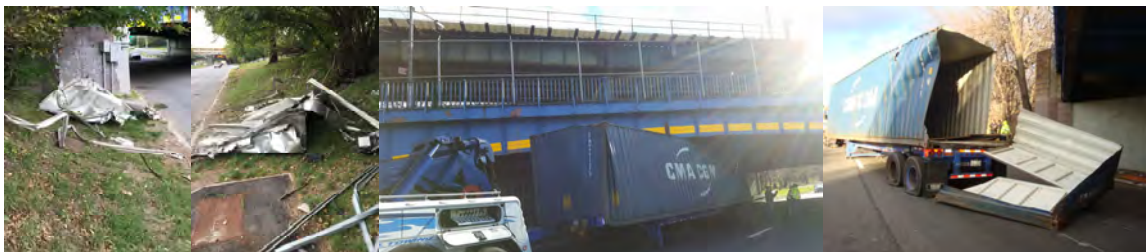
October 2016: Truck Debris Remaining at the South Side of the Bridge Along the Southbound Hutchinson River Parkway After a Bridge Strike. December 2016: Truck Tightly Wedged Under the Bridge.

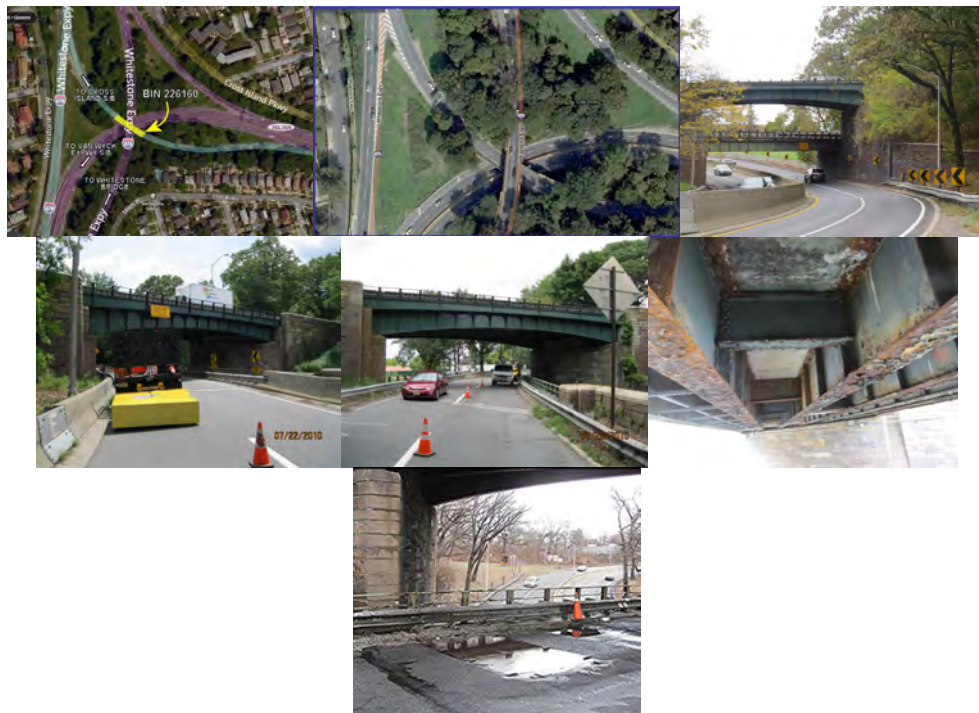
Location Map. (Credit: NYSDOT). Aerial View. Bridge (Lower Structure) in October 2016. Left and Right Elevations. (Elevation Credit: NYSDOT) Underside of Span #1 in October 2016 - Girders Have Rusted Bottom Flanges and Peeling Paint. March 2014: Steel Plates on Wearing Surface.

The bridge is a multi-girder, single span, simply supported structure with a span length of 77 feet and is 24 feet wide curb to curb. It was constructed in 1939. The roadway deck consists of an 8-inch thick concrete slab with a 2-inch thick bituminous wearing surface. The bridge has two 12-foot wide lanes running in the eastbound direction and flanked with tapered concrete safety walkways. The substructure consists of two gravity type concrete abutments. The cantilever wing walls have stone masonry facing on one side of both abutments. The west and east abutments of the existing bridge are constructed integral with the abutments of the Whitestone Bridge access ramp overpass.

There are no records of any major rehabilitation work performed on this bridge since its construction. The structural deck is in poor condition with visible mapcracking, scaling, spalling, and heavy efflorescence. Furthermore, the steel beams have deterioration at both the top and bottom flanges and there is deterioration of the expansion joints at the abutments. This reconstruction project will replace the structurally deficient roadway deck to provide a useful life of 75 years while also improving non-standard geometric features of the bridge.

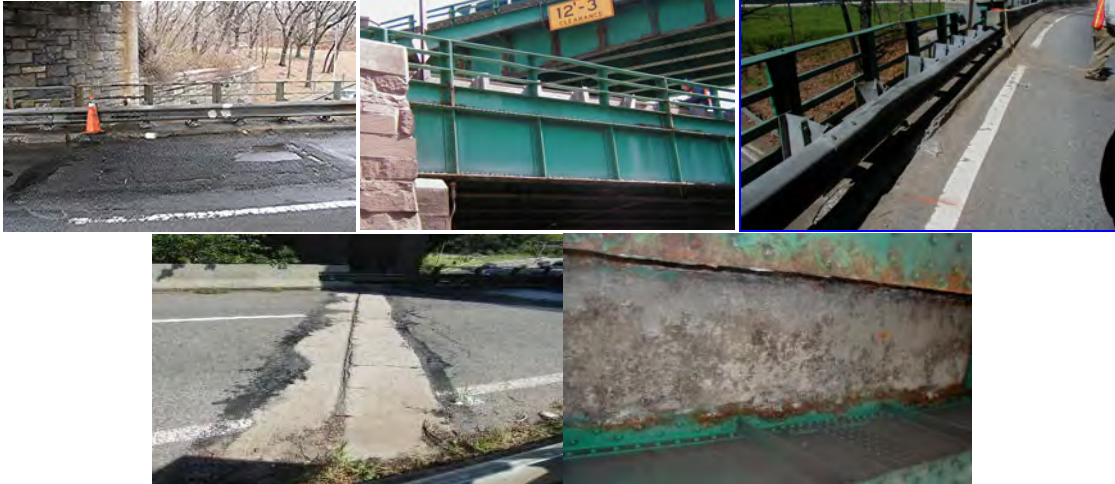
South and North Fascia - Along the Fascias are Built-Up Riveted Steel Girders. The Steel Railing Posts are Welded at the Base to the Top Flange of the Fascia Steel Girders. Deterioration of Joint at Abutment. Underside of Deck with Scaling and Efflorescence.

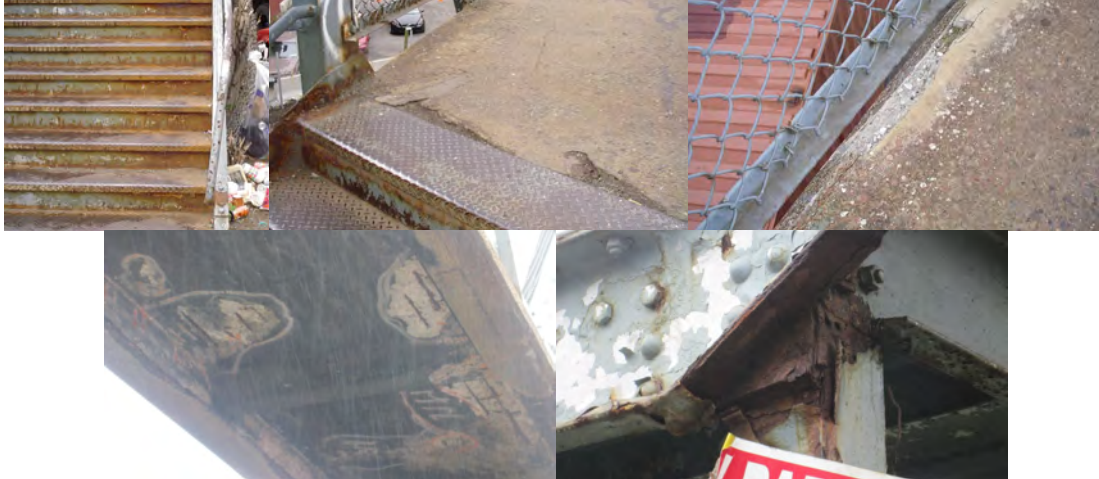
Existing Conditions: Rusty Steps and Damaged Railing. Deteriorated Deck. Spalled Concrete Deck on Main Span. Spalled Concrete – Underside of Deck. Deteriorated Steel.

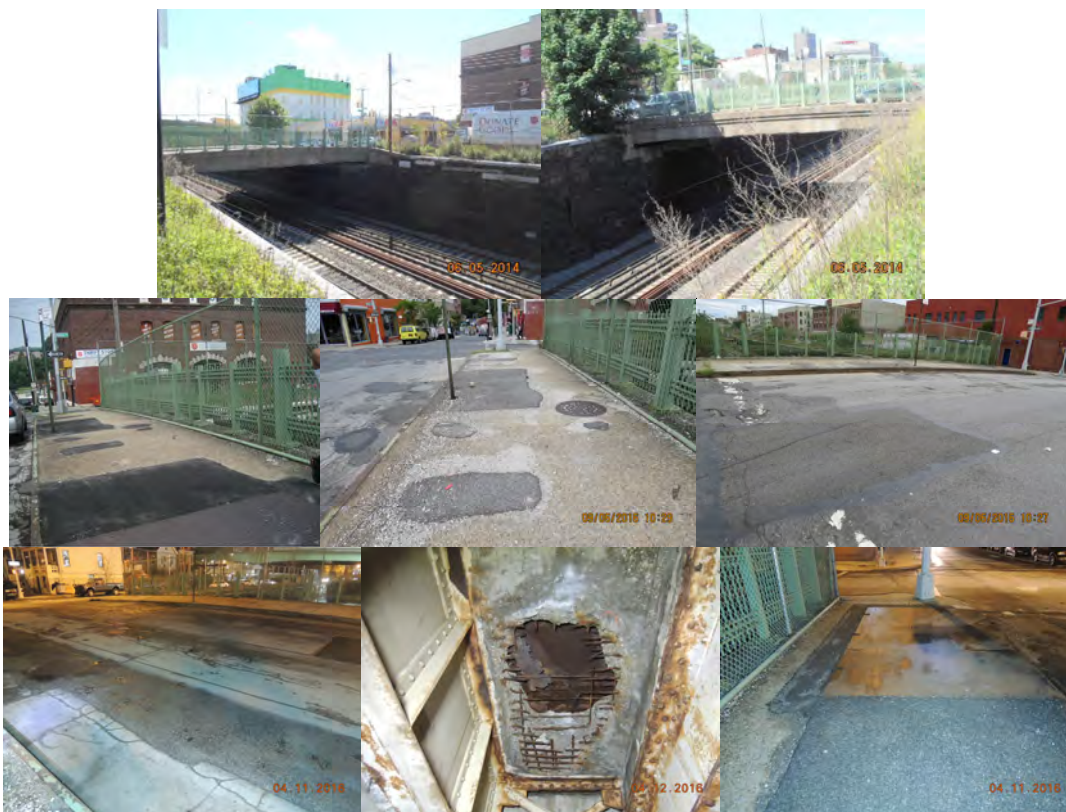
2014: East 175th Street Bridge Left and Right Elevations. (Credit: NYSDOT) Sidewalk and Road Conditions in 2016. April 2016: Span 1, Wearing Surface at Mid-Span – Uneven Asphalt Patches on Approximately 40% of the Surface Area. Underdeck of Span 1- Through Hole and a Deep Spall With Exposed Rebar Near the End Abutment. There is a Steel Cover Plate Above. (April Credit: NYSDOT)

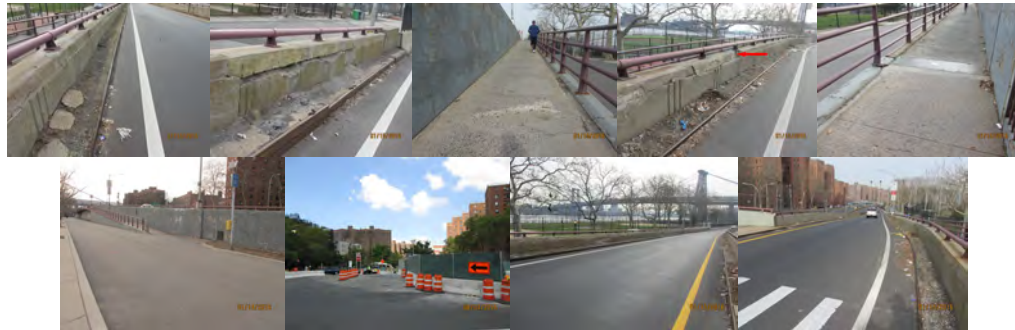
January 2016: South Approach Ramp - Span 2, Left Side Safety Walk and Curb. End Approach, Left Parapet. Span 4, Left Cantilever Sidewalk. North Approach Ramp – Span 2, Right Parapet and Safety Walk. Span 3, Right Cantilever Sidewalk. Elevation Right. 2016: Main Bridge – Spans 1 and 2 at Left Side. South and North Approach Ramps, Span 1 Top of Deck Wearing Surface.

On the main bridge, the asphalt wearing surface was worn and uneven, with many patches. The top of the concrete sidewalks and the median was scaled throughout with localized areas of spalling. Water had infiltrated into the structural slab below, resulting in delamination and spalling along the bottom of the slabs, and exposed corroded bar reinforcement for some of the slab area, with leaching and dampness observed much of the slab area. The entire underside of the bridge structure has wire mesh installed to prevent loose concrete from falling onto the roadway traffic below. On the approach ramp bridges, the curbs and sidewalks were in poor condition.

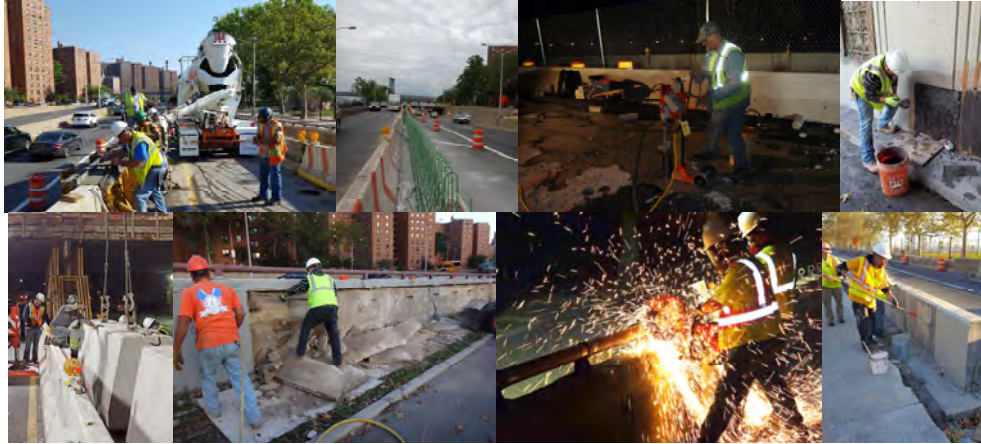
June 2016: Concrete Placement for West Barrier Wall at Entrance Ramp. Rebar for West Barrier Wall. Core Drilling Lift Holes for Stage 2 Deck Removal. October 2016.

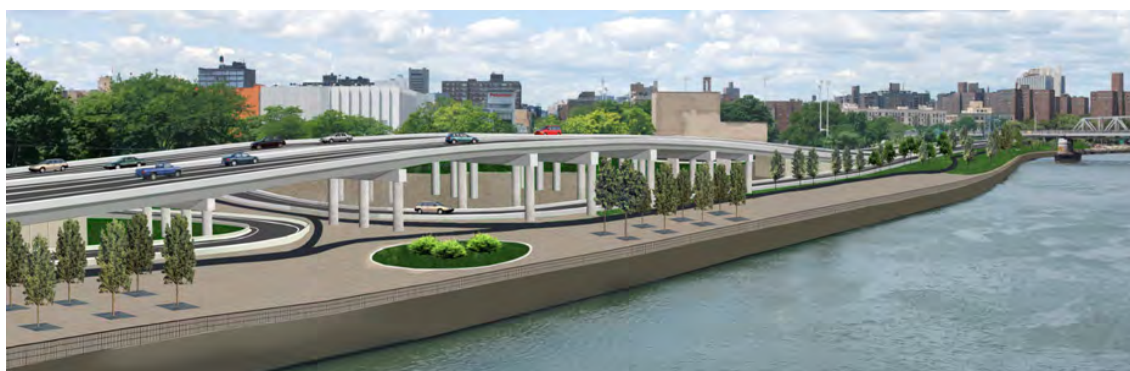
Rendering of New Harlem River Drive Bridge.

but will be supported by independent abutments at the north. The new bridge will carry two through lanes in the northbound direction, and three lanes in the southbound direction; each lane will have an average width of 11 feet. The new bridge will also include new fascia and median barriers. The abutments, wingwalls and piers will be replaced with new substructures that will conform to current seismic design criteria. The project length is approximately 3,280 feet.
