As an integral part of New York City's Department of Transportation, the Division of Bridges has a two-fold mission: to maintain an optimal transportation network by ensuring smooth mobility on the city's bridges, and to ensure the safety of the public.

ACCOMPLISHMENTS & PLANNED PROJECTS

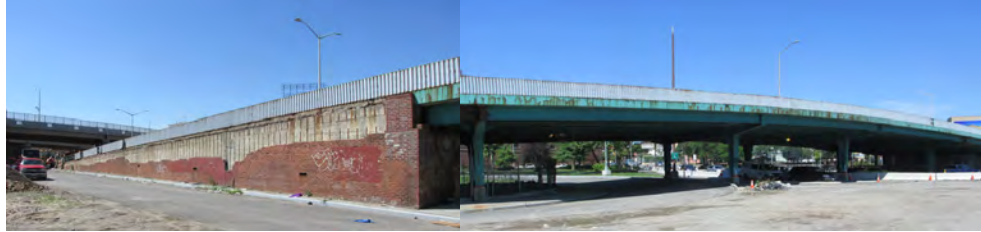
Project Location. 2014 - Left Elevation. 2015 – Right Elevation Spans 1-2 and 7-5. (Credit: NYSDOT)

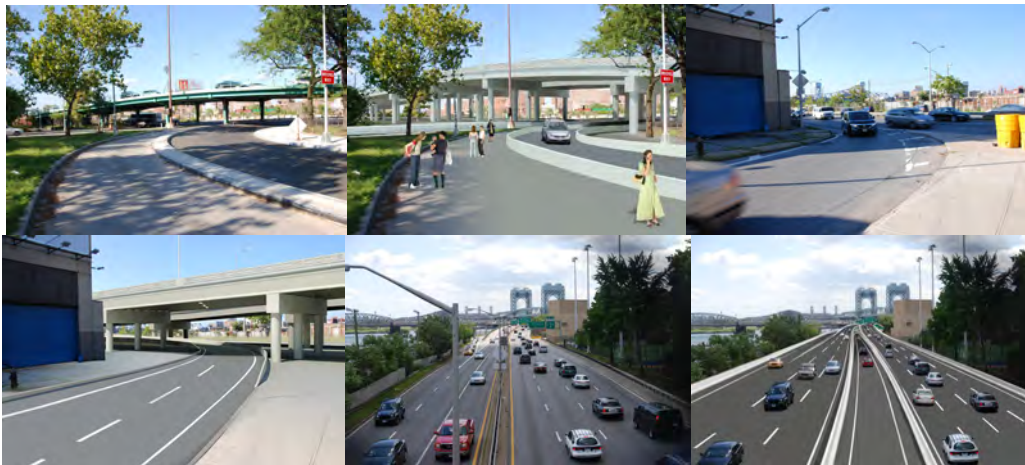
Looking East at the 127th Street Off-Ramp: Current and Proposed View. Looking East at 2nd Avenue: Current and Proposed View. Looking South From 3rd Avenue Bridge: Current Harlem River Drive and 2nd Avenue Exit and Proposed Harlem River Drive With Left Lane Exit to 2nd Avenue.

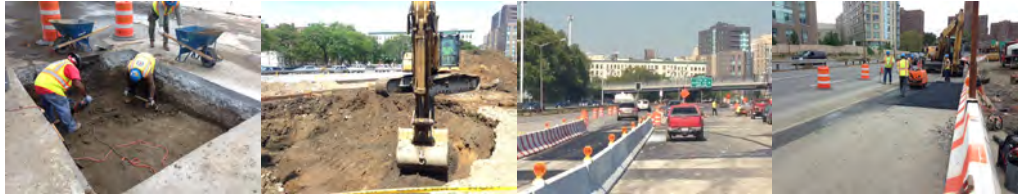
June 2015: Locating and Removing Utilities. Excavating and Removing Big Rocks. September 2015: Painted Concrete Barriers Near Ramp C and Temporary Roadway. October 2015: Adjusting the Grading on the New Temporary Roadway. (Credit: Artemio Angeles)

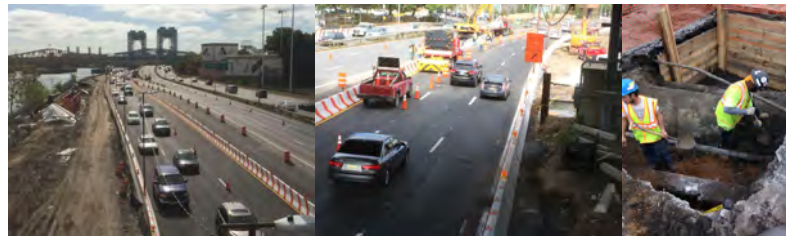
On October 5, 2015, the Temporary Roadway was Opened on the Northbound Harlem River Drive. This enabled the Start of Construction of the New 2nd Avenue Exit Ramp. December 2015: Test Pit Pier 6.

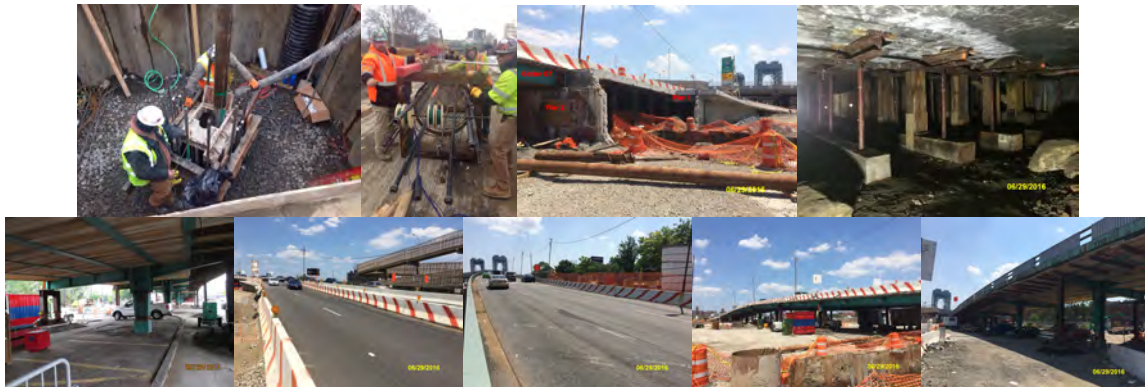
January 2016. February 2016: O-Cell. June 2016: Spans 1 and 2 - View of Removed Portion of Structure. Span 1 Temporary Timber Shoring Under Slab. Span 3 - Timber Planking at Deck Underside. Approach Begin and End. Left Elevation. Right Elevation Spans 3 - 7. (Credit: NYSDOT)

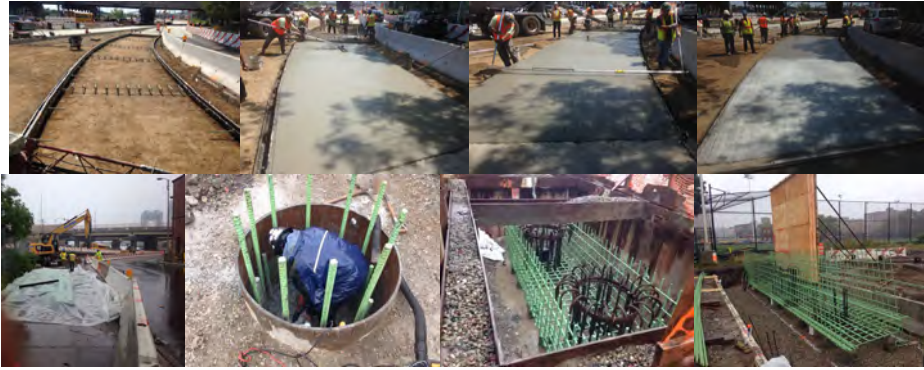
August 2016: Pouring Concrete Pavement at the Third Avenue Exit Ramp to the Southbound Harlem River Drive - The Rails are Used to Create the Proper Super-Elevation on a Curve. A Vibrating Truss Screed is Used to "Smooth" Out the Concrete and Remove any Voids in the Placement. Using a Float to Remove any High or Low Spots, the Pavement Sets Before Final Finishing. Texturing is Added using a Hand Tining Tool. The Finished Product. (Credit: Artemio Angeles) September 2016: North Abutment Pier 8 Foundation. Epoxy Reinforcement Bars to be Installed at South Abutment are Covered. Removing Concrete With a Chipping Gun. Reinforcement for Pile Cap. North Abutment - Reinforcement for the Stem and Forms. (Credit: Artemio Angeles)

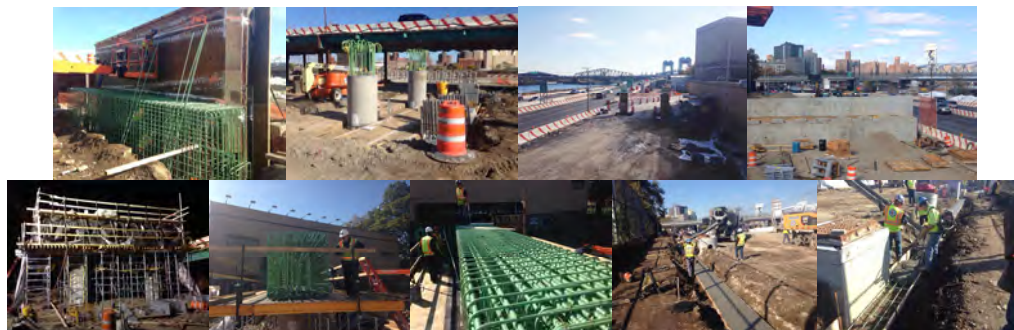
November 2016: South Abutment Stem Wall. Pier 1 - Scaffolding to Begin Setting up Steel Reinforcement and Formwork. General View of Construction Site From Pier 8 - Looking South. The North Abutment. Concrete Placement. (Credit: Artemio Angeles). Reinforcing for Pier 8 Cap Beam Being Inspected by Resident Engineer Jose Jardim. (Credit: Richard Solomon)

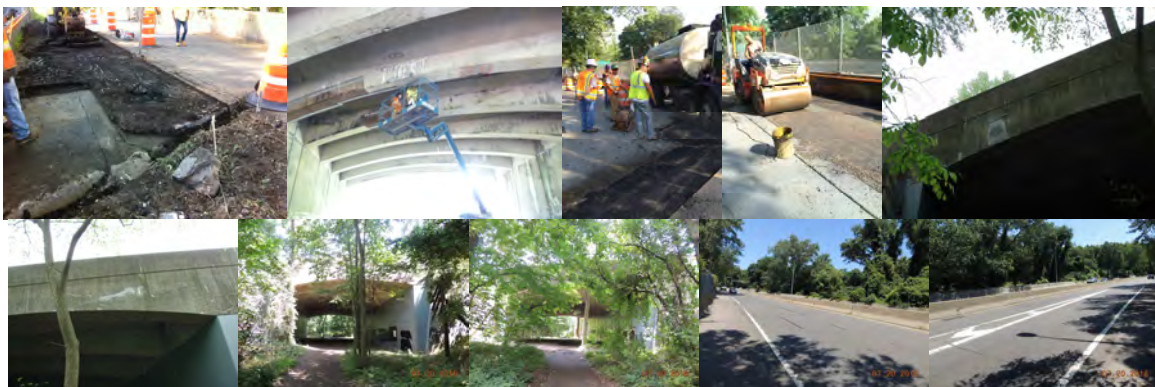
Mosholu Parkway Bridge over Conrail (Abandoned). Conditions in June 2015. Asphalt Work in July 2015. May 2016: Right Fascia Near Beginning Abutment – Repaired Spalled Concrete Area. Right Fascia Near End Abutment – Repaired Stringer. Elevation Left and Right, and Approach Begin and End in July 2016. (2016 Credit: NYSDOT)

The Mosholu Parkway Bridge over Conrail (Abandoned) was built in 1939. It is a single span concrete arch bridge. There is a concrete parapet along both the north and south fascia of the bridge. The existing bridge geometry consists of two travel lanes and a shoulder in each direction, divided by a 4'-0" wide concrete median barrier, as well as a 15'-wide asphalt path for golf carts and pedestrians on the south side of the bridge. The scope of rehabilitation work includes the following: removing and replacing the asphalt overlay, waterproofing, pavement striping, north fascia barrier replacement and median barrier repairs, corrugated guide rail transition, and wingwall joint filler; removing, storing and reinstalling lighting lamp posts on north fascia barrier and replacing luminaires with new luminaires; installing a temporary lighting system; excavating, backfilling and paving the local depression in the asphalt golf cart path; repairing chain link fence section and concrete on the underdeck and abutment walls; installing weepholes in the abutments and preformed joint seal in the concrete parapet; cleaning and flushing catch basins; and removing graffiti by power wash and applying anti-graffiti protective coating. Vehicular and pedestrian access were maintained during the rehabilitation period. Construction work began in June 2015. The Mosholu Parkway Bridge was substantially completed on December 23, 2016.

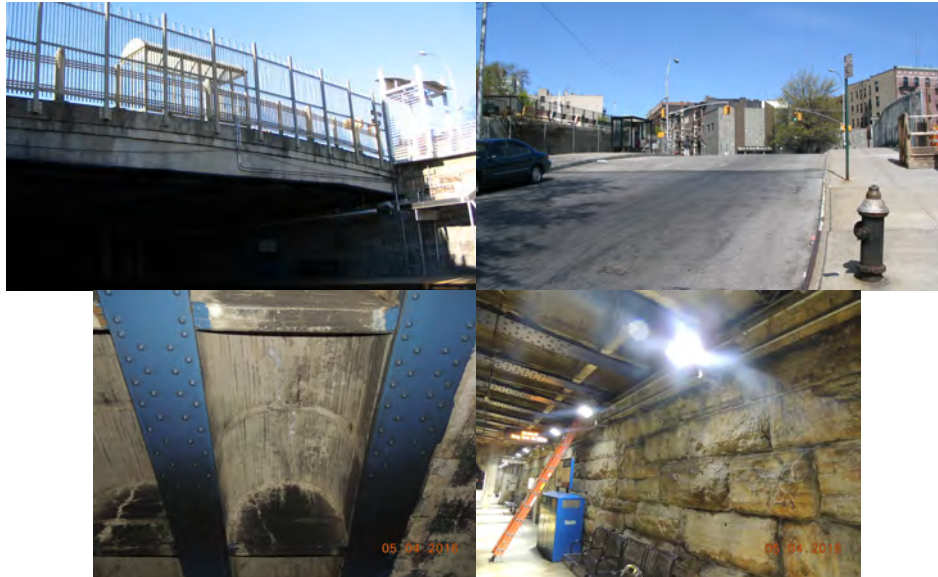
East 162nd Street Bridge over MNRR. May 2016: Span 1, Underside of Deck Exhibits Longitudinal Cracks With Efflorescence. End Abutment Stem. (Credit: NYSDOT)

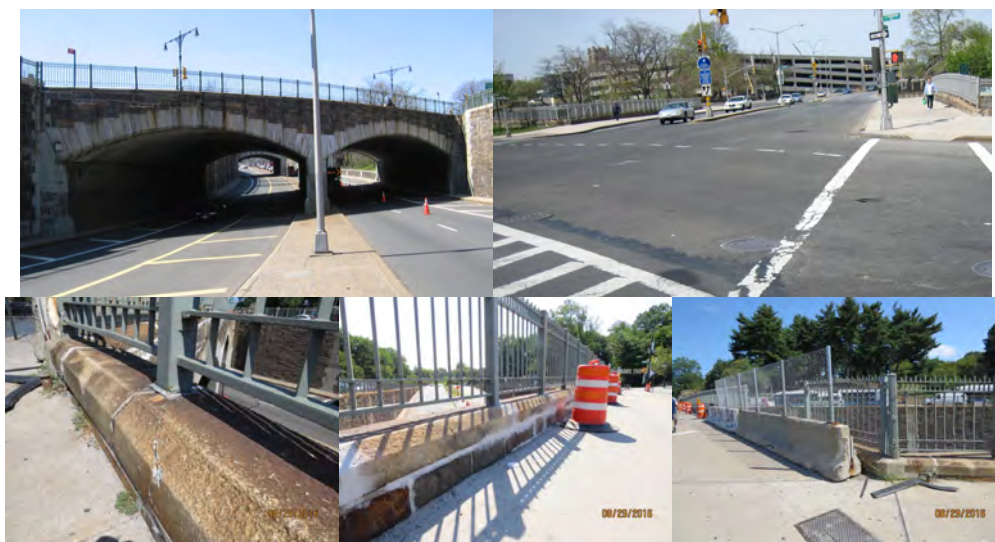
Southern Boulevard Bridge over East Fordham Road. August 2016: Cracked Cap Stone at Right Wingwall. Repaired Joints on Right Parapet. Jersey Barriers and Fence Above the Deck on Span 1.

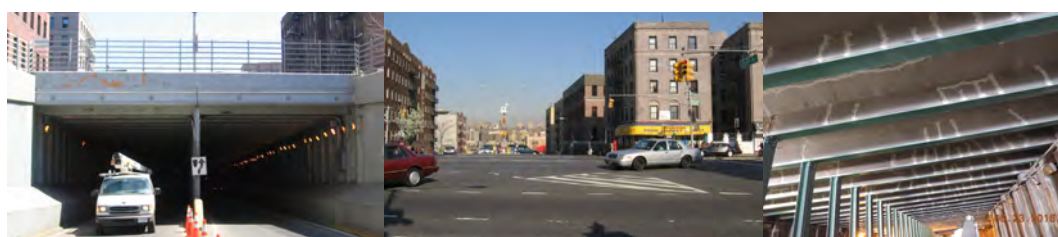
Grand Concourse Bridge over East 167th Street. June 2016: Span 1, Repaired Underdeck and Girder Concrete Encasement. (Credit: NYSDOT)

The Grand Concourse Bridge over East 167th Street was built in 1923. It is a two span steel girder bridge. The bridge has a concrete sidewalk and concrete parapet topped with a chain link fence at each fascia. The existing bridge geometry consists of two travel lanes and a turning lane in each direction on the Grand Concourse, and one travel lane, a parking lane and a sidewalk in each direction on the Grand Concourse service road. The overall structure extends several blocks to the north and south of the Grand Concourse where it carries a two-aisle parking area between the eastbound and westbound ramp lanes of East 167th Street. There is an NYCTA subway station under the Grand Concourse. Both the subway station and the railroad tracks are above East 167th Street. The subway station structures are not included in the scope of the bridge project. The scope of rehabilitation work shall include the following: removal and replacement of asphalt overlay; repairing concrete on the underdeck, abutments, piers, wingwalls and sidewalks; repairing underdeck light fixtures and drain pipe; resealing sidewalk and parapet joints; grouting the gap below the parapet curb along the pavement; and removing graffiti by power wash and applying anti-graffiti protective coating. Vehicular and pedestrian access were maintained during the rehabilitation period. Construction work began in January 2016. The Grand Concourse Bridge was substantially completed on December 23, 2016.

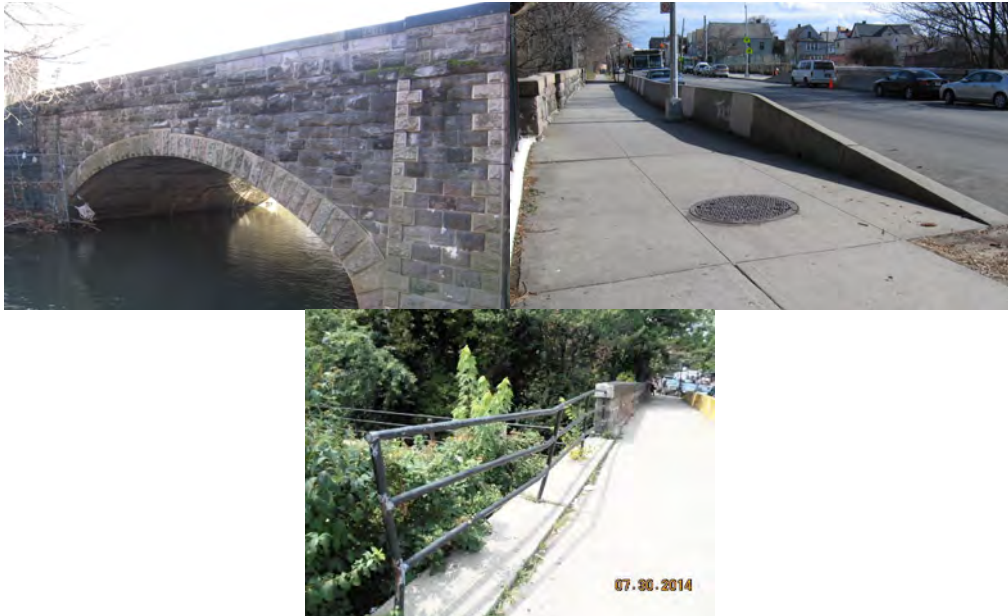
East 180th Street Bridge over Bronx River. July 2014: Bent Railing at Side Approach.
(Railing Credit: NYSDOT)

The East 180th Street Bridge over Bronx River was built in 1925. It is a single span concrete arch bridge with stone masonry facing. The bridge has a parapet at both the north and south fascia. The existing bridge geometry consists of one travel lane, a parking lane and a sidewalk in each direction; the sidewalks on both sides are protected from the roadway by a concrete barrier. The scope of rehabilitation work shall include the following: replacing pedestrian railing; repairing concrete underdeck, crack, spall and joint seal in concrete barrier, and the retaining wall at the northwest corner of the bridge; resealing sidewalk joints; repointing stone masonry and stone coping mortar joint; cleaning drain holes in the concrete barrier; removing a tree from the south fascia and northwest retaining wall; and removing graffiti by power wash and applying anti-graffiti

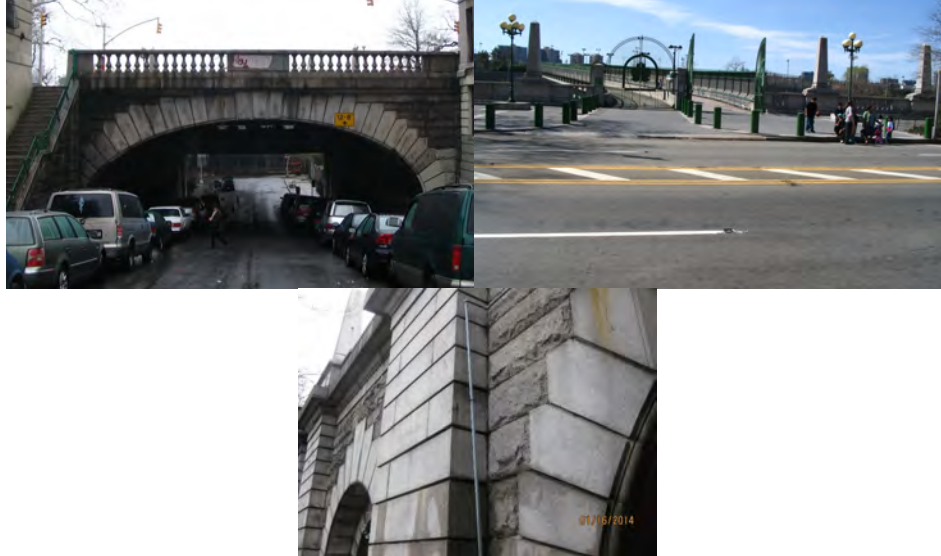
Riverside Drive Bridge over West 138th Street. January 2014: End Abutment. (Credit: NYSDOT)

The Riverside Drive Bridge over West 138th Street was built in 1920. It is a single span concrete arch bridge with stone masonry facing on the abutments and spandrel walls. There is a stone parapet on the east and the west side of the bridge. The existing bridge geometry consists of two travel lanes and a parking lane in each direction; the bridge also contains a sidewalk on the east side and an entrance to Riverbank State Park on the west side. The scope of rehabilitation work shall include the following: removing and replacing the asphalt overlay; repairing granite and brick pavers and concrete on the underdeck and sidewalk; repointing and repairing cracks in stone masonry joints; resealing underdeck joints; installing weepholes in the concrete underdeck; installing pavement striping; removing graffiti by power wash and applying anti-graffiti protective coating; cleaning and painting steel staircase railing and bollards; and replacing lighting fixture and refurbishing existing fuse box. Vehicular and pedestrian access will be maintained during the rehabilitation period. Construction work began in September 2016.

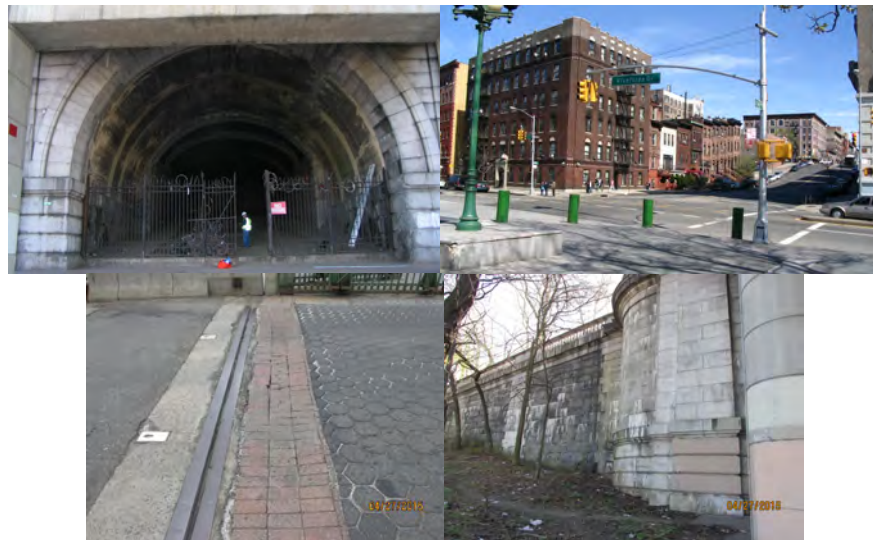
Riverside Drive Bridge over West 145th Street. April 2015: Top of Deck, at Entrance to Riverbank State Park. East Abutment Wingwall. (Credit: NYSDOT)

The Riverside Drive Bridge over West 145th Street was built in 1930. It is a single span concrete arch bridge with stone masonry facing on the abutments and west spandrel wall. There is only one fascia on this bridge; the east side of the arch bridge is a filled backwall. There is a stone parapet on the west side of the bridge. The existing bridge geometry consists of two travel lanes and a parking lane in each direction; the bridge also contains an entrance to Riverbank State Park on the west side. The scope of rehabilitation work shall include the following: clearing and grubbing; removing and replacing the asphalt overlay, concrete overlay, waterproofing membrane and granite and brick pavers; repairing concrete on the underdeck; repointing and repairing cracks in stone masonry joints; resealing underdeck joints; installing pavement striping; removing graffiti by power wash and applying anti-graffiti protective coating; removing and resetting steel gate; and cleaning and painting bollards. Vehicular and pedestrian access will be maintained during the estimated 4-month rehabilitation period.

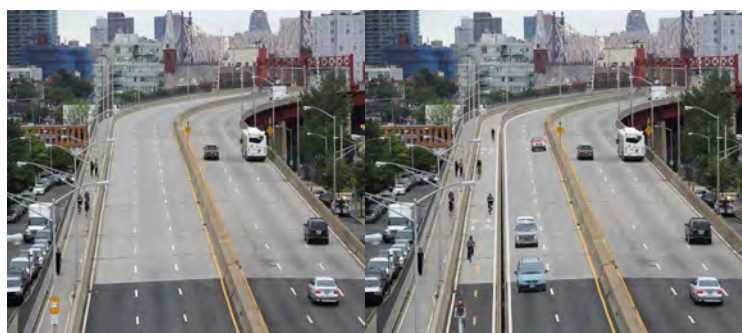
Existing and Planned Condition.

Opened in 1954 and rebuilt in 1994, the Pulaski Bridge is a 44 span bascule drawbridge that opens about 400 times a year, mostly for barges delivering heating oil to a facility on Newtown Creek. The opened drawbridge cannot support the weight of an additional concrete barrier, so in the middle of the bridge, the project will eliminate the barrier that separates the current bicycling and walking path from traffic. On this stretch, pedestrians and cyclists will have physical (metal) separation from traffic, but not between each other. Along other sections of the bridge, there will be two concrete barriers, separating the bikeway from both car traffic and pedestrians. The scope of work will also include installing impact attenuation devices at breaks in barrier system; replacing the finger joint at the center break of the bridge with a bicycle friendly joint; balancing the bascule leaves to accommodate the load of the new barrier; and installing pavement markings and signs for the new bicycle path. Construction work began in September 2015.

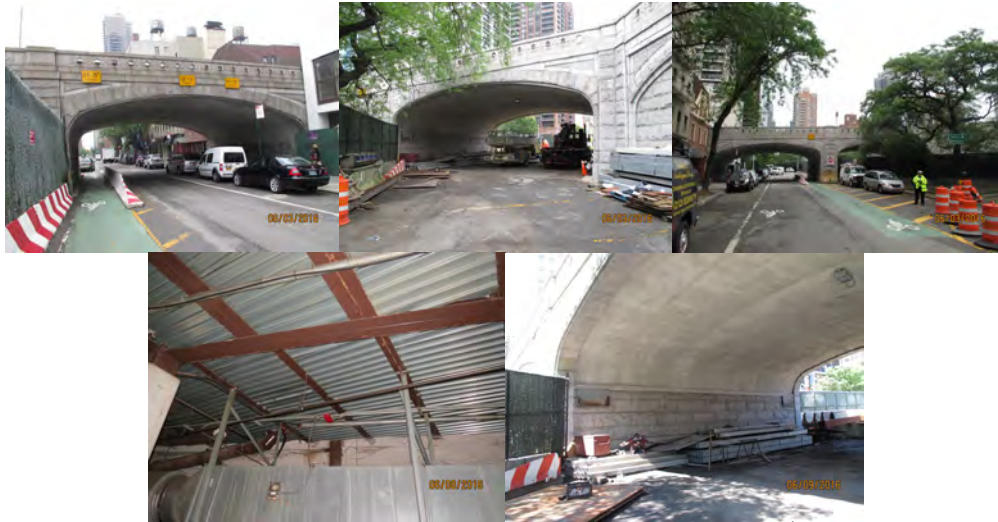
Ramp to the Ed Koch – Queensboro Bridge from East 58th Street over East 59th Street. June 2016: Westbound Span 11 Vertical Clearance Signs. Span 10 – Left Elevation. Spans 10 and 11 – Left and Right Elevations Span 8, Underside of Deck at Bay 2. Steel Stay-in-Place forms Installed as Shielding. Pier 11. (Credit: NYSDOT)

The Ramp to the Ed Koch – Queensboro Bridge from East 58th Street over East 59th Street was built in 1929. It is a twelve span ramp and carries two reversible travel lanes of traffic to (normal daily hours) and from (weekdays morning rush hours only) the Ed Koch - Queensboro Bridge south upper roadway. The bridge has a half jersey barrier running along both sides of the roadway and approaches. The scope of rehabilitation work includes the following: removing the concrete wearing surface and replacing with a thin polymer concrete overlay; repairing the deteriorated sections of concrete deck slab; removing armored joints and replacing with armorless joint system; removing and repairing the concrete in piers, the underside of the deck and the curtain walls; repointing of the stone masonry joints; repairing traffic signs and providing new pavement striping; and applying anti-graffiti coating on the repaired concrete surfaces. Vehicular and emergency access will be maintained during the rehabilitation period. Construction work began in December 2016.

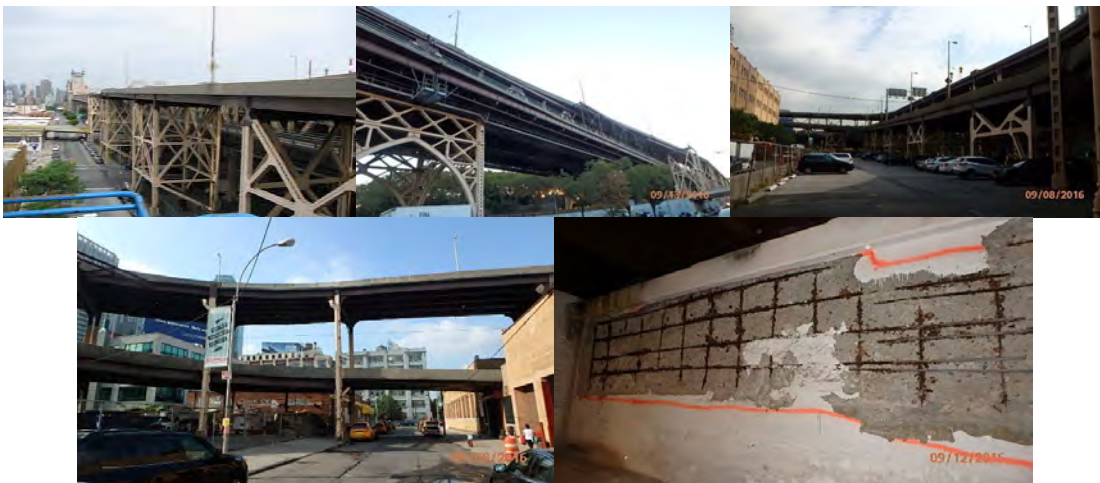
Ramp to 21st Street From NY Over 22nd Street. September 2016: Elevation Right Spans 1 to 12, 22 to 36, and 37 to 39. End Abutment Stem Wall – Spalled Concrete With Exposed Rebar. (Credit: NYSDOT)

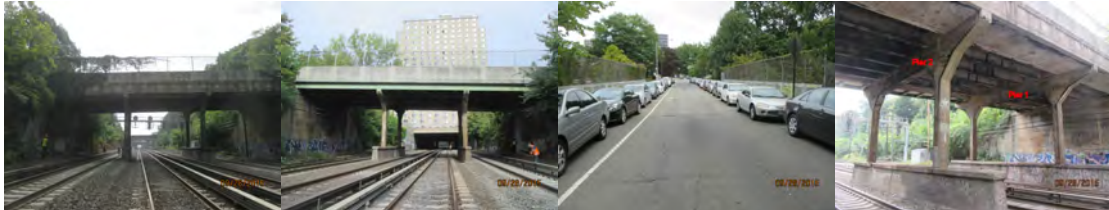
80th Road Bridge over LIRR Main Line. September 2015: Elevation Left and Right. Begin Approach. Piers 1 and 2. (Credit: NYSDOT)

has a sidewalk and a concrete parapet with chain-link fence running along both sides of the roadway and approaches. The bridge superstructure mostly consists of concrete encased steel girders with two exposed steel girders at the south fascia of the bridge. The scope of rehabilitation work includes the following: removing and replacing the north sidewalk, curb, parapet, and removing the sand fill in north sidewalk bay; removing the deteriorated concrete in the girders' encasement, north fascia, and underside of the deck; removing and replacing the asphalt wearing surfaces on the bridge and at the approaches; removing and replacing the existing northeast and southeast approach sidewalks, and erecting a temporary support shield on railroad tracks. Vehicular and pedestrian access will be maintained during the estimated 7-month rehabilitation period.

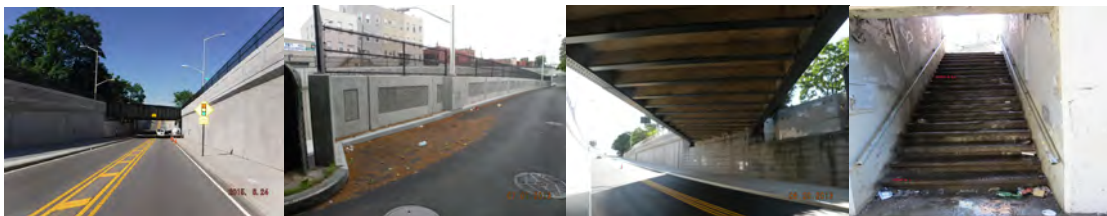
71st Avenue Bridge over Cooper Avenue. Elevation Left. Left Concrete Parapet/Guide Rail. Span 1 Bridge Framing. (Credit: NYSDOT) Stairway at Right Side of Beginning Abutment.

The 71st Avenue Bridge over Cooper Avenue was built in 1934. It is a single span bridge and carries one travel lane, a sidewalk and through girders (acting as a railing), running along both sides of the roadway. The scope of rehabilitation work included the following: removing and replacing the asphalt wearing surfaces on the bridge and approaches; repairing the concrete on the abutments, wing-walls, and underside of the deck; constructing a retaining wall at the south west corner; removing and reconstructing the concrete curb, sidewalk and driveway at the east approaches, and improving the existing under deck lighting. Vehicular and pedestrian access were maintained during the rehabilitation period. Construction work began in July 2016, and the project was substantially completed on December 12, 2016.

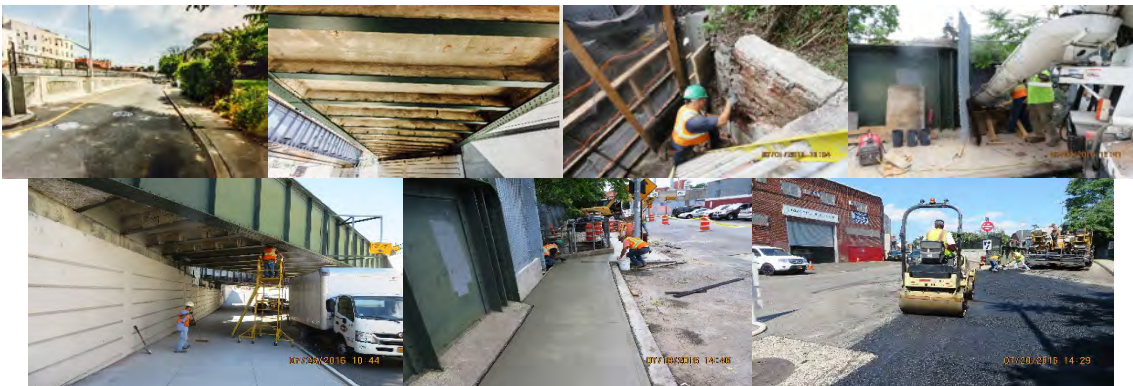
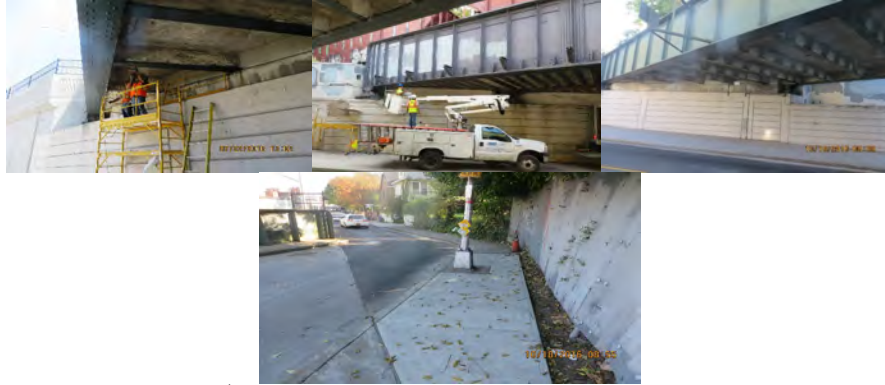
71st Avenue Bridge Before, During, and After Construction.

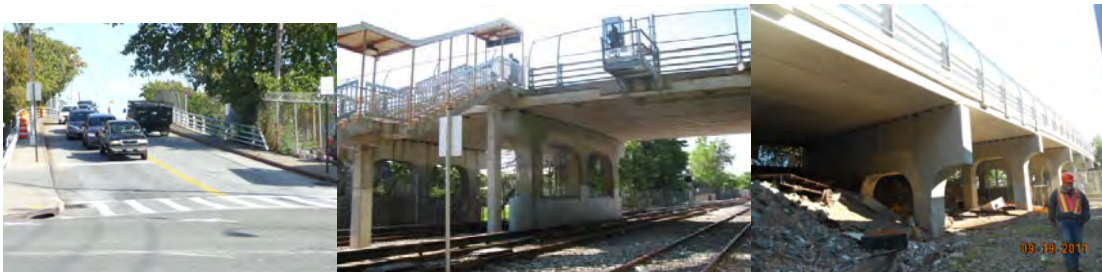
Hannah Street Bridge Over SIRT South Shore. Spans 1-4 - Right Elevation. (Credit: NYSDOT)

The Hannah Street Bridge over SIRT South Shore was built in 1935. It is a ten span bridge and carries one travel lane in each direction, a sidewalk, a railing and a steel mesh fence running along both sides of the roadway and approaches. The bridge deck has a steel bridge railing with a chain-link fence running alongside the roadway and approaches. The bridge deck consists of a reinforced concrete slab with integral wearing surface and prestressed concrete beams. The scope of rehabilitation work includes the following: removing and replacing the existing deck and approaches' wearing surface; waterproofing; repairing the concrete on the abutments, piers and the underside of the deck; removing existing armored joints and replacing with armorless joint systems; cleaning of the curbs; repairing the embankment on the north east approach, and providing new striping. Vehicular and pedestrian access will be maintained during the rehabilitation period. Construction work began in October 2016, and is expected to be substantially complete in late spring 2017.

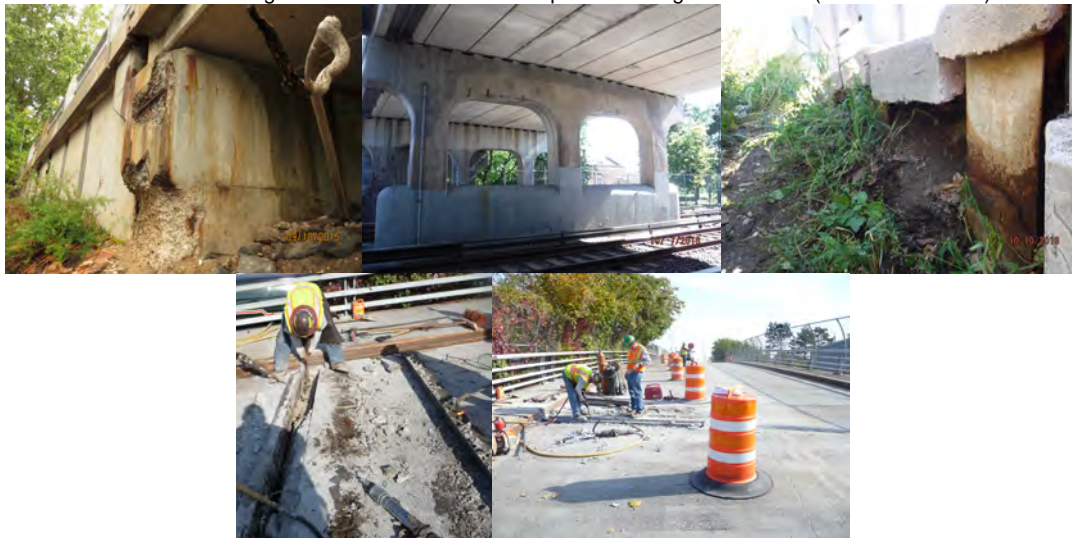
October 2015: Large Deep Spall on Right Corner of Beginning Abutment. October 2016: Eroded Left Embankment at End Approach. (Credit: NYSDOT) November 2016.

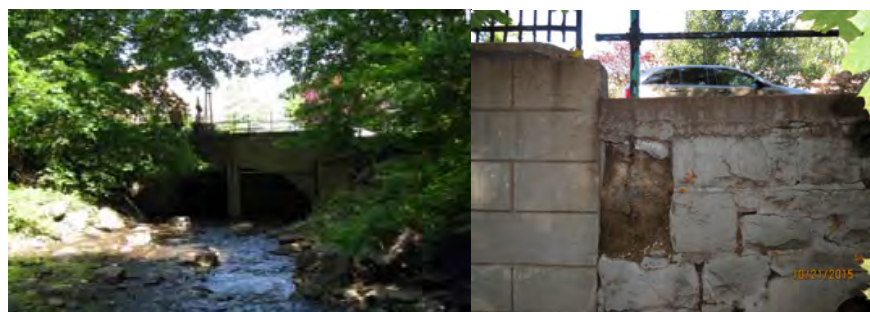
Forest Avenue Bridge Over Clove Lakes Park Stream. End Abutment Stone Masonry Wingwall. (Wingwall Credit: NYSDOT)

The Forest Avenue Bridge over Clove Lakes Park Stream was built in 1906. It is a single span concrete arch bridge and carries one travel lane in each direction, a sidewalk, and a small parapet and low railing running along the southern sidewalk. The bridge deck has an asphalt wearing surface. The scope of rehabilitation work includes the following: removing and replacing the existing nonstandard railing with a standard bridge railing; repairing the concrete on the deteriorated sections of sidewalk; cleaning and repointing of the mortared joints at the wing-walls; installing a new guide railing at the bridge approach; and providing tree and landscape protection within the park land during construction and restoration after construction. Vehicular and pedestrian access will be maintained during the estimated 3-month rehabilitation period.

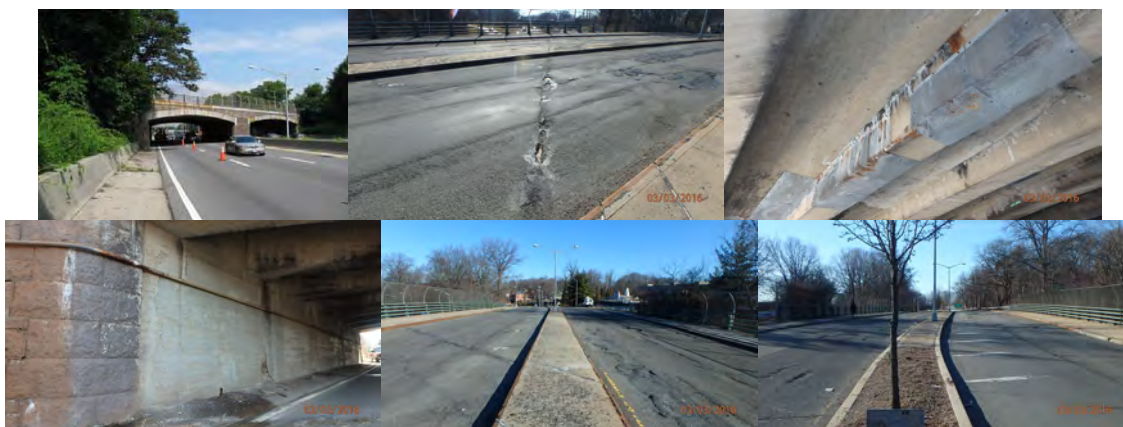
Douglaston Parkway Bridge Northbound Over Cross Island Parkway. March 2016: Top of Bridge, Asphalt Wearing Surface Above Beginning Abutment - Spalls and Uneven Wearing Surface. Span 1 - Deteriorated Concrete Covered With Wire Mesh. Abutment End. Approach Begin and End. (Credit: NYSDOT)

The Douglaston Parkway Bridge northbound over Cross Island Parkway was built in 1939. It is a single span bridge over three lanes on the northbound Cross Island Parkway and carries one travel lane, sidewalk, a wide shoulder, and a median. The bridge has a steel bridge railing with a chain-link fence running alongside of the roadway and approaches. The bridge superstructure consists of reinforced concrete beams acting as a rigid frame. The deck consists of a reinforced concrete slab with a concrete fill course and asphalt wearing surface. The scope of rehabilitation work includes the following: removing and replacing the bridge and approaches' asphalt wearing surfaces, repairing of concrete on abutments and the underside of the deck; cleaning and repointing of the mortared joints in the masonry wing walls; removing and replacing the concrete curbs at the approaches, improving lighting on the underside of the deck; providing new pavement striping, saw cutting the bridge joints on the roadway, and sealing with a sealant. Vehicular and pedestrian access will be maintained during the rehabilitation period. Construction work began in April 2016, and is expected to be substantially complete in spring 2017.

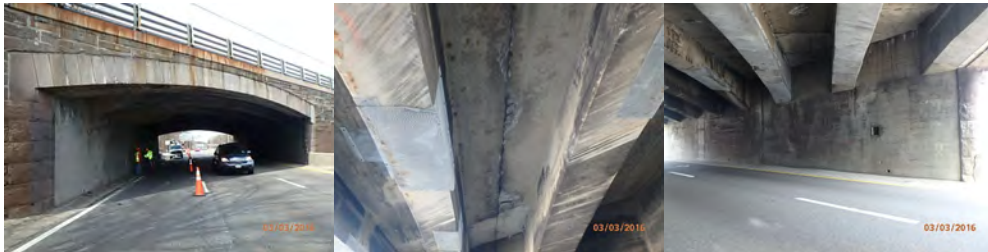
Douglaston Parkway Bridge Southbound Over Cross Island Parkway. March 2016: Right Elevation. Span 1 Concrete Beams Exhibit Spalls With Exposed Rebar Which Are Covered by Wire-Mesh Netting. (Credit: NYSDOT)

travel lane, sidewalk, wide shoulder, and a median. The bridge has a steel bridge railing with a chain-link fence running alongside of the roadway and approaches. The bridge superstructure consists of reinforced concrete beams acting as a rigid frame. The deck consists of a reinforced concrete slab with a concrete fill course and an asphalt wearing surface. The scope of rehabilitation work includes the following: removing and replacing the bridge and approaches' asphalt wearing surfaces; repairing the concrete on the abutments and the underside of the deck; cleaning and re-pointing of the mortared joints in the masonry wing walls; removing and replacing the concrete curbs at the approaches; improving the lighting on the underside of the deck; providing new pavement striping, saw cutting bridge joints on roadway, and sealing with a sealant. Tree and landscape protection will be provided during the construction. Vehicular and pedestrian access will be maintained during the rehabilitation period. Construction work began in April 2016, and is expected to be substantially complete in spring 2017.

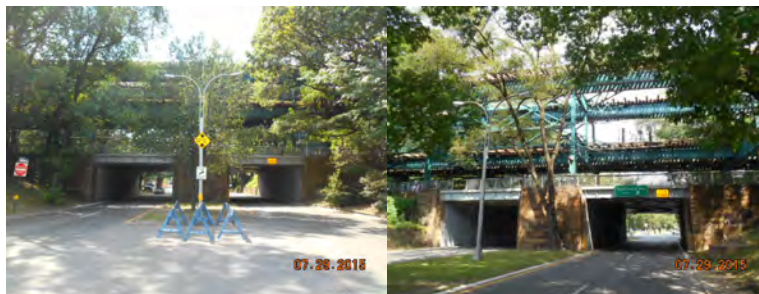
Roosevelt Avenue Bridge Over Flushing Meadow Park Road. July 2016: Elevation Left and Right. (Credit: NYSDOT)

The Roosevelt Avenue Bridge over Flushing Meadow Park Road was built in 1936. It is a four span bridge and carries two travel lanes in each direction, a wide sidewalk, and a railing running along both sides of the roadway and approaches. The bridge deck has a steel bridge railing with a chain-link fence running alongside the roadway and approaches. The bridge consists of a reinforced concrete slab. The scope of rehabilitation work included the following: removing and replacing the existing deck and approaches' asphalt overlay, waterproofing membrane, and sidewalks; repairing the concrete on the abutments and underside of the deck; improving the existing roadway lighting and drainage systems; repointing the mortared joints in the wing-walls and piers; and providing new pavement striping. Construction work began in June 2016, and the project was substantially completed on December 19, 2016.

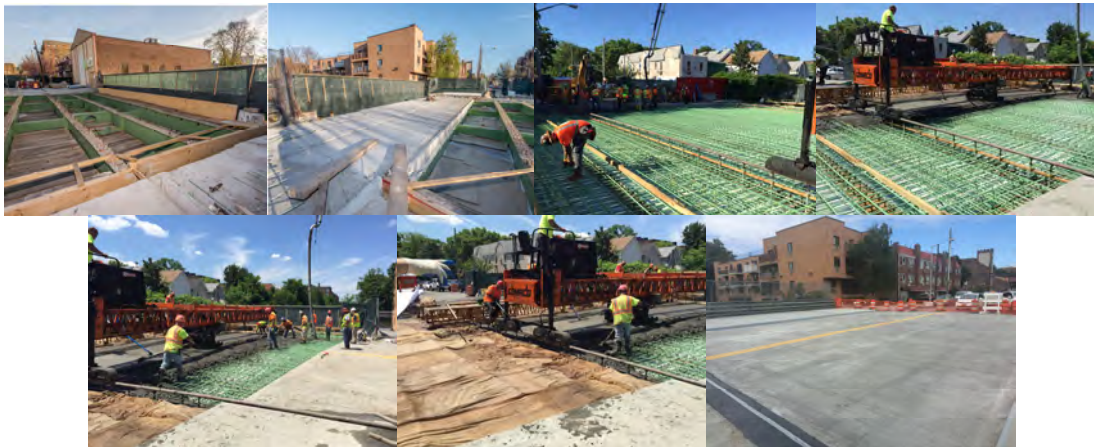
April and June 2016. New Deck in August 2016. State Senator, Toby Ann Stavisky, Councilmembers Peter Koo and Paul Vallone, and State Assemblymember Ron Kim at the Reopening Ceremony on August 4, Along With Queens Borough Nicole Garcia and Members of the 149th Street Merchants Association.

The 149th Street Bridge over LIRR was built in 1924. It is a single-span steel stringer structure and carries one travel lane and one parking lane in each direction, a sidewalk, a railing and a steel mesh fence running along both sides of the roadway. The work performed under this project included replacing the structurally deficient bridge deck constructed under Contract HBCR99B. The reconstruction of the bridge began in May 2010. In May 2012, an independent consultant determined that the deck was structurally deficient due to a shop drawing review error by the design and construction support services consultant. The City has filed a lawsuit against the consultant for this error. The scope of work included the following: installing protective shielding over the railroad during nighttime operations; removing and storing the existing bridge railing and fence; removing and replacing the superstructure slab including the sidewalk and curbing; reconstructing the header on the south abutment and the sidewalks on the south approach to install an armorless joint; reinstalling the bridge railing and fencing along the fascia; sawcutting a groove finish on the bridge deck and applying a penetrating sealer to the top of concrete; and installing traffic striping across the bridge to match the existing striping on the approaches. The project was substantially completed on August 2, 2016, and re-opened to pedestrian and vehicular traffic on August 3.

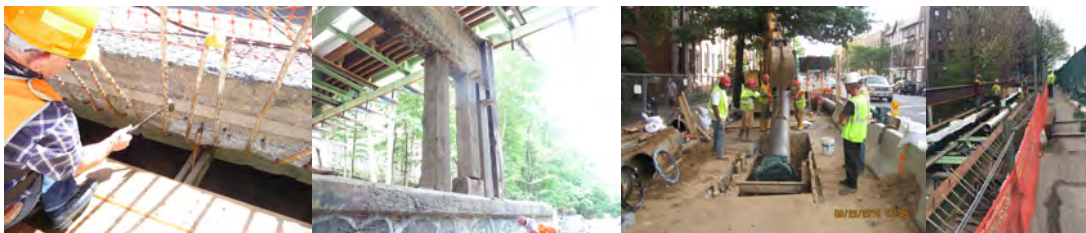
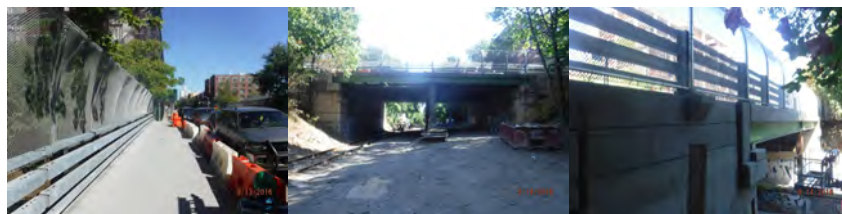
July 2014. September 2015. April 2016. September 2016: New Span 1 and 2 Left Steel Railing and Concrete Sidewalk. Left and Right Elevation. (September Credit: NYSDOT)

The scope of rehabilitation work included the following: removing the existing concrete parapets on both sides of the bridge and replacing them with a new steel bridge railing and protective fence; removing parts of the concrete deck slab and concrete-encased steel stringers below the sidewalk areas and replacing them with new steel stringers and a reinforced concrete slab; installing a new rocker bearing to support the new steel stringers; removing and installing new fences and a new fence gate; replacing a part of the abutment structures to hold a new concrete abutment seat with pedestals; disposing of the building under the bridge area; removing the existing watermain and replacing them with new steel watermain; applying a protective sealer on the concrete surfaces over the bridge seats, pedestals and backwall; removing the graffiti over the abutment, painting the surface to match the existing color and applying an anti-graffiti coating; resurfacing the existing asphalt pavement; replacing the curb and sidewalk on the approach side; repairing the spalls and hollow sounding underdeck area; installing a new armorless bridge joint system at both ends of the bridge; and providing new striping to match the existing one. Construction work was performed in two stages and began in August 2013. The project was substantially completed on October 6, 2016.

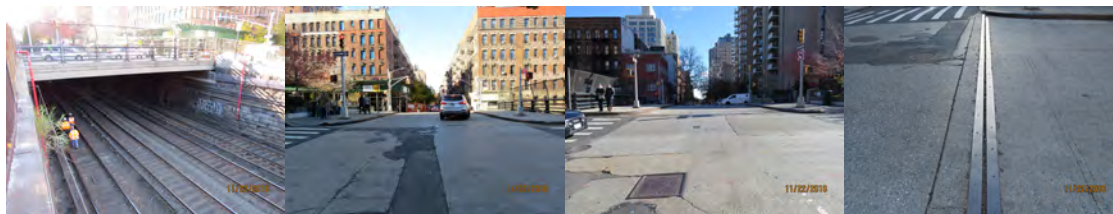
East 97th Street Bridge over Metro North. 2016: Beginning and Ending Approaches. Beginning Abutment Joint - Deteriorated Sealer Material. (Credit: NYSDOT)

The East 97th Street Bridge over Metro North Railroad was built in 1873. The structure is a one-span bridge and carries two westbound traffic lanes over the Metro North Railroad tracks. There are no parking lanes on the bridge. There are wide concrete sidewalks on each side of the bridge. The bridge superstructure consists of pre-stressed concrete box beam system with a reinforced concrete slab. The scope of rehabilitation work includes the following: sealing cracks in the concrete overlay on top of the bridge; replacing the expansion joint sealer at the roadway joints; repairing the concrete deterioration of the abutment stems, backwall, and bridge seats; providing an anti-graffiti protection coating at the concrete parapet; cleaning and painting the utility support beams and chain link fence posts, railings; removing and replacing the steel angle plates at the south sidewalk; and miscellaneous repairs of utility conduit supports. Vehicular and emergency access will be maintained during the estimated 8-month rehabilitation period.

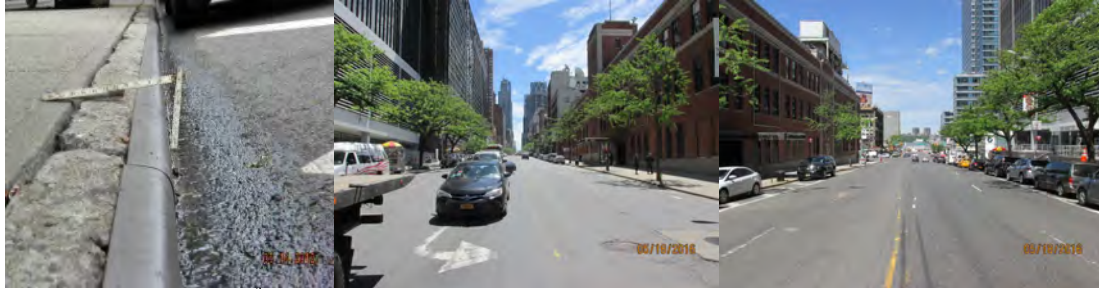
West 57th Street Bridge over Amtrak. 2016: Beginning and Ending Approaches.

The West 57th Street Bridge over Amtrak Railroad was built in 1934. The structure is a three-span bridge that carries 3 westbound and 2 eastbound traffic lanes and wide concrete sidewalks on each side of the bridge. There are buildings adjacent to the bridge on the north and south fascia. The bridge superstructure consists of 22 concrete-encased steel stringers. The scope of rehabilitation work includes the following: localized repairs to the concrete sidewalk and curbs; removal of the stringer bottom flange encasement; cleaning and painting of the exposed bottom flange; providing a protective shielding over the railroad; repairing of the concrete at the abutments, stem, piers, crashwalls and underside of deck; cleaning and painting the seating angles at the piers and at the steel columns; and anti-graffiti protective coating at the abutment and fascia. Vehicular and emergency access will be maintained during the estimated 8-month rehabilitation period.

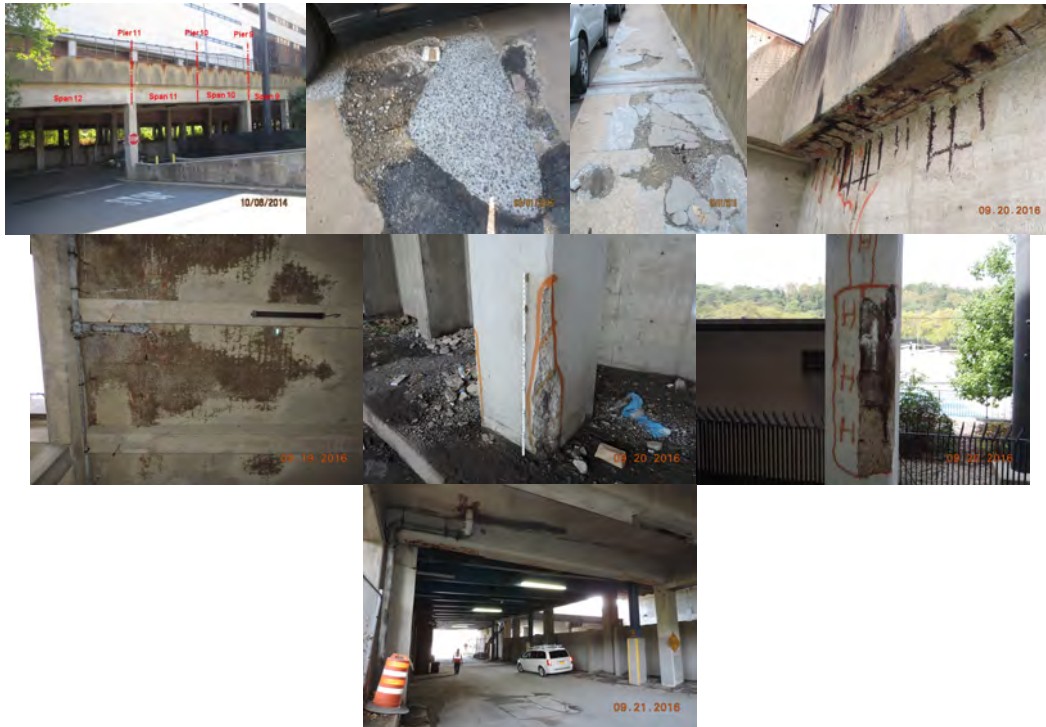
Matthewson Road Bridge over MacCracken Avenue. (Credit: NYSDOT) March 2016: Spalled and Exposed Rebar on Wearing Surface of Span 2. Left Sidewalk on Span 8. September 2016: Span 2, Underside of the Left Parapet and Left Face of Girder Exhibit Spalls with Exposed Rebar. Pier 7, Right and Left Columns Exhibit Exposed Rebar and Hollow Sounding Concrete. End Pier. (September Credit: NYSDOT)

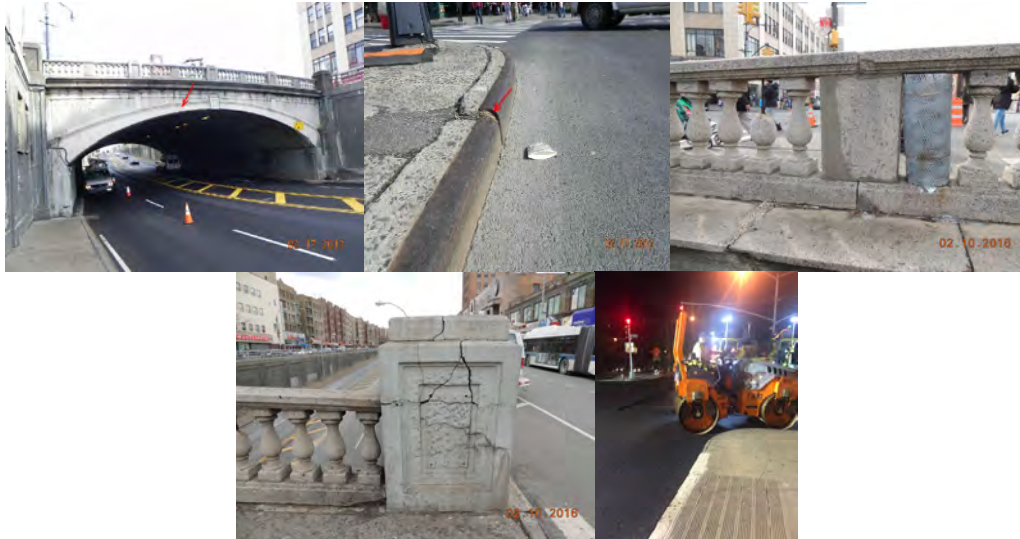
East Fordham Road Bridge over Grand Concourse. February 2016. Span 1, Left Railing Near End Abutment. Railing Balustrade Completely Spalled and Covered With Wire Mesh Netting. Span 1, Left Railing - End Pylon Exhibits Scattered Cracks Throughout. (Credit: NYSDOT) August 2016.

the asphalt wearing surface on the bridge area; repairing the top of the concrete slab with a waterproofing membrane and two layers of asphalt; repairing the deteriorated areas of concrete at the abutments and the underside of the arch; removing the safety netting to repair the concrete; installing safety netting; repairing or replacing the concrete sidewalk; restoring the mortar joints at the spandrel stone copings; replacing sections of the steel faced concrete curbs and the roadway interface sealer; repairing the deteriorated concrete of the balustrades and parapets; and performing miscellaneous repairs to the underdeck lighting. Construction work on this bridge began in April 20, 2016. The project is expected to be substantially complete in spring 2017.

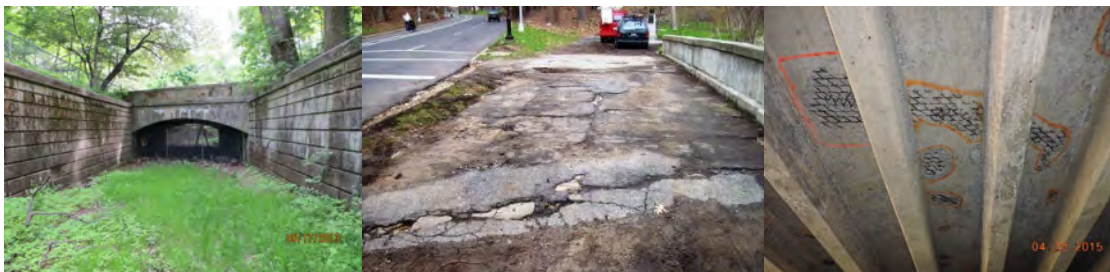
East Drive Bridge over Bridle Path. April 2015: Span 1 - Underside of Deck Exhibits Spalled Concrete With Exposed Wire Mesh. (Credit: NYSDOT)

The East Drive Bridge over the Bridle Path in Prospect Park was built in 1910. The structure is a single span bridge that carries predominantly pedestrians and cyclists and two lanes of one-way vehicular traffic during restricted hours only. There is a safety walk along the left side of the bridge and a wide sidewalk along the right side, each with concrete parapets. The scope of rehabilitation work includes the following: removing and replacing the asphalt wearing surface; installing a waterproofing membrane and two layers of asphalt; installing new bollards for the north sidewalk; repairing deteriorated areas of concrete at the underside of the deck, encasement and curbs; cleaning and painting the exposed structural steel members; and performing miscellaneous repairs to the underdeck lighting. Vehicular, pedestrian and emergency access will be maintained during the estimated 5-month rehabilitation period. The construction work on this bridge began in December 2016, and is expected to be substantially complete in spring 2017.

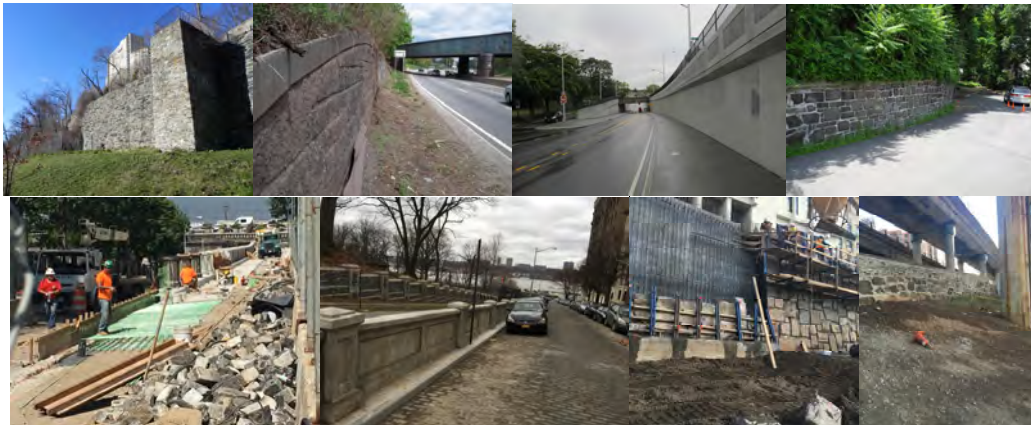
Retaining Walls: Irwin Avenue. Cross Island Parkway Southbound Before 100th Avenue. Cooper Avenue. Douglas Road. 2016: West 155th Street (Lower Level) Between Riverside Drive and Broadway During and After Rehabilitation by DDC. Riverside Drive (Northbound) to George Washington Bridge (West 168th to 171st Streets) During Rehabilitation. Riverside Drive Under George Washington Bridge Ramps (West 176th to 177th Streets). (2016 Credit: Jacob Ayman)

In May 2005, the Department started a program for the periodic inspection of City-owned retaining walls. The City currently owns 635 retaining walls. Those retaining walls were built during the interstate construction program between the 1940's and 1970's and are an important part of the city's street infrastructure. However, some of them are approaching the end of their service lives and are falling into poor condition due to various factors such as spalling/cracking of concrete, loosened mortar joints, broken stone masonry, falling coping stones, deteriorated joints, leakage through the walls due to improper drainage arrangements (clogged weep holes), bulging of walls due to hydrostatic pressure build-up on the back of the walls, and many other problems. In order to protect the infrastructure they support, the retaining walls require regular inspections and monitoring, and depending upon the condition of the walls, rehabilitation/replacement is required. Since 2005, 25 retaining walls have completed rehabilitation/replacement, and 10 retaining walls are in various stages of design and construction. The retaining walls which are in fair to poor condition will be in a capital program for future rehabilitation.
