As an integral part of New York City's Department of Transportation, the Division of Bridges has a two-fold mission: to maintain an optimal transportation network by ensuring smooth mobility on the city's bridges, and to ensure the safety of the public.

ACCOMPLISHMENTS & PLANNED PROJECTS

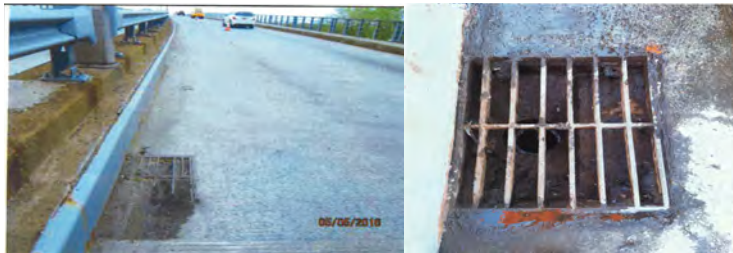
Debris and Sediment Fully Clogging a Scupper on the Northbound Roadway of the Boston Road Bridge over the Hutchinson River. Scupper After Cleaning.

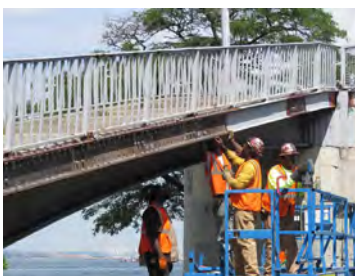
92nd Street Pedestrian Bridge over Belt Parkway in August 2016 – Repairing Span #6.

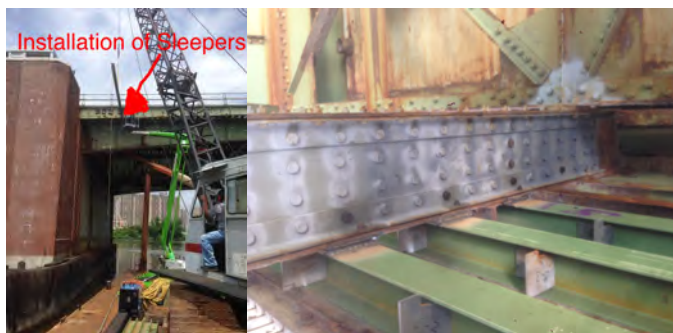
Hutchinson River Parkway Bridge - Installation of Sleeper Steel Beams to Directly Support the Steel Grating.

On the heavily traveled Hutchinson River Parkway Bridge over Hutchinson River, severe deterioration of key structural steel elements supporting the steel grid deck of the southeastern quadrant of the span forced urgent measures to be taken, first, by providing immediate temporary replacements to take over part of the lost support capability, and subsequently, by installing new steel replacement “sleeper” beams and heavy local support at deteriorated stringer sections.

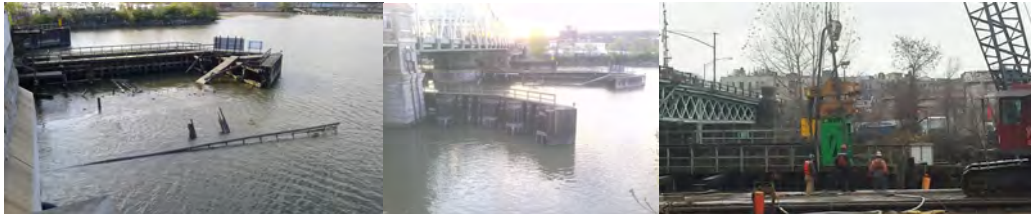
May 2015 – University Heights Collapsed Fender System. Collapsed Fender System in East Channel.
December 2015: Loosening the Existing Wooden Pile to Facilitate its Easy Removal From the River (Mud) Bed. The Vibrating Hammer is Attached to the Crane Initially to Vibrate it and Ultimately Loosen the Existing Piles.

The salvage and restoration operations commenced in October 2015, utilizing barge-mounted cranes and associated salvage equipment situated in the East Channel. To date, all dislodged piles and bracing elements have been removed from the East Channel river bed, and the contractor received approximately 400+ new timber piles in early 2016. The project is scheduled to be completed by August 2017.

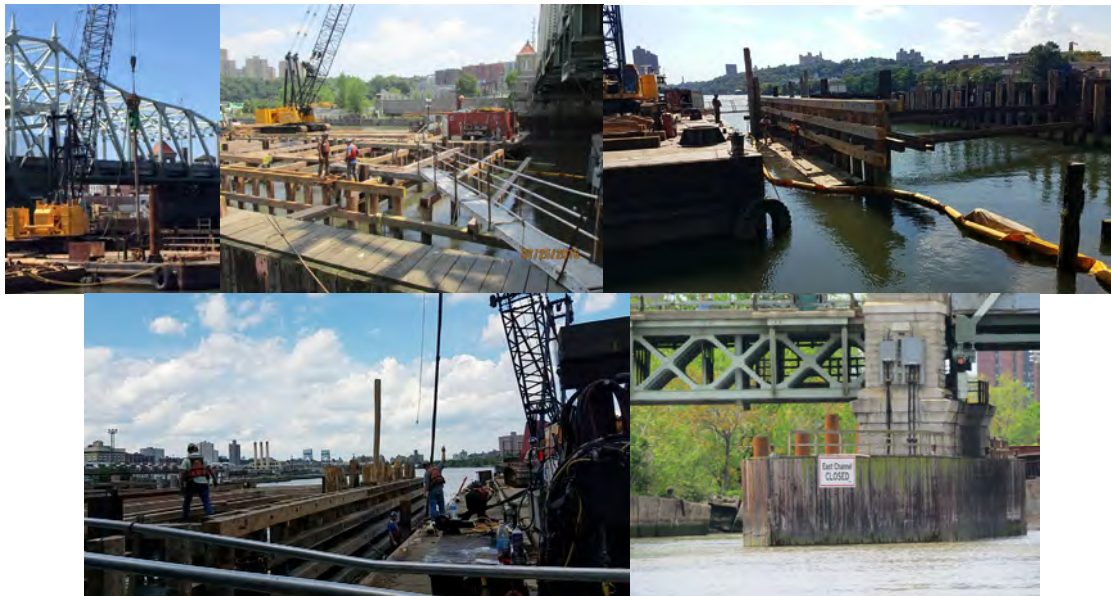
University Heights Bridge. April 2016: Pile Driving Operation. July 2016: Pier 3, Left Side, Repaired Wooden Catwalk. (July Credit: NYSDOT) September 2016: Installing and Securing the Whaler Timbers at the South and East Faces of the Fender. East Channel Closed Sign.

During the construction phase of the project to replace the north and south fender system, further issues were found beneath the center pier system. Although a full-length timber pile was not feasible, the unit and its contractor determined a way to conduct a difficult but attainable repair. A change in design was initiated to introduce steel H-piles spliced together. This method made it

The replacement fender will replace the existing fender system largely “in-kind” in the sense that the fender will maintain the same footprint as the existing fender and will employ timber framing. The existing Western annex, added in the late 1980’s will not be demolished and will be incorporated into the replacement fender system.

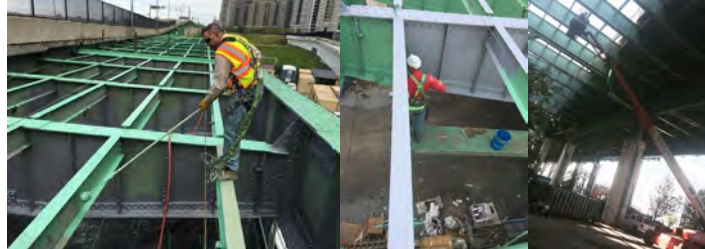
Bridge Painter Juscelino Andrade Painting the Miller Highway (Joe DiMaggio Highway) over Terrain. (Credit: Arlindo Lima)

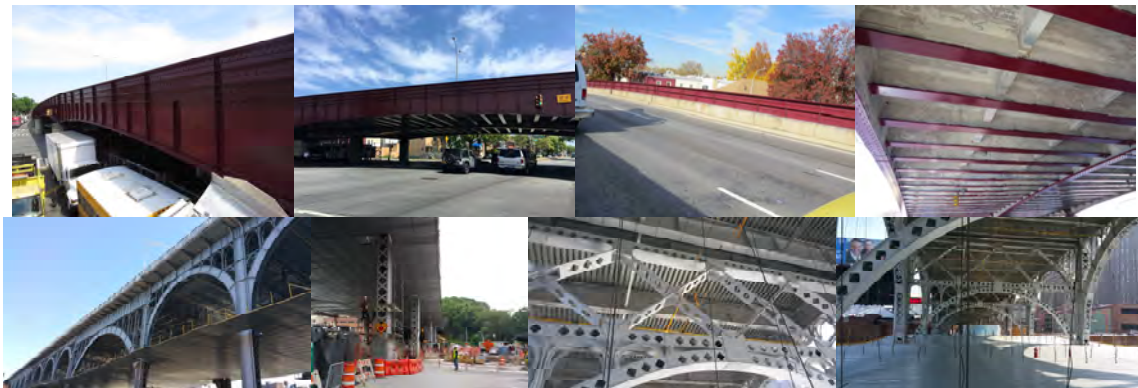
Woodhaven Boulevard Bridge over Atlantic Avenue. Riverside Drive Viaduct over West 125th to West 134th Streets. (Riverside Credit: Vadim Sokolovsky)

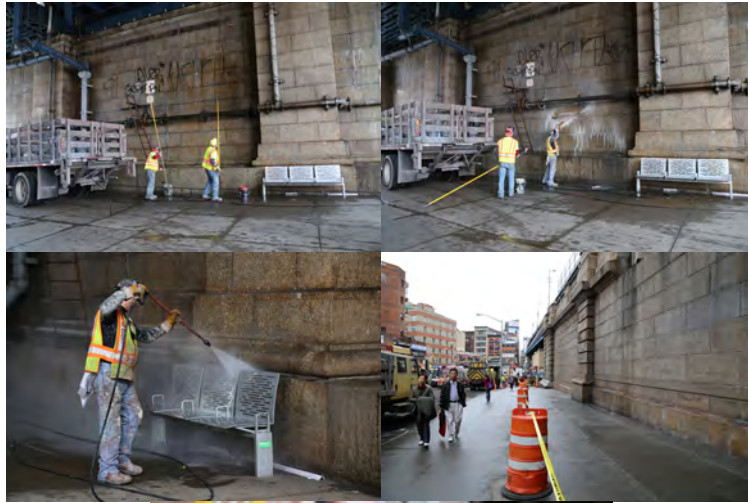
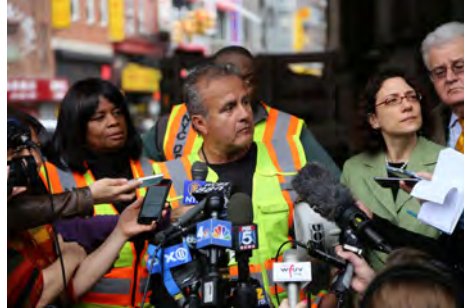
April 2016: Removing Graffiti on the Manhattan Bridge. At the Removal Demonstration: Deputy Director of In-House Painting Earlene Powell, Supervisor Bridge Painter Cesar Pazmino, Commissioner Polly Trottenberg, and Chief Bridge Officer Robert O. Collyer.

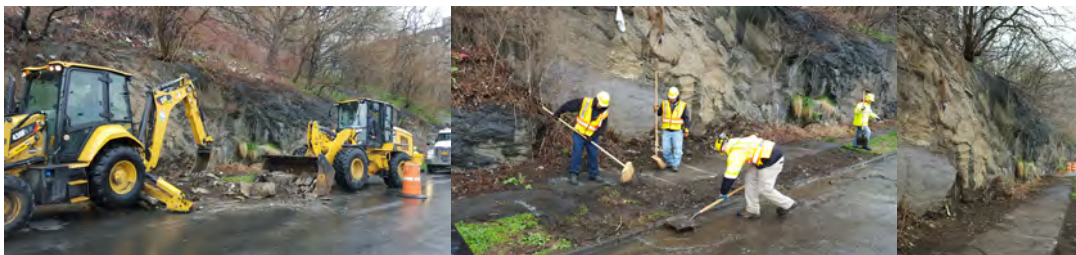
April 2016: The Department of Sanitation Requested Assistance Because Rocks had Slid Down From a Rock Outcropping on the East Side of Sedgwick Avenue Between University Avenue and 167th Street. Tractor Operator Andrew Mondl. Assistant City Highway Repairers James Kelleher, Anthony Angioletti, and James Cummings, and Highway Repairer Jonathan Adorno. Cleared Condition. (Credit: Paul Schwartz)

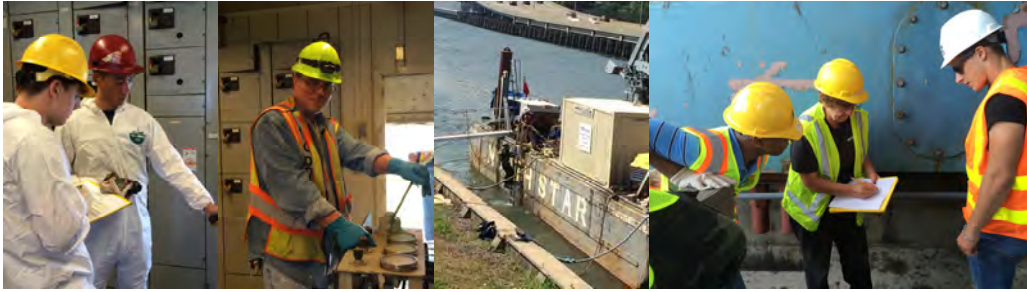
June 2016: Summer College Intern Jimmy Yeung, College Aide Philipp Zagika, and Oiler Thomas McCarthy on the Macomb's Dam Bridge During Hydraulic System Exercising. Diver Ascending Stairs on Barge Adjacent to the Bridge. (Credit: Vera Ovetskaya) July 2016: Assistant Mechanical Engineers Shyam Baidya and Vera Ovetskaya and Mechanical Engineering Intern Nazariy Davydovych Checking Results on the Ninth Street Bridge. (Credit: Jimmy Yeung)

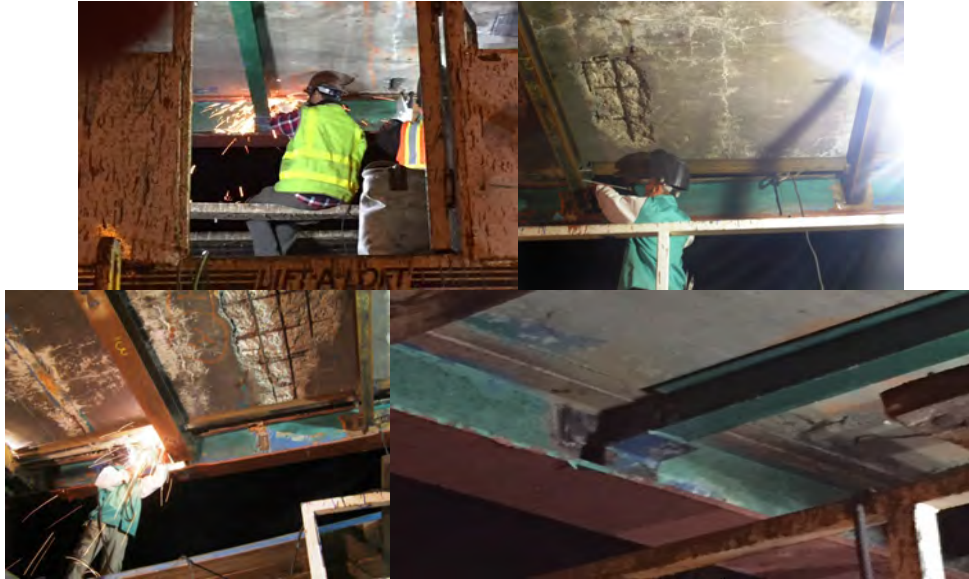
November 2016: Ironworkers Repairing a Diaphragm Connection on the East 128th Street Pedestrian Bridge After a Recent Truck Strike.
