# EASTERN PARKWAY AND BUFFALO AVENUE

Presentation to CB 8

April 26, 2022

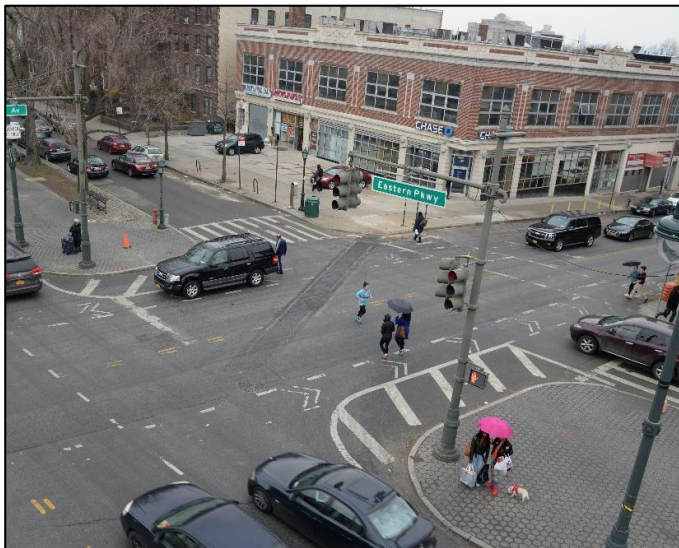
**Before  
(2017)**

Bedford Ave  
service road

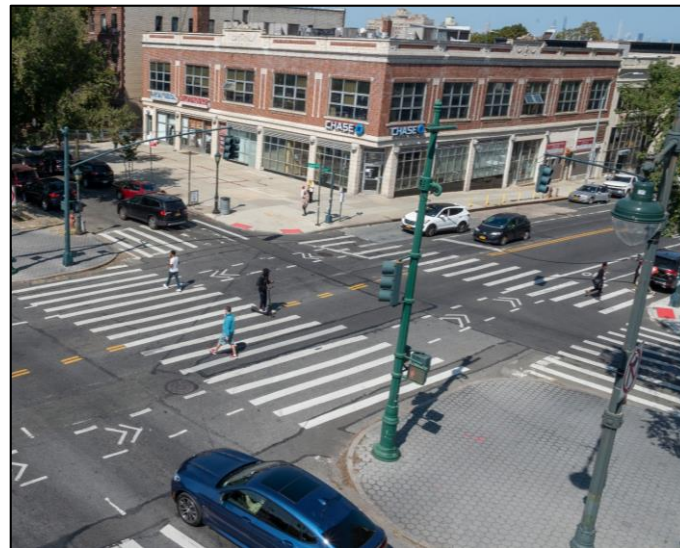
**After  
(2018)**

Bedford Ave  
service road  
with signalized  
control and new  
crosswalk

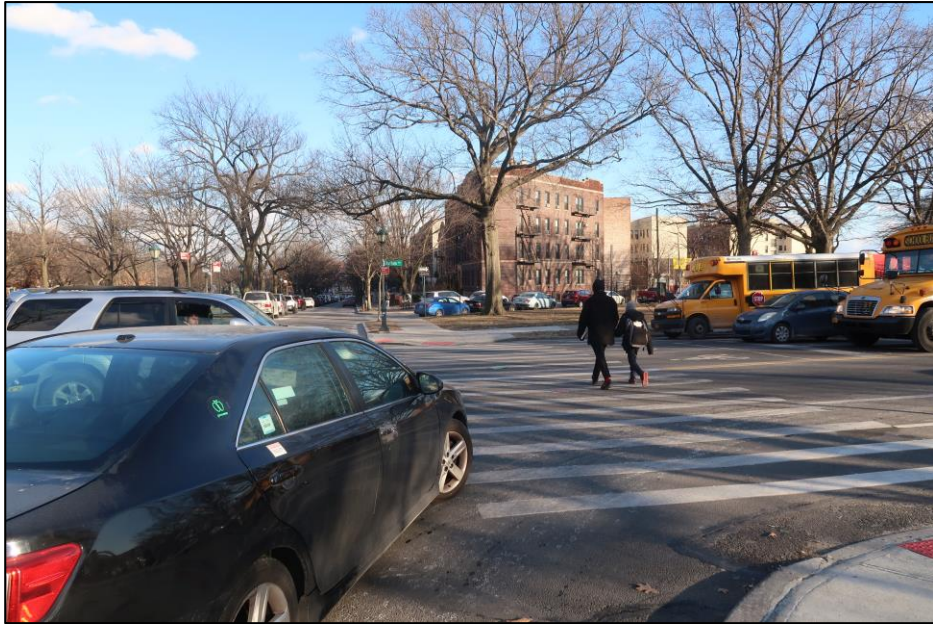
- Uncontrolled and unmarked crosswalks throughout intersection

Eastern Pkwy eastbound service road facing east at Buffalo Ave

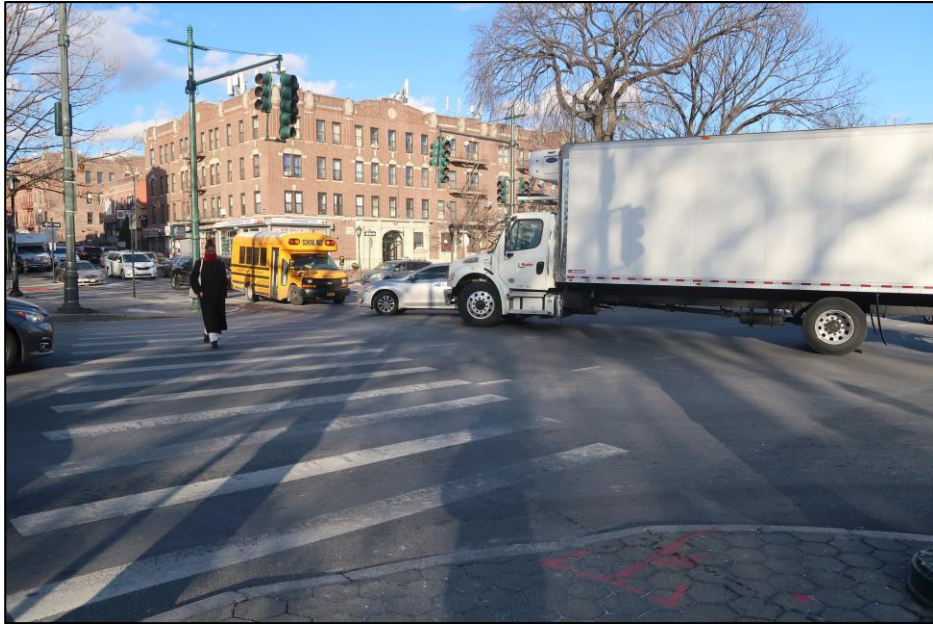
- Double northbound left turn is required to yield to pedestrians on west crosswalk

Buffalo Ave facing north at Eastern Pkwy

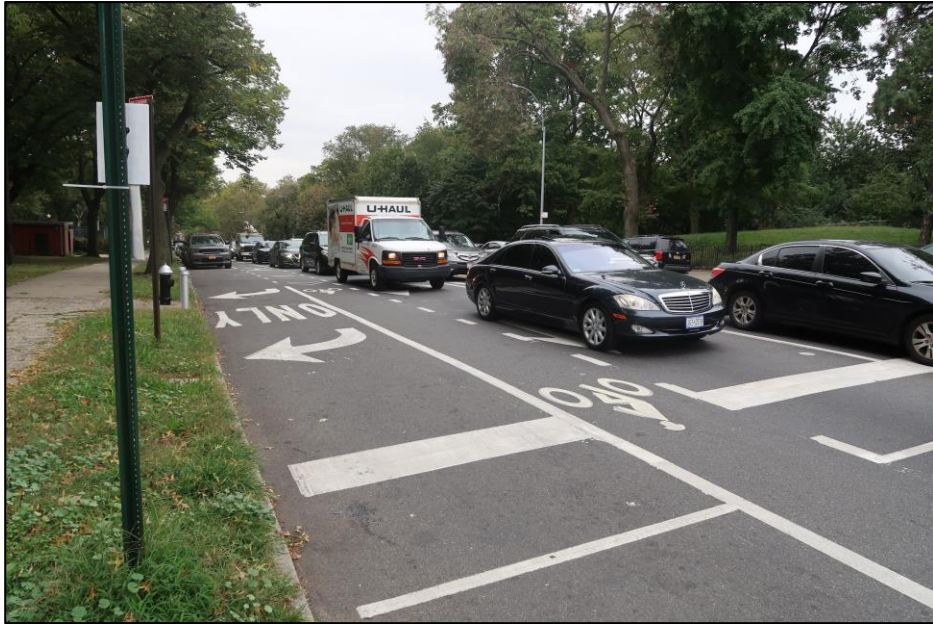
- Shared lane for left turn and through movements cause delay for both
  - Dedicated right turn lane has low volume

Buffalo Ave facing south at Eastern Pkwy

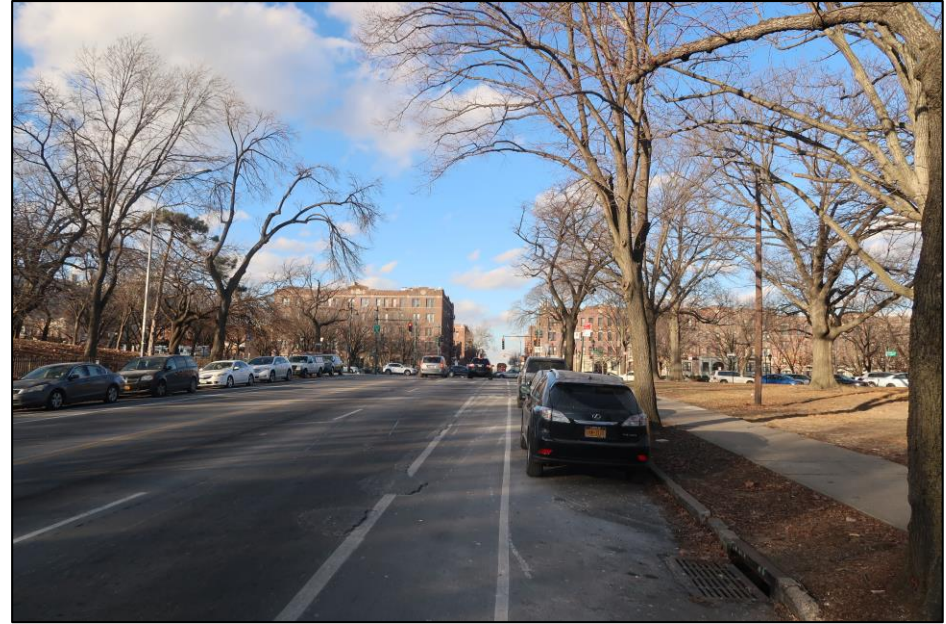
- Conventional bike lanes leave bicyclists unprotected from adjacent travel lane

Buffalo Ave facing north midblock from Eastern Pkwy

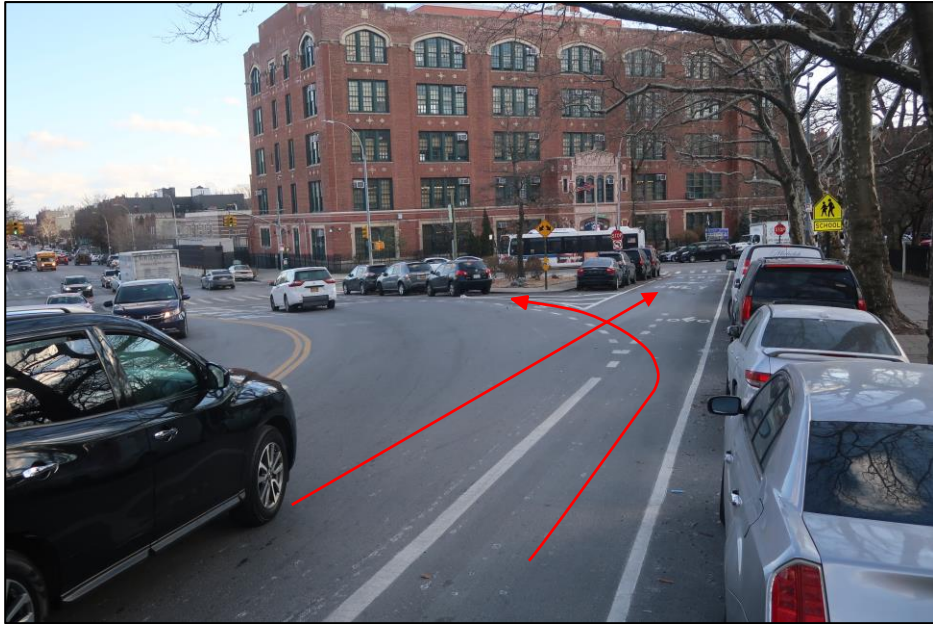
- Lane split at Rockaway Pkwy and East New York Ave causes conflict between bicyclists and vehicles

Buffalo Ave facing south at approach of E New York Ave

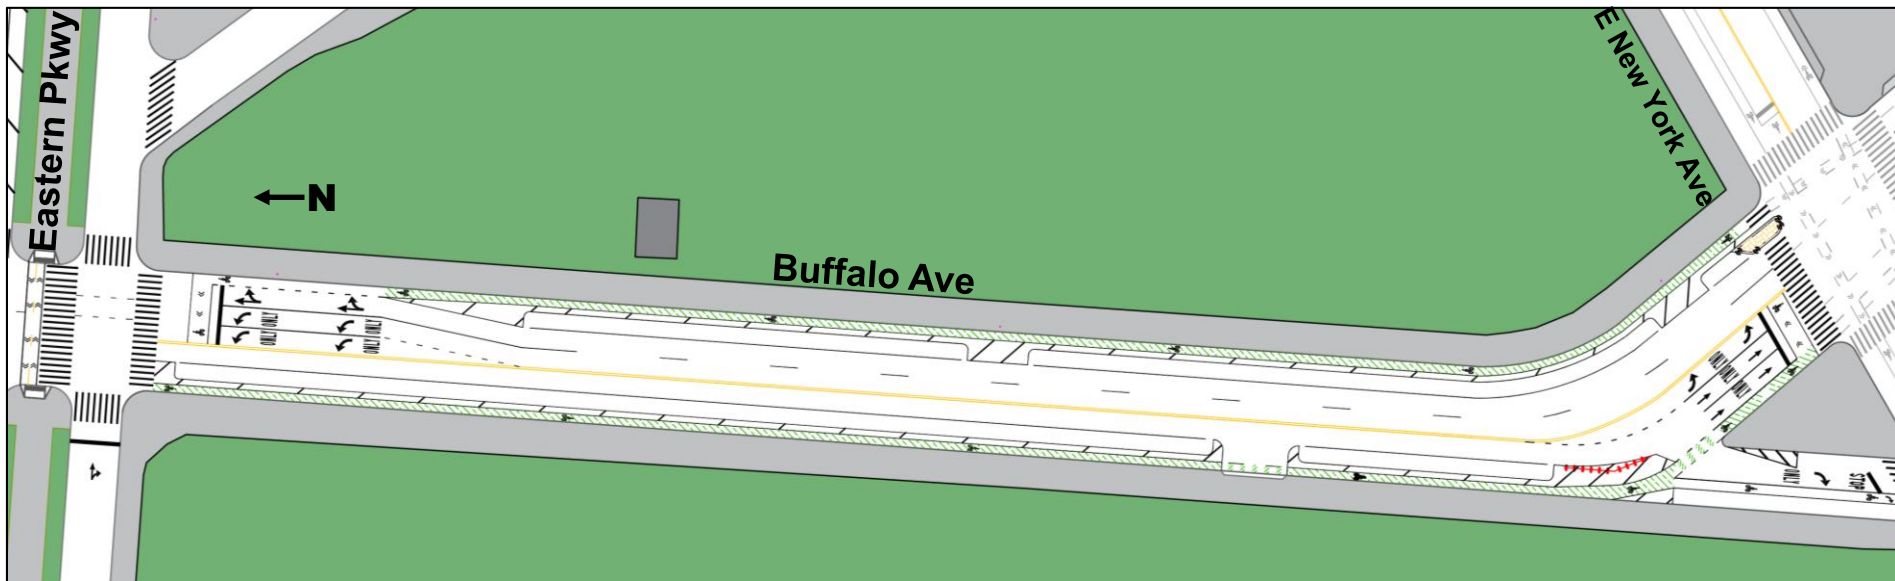
- Upgrade conventional bike lanes from Eastern Pkwy to E New York Ave to parking protected bike lanes

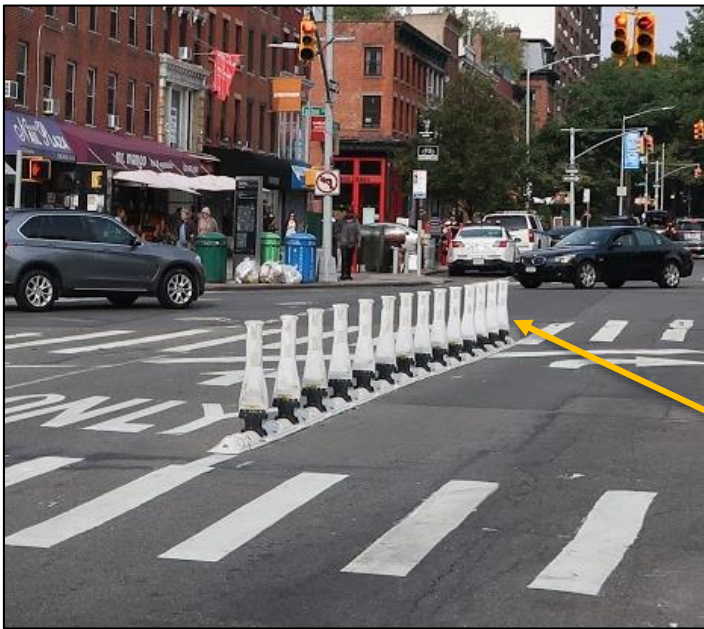
- Install Qwick Kurb vertical barriers to slow southbound right turn vehicles and improve yielding to bicyclists
- Install painted pedestrian island to shorten crosswalk
