100th St & McIntosh St

Community Board 3

Spring 2023

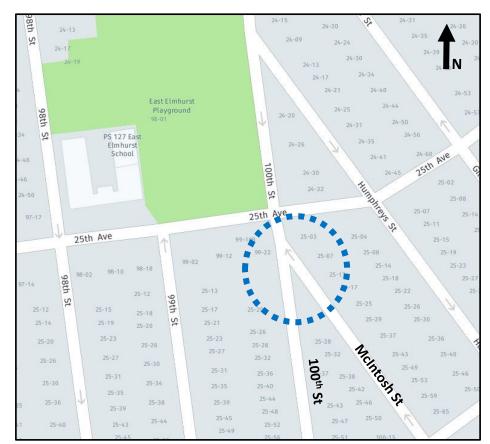
- Intersection located in East Elmhurst adjacent to the Helen Marshall playground and near 2 schools, P.S.127 and P.S. 329Q
- Residential land use around the intersection
- Child fatality at the intersection in September of 2022
- New all-way stop recently installed at the intersection of 100th St and 25th Ave to improve crossing safety

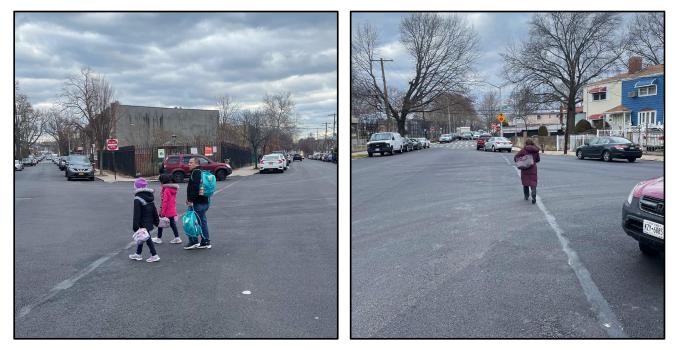
- Wide and open road layout encourages speeding and allows for unpredictable vehicle turning movements
- Lack of marked pedestrian crossings for school children and residents
- Uncontrolled intersection where vehicles turning onto southbound 100th St from northbound McIntosh St may pose danger to pedestrians and other drivers due to limited visibility

Residents and children, who frequently utilize the intersection, cross in the middle of the intersection without established crossings

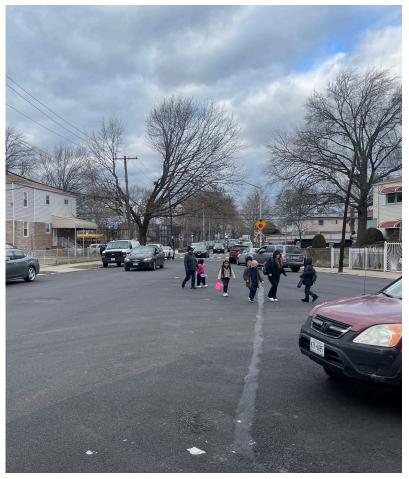
School children cross at the intersection while a vehicle travels south on 100th St at the same time
