Metropolitan Ave at Union Turnpike

CB 6 Transportation Committee

April 27, 2023

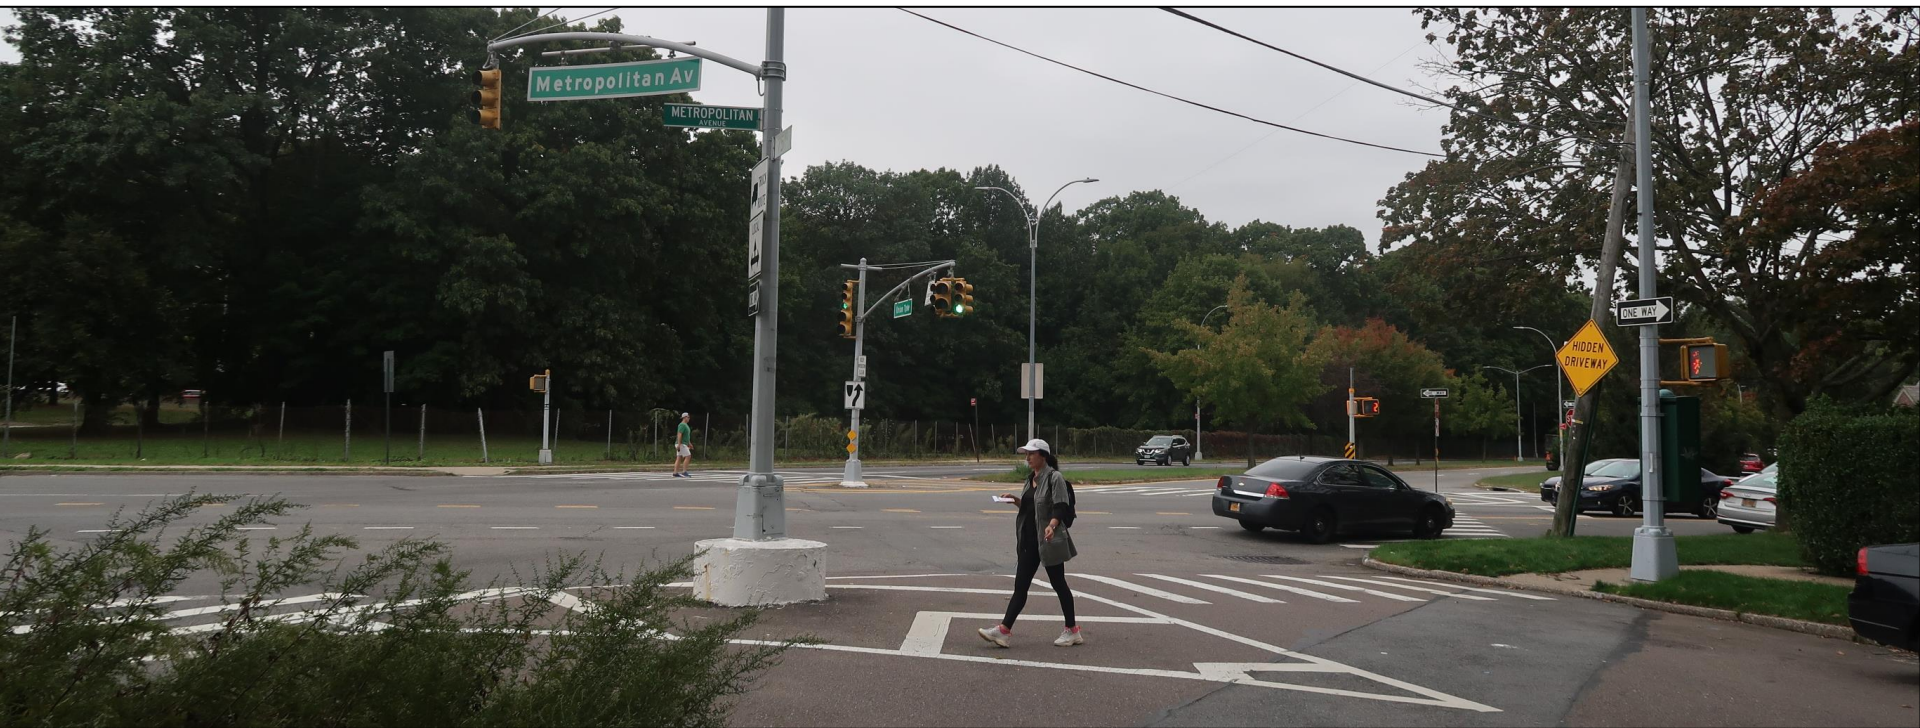
Metropolitan Ave and Union Turnpike

Injury summary. 2016-2020 (5 years)

Total Injuries	Severe Injuries	Fatalities	KSI
Pedestrian	3	1	0	1
Bicyclists	2	0	0	0
Motor Vehicle Occupant	67	3	0	3
Total	72	4	0	4

3 pedestrian injuries since 2016

72 total injuries since 2016

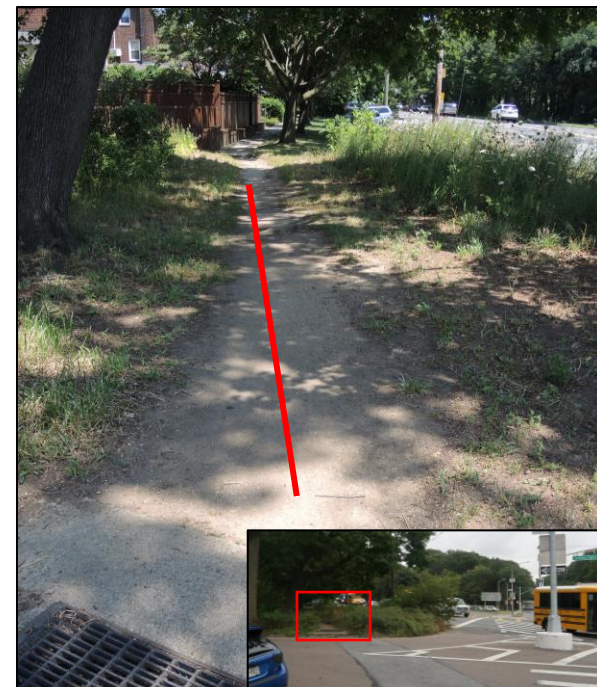
Dirt pathway connects street to sidewalk

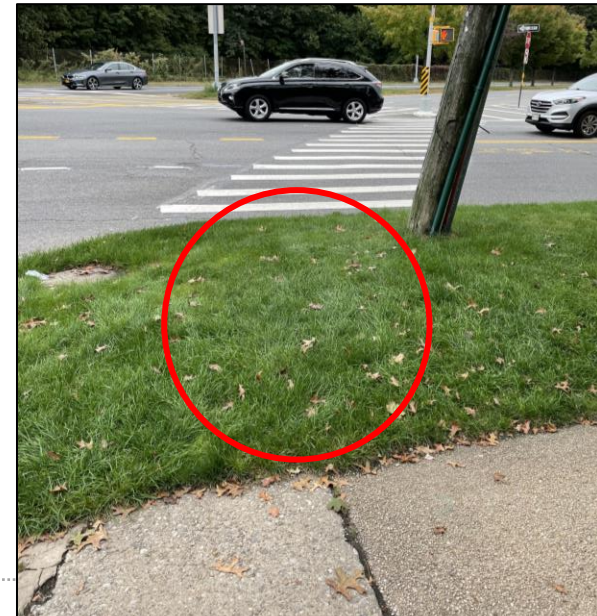
No sidewalk/ramp to west crosswalk

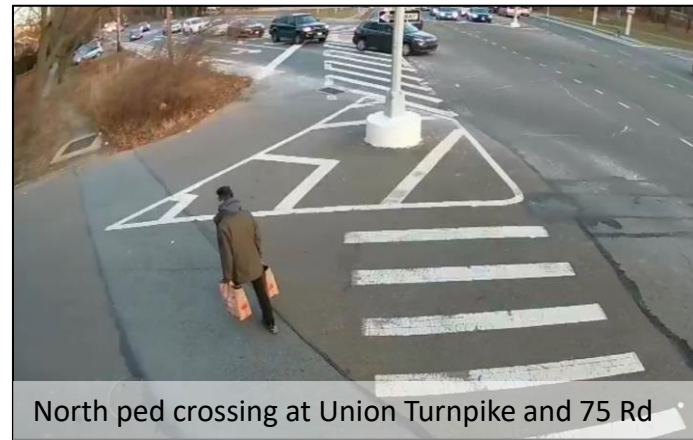
North ped crossing at Union Turnpike and 75 Rd

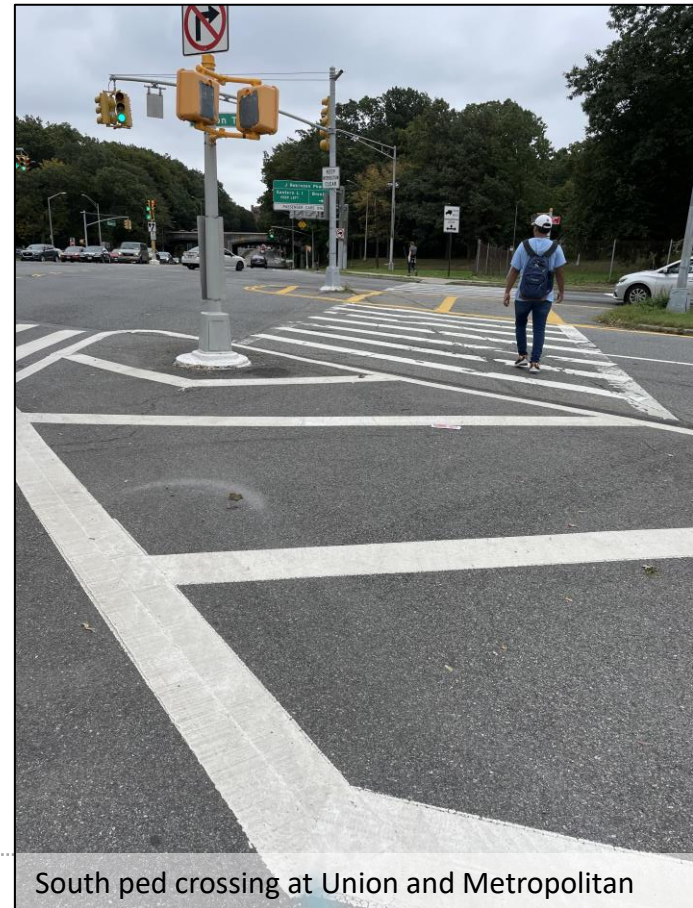
South ped crossing at Union and Metropolitan

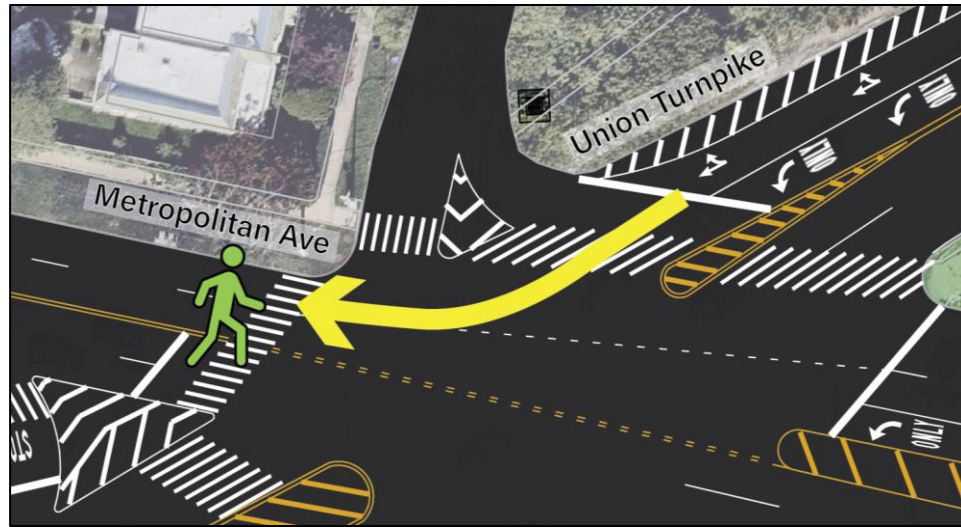
1. Soft right turns from Union Turnpike southbound to Metropolitan Ave westbound conflict with pedestrians in west crosswalk:

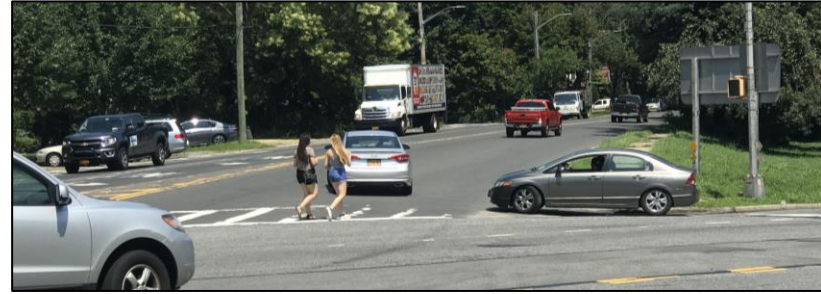
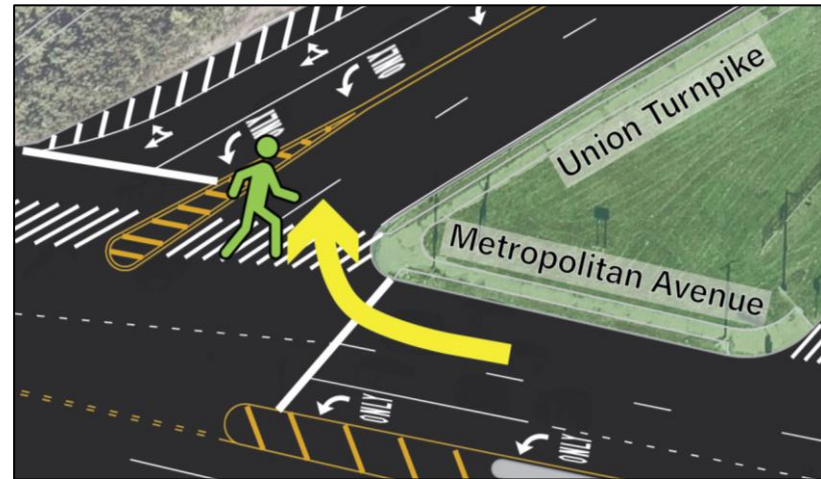
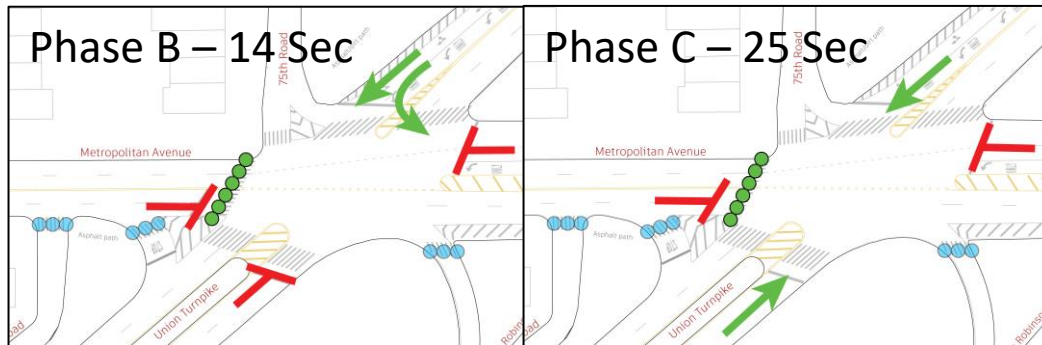
2. High vehicle volumes from Metropolitan Ave to Union Turnpike conflict with pedestrians in north crosswalk:

— Red / held traffic
 ●● Free flow (not part of signalized intersection)
 → Green/traffic flow
 ●●● Ped Walk

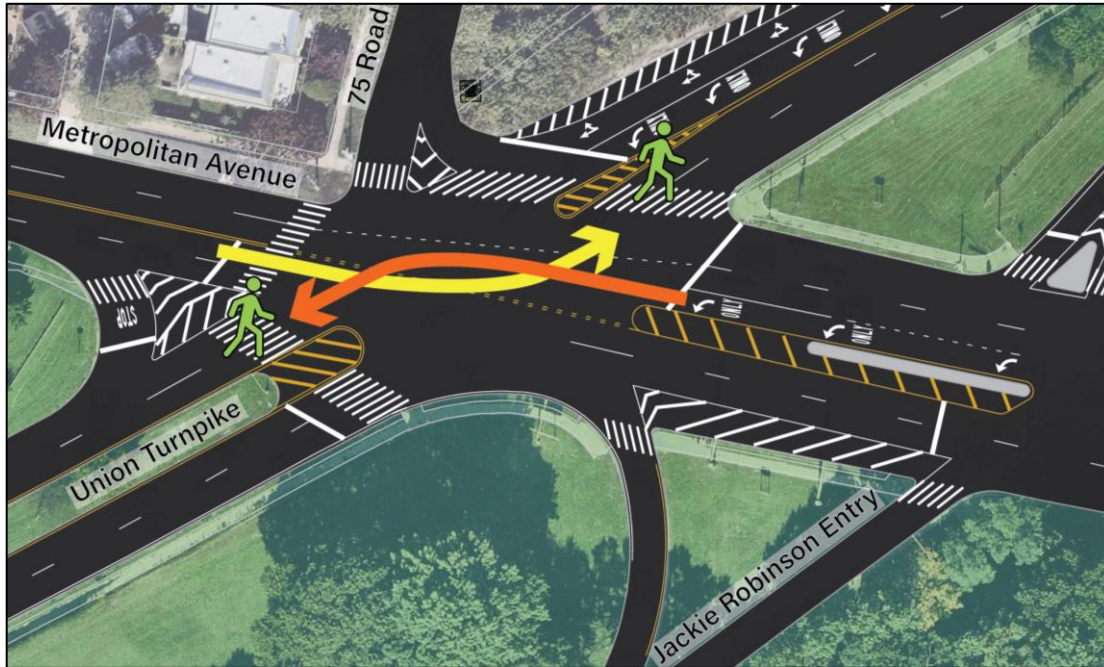
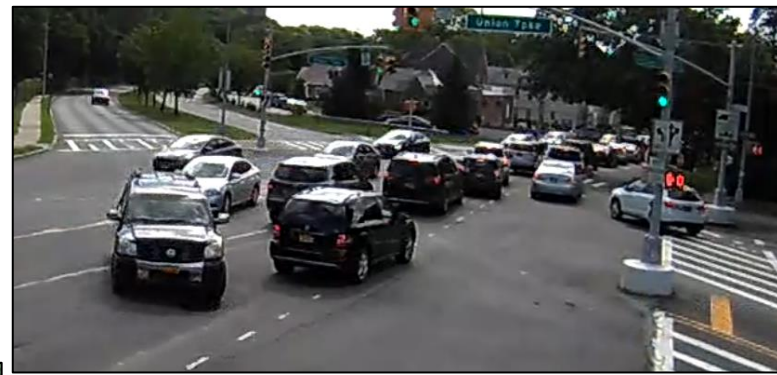
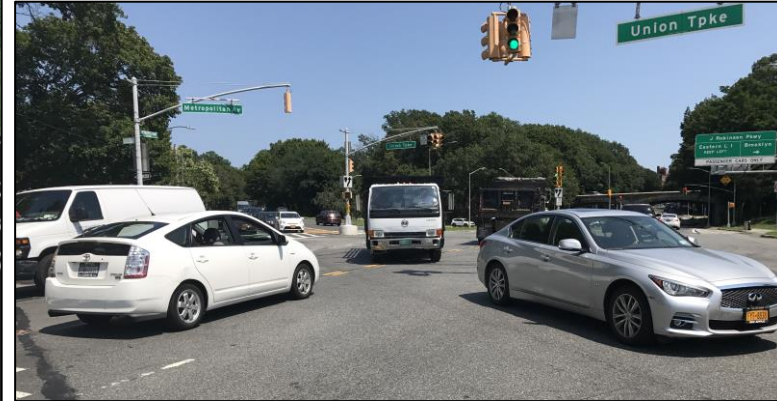
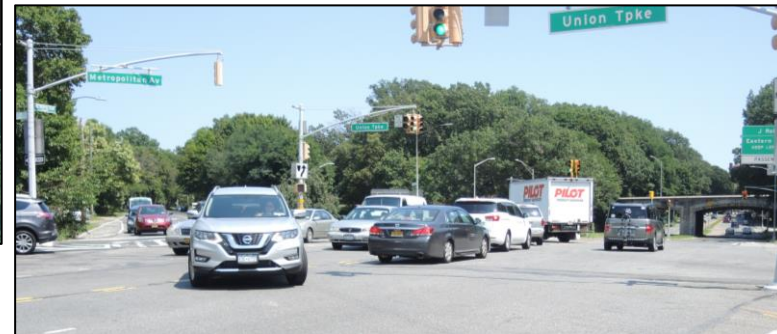
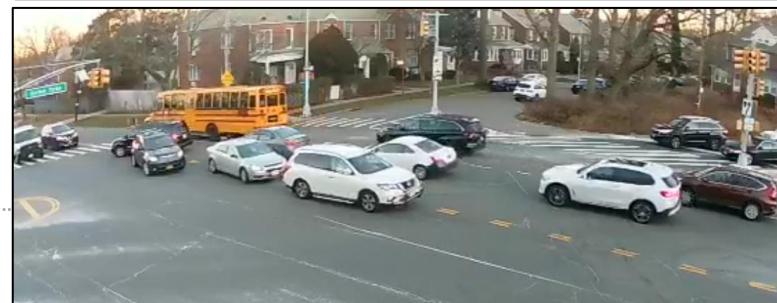
Phase A – 38 Sec

Left turns from Metropolitan onto Union Turnpike are misaligned, have high volumes, and conflict with pedestrians

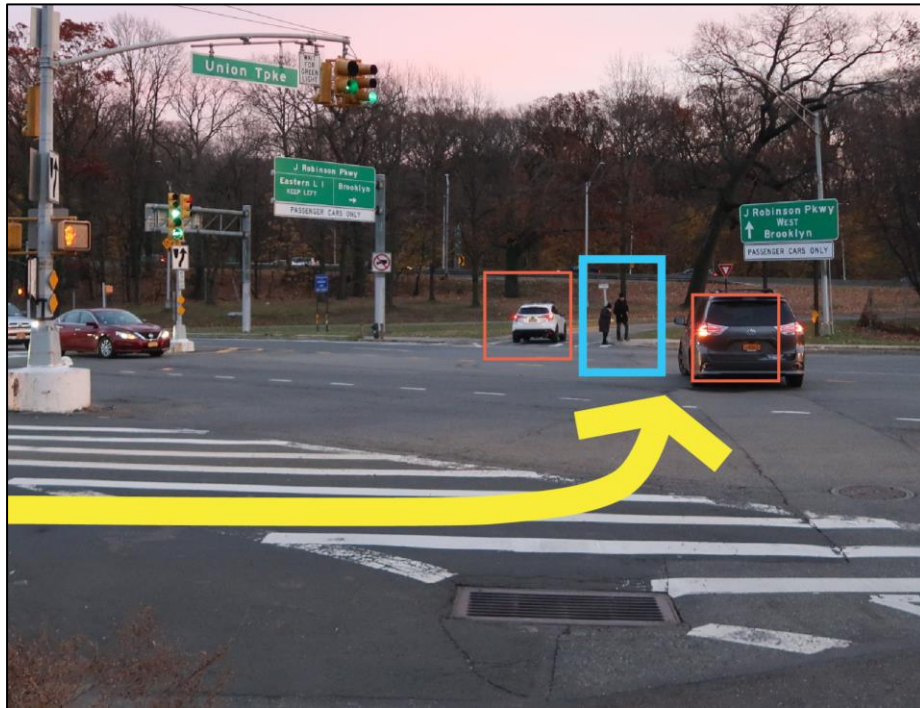
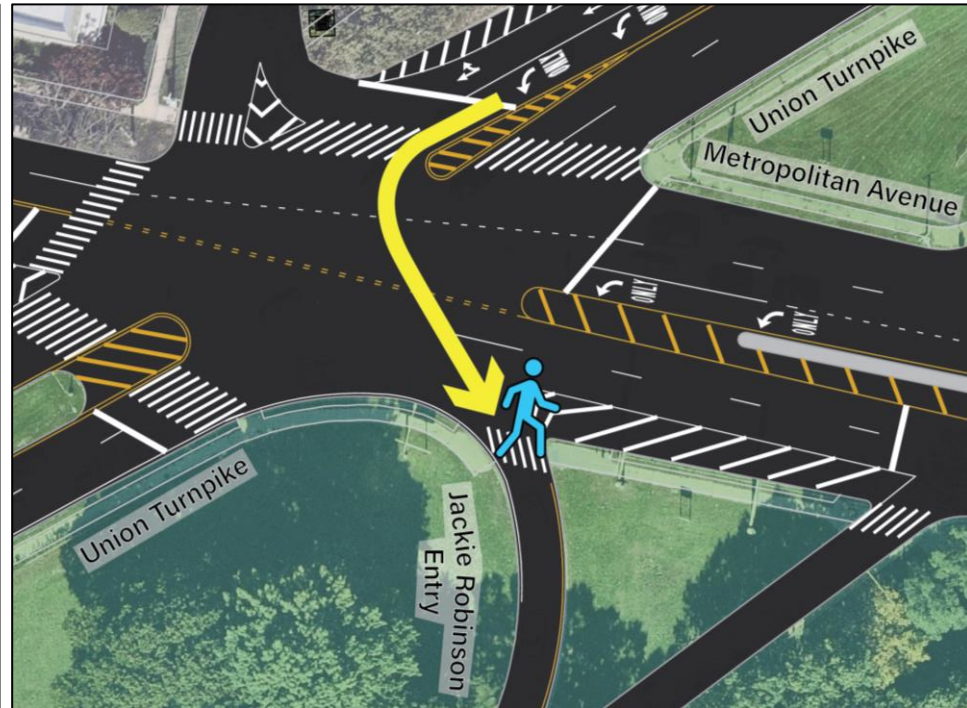
Entry Ramp Conflicts

- Left turning vehicles have a long, straight approach to crosswalk
- Straight approach causes vehicles to accelerate into crosswalk

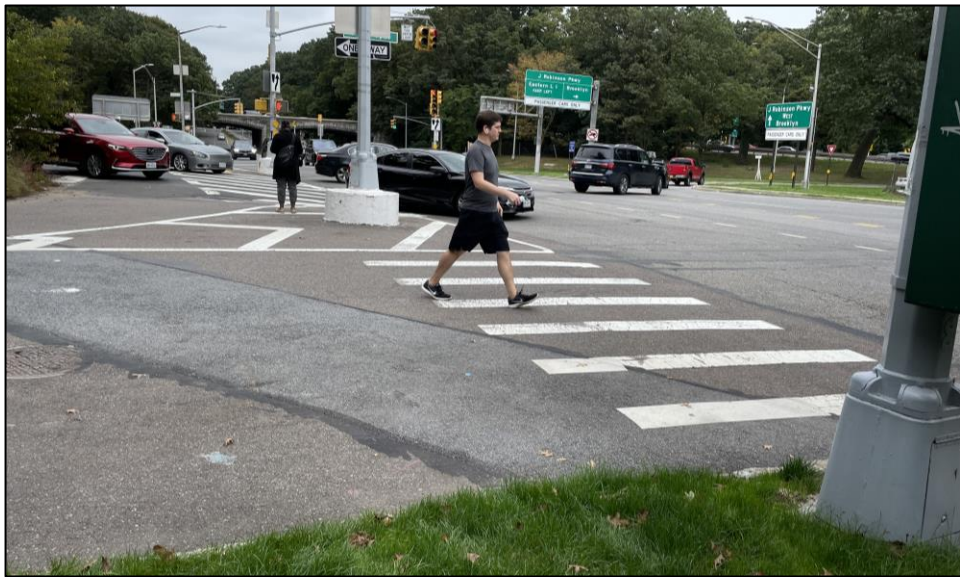
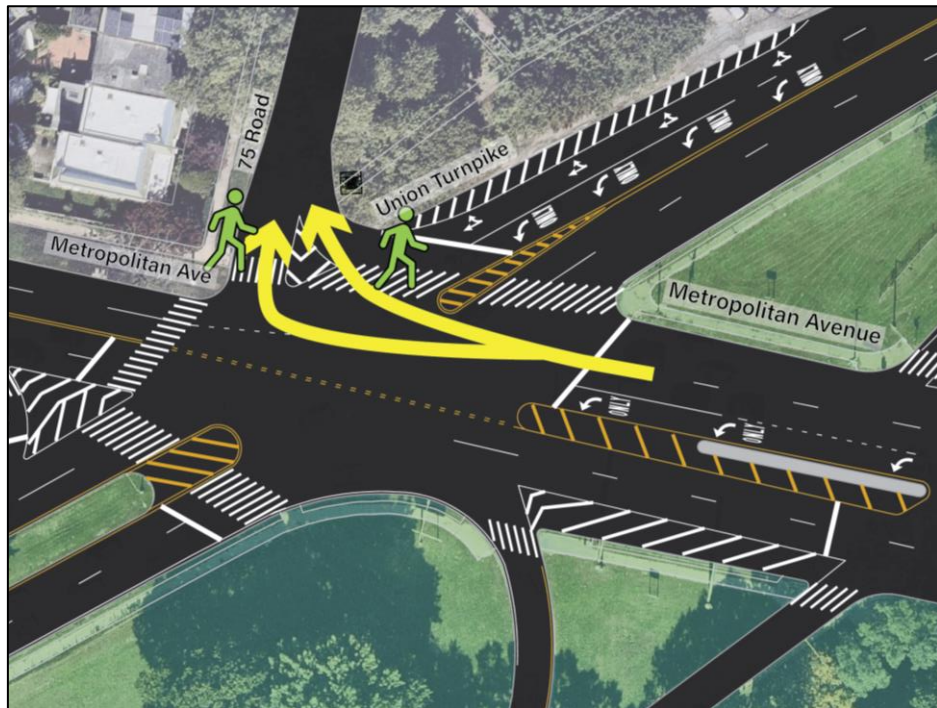
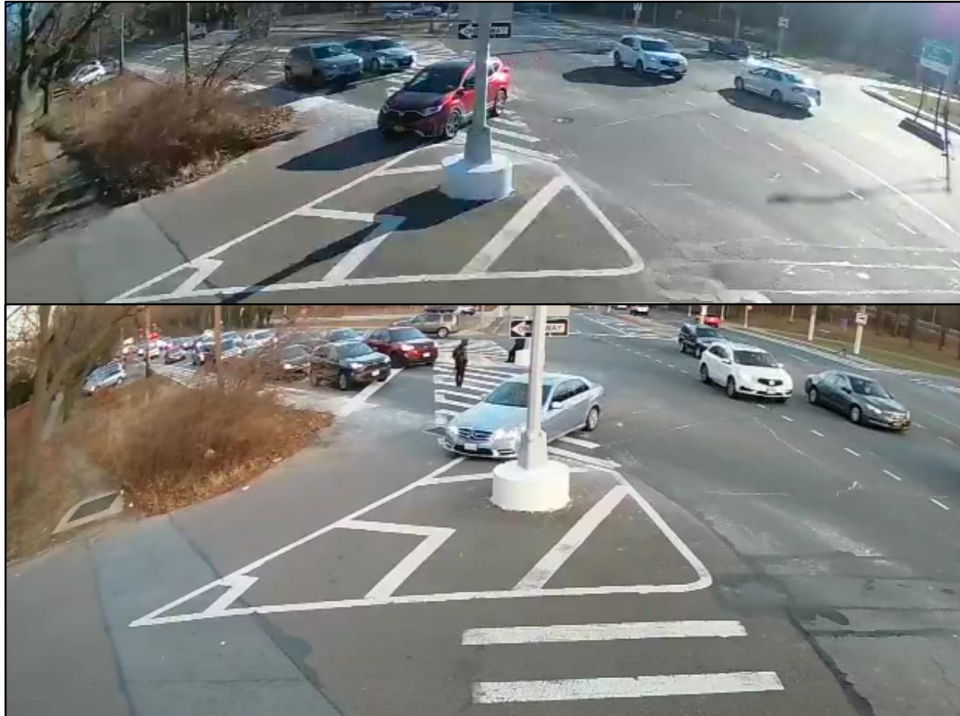
Unclear Vehicular Turns, Redundant Slip Lanes

1. Turns onto 75 Rd are unpredictable with which slip they turn through
2. Creates problem for pedestrian visibility and conflict in the crossing
3. 75 Rd is a low volume road

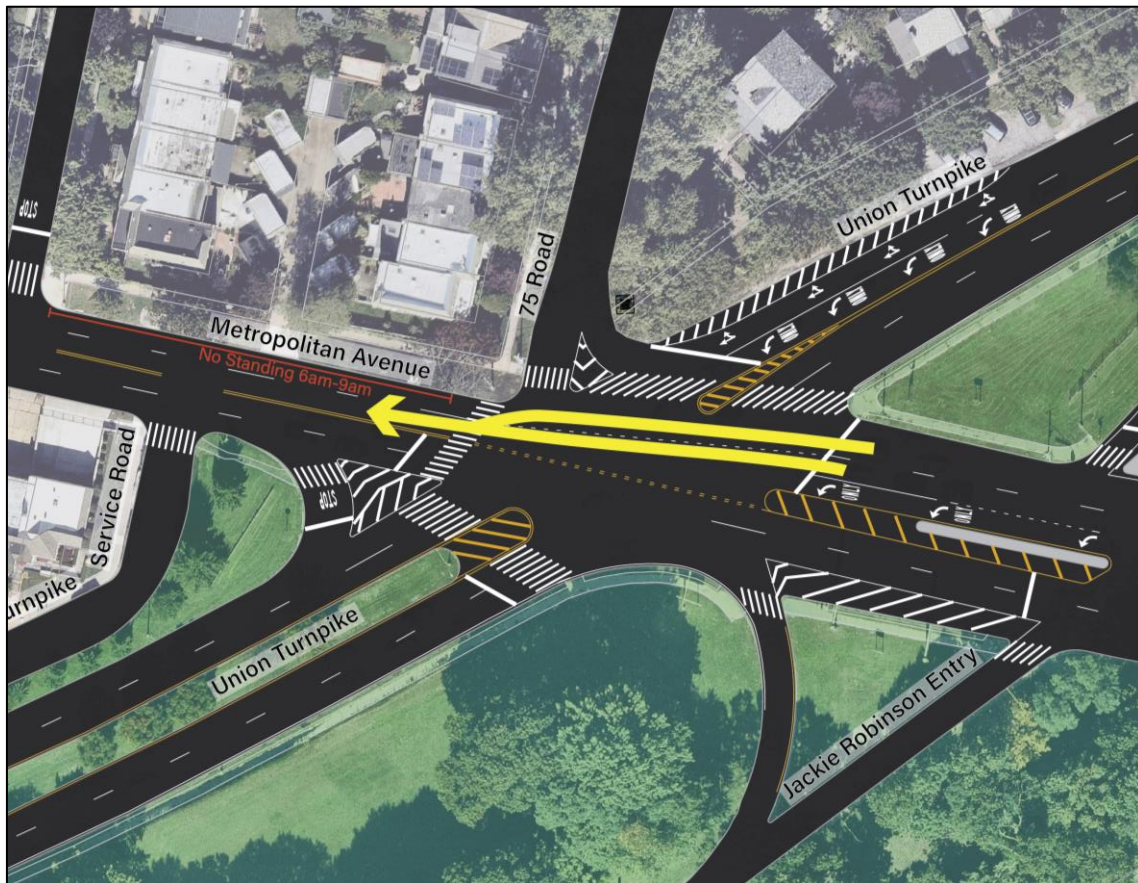
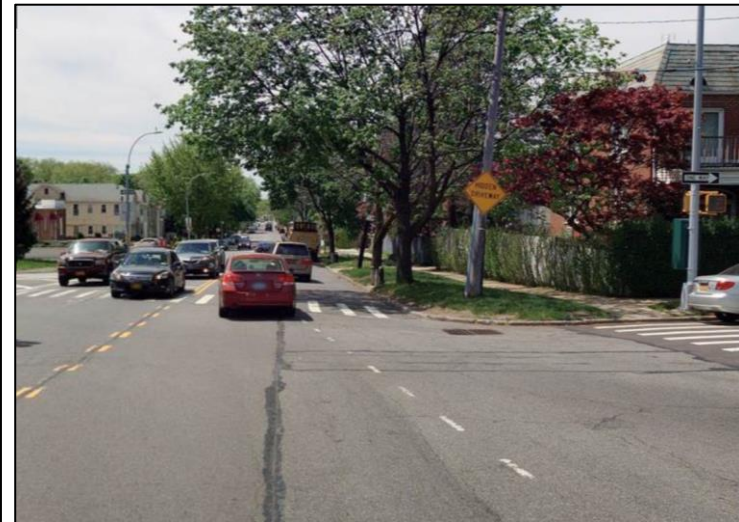
Mid-intersection merge

- AM Rush hour no parking, all other hours parking allowed
- Two lanes westbound on Metropolitan merge into one lane causing mid-intersection congestion

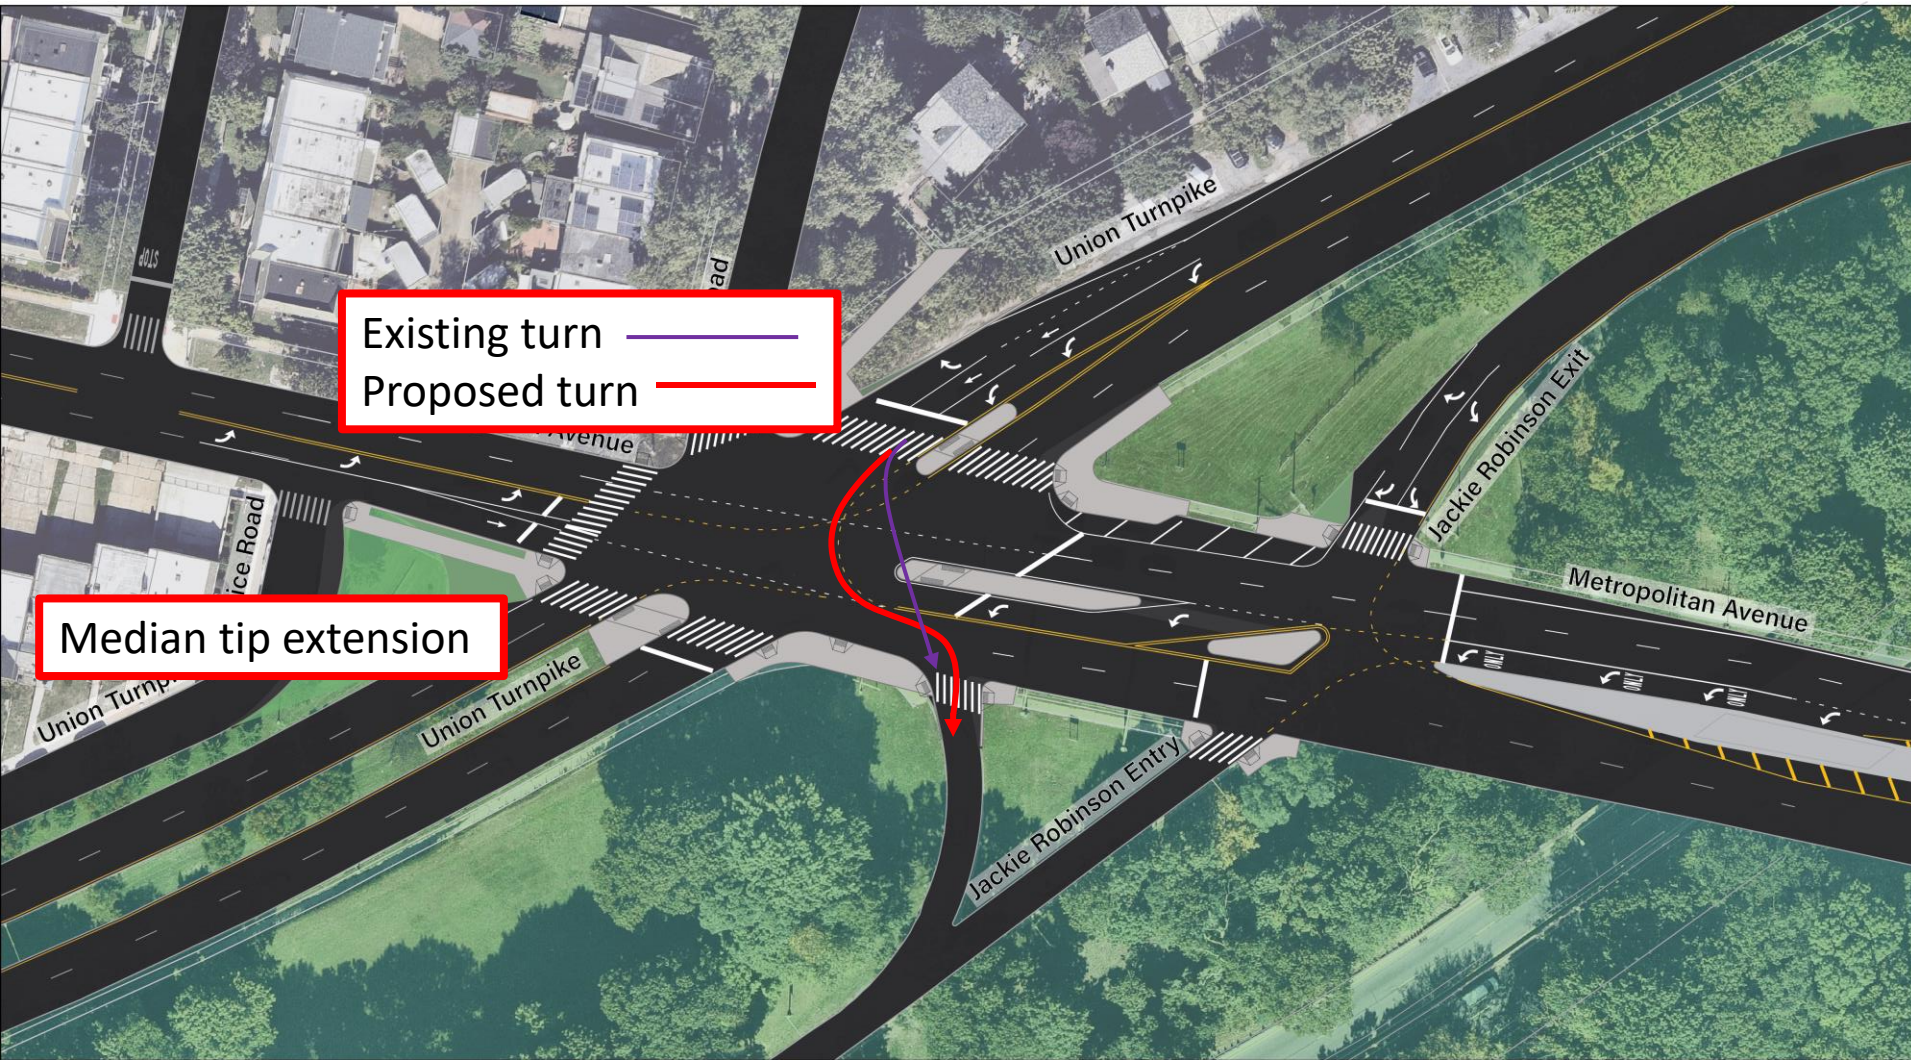
Proposal – pedestrian refuge islands

Calmed vehicular turns
New S-turn onto ramp

Protected refuge area in crosswalk
