Transportation Project Report

Project Scoping Report

Shore Road Bridge over the Hutchinson River
Project Identification Number (PIN): X773.63
Bridge Identification Number (BIN): 2-24020-0
Bronx County, City of New York

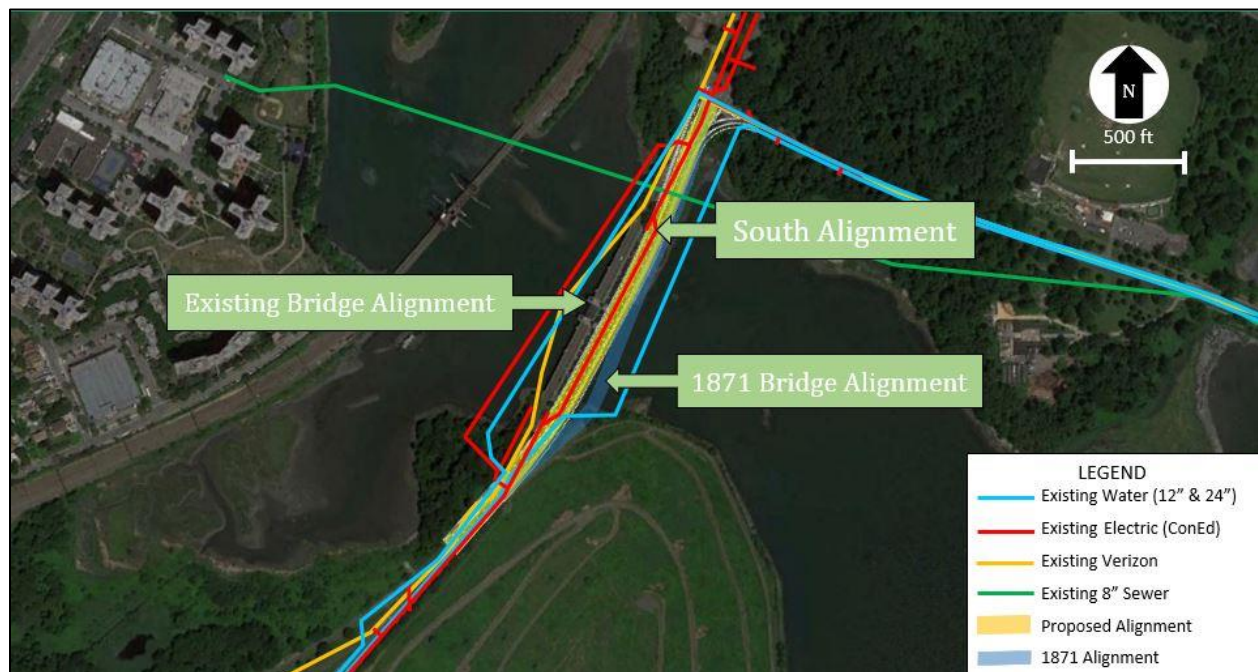
Figure 6 - South Bridge Alignment

The centerline of the new bridge in both Concepts 1 and 2 would be located approximately 100 feet to the south of the centerline of the existing bridge (**See Figure 6**). The alignment would transition back to meet the approaches at either end of the bridge. The existing roadway geometry is compatible with a southern alignment since a former bridge, predating the current 1908 bridge, was on this southerly alignment. The alignment only conflicts with one existing utility crossing, a Con Edison line that was abandoned in place in 1971. The southerly alignment increases the distance between the Shore Road Bridge and the adjacent Amtrak Bridge, which, when combined with spanning a wider segment of the mapped channel, results in a substantial improvement for navigation.

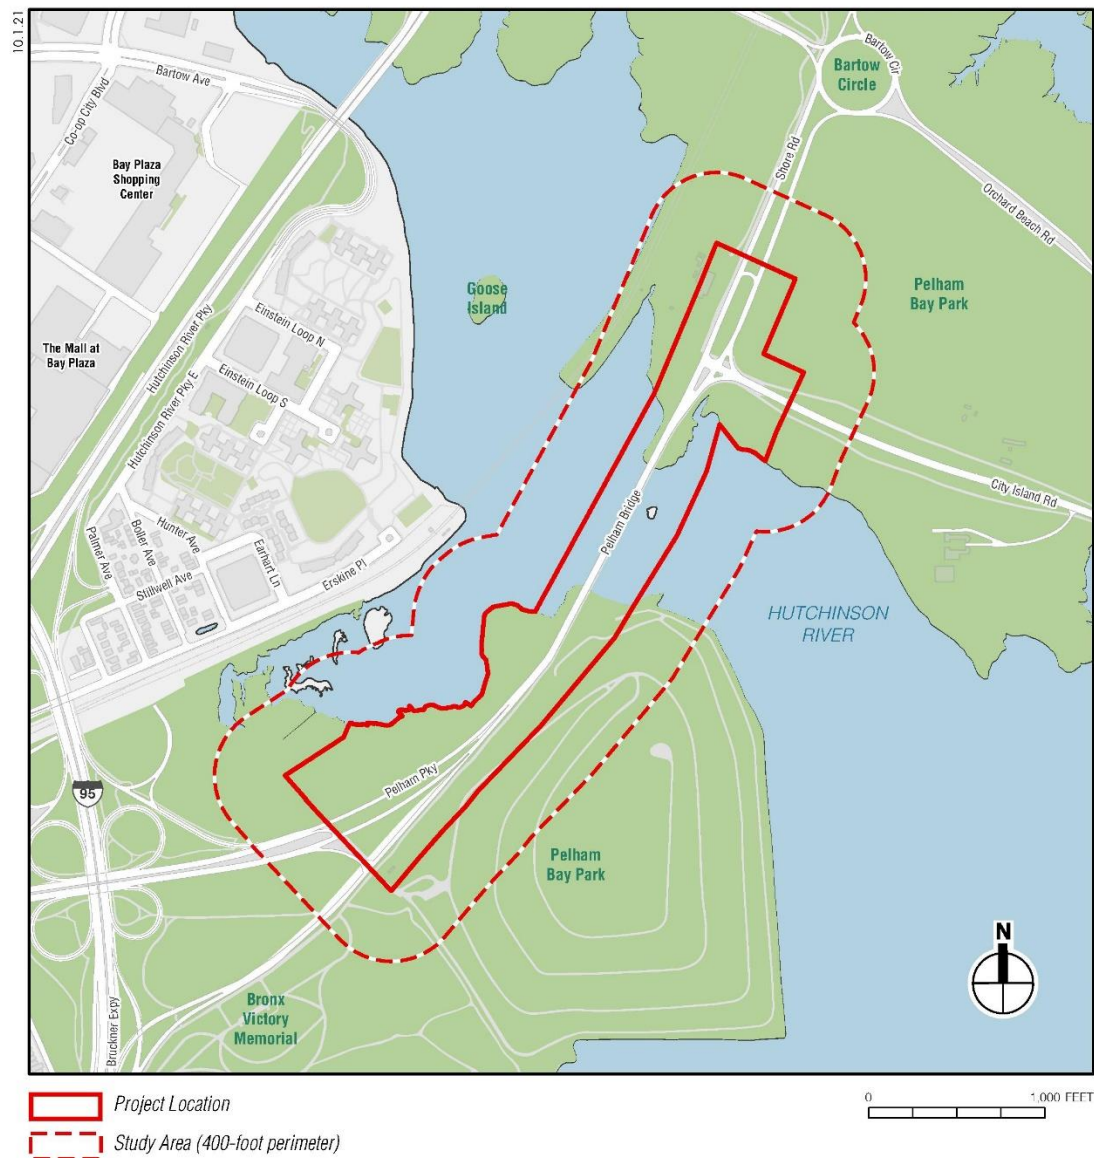
Figure 12 - Study Area

The Project is located along the 1.2-mile-long section of Shore Road between the Bruckner Expressway and Orchard Beach Road (see **Figure 12**). The General Study Area for the Project is comprised of a 400-foot radius from the area extending along Shore Road east 900 feet beyond the intersection of Shore Road and City Island Road; along Shore Road west 575 feet beyond the tip of the physical gore formed by intersecting Shore Road and Crimi Road; along Crimi Road 900 feet beyond the tip of the physical gore formed by intersecting of Shore Road and Crimi Road; and along City Island Road south 375 feet beyond the intersection of Shore Road and City Island Road. This General Study Area will be used for the evaluation of most social, economic, and environmental topics. However, for some topics, the Study Area may vary, depending on environmental methodologies and analysis requirements.

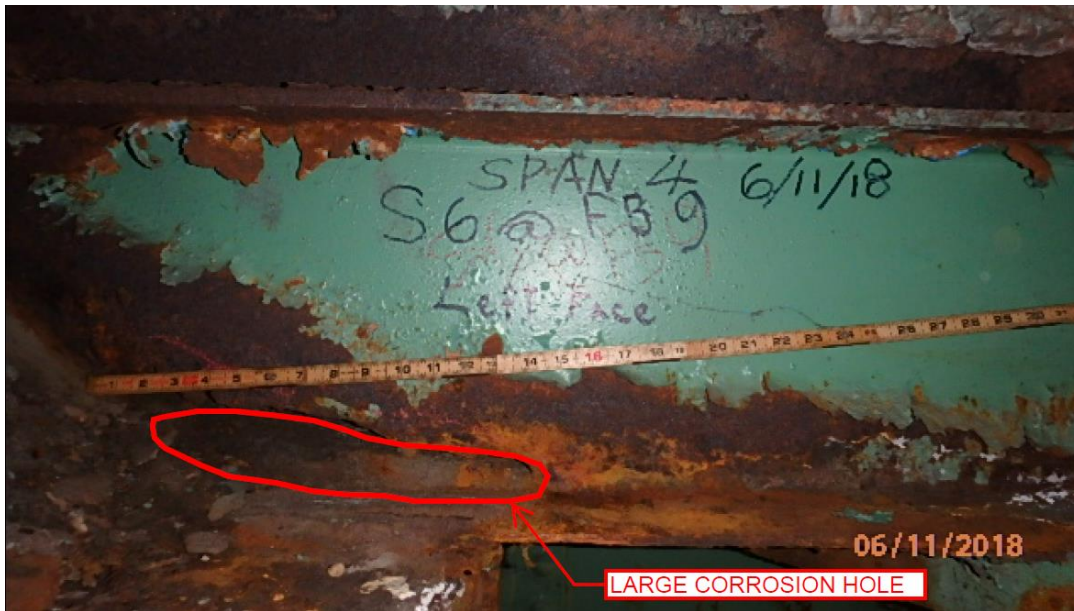
Figure 1: Stringer exhibiting large corrosion holes and severe section loss along interface to concrete counterweight.
Source: 2018 NYSDOT Biennial Inspection Report

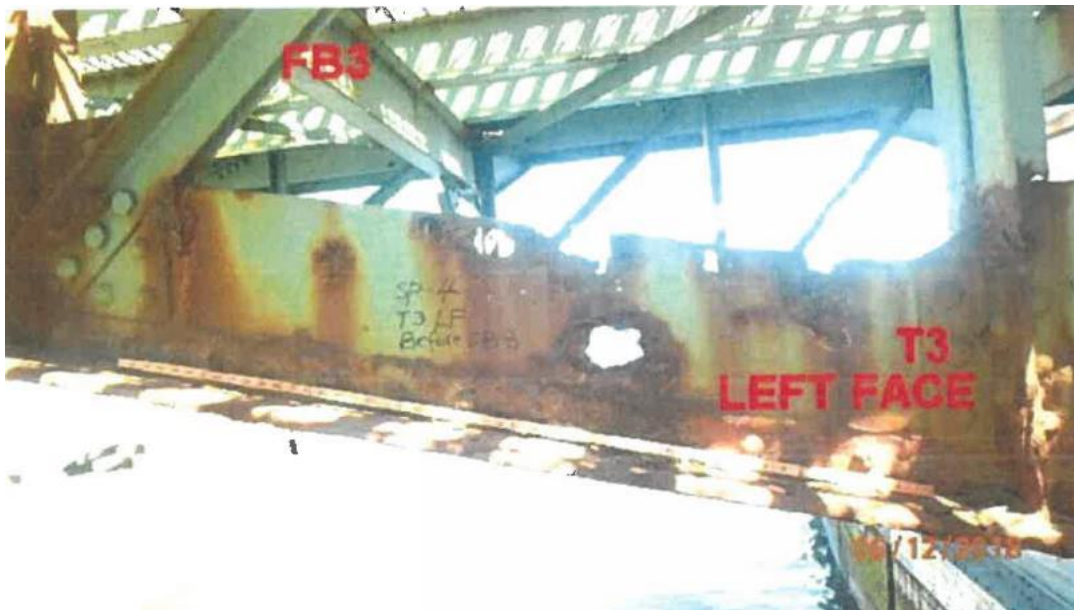
Figure 2: Corrosion holes and severe section loss on bottom chord vertical plate of Truss T3
Source: 2018 NYSDOT Yellow Flag NB185QW015

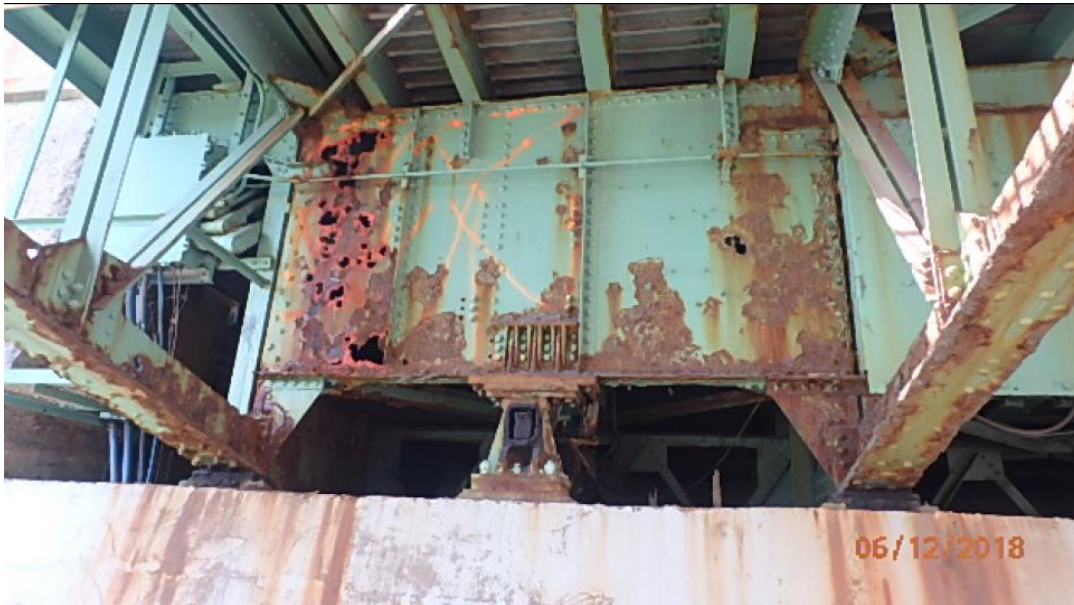
Figure 3: Span 4, west leaf, Floorbeam FB1 between Truss T3 and T4, exhibiting numerous corrosion holes and severe section loss. Source: 2018 NYSDOT Biennial Inspection Report

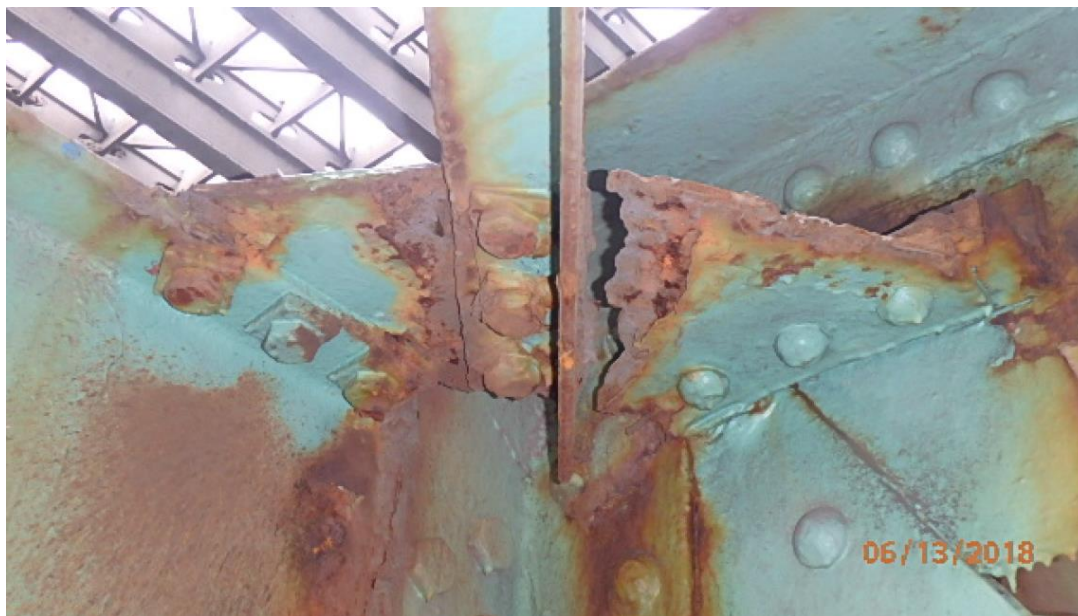
Figure 4: Right side of Truss T2, connecting to Floorbeam FB5, exhibits completely broken gusset plate along T2. Source: 2018 NYSDOT Biennial Inspection Report

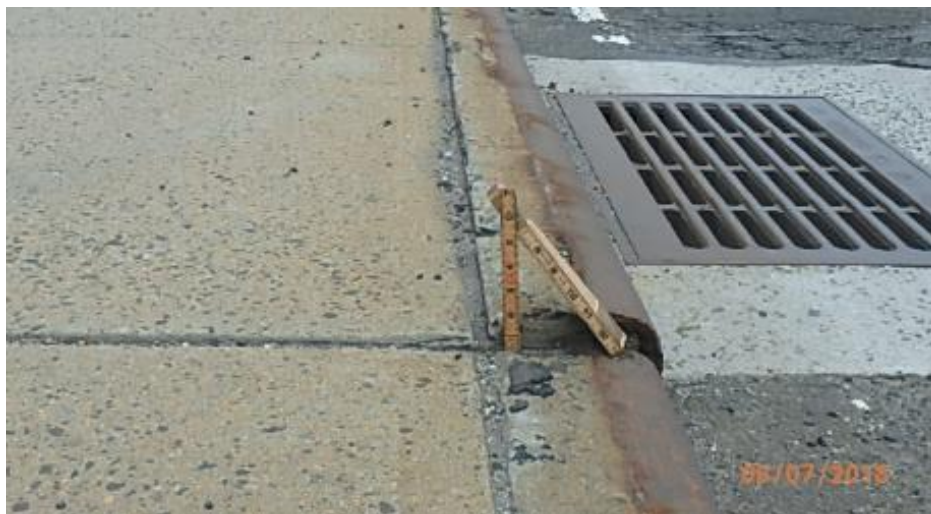
Previous studies identified settlement of fill within the arches as an ongoing concern. In the 2002 interim rehabilitation, the scuppers were reset at grade. However, continued settlement of the roadway, evident by the 3"-6" settling of the roadway scuppers, was observed in the 2018 NYSDOT Inspection Report (see Figure 5). Span 3 at Pier 2 exhibits differential elevation of the right sidewalk curb, indicative of settling of the roadway. On Span 4 at mid-span, the right sidewalk in full width exhibits up to 1.5 inches differential elevation across the length of the bascule span. Without replacement of the underlying fill and subsequently the arches themselves, settlement would continue to occur in these locations.

Figure 5: Differential elevation between the curbs at Span 3.

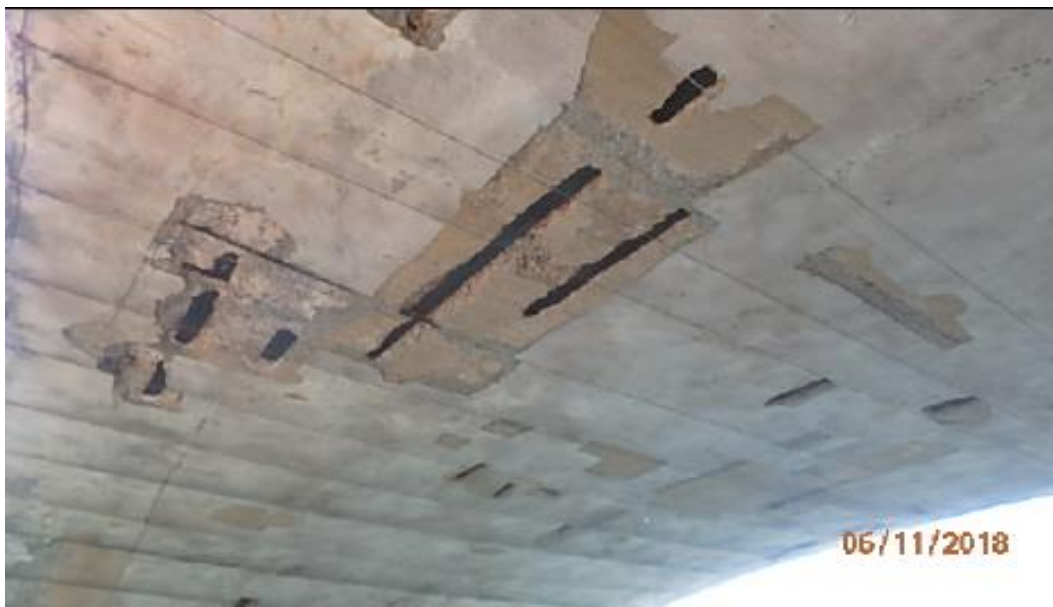
The concrete barrel vault arch spans exhibit extensive hollow, spalled, and deteriorated concrete on the undersides of the arches (see Figure 6) and the structural load carrying capacity is marginal. The 1998 BRPR determined that the arches are highly vulnerable to seismic forces. The concrete arches would need to be repaired to their original condition and then underpinned and strengthened to meet the latest structural and seismic loading requirements. In areas that lack reinforcement, hook type bolts would need to be drilled and grouted as required around the truss frame and would be attached to new wire mesh. After the new wire mesh and new rebar are in place, new repair concrete would be placed. Then, the arches would be underpinned and strengthened with new reinforced concrete arch sections below the bottom of the existing repaired concrete arches, to act as redundant support.

Figure 6: Span 5 underside exhibits spalled and hollow sounding concrete on arch intrados.
Source: 2018 NYSDOT Biennial Inspection Report

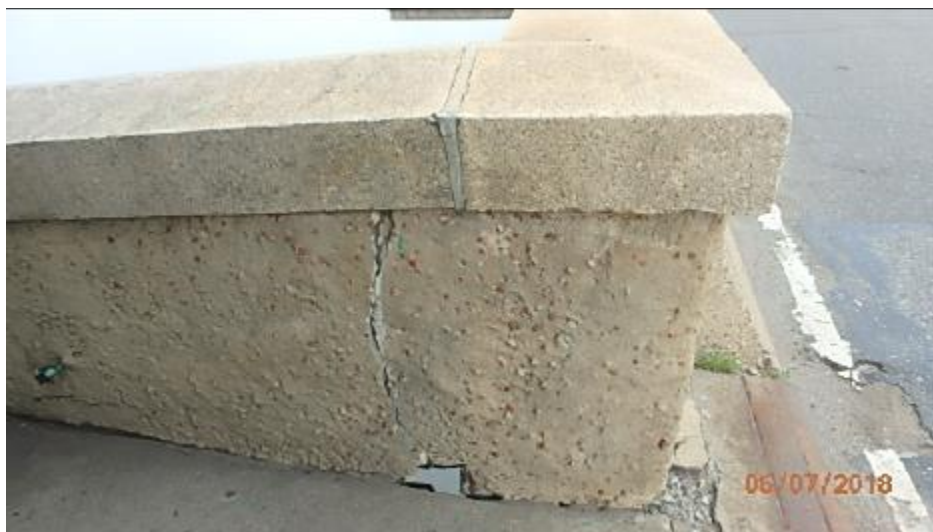
the bottom and the supporting concrete pylon has a large spall on the right half. There are four external steel straps (tensioning rods) across this crack anchored to the side of the Operator's house to prevent further expansion of the crack and to prevent further leaning of the house. NYCDOT has been monitoring five cracks in the bridge house wall and the lean of one Operator House since 1999. A large crack in the northeast house was stabilized during the 2002 interim rehabilitation work, however this was not a permanent repair to the house. The external steel straps were installed in the 2002 interim rehabilitation work. In order to permanently repair the structural damage to the house, partial reconstruction would be required to replace the cracked walls.

Figure 7: Parapet at Pier 4 along the side of the operator house exhibits a wide vertical crack with a hole at the bottom.

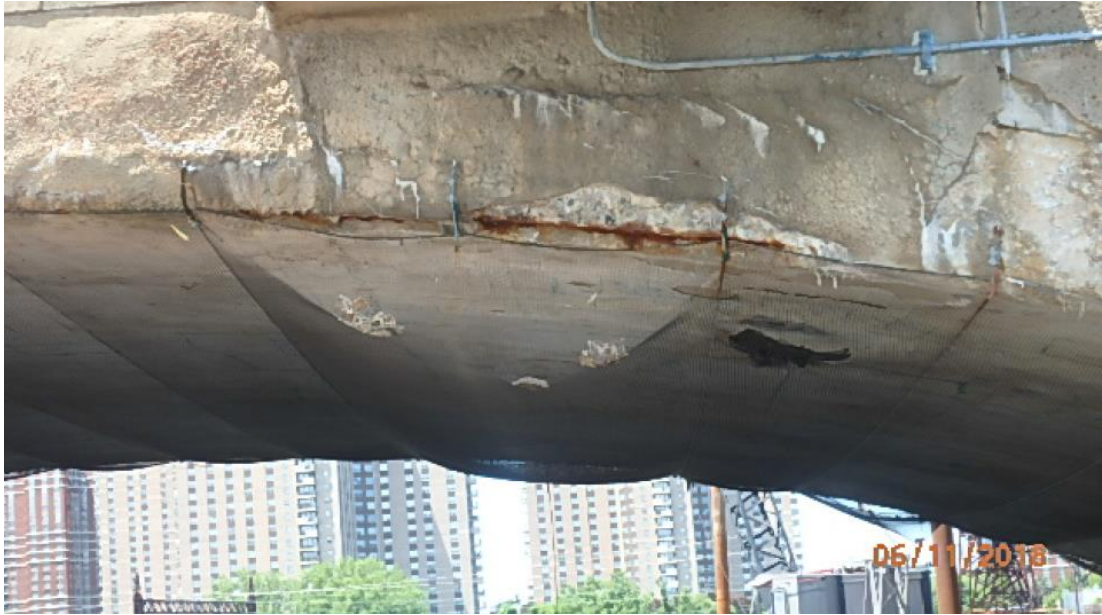
Figure 8: Typical deterioration at underside of arch spans. Note the small chunks of concrete that fell (at Span 3 near Pier 3) on nylon mesh netting covering entire arch intrados. Source: 2018 NYSDOT Biennial Inspection Report

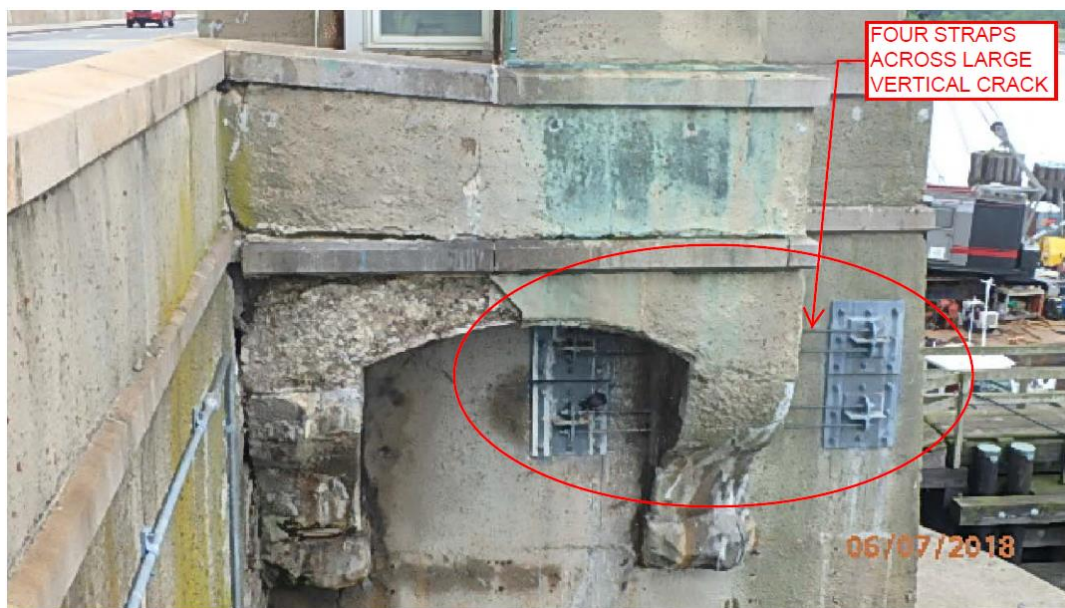
Additionally, the numerous cracks and spalls along the outside of the houses could be addressed with a series of patchwork structural repairs, but more serious cracks require reconstruction in order to repair.

Figure 9: Spalled and cracked concrete in left parapet along the side of the Operator's house. Note the large vertical crack along the side of the Operator's house supported by four steel straps (tensioning members) anchored to the side of the Operator's house to prevent further expansion of the crack. Source: 2018 NYSDOT Biennial Inspection Report

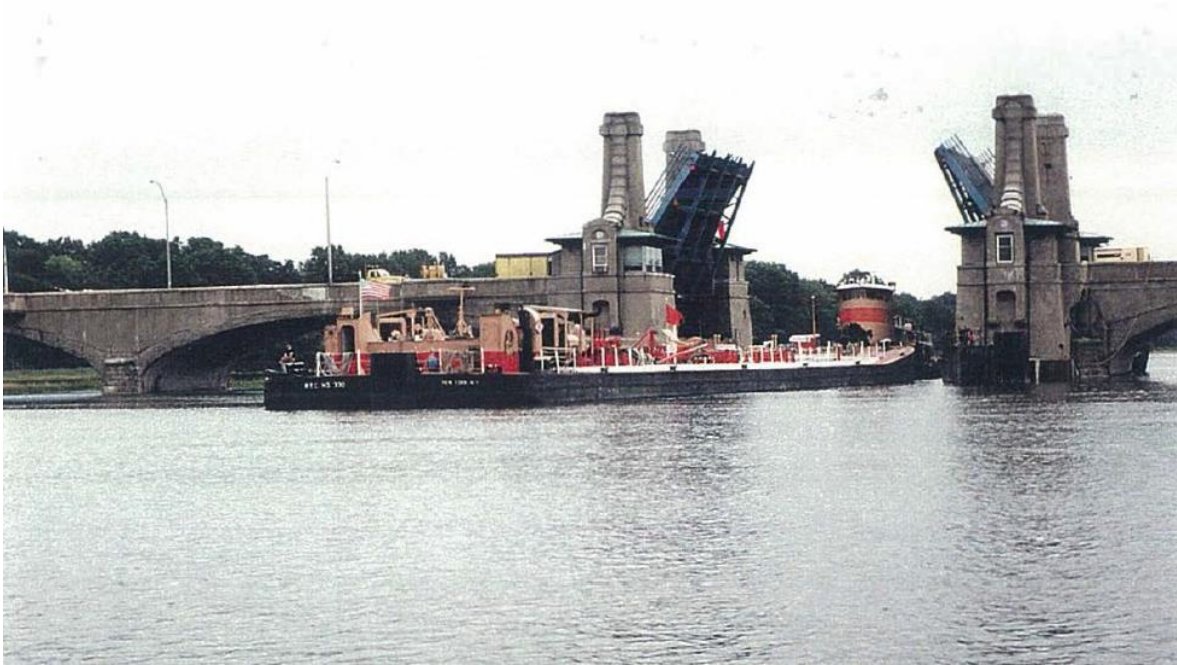
The existing vertical clearance is also a concern and results in an increased number of bridge openings. In the closed position, the bridge provides 13 feet of vertical clearance above mean high water. Due to sea level rise, this clearance would decrease over time requiring additional openings. Excessive bridge openings create vehicle traffic delays and can intensify wear on a bridge's mechanical system. With bridge rehabilitation, the vertical clearance could not be practically improved. Vertical clearance can only be changed by replacement of the bridge.

Figure 10: Oil barge passing northbound through the open bridge. Source: 1998 BRPR Shore Road Bridge, Volume 1
