PROJECT LOCATION

BACKGROUND

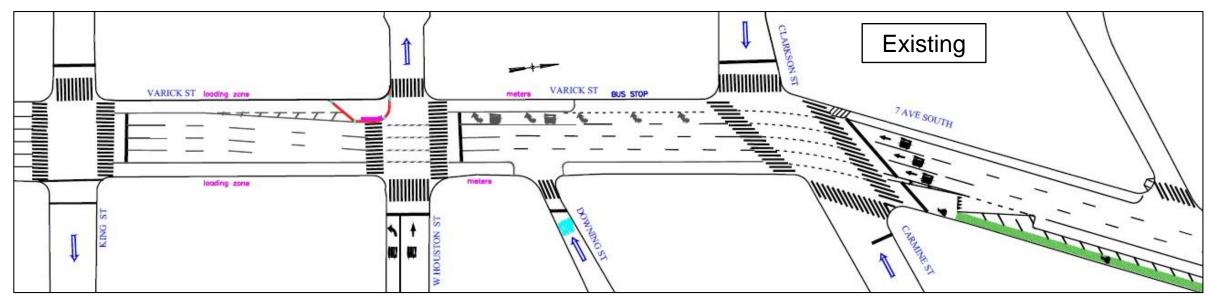
- Houston St & Varick St is a Vision Zero Priority intersection
 - From Jan 2012 through June 2016, 23 pedestrian injuries, including 3 severe injuries
- Spillback from Holland Tunnel often extends to this area
- In 2016, painted neckdown installed on southwest corner of Houston St & Varick St
 - Helps protect south crosswalk from heavy volume of westbound left-turning vehicles
 - Southbound right lane on Varick St approaching Houston St made right-turn-only
- In 2018, parking protected bike lane installed on 7 Ave S between W 11 St and Carmine St
 - No. of through lanes reduced from 4 to 3
- Motorists ignore southbound right-turn-only lane and drive through the neckdown

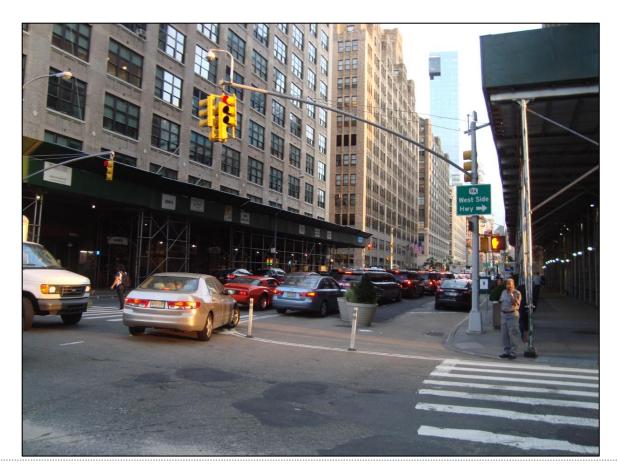
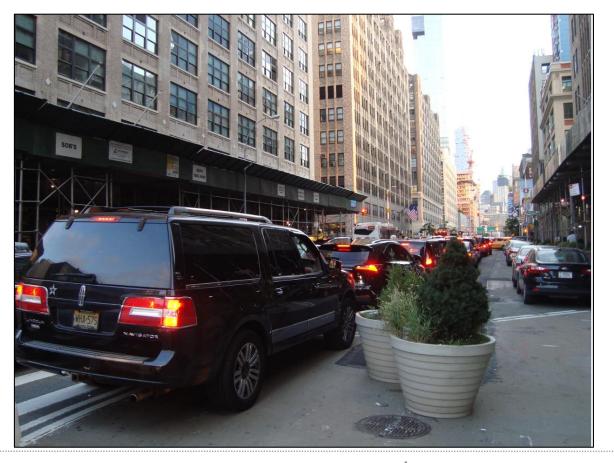
Motorist ignore southbound right-turn-only lane and drive through the neckdown on the southwest corner of Houston St & Varick St

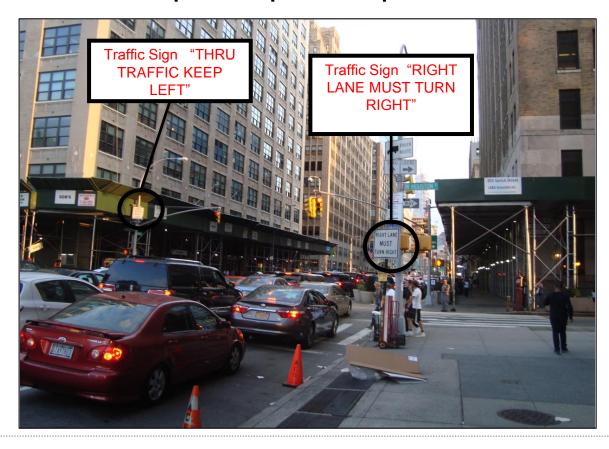
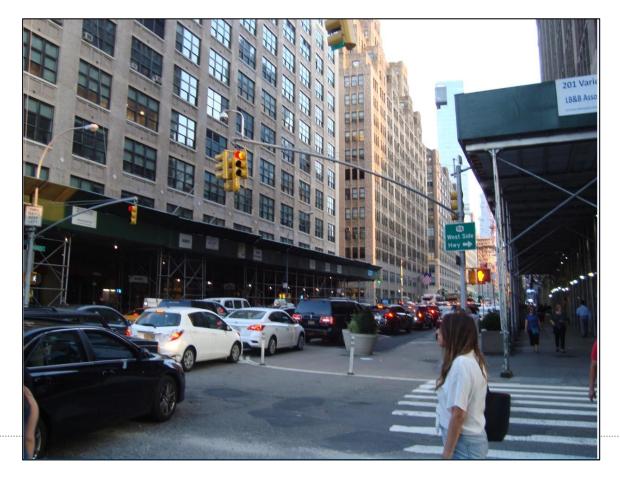
- Traffic signs at this intersection are inconspicuous
- Frequent queue spillback from Holland Tunnel

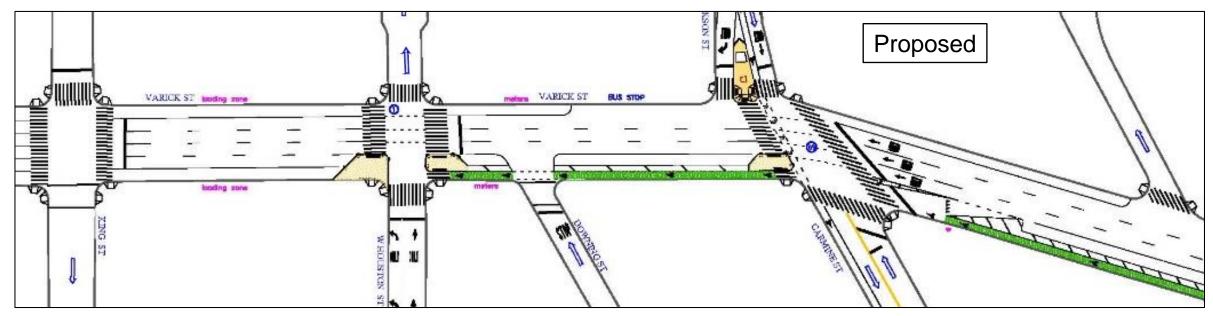
- Extend parking-protected bike lane 1 block south to Houston St
 - Painted islands at southeast corner of Carmine St and northeast corner of Houston St
- Install concrete splitter island on eastbound approach of Clarkson St
- Remove right-turn-only lane
- Relocate painted neckdown on Houston St and Varick St from southwest corner to southeast corner

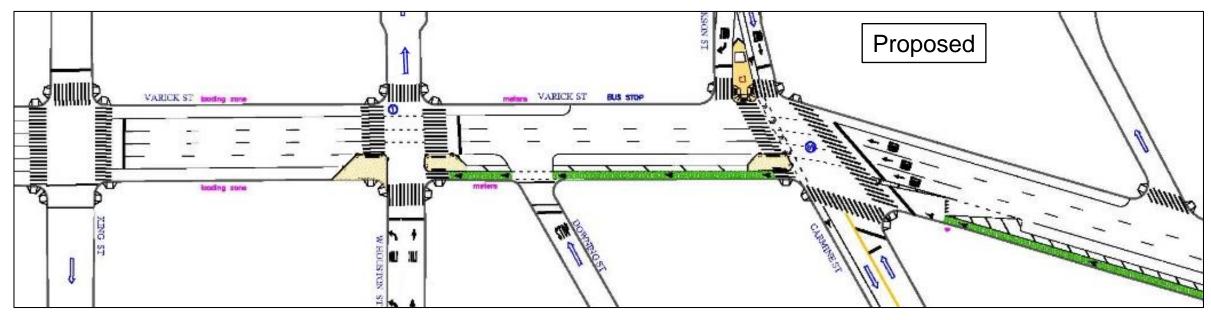
- South crosswalk at Carmine/Clarkson St:
 - Shortened crossing distance
 - Exposure to eastbound right turning vehicles eliminated
- North crosswalk at Houston St
 - Shortened crossing distance

- South crosswalk at Houston St
 - Maintains shortened crossing distance
 - Eliminates driver temptation to drive over neckdown
- Extends bike lane 1 block south
- Three continuous lanes of traffic on right side
 - Fourth lane on left side after Houston St
