# YELLOWSTONE BLVD AND AUSTIN STREET

School Safety Improvements

Presentation to CB 6 Transportation Committee

January 5, 2017

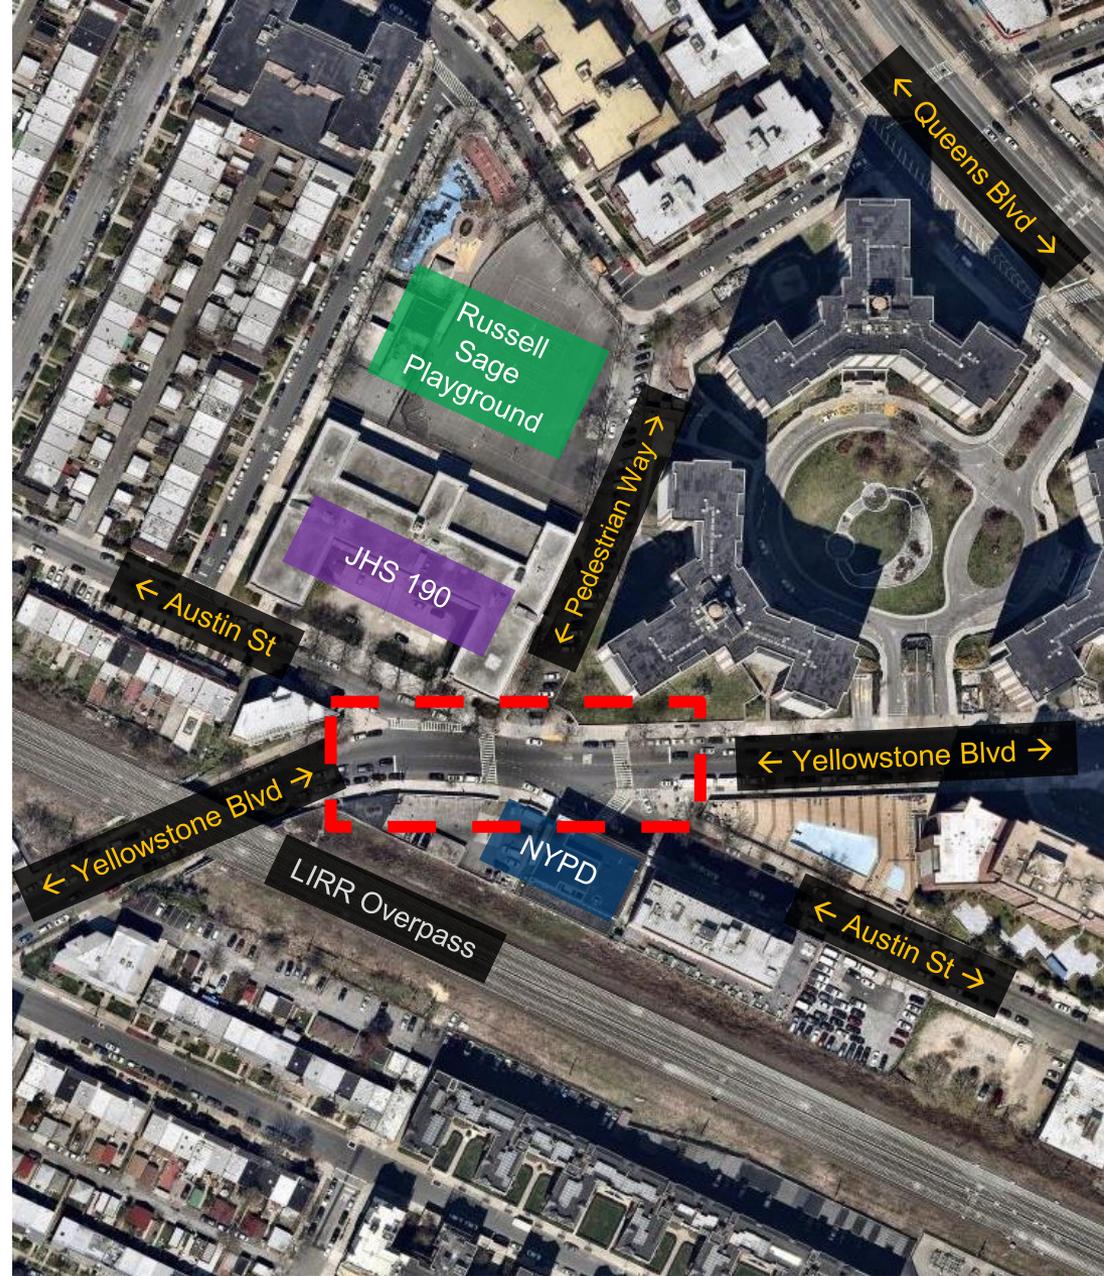
# PROJECT AREA

## Yellowstone Blvd and Austin St

- JHS 190 Russell Sage
- High-density residential
- Senior Safety Area, nearby senior center
- Yellowstone Blvd is important north-south connection across LIRR right of way
- Austin St commercial corridor
- Q23, QM12, and QM42 buses

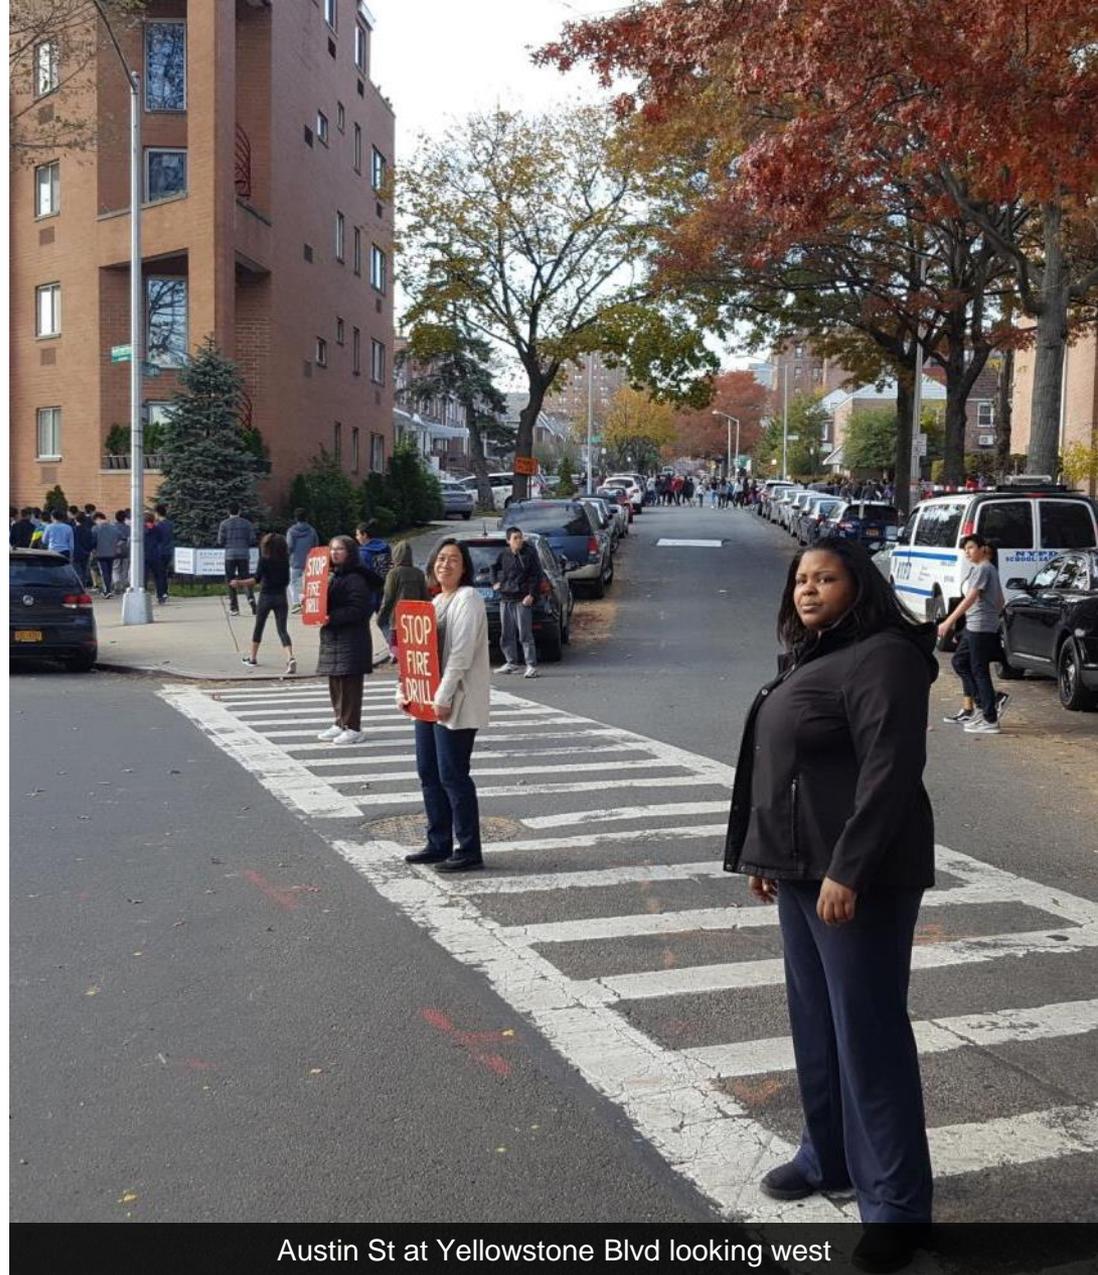
Austin St at Yellowstone Blvd looking west

- Long, skewed intersection
- Requests from BP Katz and CB 6 for safer crosswalk on Austin St in front of JHS 190
- Requests from community and 112<sup>th</sup> Precinct to address unpermitted left turns from Yellowstone Blvd to Austin St
- Request from 112<sup>th</sup> Precinct for parking lane stripes to organize traffic and reduce side swipes

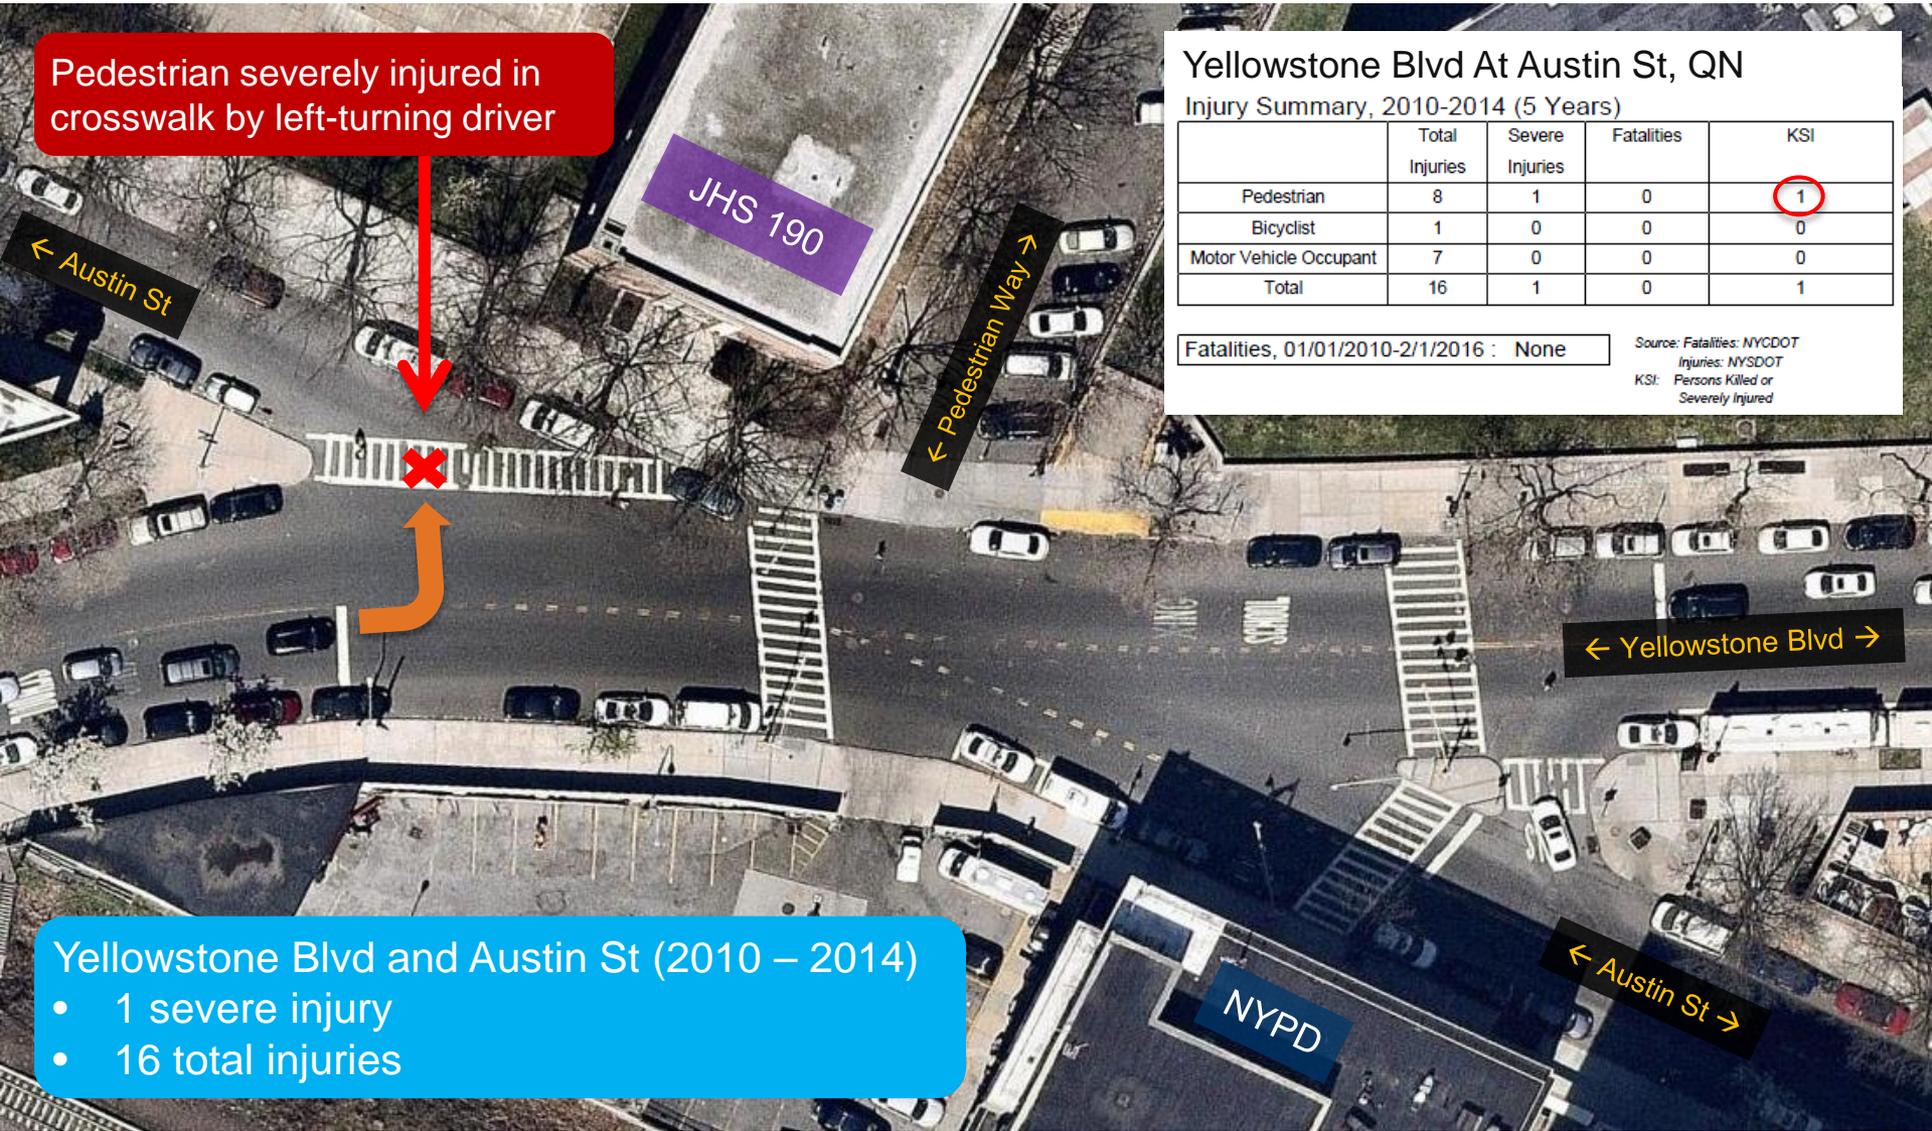
Yellowstone Blvd and Austin St (2010 – 2014)

Pedestrian severely injured in crosswalk by left-turning driver

- 1 severe injury
- 16 total injuries

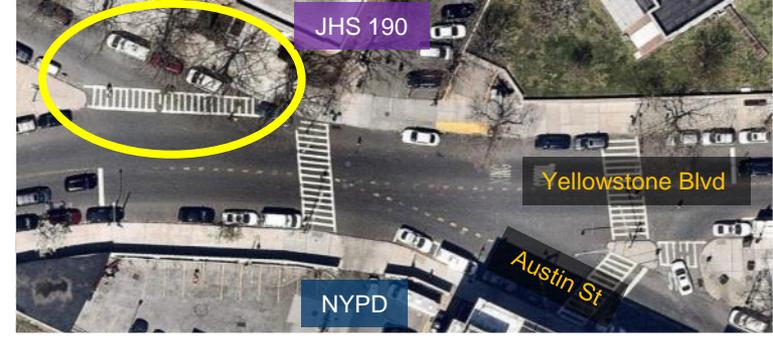
Austin St at Yellowstone Blvd looking east

Parked vehicles obscure view of pedestrians using crosswalk

Long crossing distances for pedestrians, especially seniors and children

Crosswalk is 85 feet long

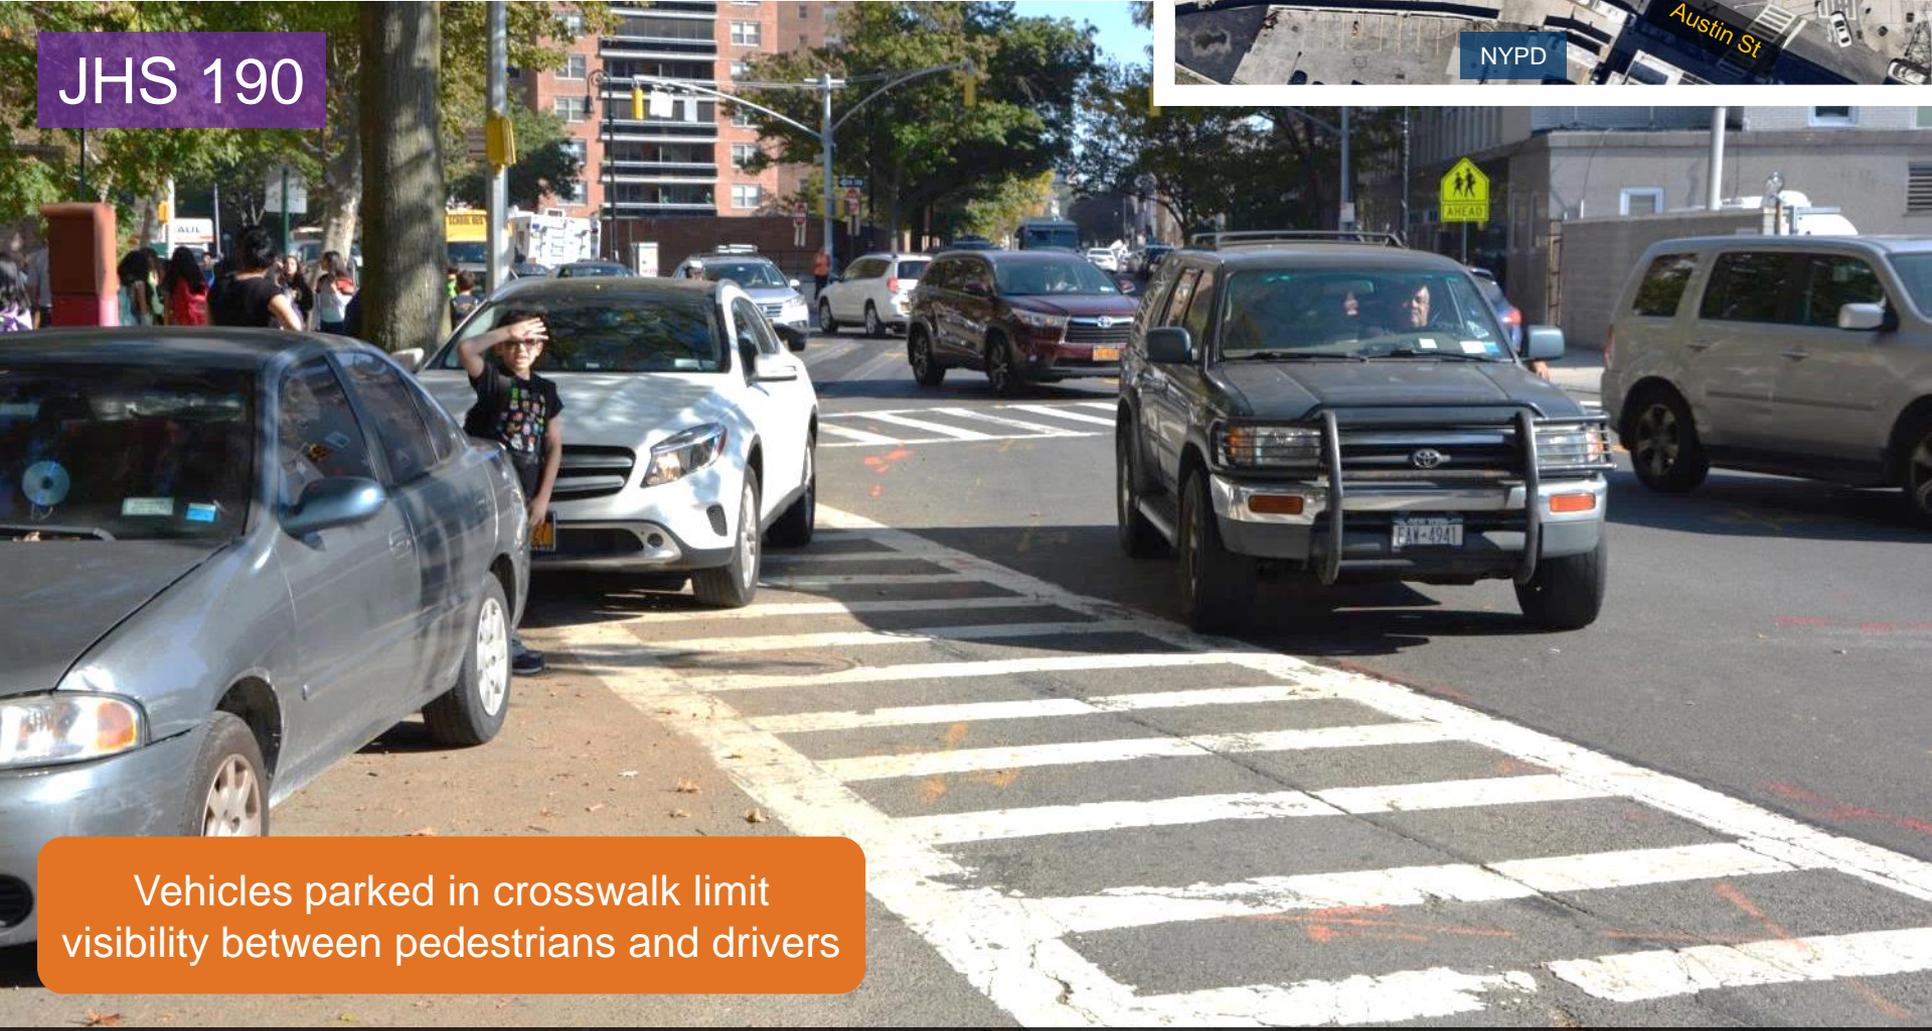
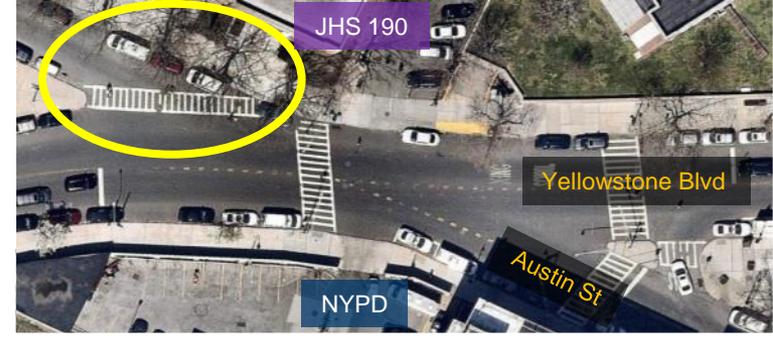
Austin St at Yellowstone Blvd looking east

Vehicles parked in crosswalk limit visibility between pedestrians and drivers

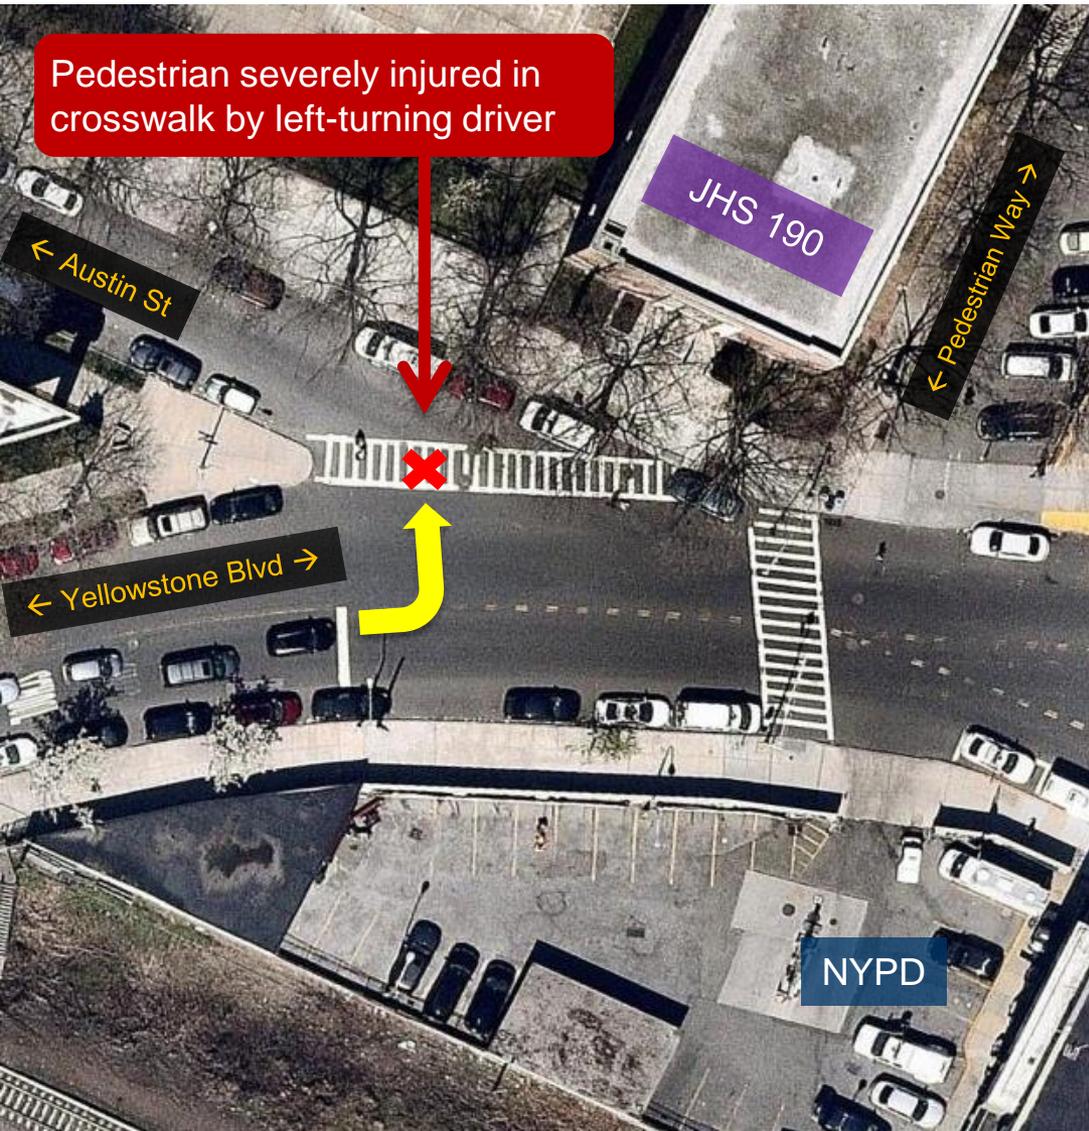
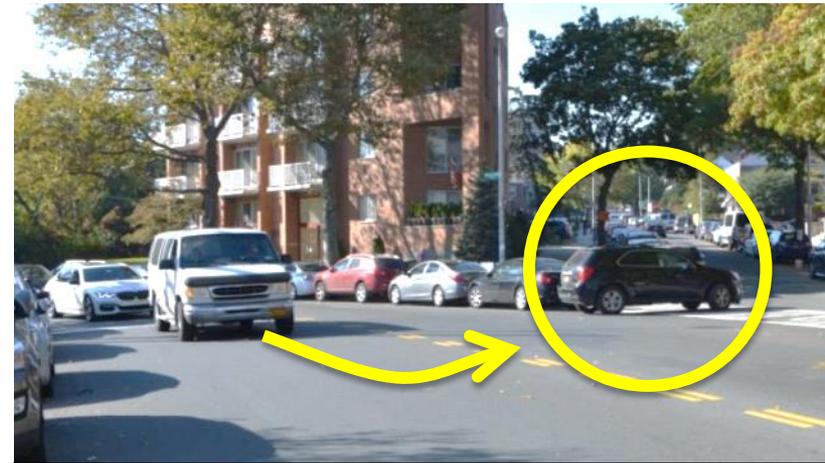
Driver turning from westbound Yellowstone Blvd to eastbound Austin St against signal

Eastbound drivers turn left onto Austin St against signal

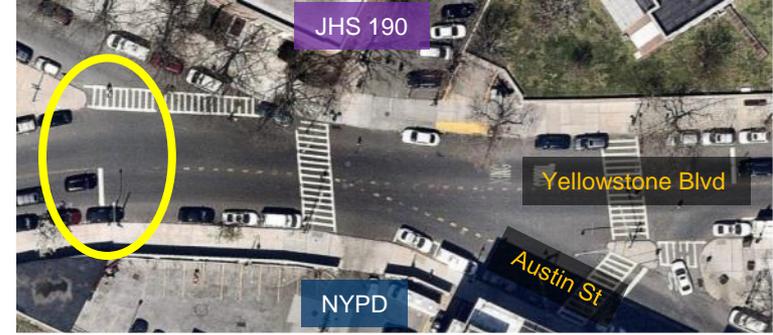
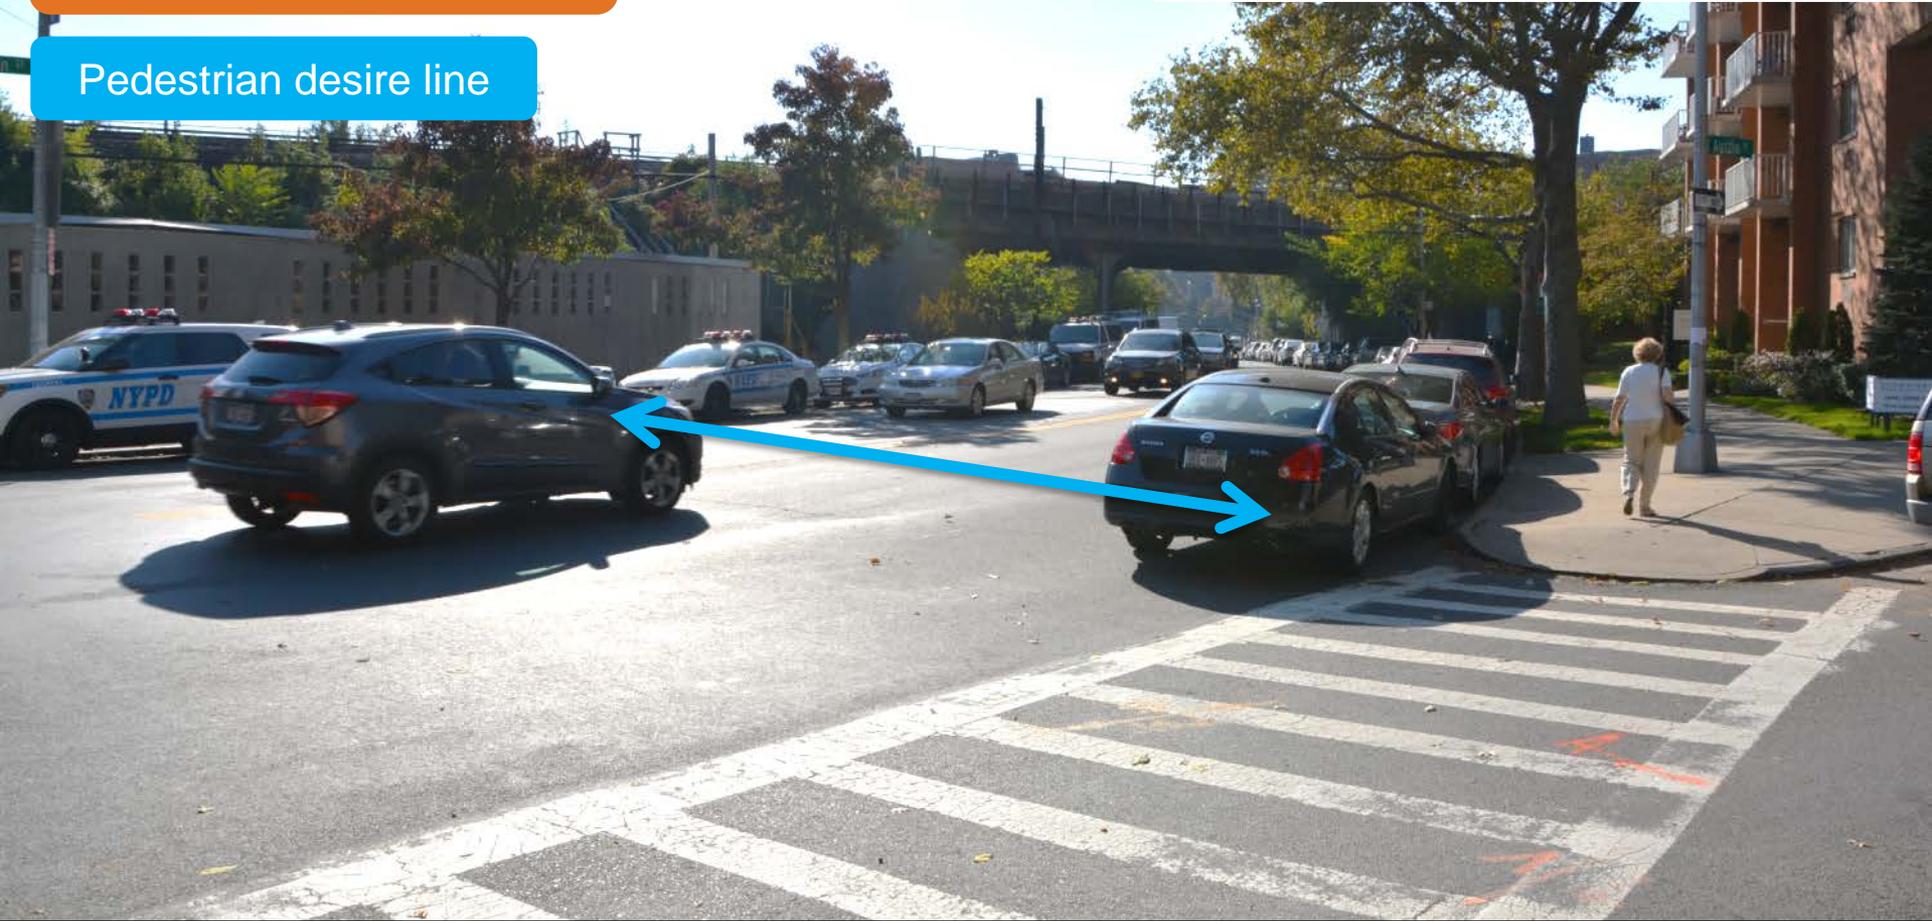
Austin St at Yellowstone Blvd looking south

Crosswalk not marked on west side of intersection

Pedestrian desire line

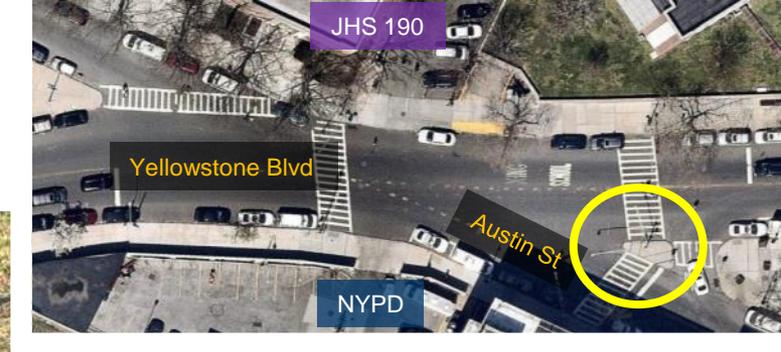
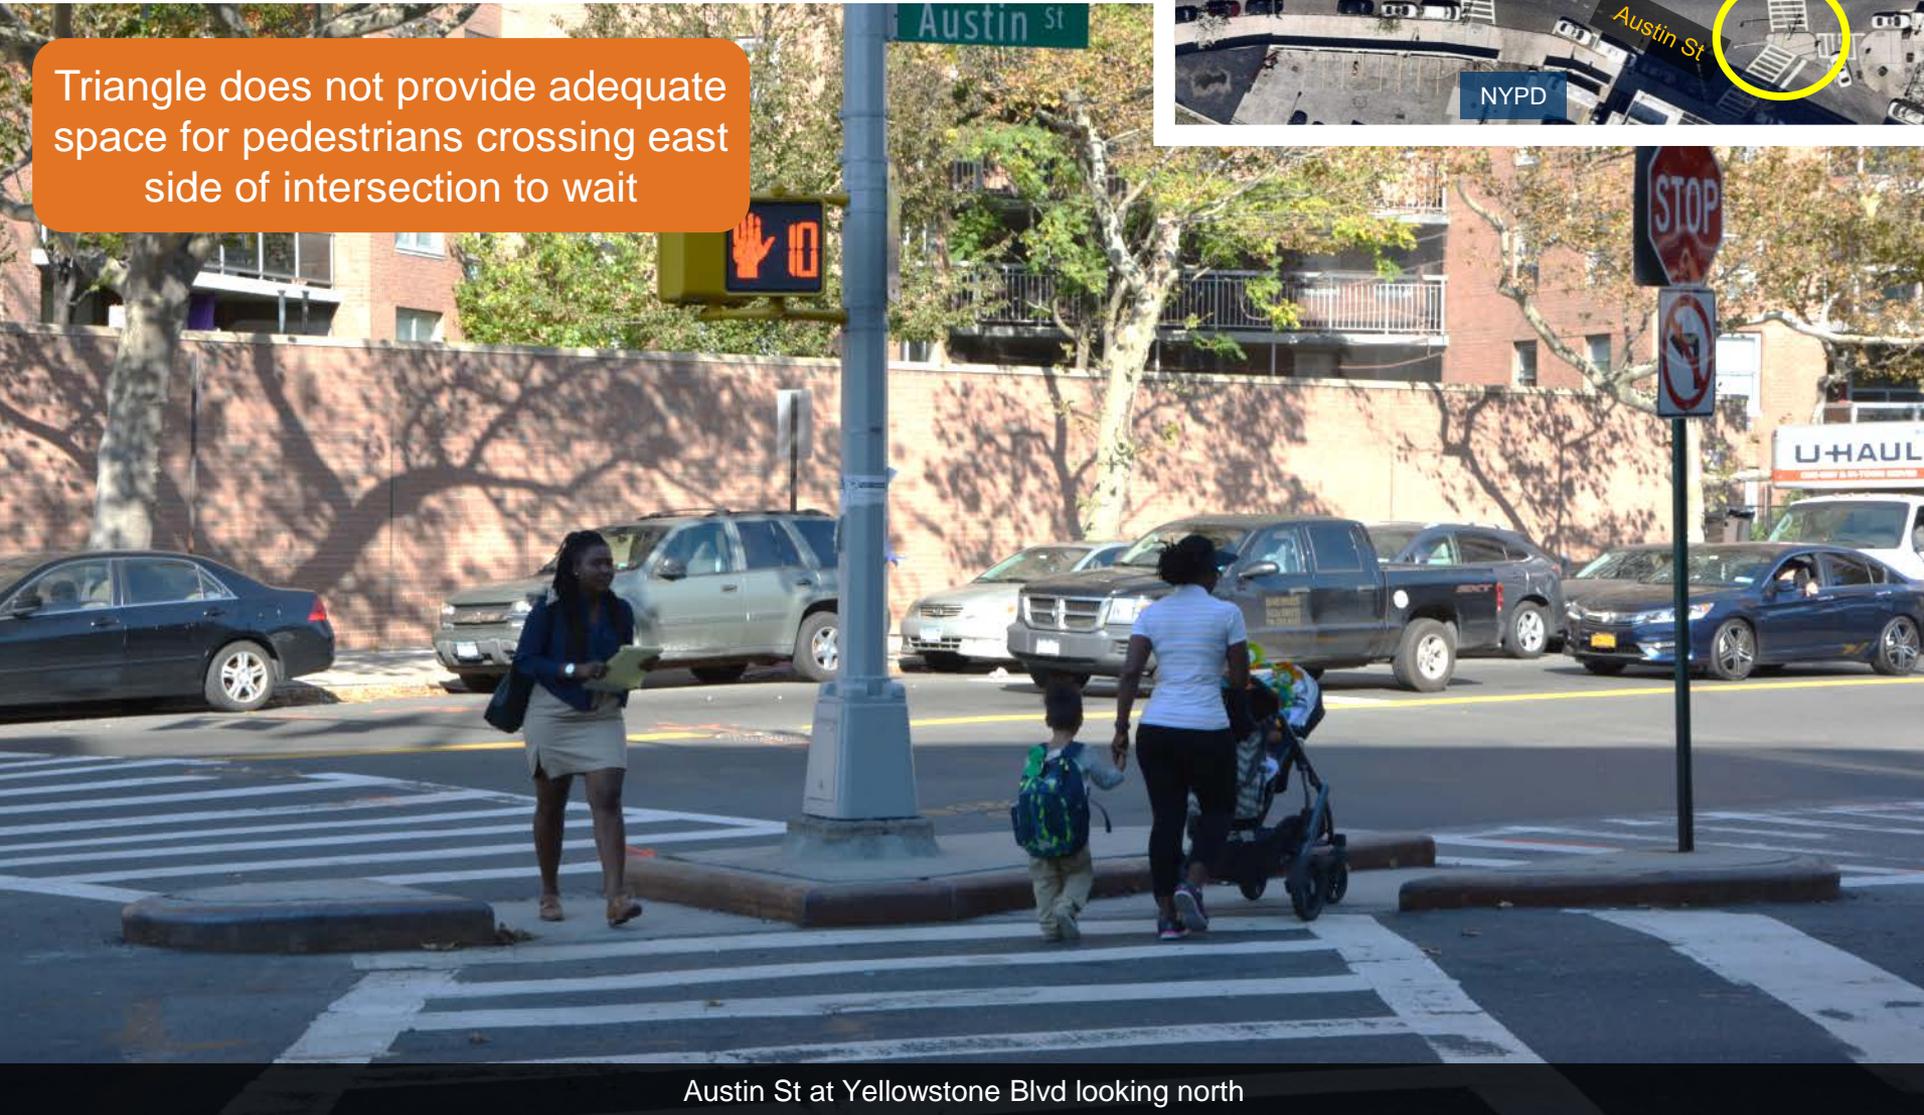
Austin St at Yellowstone Blvd looking north

Triangle does not provide adequate space for pedestrians crossing east side of intersection to wait

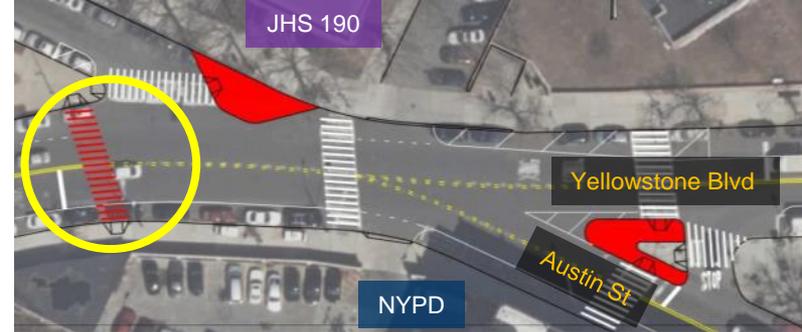
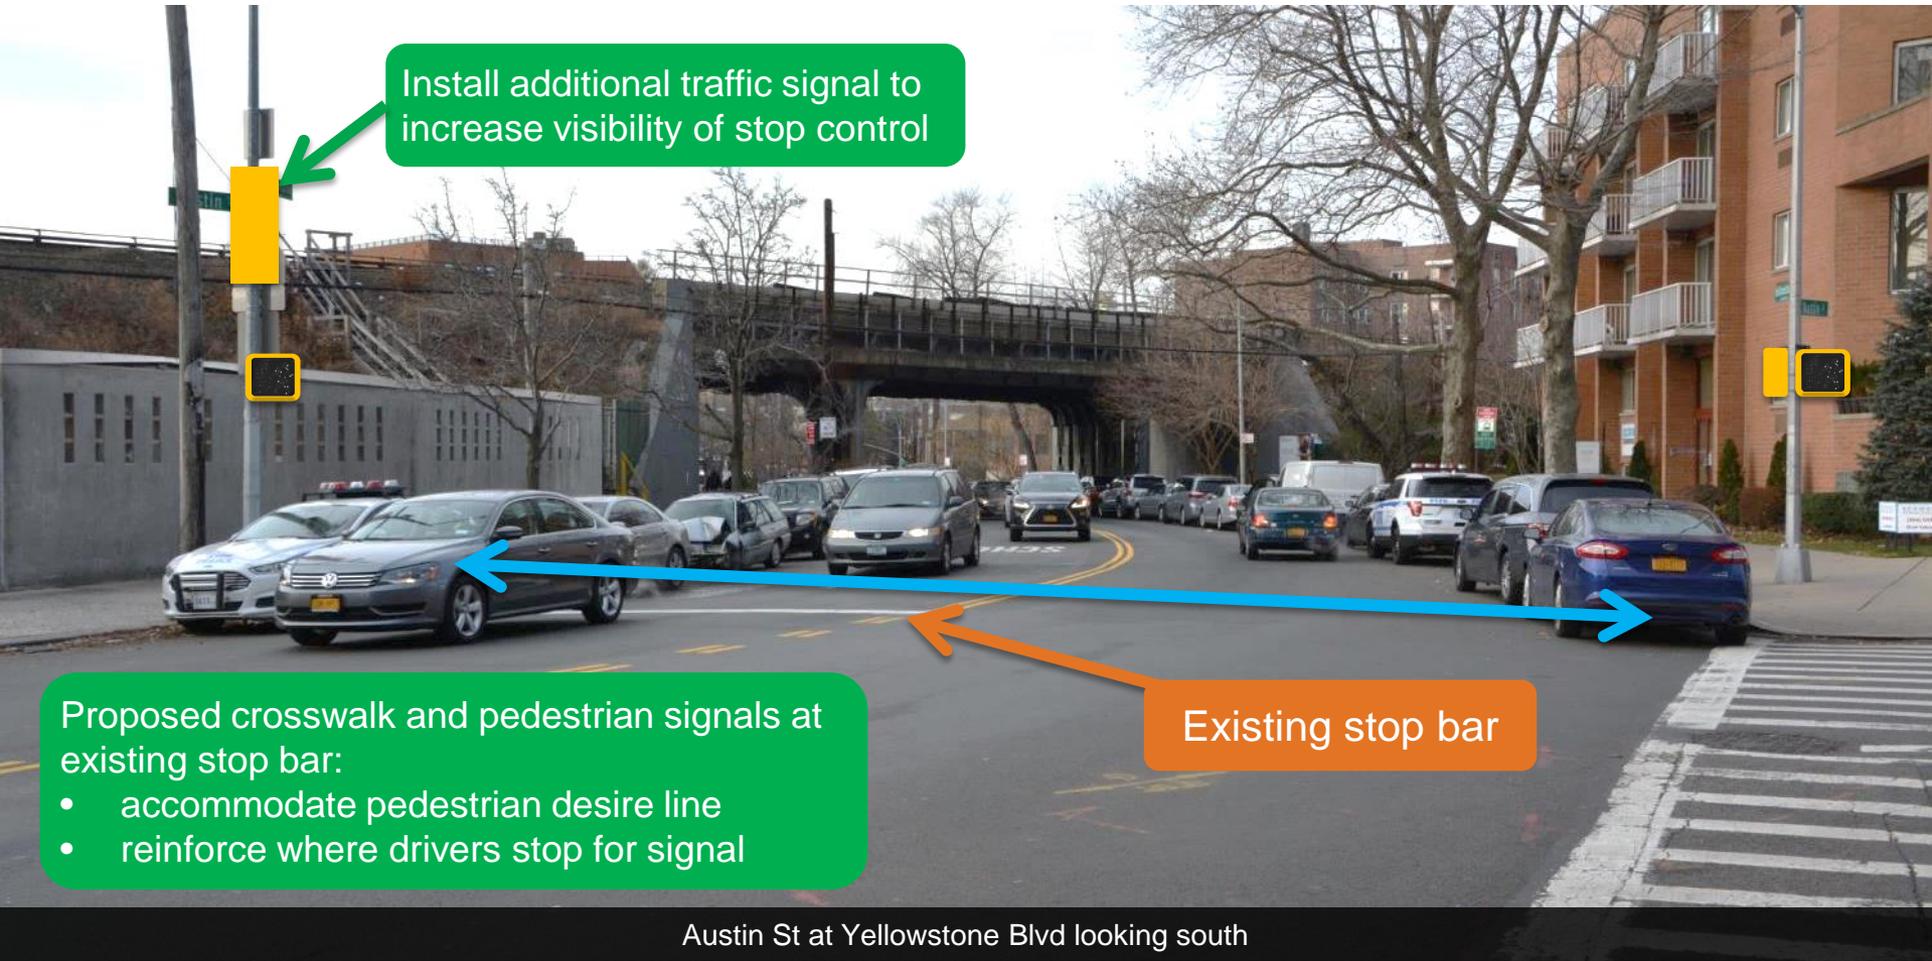
## New Crosswalk and Traffic Signal

1. Add new crosswalk and pedestrian signals on west leg of intersection
2. Install additional traffic signal to increase visibility
3. Install concrete curb extension in front of JHS 190 to shorten crossing and control vehicle turns
4. Expand pedestrian island on east leg of intersection to make crossing ADA-accessible

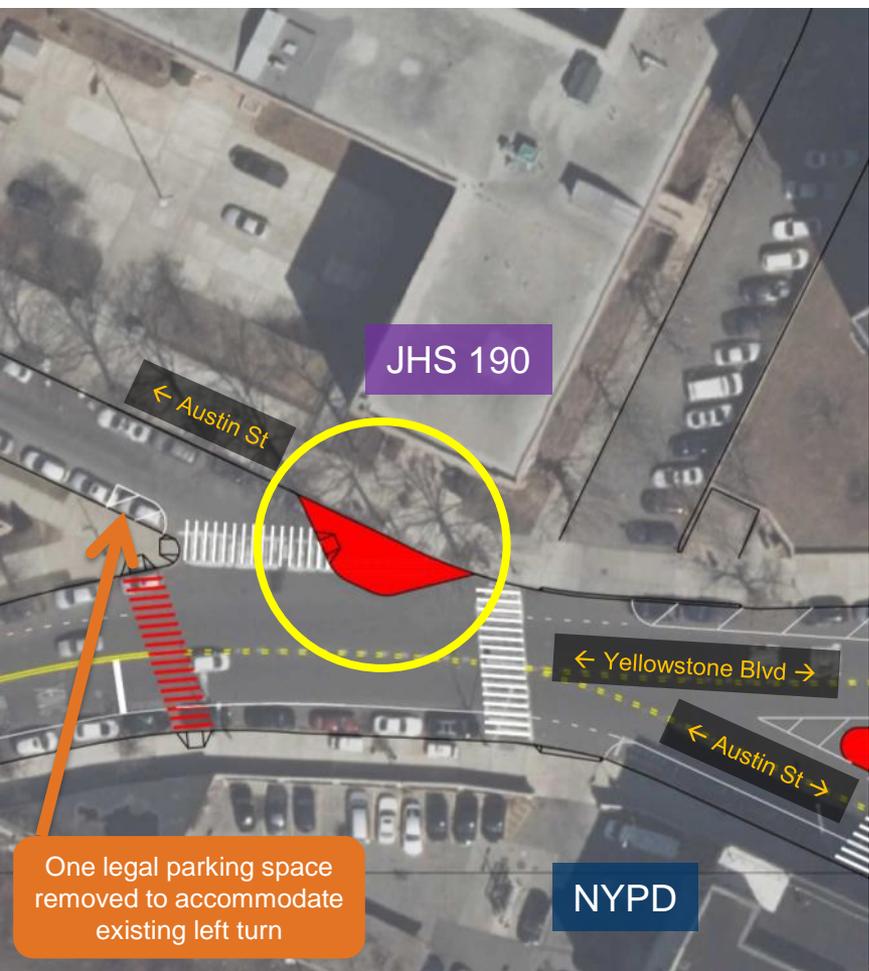
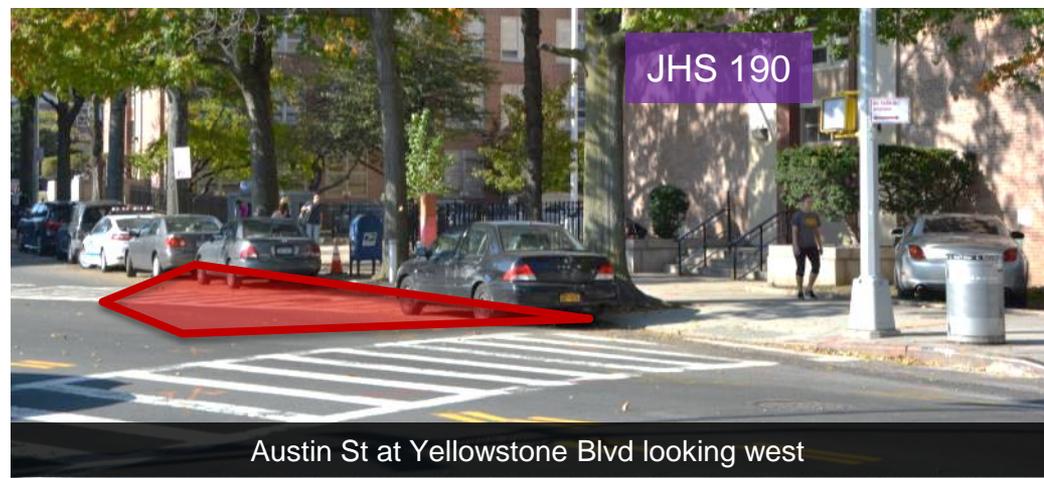
Austin St at Yellowstone Blvd looking west

## Concrete curb extension in front of JHS 190

- Increases pedestrian visibility
- Controls vehicle turns onto Austin St
- Shortens pedestrian crossing distances
- Pedestrian signal indicates exclusive crossing phase

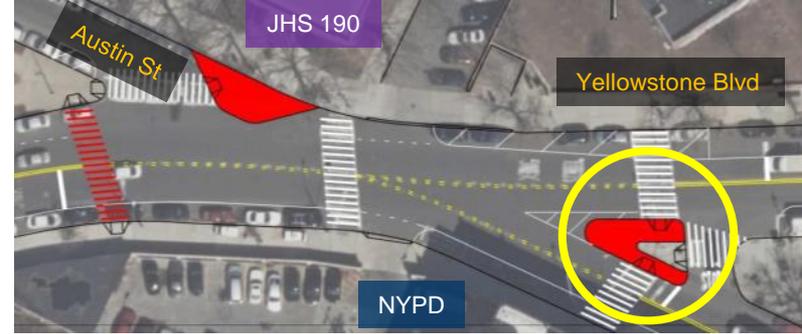
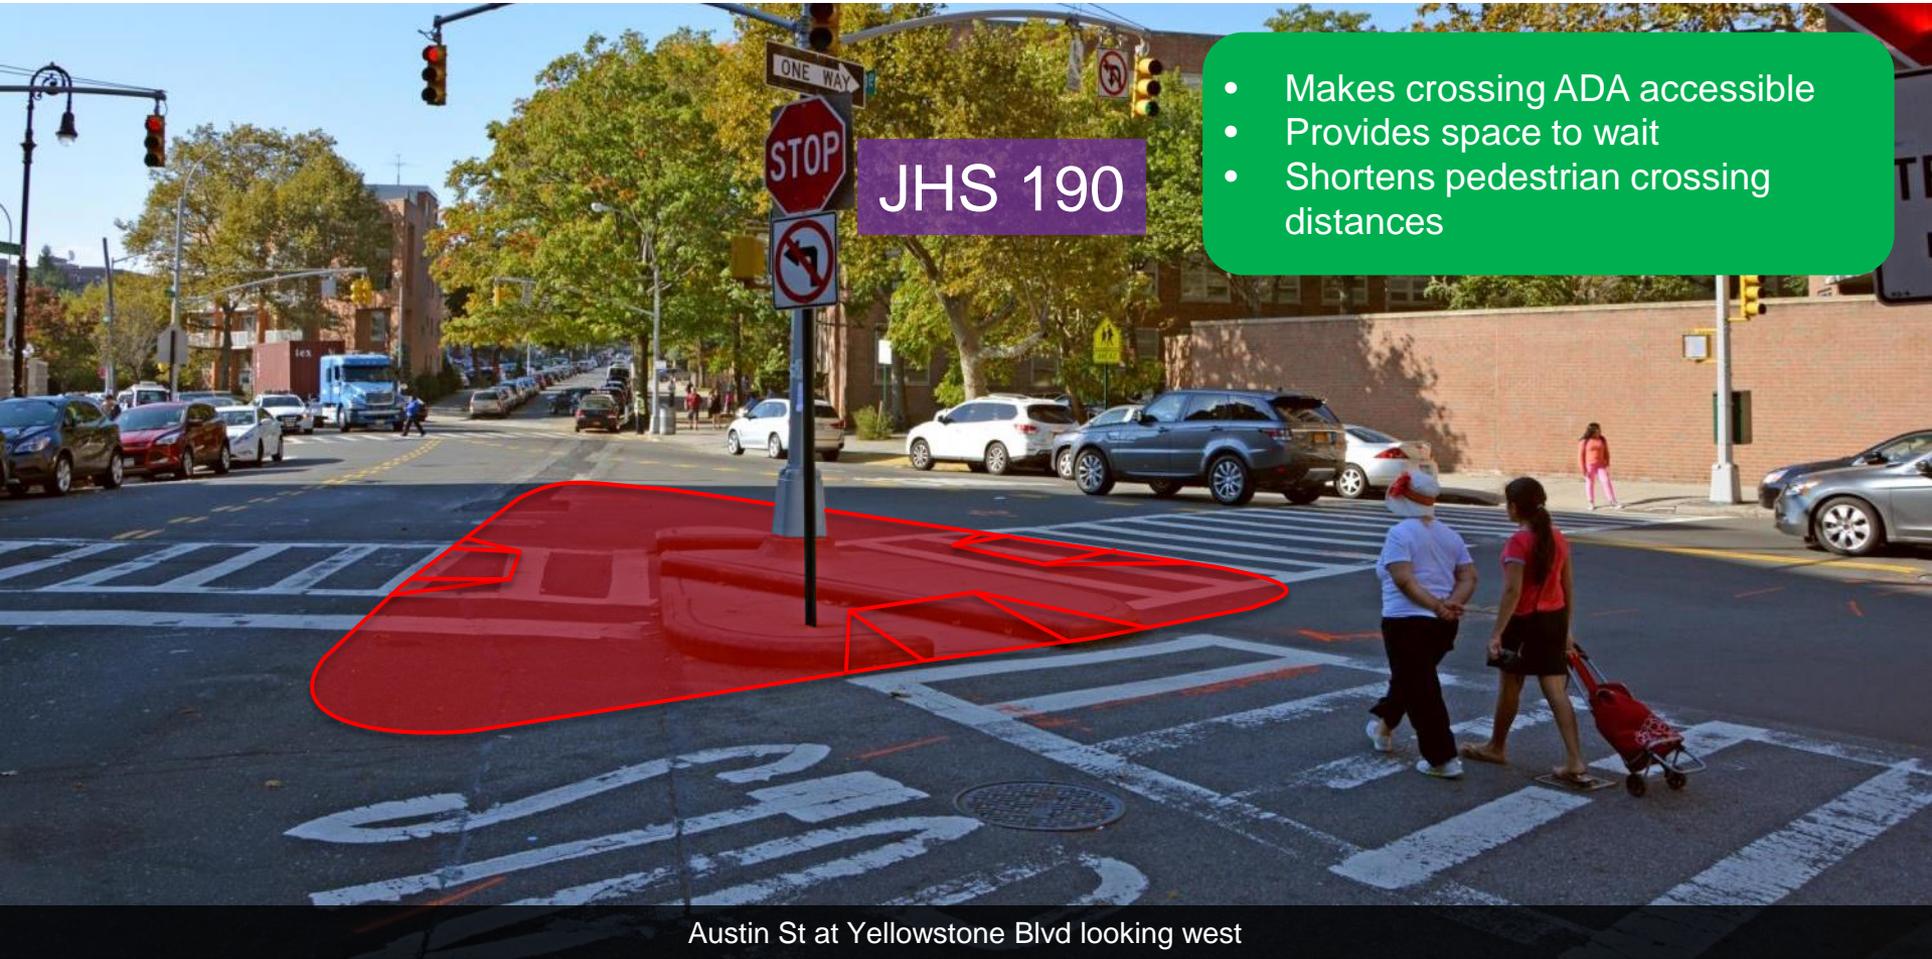
Austin St at Yellowstone Blvd looking west

## Expand Pedestrian Island

- Makes crossing ADA accessible
- Provides space to wait
- Shortens pedestrian crossing distances
