**Environmental Assessment
Determinations and Compliance Findings for HUD-assisted Projects
24 CFR Part 58**

Hope Gardens: Groups A-E CDBG-DR Storm Resiliency
Multiple Addresses
Brooklyn, New York 11221

HEROS Number: 900000010361422

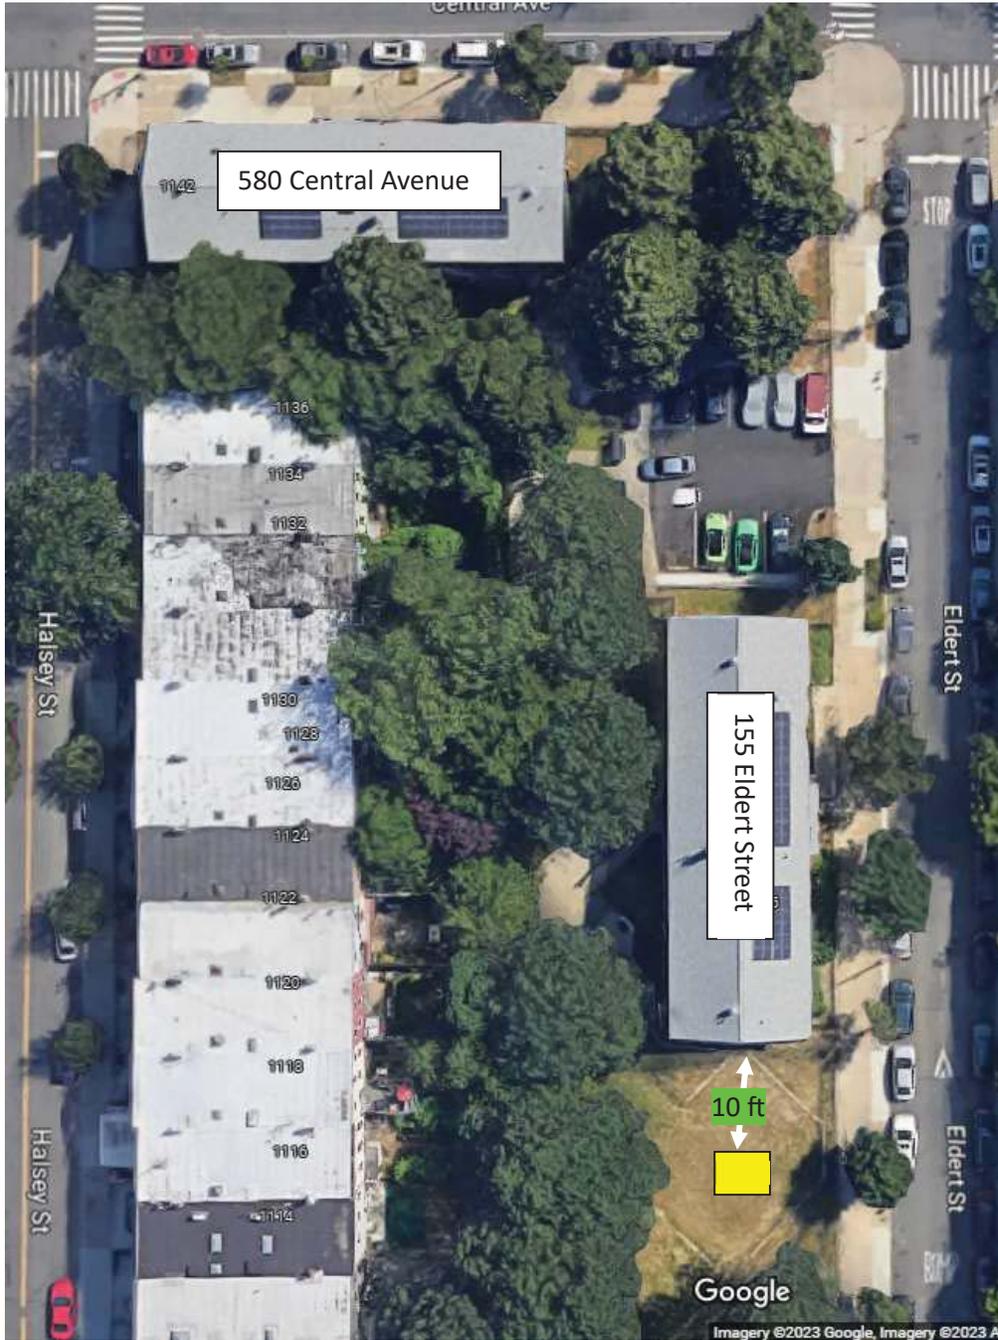
1. Pod A-1 to serve 2 buildings: 580 Central Avenue, 155 Eldert Street
 - Tree impact: none
 - Playground equipment impact: none
 - Approximately 10 ft to closest building, 155 Eldert

Pod A-1 seen in yellow will be approximately 160 SF; not drawn to scale.

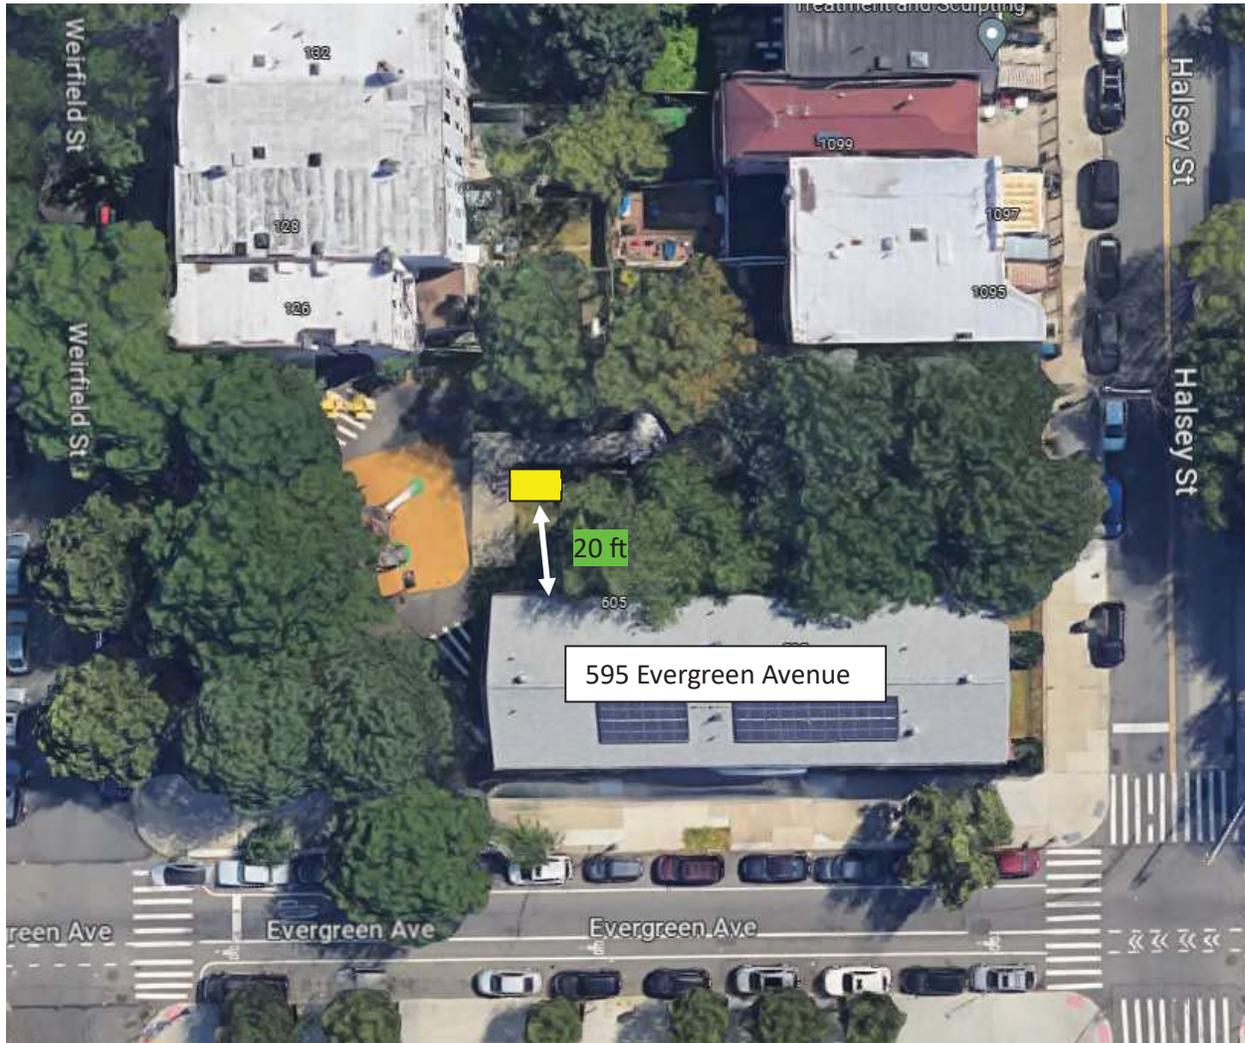
2. Pod A-2 is to serve 1 building: 595 Evergreen Avenue
 - Tree impact: adjacent to trees but none to be impacted or removed
 - Playground equipment impact: none
 - Approximately 20 ft to closest building, 595 Evergreen

Pod A-2 shown in yellow will be approximately 160 SF; not drawn to scale.

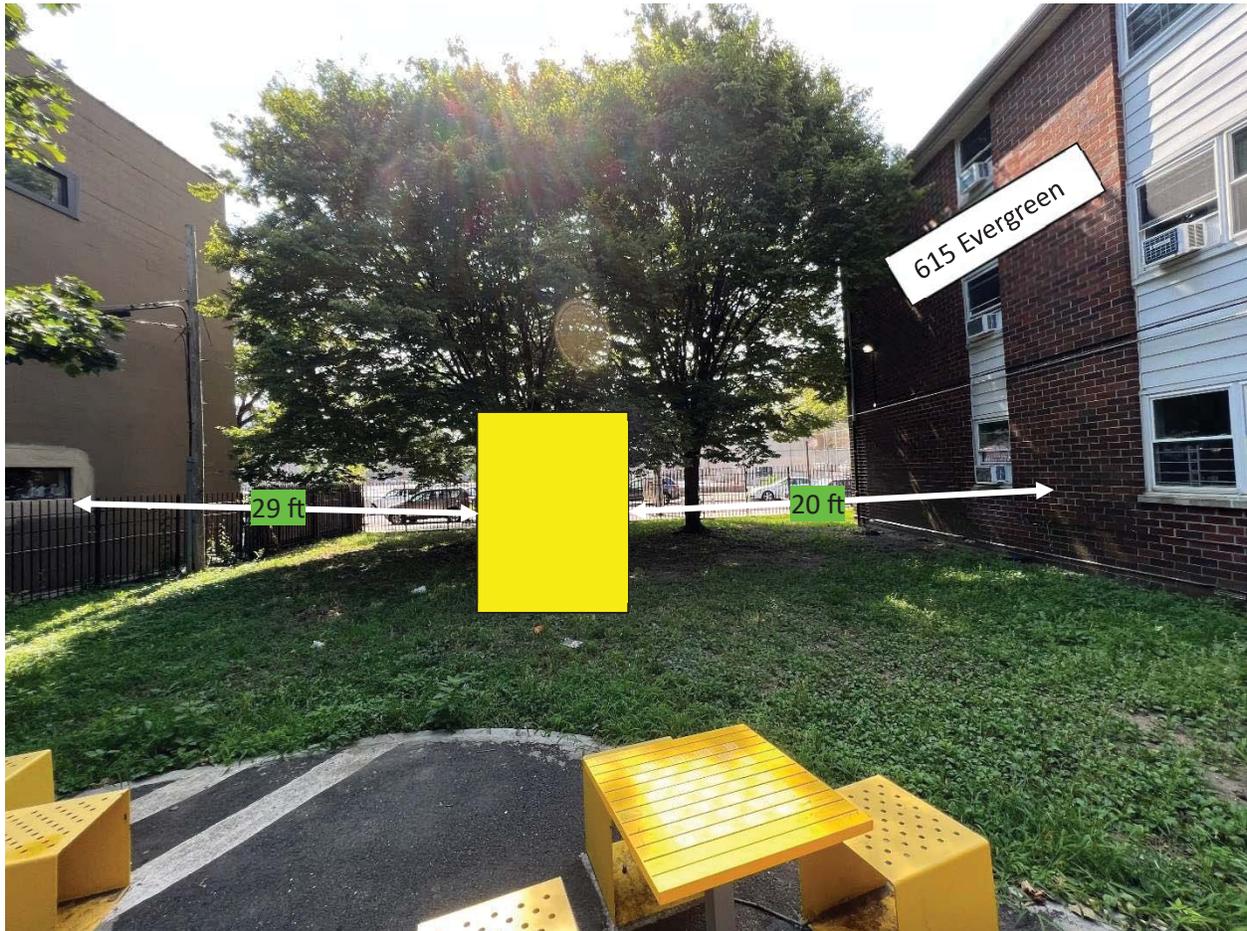
3. Pod A-3 is to serve 1 building: 615 Evergreen Avenue
- Tree impact: adjacent to trees but none to be impacted or removed
 - Playground equipment impact: none
 - Approximately 20 ft to closest building, 615 Evergreen

Pod A-3 shown in yellow will be approximately 160 SF; not drawn to scale.

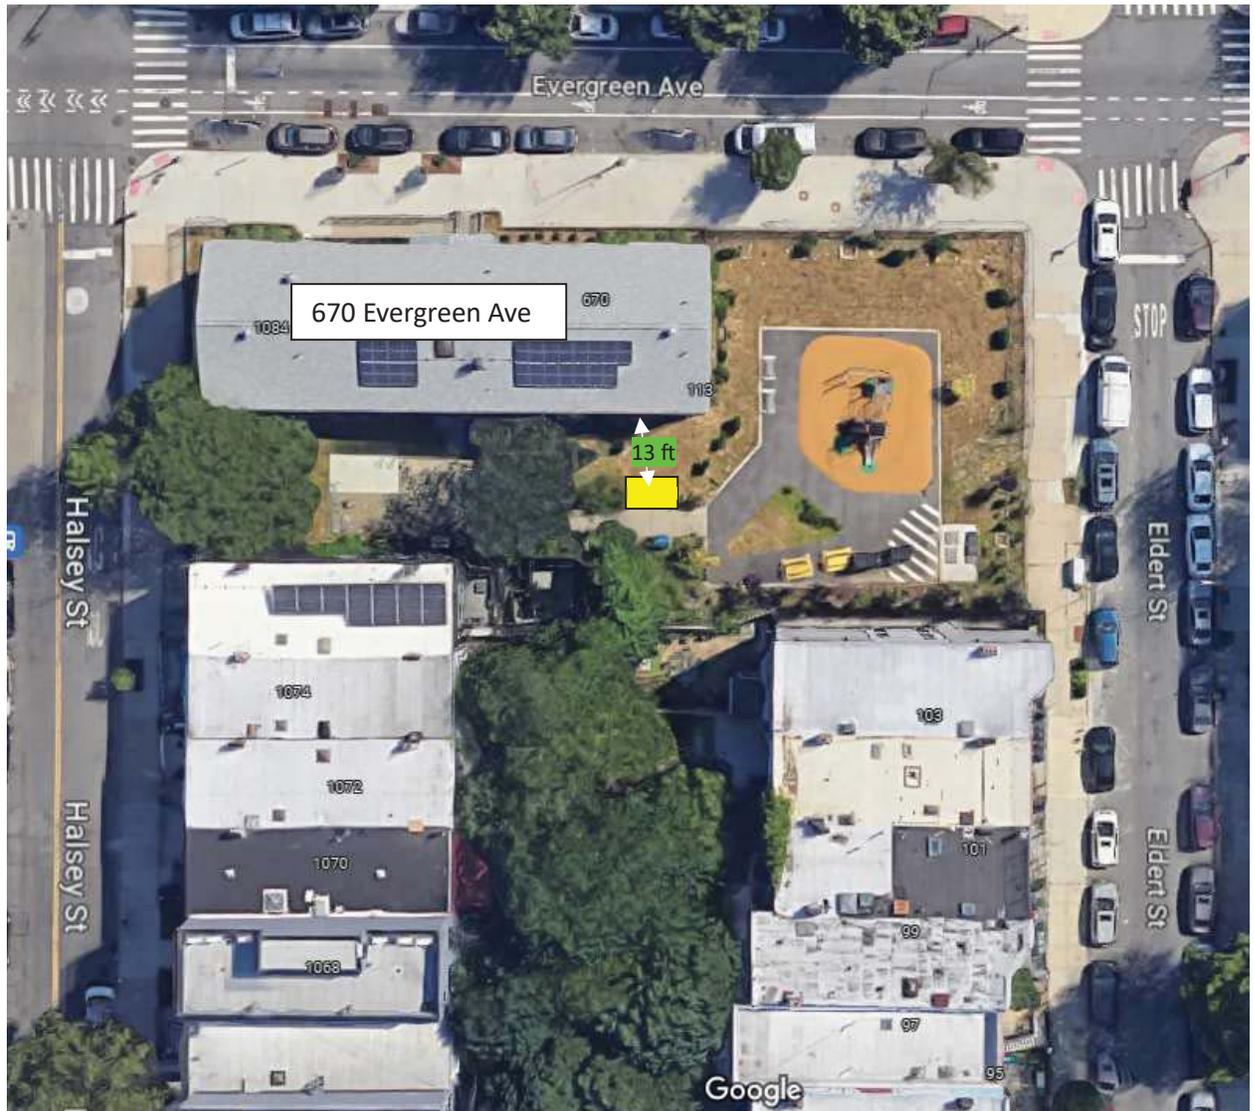
- 4. Pod A-4 is to serve 1 building: 670 Evergreen Avenue
 - Tree impact: adjacent to trees but none to be impacted or removed
 - Relocation of playground equipment: none
 - Approximately 13 ft to closest building, 670 Evergreen

Pod A-4 shown in yellow will be approximately 160 SF; not drawn to scale.

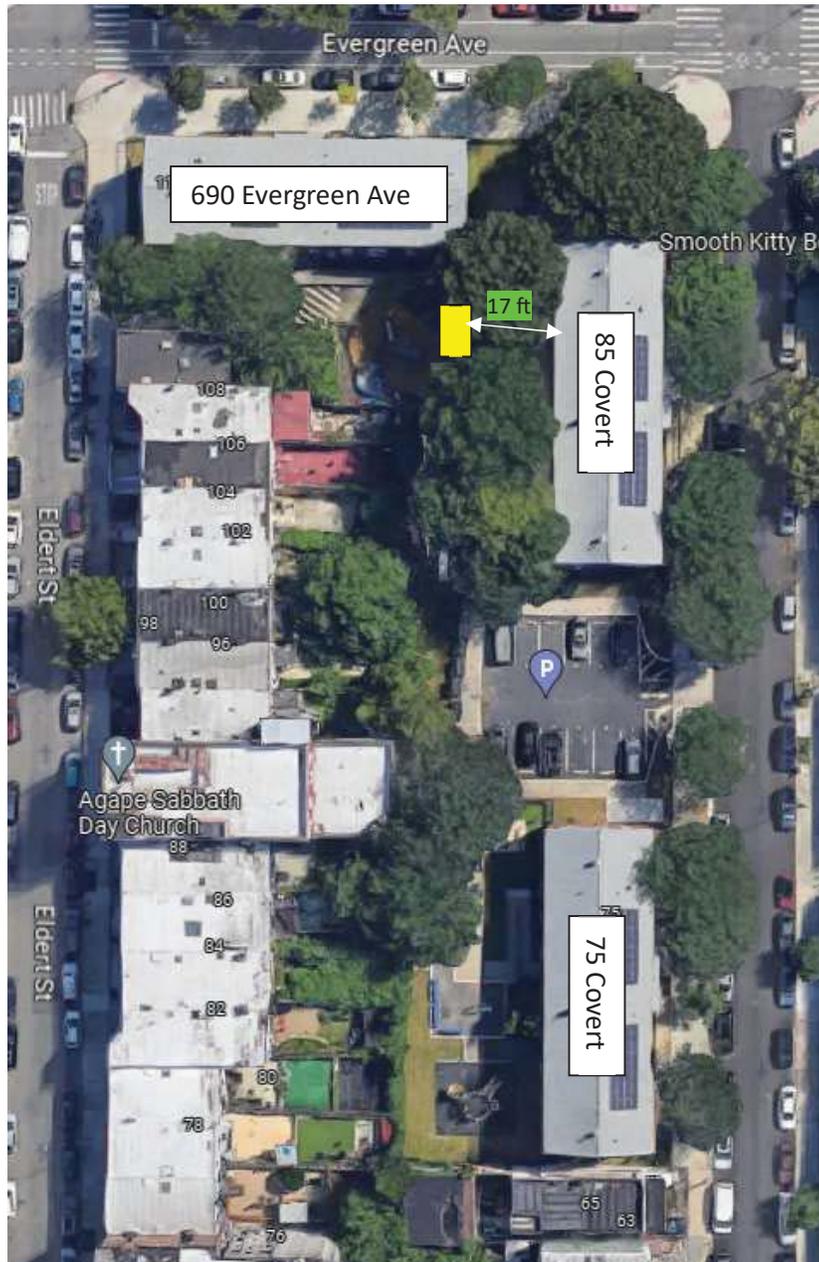
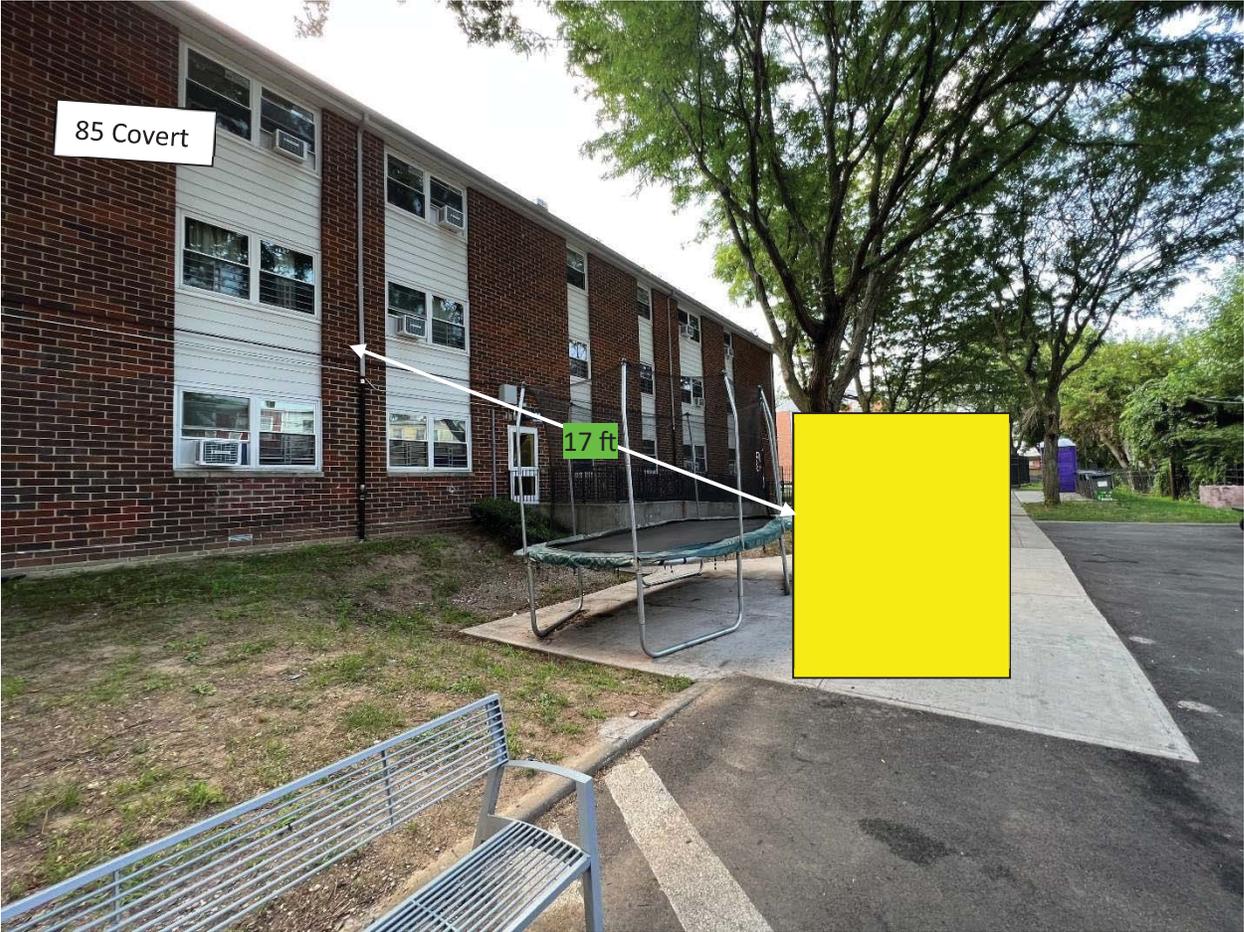
5. Pod A-5 is to serve 3 buildings: 690 Evergreen Avenue, 85 Covert Street, and 75 Covert Street
 - Tree impact: adjacent to trees but none to be impacted or removed; pod to be installed over paved surface
 - Relocation of playground equipment: adjacent to playground but none to be impacted
 - Approximately 17 ft to closest building, 85 Covert Street

Pod A-5 shown in yellow will be approximately 240 SF; not drawn to scale.

Alternate view of Pod A-5 shown in yellow; not drawn to scale. Unauthorized personal property to be removed.

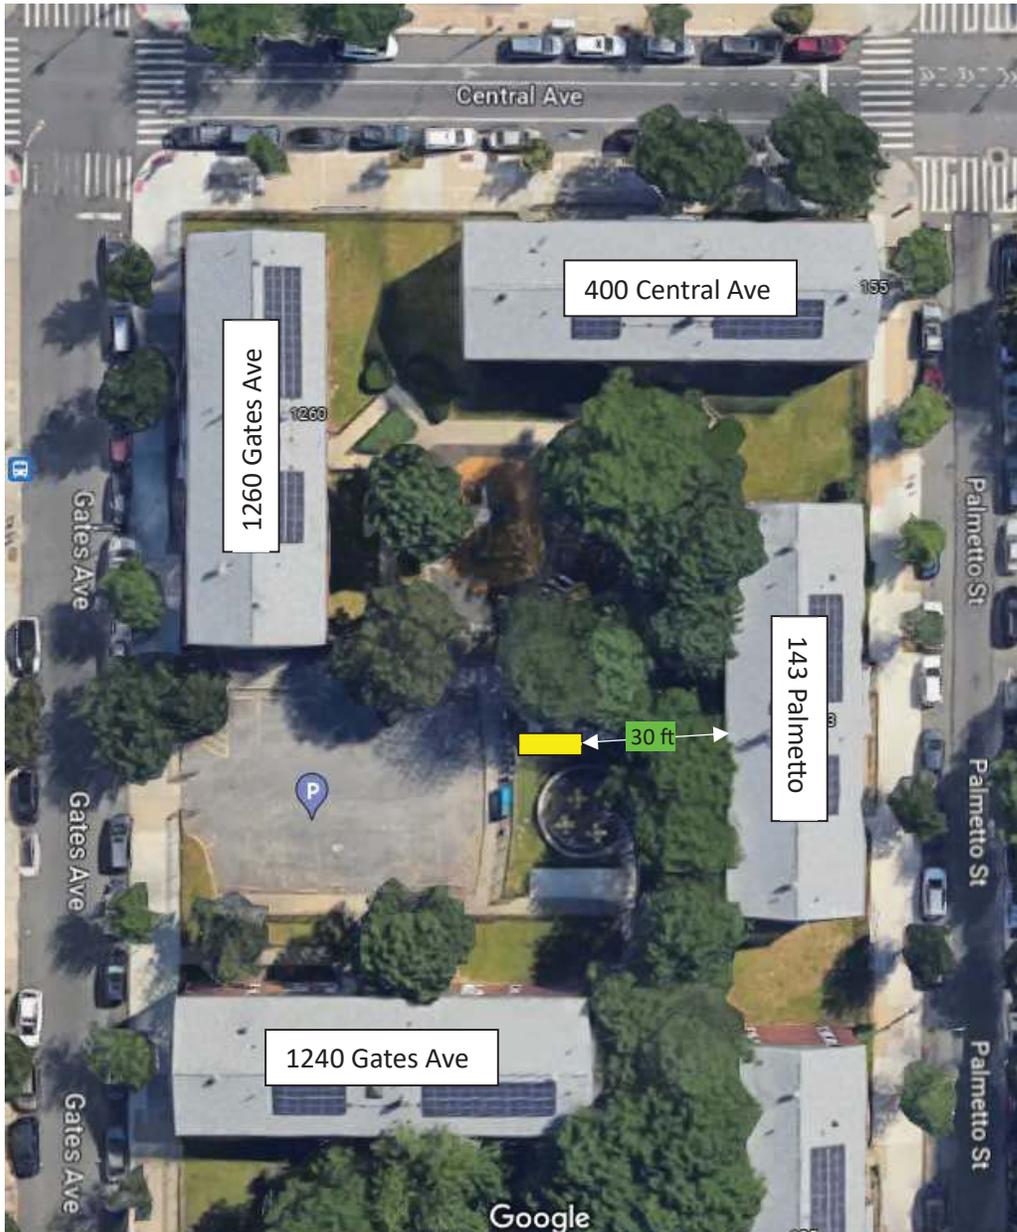
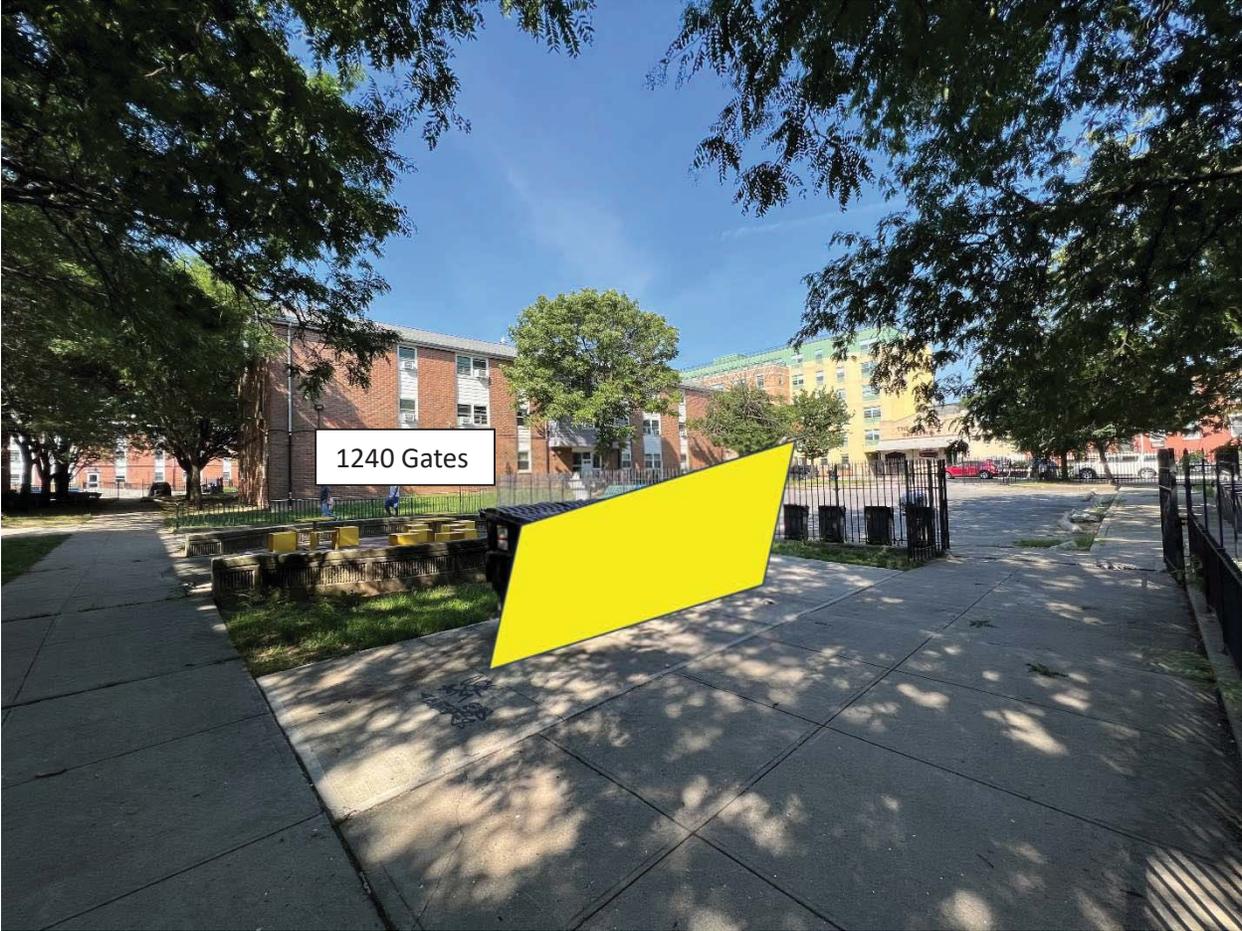
6. Pod B-1 is to serve 3 buildings: 1260 Gates Avenue, 400 Central Avenue, and 143 Palmetto
 - Tree impact: None to be impacted or removed; pod to be installed over paved surface
 - Playground equipment impact: none
 - Approximately 30 ft from closest building, 143 Palmetto

Pod B-1 shown in yellow will be approximately 240 SF; not drawn to scale.

Alternate view of pod B-1 shown in yellow below; dumpsters to be relocated.

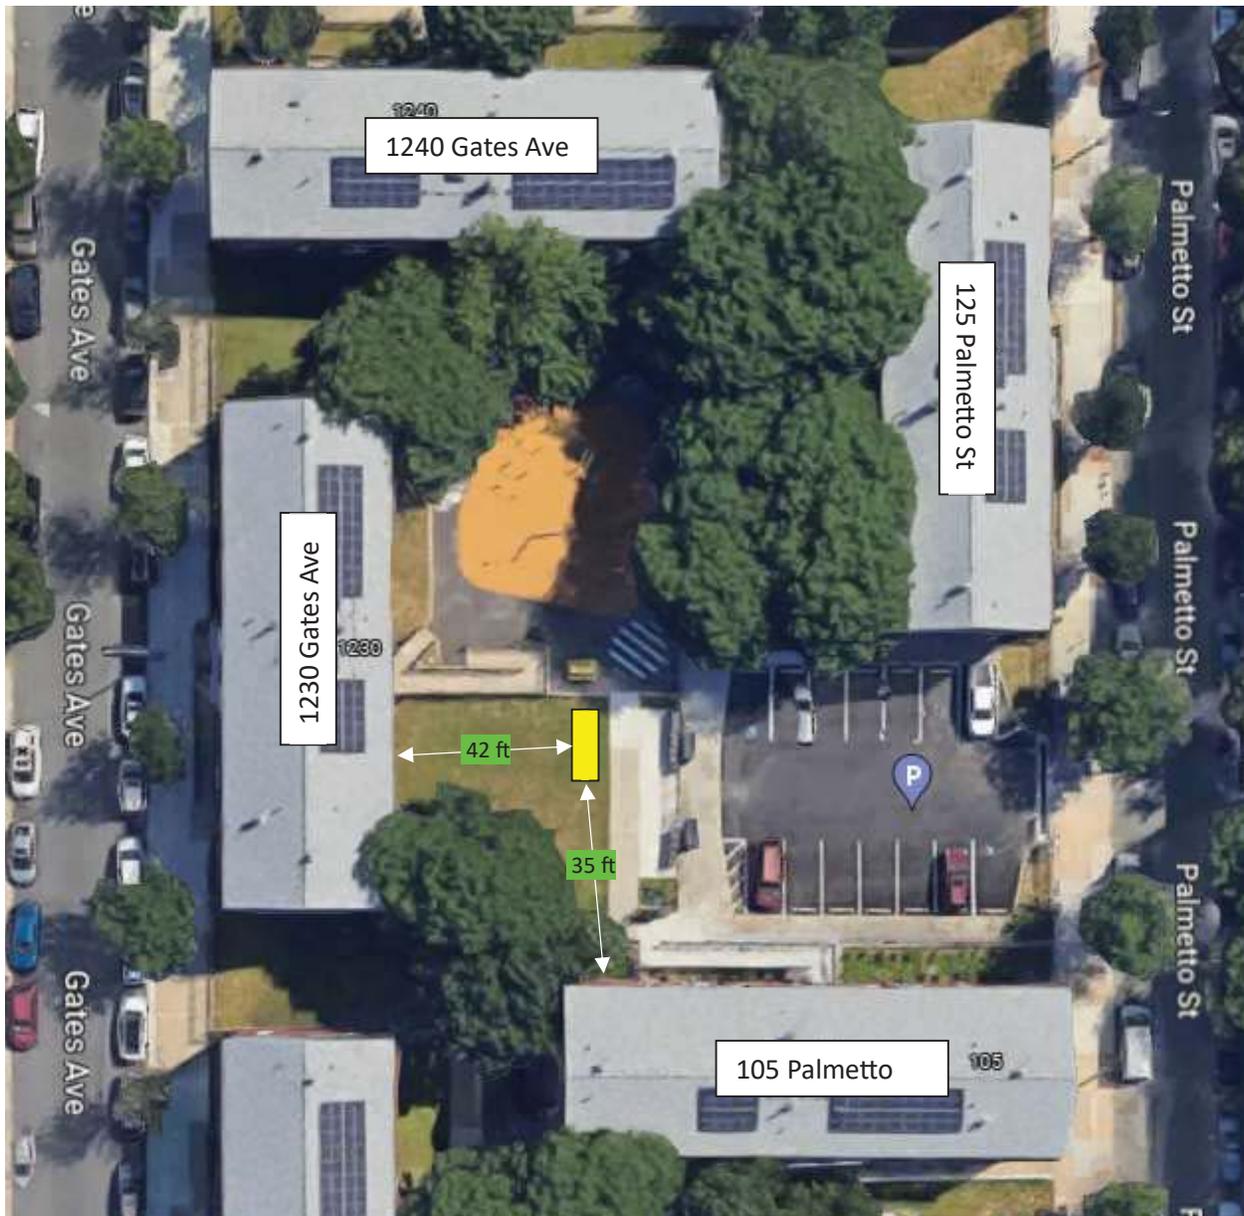
7. Pod B-2 is to serve 3 buildings: 1240 Gates Avenue, 1230 Gates Avenue, and 125 Palmetto Street
 - Tree impact: none
 - Playground equipment impact: none
 - Approximately 35 ft from closest building, 105 Palmetto

Pod B-2 shown in yellow will be approximately 240 SF; not drawn to scale

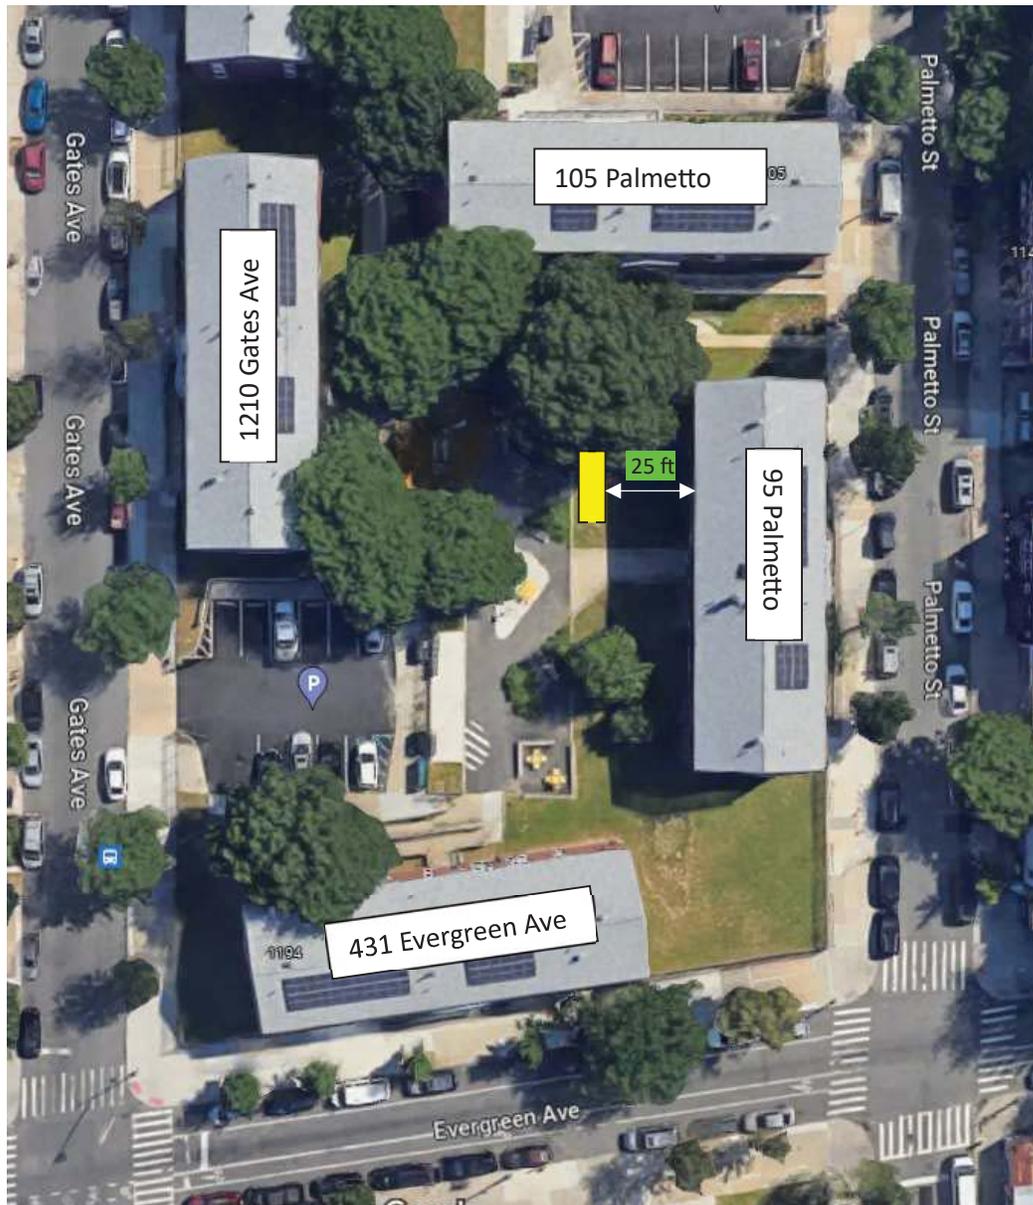
8. Pod B-3 is to serve 4 buildings: 1210 Gates Avenue, 105 Palmetto Street, 95 Palmetto Street, and 431 Evergreen Avenue
- Tree impact: adjacent to a tree but none to be impacted or removed
 - Playground equipment impact: none
 - Approximately 25 ft from closest building, 95 Palmetto

Pod B-3 shown in yellow will be approximately 240 SF; not drawn to scale

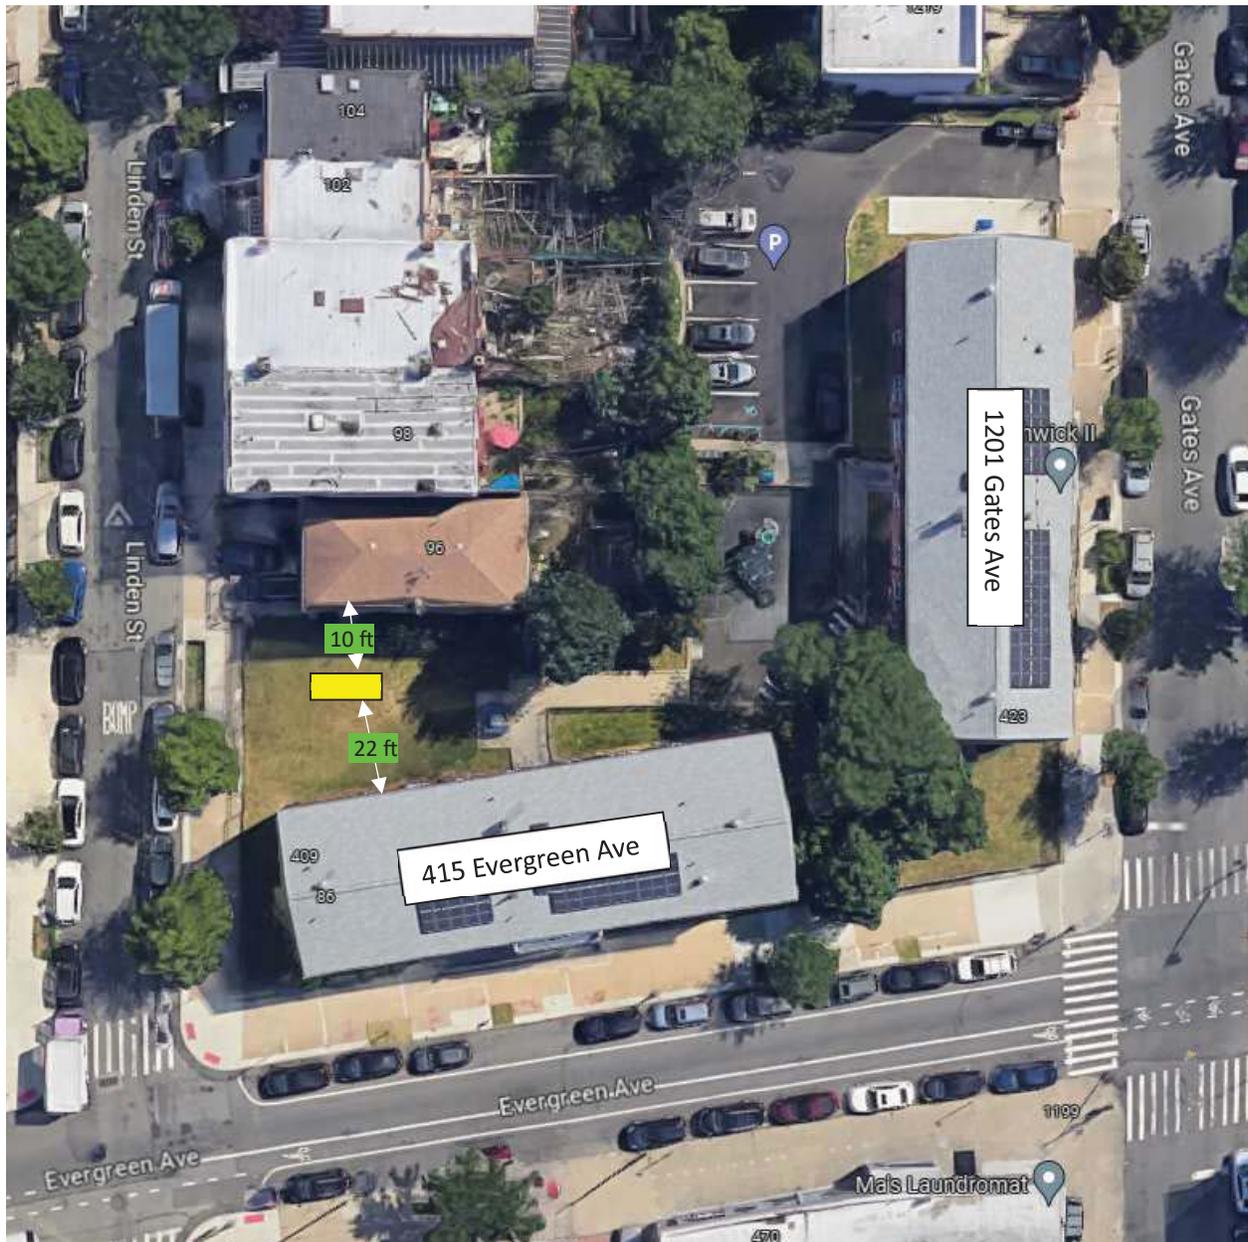
9. Pod B-4 is to serve 2 buildings: 1201 Gates Avenue, 415 Evergreen Avenue
- Tree impact: none
 - Playground equipment impact: none
 - Approximately 22 ft from closest project building, 415 Evergreen

Pod B-4 shown in yellow will be approximately 160 SF; not drawn to scale

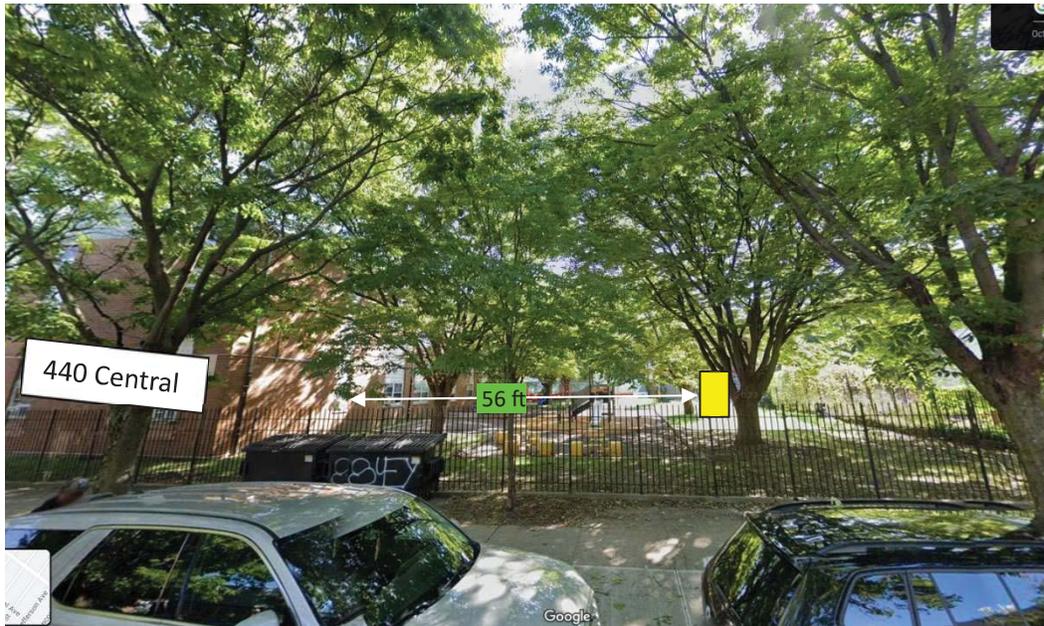
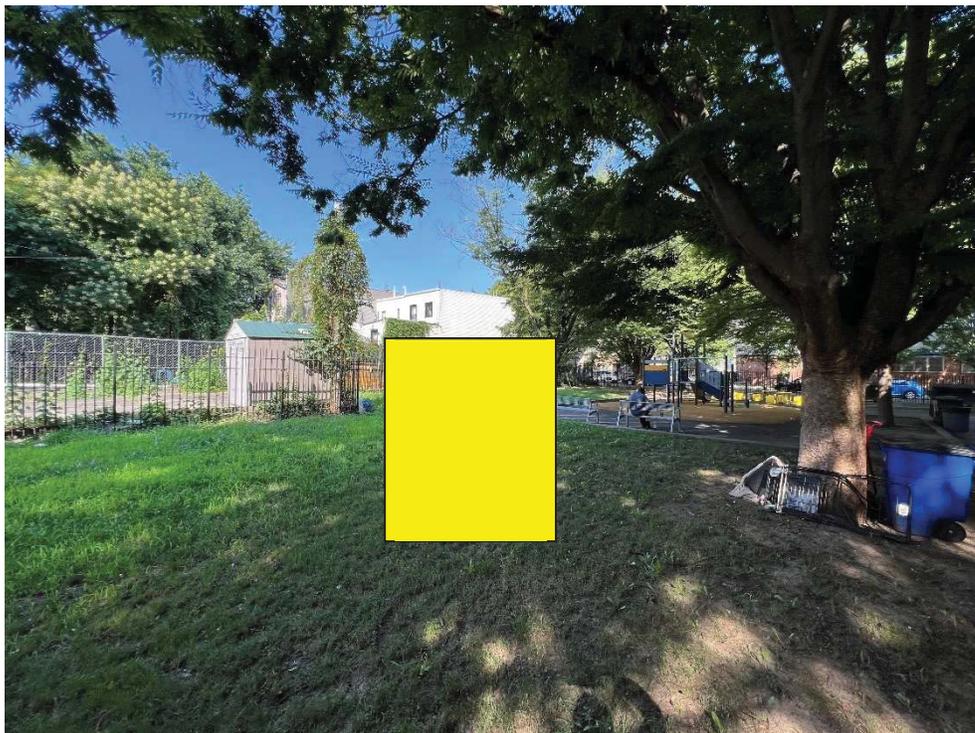
10. Pod B-5 is proposed to serve 1 building: 440 Central Avenue
- Tree impact: adjacent to two trees but none to be impacted or removed
 - Playground equipment impact: none
 - Approximately 56 ft from closest building, 440 Central

Pod B-5 shown in yellow will be situated between two trees and be approximately 160 SF; not drawn to scale. Alternate view below.

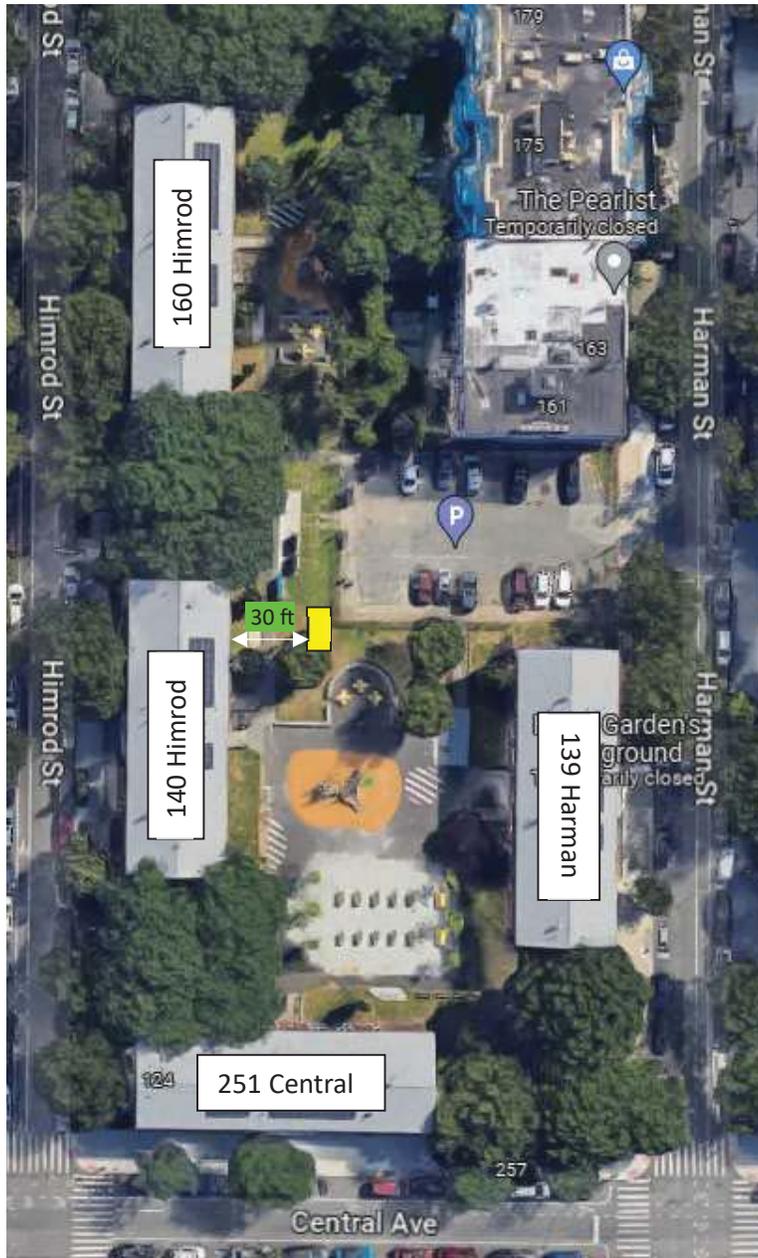
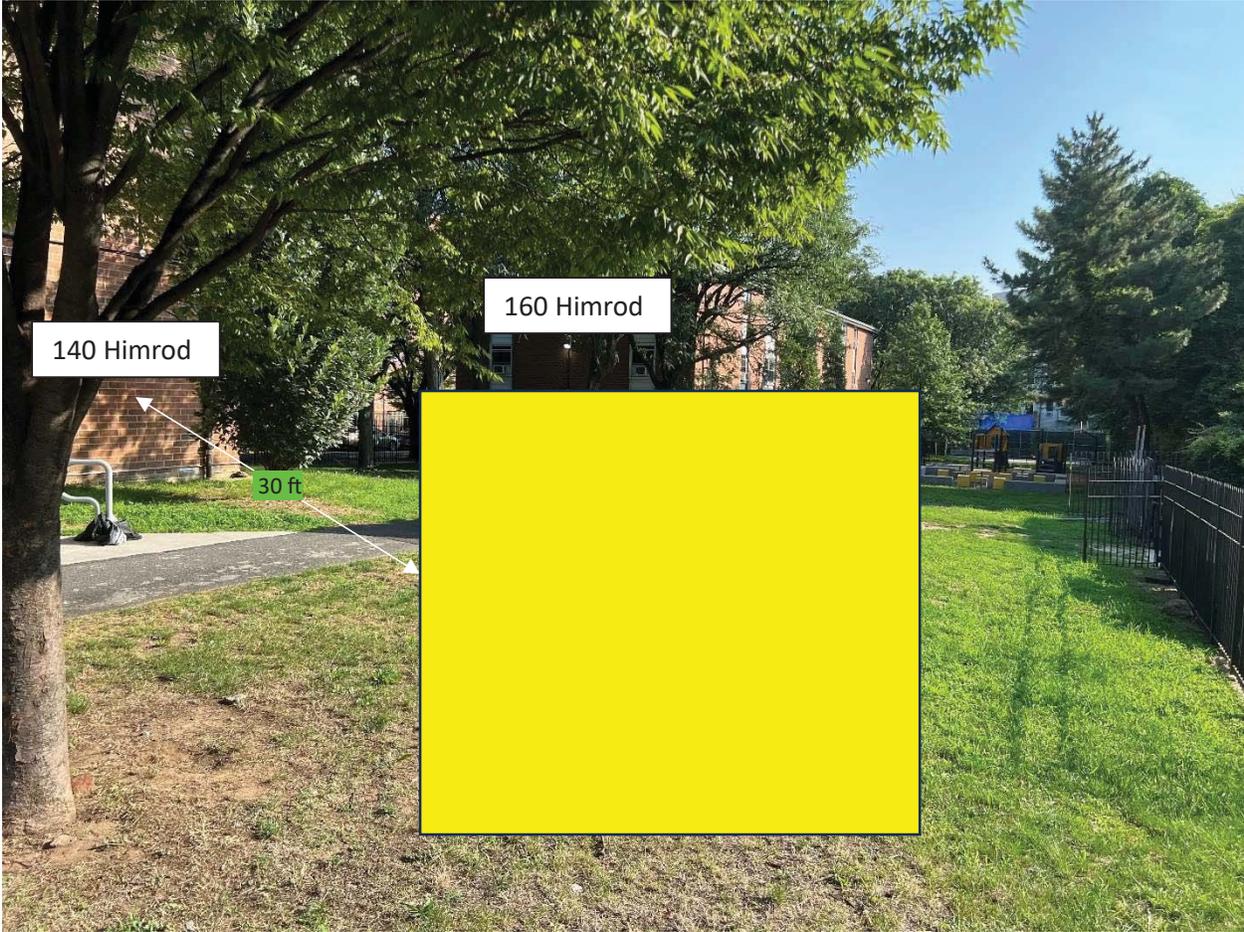
11. Pod C-1 is to serve 4 buildings: 160 Himrod Street, 140 Himrod Street, 139 Harman Street, and 251 Central Avenue

- Tree impact: adjacent to a tree, but none expected to be impacted
- Playground equipment impact: none
- Approximately 30 ft from closest building, 140 Himrod

Pod C-1 shown in yellow will be adjacent to a nearby tree and will be approximately 240 SF; not drawn to scale.

Alternate view of Pod C-1 adjacent to tree shown below; not drawn to scale

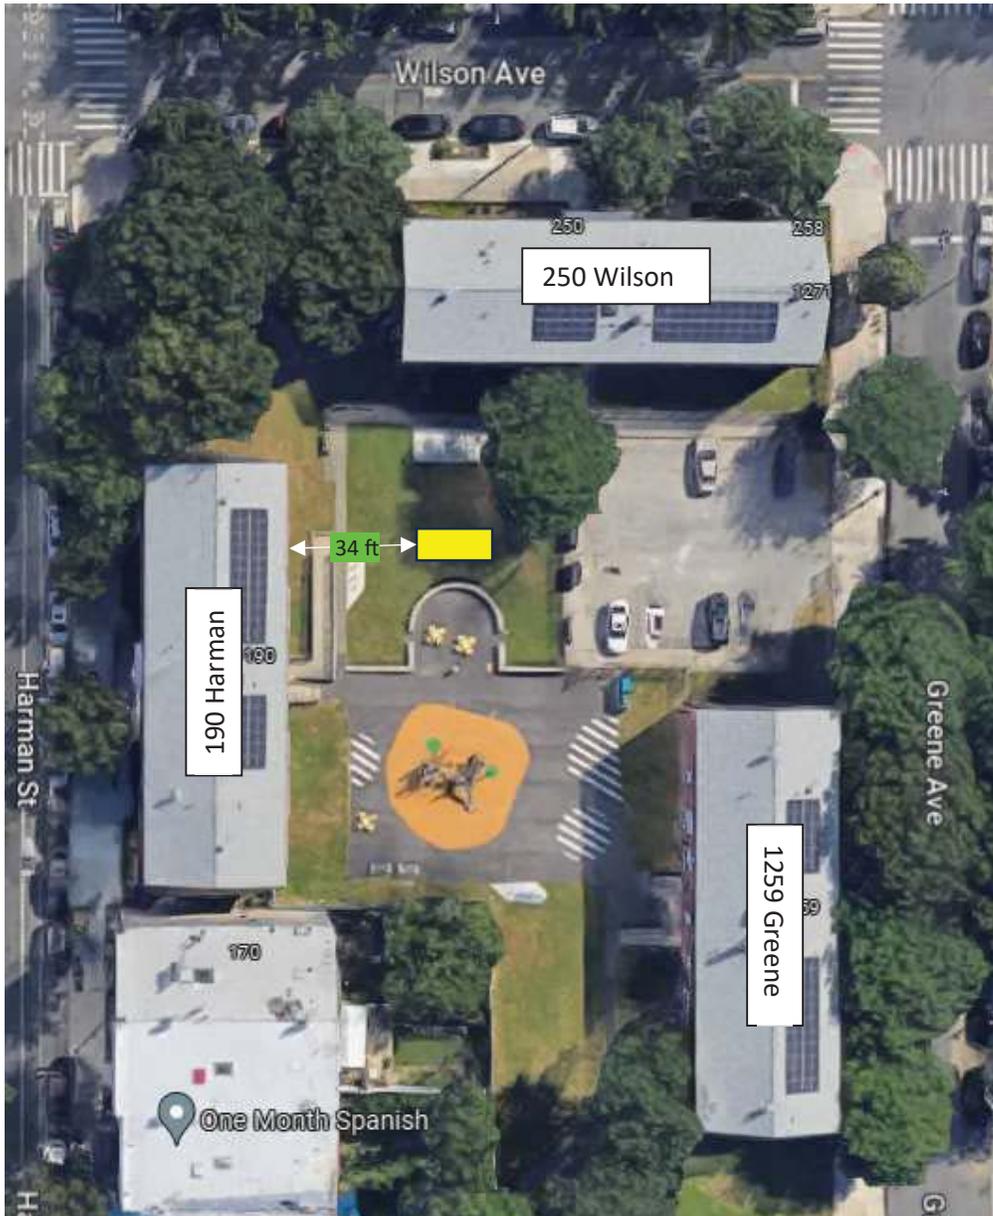
12. Pod C-2 is to serve 3 buildings: 250 Wilson Avenue, 190 Harman Street, and 1259 Greene Avenue
- Tree impact: none
 - Playground equipment impact: none
 - Approximately 34 ft from closest building, 190 Harman

Pod C-2 shown in yellow will be approximately 240 SF; not drawn to scale.

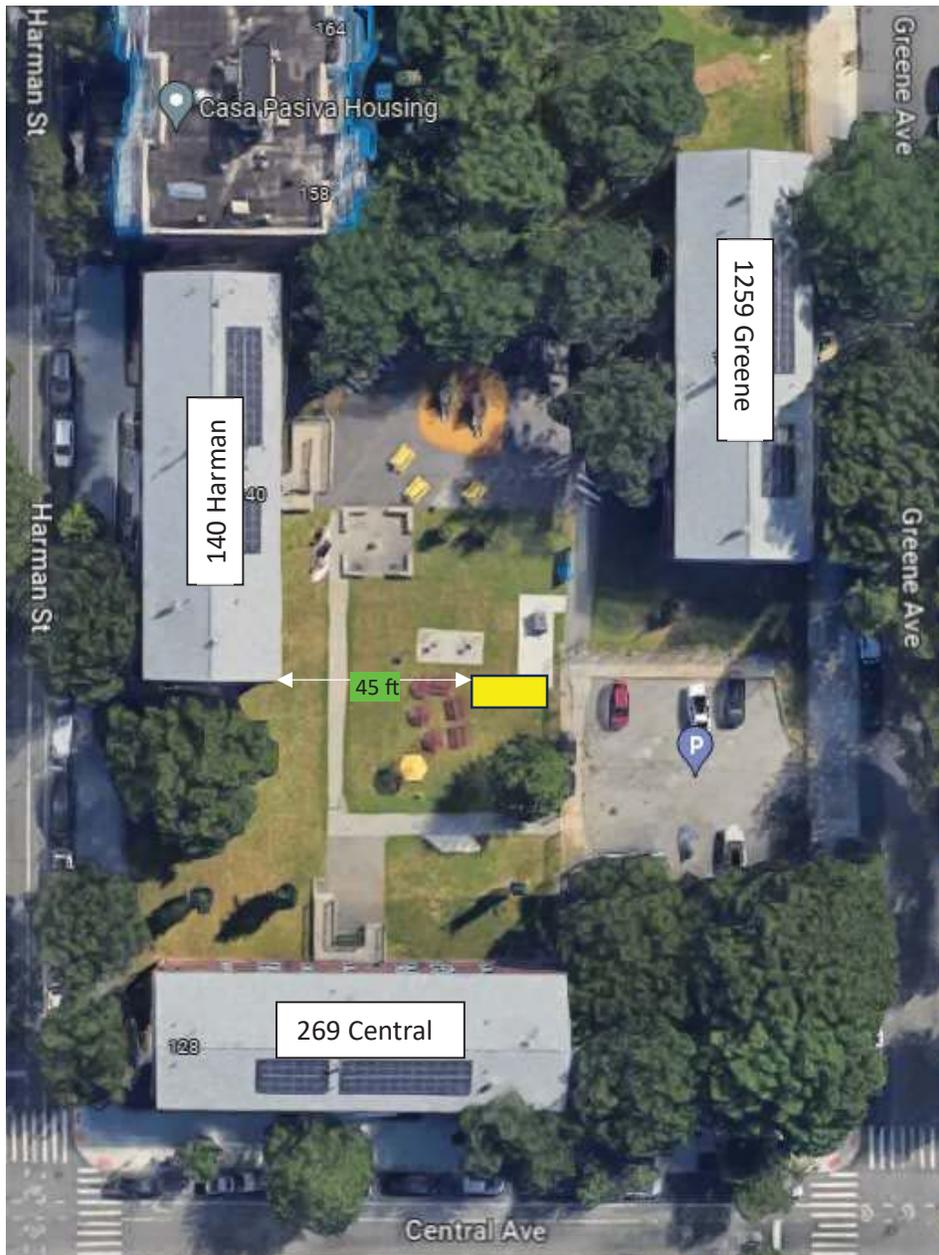
13. Pod C-3 is to serve 3 buildings: 140 Harman Street, 1229 Greene Avenue, and 269 Central Avenue
- Tree impact: adjacent to a tree but no impact expected
 - Playground equipment impact: none; tables to be relocated nearby
 - Approximately 45 ft from closest building, 140 Harman

Pod C-3 shown in yellow will be approximately 240 SF; not drawn to scale.

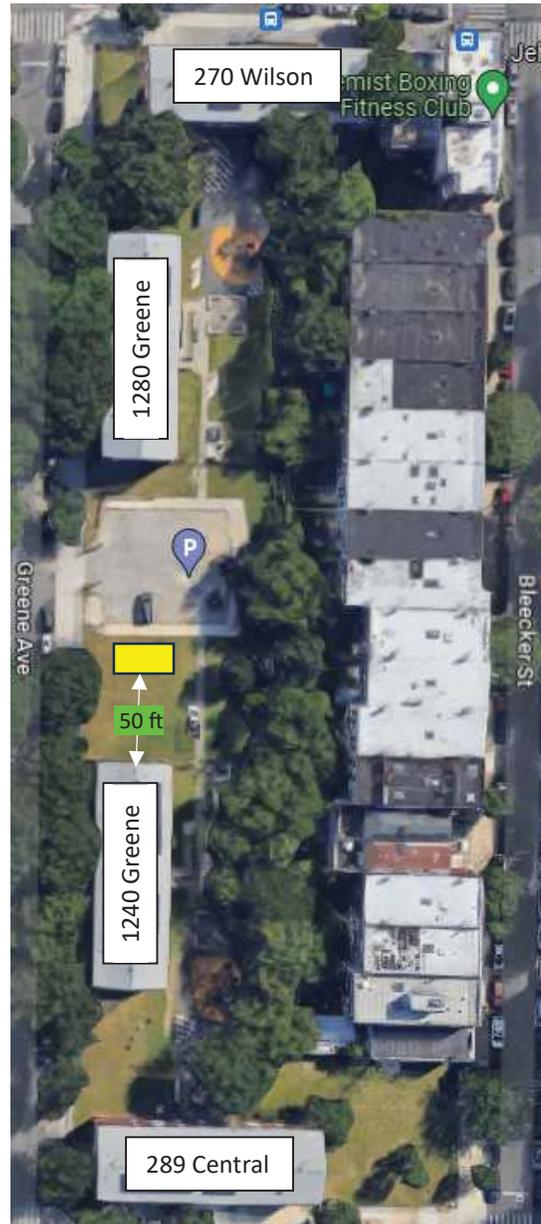
- Tree impact: none
- Playground equipment impact: none
- Approximately 50 ft from closest building, 1240 Greene

Pod C-4 shown in yellow will be approximately 240 SF; not drawn to scale.
