**Environmental Assessment
Determinations and Compliance Findings for HUD-assisted Projects
24 CFR Part 58**

Hope Gardens: Groups A-E CDBG-DR Storm Resiliency
Multiple Addresses
Brooklyn, New York 11221

HEROS Number: 900000010361422

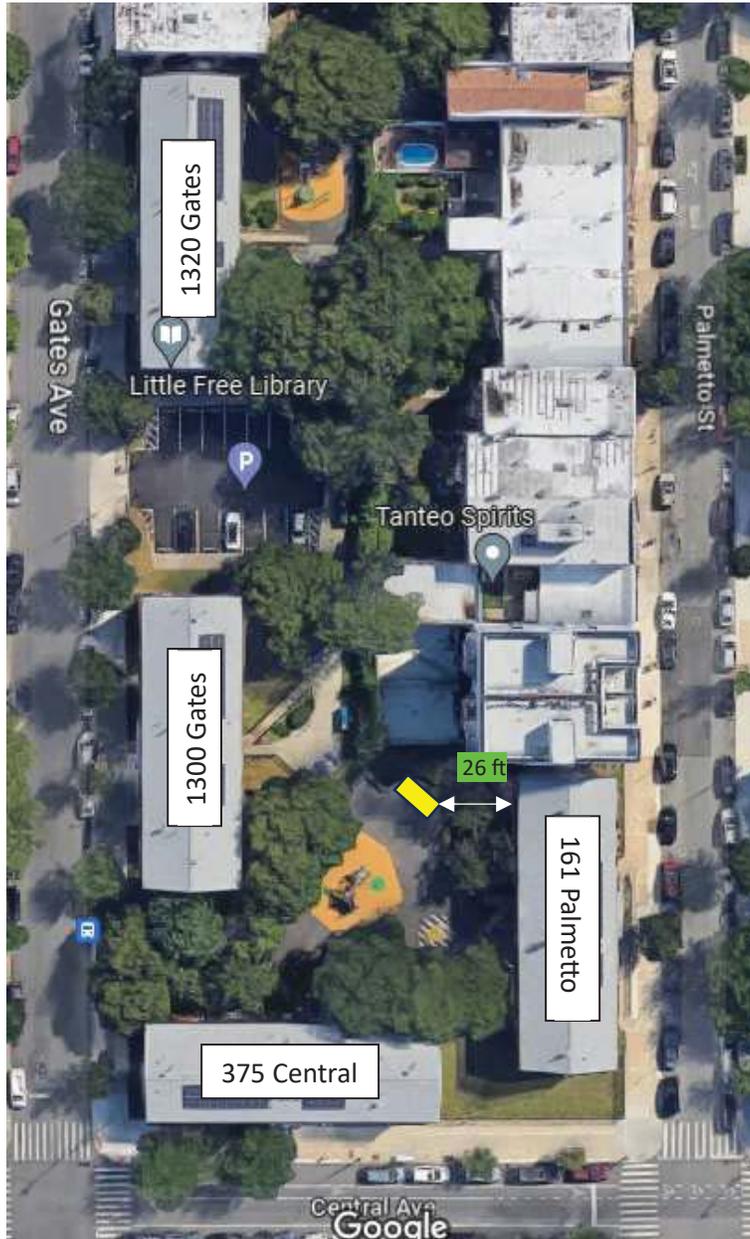
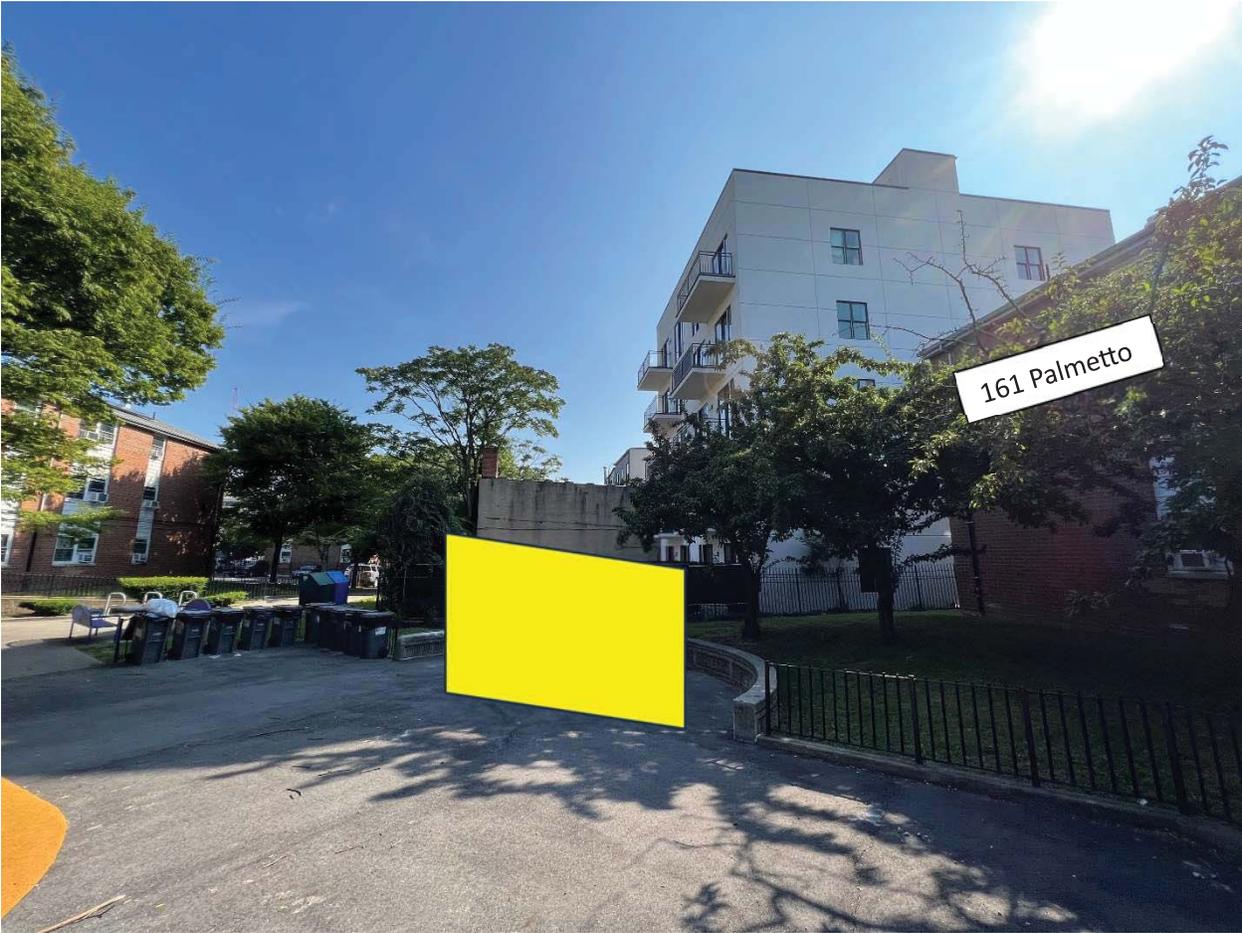
- Tree impact: none; pod to be installed on paved surface
- Playground equipment impact: none
- Approximately 26 ft from closest building, 161 Palmetto

Pod D-1 shown in yellow will be approximately 240 SF; not drawn to scale.

Alternate view of Pod D-1 shown in yellow. To be installed over paved surface; not drawn to scale.

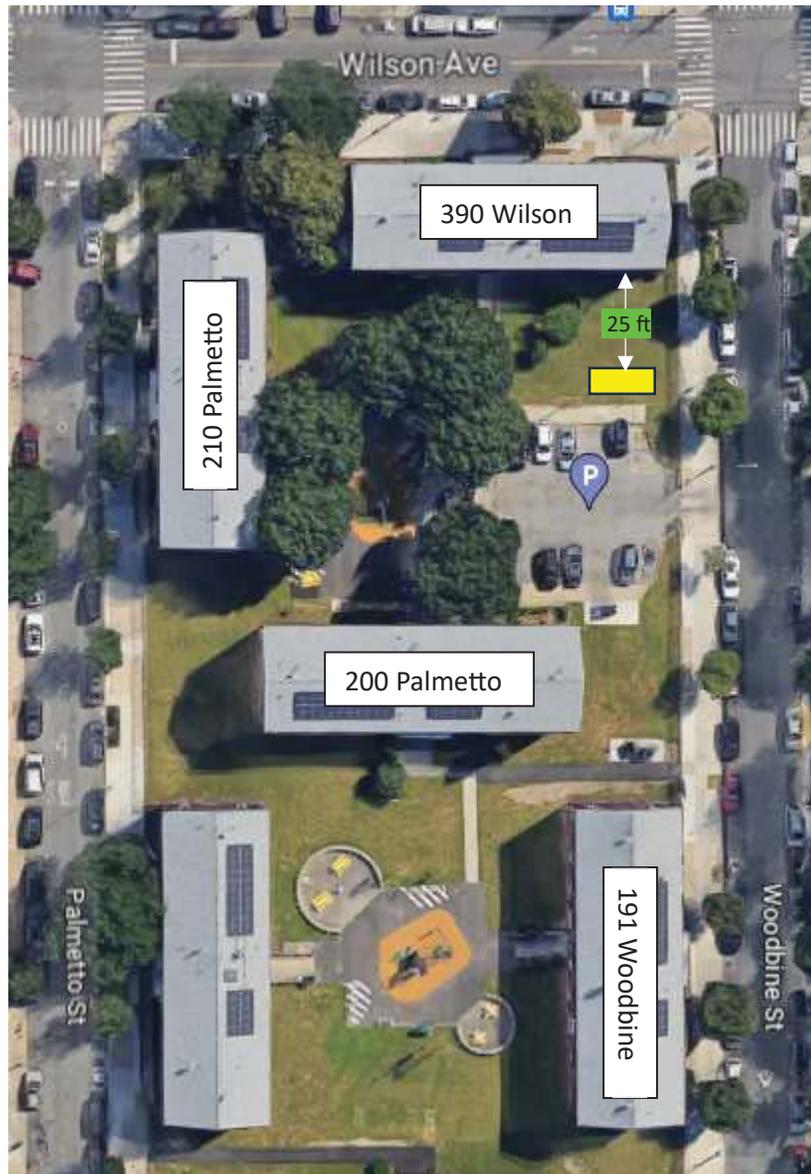
16. Pod D-2 is to serve 4 buildings: 210 Palmetto Street, 200 Palmetto Street, 390 Wilson Avenue, and 191 Woodbine Street

- Tree impact: none
- Playground equipment impact: none
- Approximately 25 ft from closest building, 390 Wilson

Pod D-2 shown in yellow will be approximately 240 SF; not drawn to scale.

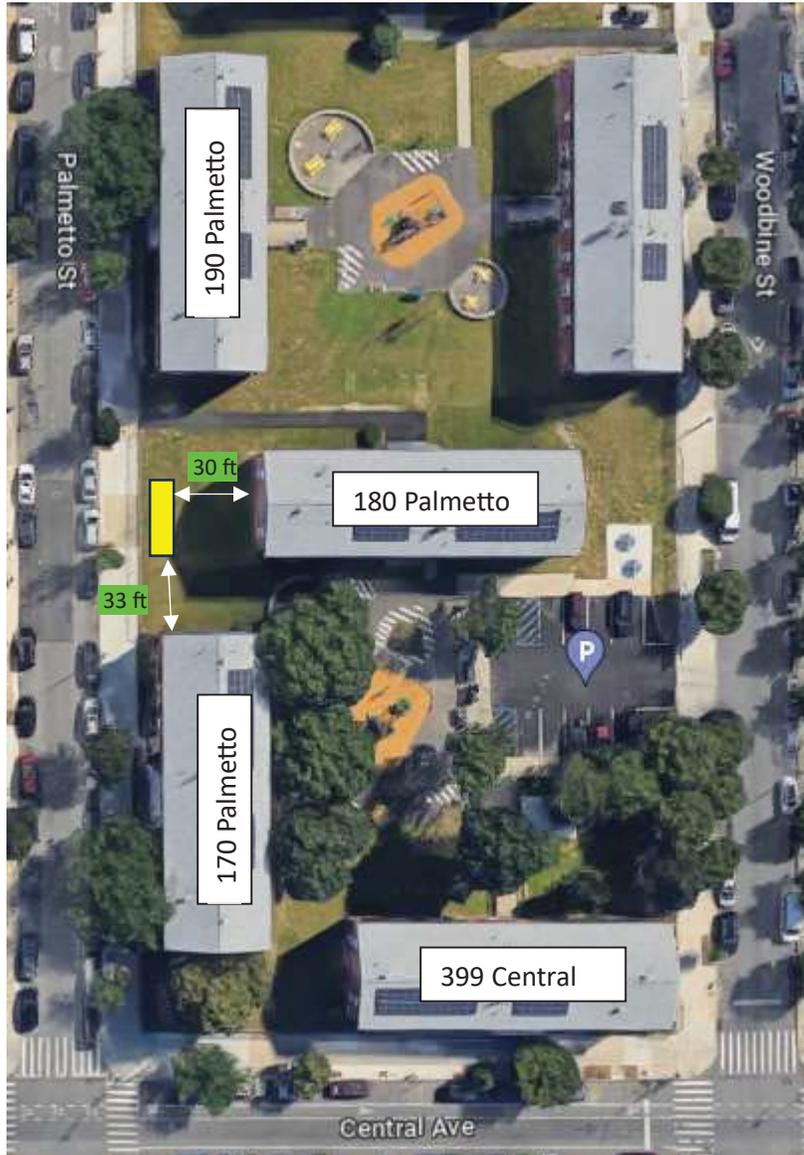
- Tree impact: none
- Playground equipment impact: none
- Approximately 30ft from closest building, 180 Palmetto

Pod D-3 shown in yellow will be approximately 240 SF; not drawn to scale.

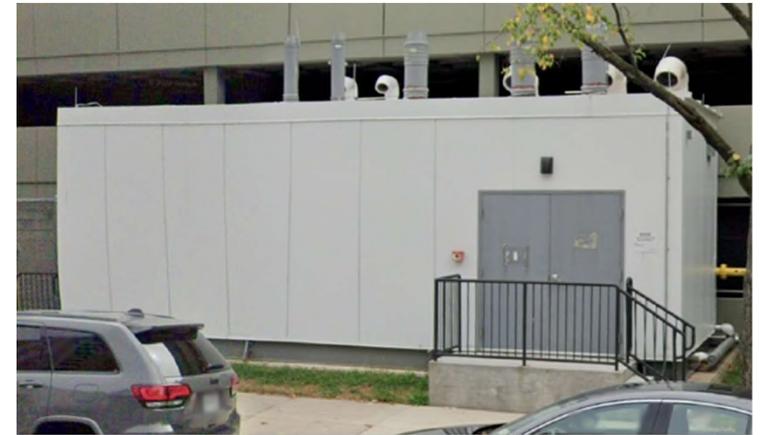
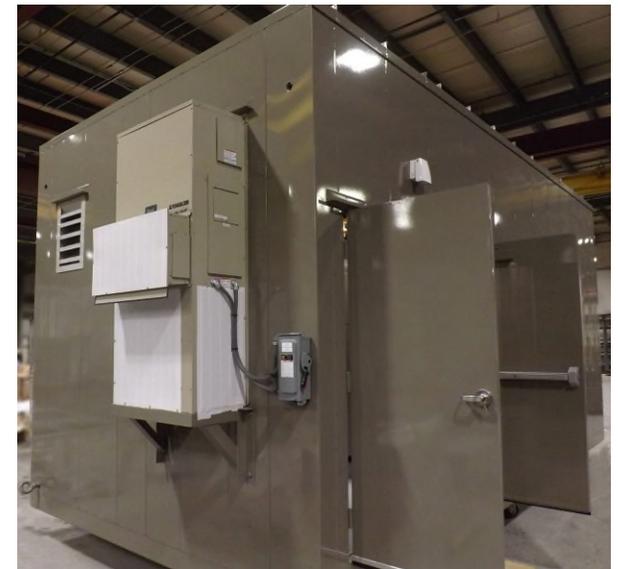
- Replace below-grade mechanical and electrical equipment for 52 buildings
 - Groups A-D: 17 above grade boiler pods to serve 1-4 buildings each
 - Group E: 5 boiler pods on roof tops
 - Pod sizes are 200-300SF
- Electrical equipment at risk of flooding to be moved; trenching to connect utilities
- Backwater valves to be installed at high-risk buildings to mitigate flooding
- Will not impact any parking spaces or playgrounds; primarily placed on open grass
- Maintain lighting and visibility around pods
- Will result in more stable hot water heating

Sample boiler pod

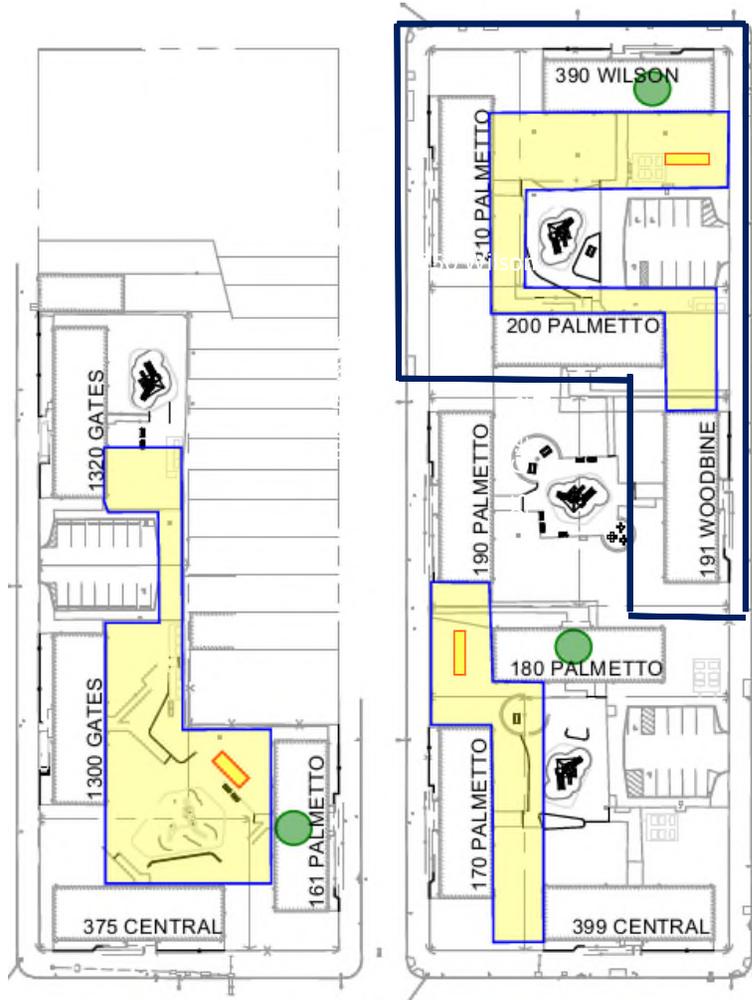
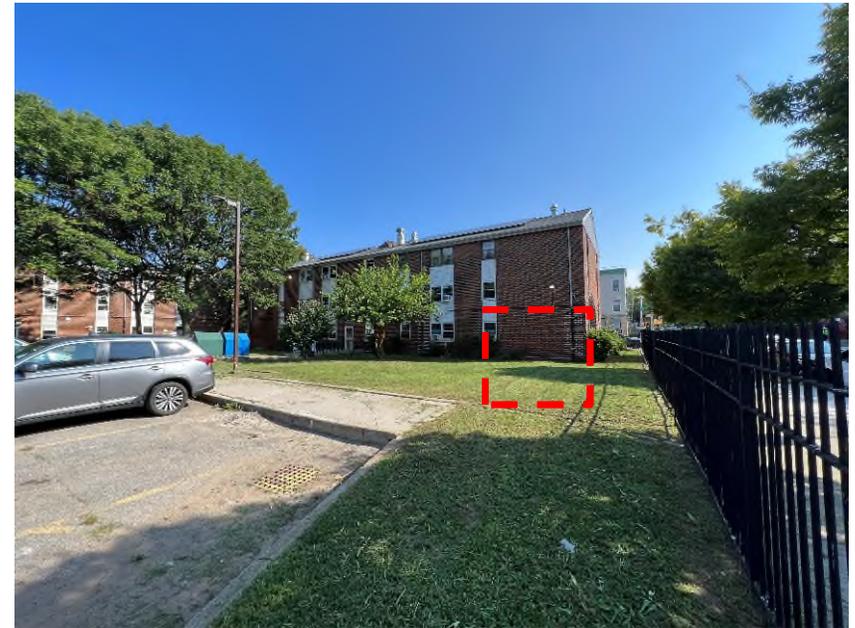
Proposed Pod Location at Group D

Approximate proposed pod location to serve 4 buildings:
390 Wilson, 210 Palmetto, 200 Palmetto, 191 Woodbine

Not to scale – for illustrative purposes only

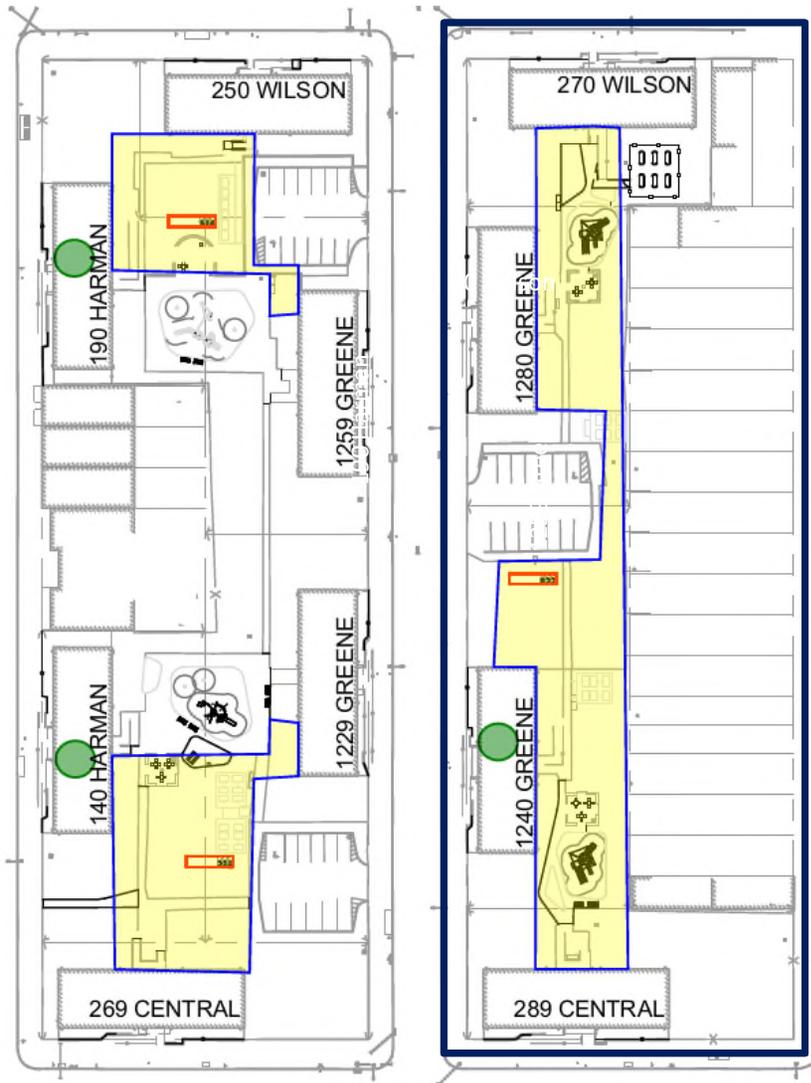
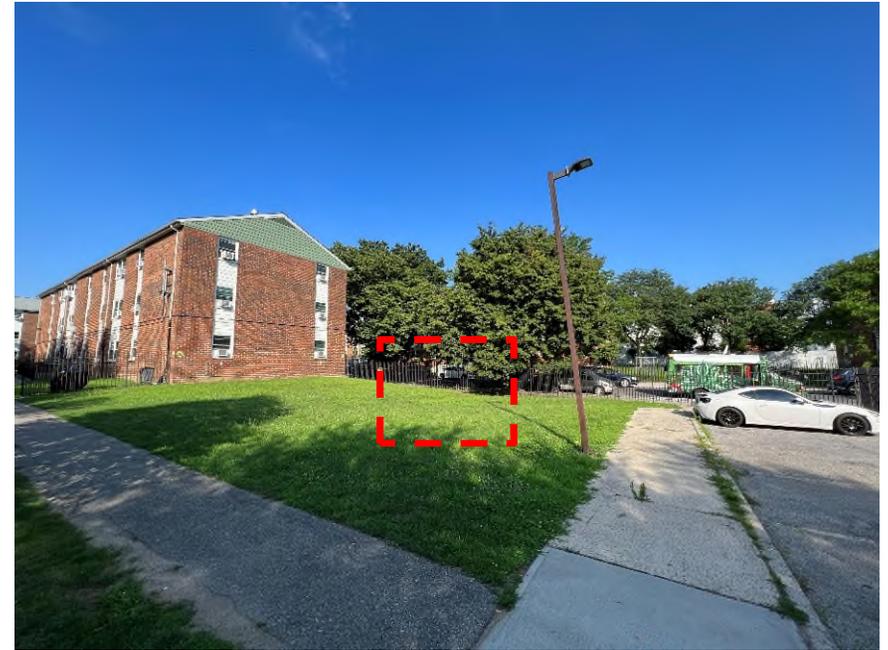
Proposed Pod Location at Group C

Approximate proposed pod location to serve 4 buildings:
270 Wilson, 1280 Greene, 1240 Greene, 289 Central

Not to scale – for illustrative purposes only
