9.11 VILLAGE OF NELSONVILLE

9.11.1 VILLAGE OF NELSONVILLE PROJECT DESCRIPTION

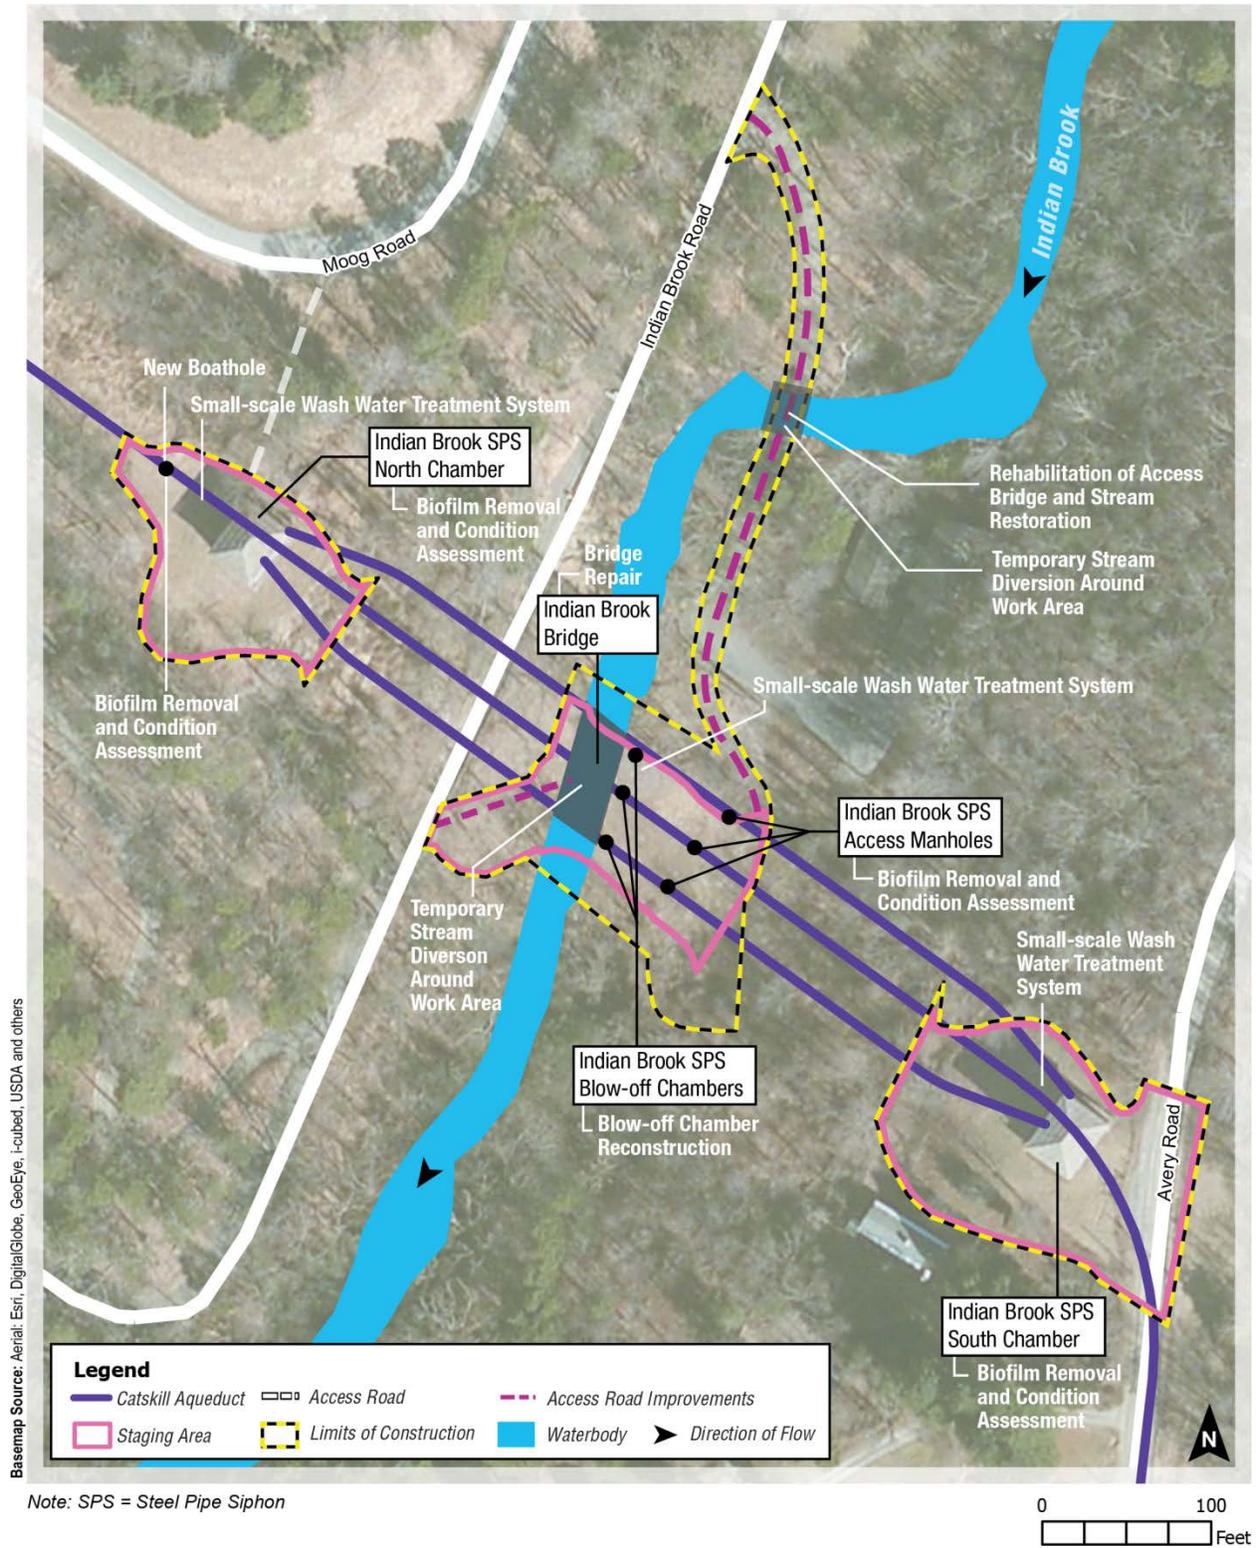
Figure 9.12-4: Site Plan – Indian Brook Road Study Area

Preparation of the new boathole upstream of the North Siphon Chamber would occur during the same time period. The work would consist of the excavation of approximately 45 cubic yards of soil and construction of a cast-in-place concrete collar. Boathole installation, which requires unwatering of the aqueduct to tie into the crown of the cut-and-cover tunnel, would take place during the second 10-week shutdown in fall ~~2019~~²⁰¹⁸.

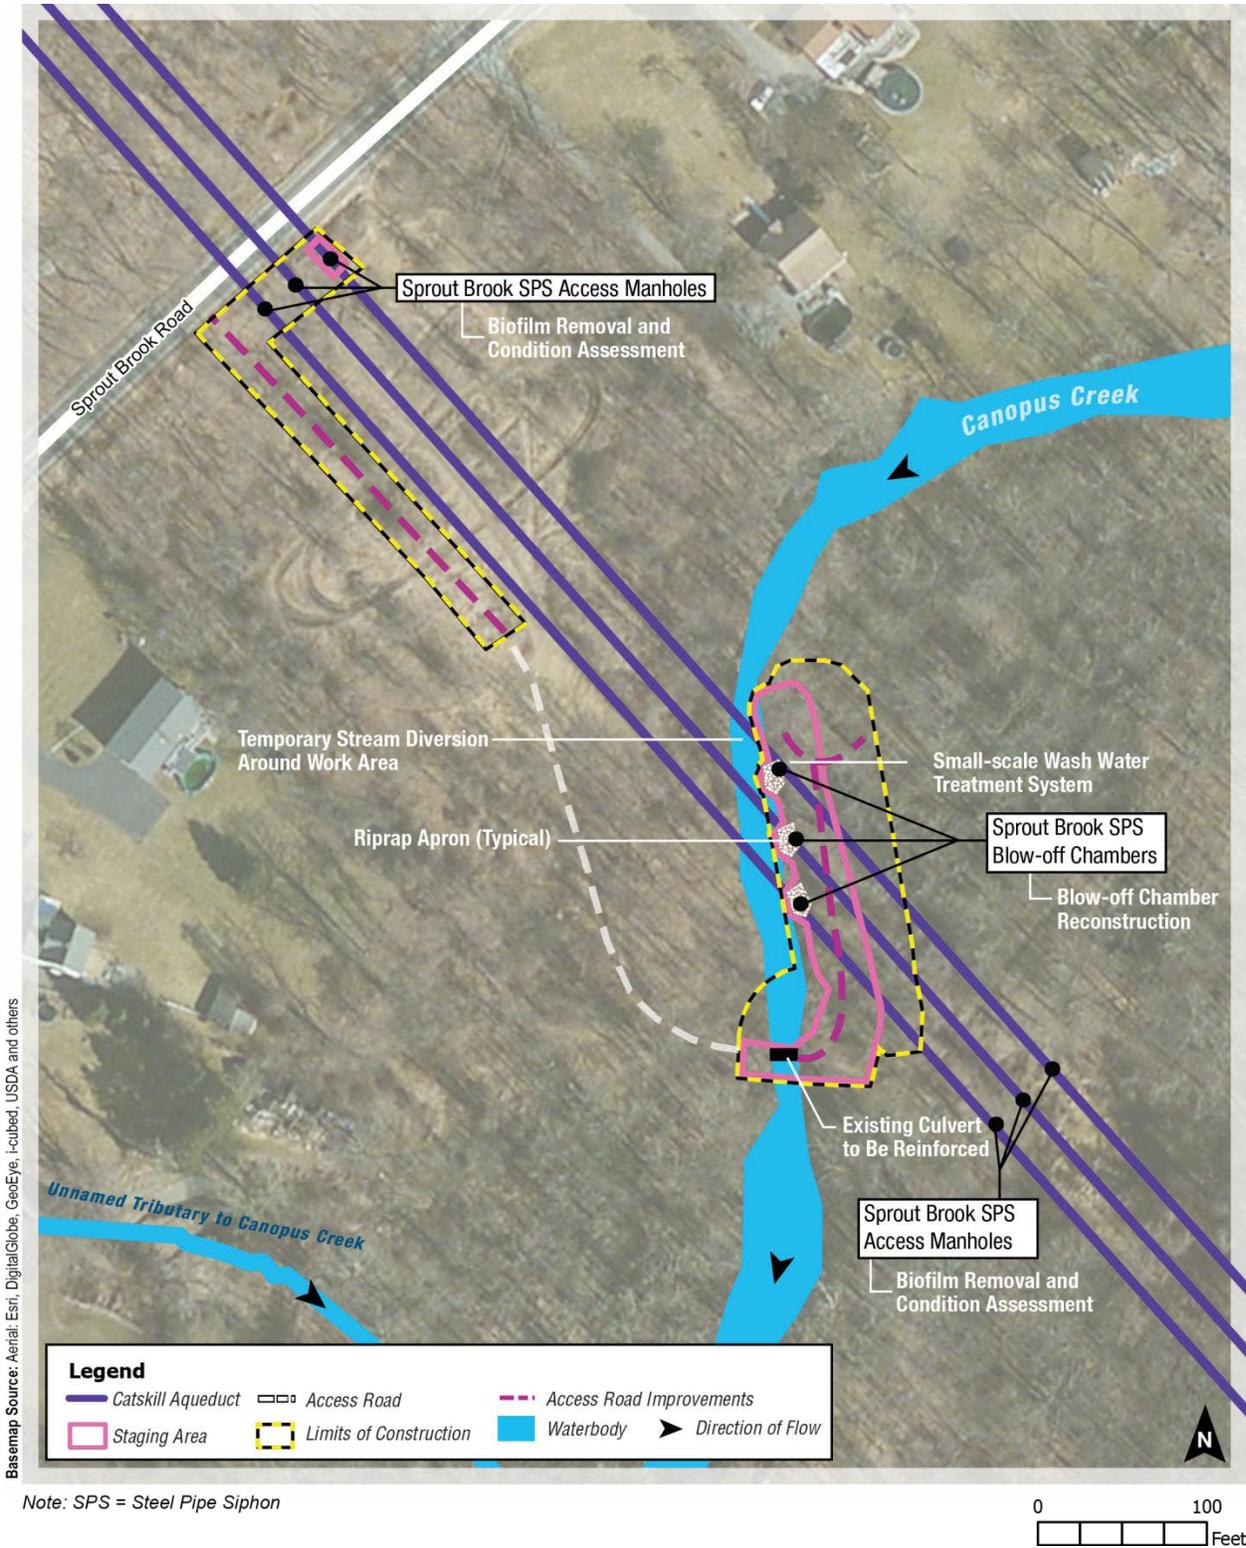
Figure 9.12-24: Site Plan for Sprout Brook SPS Blow-off Chambers – Sprout Brook Road Study Area

Restoration and protection of the portion of Canopus Creek adjacent to the Blow-off Chambers would also occur in summer ~~2019~~2018. The work would include regrading, and installing permanent riprap aprons to repair bank erosion and minimize future bank erosion at this location. To ensure a dry working environment, a temporary stream diversion would be installed, serving to partially

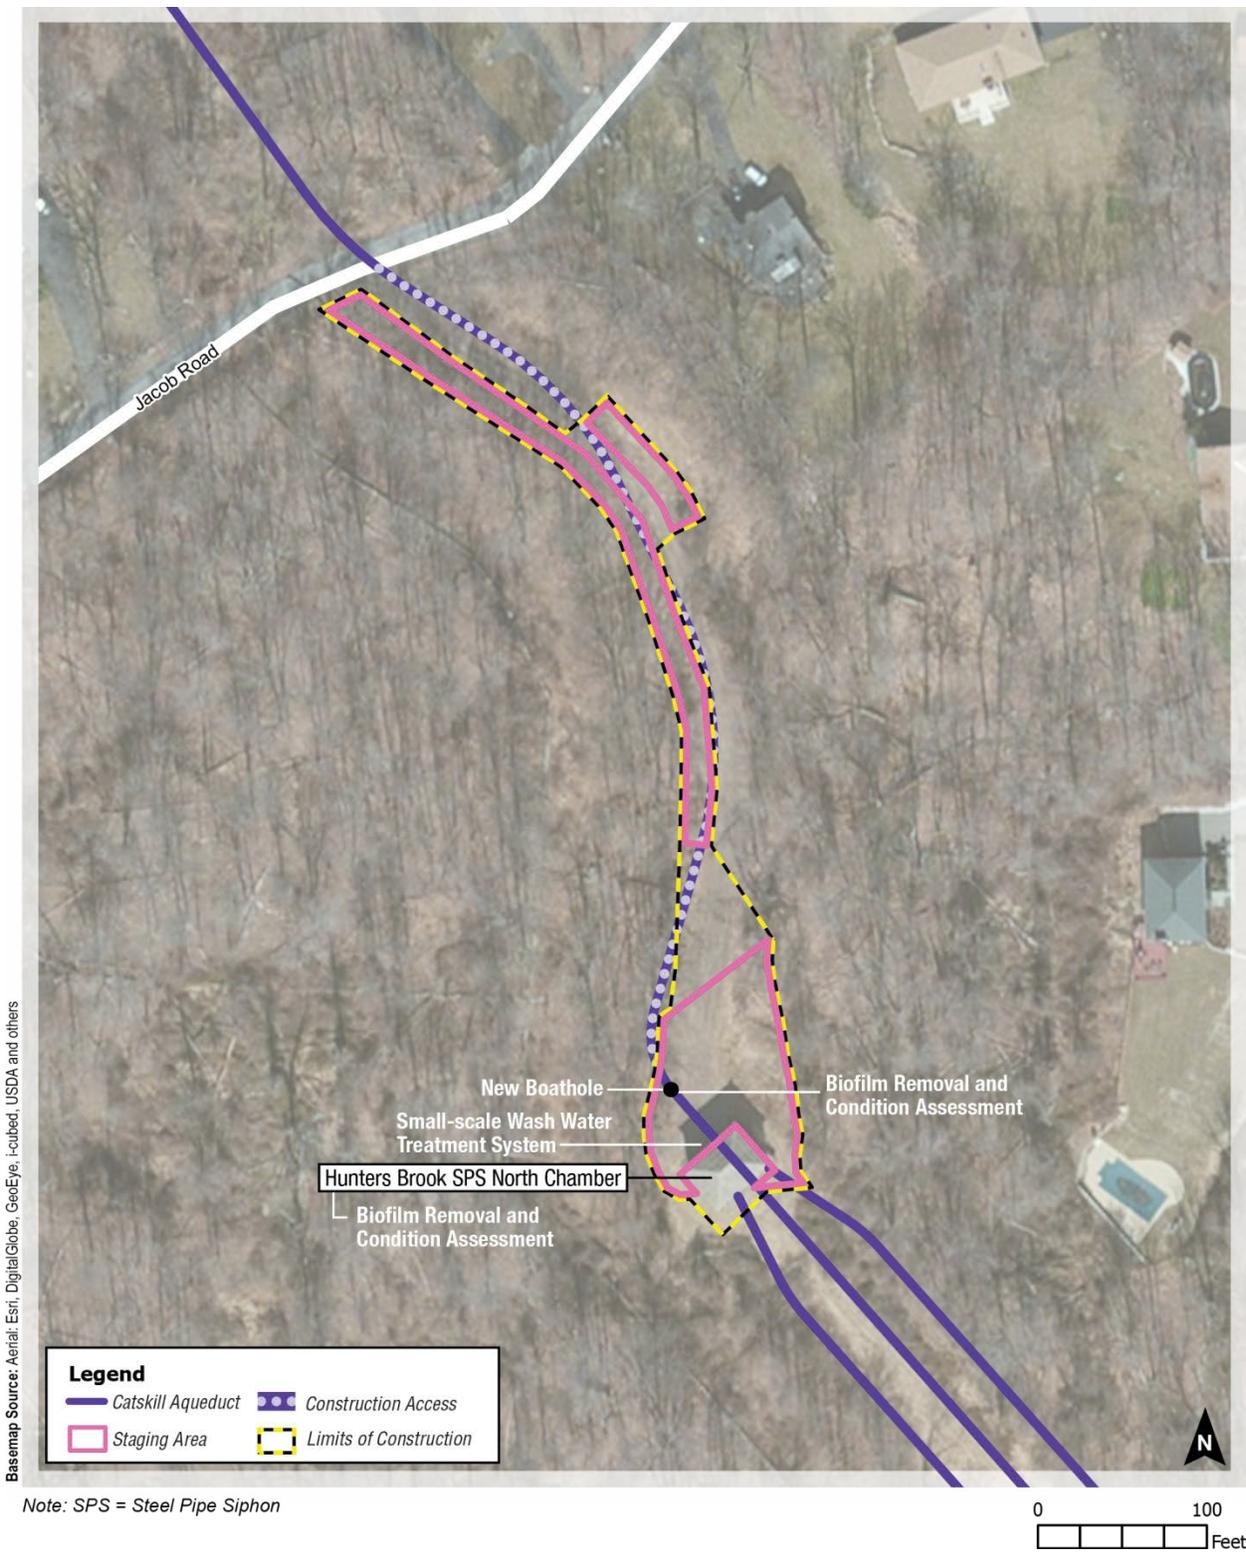
Figure 9.14-6: Site Plan for Hunters Brook SPS North Chamber – Jacob Road Study Area

Work in the study area would begin with staging and access improvements in summer ~~2019~~2018. At the entrance off Jacob Road, grading of approximately 7,100 square feet would be required to facilitate loading and unloading of heavy equipment restricted from traveling over the cut-and-cover tunnel. To the north of Hunterbrook Road, all-terrain vehicle access to the set of existing access manholes would be provided. Improvements would also involve gravel placement for leveling and erosion control on the shoulder of White Hill Road. The removal of approximately 25 trees may be required within the Jacob Road Study Area.
