**NYC Parks**

***Equestrian Statue of  
Theodore Roosevelt***  
**by James Earle Fraser**  
**Proposed Relocation**  
**Theodore Roosevelt Park, MN**

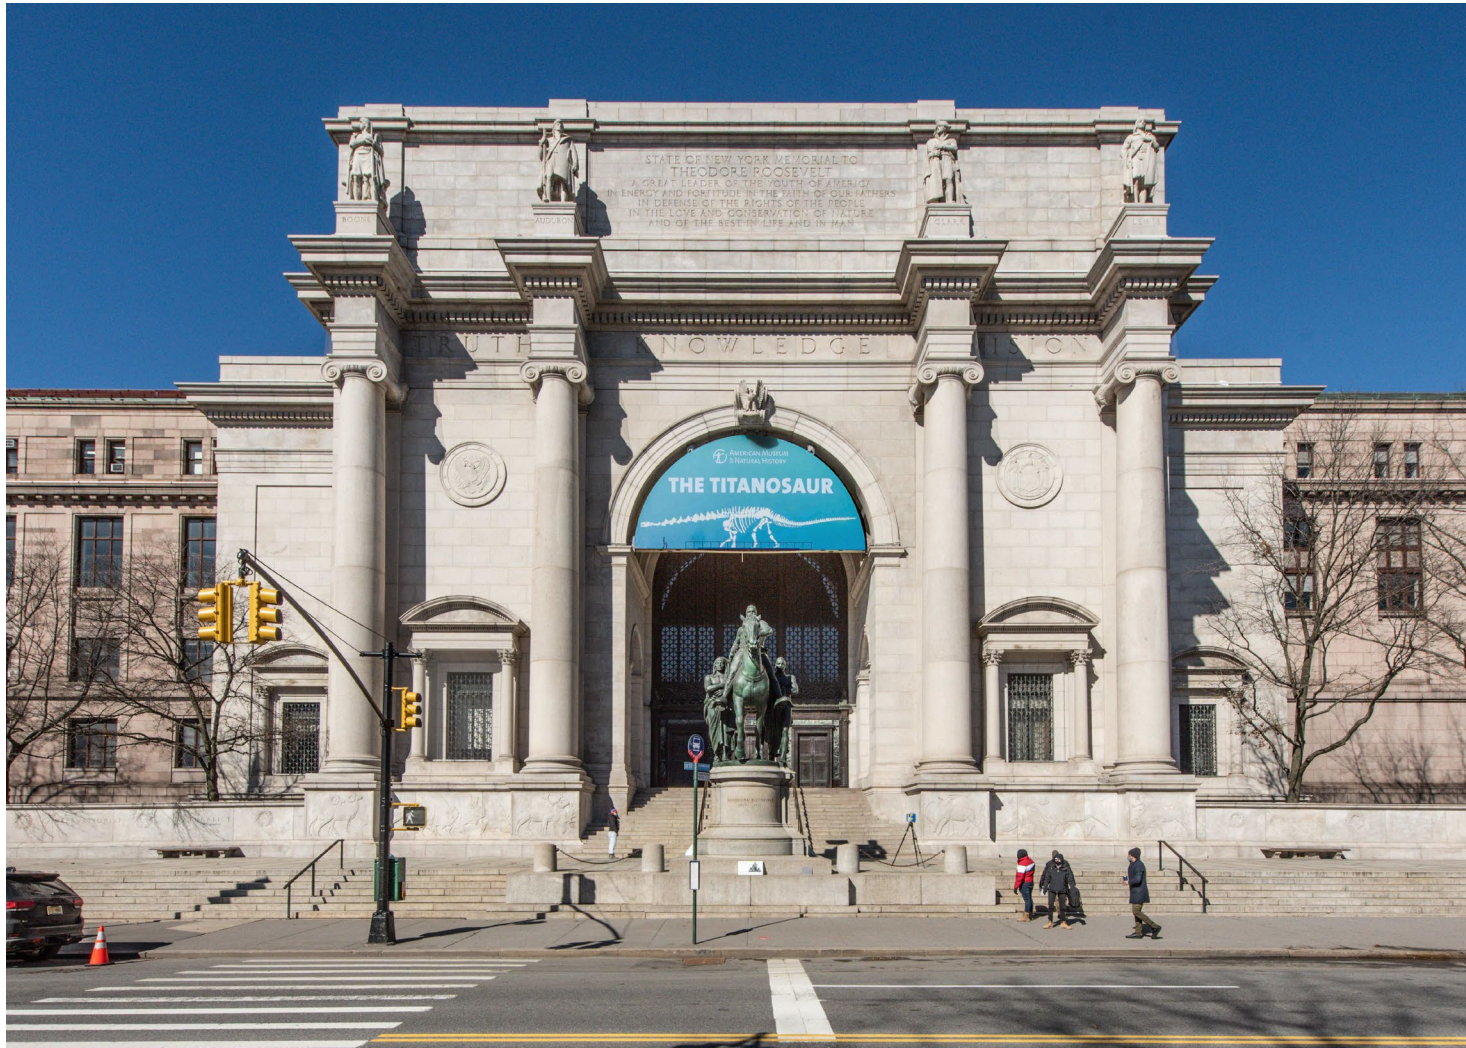
# Theodore Roosevelt Memorial (Existing)

American Museum of Natural History, Central Park West entrance with statue, AMNH

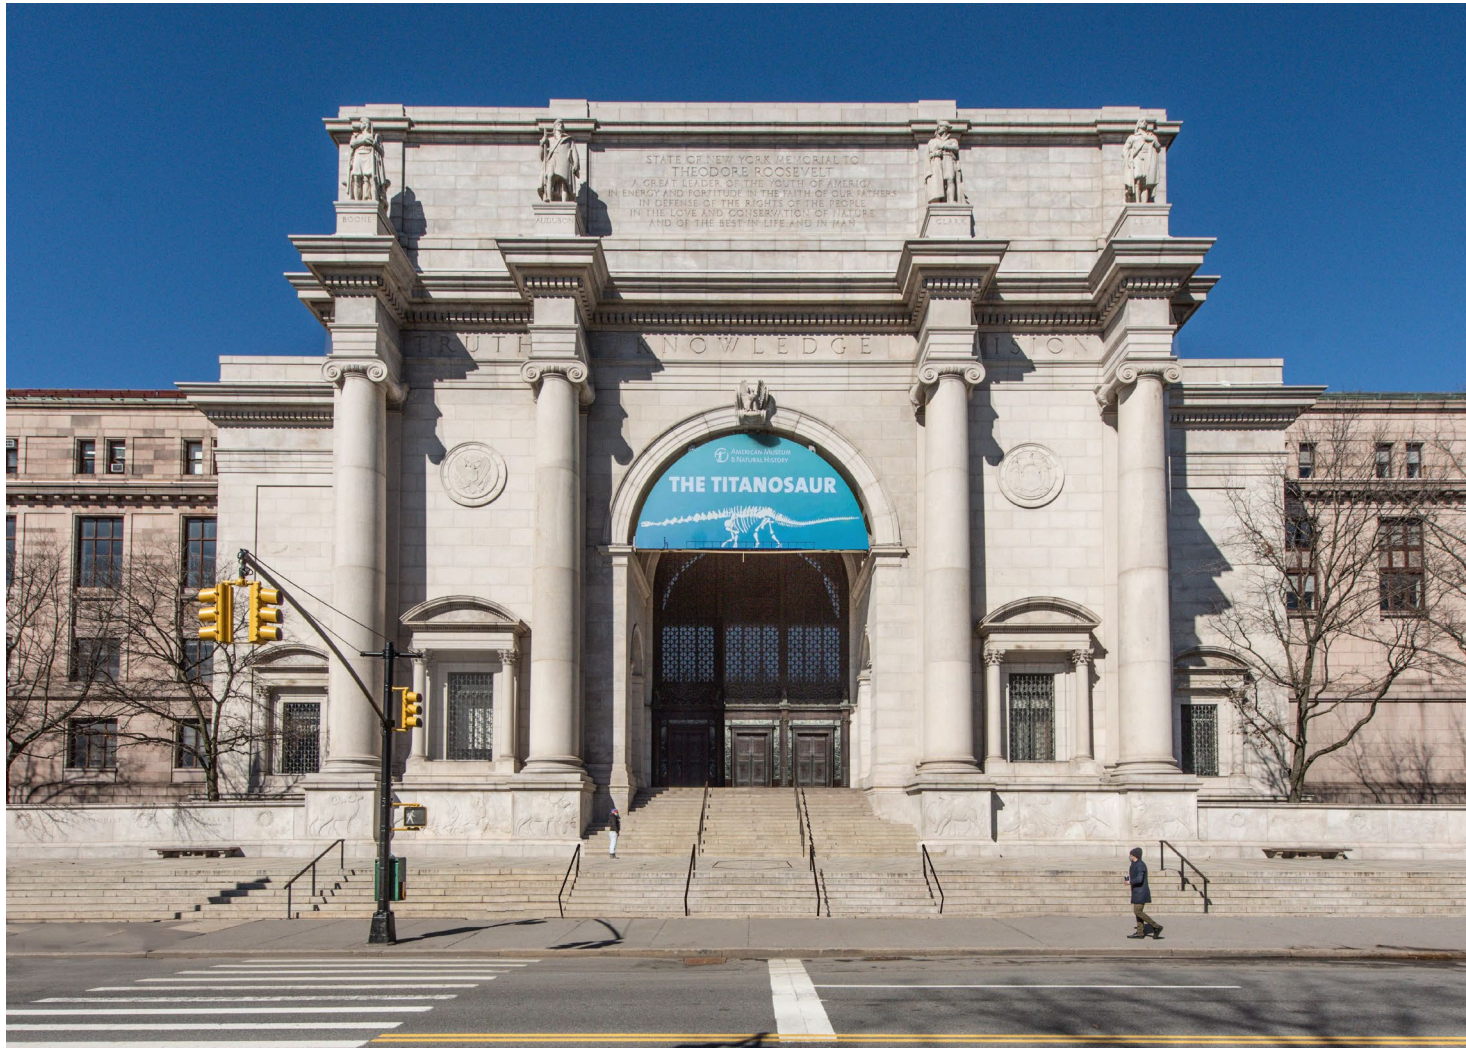
# Theodore Roosevelt Memorial (Proposed)

American Museum of Natural History, Central Park West entrance without statue (Rendering), AMNH

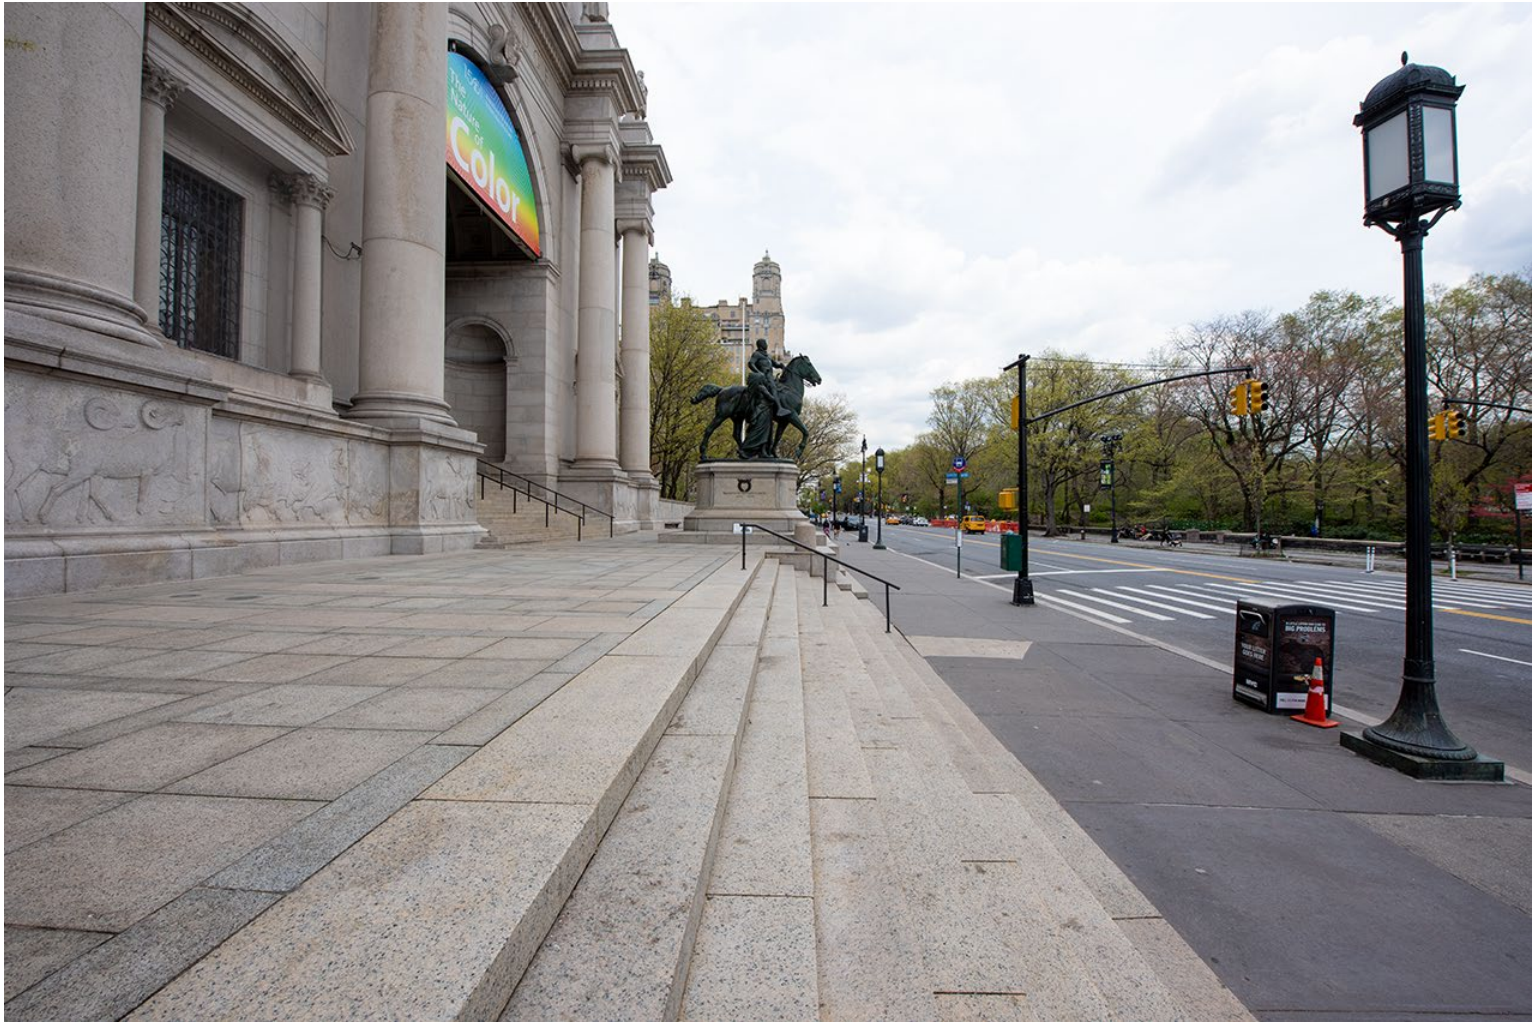
## Plaza View (Existing)

American Museum of Natural History Central Park West entrance, existing stairs and plaza treatment, AMNH

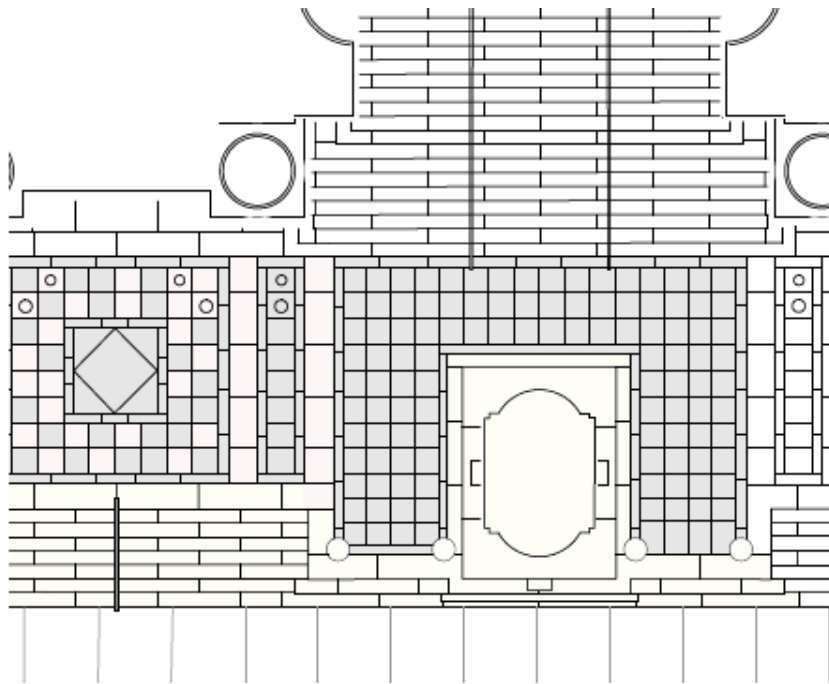
Central Park West

Existing

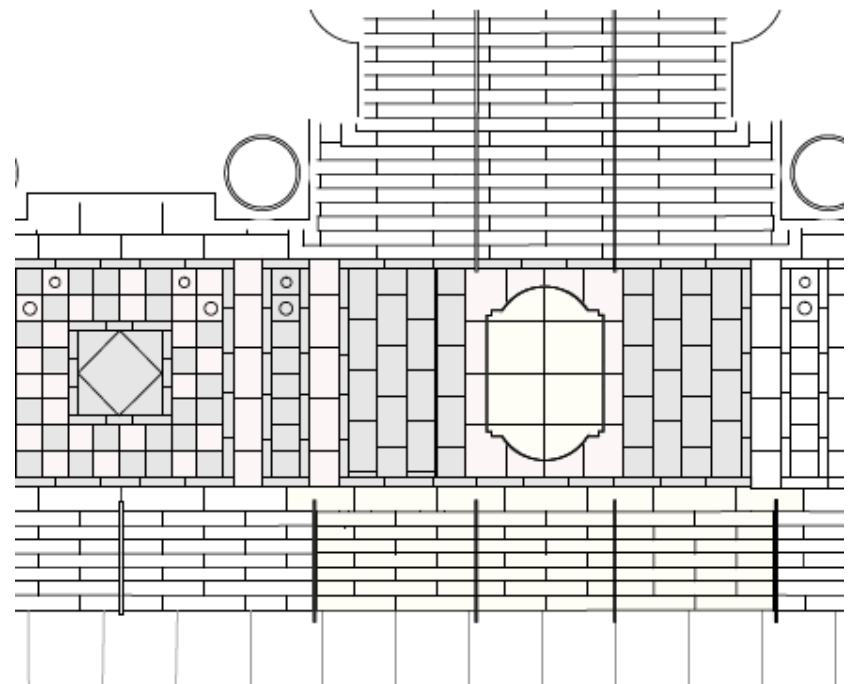
Central Park West

Proposed

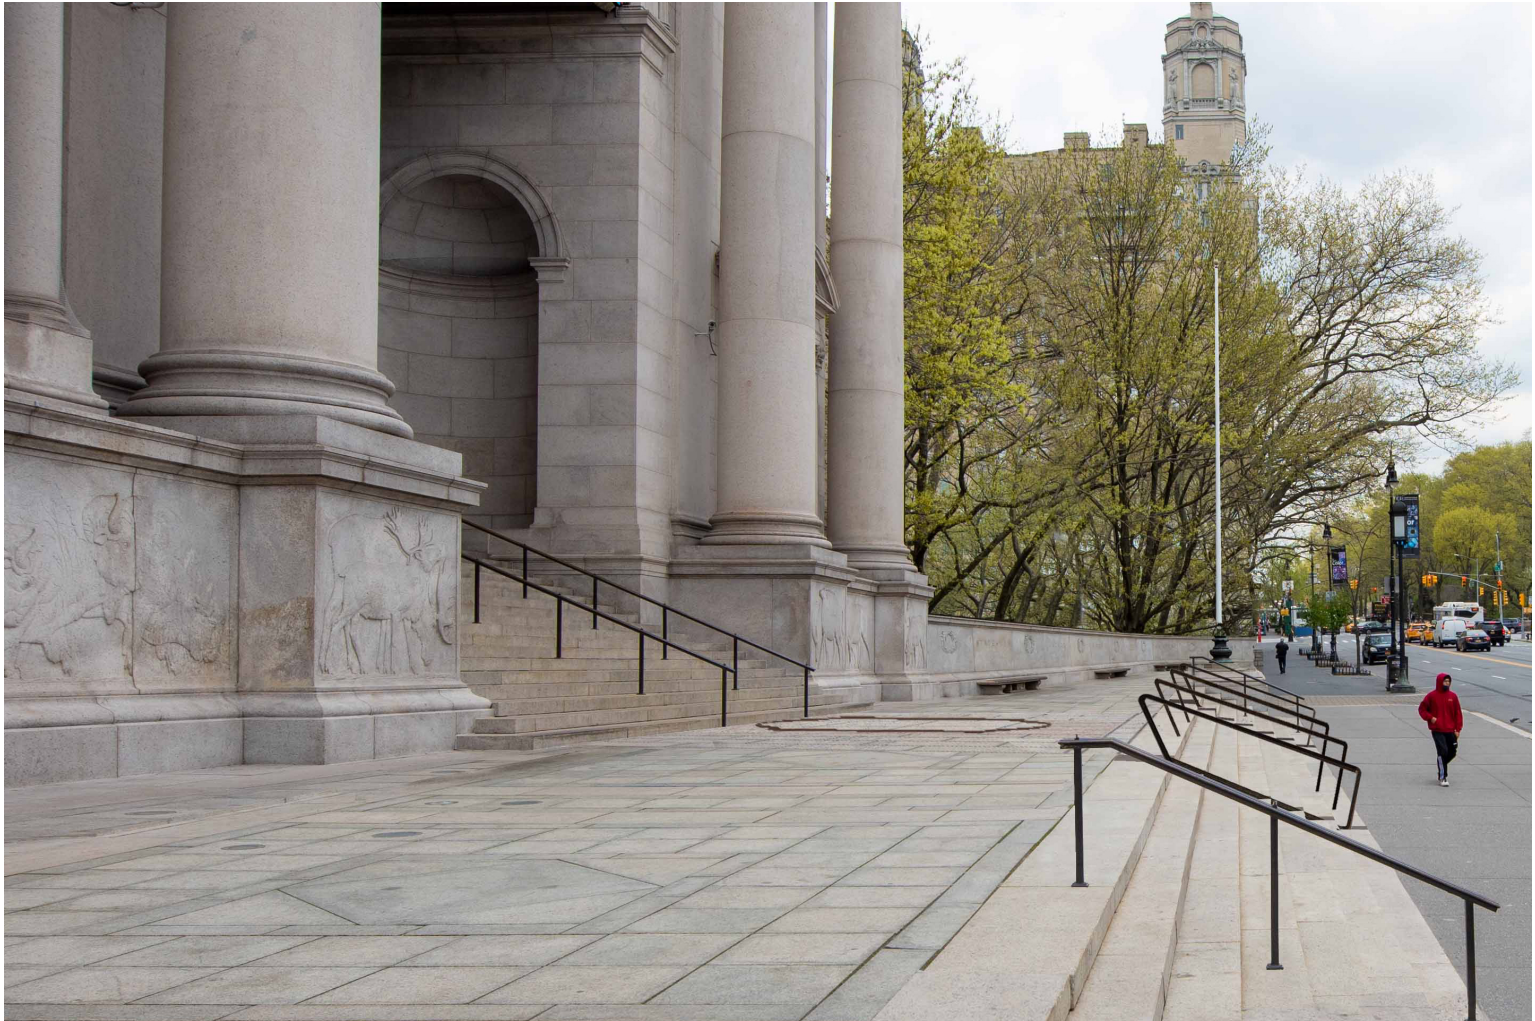
## Plaza View (Proposed)

American Museum of Natural History Central Park West entrance, proposed plaza and stair treatment without statue, AMNH

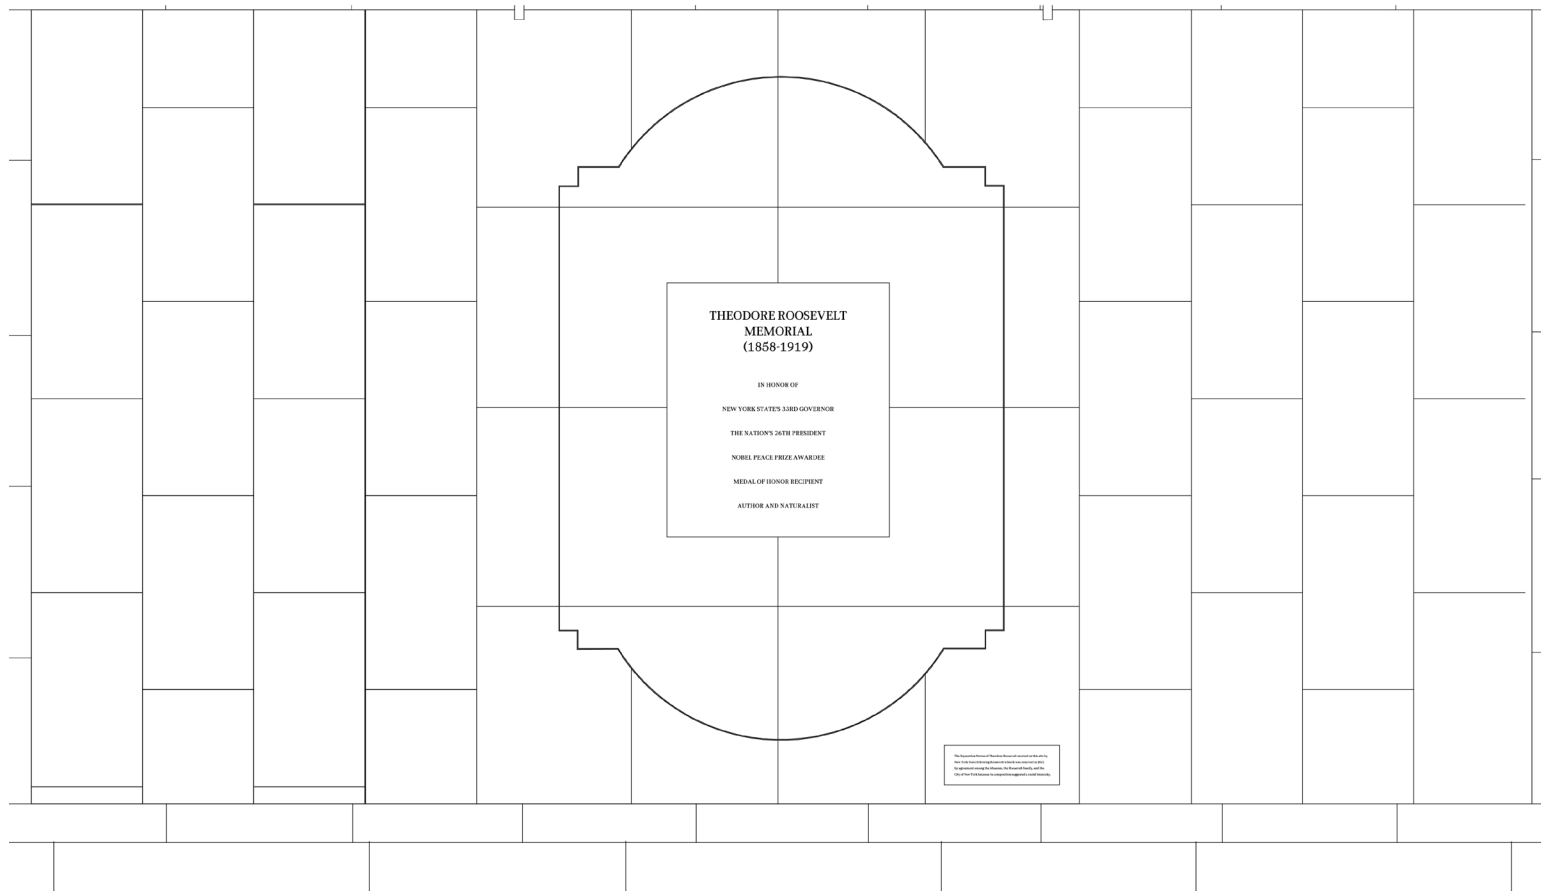
Two plaques

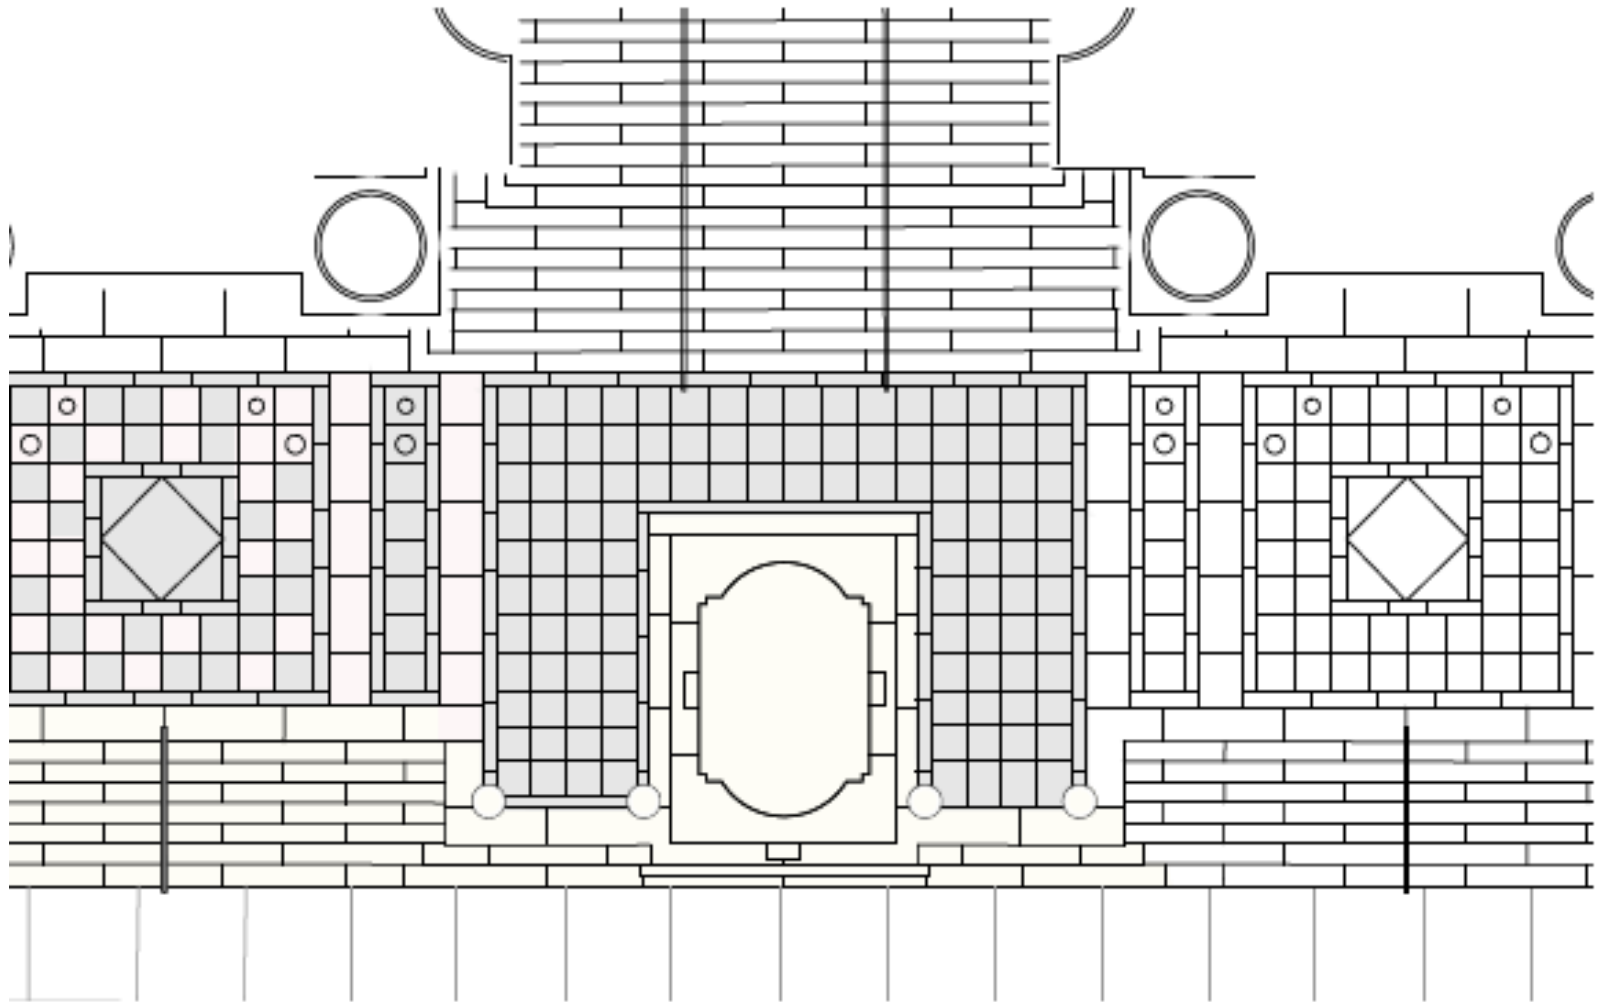
## Plaza and Stair Detail (Existing)

Central Park West

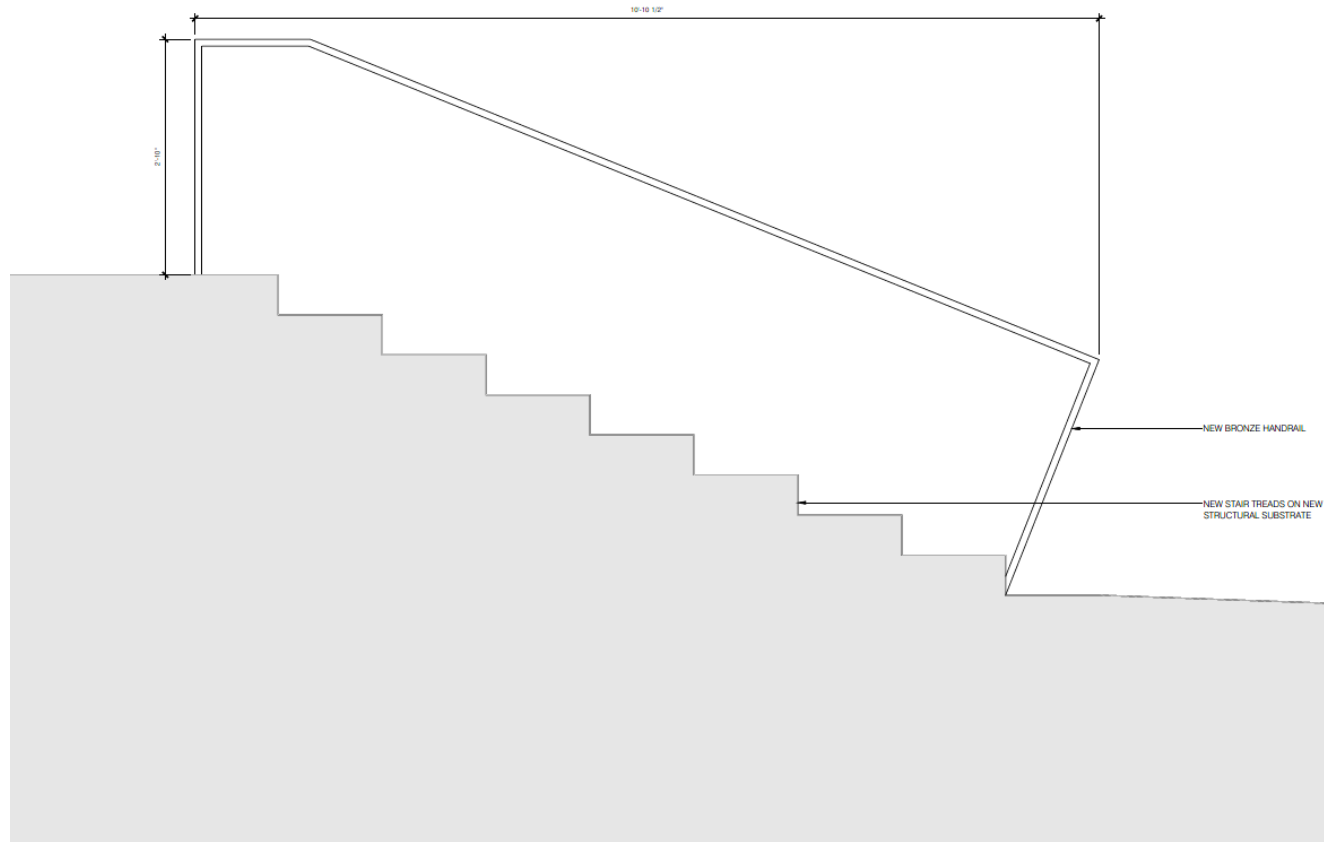
# Railing Section

American Museum of Natural History Central Park West entrance, railing section, AMNH

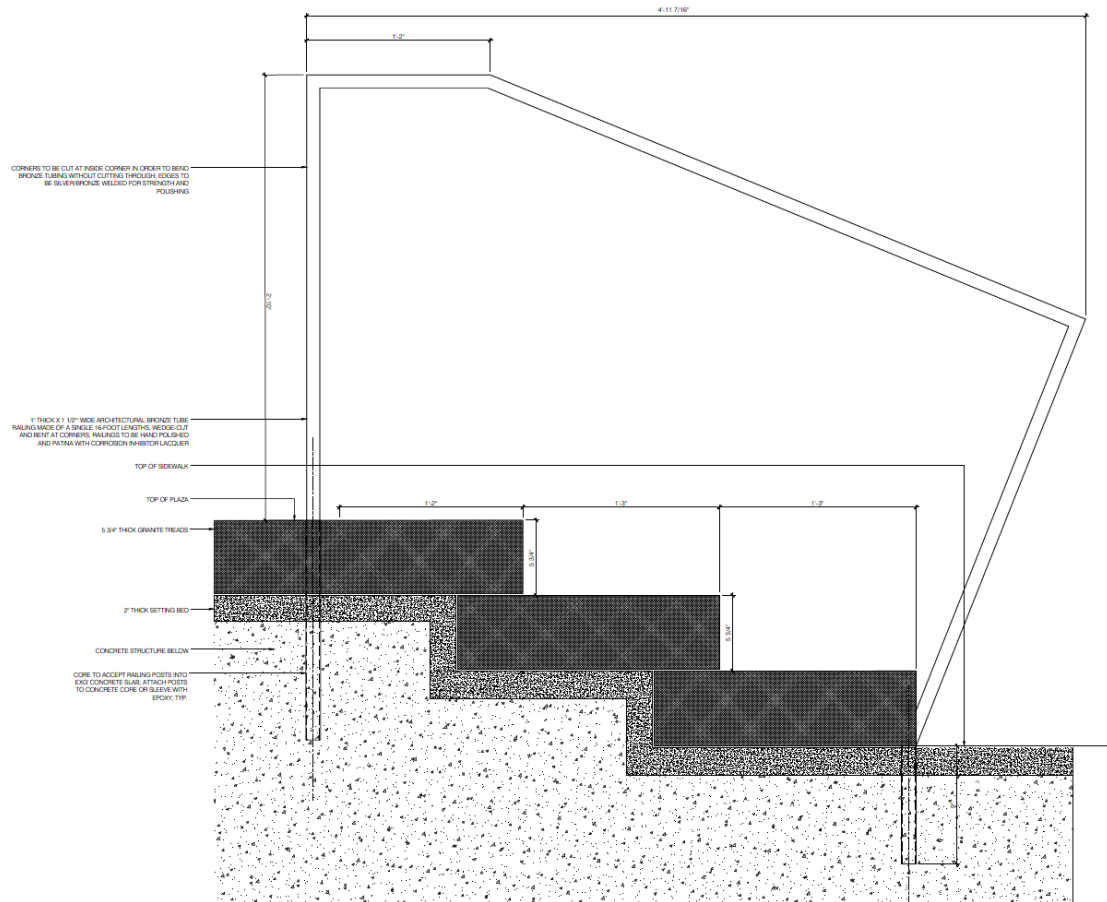
## Railing Detail

American Museum of Natural History Central Park West entrance, railing detail, AMNH

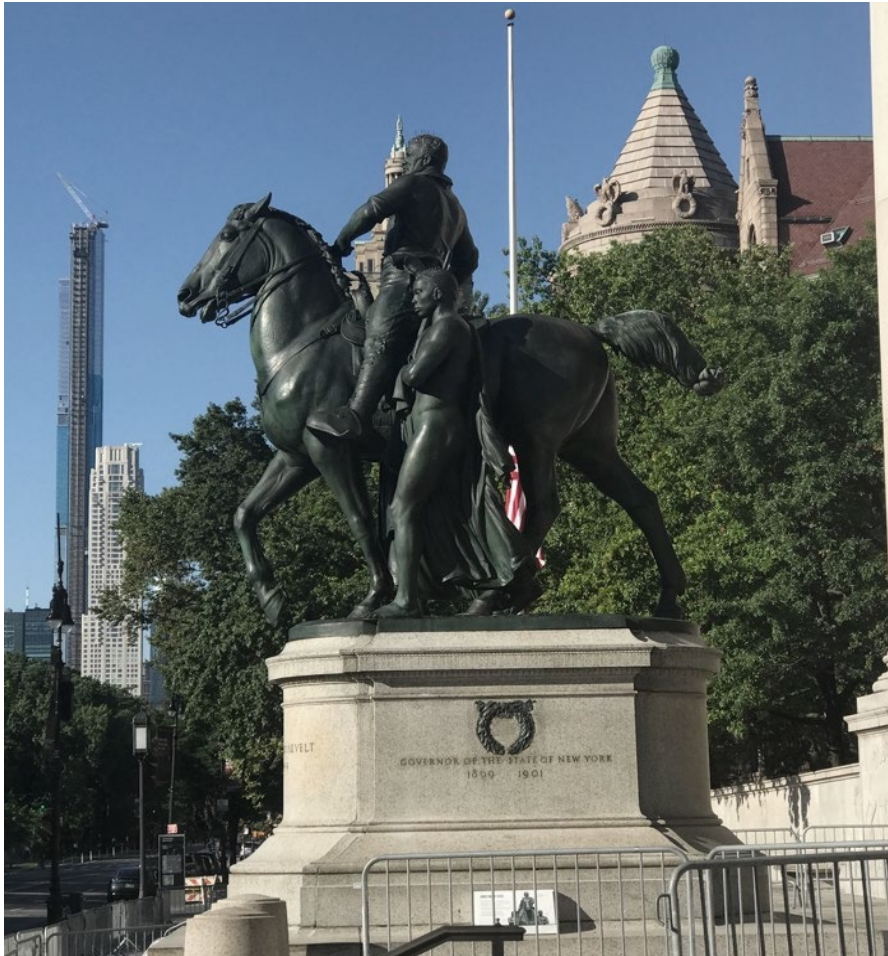
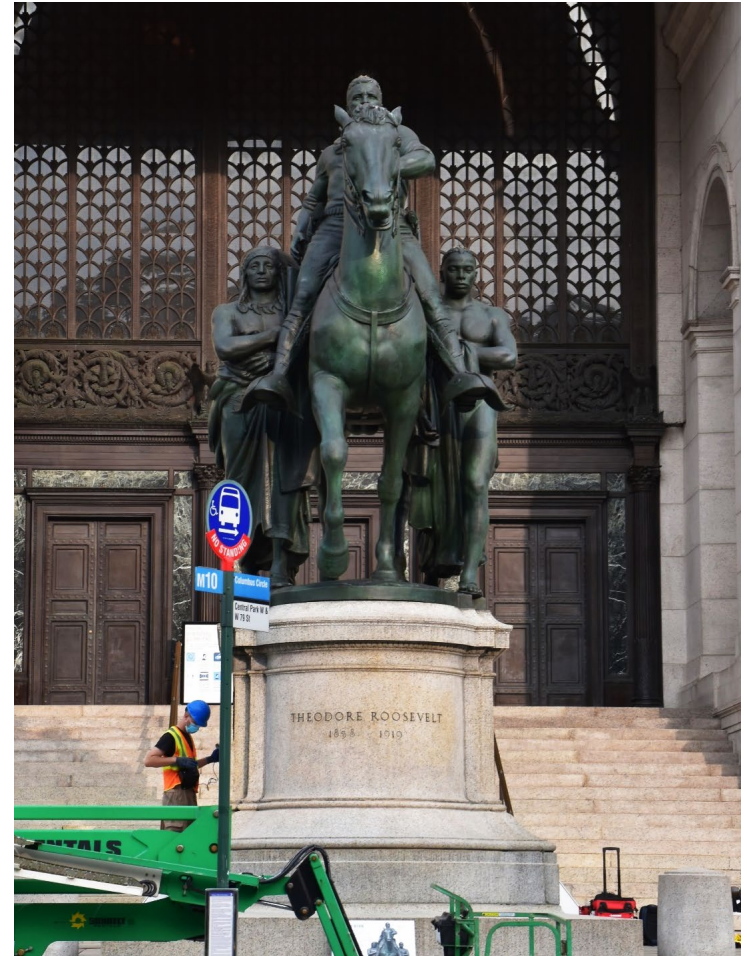
## Statue Detail

Equestrian Statue of Theodore Roosevelt, American Museum of Natural History. (Photos: EverGreene September 2020).

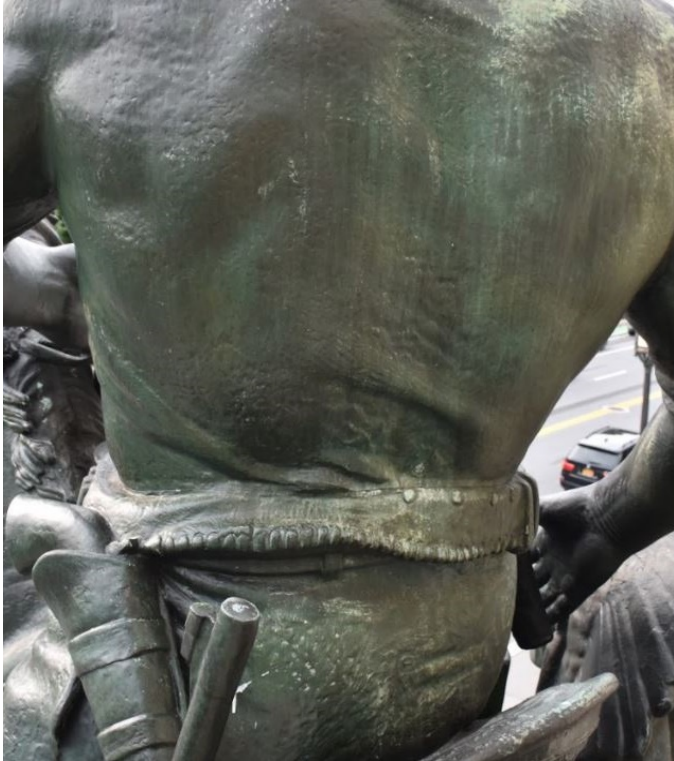
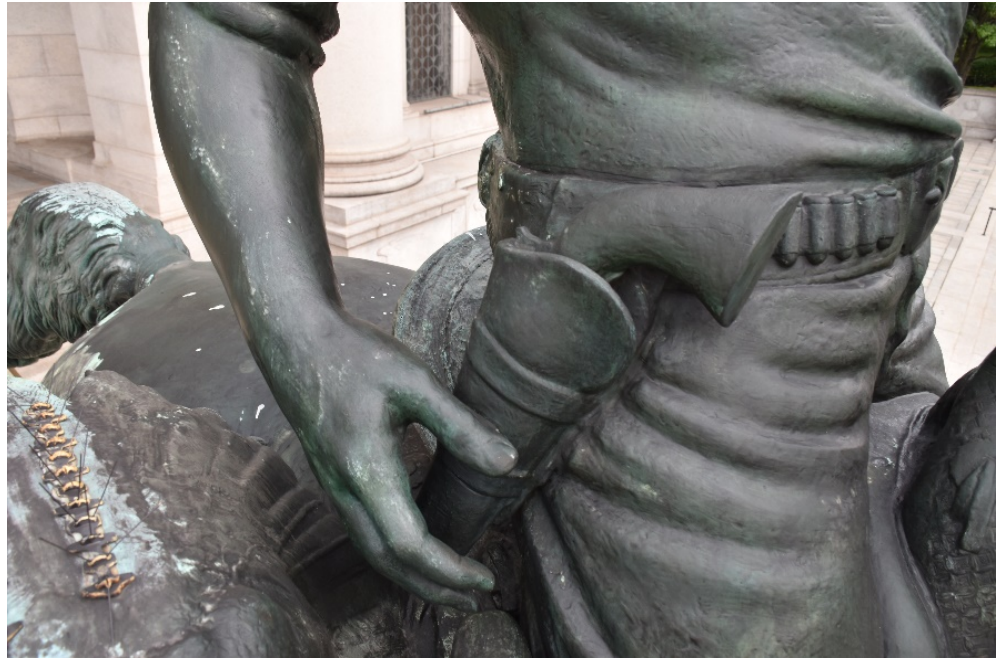
Equestrian Statue of Theodore Roosevelt, American Museum of Natural History. Seam at the waist, noted. Also, the small connection between the gun holster and finger that will need to be cut to remove the upper section of the figure. (Photos: EverGreene September 2020).

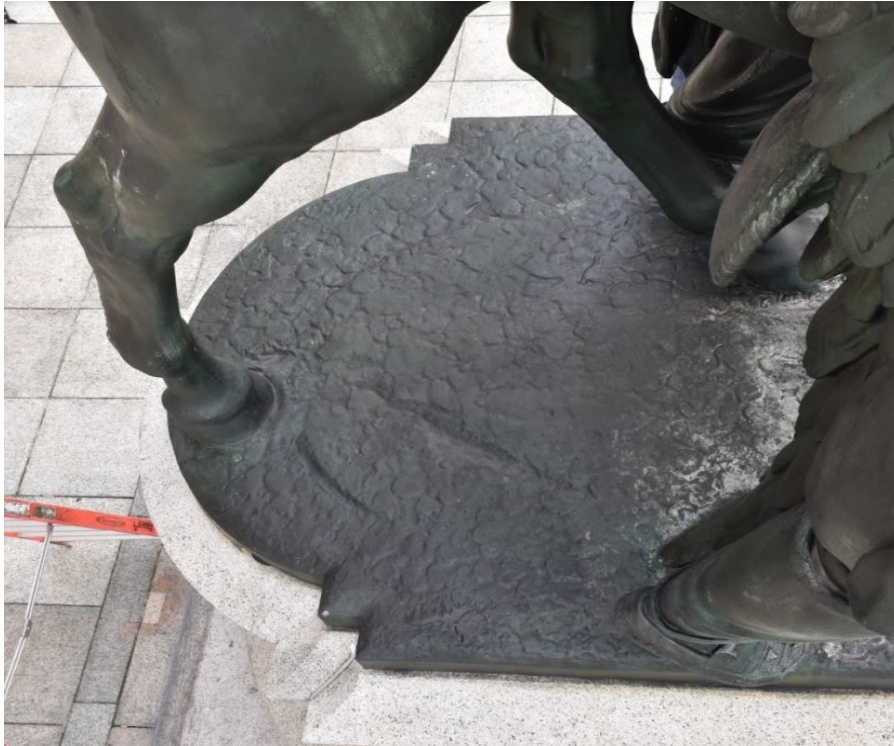
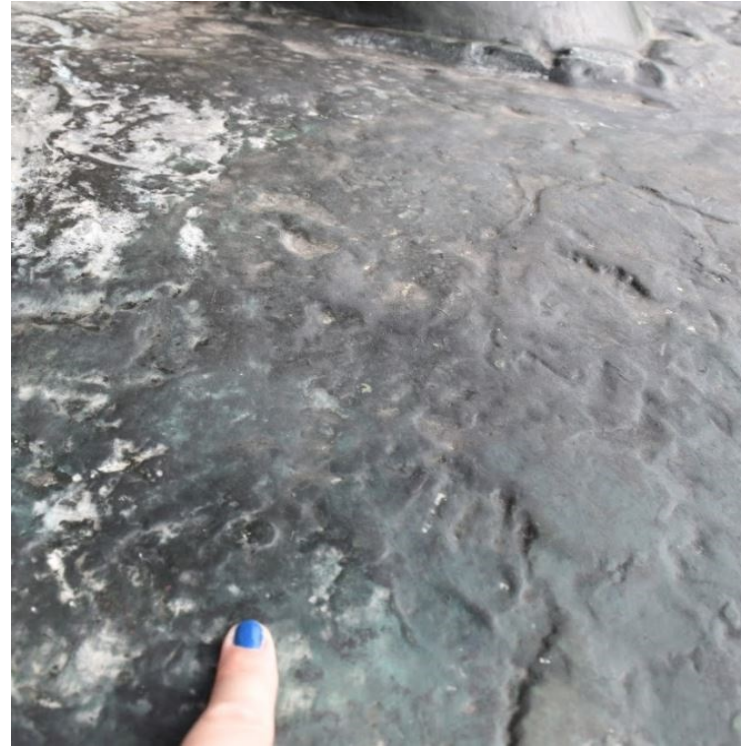
Equestrian Statue of Theodore Roosevelt, American Museum of Natural History. The tooled heads of pins can be seen around the sculpture self-base; left: location on southwest; right: location on southeast (Photos: EverGreene September 2020).

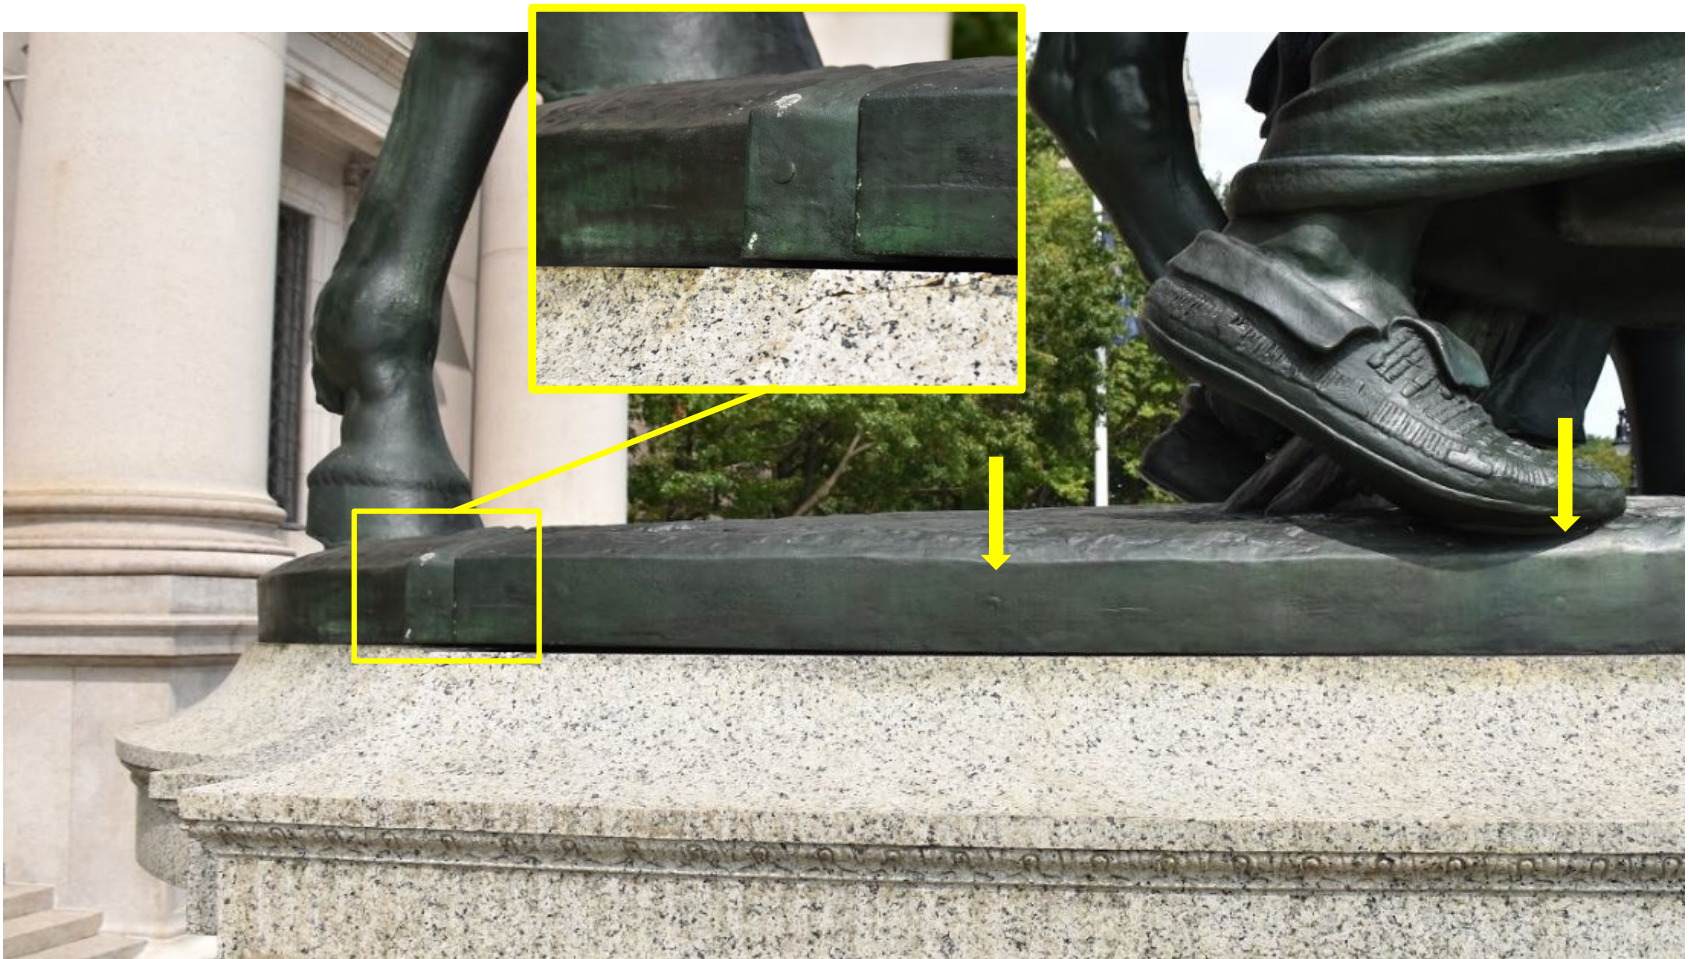
Equestrian Statue of Theodore Roosevelt, American Museum of Natural History. Close-up of bars set into stone and pinned in to self-base with dowels. (Photo: EverGreene September 2020).
