# TREMONT

## EMERGING COMMERCIAL CORRIDOR

### INTRODUCTION

#### SYNOPSIS

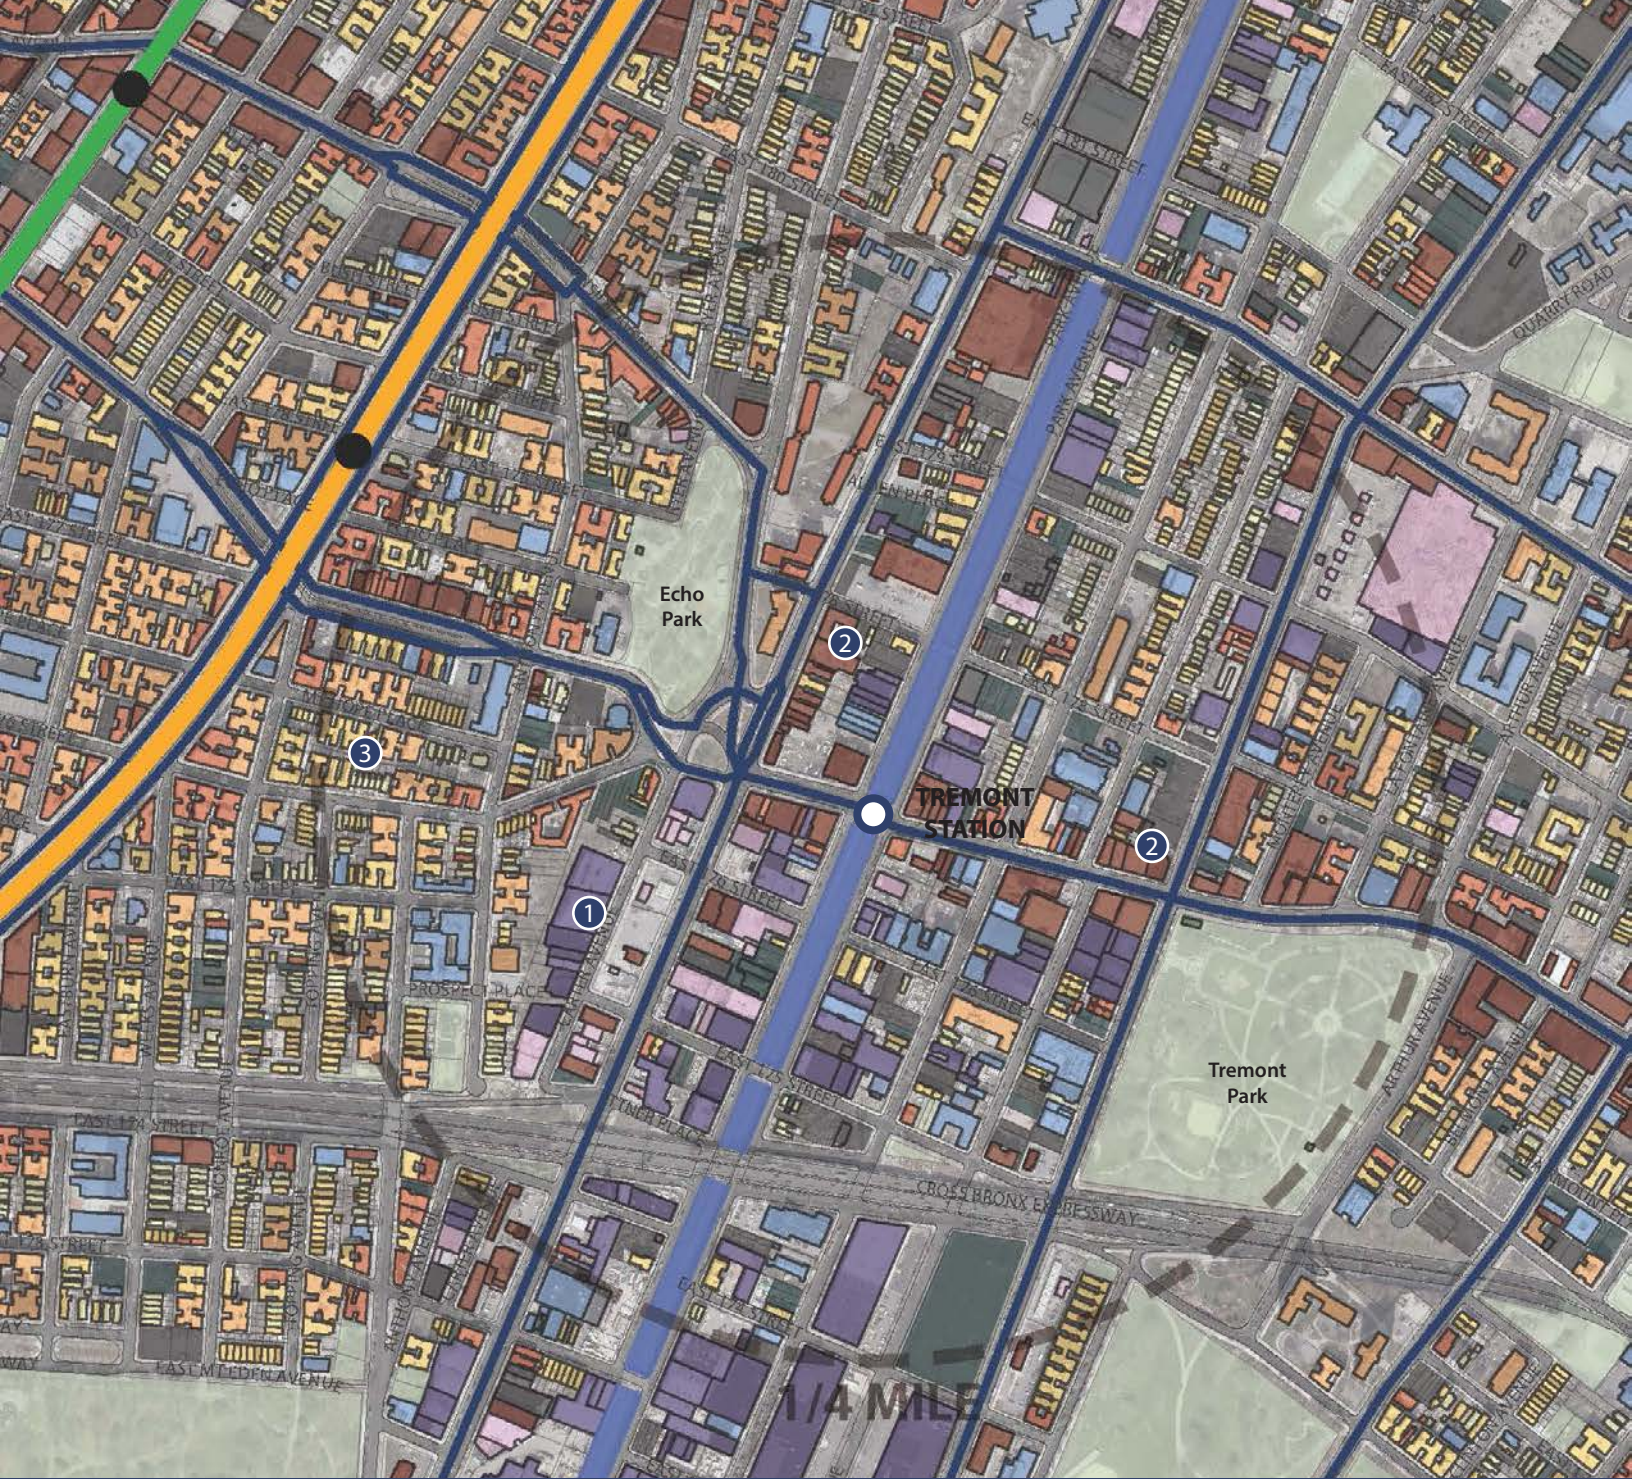
- One and Two Family Homes
- Multi-Family Walkups
- Multi-family Elevator buildings
- Mixed Com/Residential Buildings
- Commercial Buildings
- Institutional Buildings
- Manufacturing Buildings
- Transportation/Utility Buildings
- Park/Open Space
- Parking Lots
- Vacant Land

- ① Manufacturing and institutional uses east of Webster Avenue and along Carter Avenue
- ② Several commercial buildings along Webster Avenue north of Tremont Avenue, and along Tremont Ave east of Park Ave (Tremont Commercial Corridor)
- ③ Residential and Mixed Commercial/Residential uses west of Webster Avenue

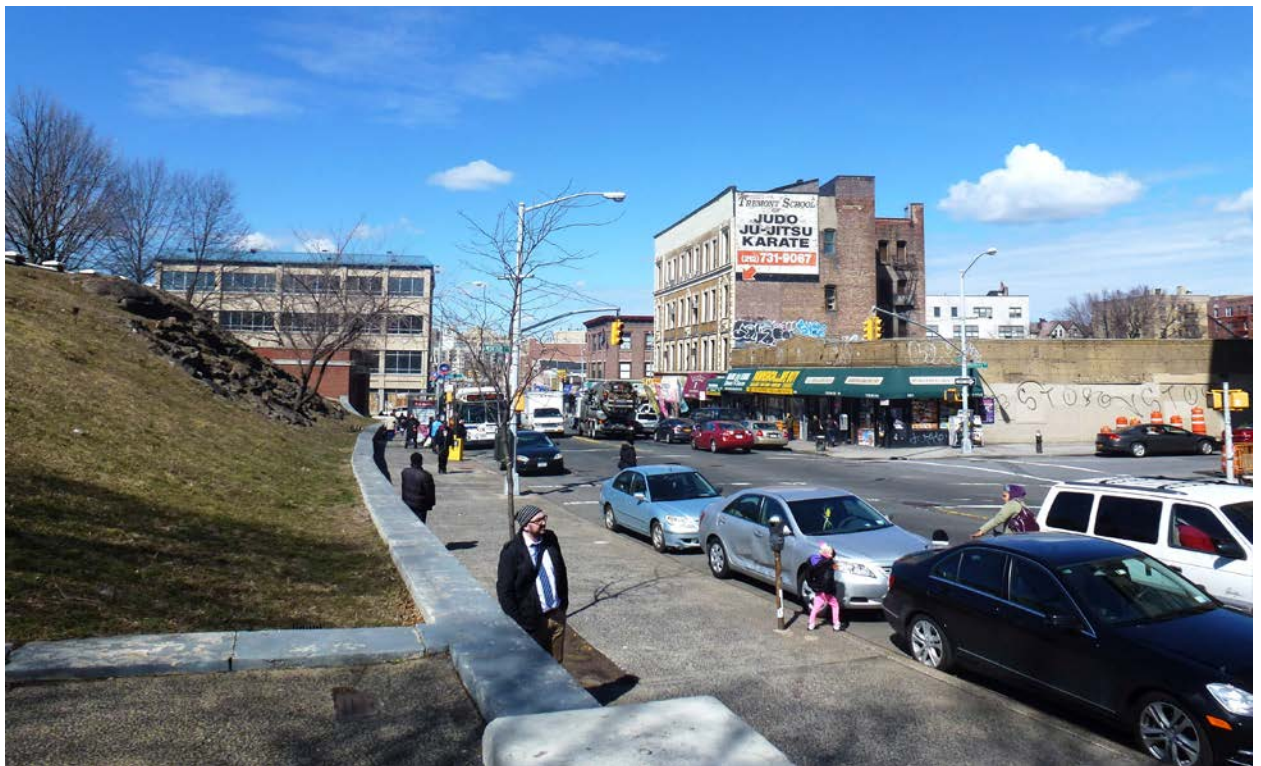
**FIGURE 5** | Tremont Park, intersection of East Tremont and Monterey Avenues. The steep grade of the park (left) and blank street walls (right) are challenges for the community.

- A **lack of street furniture**, such as bus shelters and benches, discourages users from lingering on the corridor or using mass transit.
- **Tremont Park** is located on a steep grade as it approaches 3rd Avenue. This causes its amenities, namely its lighting, to be distanced from the street, creating an uncomfortable pedestrian experience at night along the park's edge. The comfort station at the corner of 3rd Avenue and East Tremont is inactive and the grand steps on 3rd Avenue south of Tremont lead to an empty space where the former Bronx Borough Hall existed until 1969.

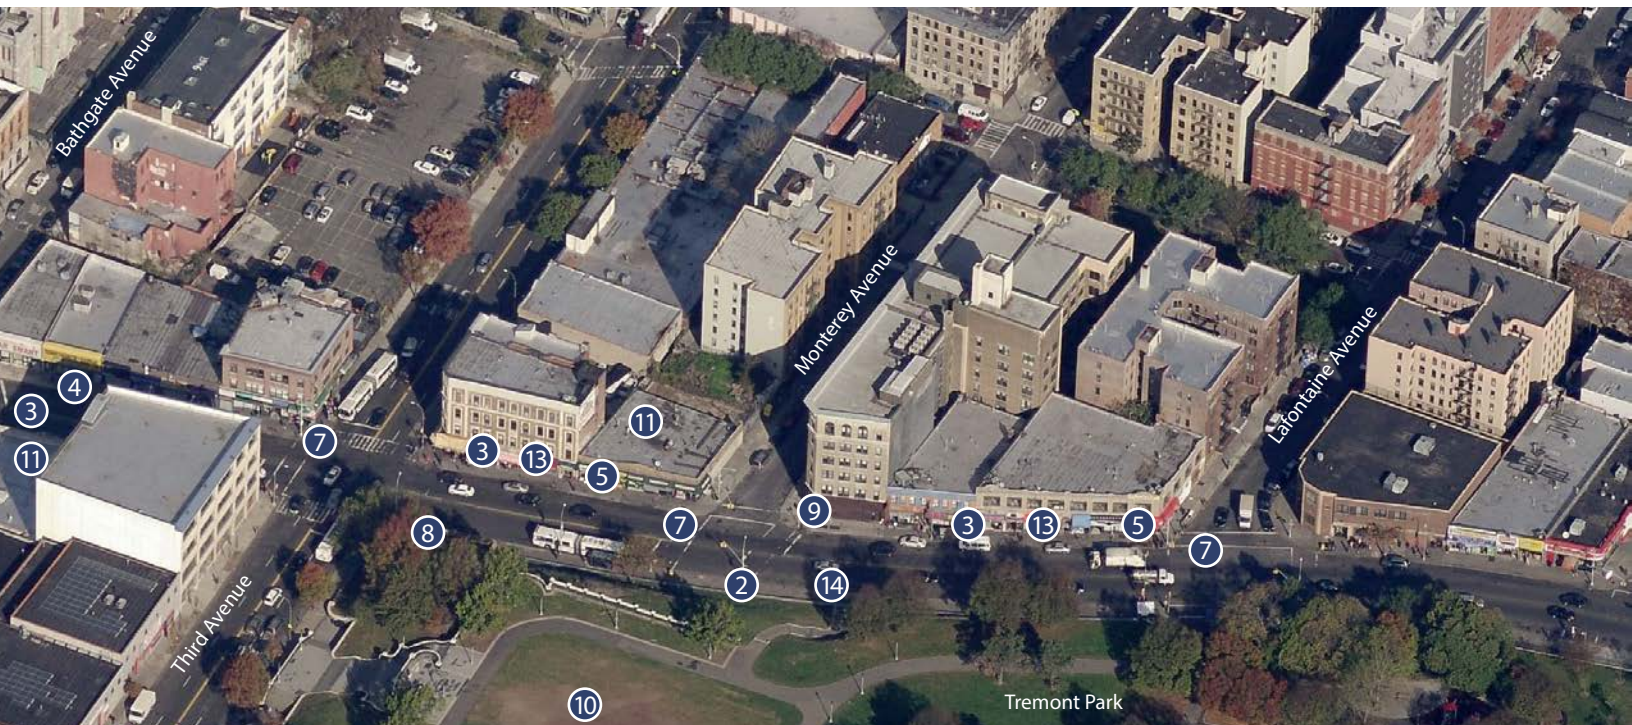
FIGURE 7 | Existing Conditions, northwest along East Tremont Avenue, half a block east of Tremont Station.

**Figure 7 Existing Conditions**

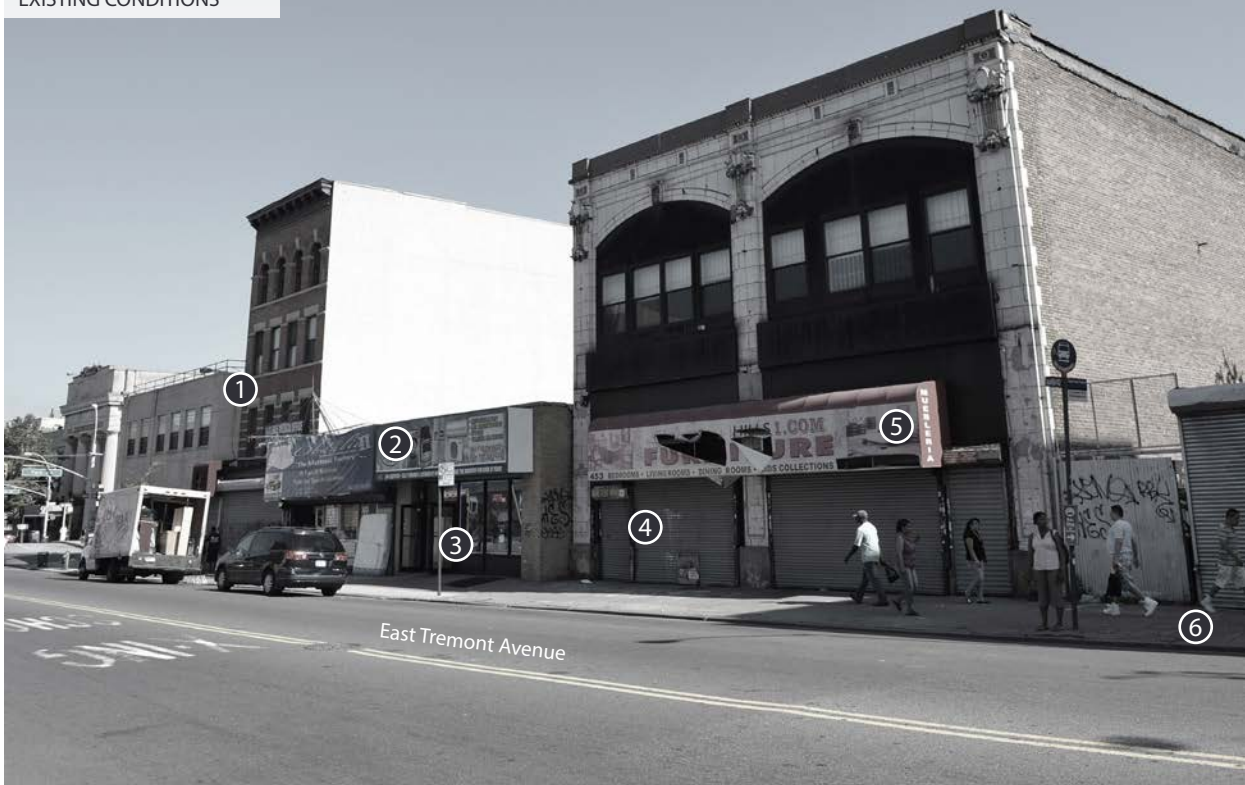
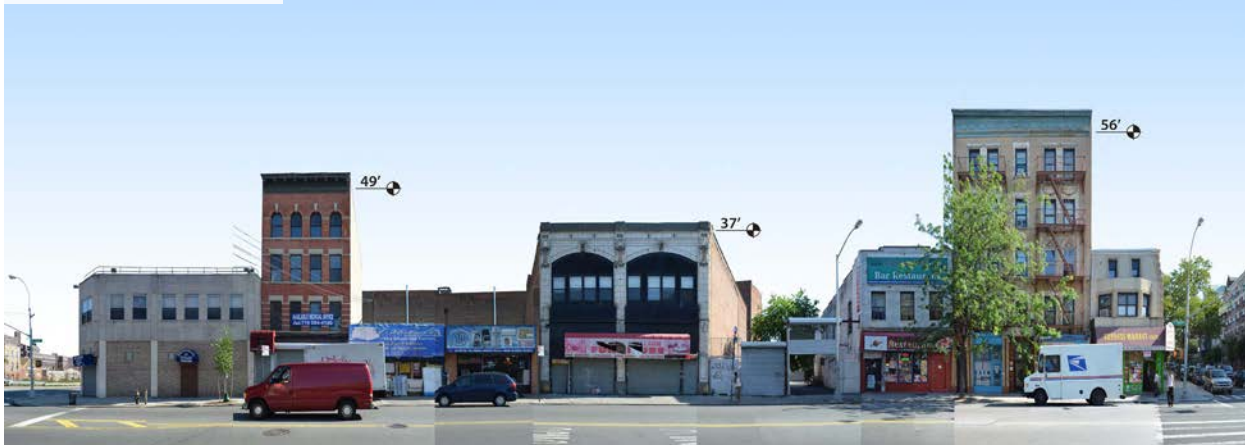
- ① Uneven street wall along Tremont Avenue
- ② Inconsistent building typology and design
- ③ Few streetscape amenities
- ④ Inactive ground uses and limited transparency
- ⑤ Little transportation signage, awnings, and window displays
- ⑥ Unkept and uneven sidewalks

Figure 7 shows the current state of East Tremont Avenue looking west from 3rd Avenue. Figure 8 identifies potential improvements that promote a vibrant pedestrian environment along East Tremont Avenue and displays the development potential of recent zoning changes.

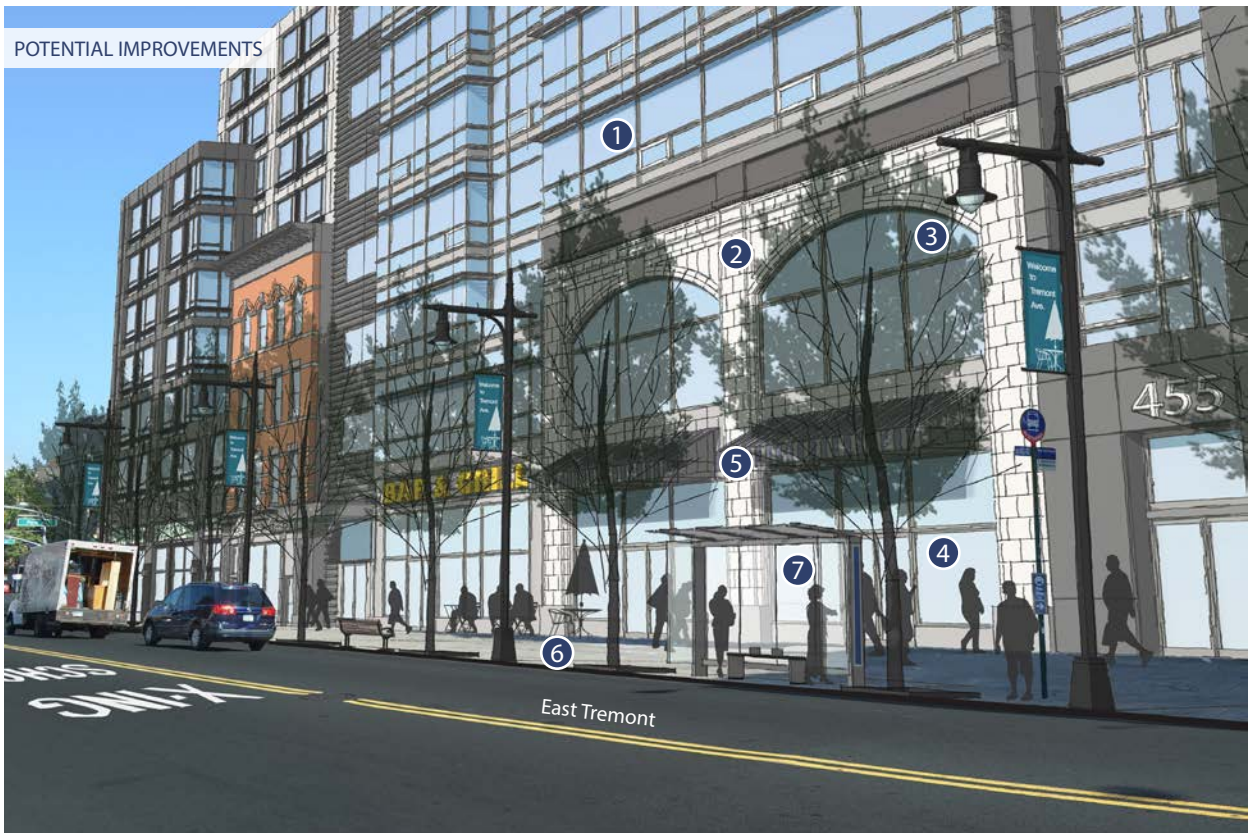
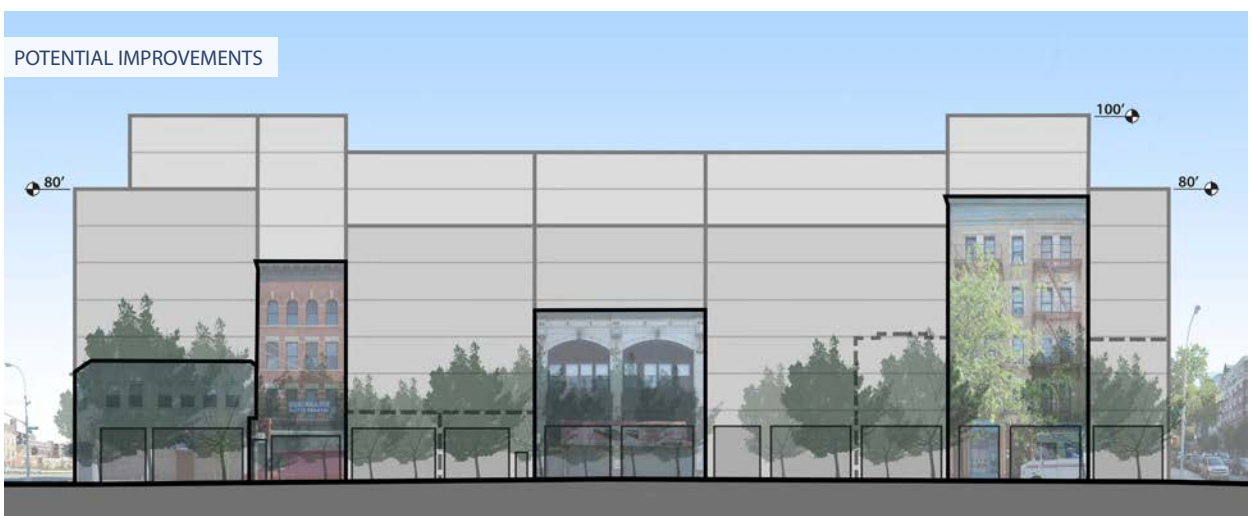
**FIGURE 8** | Potential improvements, northwest along East Tremont Avenue, half a block east of Tremont Station.

- ① Develop strong street wall along both sides of Tremont Avenue
- ② Incorporate existing buildings to create visual interest between old and new buildings
- ③ Add street trees and street lamps at regular intervals
- ④ Promote active ground uses, ample transparency; limit size of residential lobbies and community facility uses
- ⑤ Coordinate signage, awnings, and window displays; add street banners along corridor
- ⑥ Improve and extend sidewalk width where vehicular right of way permits
- ⑦ Add street furniture like bus shelters and benches
