GILBOA DAM

Post-Hurricane Briefing

September 6, 2011

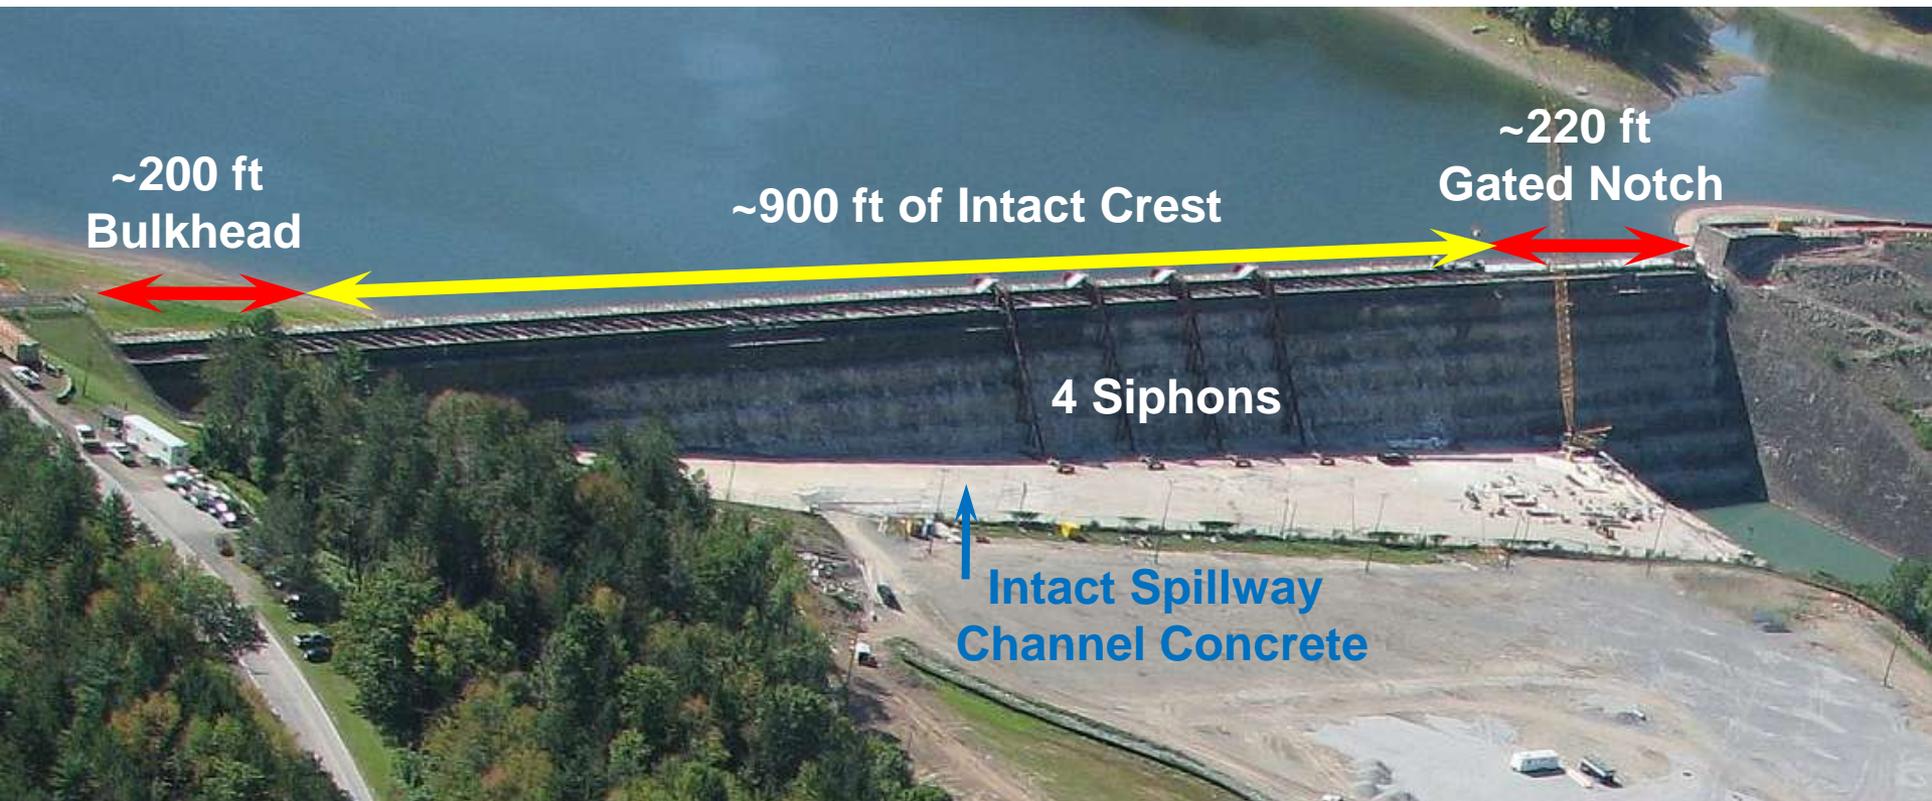
Key Spillway Control Section and Side Channel Features

- Gates are installed in 220' notch
- Gates maintained in lowered position
- Hydraulic Control Elev. 1125.07 ft (i.e., crest)
- Pre-storm pool elev. 1118.04 ft
- Equipment and materials fully evacuated by Saturday night

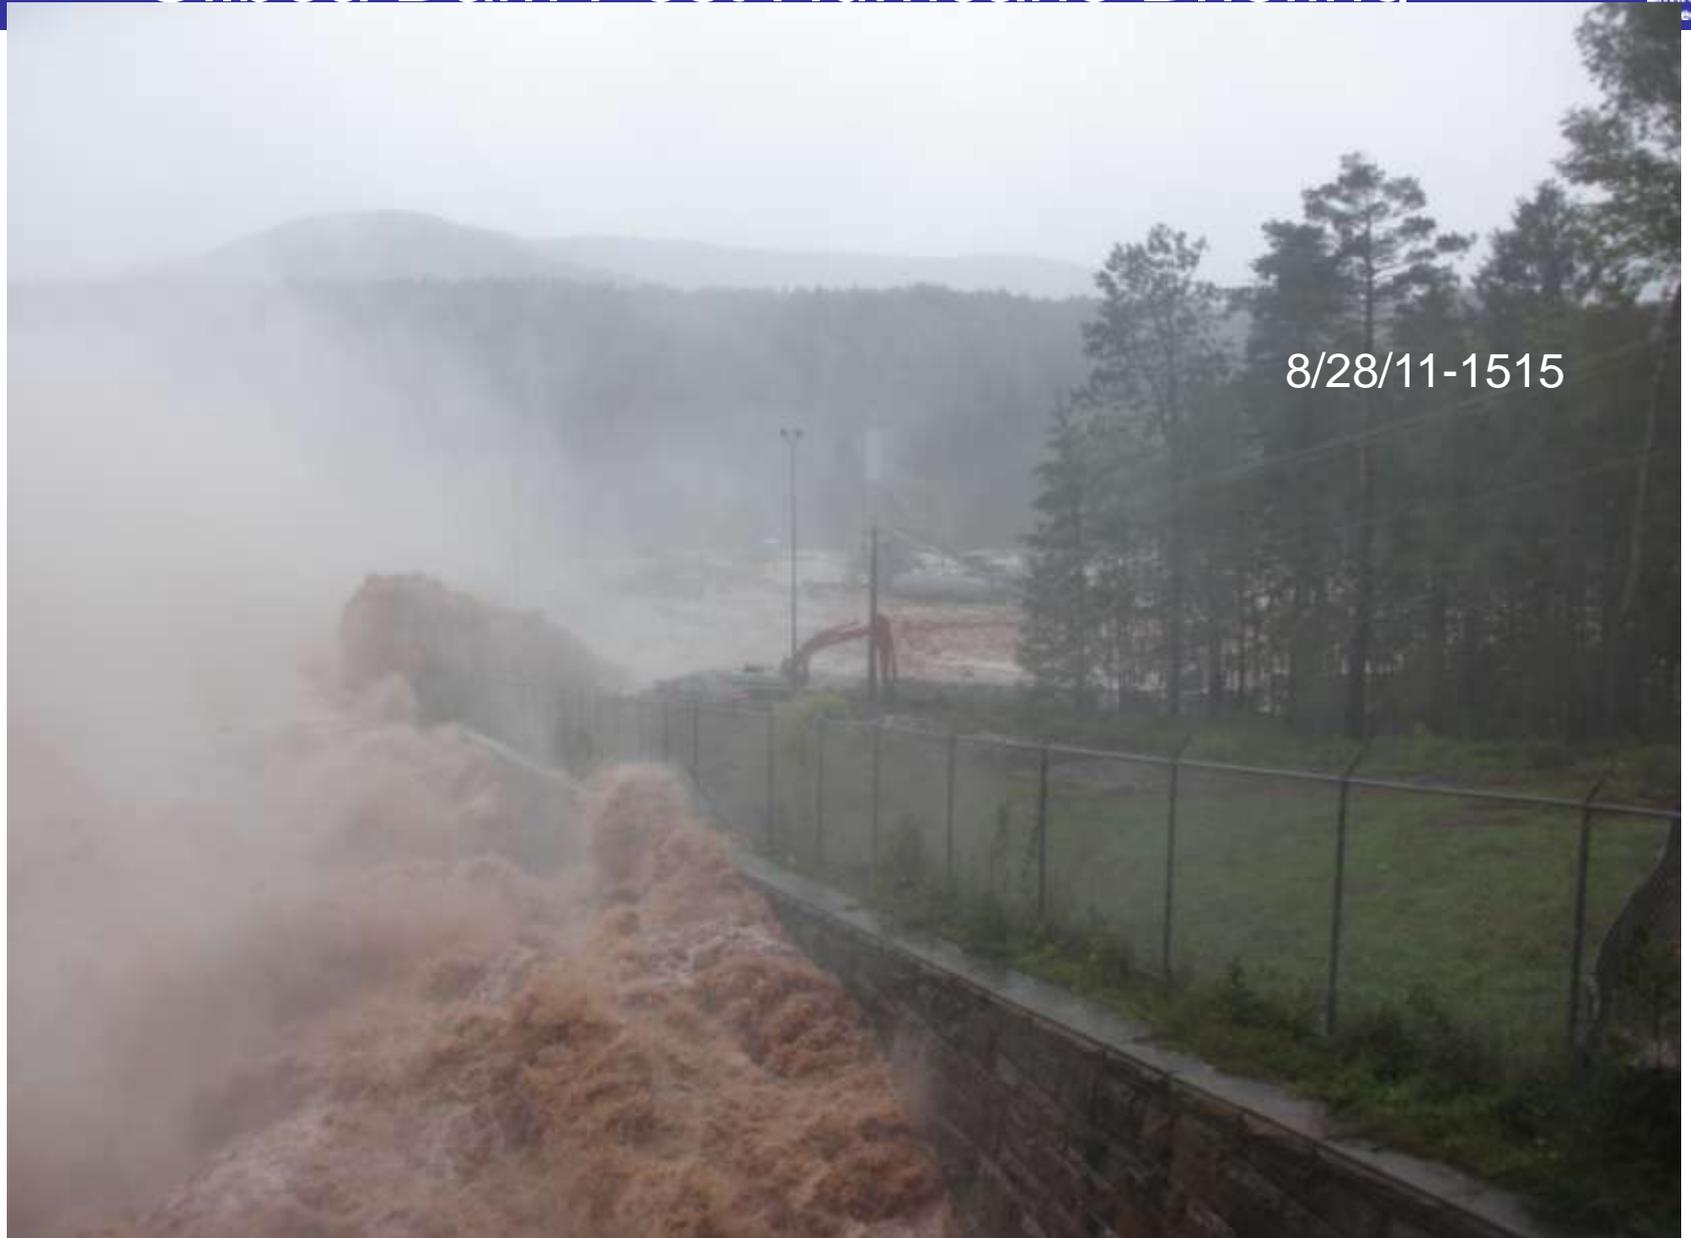
8/28/11-1515

- Inspection of Dam – Sun thru Wed (Aug 28-31)
- Incident Report submitted Friday, September 2nd
- Conditions observed:
 - Loss of power and instrumentation feed at site
 - No apparent damage to spillway control section or embankment
 - Erosion in certain areas of Spillway Channel (3 locations)
 - Significant damage to Contractor work area and temporary on-site facilities
 - Significant stream channel and bank erosion
 - Significant debris accumulation in reservoir
