**New York City Department of Transportation
Office of School Safety Engineering**

School Safety Engineering Project

FINAL REPORT: P.S. 18 (John Greenleaf Whittier School), Staten Island

Prepared by
The RBA Group/Urbitrans Associates

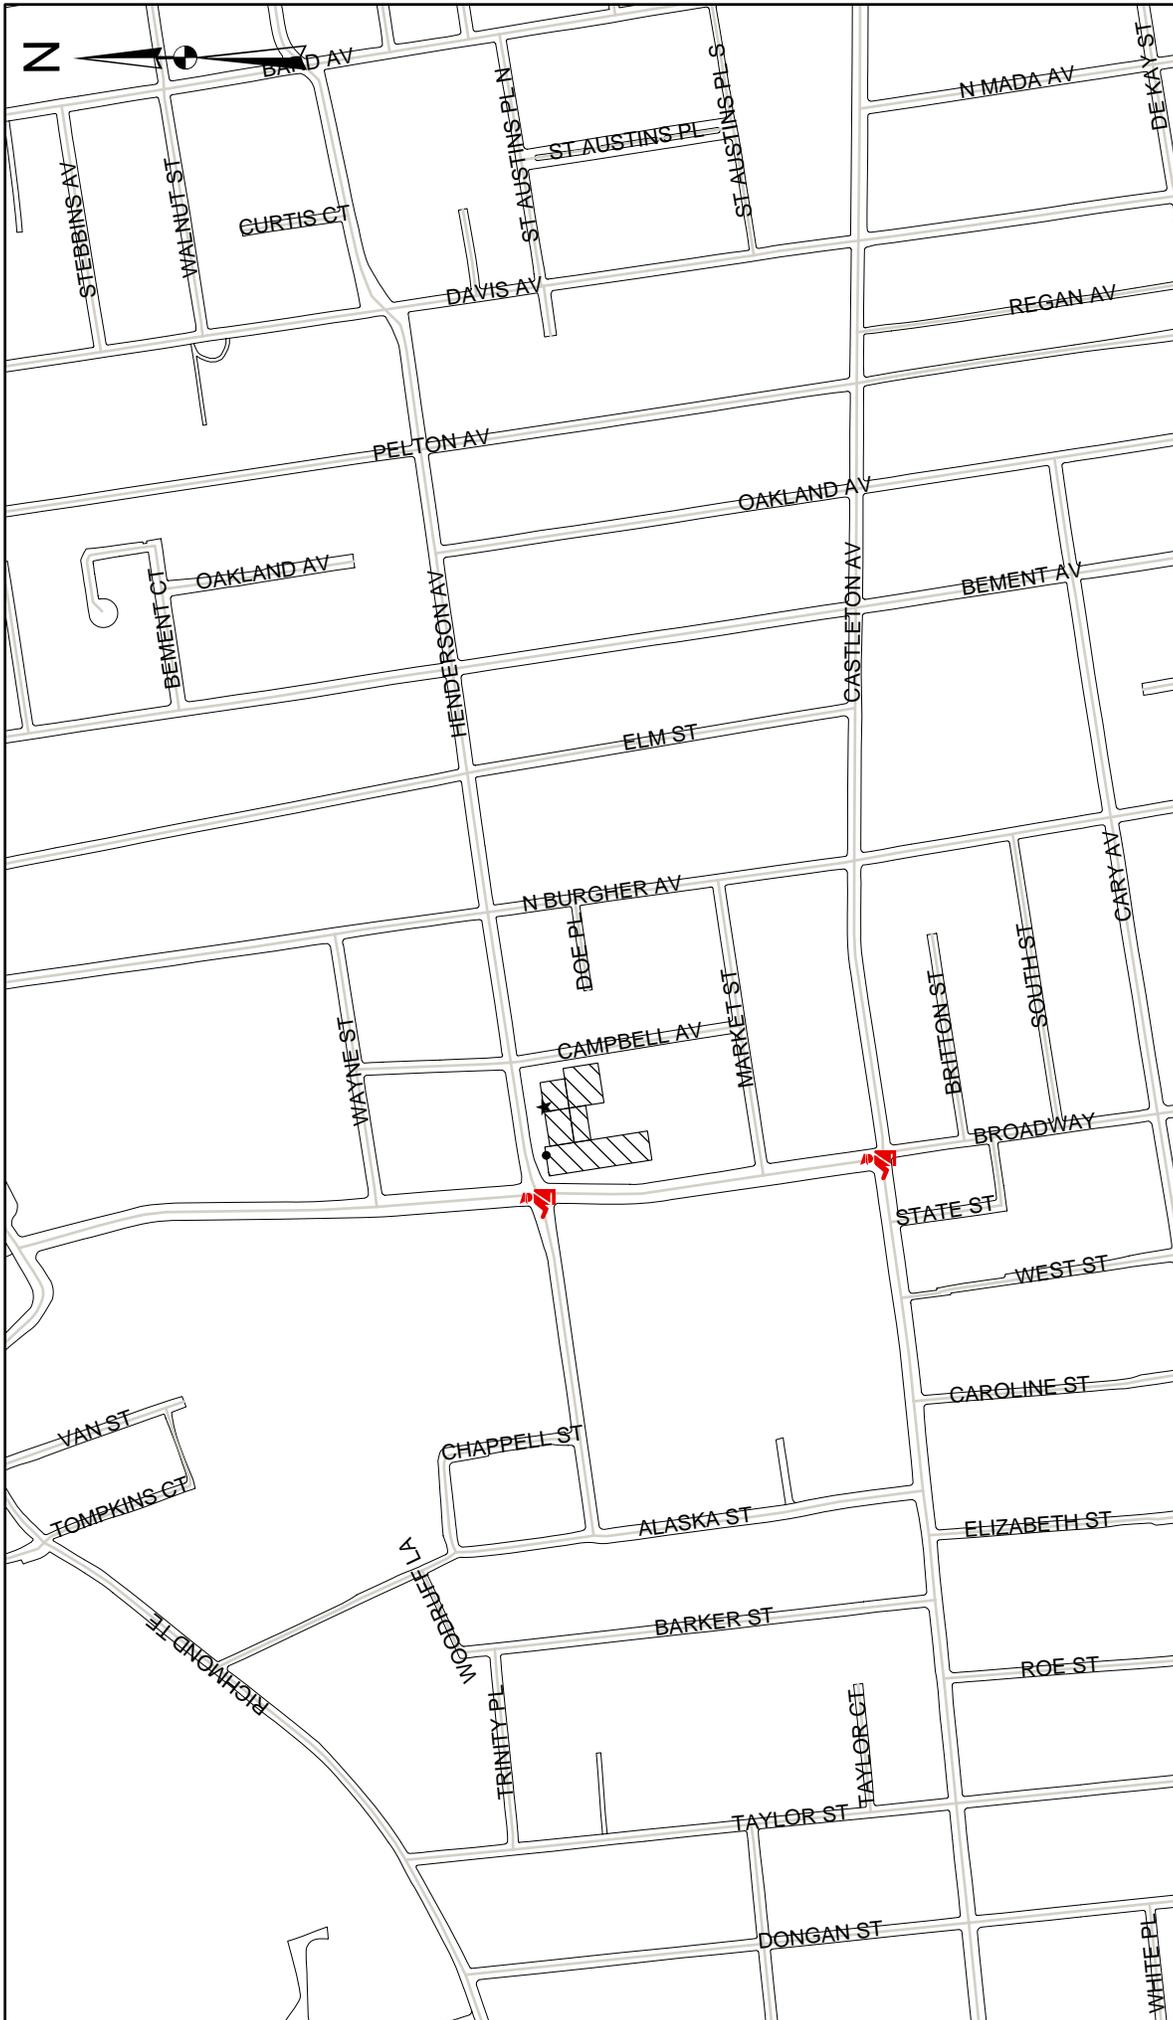
EXHIBIT 4
P.S. 18 STATEN ISLAND
J. GREENLEAF WHITTIER SCHOOL
CROSSING GUARD LOCATIONS

There are two crossing guards assigned to P.S. 18. According to the school officials, the crossing guards are located at the intersections of Castleton Avenue and Broadway, and Henderson Avenue and Broadway. Exhibit 4 shows the crossing guard locations.

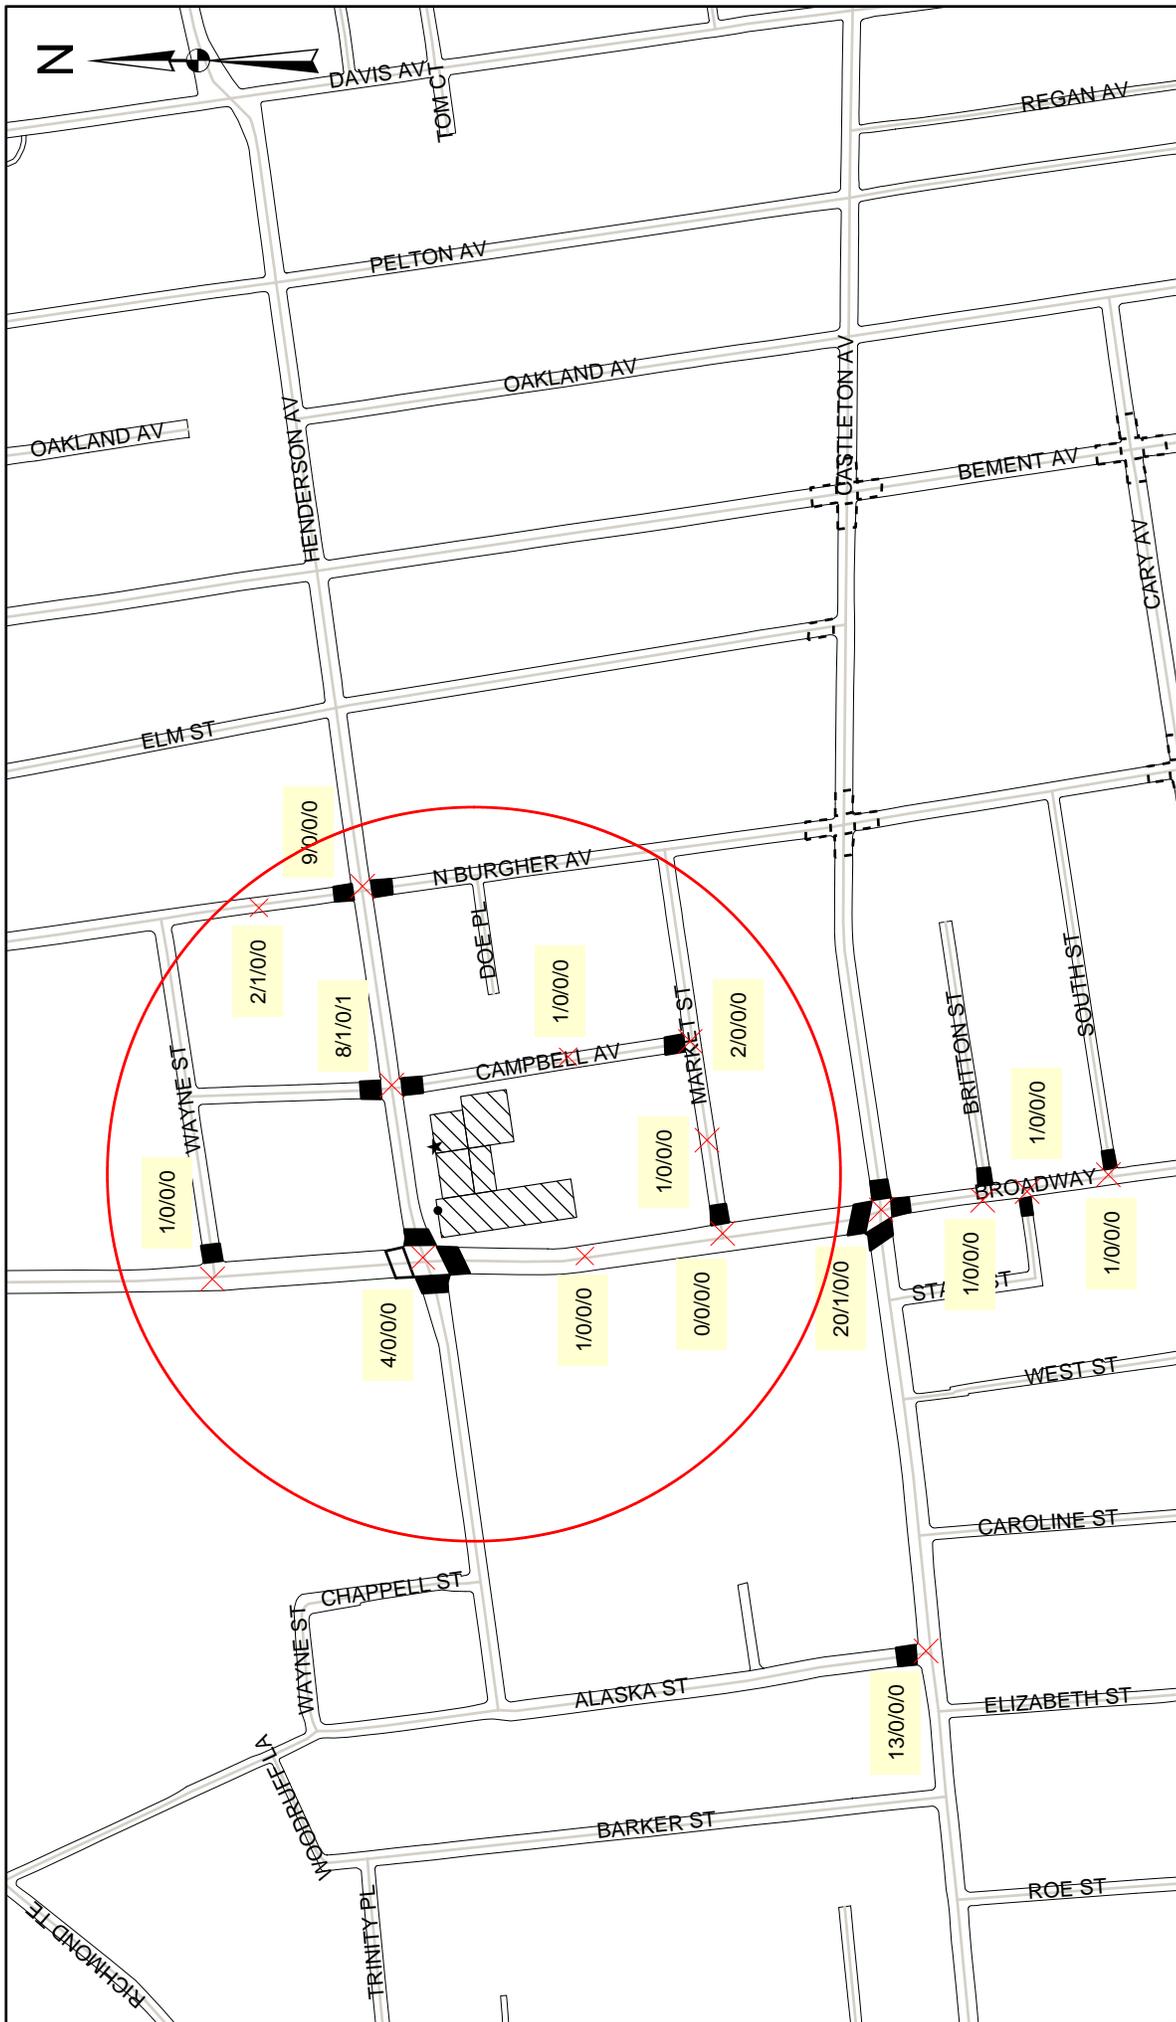
EXHIBIT 6

**P.S. 18 STATEN ISLAND
J. GREENLEAF WHITTIER SCHOOL
ACCIDENT SUMMARY (1998-2000)**
