1009 FIFTH AVENUE

WJE Engineers & Architects, P.C.

INITIAL LPC SUBMISSION: 3.23.2016
REVISED LPC SUBMISSION: 4.05.2016

BACKGROUND: RETAINING WALL PROBLEMS

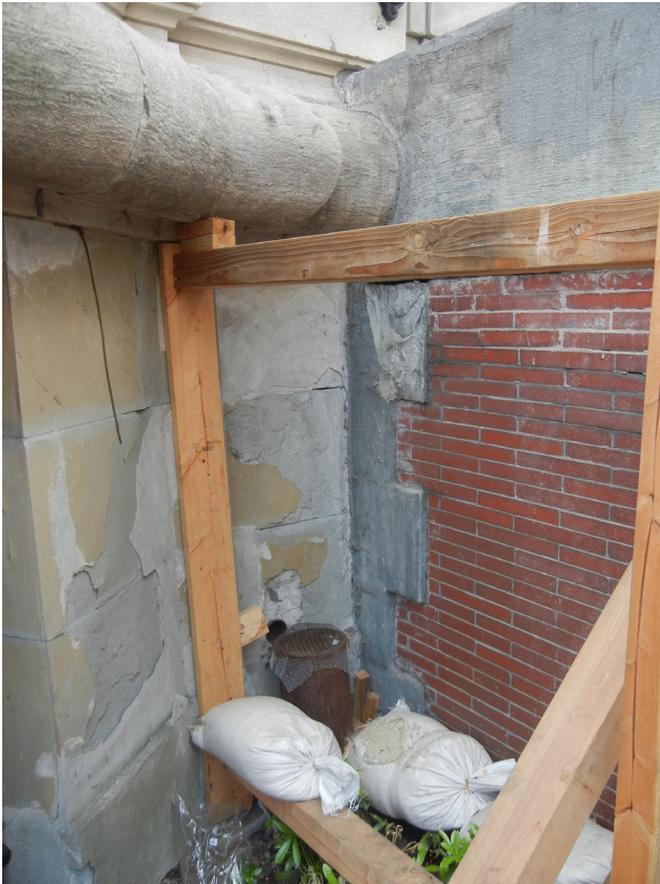
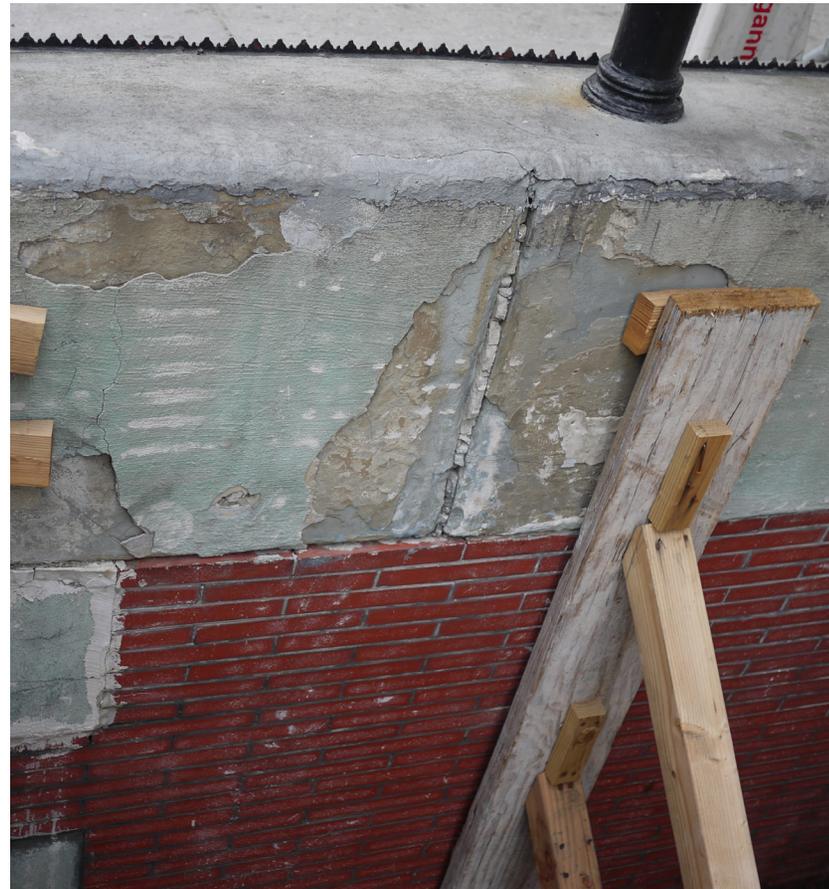
CONDITIONS: STONE MASONRY

- THE COPINGS AND ASHLAR BLOCKS AT THE INBOARD WALL ARE BLUESTONE
- DUE TO DETERIORATION THE STONE IS CURRENTLY CRACKED, DELAMINATING AND SPALLING
