INVESTIGATION REPORT:

JANUARY 14, 2008 SHORING COLLAPSE
AT 9 DOMINICK ST. (AKA 246 SPRING ST.)
MANHATTAN

EXECUTIVE SUMMARY

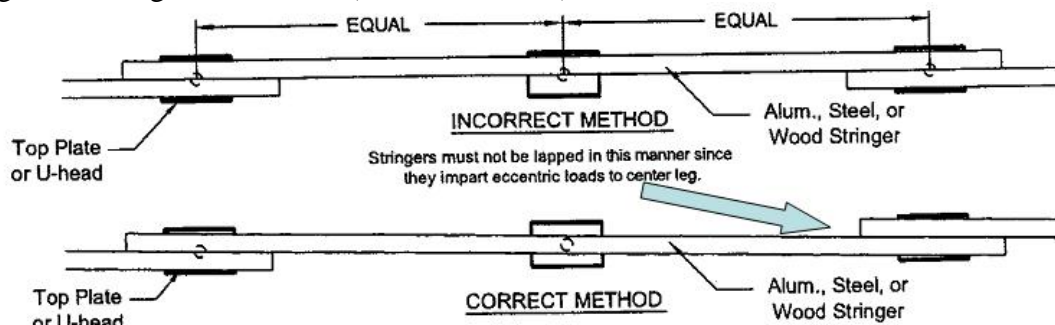
Figure 2 Stringer Setting - Patent Instructions

The investigators found that the manufacturer requires the top stringer to be set at a slight angle to ensure centric loading of the shore legs (see Figure 2 - Stringer Setting –from Patent Instructions and Figure 8 Lapping of stringers – from Patent Instructions). The recommended type of setting stringers was not found at any location, and the violation of this instruction was the subject of detailed engineering analysis

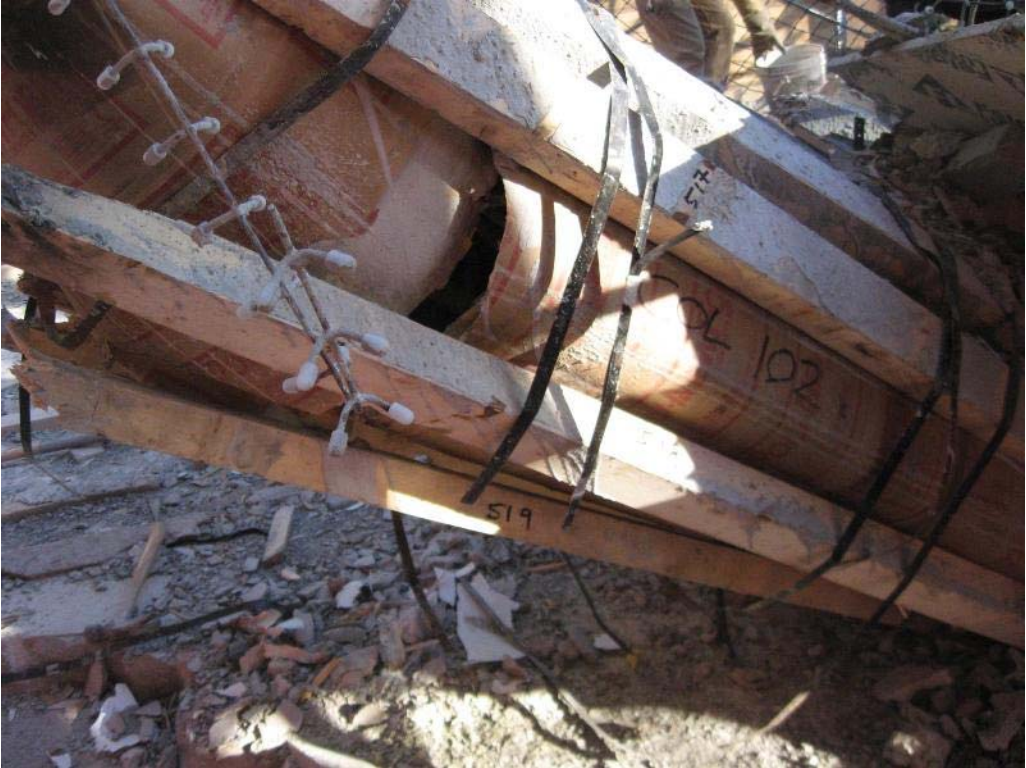
Photo 16 Round Formwork

The round column formwork at column 102 was Poli New Form, as manufactured by Newark Products (see Photo 16). The rest of the column forms on the site were Sonotube formwork. The choice of different types of round formwork was probably determined by the fact that Sonotube does not manufacture forms taller than 20 feet. Both formwork manufacturers represent their products as calculated to resist the pressures produced by freshly poured concrete. Although, based on the manufacturer literature, the formwork does not appear to need any stiffening, as the stresses are equalized in loops, the usual practice is to stabilize the formwork against possible lean or separation from the horizontal forms. Here, the system was reinforced by vertical pieces of wood tied together with wire. The investigation found the bottom nine feet of the round paper form not torn. The proper practice required that concrete had to be poured in the column prior to the slab pour and vibrated as well.

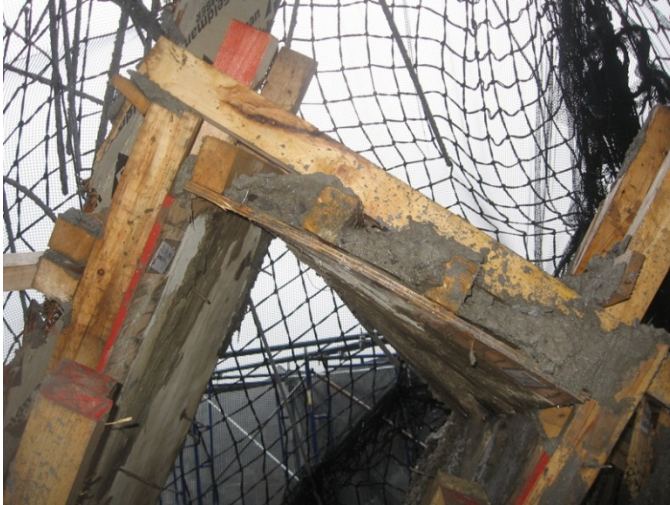
Photo 17 Beam Form (Upside-down)

The beam formwork was composed of plywood reinforced with 3x4 wood ribs and kept together with Meadow-Burke ties set at 30". Some of the forms (the 3 sides) were found in the debris. The investigation was not able to recover intact formwork in significant amounts (see Photo 17). The investigation also could not reconstitute the means of support (if any) of the top of the beam side formwork (where it meets the horizontal forms). The snap tie hardware is from Meadow Burke, with the ties having a diameter of .22". The ties are attached via wedges to pairs of 3x4 joists (see Photo 18 –Beam Formwork –Ties and Ribs).

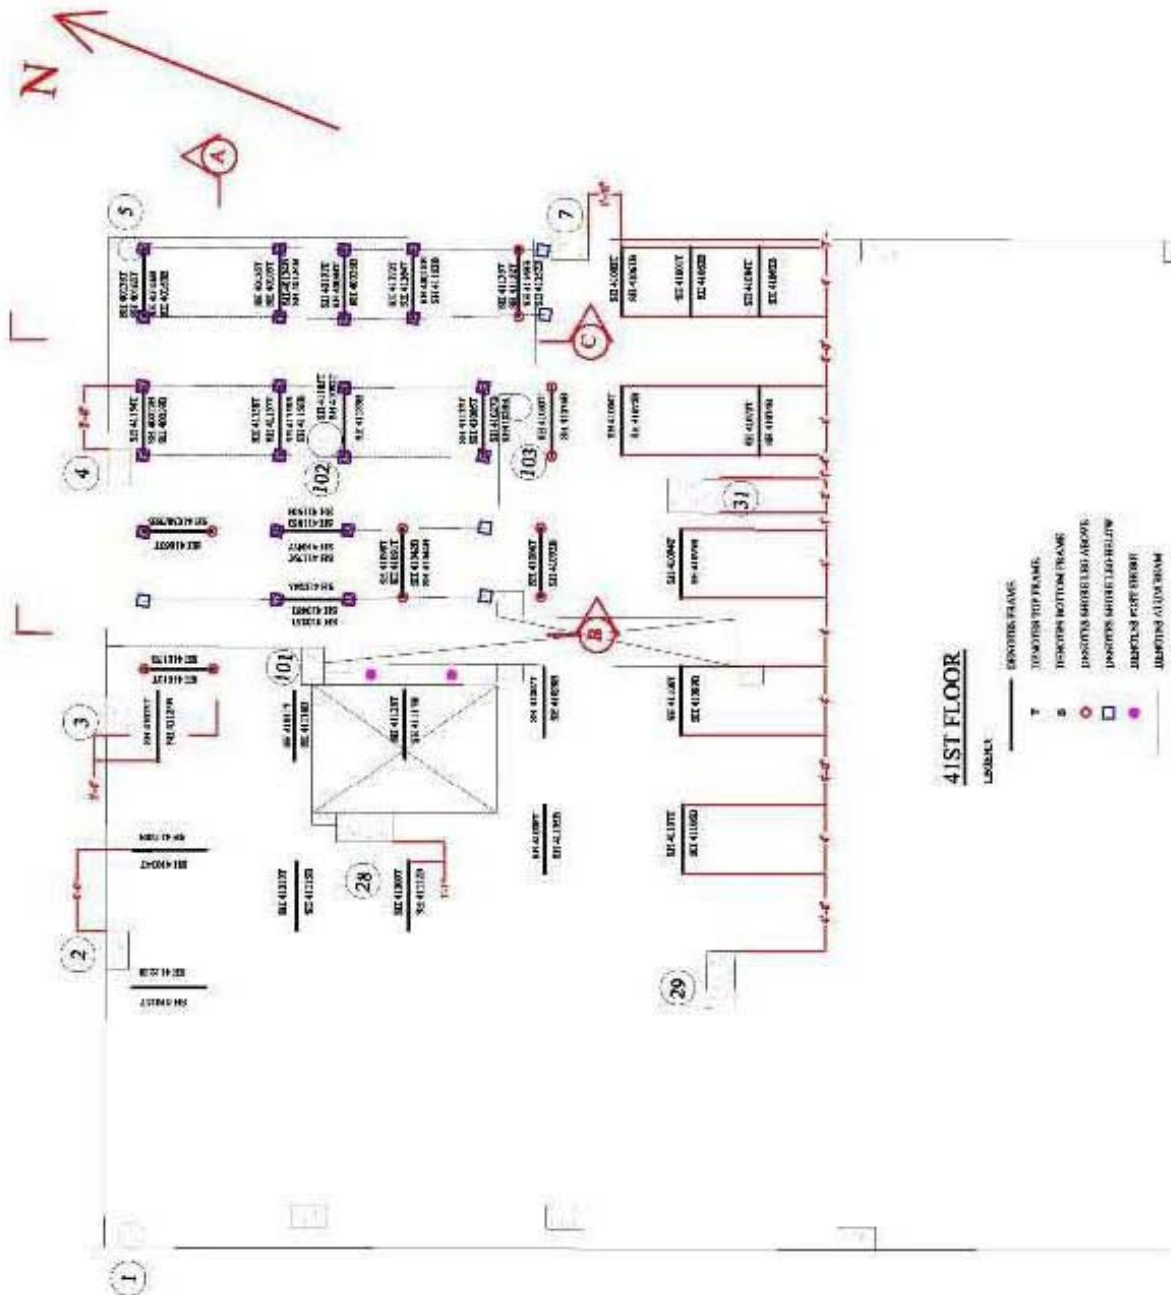
Figure 3 Plan Shoring at 41st Fl. Reconstruction

As mentioned above, the aluminum stringers in the area had different lengths (10, 12 and 16 ft). While the stringer centerline plan position (alignment) was established with good reliability, the identification of each stringer length location is less definitive (see Figure 3 Plan Shoring 41st Fl. and Figure 4 Plan Shoring 42nd).

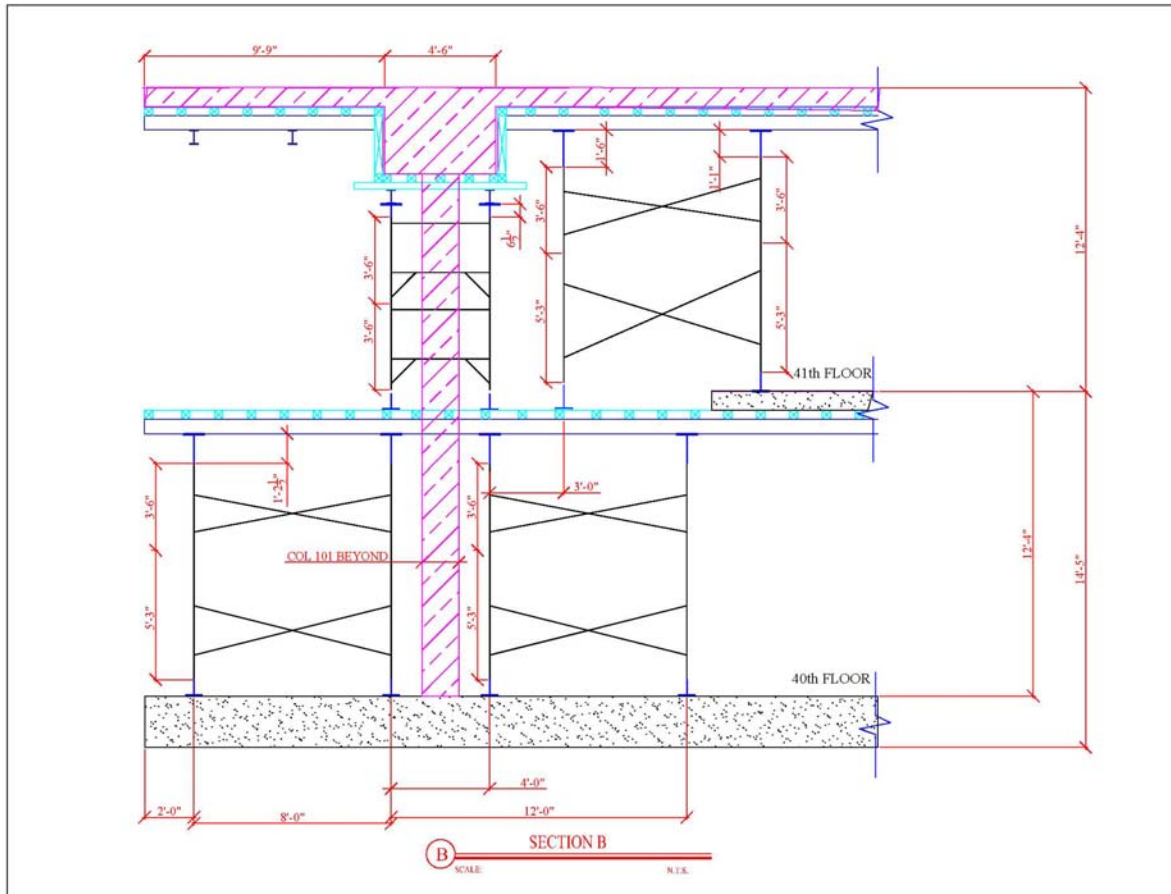
Figure 6 Section B. Reconstruction Shoring (Looking East)

performed directly from the top leg to the bottom or via a system capable of sustaining the forces. In our case, the plywood and joists were interposed between the legs (see Figures 6 and 7 and Photo 21). Note in Photo 21 the almost precise contour of the base plate defined by the punch hole and the relative position of the nails. The alignment of nails indicates the position of the joists. Clearly the plate was set between the joists and not on top of them. Several punch-holes like this were found in the debris.

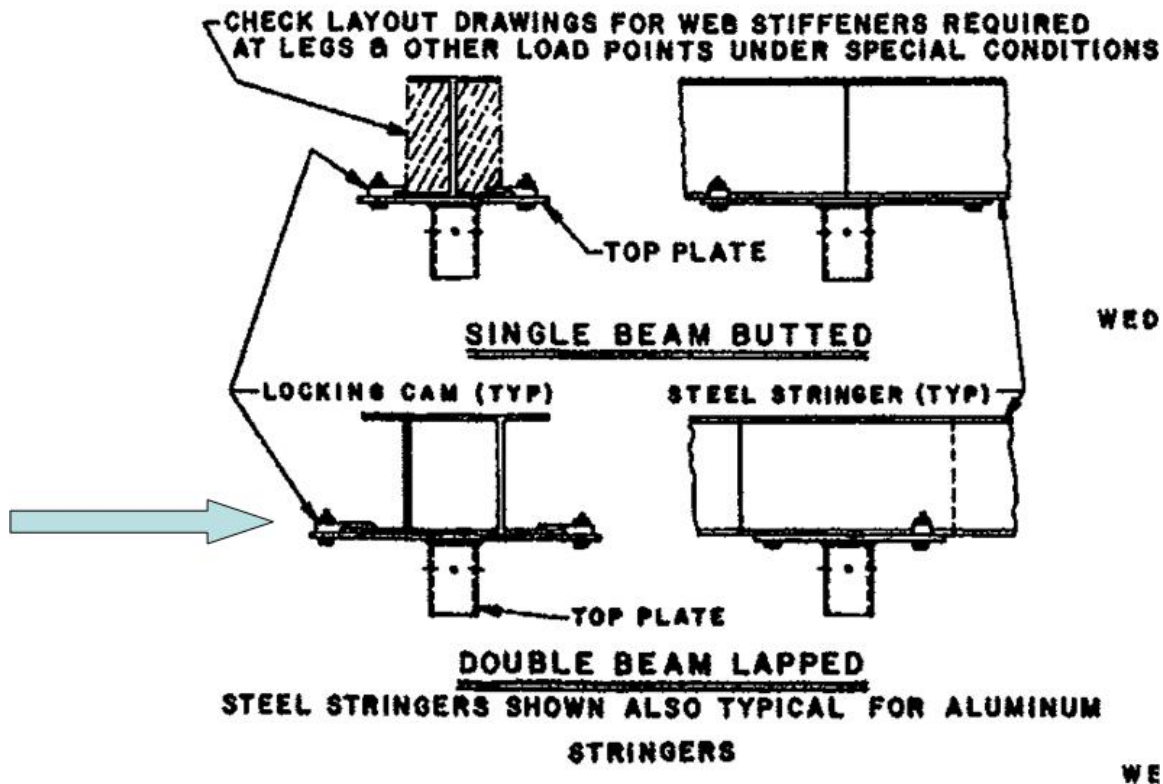
Figure 8 Lapping of Stringers - Patent Instructions

Patent's instructions require the stringer to be set in a manner to ensure a centered load on the head plate (Figure 8 Lapping of Stringers – from Patent Instructions). In fact, this layout is shown on each of the drawings, underscoring the importance of the requirement. The extent of the damage in the collapsed zone prevented the investigators from ascertaining whether the stringers were properly installed in the portion that collapsed, but proper installation (as shown in Patent's sketch) was not found anywhere else (i.e., in areas immediately adjoining the collapse or in areas to the south of the building that used the same tower configuration) (see Photo 20 Eccentric Stringer Position). It is thus a reasonable inference that the collapsed portion was similarly improperly installed.

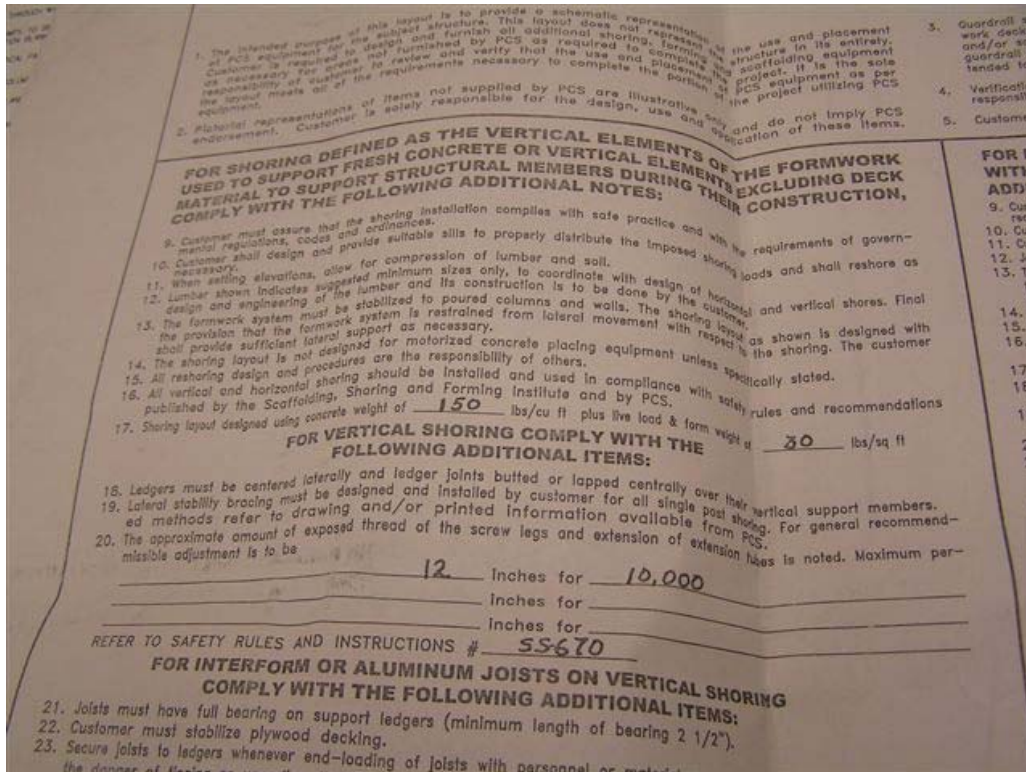
Photo 19 Exposed Thread of Adjustment Screw Leg Instruction by Patent

One drawing note in particular merits mention. On Sheet 1, a note indicates a 12 in. maximum leg extension for a capacity of 10,000 lbs (see Photo 19). It is not clear whether the extension is limited to this dimension for all leg extensions, or only when such capacity is required. It is the opinion of the investigators that the engineer who prepared the drawings meant that 12 in. was the extension for a certain capacity (specifically, 10,000 lbs.), not for all capacities. The investigators so conclude because the design engineer had the obligation to establish the parameters under which the tower was to work (see also 6.1.2). The aluminum frame here (two legs) was rated at 20,000lbs. The installer had no other guidance for installation and had no way to determine on his own what the rating would be for a larger extension.

The typical drawing S1 and Publication SS670R1 indicate various reductions in tower capacity as a result of increased extension of the tower leg (exposed thread). Note that the manufacturer's instruction allows extensions of the leg, but Patent, as the designer of record for the shoring, indicated on Sheet 1, that "extension shall not exceed 12" for 10,000 lbs." The investigation found this dimension exceeded. In Photo 11 the screw extension is between 15 and 16 inches. The report analyzed in detail the results of this weakening (see Appendix A). Since the shoring installer is not supposed to estimate loads, and would not know if the 10,000 lbs value was reached or not, 12 inches should be in fact considered as the maximum allowed extension for this job.

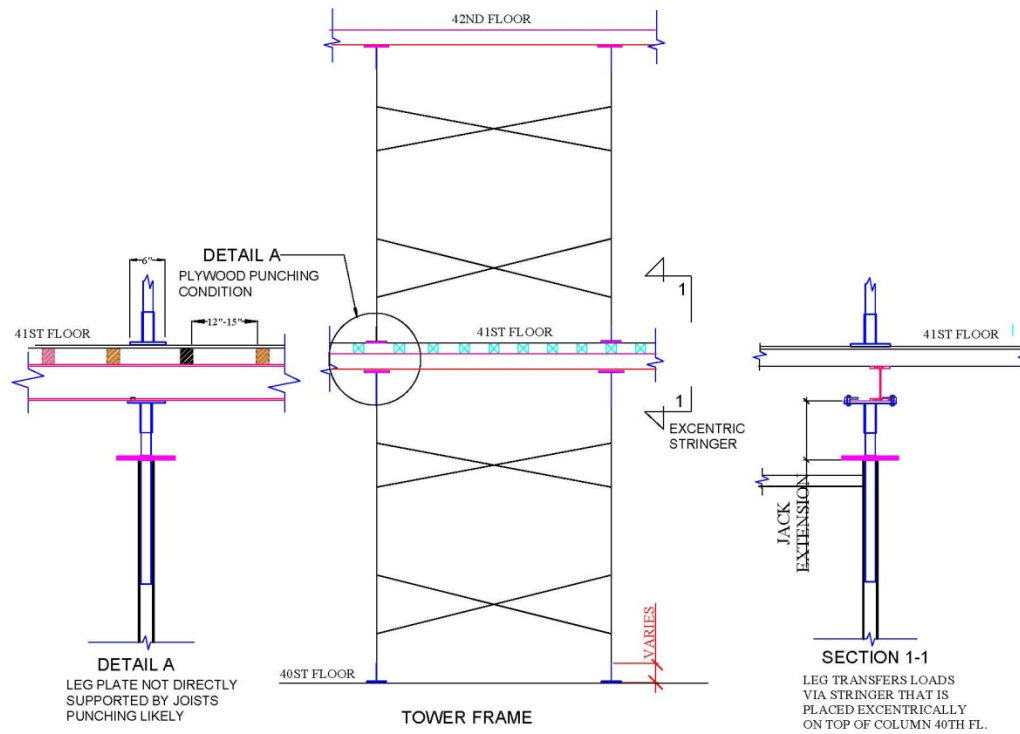
Figure 10 Transfer of Loads at “Mud Floor” – Before Loading and Collapse

This scenario (Figures 10 and 11) clearly explains the global failure of the entire stacked system and is supported by calculations, lab testing and numerous pieces of broken adjustment screws found in the debris. The scenario follows naturally from the mode of failure on the floor above (see 8.1.1). Since such failure would have occurred in any tower under the central beam (where the loads are maximum) the resulting general collapse would be consistent with the layout of the debris existing at the site.

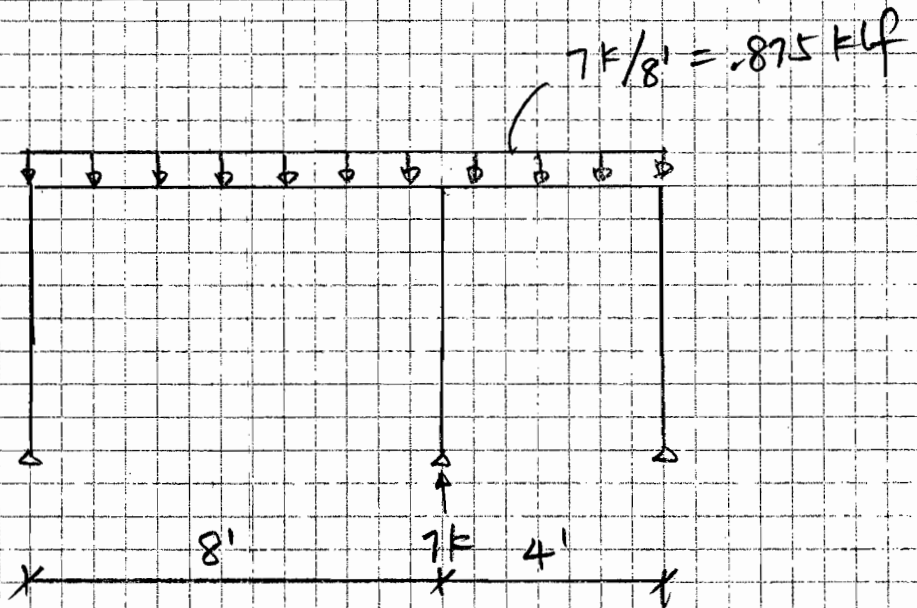
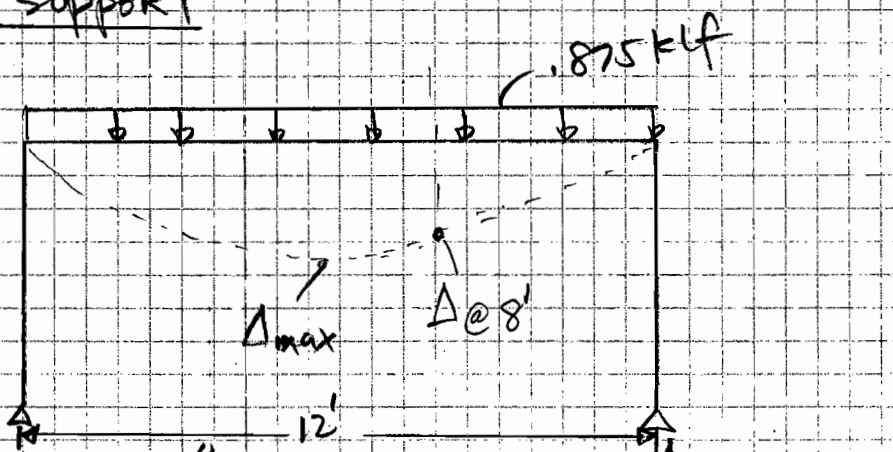
① CONDITION 1 - MIDDLE SUPPORT IS LOOSE
ORIGINAL CONDITION

LOOSE SUPPORT

• $\Delta_{max} = \frac{5}{384} \frac{wL^4}{EI} = 1.16''$

• $R_B \text{ TOTAL} = \frac{7k}{2} + 7k = 10.5 k$

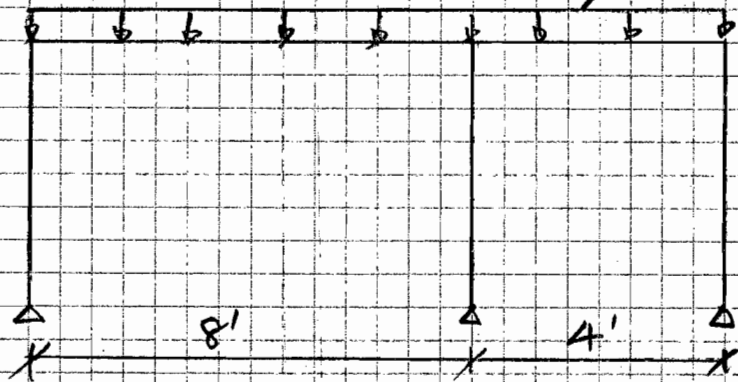
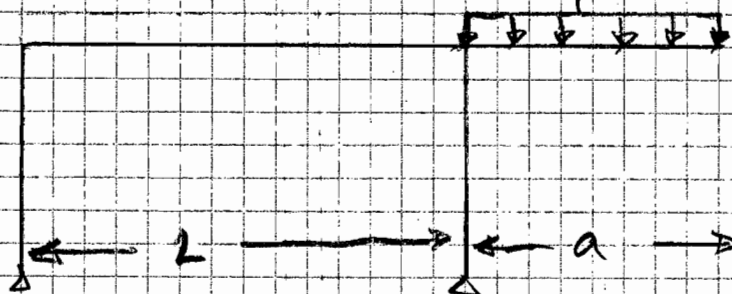
② CONDITION 2 - OUTER SUPPORT IS LOOSE
ORIGINAL CONDITION $w = 7k/8' = .875 k/ft$

LOOSE SUPPORT

$2' \times \frac{1}{2} F = .875 \times 4' = 3.5 k$
 $\downarrow .875 k/ft$

$$R_B = \frac{3.5 \times (8' + 2')}{8'}$$

$$= 4.375 k$$

$$R_{BTOTAL} = R_B + 7k = 11.375 k$$

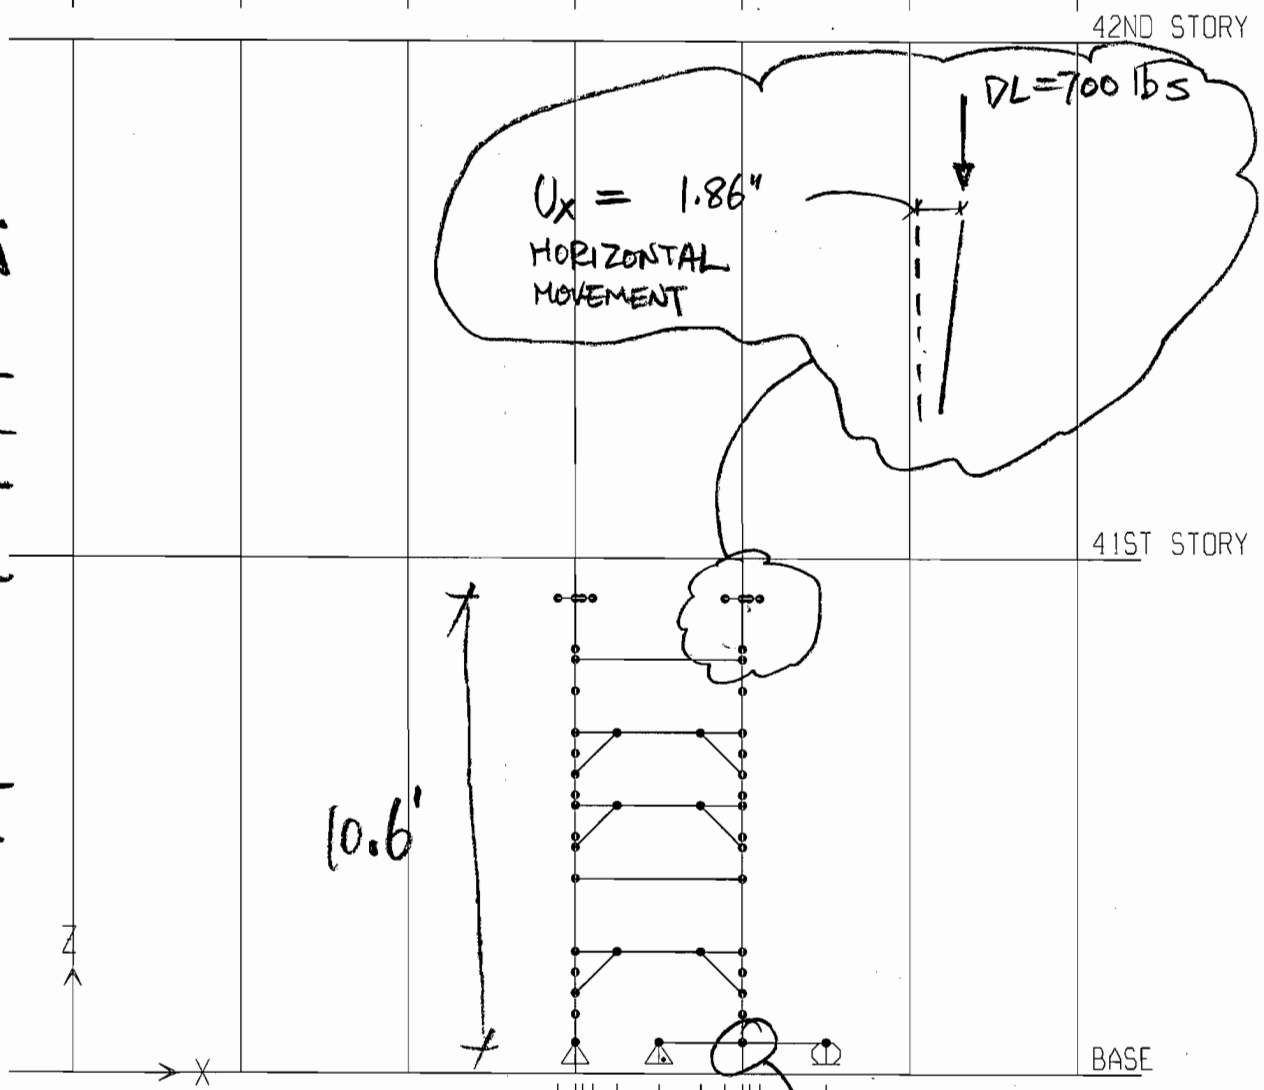
DEVELOPING 2% LATERAL FORCE BY PUNCHING OF PLYWOOD.

1/8" DEFLECTION LIMIT DUE TO PLYWOOD PUNCH.

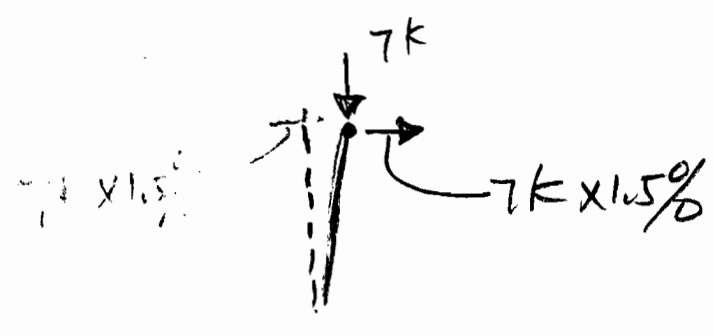
HORIZONTAL DEFLECTION ON THE TOP CAUSED BY THE DEAD LOAD AND 18" LIMITED SUPPORT DUE TO PUNCHING OF PLYWOOD,

kip $\times \frac{1.86''}{10.6' \times 12} = \underline{\underline{1.5\%}}$

BASED ON GEOMETRY
