**808 COLUMBUS AVENUE  
REPORT OF INVESTIGATION  
FEBRUARY 15, 2008**

**DAN ESCHENASY, PE  
DEPUTY ASSISTANT COMMISSIONER  
FORENSIC ENGINEERING UNIT**

## I. EXECUTIVE SUMMARY

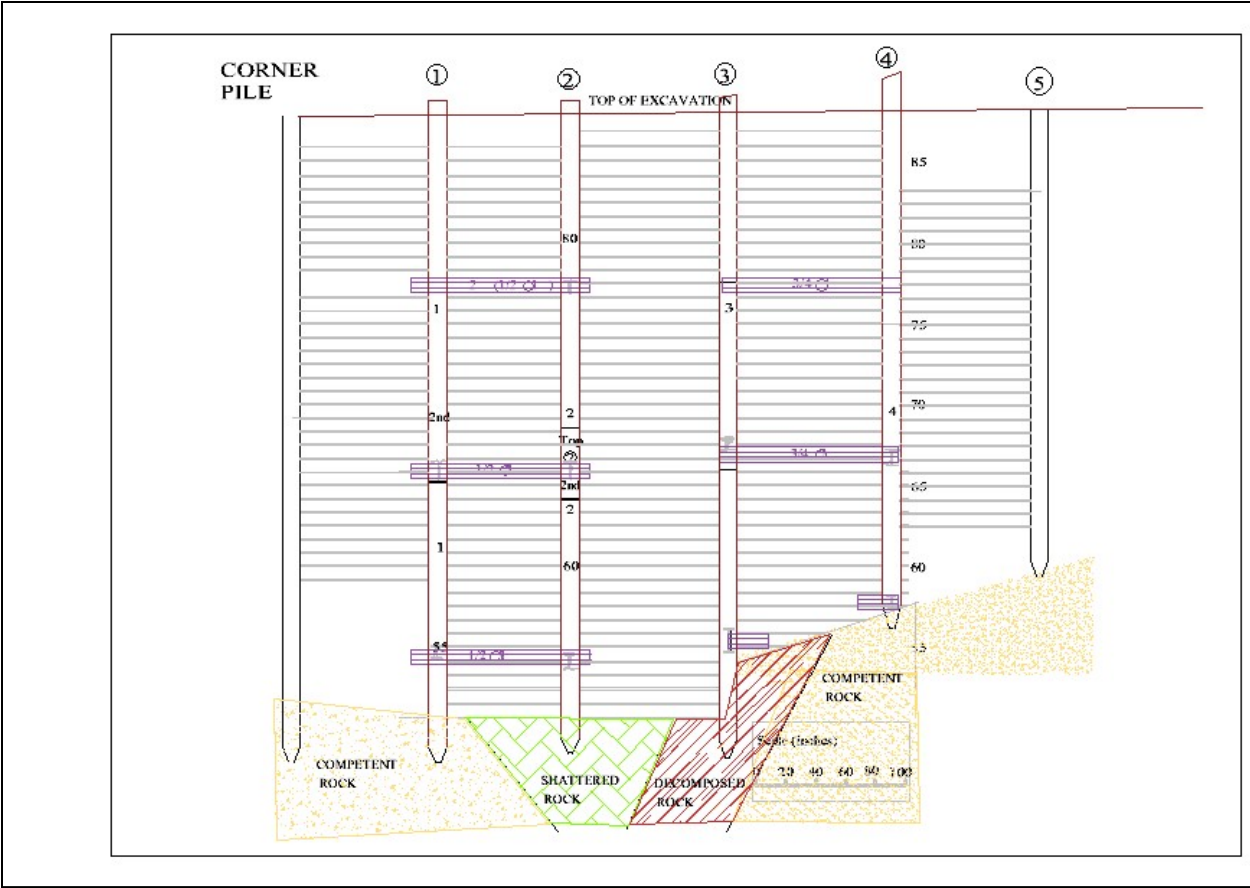
Figure 1 Installed Sheet Piling Elevation

The rock mass in the area of the collapse was observed and mapped in detail during excavation on August 27, 2007 and August 28, 2007. Figure 1 is a sketch of the exposed rock face between new piles #1 and #3. Figure 2 is a sketch in the vicinity of pile #1 and the SE corner of the bay.

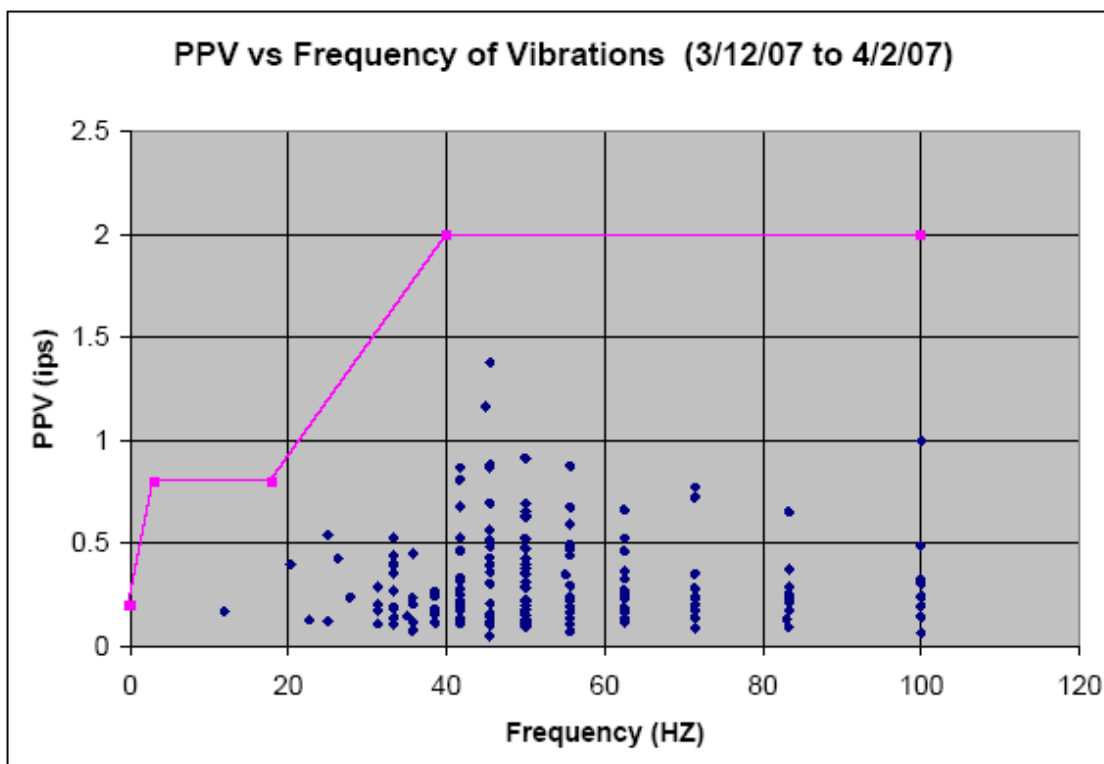
**Figure 7 – Particle Velocity v. Frequency**

It is clear from the vibration records that with one exception all vibration frequencies exceeded 20 Hz. Most of the frequencies were in the 40-60 Hz range. This compares well with the usual building structures frequencies that are in the 5-10 Hz range.

The graph of particle velocity versus frequency meets the criteria of the Bureau of Mines study. These data are represented by the pink line in the chart. The particle velocity also met, except in two cases, the requirements of FDNY.

The absence of cracks on the building interior and exterior is consistent with the vibration measurements performed by Metric (see Figure 7). The frequency is higher than 20Hz. Of the few cracks observed in the building practically none could be attributed to blast. This is a positive indication that the level of blasting that occurred without dynamic monitoring was within acceptable limits for cosmetic damage of permanent buildings.

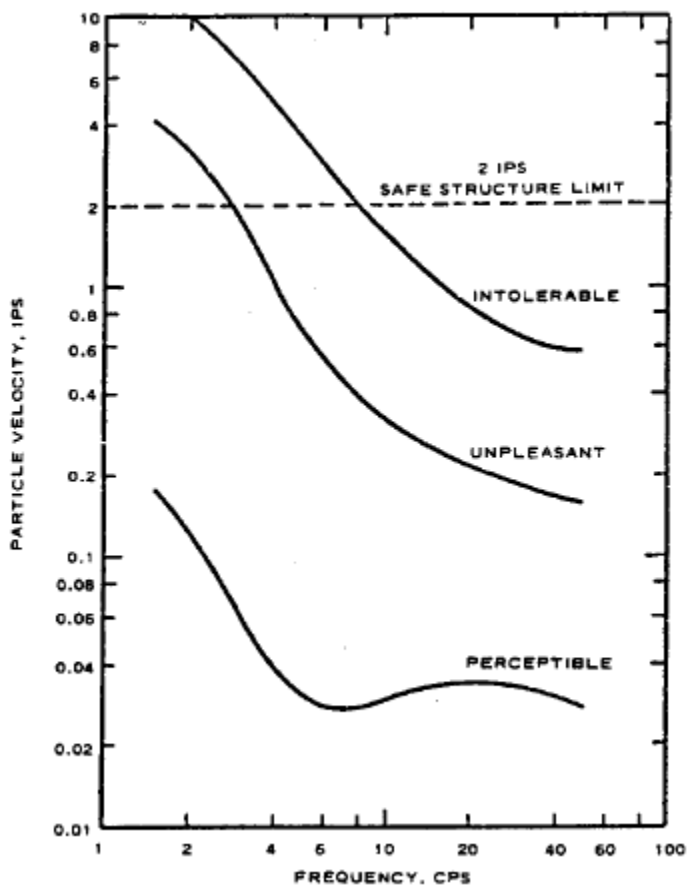
**Figure 8 Subjective response of the human body to vibrations**  
From EM 1110-2-3800

Vibration resulting from blasting operations can be annoying and discomforting to the public, even when the blasting procedure is safe. The human reaction to vibration is subjective and many studies have been performed to analyze the level of public complaints. See attached graph from EM 1110-2-3800. An interpretation of seismic readings from the Metric monitoring places some of the vibrations between the unpleasant and intolerable level. This explains the complaints from residents of 784 Columbus.

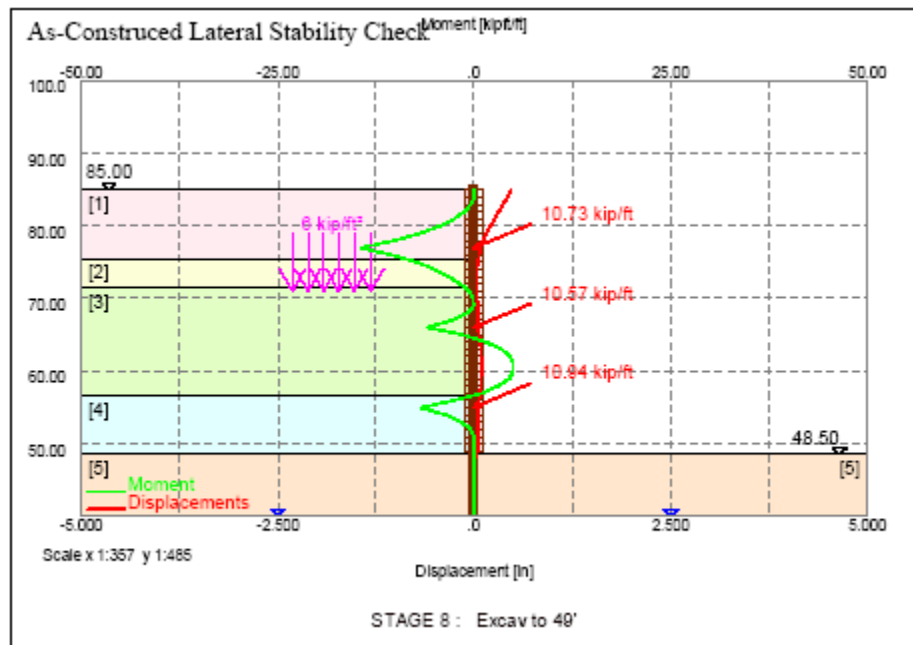
**Figure 12 FREW Analysis –As-Constructed wall design check**

Since pile 2 is the deepest pile with the largest distance between the bottom anchor and the pile toe, that pile would provide the largest wall moment and forces in the anchors. The anchor lengths were assumed to be similar to the design drawing, using a bond length of 20 feet. Likewise, the pre-stress loads were assumed to be the same as the design drawing.

The existing building 784 Columbus Ave is supported on shallow footings. The footing load is applied to the FREW analyses as six ksf vertical pressure acting at elevation 71 ft, 10.5 feet from the wall. The following construction sequences are analyzed in the FREW analysis:

- Set up initial stress, including the existing building footing load
- Install soldier pile and lagging wall
- Excavate to EL. 76 ft
- Install Anchor 1 at EL. 77 ft, preload to 84 kips
- Excavate to EL. 65 ft
- Install Anchor 2 at EL. 66 ft, preload to 77 kips
- Excavate to EL. 54 ft
- Install Anchor 3 at EL. 55 ft, preload to 84 kips
- Excavate to bottom of pile

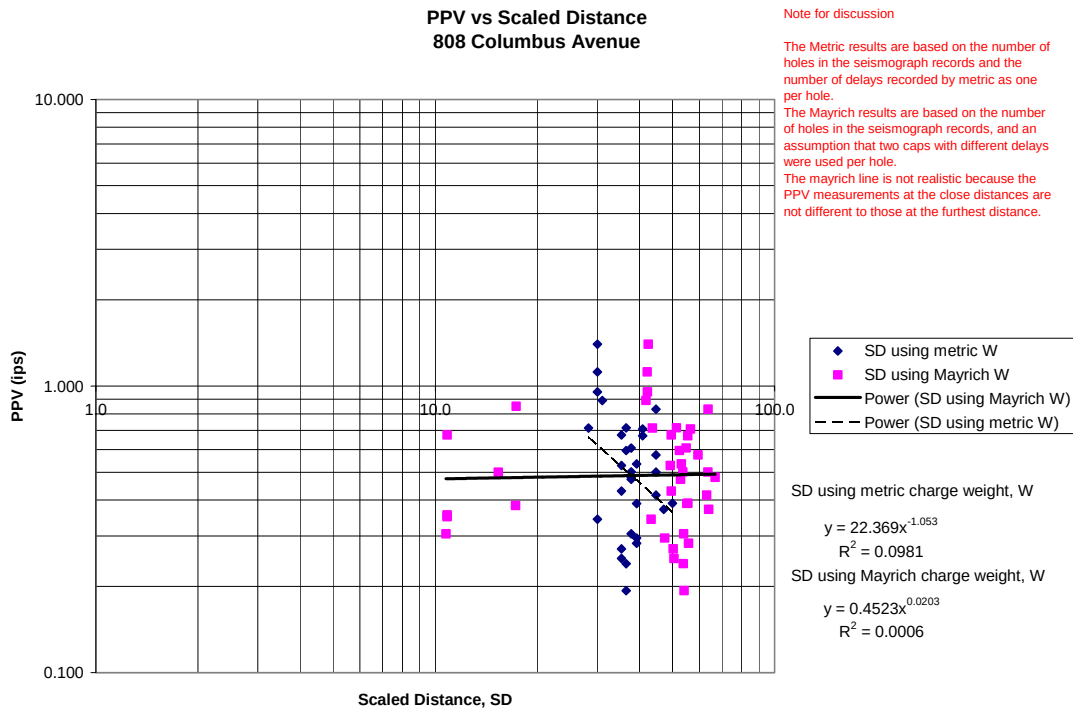
**Figure 18 PPV vs Scaled Distance.**

There are two sources of data for charge weight: the records of the contractor, Mayrich and the records of the instrumentation and monitoring firm, Metric. The Metric data are superior in that they include more information, such as number of holes and velocity measurements but they are only available for part of the blasting program. There are no records for the closest blasting carried out.

The PPV vs. Scaled distance (SD) plot using the Metric data for charge weight, distance and vector sum velocity gives the following relationship:

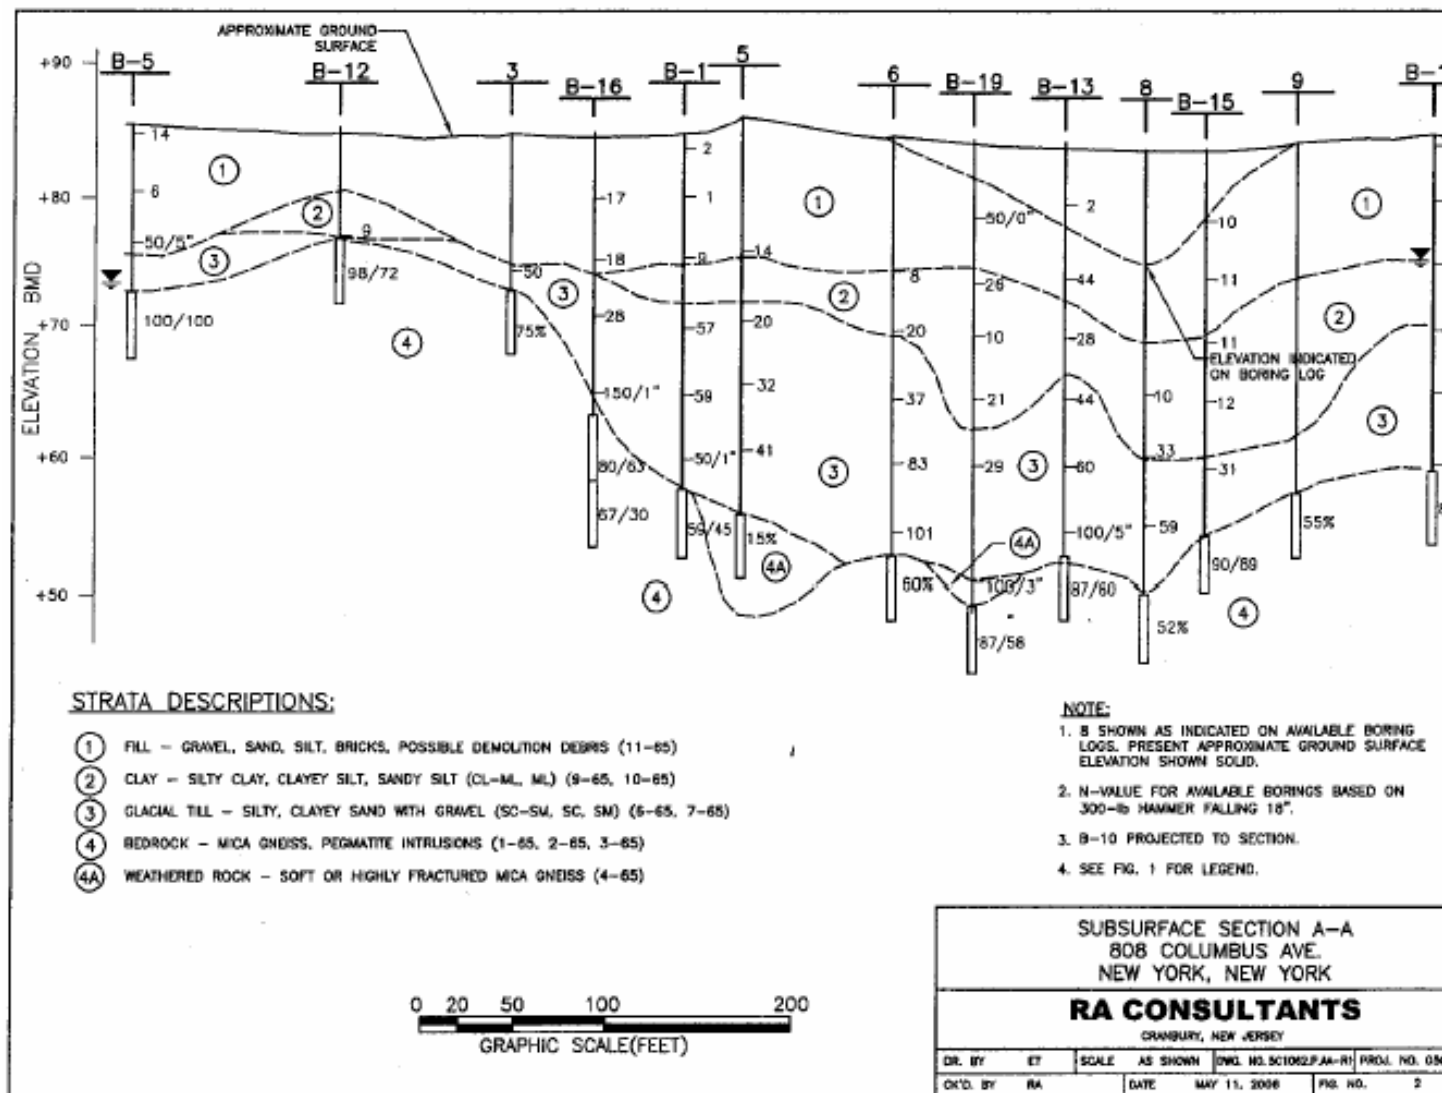
Figure 24 Section thru Site -RA Consultants (Alperstein)

- o The drilling for the pile found soft rock and the socket for pile #3 was over-drilled because the piles were not driven and we can see the extension of the top of the pile with timber.
- o The drilling for the blast holes encountered soft drilling in the same area.
- o Test borings performed before construction had revealed a location of poor quality rock. This was interpreted as such and put on a geological section by Alperstein. (figure 24)
