PROJECT NAME: NYC BOROUGH BASED JAILS SYSTEM, MANHATTAN  
FACILITY PROJECT

PROJECT OWNER: NYC DEPARTMENT OF DESIGN & CONSTRUCTION

PREPARED BY: TUTOR PERINI CORPORATION/O&G

# NOISE, VIBRATION & DUST MONITORING REPORT Number 003

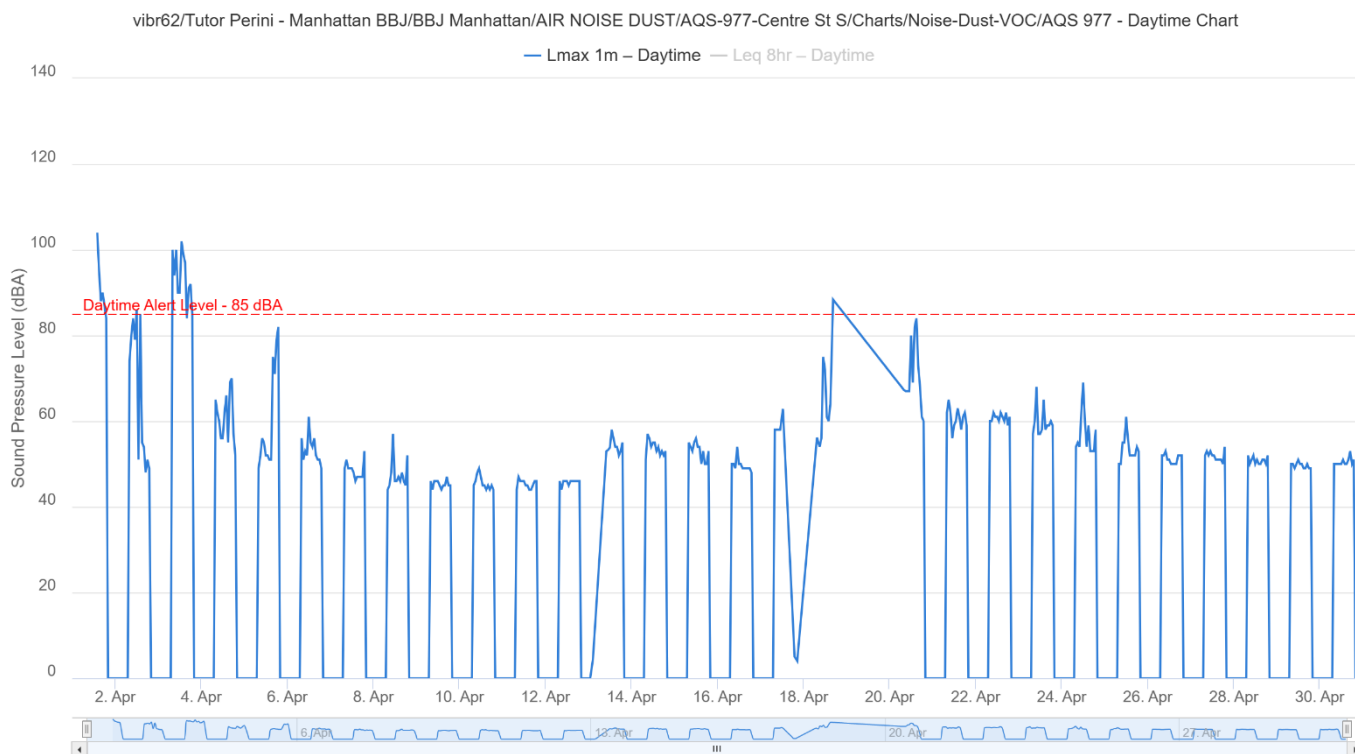
### Noise Monitoring Station #977 Lmax - Daytime

| 977 - APR-01-DAY | 95 | N/A | Based on a review of site operations, construction activities were not the dominant contributor to the exceedance. The exceedance was primarily attributed to background urban noise sources such as vehicular traffic and other off-site ambient conditions. |
| 977 - APR-01-DAY | 92 | N/A | Based on a review of site operations, construction activities were not the dominant contributor to the exceedance. The exceedance was primarily attributed to background urban noise sources such as vehicular traffic and other off-site ambient conditions. |

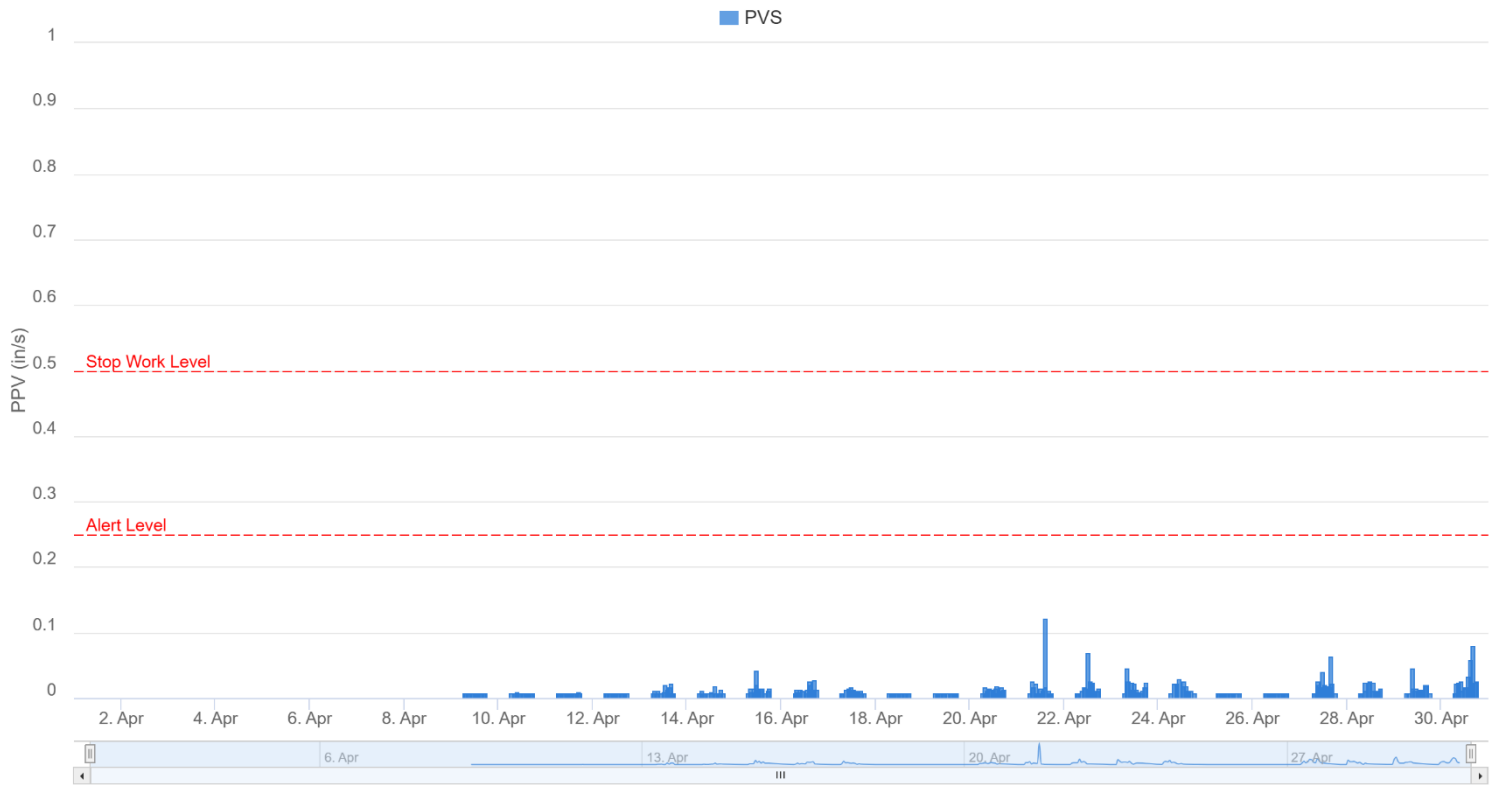
## R04

Monitor R05 at Chung Pak recorded a single exceedance on April 15, 2026, while the other monitors in the same building (R04 and R06) did not register any stop-work exceedances. Early temp SOE Work was occurring near Monitor R06 at the time without triggering an exceedance. Following identification of the event, the Engineer of Record inspected the installation and surrounding area on April 23, 2026, and found no issues. The exceedance at R05 may be attributed to vibration or external environmental factors at the installation location.
