CONSTRUCTION ADVISORY:

**PROBLEMATIC
CHARACTERISTIC
OF BRICK FAÇADE:
DIAGONAL HEADERS**

ISSUE: 2024-001

**CRACKED, DELAMINATED, AND
OUT-OF-PLUMB MASONRY
WALLS CAN LEAD TO UNSAFE
CONDITIONS AND RESULT IN
CATASTROPHIC EVENTS**

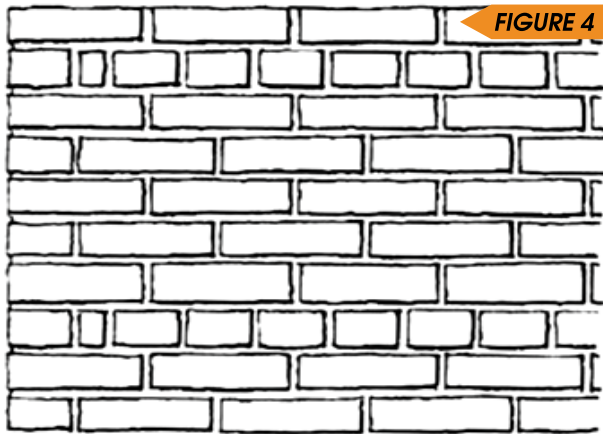
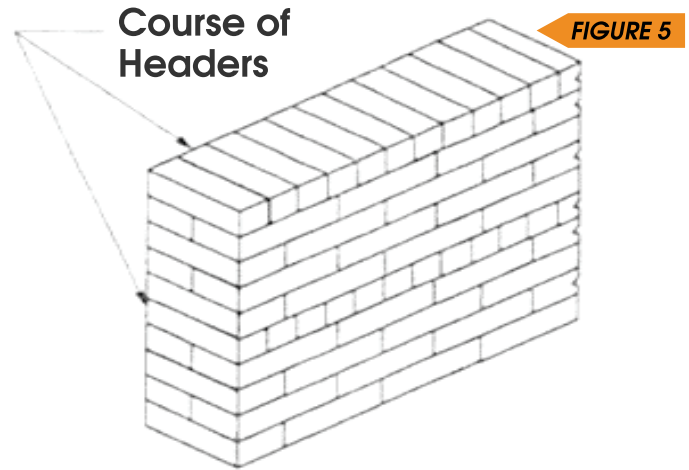
An example of a wall type where there are no diagonal headers is a wall constructed in a **common bond** (Fig. 4 & 5). It features a course of headers inserted every five to six rows, indicating that the exterior wythe is tied back to the backup wall with header bricks (bricks laid with their end facing out).
