Forensic Engineering: Existing Buildings, Alterations and New Construction Course Number SW0517

Yegal Shamash, P.E. Jill Hrubecky, P.E. Anthony Devito, P.E.

May 3, 2017

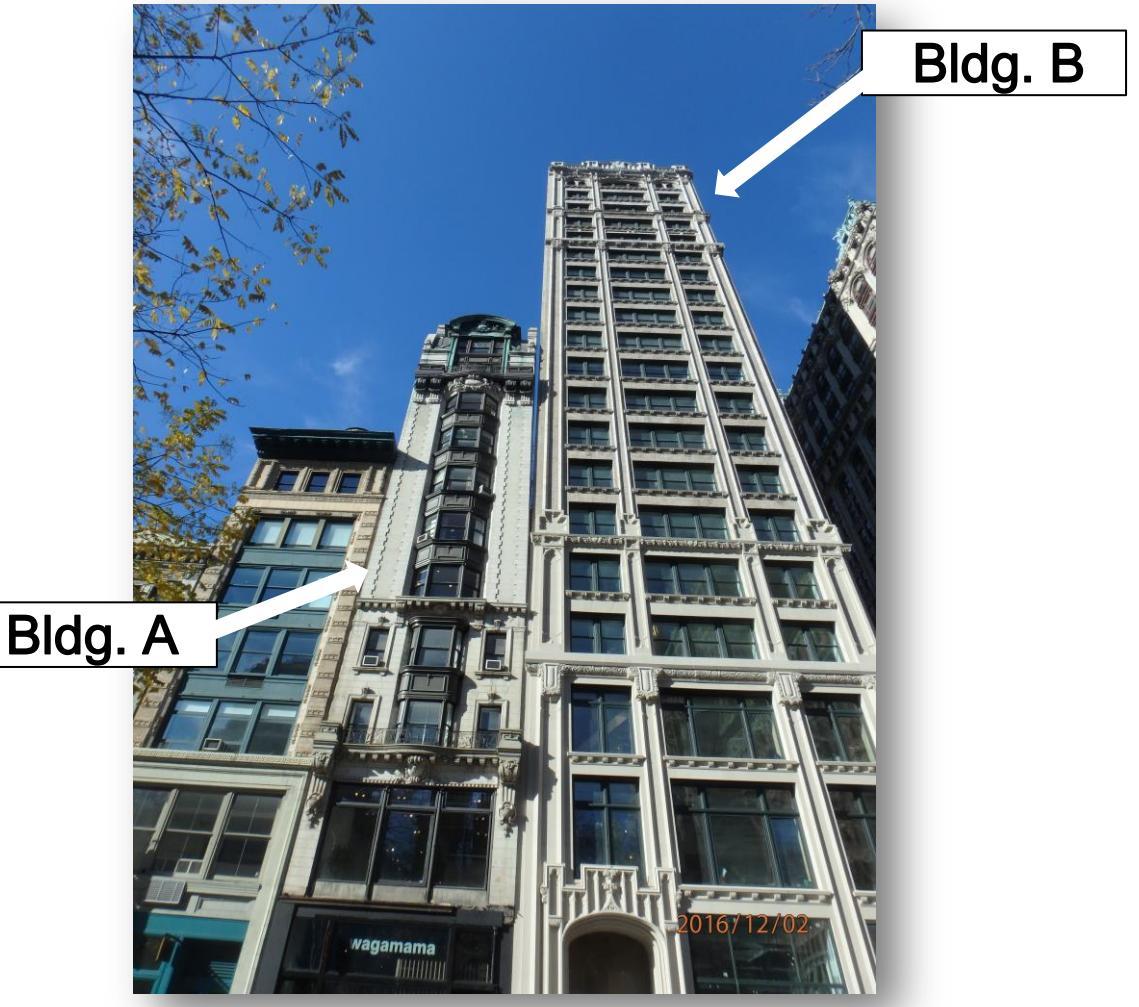
# CASE 1: LEANING BUILDING (EXISTING)

- Referral from BSIU
- Complaint was for a gap between buildings

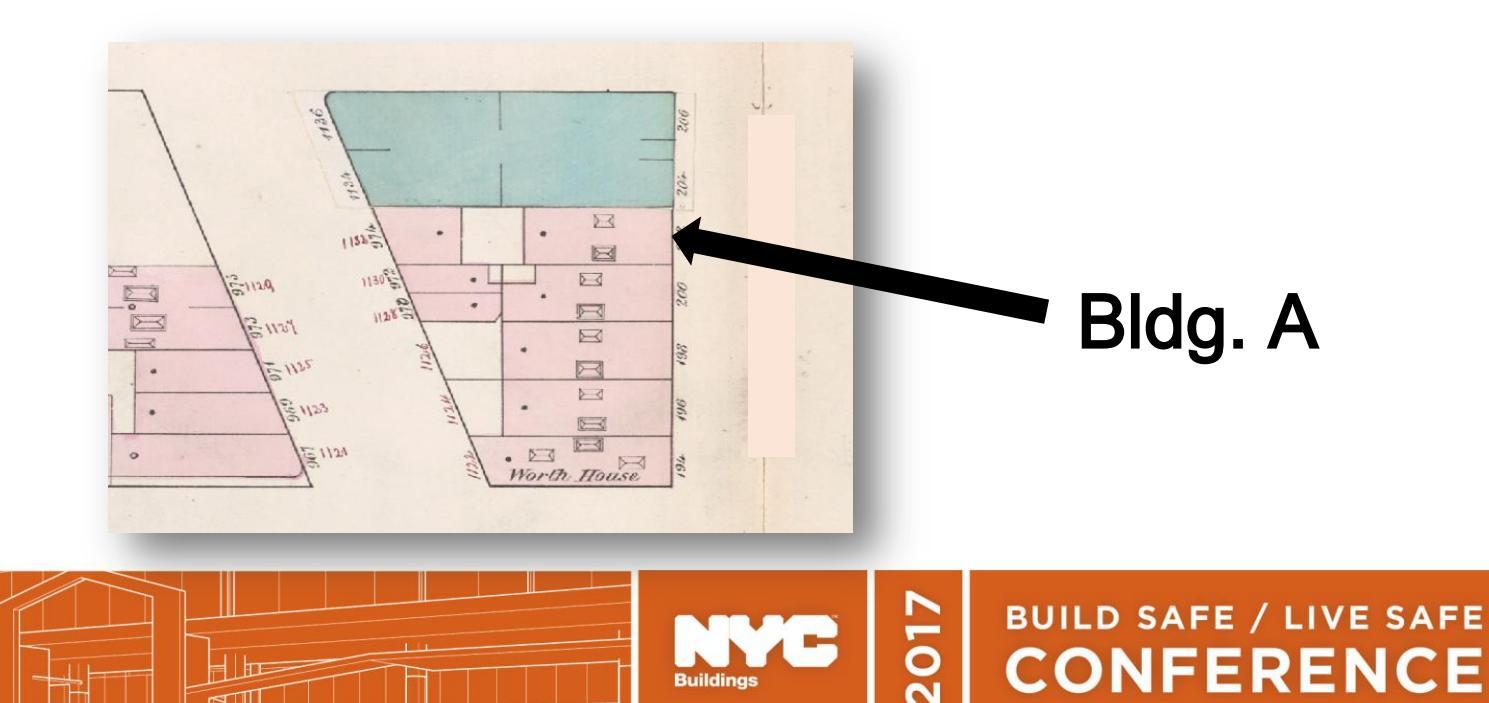
- Construction of buildings determined from historic tax maps
  - 1852 nothing on site
  - 1857 Building A lot has 3 story townhouse

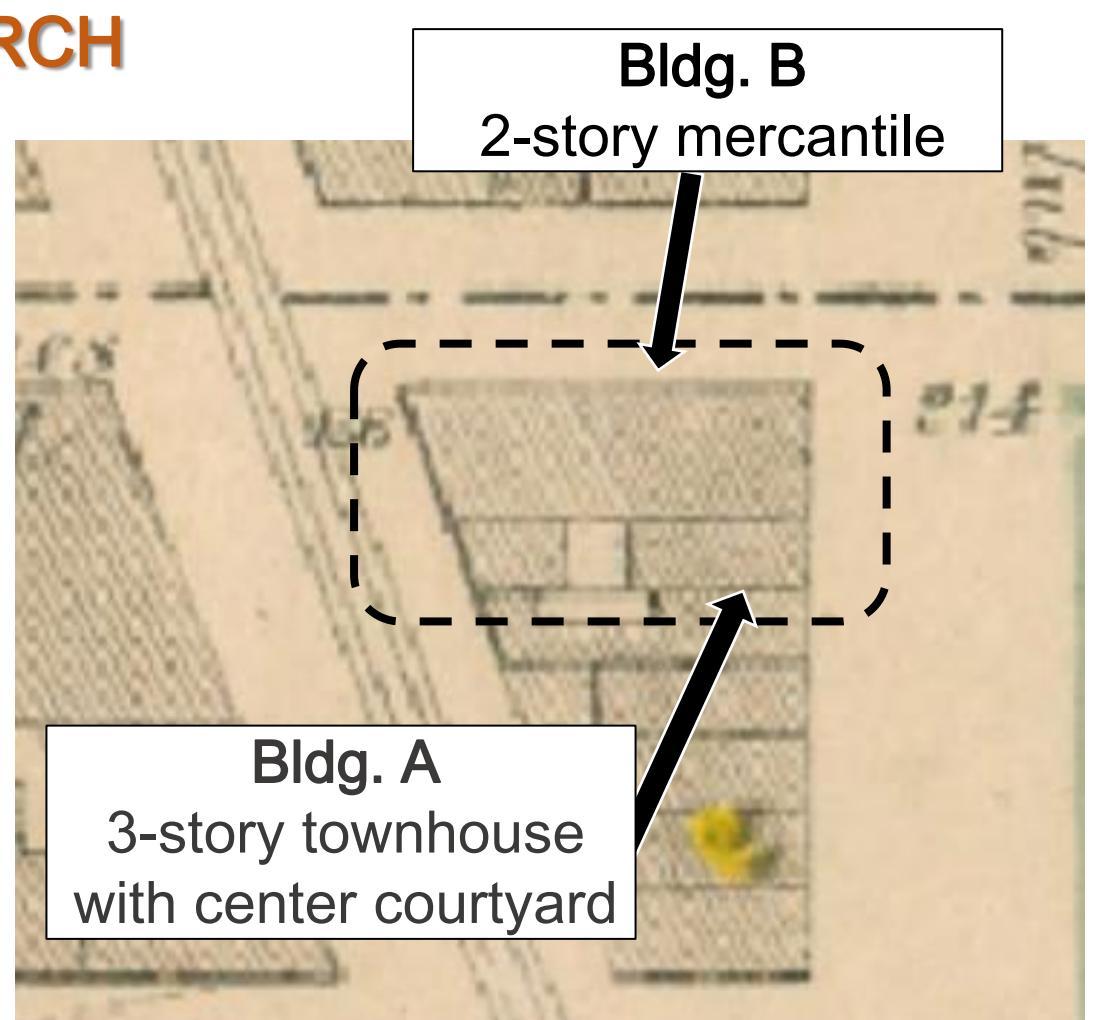
- Buildings on both lots by 1860
- Both buildings vertically enlarged to four (4) stories by late 1800s
- Extensions were made on original foundations

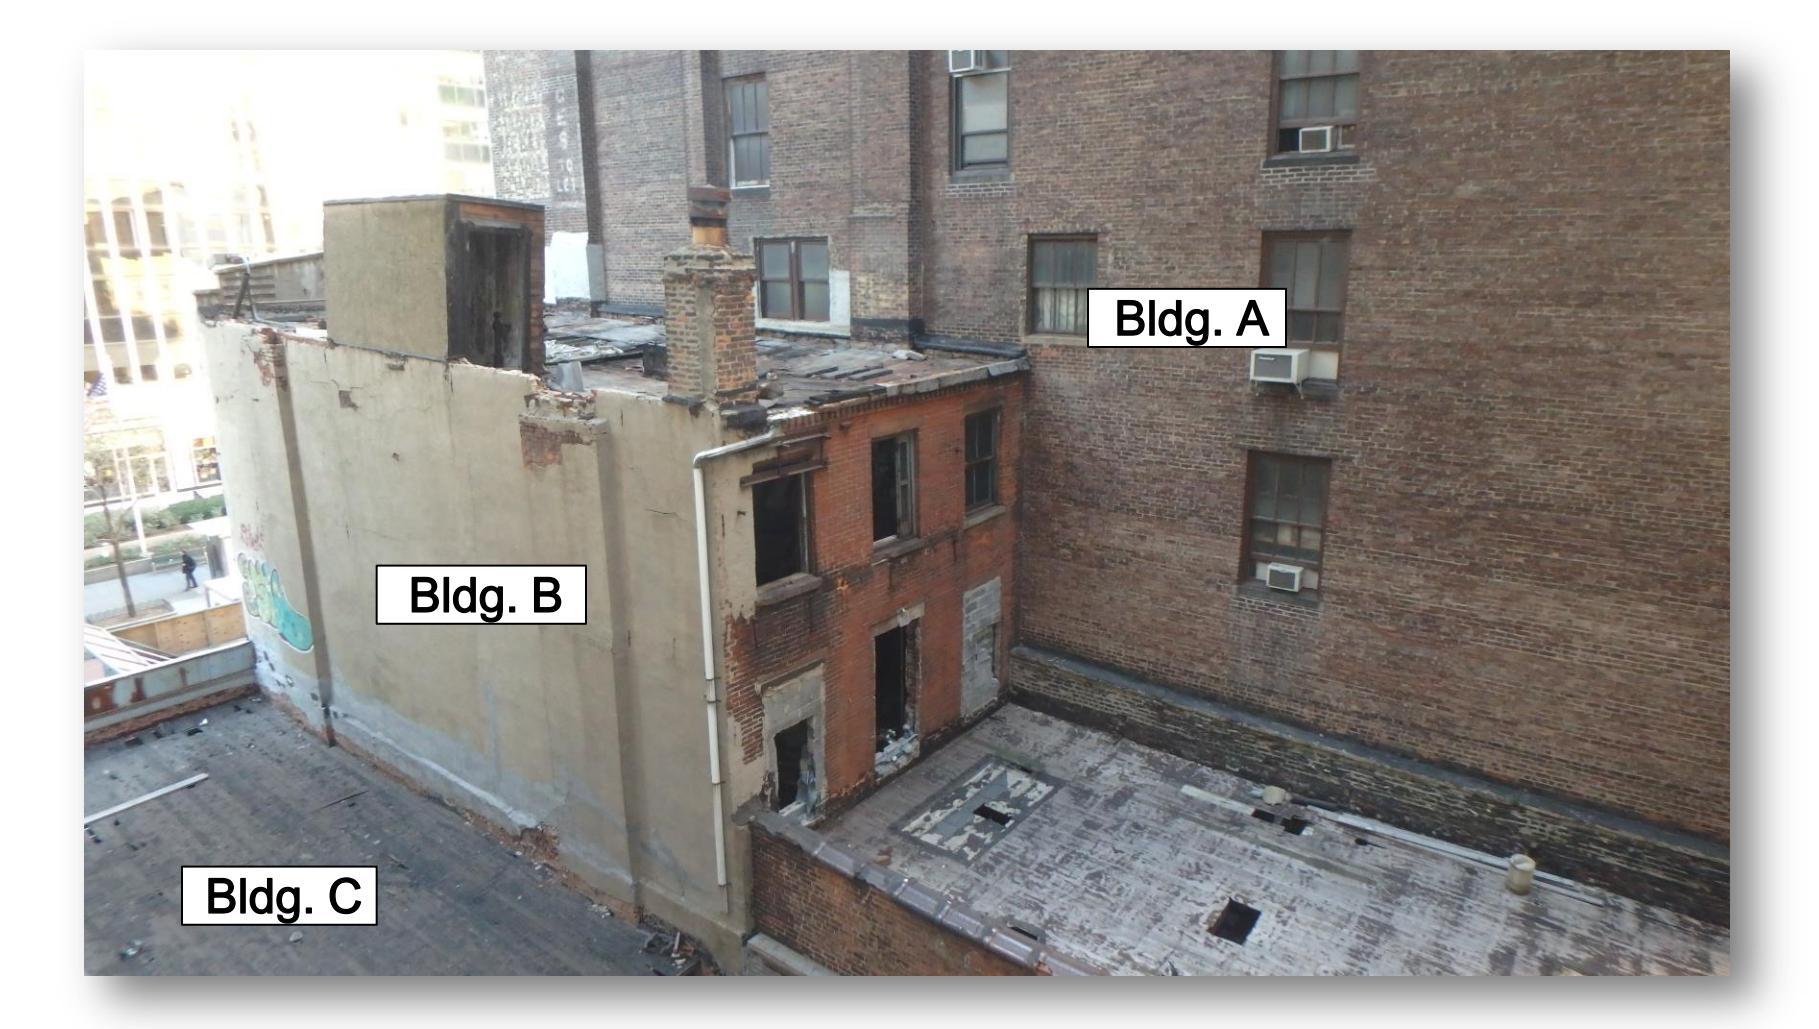
#### **CASE 2: INSPECTION**

- Fire and water damage
- Roofs compromised
- Wood roof and floor joists rotted and deflecting
- All buildings vacated
- DOB violations issued to effect either full or partial demolition
- All buildings demolished to grade under permit

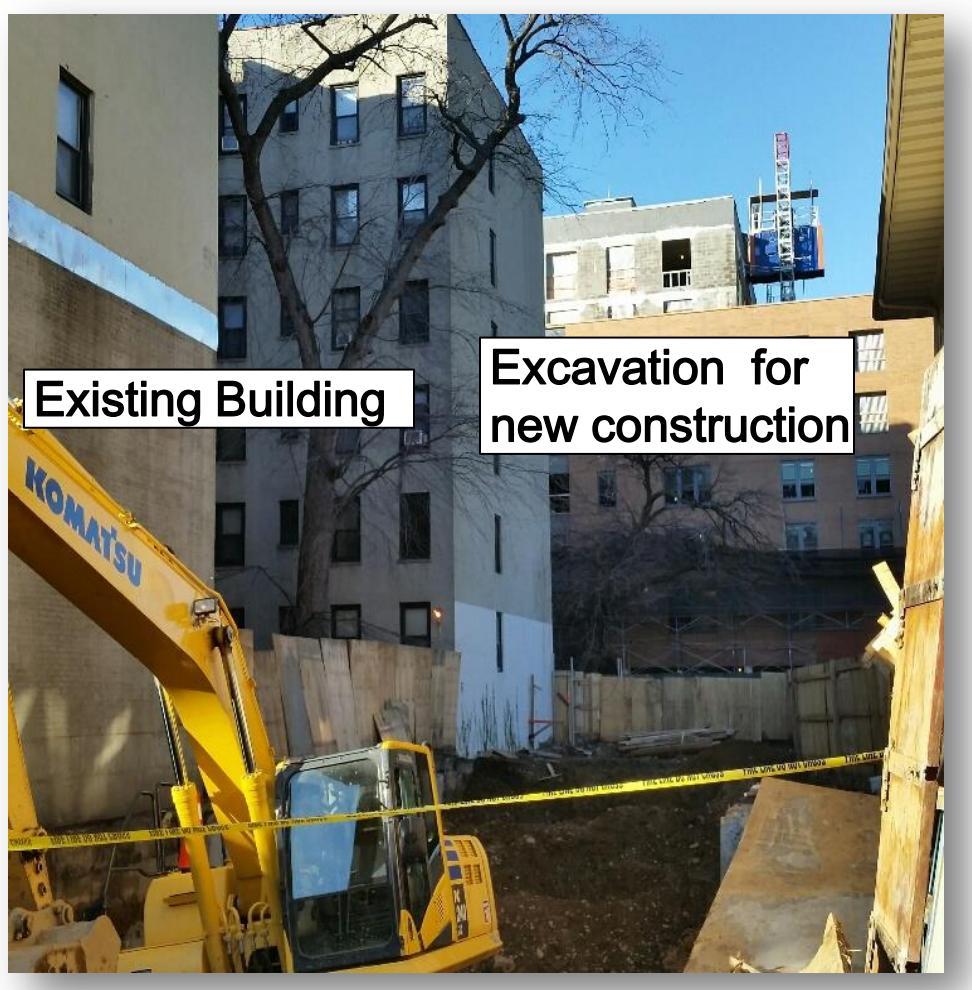
- Referral from ERT
- Report of a construction vehicle hitting the side of an existing building causing cracks from 1<sup>st</sup> floor to parapet
- Response: IMMEDIATE

NOTE: Reported - sound of vehicle hitting building; what may have actually been the sound of the building cracking

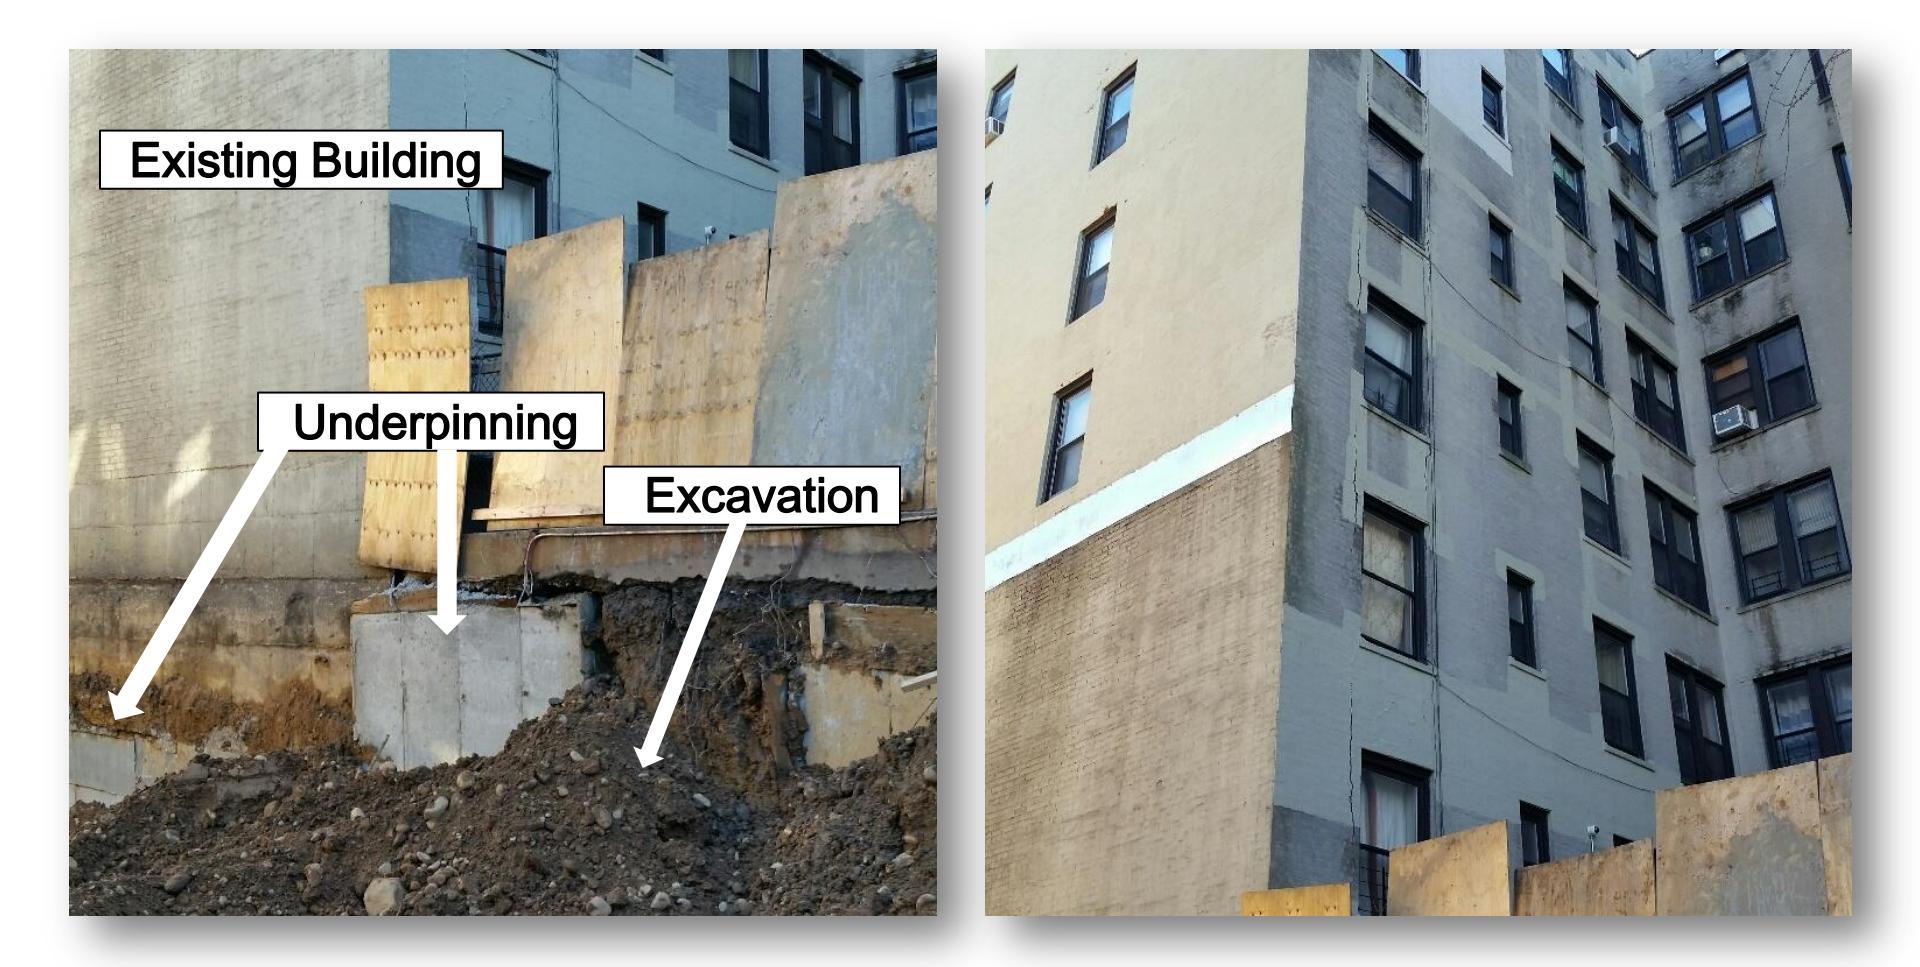
#### **CASE 3: INSPECTION**

- The underlying soil under line 'A' at the existing building became unstable due to ongoing excavation at NB site
- Recent underpinning was observed supporting existing building foundation wall
- Vertical support of this corner was not uniform and generated additional uneven loading at this corner
- Cracks on the exterior wall and inside the apartments were significant and affected the structural stability of line 'A' apartments

- Three (3) DOB Violations
  - Building monitoring
  - Temporary stabilization (strapping)
  - Permanent repairs

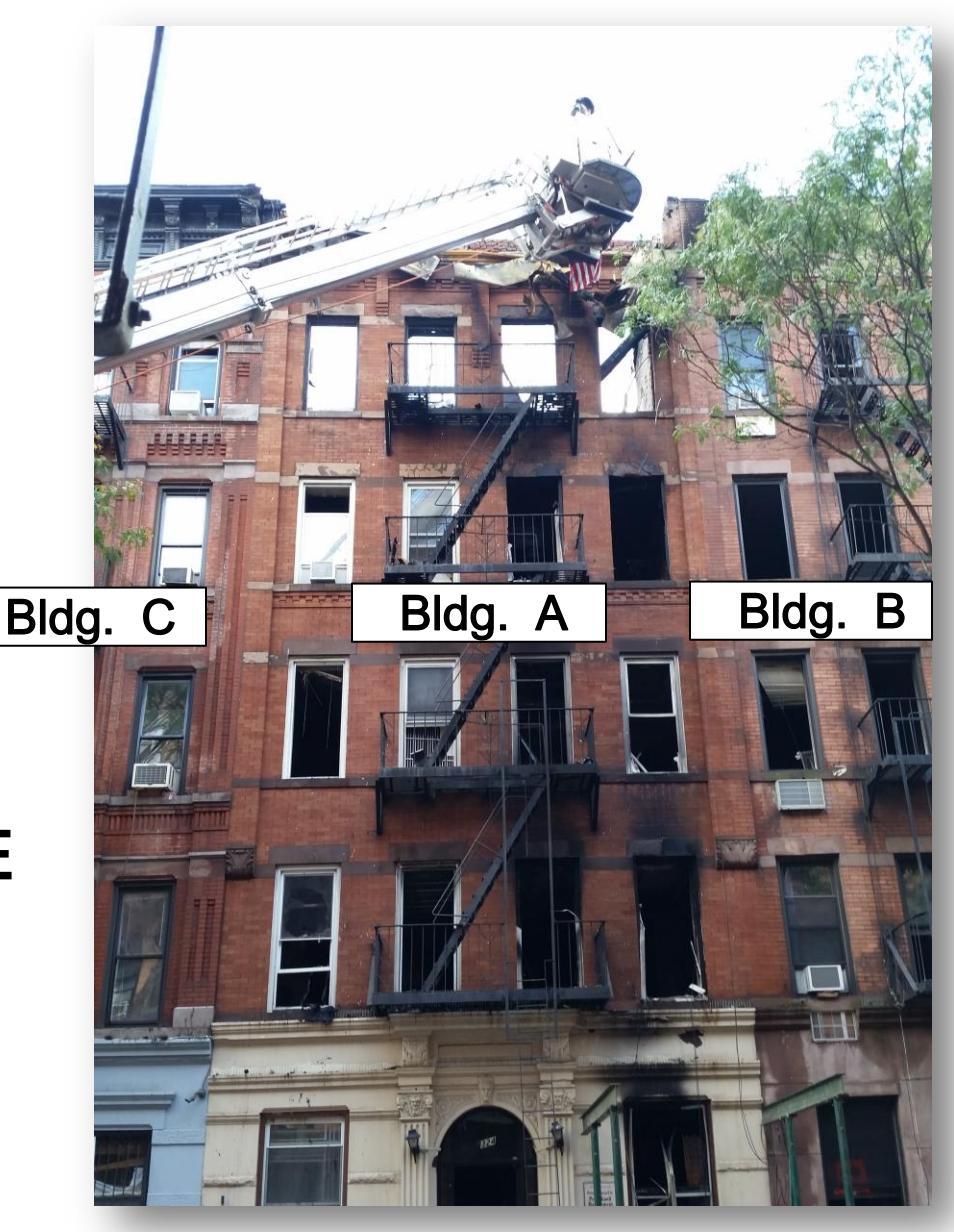
- Referral from ERT
- 6 Alarm Fire in residential rowhouse
  - 1 Fatality
  - 17 Injuries
- Response: IMMEDIATE
