19TH CENTURY CORNER LOT BUILDING

TIMOTHY D. LYNCH, PE Chief Engineer

20 build safe live safe DIGITAL CONSTRUCTION 21 SAFETY CONFERENCE

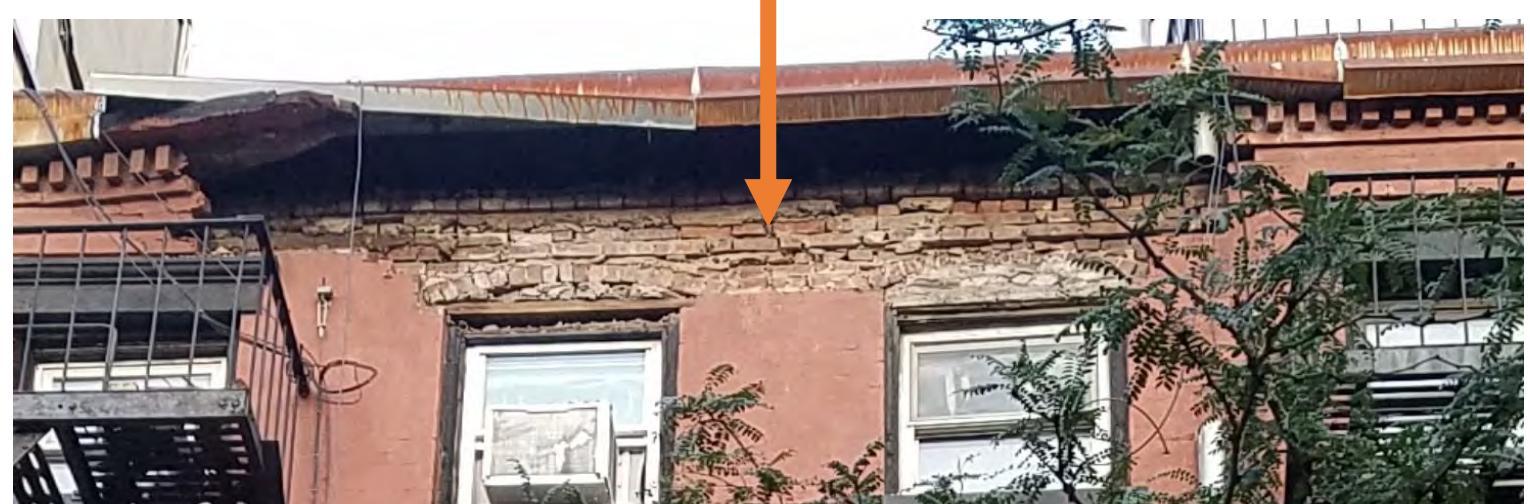
Collapse of Wood Cornice & Face Brick

Original wood cornice collapse and delamination of face brick; very common with running bond walls

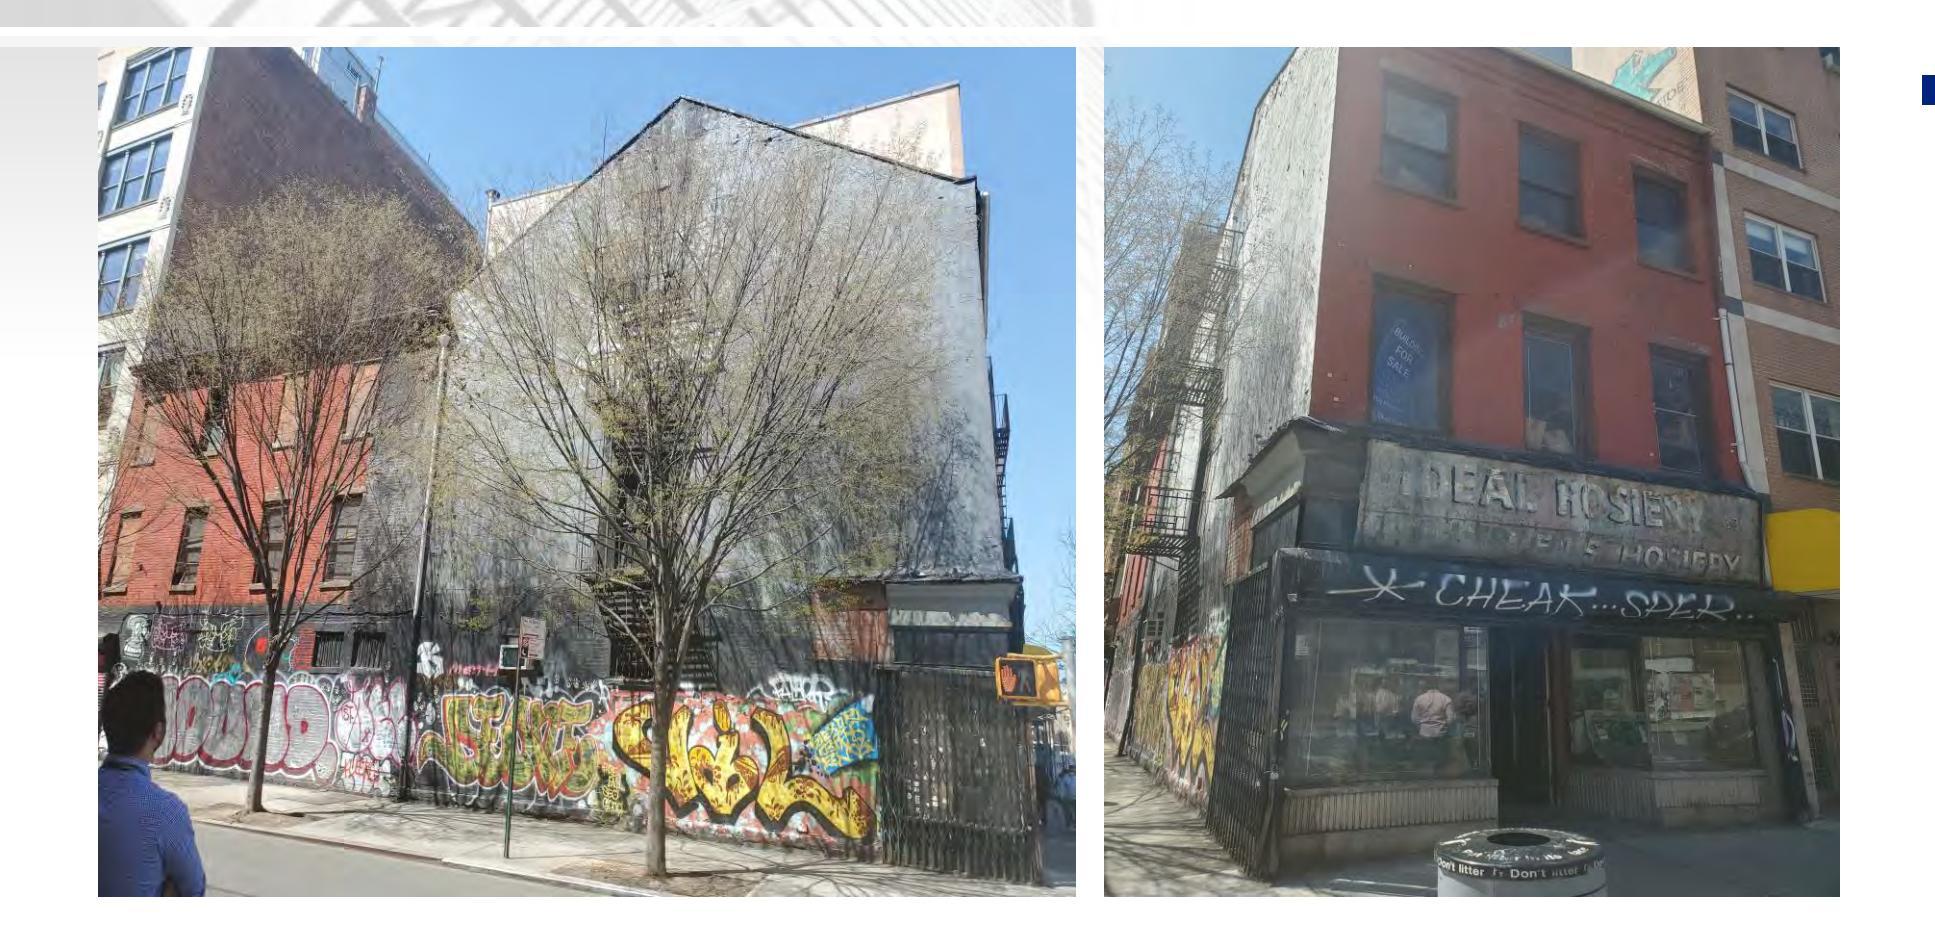
MANHATTAN CORNER LOT BUILDING

Corner lot building from 1830, built by JJ Astor

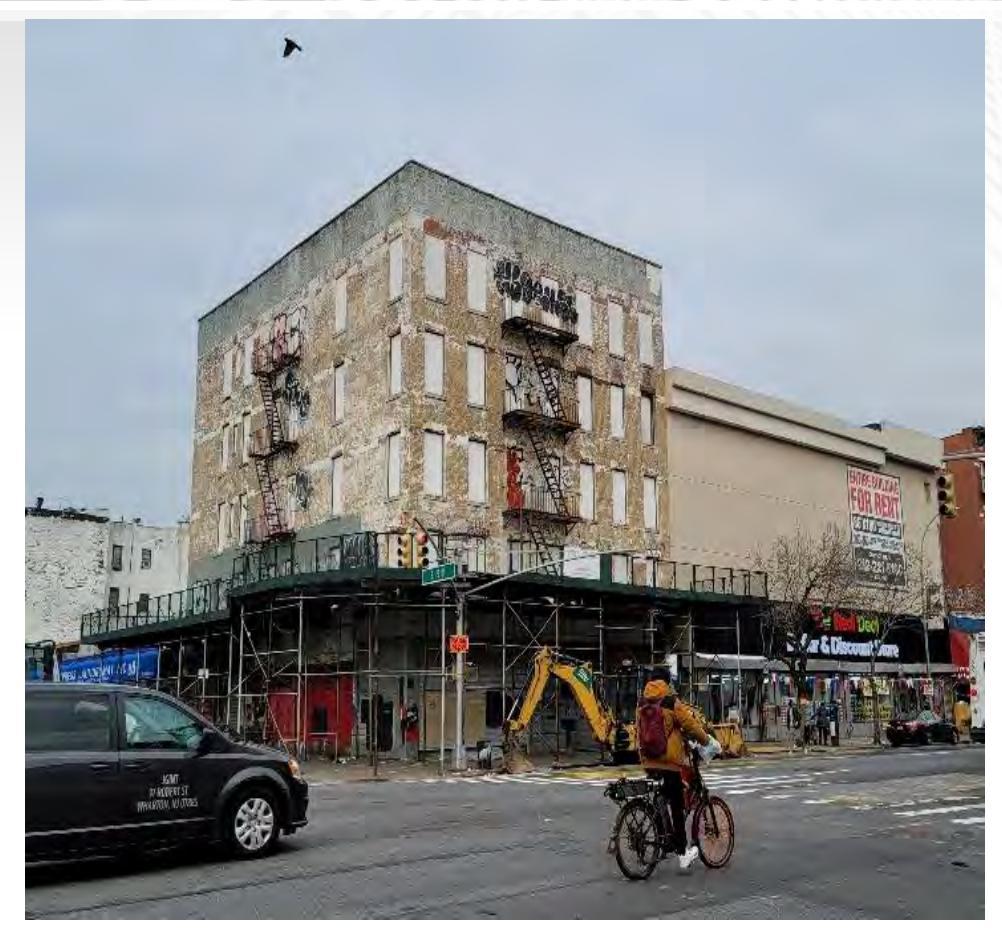
MANHATTAN MIXED-USE BUILDING

- Corner of building on street/avenue with major cracks throughout
- 12 DHCRs
- OLT owner moved all tenants out
- Owner/Carita has all four contiguous lots; emptying lots in pieces

- Severely buckled bearing walls
- Some upgrades to foundations

RENOVATE VACANT BLDG AS PER PLANS. REPLACE/REPAIR ROOF & PARAPET. REPAIR & Work on Floor(s): CEL,ROF 002 thru 005
