CHAPTER 3: PUMPING STATIONS

Pumping Stations At-Risk of Storm Surge Inundation

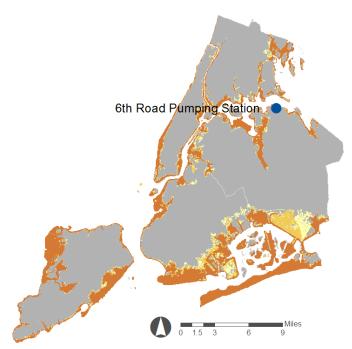
6th Road Critical Flood Elevation 15.5 ft NAVD88

The critical flood elevation would completely inundate the below grade station, and the surrounding flood would be nearly 5 feet above local grade. Water would flood and damage the pump controls. The submersible pumps should withstand flooding.

The 6th Road pumping station requires adaptive measures to withstand the critical flood elevation. Potential strategies were evaluated against such factors as flood depth, equipment location, and space. Viable strategies were reviewed to identify the most cost-effective, resilient option. The significant flood depth of about five feet and the station's location in an industrial area led to the selection of the most resilient option; the recommended strategy at 6th Road is to elevate the pumping station's controls in a new building. Residual risk is related to a greater depth of flooding from larger storms or more extreme climate change.

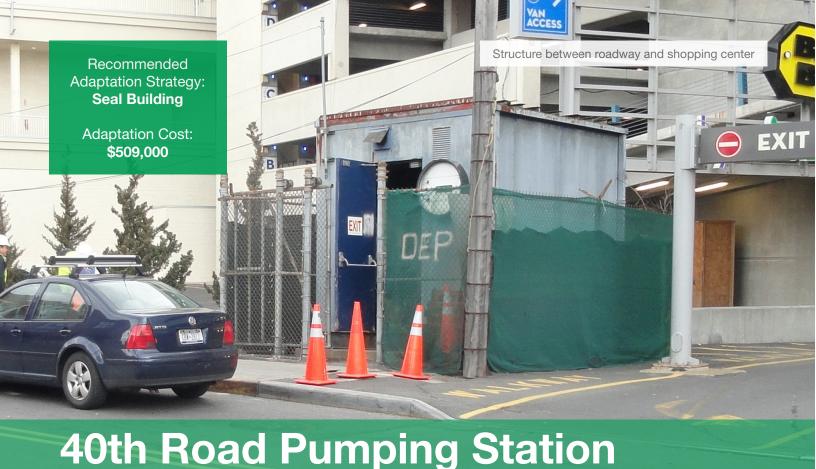
The 40th Road sanitary pumping station is near the corner of 40th Road and College Point Boulevard, between 40th Road and a shopping plaza, in Queens. Controls are located in a small metal structure next to the sidewalk. The dry and wet wells are accessible through hatches in the sidewalk. The Pumping Station Summary table lists the general characteristics of the 40th Road pumping station, the potential effect of its failure, and the recommended adaptation strategy. The station is located in a commercial area. Failure of the station would affect an area of approximately 66 acres. There are four critical facilities within that area that could be affected if the station failed.

This pumping station flooded during Hurricane Sandy. The control room flooded to a depth of approximately 3 inches, and the surrounding area was flooded to a depth of 2 to 3 feet. The station suffered damage to lighting and ventilation equipment, but the submersible pumps remained operating throughout the storm and were not damaged. There is no history of flooding aside from Hurricane Sandy.

The critical flood elevation would completely inundate the station, and the surrounding flood would be more than 6 feet above local grade. This would flood and damage the pump controls, a compressor, and the lighting panel. The submersible pumps should withstand flooding.

The 40th Road pumping station requires adaptive measures to withstand the critical flood elevation. Potential strategies were evaluated against such factors as flood depth, equipment location, and space. Pumps are submersible and do not require any modifications, but electrical controls, located in the existing above grade structure, are vulnerable to flood water. Property size and location limits the potential for a new, larger structure. Viable strategies include moving controls to the walls or roof of the existing structure as well as sealing the building; these strategies were reviewed to identify the most cost-effective, resilient option. The recommended strategy at 40th Road is to seal the existing building and add sluice gates to restrict inflows. Because water tight cases, doors, and building sealants are only rated up to a certain pressure, if flood depth is greater than expected the water pressure could exceed the rating and the building sealing could fail. Therefore, residual risk is related to a greater depth of flooding from larger storms or more extreme climate change and the potential for water pressure to exceed the rating of the sealing measures.

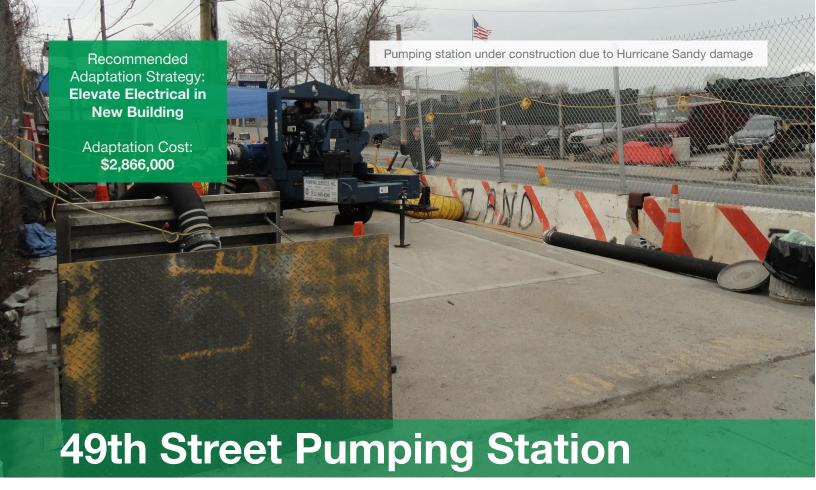
The 49th Street sanitary pumping station is near the southeast corner of 57th Avenue and 49th Street in Queens. It is entirely below grade and is accessible through hatches in the sidewalk along 49th Street. At the time of the visit the station was under construction and it was running on a bypass pump.

The 49th Street pumping station requires adaptive measures to withstand the critical flood elevation. Potential strategies were evaluated against such factors as flood depth, equipment location, and space. Viable strategies were reviewed to identify the most cost-effective, resilient option. Viable options included elevating electrical controls on a platform, on the adjacent wall, or in a new building. The station's flooding history and the significant depth of the critical flood contributed to the selection of the most resilient option; the recommended strategy at 49th Street is to elevate the pumping station's controls in a new building. Residual risk is related to a greater depth of flooding from larger storms or more extreme climate change.

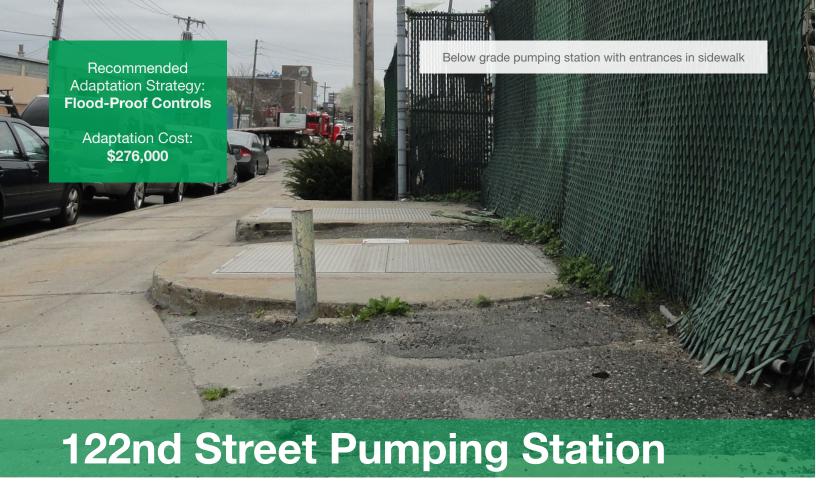
The 122nd Street sanitary pumping station is near the intersection of 122nd Street and 28th Avenue in Queens. The hatch entryways to the below grade station are located in the sidewalk between the roadway and a concrete plant. A chain-link fence runs along the back of the sidewalk.

The 122nd Street pumping station requires adaptive measures to withstand the critical flood elevation. Potential strategies were evaluated against such factors as flood depth, equipment location, and space. Viable strategies were reviewed to identify the most cost-effective, resilient option. Because the below grade pumping station's entrances are located within a sidewalk, any strategy that requires an above grade structure, such as elevating controls or constructing a barrier, is not feasible. The recommended strategy at 122nd Street is to flood-proof electrical controls. Because water tight cases, doors, and building sealants are only rated up to a certain pressure, if flood depth is greater than expected the water pressure could exceed the rating and the seals could fail. Therefore, residual risk is related to the potential for water pressure to exceed the rating of the flood-proofing enclosures.

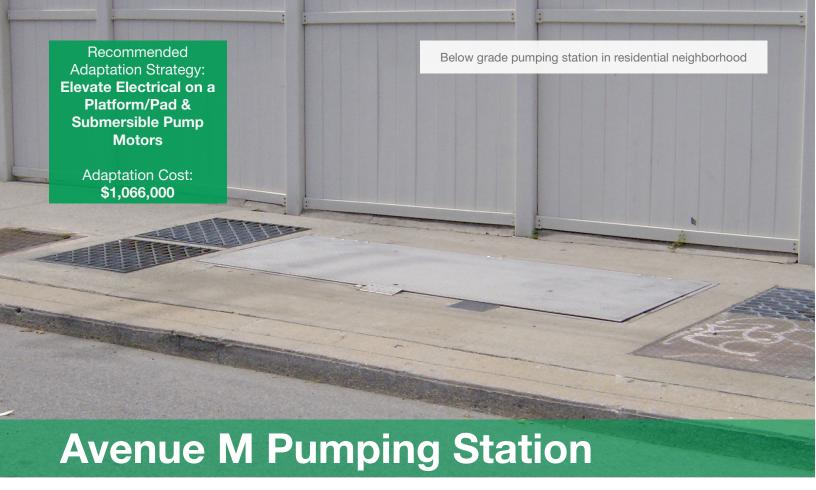
The Avenue M sanitary pumping station is near the intersection of Avenue M and East 99th Street in Brooklyn. It is an entirely below grade station with hatch entryways located in the sidewalk.

The critical flood elevation would completely inundate the station, and the surrounding flood would be nearly 4 feet above grade. Water would flood and damage the pump controls and the non-submersible pumps. The Avenue M pumping station is connected to another station; however it discharges to this station, rather than receiving flow from it. Therefore, loss of function at Avenue M does not increase the vulnerability of an additional pumping station.

The Avenue M pumping station requires adaptive measures to withstand the critical flood elevation. Potential strategies were evaluated against such factors as flood depth, equipment location, and space. Viable strategies were reviewed to identify the most cost-effective, resilient option. Due to the critical flood depth of nearly 4 feet, the controls must be elevated to withstand the flood. Because the station is located beneath a sidewalk in a residential neighborhood, the recommended strategy at Avenue M is to elevate the pumping station's controls on a platform and install submersible pumps. Residual risk is related to a greater depth of flooding from larger storms or more extreme climate change.

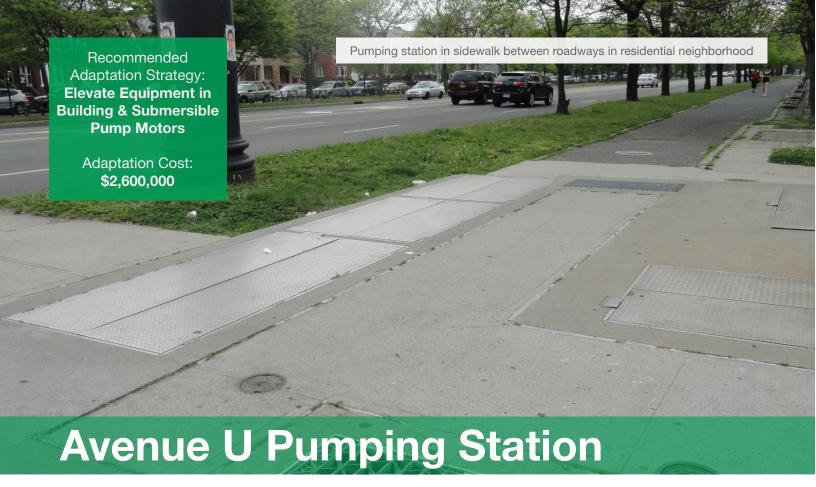
The Avenue U sanitary pumping station is located near the intersection of Ocean Parkway and Avenue U in Brooklyn. The station is below grade in a sidewalk that runs between Ocean Parkway and its parallel service road. A vent in a decorative housing sits above grade.

The critical flood elevation would completely inundate the station, and the surrounding flood would be more than 3 feet above grade. This would flood and damage the pump controls and the non-submersible pumps.

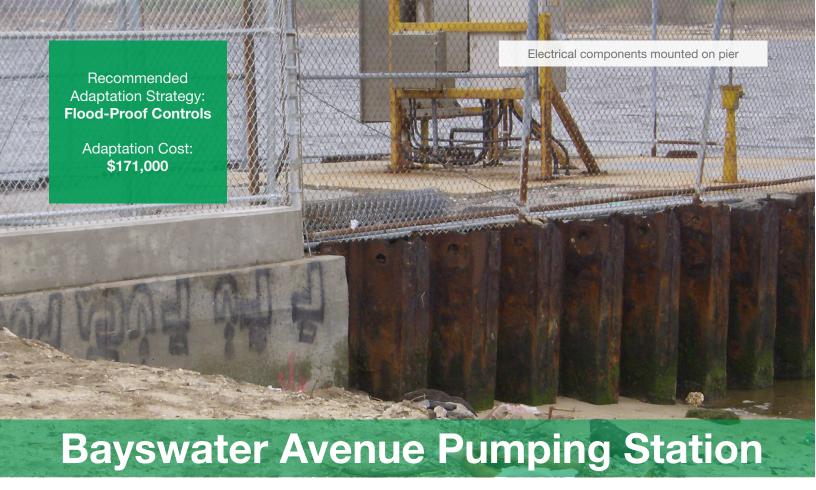
The Bayswater Avenue sanitary pumping station is near the intersection of Bayswater Avenue and Norton Drive in Queens. It is adjacent to an inlet off of Jamaica Bay, and its controls are mounted above grade on a pier that juts into the water.

The critical flood elevation would be nearly 9 feet above grade. The electrical controls, mounted about 6 feet above grade, would be flooded and would sustain damage. The submersible pumps should withstand flooding.

The Bayswater Avenue pumping station requires adaptive measures to withstand the critical flood elevation. Potential strategies were evaluated against such factors as flood depth, equipment location, and space. Viable strategies were reviewed to identify the most cost-effective, resilient option. Because controls are currently exposed but would be submerged by the critical flood, the recommended strategy at Bayswater Avenue is to waterproof controls. Further review and design may indicate that this option is not sufficiently resilient in which case electrical controls will be elevated on a platform. Residual risk is related to a greater depth of flooding from larger storms or more extreme climate change.

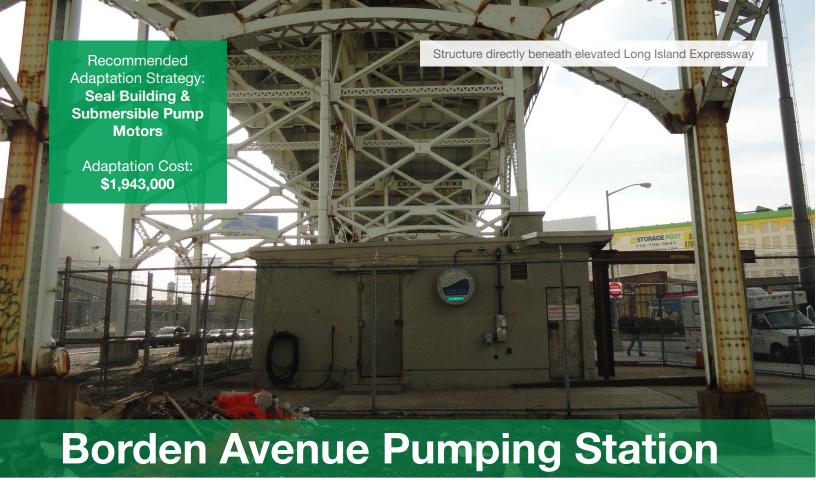
The Borden Avenue combined pumping station is located near the northeast corner of Borden Avenue and Review Street in Queens. Its one-story structure sits directly underneath an elevated section of the Long Island Expressway.

The critical flood elevation would be 4 feet above grade. It would also flood and damage the control panels, which are located on the main floor of the structure less than 2 feet above grade. The non-submersible pumps located below grade would also be damaged.

The Borden Avenue pumping station requires adaptive measures to withstand the critical flood elevation. Potential strategies were evaluated against such factors as flood depth, equipment location, and space. Viable strategies were reviewed to identify the most cost-effective, resilient option. Because there is a substantial existing building but non-submersible pumps are below grade, the recommended strategy at Borden Avenue is to seal the building and install submersible pumps.

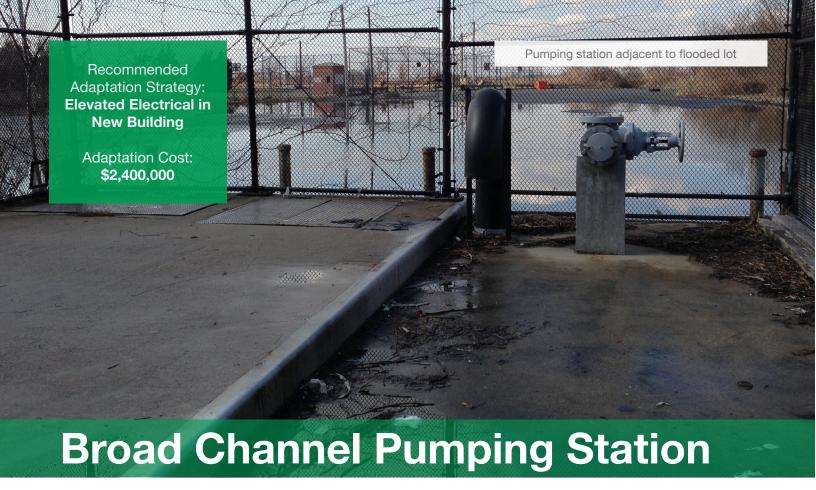
The Broad Channel sanitary pumping station is near the intersection of West 22nd Street and Shad Creek Road in Queens. It is adjacent to both Cross Bay Boulevard and a parking lot for the Broad Channel American Park, and is less than 500 feet from the open water of Jamaica Bay. The pumping station is predominantly below grade, with control panels mounted above grade.

The area surrounding the pumping station is flat and at risk of experiencing overland flooding. Hurricane Sandy caused flooding more than 3.5 feet above grade.

The critical flood elevation would be nearly 9 feet above grade, inundating all components both above and below grade. This would damage the pump controls, but the submersible pumps should withstand flooding.

The Broad Channel pumping station requires adaptive measures to withstand the critical flood elevation. Potential strategies were evaluated against such factors as flood depth, equipment location, and space. Viable strategies were reviewed to identify the most cost-effective, resilient option. Because space is available and flood depth is extreme at 9 feet, the most resilient option was selected; the recommended strategy at Broad Channel is to elevate the pumping station's controls in a new building.

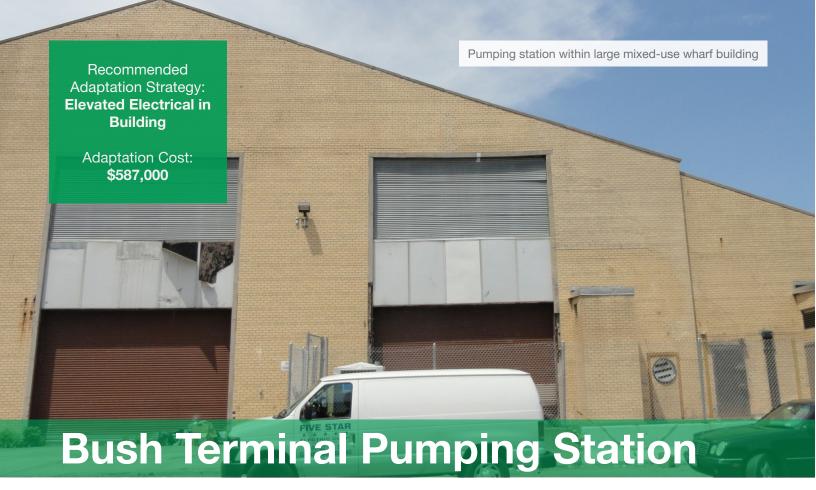
The Bush Terminal combined sanitary and stormwater pumping station is located on 2nd Avenue, north of 29th Street, in Brooklyn. The pumping station is located in a wharf building that juts into Gowanus Bay. The age of the plans (dated 1985) and the cost involved with rehabilitating a 7.2-million-gallon-per day facility prompted a thorough inspection.

This station was inundated during Hurricane Sandy; flood depth was 2 feet above grade. Electrical equipment was damaged, and repairs were in progress at the time of the inspection. While the motors were not damaged during the storm, they were not in operation at the time of the inspection due to electrical problems. A portable diesel pump was running the station. DEP indicated there is also a history of flooding at this location due to smaller storms.

The risk of the Bush Terminal pumping station was first assessed based on a review of the station's plan drawings, comparing the elevation of the critical components to that of the FEMA March 2013 Advisory Base Flood Elevation (ABFE) 100-year flood plus 30 inches of sea level rise (critical flood elevation). These elevations and other notable characteristics were confirmed during a thorough station visit that included entering the control room and the dry well. The critical flood elevation would cause a flood more than 8 feet above grade. This would flood and damage all of the pump controls. The submersible pumps should withstand flooding.

The Bush Terminal pumping station requires adaptive measures to withstand the critical flood elevation. Potential strategies were evaluated against such factors as flood depth, equipment location, and space. Viable strategies were reviewed to identify the most cost-effective, resilient option. Controls must be elevated to withstand the critical flood. The existing building is large and may be able to accommodate the controls to the second floor or roof. Therefore, the recommended strategy at Bush Terminal is to elevate the electrical controls to one of these locations in the existing building. Residual risk is related to a greater depth of flooding from larger storms or more extreme climate change.

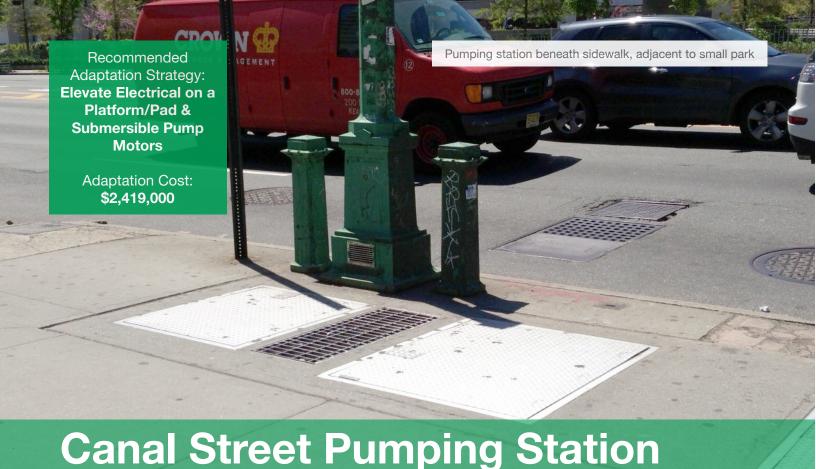
The Canal Street sanitary pumping station is located on the northeast side of Canal Street between Varick Street and 6th Avenue in Manhattan. It is an entirely below grade station with access hatches in the sidewalk.

The critical flood elevation would be approximately 4 feet above local grade, completely inundating the entire station. The electrical controls and non-submersible pumps are all located below grade and would be flooded and damaged.

The Canal Street pumping station requires adaptive measures to withstand the critical flood elevation. Potential strategies were evaluated against such factors as flood depth, equipment location, and space. Viable strategies were reviewed to identify the most cost-effective, resilient option. Due to the depth of the critical flood, controls must be elevated and pumps must be submersible to withstand the flood. The pumping station's entrances are located in a sidewalk, but there is a small park directly behind the sidewalk; the recommended strategy at Canal Street is to elevate electrical controls on a platform and install submersible pumps. Residual risk is related to a greater depth of flooding from larger storms or more extreme climate change.

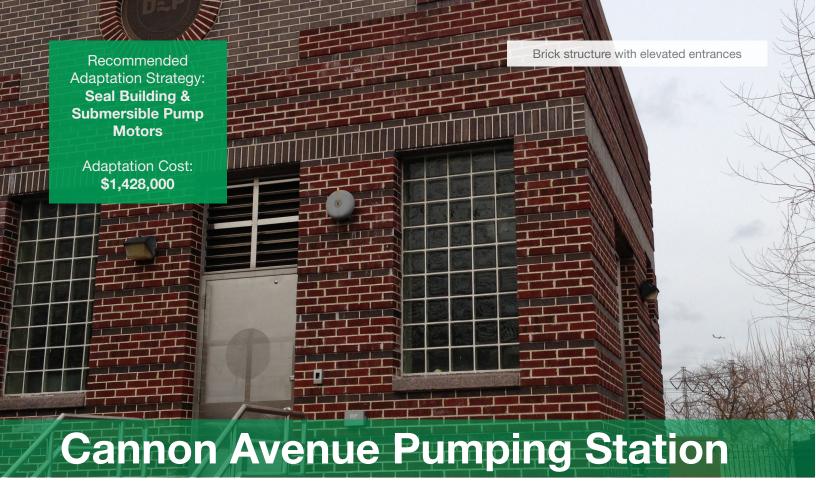
The Cannon Avenue sanitary pumping station is located on Cannon Avenue near Glen Street, close to the western shore of Staten Island. A brick building houses the motor control center, and wet and dry wells are located below grade.

During Hurricane Sandy, flood depth in the area surrounding the Cannon Avenue pumping station was 2.5 feet above grade. Flood waters from the storm surge did not enter the station, but loss of power caused the wet well to flood into the dry well during the event. At the time of the inspection, pumps and some electrical components were under repair, and an emergency pump-around was in place. DEP indicated there is also a history of flooding at this location due to smaller storms.

The Cannon Avenue pumping station requires adaptive measures to withstand the critical flood elevation. Potential strategies were evaluated against such factors as flood depth, equipment location, and space. Viable strategies were reviewed to identify the most cost-effective, resilient option. Because there is a substantial existing structure, but non-submersible pumps are well below grade, the recommended strategy at Cannon Avenue is to seal the building and install submersible pumps. Because water tight cases, doors, and building sealants are only rated up to a certain pressure, if flood depth is greater than expected the water pressure could exceed the rating and the building sealing could fail. Therefore, residual risk is related to a greater depth of flooding from larger storms or more extreme climate change and the potential for water pressure to exceed the rating of the sealing measures.

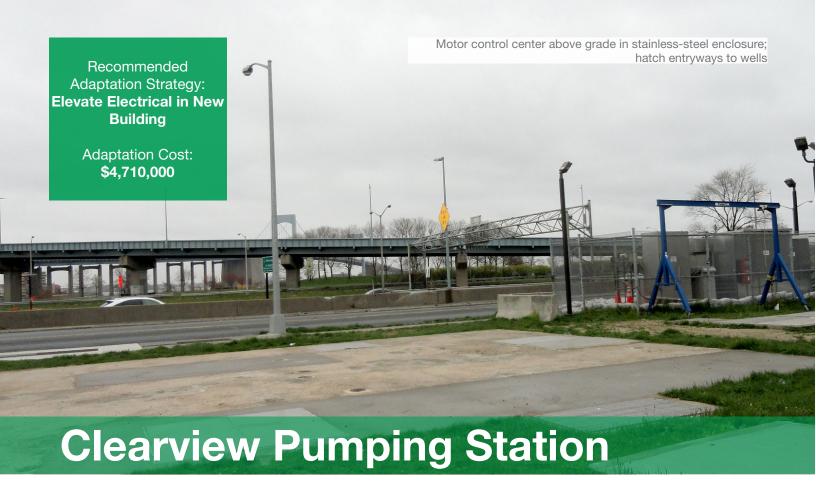
The Clearview pumping station is located in Queens along the Clearview Expressway service road, in a triangle of land that runs between the service road, the expressway, and an exit ramp from the expressway. The motor control center and other electrical components sit on a grade level concrete slab in stainless steel enclosures, and the wells are accessible through hatches.

The critical flood elevation would be more than 3 feet above grade. This would flood and damage the grade-level motor control center and pump.

The Clearview pumping station requires adaptive measures to withstand the critical flood elevation. Potential strategies were evaluated against such factors as flood depth, equipment location, and space. Viable strategies were reviewed to identify the most cost-effective, resilient option. Due to the critical flood depth and the lack of an existing structure, the recommended strategy at Clearview is to elevate the pumping station's controls in a new building. Residual risk is related to a greater depth of flooding from larger storms or more extreme climate change.

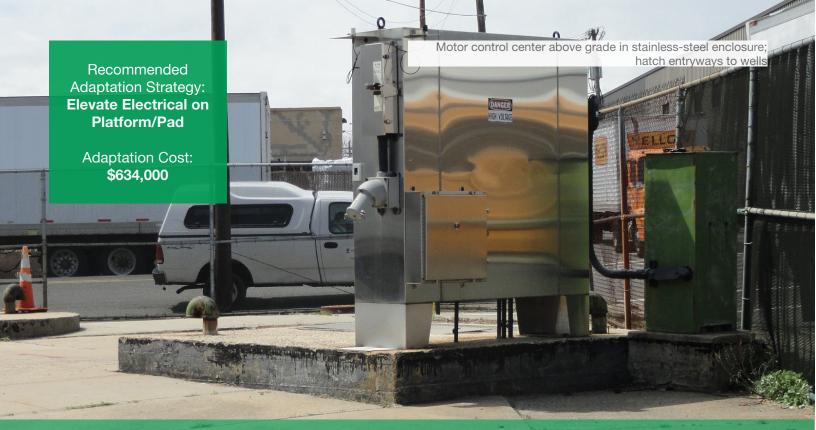
Commerce Avenue Pumping Station

Base Flood Elevation (ABFE) 100- year flood plus 30 inches of sea level rise (critical flood elevation). A visit to the pumping station to view its exterior revealed that the electrical controls, which are shown below grade in the drawings, have been moved to a slab above grade. The critical flood elevation would be 5 feet above grade. Water would flood and damage the motor control center. The submersible pumps should withstand flooding.

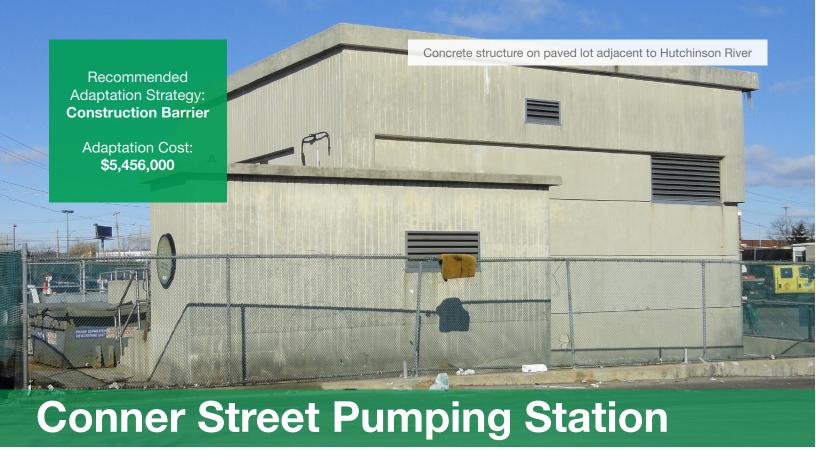
The Conner Street combined sanitary and stormwater pumping station is near the end of Conner Street in the Bronx; the property is bounded by Conner Street to the west and the Hutchinson River to the east. Controls are located on the main floor of the station's concrete structure. Overhead power lines connect to buried power lines near the western edge of the lot, and the buried lines run under the station's parking lot to two transformers on the main floor.

This station has experienced multiple flooding events during which water approached the station from the adjacent Hutchinson River. During Hurricane Sandy, the lot surrounding the station flooded to a depth of around 1 foot. Fuses on the poles supporting the overhead power lines blew out, cutting power before it reached the transformers. At the time of the visit, ventilation in the wet well was not working due to flooding damage.

The Conner Street pumping station requires adaptive measures to withstand the critical flood elevation. Potential strategies were evaluated against such factors as flood depth, equipment location, and space. Viable strategies were reviewed to identify the most cost-effective, resilient option. Because there is an existing structure, but there are extensive controls which could not easily be moved, the recommended strategy at Conner Street is to construct a barrier. The installation of a backup generator is also recommended, and when pumps need to be replaced as part of regular maintenance, submersible pumps should be installed. Residual risk is related to a greater depth of flooding from larger storms or more extreme climate change.

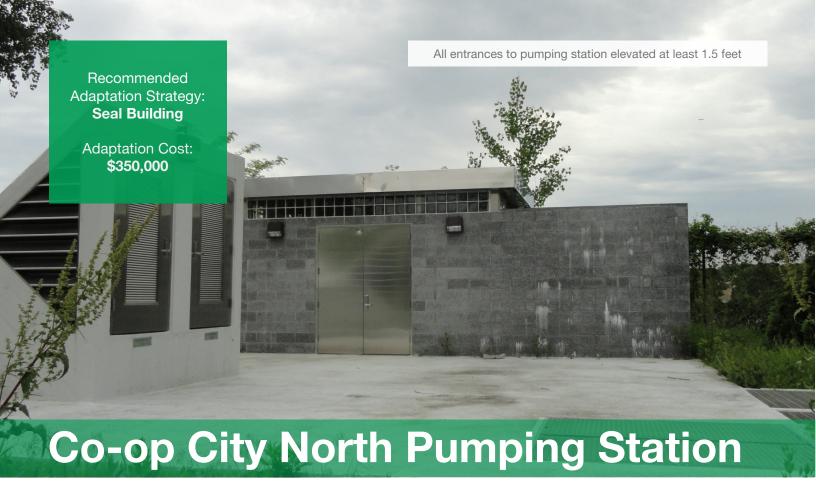
The Co-op City North sanitary pumping station is located at the corner of Co-op City Blvd. and Bellamy Loop. The Hutchinson River runs behind the station. The pumping station has a cinder block structure as well as concrete-housed vents atop a concrete slab.

The critical flood elevation would be 2 feet above local grade. Electrical controls are below grade within the structure, and the doorway threshold into the structure is about 1 foot above grade, which is 1 foot below the critical flood elevation. Flood waters could enter the structure and damage the electrical controls. The submersible pumps should withstand flooding. The Co-op City North pumping station has the ability to receive flow from another pumping station. Therefore, loss of function at Co-op City North increases the vulnerability of an additional pumping station, tributary area, and population.

The Co-op City North pumping station requires adaptive measures to withstand the critical flood elevation. Potential strategies were evaluated against such factors as flood depth, equipment location, and space. Viable strategies were reviewed to identify the most cost-effective, resilient option. Because there is a significant existing structure, the recommended strategy at Co-op City North is to seal the building. Because water tight cases, doors, and building sealants are only rated up to a certain pressure, if flood depth is greater than expected the water pressure could exceed the rating and the building sealing could fail. Therefore, residual risk is related to a greater depth of flooding from larger storms or more extreme climate change and the potential for water pressure to exceed the rating of the sealing measures.

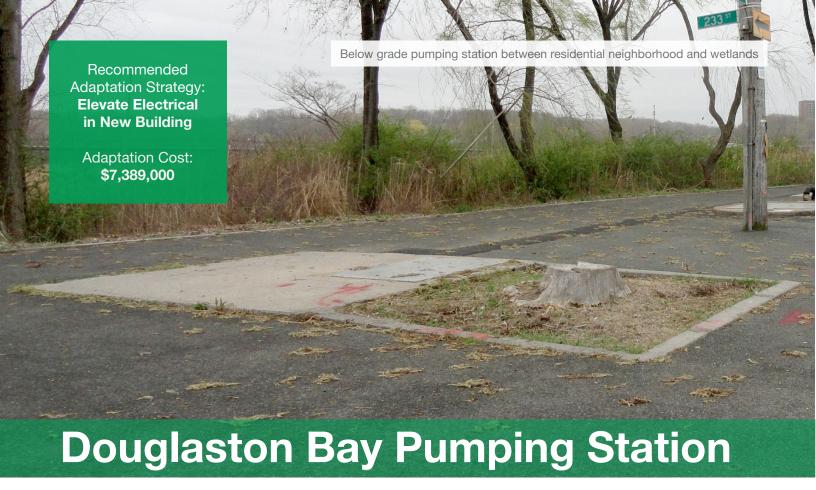
The Douglaston Bay sanitary pumping station is located near the corner of 41st Avenue and 233rd Street in Queens. It is situated in a paved area between the roadway and wetlands that run along the southeastern shore of Little Neck Bay. The Douglaston Bay pumping station is entirely below grade and is accessible through hatches in the pavement.

Collection Systems staff provided further details on the station's flooding history and vulnerability. The critical flood elevation would be more than 8 feet above local grade, completely inundating the entire station. The electrical controls, which are below grade, would be flooded and damaged. The submersible pumps should withstand flooding.

The Doug Bay pumping station requires adaptive measures to withstand the critical flood elevation. Potential strategies were evaluated against such factors as flood depth, equipment location, and space. Viable strategies were reviewed to identify the most cost-effective, resilient option. Due to the 8-foot depth of the critical flood and the lack of an existing structure, the recommended strategy at Doug Bay is to elevate electrical controls in a new building. Residual risk is related to a greater depth of flooding from larger storms or more extreme climate change.

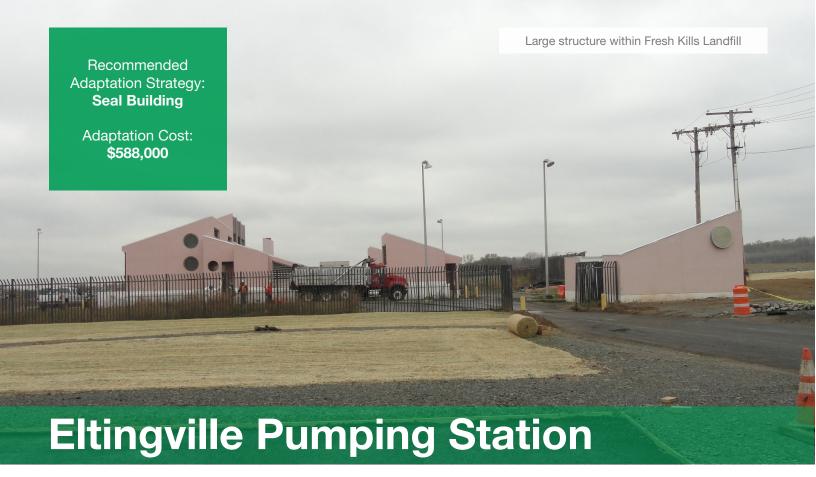
The Eltingville sanitary pumping station is located within the Fresh Kills landfill on Staten Island, along a service road that runs into the landfill. The entrance to the service road is on Arthur Kill Road across from Brookfield Avenue. The station is in a large stucco structure completely surrounded by a driveway. Two entrances to the wet well are located in back of the structure.

The critical flood elevation would be just under 1 foot above local grade. Because electrical controls and non-submersible pumps are located below grade and below the flood elevation, they could be damaged if water enters the structure.

The Eltingville pumping station requires adaptive measures to withstand the critical flood elevation. Potential strategies were evaluated against such factors as flood depth, equipment location, and space. Viable strategies were reviewed to identify the most cost-effective, resilient option. Because there is a significant existing structure, the recommended strategy at Eltingville is to seal the building so that flood waters cannot enter; this is a less expensive option than those that involve moving electrical controls or motors. While this strategy will provide resilient protection, there is the potential for leaks, inflows to the wells, or unidentified flow paths. DEP will consider replacing the non-submersible pumps with submersibles as normal replacement is needed as part of regular maintenance. Because water tight cases, doors, and building sealants are only rated up to a certain pressure, if flood depth is greater than expected the water pressure could exceed the rating and the building sealing could fail. Therefore, residual risk is related to a greater depth of flooding from larger storms or more extreme climate change and the potential for water pressure to exceed the rating of the sealing measures.

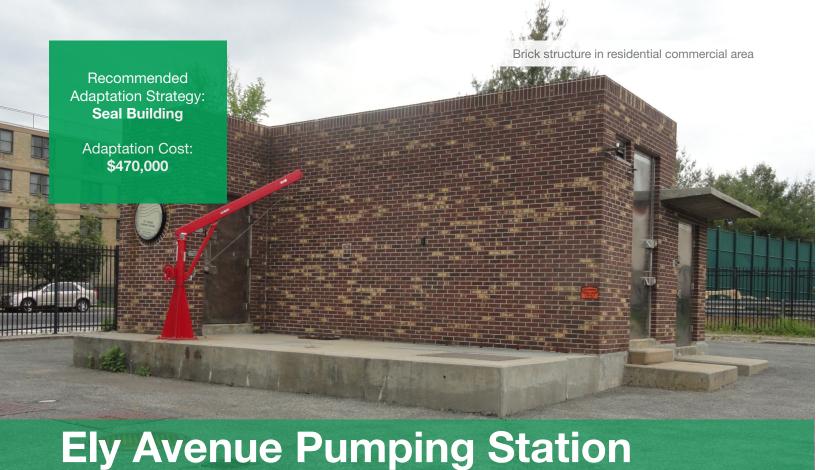
The Ely Avenue sanitary pumping station is located at the corner of Ely Avenue and Waring Avenue in the Bronx, adjacent to a Home Depot parking lot. The station has a brick structure with entrances and the main floor situated approximately 2 feet above grade.

The critical flood elevation would be 2 feet above local grade, which is equal to the elevation of the main floor of the structure where electrical controls are housed. This could cause damage to the electrical controls; submersible pumps should be unaffected.

The Ely Avenue pumping station requires adaptive measures to withstand the critical flood elevation. Potential strategies were evaluated against such factors as flood depth, equipment location, and space. Viable strategies were reviewed to identify the most cost-effective, resilient option. Because there is a substantial existing structure with entrances above the critical flood elevation, the recommended strategy at Ely Avenue is to seal the building. Because water tight cases, doors, and building sealants are only rated up to a certain pressure, if flood depth is greater than expected the water pressure could exceed the rating and the building sealing could fail. Therefore, residual risk is related to a greater depth of flooding from larger storms or more extreme climate change and the potential for water pressure to exceed the rating of the sealing measures.

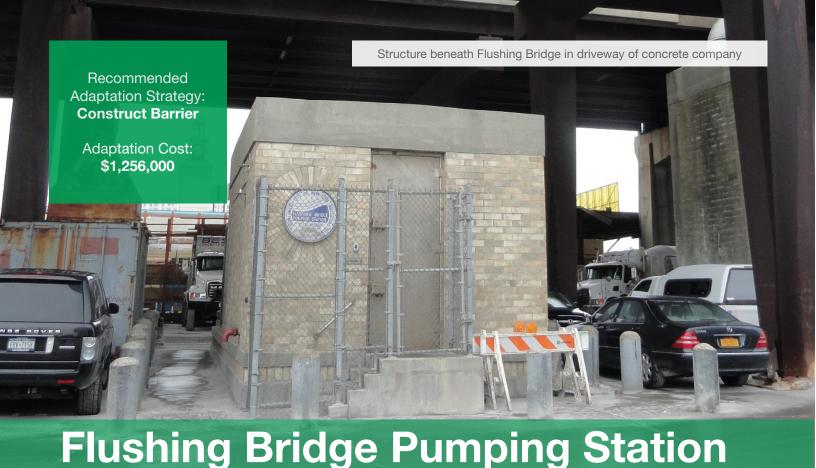
The Flushing Bridge sanitary pumping station is located within the parking lot and driveway of Best Concrete Mix Corp. at 3510 College Point Boulevard in Queens. The station's small brick structure is located directly underneath the roadway of the Flushing Bridge. Hatch entryways to the wells are located in the concrete directly behind the structure.

The Flushing Bridge pumping station requires adaptive measures to withstand the critical flood elevation. Potential strategies were evaluated against such factors as flood depth, equipment location, and space. Viable strategies were reviewed to identify the most cost-effective, resilient option. Because there is an existing structure, but there are numerous potential flood entryways, the recommended strategy at Flushing Bridge is to seal the main door and construct a barrier around the vents on the rear pad of the station. Because water tight cases, doors, and building sealants are only rated up to a certain pressure, if flood depth is greater than expected the water pressure could exceed the rating and the seal could fail. Therefore, residual risk is related to a greater depth of flooding from larger storms or more extreme climate change and the potential for water pressure to exceed the rating of the sealing measures.

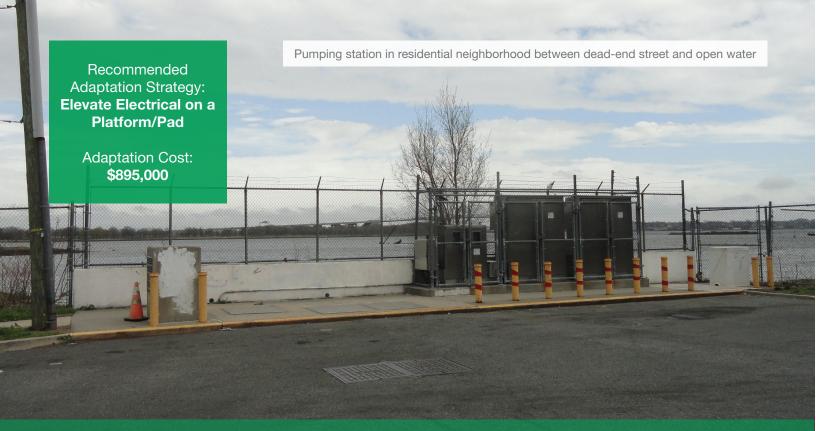
Gildersleeve Avenue Pumping Station

The Gildersleeve Avenue sanitary pumping station is located at the dead end of Gildersleeve Avenue near the intersection with Betts Avenue in the Bronx. It is less than 20 feet from an inlet that connects to Long Island Sound. The motor control center (MCC) and electric meters sit on the sidewalk in stainless-steel enclosures. There are hatch entryways to the wells in the sidewalk.

The critical flood elevation would be 3 feet above local grade. Electrical controls sit only a few inches above grade on the sidewalk, and they would be damaged. The submersible pumps should withstand flooding.

The Gildersleeve Avenue pumping station requires adaptive measures to withstand the critical flood elevation. Potential strategies were evaluated against such factors as flood depth, equipment location, and space. Viable strategies were reviewed to identify the most cost-effective, resilient option. Due to the flood depth and the fact that exposed above grade components are acceptable in this location, the recommended strategy at Gildersleeve Avenue is to elevate electrical controls on a platform. Residual risk is related to a greater depth of flooding from larger storms or more extreme climate change.

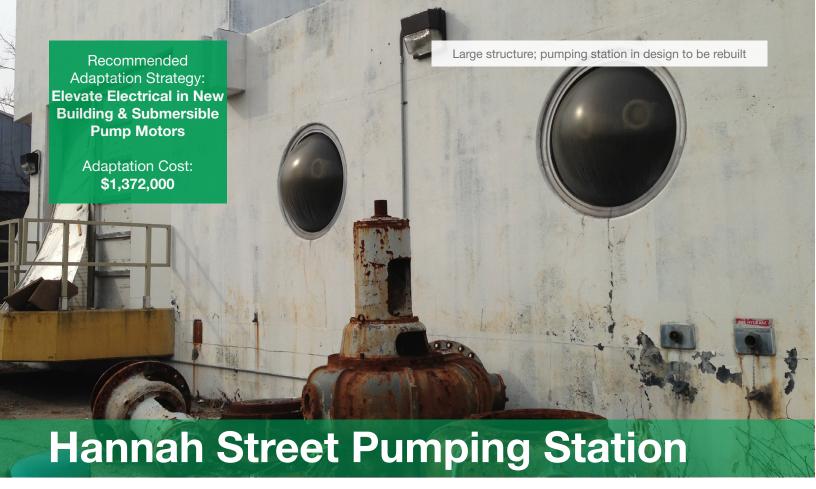
The Hannah Street combined pumping station is located near the intersection of Hannah Street and Murray Hulbert Avenue in Staten Island. The site is approximately 300 feet from the open water of the Narrows. The station consists of large above- and below grade structures. The motor control center and non-submersible pumps are housed below grade within the structure.

The Hannah Street pumping station requires adaptive measures to withstand the critical flood elevation. Potential strategies were evaluated against such factors as flood depth, equipment location, and space. Viable strategies were reviewed to identify the most cost-effective, resilient option. The Hannah Street pumping station is currently in design to be rebuilt. To add resiliency, the new plans should include elevating electrical controls and installing submersible pumps. Residual risk is related to a greater depth of flooding from larger storms or more extreme climate change.

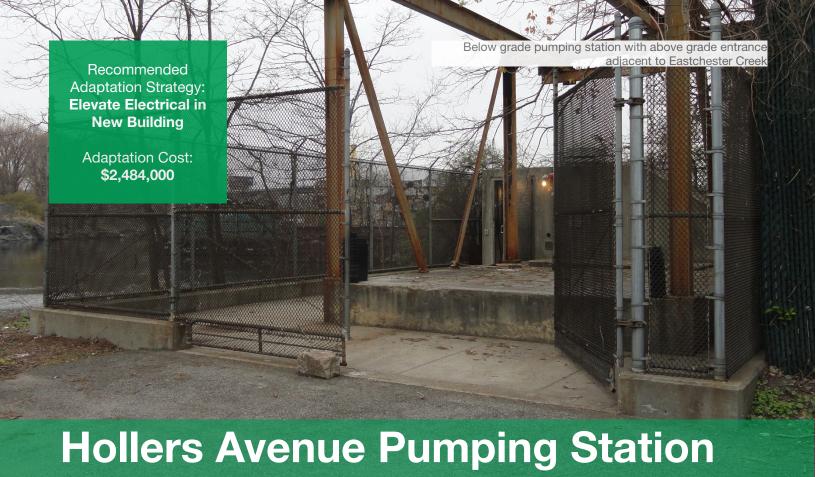
The Hollers Avenue sanitary pumping station is located at the corner of Hollers Avenue and Eastchester Place in the Bronx; it is situated between the roadway and Eastchester Creek. The below grade control room is accessible by a stairwell that has an enclosed doorway entrance above grade, and wells are accessible through hatches. There is an adjacent substation that can be used as backup when the primary station must be taken offline.

The predicted critical flood elevation would be 7 feet above local grade. This would damage the below grade electrical controls. The submersible pumps should be unaffected.

The Hollers Avenue pumping station requires adaptive measures to withstand the critical flood elevation. Potential strategies were evaluated against such factors as flood depth, equipment location, and space. Viable strategies were reviewed to identify the most cost-effective, resilient option. Due to the significant depth of the critical flood, the lack of an existing structure, and the available space, the recommended strategy at Hollers Avenue is to elevate electrical controls in a new building. Residual risk is related to a greater depth of flooding from larger storms or more extreme climate change.

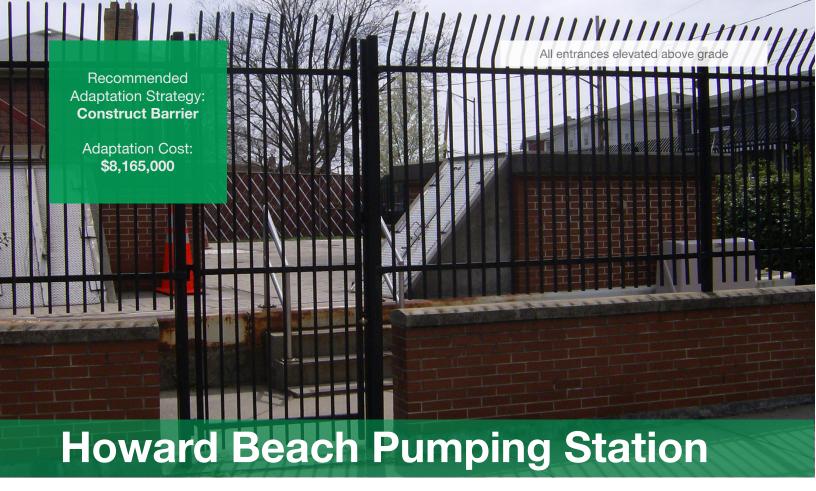
The Howard Beach combined pumping station is located near the corner of 155th Avenue and 100th Street in Queens. The station is below grade, but the entrances to it are elevated about 2 feet above grade on a concrete slab.

The critical flood elevation would be about 7 inches above local grade. While entrances are elevated above the flood height, the structure is not flood-proof, and the below grade electrical controls and non-submersible pumps could be flooded and damaged.

The Howard Beach pumping station requires adaptive measures to withstand the critical flood elevation. Potential strategies were evaluated against such factors as flood depth, equipment location, and space. Viable strategies were reviewed to identify the most cost-effective, resilient option. Because of the shallow depth of the critical flood and the location of most entrances above the flood elevation, the recommended strategy at Howard Beach is to add watertight doors in the existing wall at pedestrian and vehicle entry points. Sandbagging is also a potential option but water tight access doors provide a permanent and more resilient solution. The installation of emergency generators is also recommended. Residual risk is related to a greater depth of flooding from larger storms or more extreme climate change.

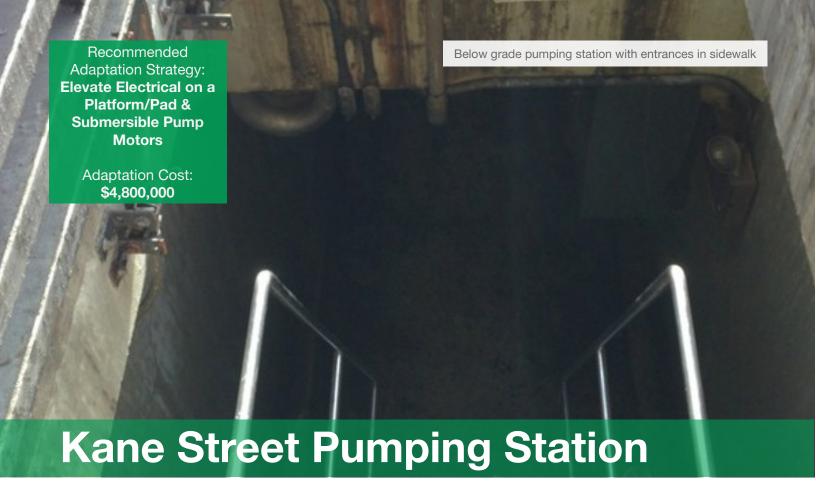
The Kane Street stormwater pumping station is located on the northwest corner of the intersection of Kane Street and Hicks Street in Brooklyn. The station is located completely below grade, under a sidewalk between residential buildings and the southbound lanes of Hicks Street.

The predicted critical flood elevation would be more than 2 feet above local grade. This would damage the electrical controls and the non-submersible pumps, all of which are located below grade.

The Kane Street pumping station requires adaptive measures to withstand the critical flood elevation. Potential strategies were evaluated against such factors as flood depth, equipment location, and space. Viable strategies were reviewed to identify the most cost-effective, resilient option. Due to space limitations, the lack of an existing structure, and the current vulnerability of the pumping station, the recommended strategy at Kane Street is to elevate electrical controls on an aboveground platform and install submersible pumps. Residual risk is related to a greater depth of flooding from larger storms or more extreme climate change.

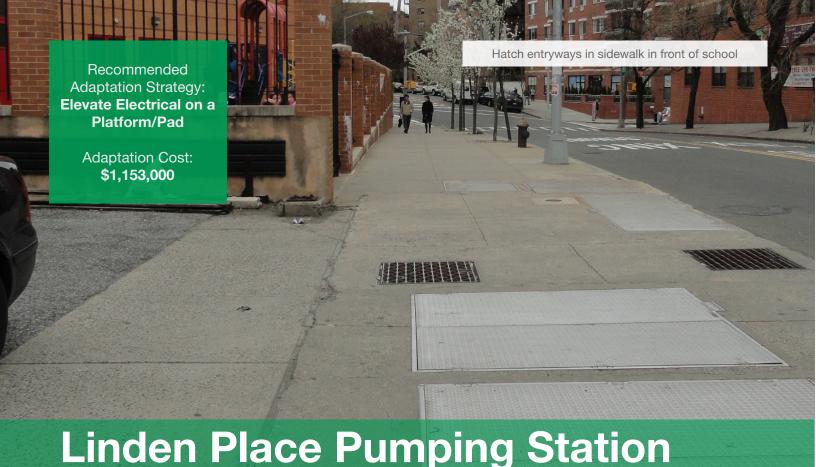
The Linden Place combined pumping station is located near the northeast corner of Linden Place and 31st Road in Queens. The pumping station is below grade with grating and hatch entryways in the sidewalk in front of a school.

The critical flood elevation would be more than 2 feet above local grade, completely inundating this below grade station. Water would damage the electrical controls, but the submersible pumps should be unaffected.

The Linden Place pumping station requires adaptive measures to withstand the critical flood elevation. Potential strategies were evaluated against such factors as flood depth, equipment location, and space. Viable strategies were reviewed to identify the most cost-effective, resilient option. Due to the need to move electrical controls out of the reach of flood waters and limited available space, the recommended strategy at Linden Place is to elevate electrical controls on a platform. Residual risk is related to a greater depth of flooding from larger storms or more extreme climate change.

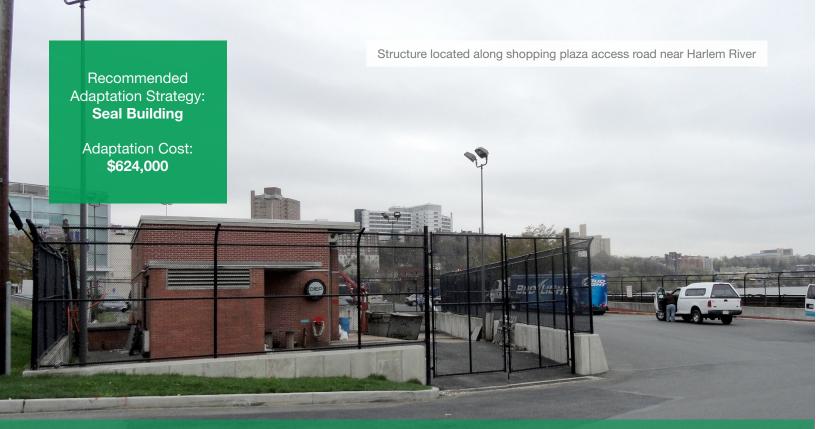
Marble Hill Pumping Station

During Hurricane Sandy nearby areas flooded to a depth of about 6 inches and the station experienced minor impacts. There is no history of flooding at this location beyond flooding caused by Hurricane Sandy.

The Marble Hill pumping station requires adaptive measures to withstand the critical flood elevation. Potential strategies were evaluated against such factors as flood depth, equipment location, and space. Viable strategies were reviewed to identify the most cost-effective, resilient option. Because there is a significant existing structure, the recommended strategy at Marble Hill is to seal the building so that flood waters cannot enter. This is a less expensive option than those that involve moving electrical controls or motors. Because water tight cases, doors, and building sealants are only rated up to a certain pressure, if flood depth is greater than expected the water pressure could exceed the rating and the building sealing could fail. Therefore, residual risk is related to a greater depth of flooding from larger storms or more extreme climate change and the potential for water pressure to exceed the rating of the sealing measures.

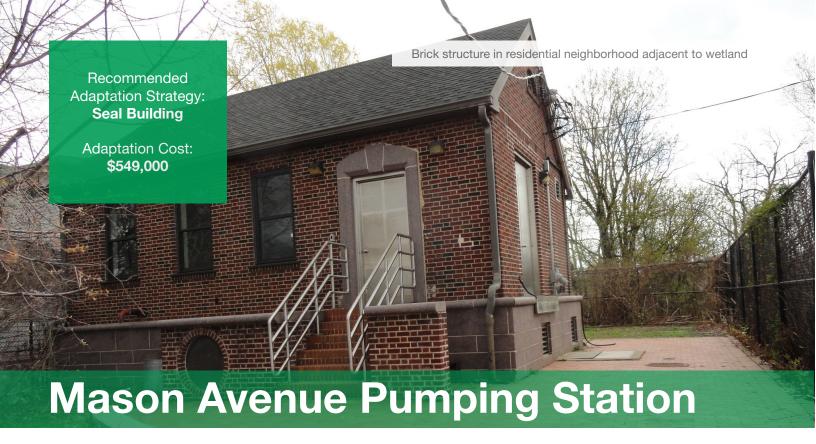
The Mason Avenue sanitary pumping station is on the east side of Mason Avenue, south of Slater Boulevard, on Staten Island. It is in a residential neighborhood adjacent to tidal wetlands. The station has a brick structure whose main floor is about 4 feet above grade; a fence surrounds the lot.

During Hurricane Sandy, the surrounding area flooded to a depth of more than 5 feet above grade. A resident across the street described Sandy's flood waters as coming in through the wetlands and into the neighborhood "like a wave." DEP Collections System staff on site at the time of the visit indicated that the station flooded and suffered significant damage during the storm. Electrical components on the main floor were damaged, and the station went offline due to power loss, damage to electrical equipment, and loss of telemetry. The damaged electrical equipment has since been replaced. DEP indicated there is also a history of flooding at this location due to smaller storms.

Because water tight cases, doors, and building sealants are only rated up to a certain pressure, if flood depth is greater than expected the water pressure could exceed the rating and the building sealing could fail. Therefore, residual risk is related to a greater depth of flooding from larger storms or more extreme climate change and the potential for water pressure to exceed the rating of the sealing measures. Failure of seals could result in damage to controls and the pump motors.

The Mason Avenue pumping station requires adaptive measures to withstand the critical flood elevation. Potential strategies were evaluated against such factors as flood depth, equipment location, and space. Viable strategies were reviewed to identify the most cost-effective, resilient option. Because there is a significant existing structure, the recommended strategy at Mason Avenue is to seal the building so that flood waters cannot enter; this is a less expensive option than those that involve moving existing electrical controls and pump motors. While this strategy will provide resilient protection, there is the potential for leaks, inflows to the wells, or unidentified flow paths. DEP will consider replacing the non-submersible pumps with submersibles as normal replacement is needed as part of regular maintenance.

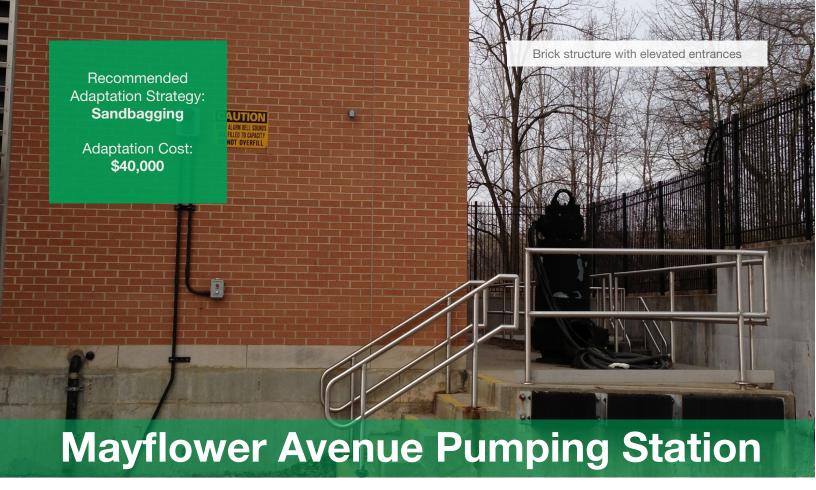
The Mayflower Avenue sanitary pumping station is located near the intersection of Arthur Kill Road and Huguenot Avenue in Staten Island. The pumping station includes a large superstructure located on a gated lot. The station is equipped with a permanent backup diesel generator on the main floor of the superstructure. Electrical controls are also located on the main floor, and non-submersible pumps are located below grade. The main floor and doorway thresholds are 3 feet above local grade.

The critical flood elevation would inundate the area surrounding the facility with over 3 feet of water. If flood waters were able to find a pathway into the pumping station, electrical controls and motors could be damaged.

The Mayflower Avenue pumping station requires minor adaptive measures to withstand the critical flood elevation. Potential strategies were evaluated against such factors as flood depth, equipment location, and space. Viable strategies were reviewed to identify the most cost-effective, resilient option. Because there is a substantial existing structure and most entryways are elevated, the recommended strategy at Mayflower Avenue is to sandbag potential flood entry points. Residual risk is related to a greater depth of flooding from larger storms, more extreme climate change, failure of the sandbag barrier, or leakage through alternative flow pathways.
