CHAPTER 3: PUMPING STATIONS

Pumping Stations At-Risk of Storm Surge Inundation

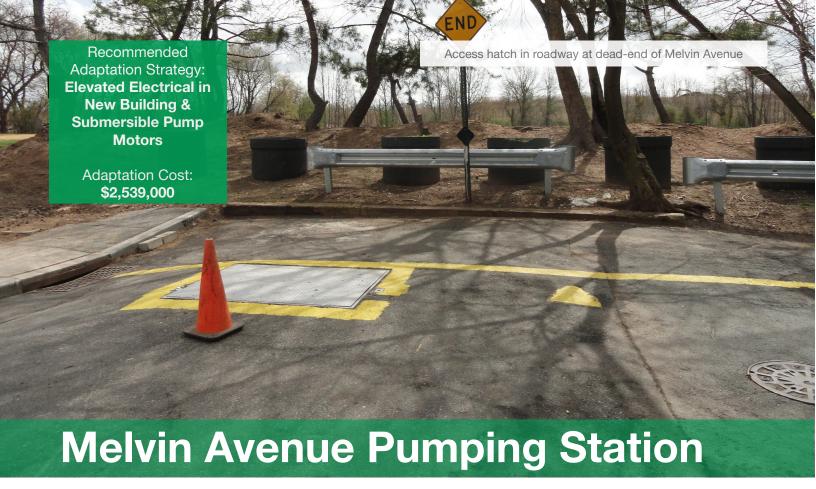
The Melvin Avenue sanitary pumping station is located underneath the roadway at the dead end of Melvin Avenue where the road abuts Schmul Park. There is one hatch in the road to access the wet well; the meter and what appear to be controls are mounted in a box on a telephone pole. Power is supplied by overhead lines.

The Melvin Avenue pumping station requires adaptive measures to withstand the critical flood elevation. Potential strategies were evaluated against such factors as flood depth, equipment location, and space. Viable strategies were reviewed to identify the most cost-effective, resilient option. Due to the station's current vulnerability, the extreme depth of the critical flood, and available space nearby, the recommended strategy at Melvin Avenue is to elevate electrical controls in a new building and install submersible pumps. Residual risk is related to a greater depth of flooding from larger storms or more extreme climate change.

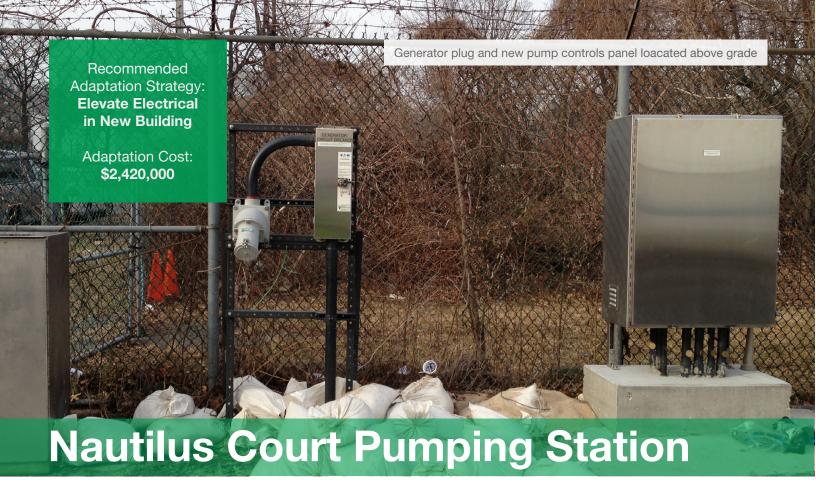
The Nautilus Court combined pumping station is at the eastern end of Cliff Street near Nautilus Court on Staten Island. The pumping station is almost entirely below grade and located approximately 100 feet from the banks of The Narrows, leaving it vulnerable to flooding. The site consists of a flat asphalt surface with two access points to the pumping station: a hatch to access the electrical control vault and an open grate over the wet well, which houses three submersible pumps.

Nautilus Court pumping station was completely inundated by the storm surge during Hurricane Sandy, which damaged the electrical controls. DEP indicated there is also a history of flooding at this location due to smaller storms.

The critical flood elevation would inundate the area surrounding the facility with over 12 feet of water. This would damage electrical controls but would not affect the submersible pumps. The Nautilus Court pumping station is connected to another station; however it discharges to it rather than receiving flow. Therefore, loss of function at Nautilus Court does not increase the vulnerability of an additional pumping station.

The Nautilus Court pumping station requires adaptive measures to withstand the critical flood elevation. Potential strategies were evaluated against such factors as flood depth, equipment location, and space. Viable strategies were reviewed to identify the most cost-effective, resilient option. Due to the lack of an existing structure and the extreme depth of the critical flood, the recommended strategy at Nautilus Court is to elevate electrical controls in a new building. Residual risk is related to a greater depth of flooding from larger storms or more extreme climate change.

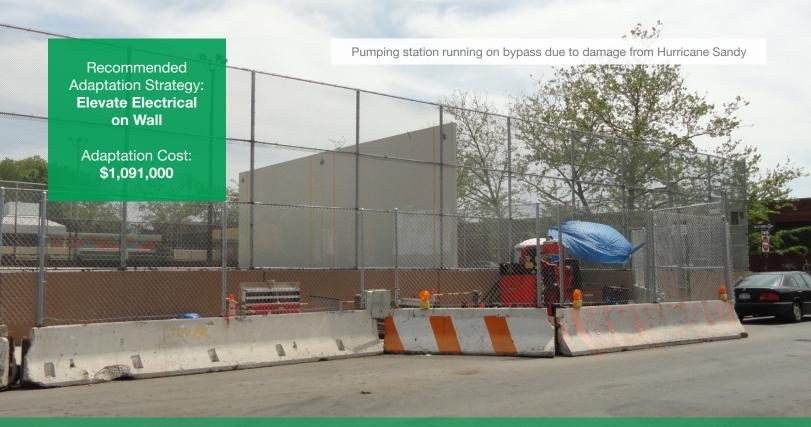
Nevins Street Pumping Station

The critical flood elevation would inundate the area surrounding the facility with over 5 feet of water. This would damage electrical controls but would not affect the submersible pumps. The Nevins Street pumping station is connected to another station; however it discharges to it rather than receiving flow. Therefore loss of function at Nevins Street does not increase the vulnerability of an additional pumping station.

The Nevins Street pumping station requires adaptive measures to withstand the critical flood elevation. Potential strategies were evaluated against such factors as flood depth, equipment location, and space. Viable strategies were reviewed to identify the most cost-effective, resilient option. Due to limited available space and the extreme depth of the critical flood, the recommended strategy at Nevins Street is to elevate electrical controls onto the nearby wall. Residual risk is related to a greater depth of flooding from larger storms or more extreme climate change.

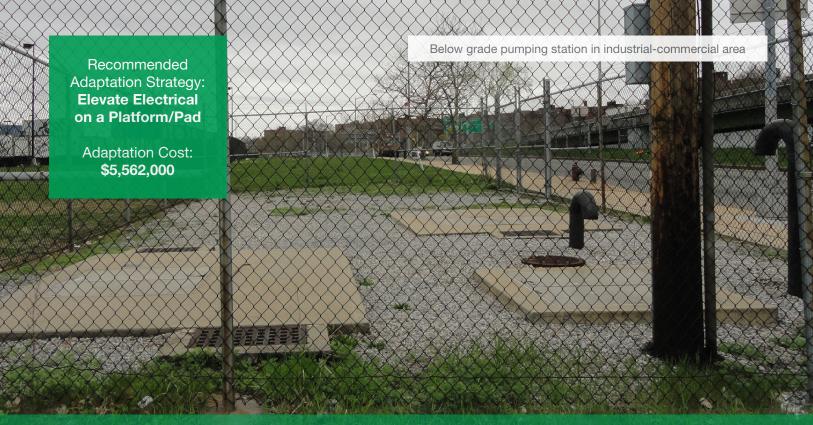
New York Times Pumping Station

The critical flood elevation would be 6 feet above local grade, completely inundating the entire station. The electrical controls, which are below grade, would be flooded and damaged. The submersible pumps should withstand flooding.

The New York Times pumping station requires adaptive measures to withstand the critical flood elevation. Potential strategies were evaluated against such factors as flood depth, equipment location, and space. Viable strategies were reviewed to identify the most cost-effective, resilient option. Because of the significant depth of the critical flood, the recommended strategy at New York Times is to elevate electrical controls on a platform. The installation of backup generators is also recommended. Residual risk is related to a greater depth of flooding from larger storms or more extreme climate change.

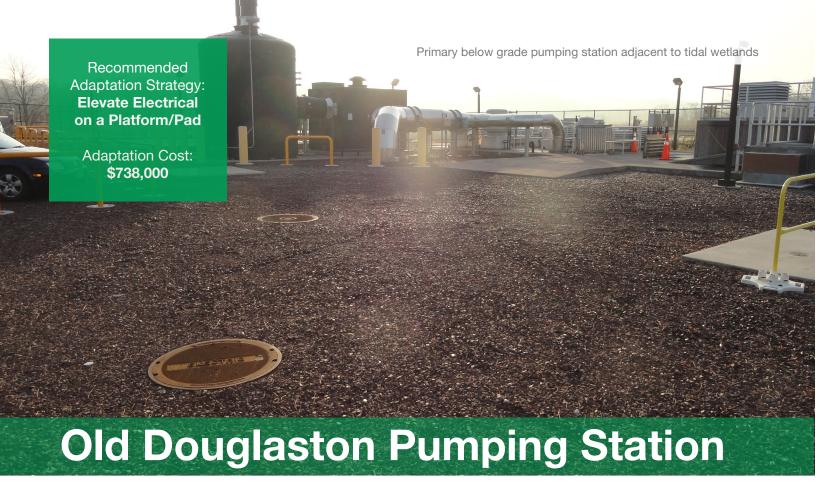
The Old Douglaston sanitary pumping station is located on park land, along the south side of Northern Blvd. and west of the intersection with 234th Street in Queens. The pumping station site is adjacent to wetlands. The station, rebuilt in 2010, is almost completely below grade.

The critical flood elevation would inundate the area surrounding the facility with nearly 5 feet of water. This would damage electrical controls but would not affect the submersible pumps.

The Old Douglaston pumping station requires adaptive measures to withstand the critical flood elevation. Potential strategies were evaluated against such factors as flood depth, equipment location, and space. Viable strategies were reviewed to identify the most cost-effective, resilient option. To achieve resiliency while respecting park structure limitations, the recommended strategy at Old Douglaston is to elevate electrical controls on a platform. Residual risk is related to a greater depth of flooding from larger storms or more extreme climate change.

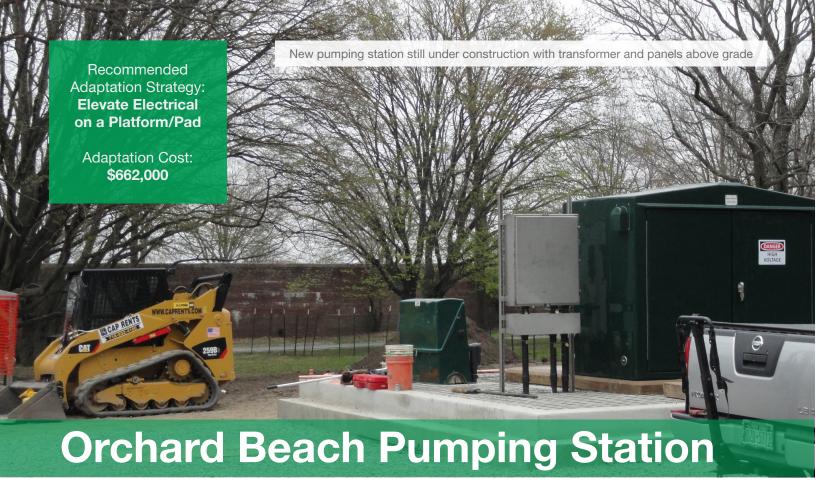
The station is located in Pelham Bay Park near Orchard Beach in the Bronx. The Orchard Beach pumping station is a new station that was still under construction during the development of this report. The station consists of a wet well below grade and electrical components, including control panels and a high-voltage transformer, mounted above grade on a concrete and gravel structure.

The Orchard Beach pumping station requires adaptive measures to withstand the critical flood elevation. Potential strategies were evaluated against such factors as flood depth, equipment location, and space. Viable strategies were reviewed to identify the most cost-effective, resilient option. Because controls are currently exposed, the addition of a surrounding building does not appear to be necessary, but electrical equipment must be moved above the flood elevation. Therefore, the recommended strategy at Orchard Beach is to elevate electrical controls on a platform. Residual risk is related to a greater depth of flooding from larger storms or more extreme climate change.

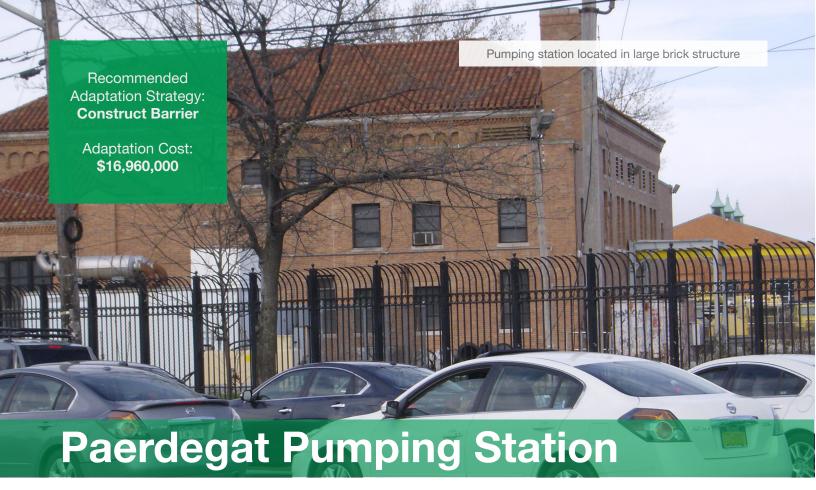
The Paerdegat combined pumping station is located at 6016 Flatlands Avenue in Brooklyn. The pumping station has a large brick structure that sits between the roadway and the Paerdegat Basin.

The Paerdegat pumping station requires adaptive measures to withstand the critical flood elevation. Potential strategies were evaluated against such factors as flood depth, equipment location, and space. Viable strategies were reviewed to identify the most cost-effective, resilient option. Because the extensive controls would be difficult to relocate, the recommended strategy at Paerdegat is to construct a barrier around the station. The installation of backup generators is also recommended. Residual risk is related to a greater depth of flooding from larger storms or more extreme climate change, or alternative pathways for floodwaters.

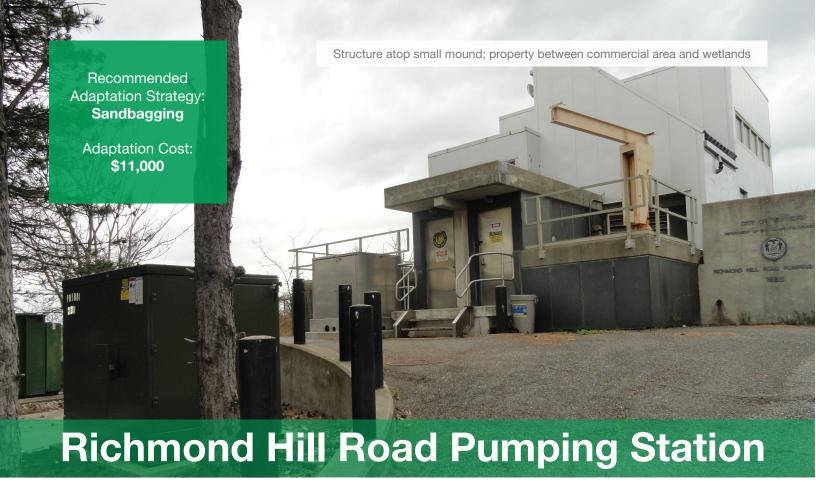
The Richmond Hill Road sanitary pumping station is located at the dead end of Richmond Hill Road near the intersection with Richmond Avenue on Staten Island. The property borders the tidal wetlands of the William T. Davis Wildlife Refuge. The pumping station's substantial structure is located atop a small mound of land. Transformers and a generator fuel tank sit outside the station within its fenced-in lot.

The critical flood elevation would be about an inch above local grade. Because the electrical controls and non-submersible pumps are located below grade, infiltration along piping and through well walls could potentially enter the building and damage those components.

The Richmond Hill Road pumping station requires adaptive measures to withstand the critical flood elevation. Potential strategies were evaluated against such factors as flood depth, equipment location, and space. Viable strategies were reviewed to identify the most cost-effective, resilient option. Due to the shallow depth of the critical flood and the substantial existing structure, the recommended strategy at Richmond Hill Road is to place sandbags around potential water entry points prior to flooding events. Residual risk is related to a greater depth of flooding from larger storms or more extreme climate change, or from sandbags being stacked improperly or disturbed by residents. Because the property is fenced in, sandbags are unlikely to be disturbed.

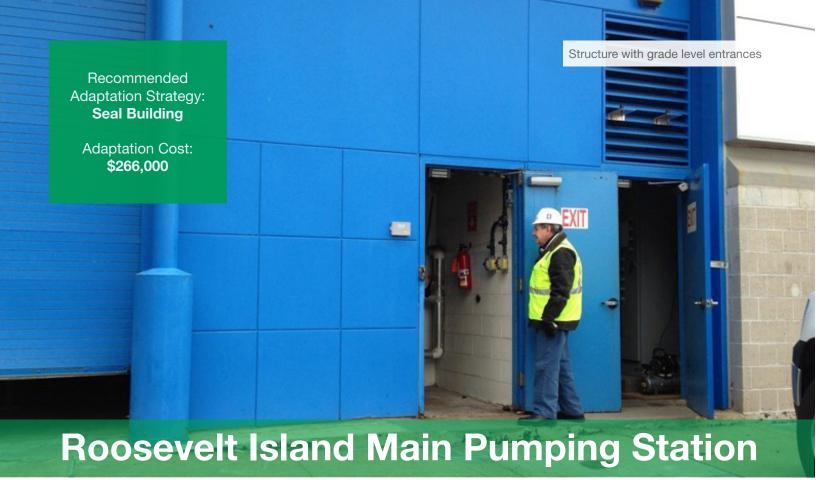
The Roosevelt Island Main sanitary pumping station is located within the Department of Sanitation facility off of Main Street on Roosevelt Island. The large superstructure has an electrical control room at grade where the main controls are housed. Submersible pumps and additional electrical controls are located below grade.

The critical flood elevation would inundate the area surrounding the facility with about 1.6 feet of water. This flood elevation could damage the electrical controls housed in the above grade structure as well as any electrical components below grade. The submersible pumps would not be affected by a flood. The Roosevelt Island Main pumping station receives flow from two additional stations. Therefore loss of function at Roosevelt Island Main increases the vulnerability of additional pumping stations, tributary areas, and populations.

The Roosevelt Island Main pumping station requires adaptive measures to withstand the critical flood elevation. Potential strategies were evaluated against such factors as flood depth, equipment location, and space. Viable strategies were reviewed to identify the most cost-effective, resilient option. Because there is a substantial existing structure, the recommended strategy at Roosevelt Island Main is to seal the building. Because water tight cases, doors, and building sealants are only rated up to a certain pressure, if flood depth is greater than expected the water pressure could exceed the rating and the building sealing could fail. Therefore, residual risk is related to the potential for water pressure to exceed the rating of the sealing measures.

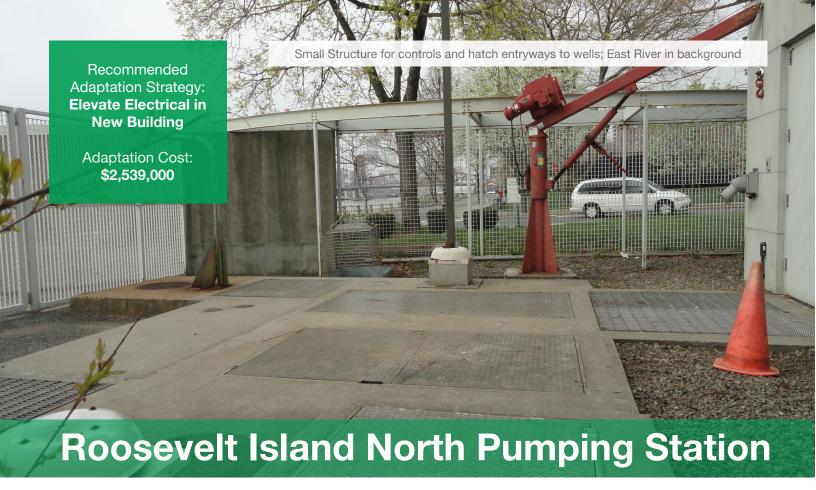
The Roosevelt Island North sanitary pumping station is located at the southeast corner of the Coler Hospital property along East Road on Roosevelt Island. An above grade concrete structure houses the motor control center; the wells are accessible through grade-level hatches.

The critical flood elevation would be more than 6 feet above local grade, completely inundating the wells and the above grade control panels. This would damage the electrical controls, but the submersible pumps should be unaffected. The Roosevelt Island North pumping station is connected to another station; however it discharges to it rather than receiving flow. Therefore loss of function at Roosevelt Island North does not increase the vulnerability of an additional pumping station.

The Roosevelt Island North pumping station requires adaptive measures to withstand the critical flood elevation. Potential strategies were evaluated against such factors as flood depth, equipment location, and space. Viable strategies were reviewed to identify the most cost-effective, resilient option. Due to the significant depth of the critical flood and the small size of the existing structure, the recommended strategy at Roosevelt Island North is to elevate electrical controls in a new building. Residual risk is related to a greater depth of flooding from larger storms or more extreme climate change.

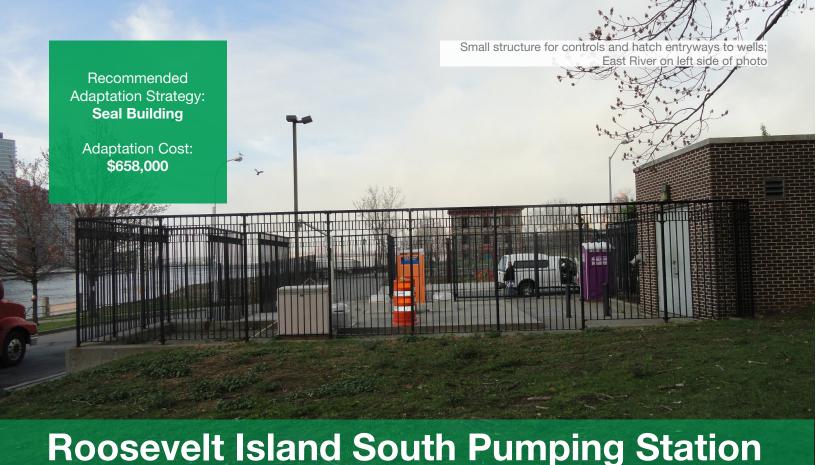
The Roosevelt Island South sanitary pumping station is located at the corner of East Road and Road 3 behind the Goldwater Hospital on Roosevelt Island. The site is less than 100 feet from the open water of the East River. The electrical controls are housed above grade in a small brick superstructure, and there are hatch entryways to the wells.

During Hurricane Sandy, the door to the electrical control room was sandbagged, which prevented the shallow floodwaters from reaching critical electrical equipment. Though the station lost power, no damage occurred. There is no history of flooding due to smaller events.

The critical flood elevation would inundate the area surrounding the facility with about 2.4 feet of water. This would damage the electrical controls house in the above grade structure as well as any electrical components below grade. The submersible pumps would not be affected by a flood. The Roosevelt Island South pumping station is connected to another station; however it discharges to it rather than receiving flow. Therefore loss of function at Roosevelt Island South does not increase the vulnerability of an additional pumping station.

The Roosevelt Island South pumping station requires adaptive measures to withstand the critical flood elevation. Potential strategies were evaluated against such factors as flood depth, equipment location, and space. Viable strategies were reviewed to identify the most cost-effective, resilient option. Due to the shallow depth of the critical flood and the presence of an existing building to house controls, the recommended strategy at Roosevelt Island South is to seal the building. Because water tight cases, doors, and building sealants are only rated up to a certain pressure, if flood depth is greater than expected the water pressure could exceed the rating and the building sealing could fail. Therefore, residual risk is related to the potential for water pressure to exceed the rating of the sealing measures.

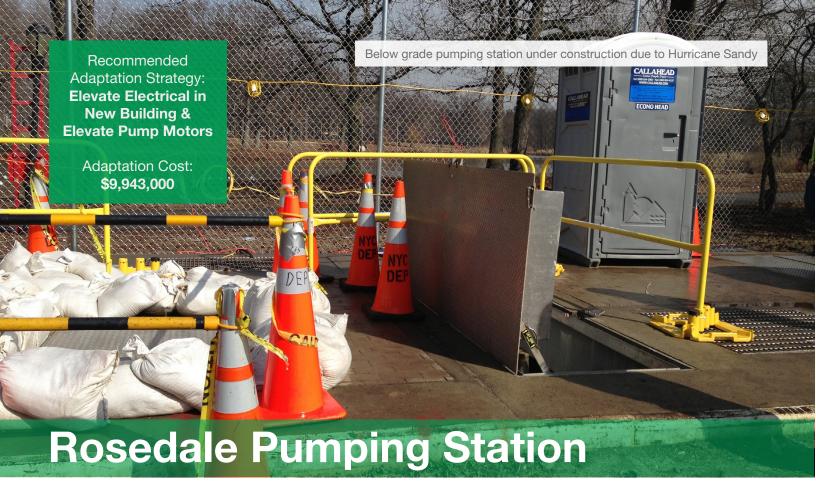
The Rosedale sanitary pumping station is located near the intersection of 147th Avenue and 235th Street in Queens, on a flat parcel of land adjacent to Brookville Park. The edge of Conselyeas Pond, in the park, and the creek into which it drains, are just over 100 feet from the pumping station. Rosedale pumping station is completely below grade, with the exception of some ventilation equipment housed in an onsite brick structure. Damage from Hurricane Sandy prompted reconstruction, including replacing pump controls, sump pumps, ventilation and heating equipment, and compressors.

Rosedale pumping station was completely inundated by the storm surge during Hurricane Sandy, which damaged the electrical controls and non-submersible pump motors. DEP staff indicated there is also a history of flooding at this location due to smaller storms.

The critical flood elevation would inundate the area surrounding the facility with over 4 feet of water. This would damage electrical controls and the non-submersible pump motors. The Rosedale pumping station receives flow from another pumping station. Therefore loss of function at Rosedale increases the vulnerability of an additional pumping station.

The Rosedale pumping station requires adaptive measures to withstand the critical flood elevation. Potential strategies were evaluated against such factors as flood depth, equipment location, and space. Viable strategies were reviewed to identify the most cost-effective, resilient option. Due to the depth of the critical flood, the lack of an existing structure, and concerns about vandalism in the area, the recommended strategy at Rosedale is to elevate electrical controls and pump motors in a new building. Elevating pump motors and replacing existing motors with submersibles are both acceptable solutions, however elevating pump motors may be a more cost-effective adaptation for this pumping station. Residual risk is related to a greater depth of flooding from larger storms or more extreme climate change.

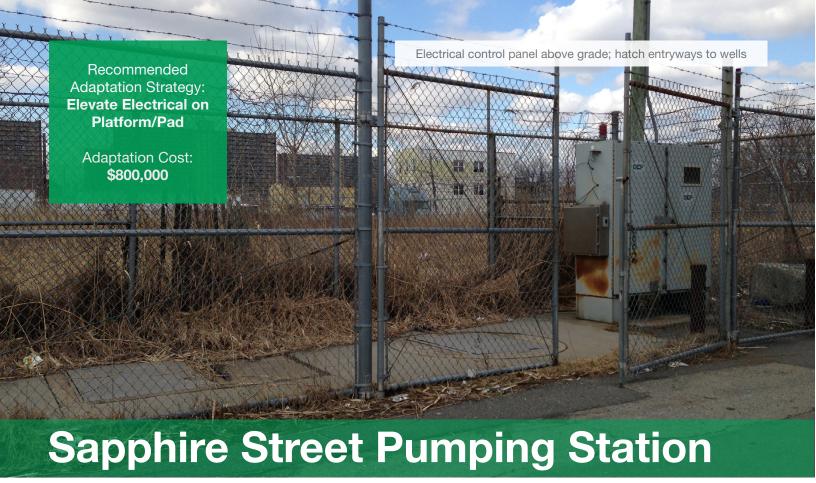
The Sapphire Street stormwater pumping station is located on Sapphire Street between Linden Boulevard and Dumont Avenue in Brooklyn, along the side of a minor street and adjacent to an empty lot. Sapphire Street is a small and simply designed station with two submersible pumps in a wet well surrounded by a fence. Electrical controls are elevated on a pole.

Though this station was not damaged during Hurricane Sandy, DEP staff indicated that overland flooding from stormwater runoff, predominantly from the vacant lot to the west, has been an issue at this station in the past. Evidence of this was found in the electrical control panel. The controls themselves have not been damaged, but flood waters have reached the bottom of the control panel housing and deposited debris there. The station's operation has not been affected by flooding and is therefore not considered to have a problem with historic flooding, but access to the station may be affected by localized flooding issues.

The critical flood elevation would inundate the area surrounding the facility with over 8 feet of water. This would damage electrical controls. Submersible pump motors would not be affected.

The Sapphire Street pumping station requires adaptive measures to withstand the critical flood elevation. Potential strategies were evaluated against such factors as flood depth, equipment location, and space. Viable strategies were reviewed to identify the most cost-effective, resilient option. Because components are currently exposed above grade but need to be moved out of reach of potential flood waters, the recommended strategy at Sapphire Street is to elevate electrical controls on a platform. Residual risk is related to a greater depth of flooding from larger storms or more extreme climate change.

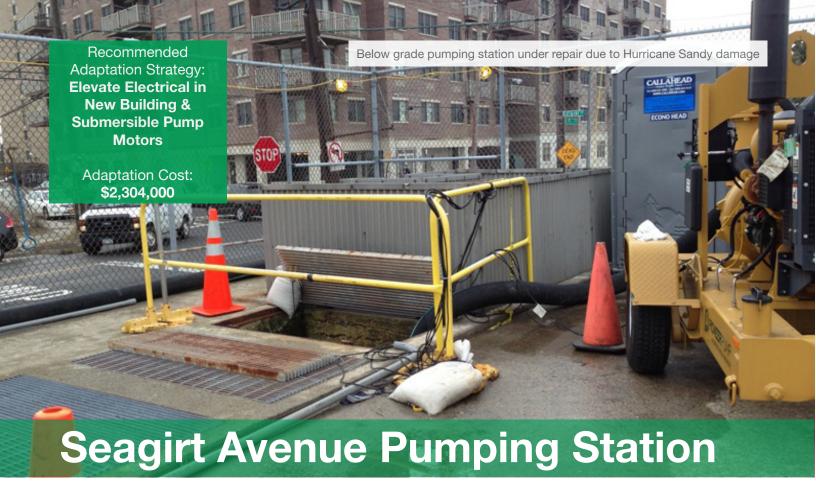
The Seagirt Avenue sanitary pumping station is located on the southwest corner of the intersection of Seagirt Avenue and Beach 9th Street, about 500 feet from the open water of Reynolds Channel. All critical electrical components and non-submersible motors are located on the below grade main floor of the onsite concrete superstructure. The pumping station may be accessed through a stairwell that runs from the top of the concrete structure into the station, as well as through hatches and vents on top of the structure.

The Seagirt Avenue pumping station was not inundated by the storm surge during Hurricane Sandy, but loss of power caused the wet well to flood the station, damaging motors and the electrical controls in the process. There is no history of flooding due to smaller storms at this location.

The critical flood elevation would inundate the area surrounding the facility with over 6 feet of water. This would damage electrical controls and pump motors.

The Seagirt Avenue pumping station requires adaptive measures to withstand the critical flood elevation. Potential strategies were evaluated against such factors as flood depth, equipment location, and space. Viable strategies were reviewed to identify the most cost-effective, resilient option. Due to the significant depth of the critical flood, the recommended strategy at Seagirt Avenue is to elevate electrical controls in a new building. When pumps need to be replaced as part of regular maintenance, submersible pumps should be installed. Residual risk is related to a greater depth of flooding from larger storms or more extreme climate change.

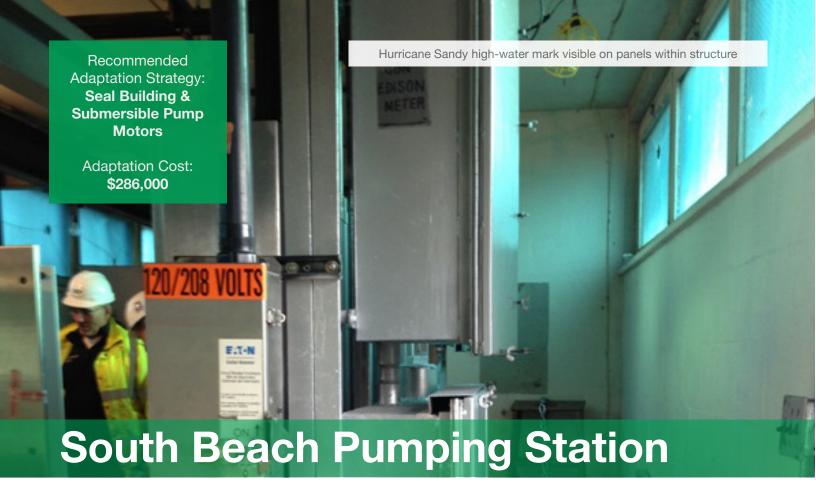
The South Beach sanitary pumping station is located at 300 Father Capodanno Blvd. in Staten Island about 650 feet from the open water of the Lower Bay. The pumping station consists of an aboveground structure, where critical electrical components are located; non-submersible pump motors are located below grade.

The South Beach pumping station was inundated by the storm surge during Hurricane Sandy, which damaged motors and the electrical controls. DEP staff indicated there is a history of flooding due to smaller storms at this location.

The critical flood elevation would inundate the area surrounding the facility with almost 9 feet of water. This would damage electrical controls and pump motors in the process.

The South Beach pumping station requires adaptive measures to withstand the critical flood elevation. Potential strategies were evaluated against such factors as flood depth, equipment location, and space. Viable strategies were reviewed to identify the most cost-effective, resilient option. Because there is a substantial existing structure, the recommended strategy at South Beach is to seal the existing building. When pumps need to be replaced as part of regular maintenance, submersible pumps should be installed. Because water tight cases, doors, and building sealants are only rated up to a certain pressure, if flood depth is greater than expected the water pressure could exceed the rating and the building sealing could fail. Therefore, residual risk is related to a greater depth of flooding from larger storms or more extreme climate change and the potential for water pressure to exceed the rating of the sealing measures.

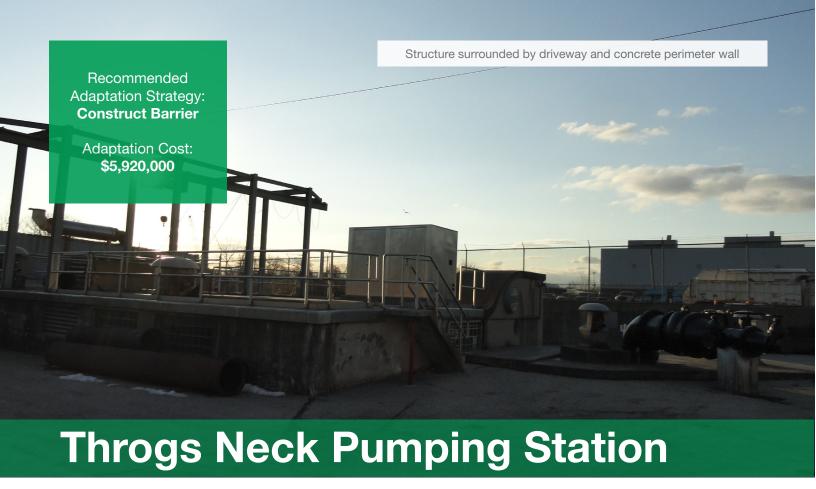
The Throgs Neck combined pumping station is located at the intersection of Lafayette Avenue and Zerega Avenue in the Bronx, behind the Department of Sanitation building. Controls and pumps are located on and below the below grade main floor of the structure onsite.

The critical flood elevation would completely inundate the station, and the surrounding flood would be 5 feet above local grade. This would damage electrical controls but would not affect the submersible pumps.

The Throgs Neck pumping station requires adaptive measures to withstand the critical flood elevation. Potential strategies were evaluated against such factors as flood depth, equipment location, and space. Viable strategies were reviewed to identify the most cost-effective, resilient option. Because the extensive electrical controls would be difficult and expensive to move, the recommended strategy at Throgs Neck is to construct a barrier around the station. Residual risk is related to a greater depth of flooding from larger storms or more extreme climate change.

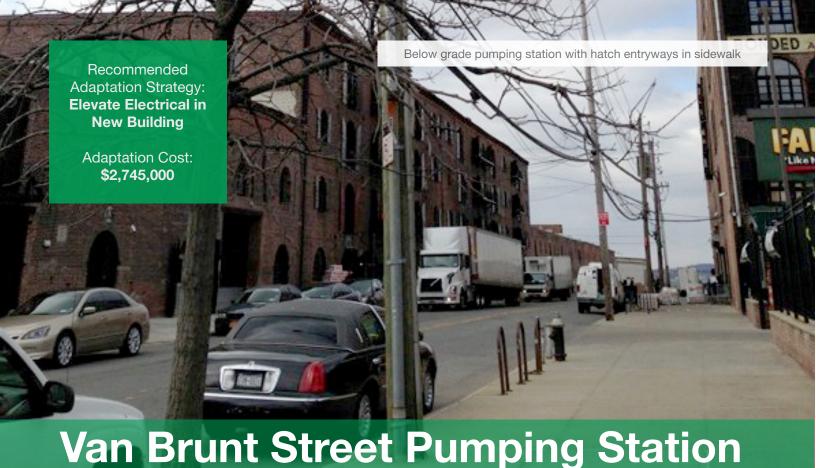
The Van Brunt combined pumping station is located in Brooklyn at the intersection of Van Brunt Street and Reed Street, less than 500 feet from the open water of the Upper Bay. The station is located entirely below grade, with the exception of telemetry equipment. Hatch entryways are located in the sidewalk.

During Hurricane Sandy, the Van Brunt pumping station was completely inundated. All electrical equipment had to be replaced following the storm and new telemetry equipment was relocated above grade. DEP indicated there is a history of flooding at this location due to smaller storms.

The critical flood elevation would completely inundate the station, and the surrounding flood would be nearly 9 feet above local grade. This would damage electrical controls but would not affect the submersible pumps.

The Van Brunt Street pumping station requires adaptive measures to withstand the critical flood elevation. Potential strategies were evaluated against such factors as flood depth, equipment location, and space. Viable strategies were reviewed to identify the most cost-effective, resilient option. Due to the extreme depth of the critical flood and the lack of an existing structure, the recommended strategy at Van Brunt Street is to elevate electrical controls in a new building. Residual risk is related to a greater depth of flooding from larger storms or more extreme climate change.

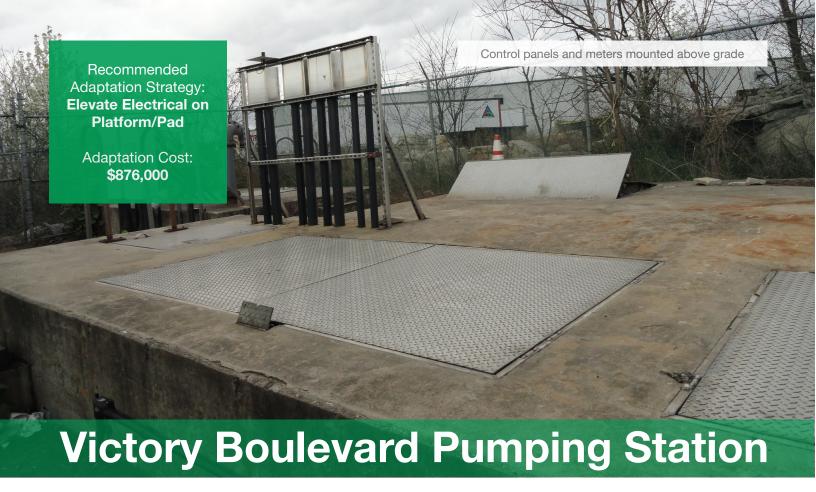
The Victory Boulevard sanitary pumping station is located at the southwestern dead end of Victory Blvd. on Staten Island. It is adjacent to the property surrounding a Con Edison plant and is only a few hundred feet from the tidally influenced Arthur Kill. The station is primarily below grade underneath a concrete slab with control panels and meters mounted above the slab.

The Victory Boulevard pumping station requires adaptive measures to withstand the critical flood elevation. Potential strategies were evaluated against such factors as flood depth, equipment location, and space. Viable strategies were reviewed to identify the most cost-effective, resilient option. Because controls are located above the critical flood elevation, but only by a small margin, the recommended strategy at Victory Boulevard is to elevate controls on a platform. Residual risk is related to a greater depth of flooding from larger storms or more extreme climate change.

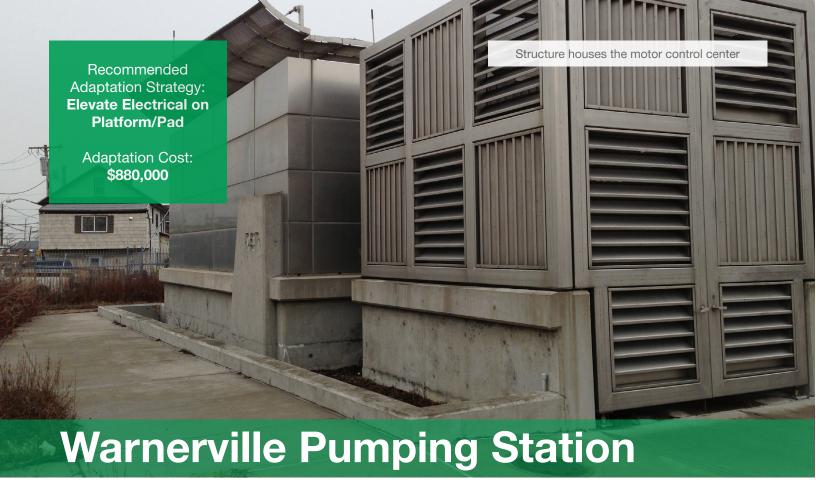
The Warnerville sanitary pumping station is located near the intersection of Brookville Boulevard and Rockaway Boulevard in Queens. All critical electrical components are located above grade either outdoors on a concrete pad or within the onsite superstructure. The Warnerville pumping station includes four submersible sewage pumps and grinders located below grade and accessible by hatches.

During Hurricane Sandy, the station lost power. The power outage caused the wet well to flood the dry well; however, no equipment was damaged during the flooding. There is no additional history of flooding due to smaller storms at this location.

The critical flood elevation would inundate the area surrounding the facility with over 4 feet of water. This would damage electrical controls but would not affect the submersible pumps. The Warnerville pumping station is connected to another station; however it discharges to it rather than receiving flow. Therefore loss of function at Warnerville does not increase the vulnerability of an additional pumping station.

The Warnerville pumping station requires adaptive measures to withstand the critical flood elevation. Potential strategies were evaluated against such factors as flood depth, equipment location, and space. Viable strategies were reviewed to identify the most cost-effective, resilient option. Because electrical controls are currently mounted outdoors but need to be moved out of the reach of flood waters, the recommended strategy at Warnerville is to elevate electrical controls on a platform. Residual risk is related to a greater depth of flooding from larger storms or more extreme climate change.

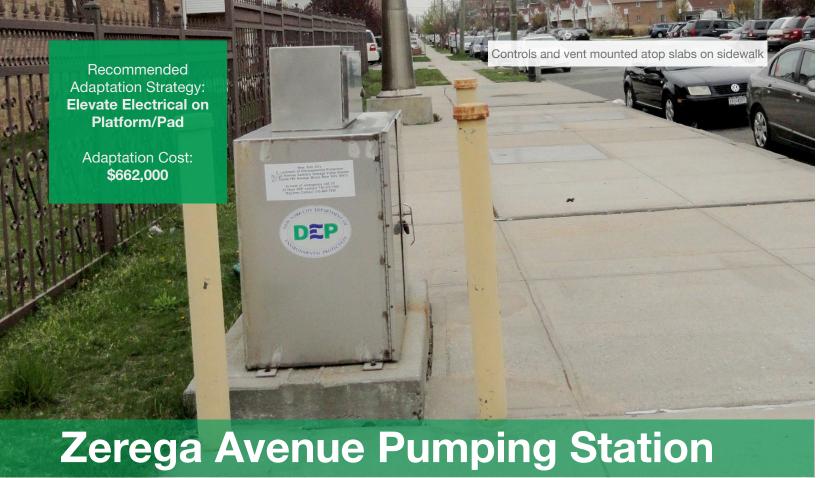
The Zerega Avenue sanitary pumping station is located at the southern dead end of Zerega Avenue near the corner of Castle Hill Avenue. It is across the street from a YMCA and is less than 500 feet from the East River. The pumping station is mostly below grade; the wells are accessible through hatches in the sidewalk, and electrical controls are located in a stainless-steel box on the sidewalk.

The critical flood elevation would be almost 6 feet above local grade, completely inundating the wells and the above grade control panels. This would damage the electrical controls, but the submersible pumps should be unaffected.

The Zerega Avenue pumping station requires adaptive measures to withstand the critical flood elevation. Potential strategies were evaluated against such factors as flood depth, equipment location, and space. Viable strategies were reviewed to identify the most cost-effective, resilient option. Because controls are currently exposed, space is limited, and controls need to be moved above the flood elevation, the recommended strategy at Zerega Avenue is to elevate electrical controls on a platform. Residual risk is related to a greater depth of flooding from larger storms or more extreme climate change.
