# NYC WASTEWATER RESILIENCY PLAN

## CLIMATE RISK ASSESSMENT AND ADAPTATION STUDY

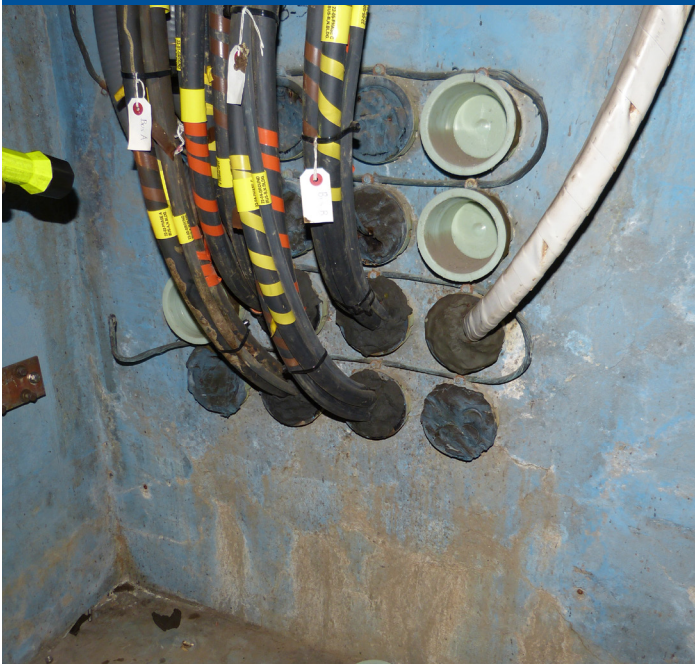
Electrical conduits in the basement of the Main Building provided a pathway for floodwaters during Hurricane Sandy.

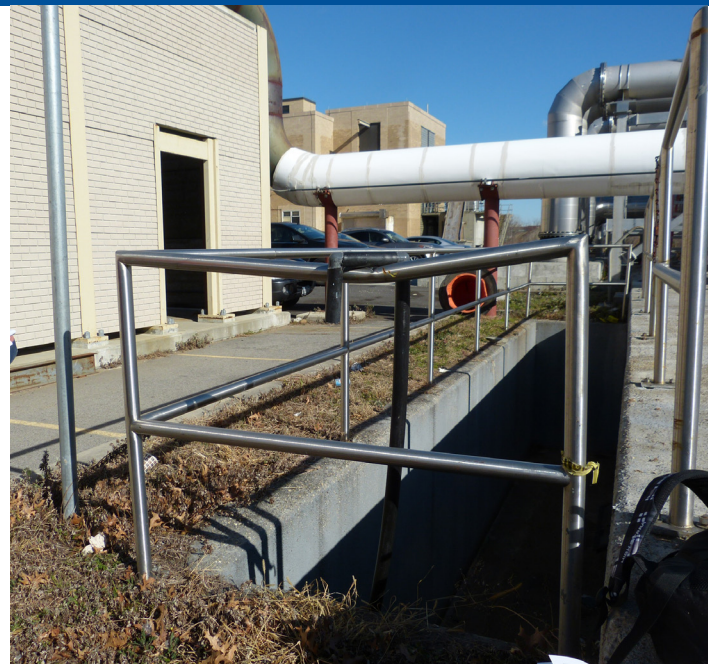
A basement access way leading to the Primary Sludge Gallery would be a flood pathway during the critical flood event.

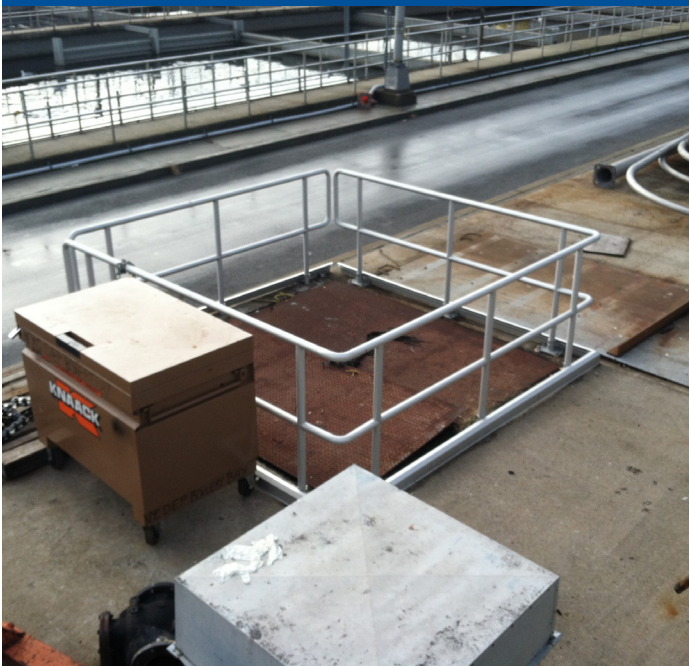
Typical hatch at grade level leading to tunnel system

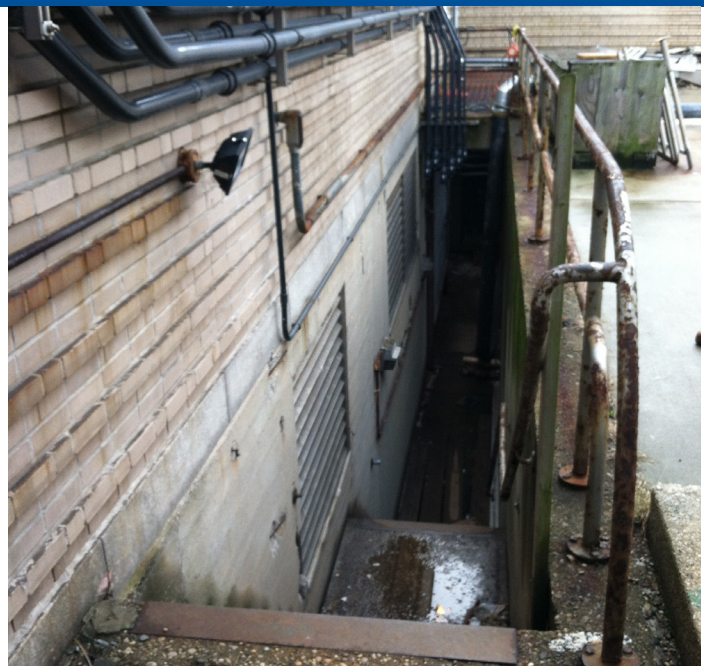
Stairway at grade leading to the Main Building

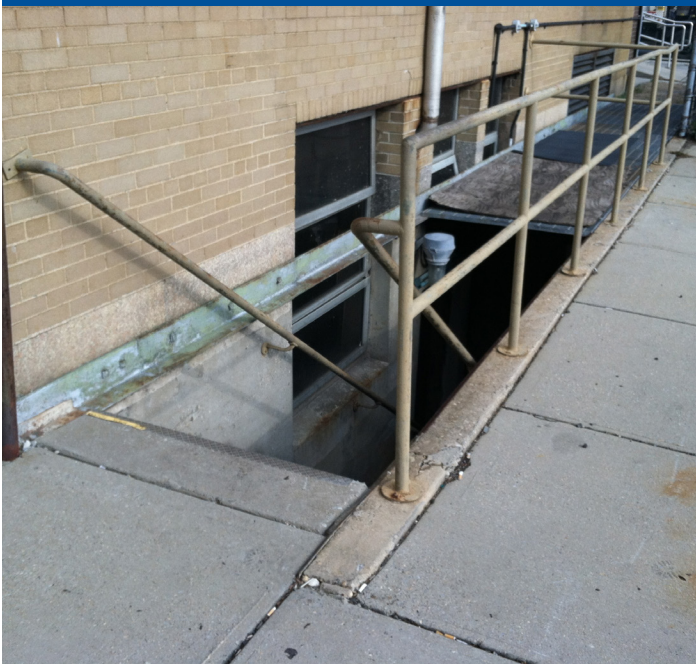
Access stairway to the basement and gas booster room of the Pump and Power Building

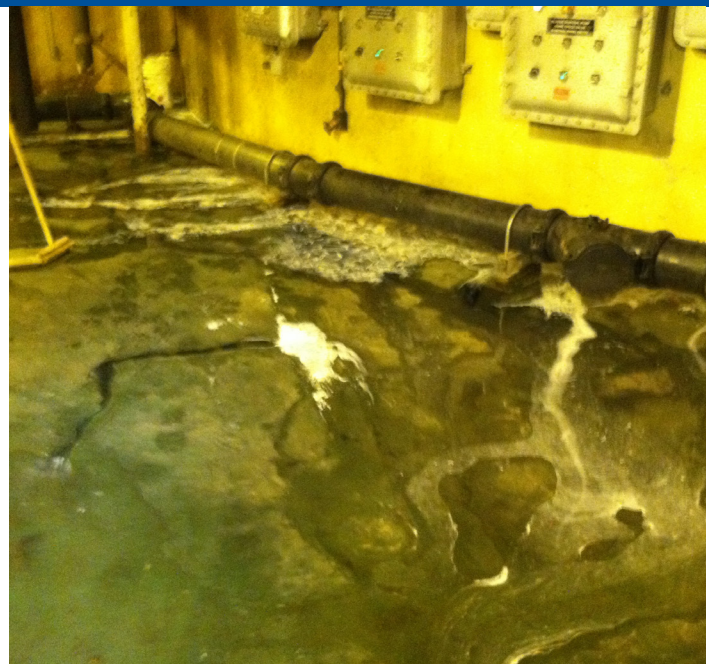
Sinkholes developed near the Sludge Storage Area after Hurricane Sandy. Groundwater may present a flood risk during the next critical flood event

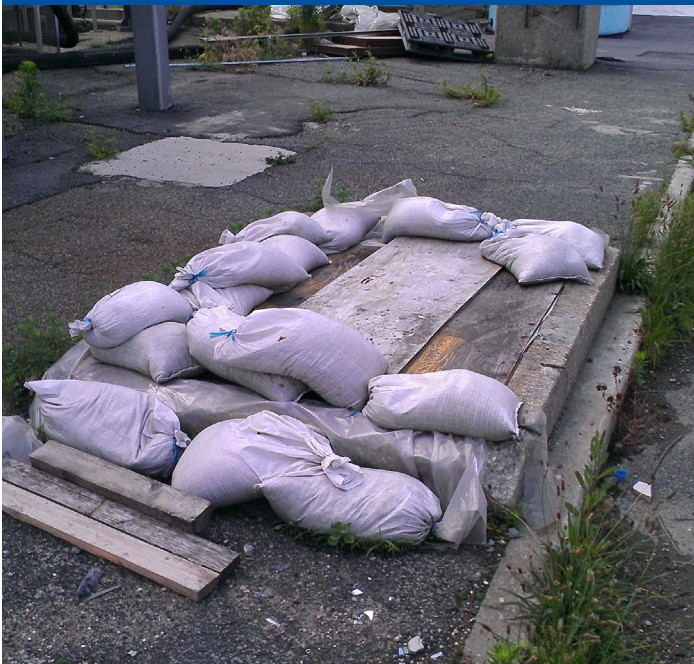
The overhead grate above the Aeration Gallery is a potential flood pathway to the sludge pumps.

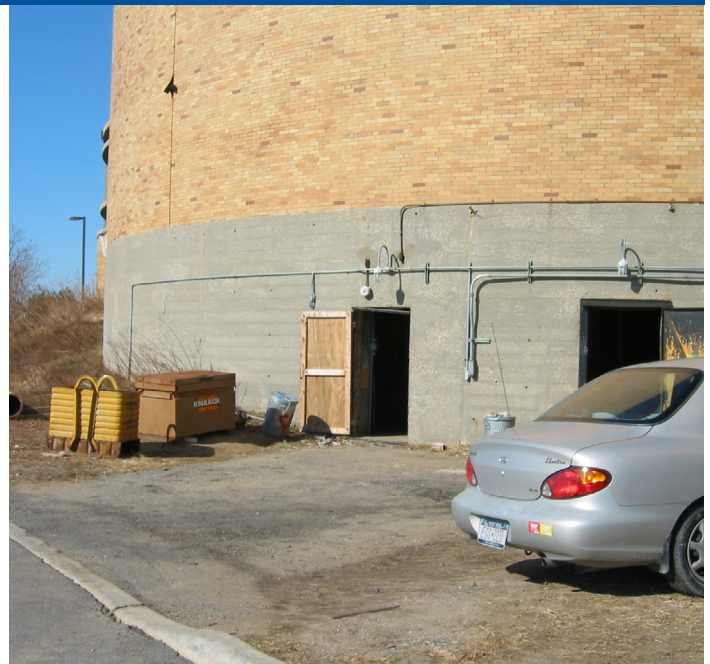
Access doors to the Sludge Storage Tanks next to the East River

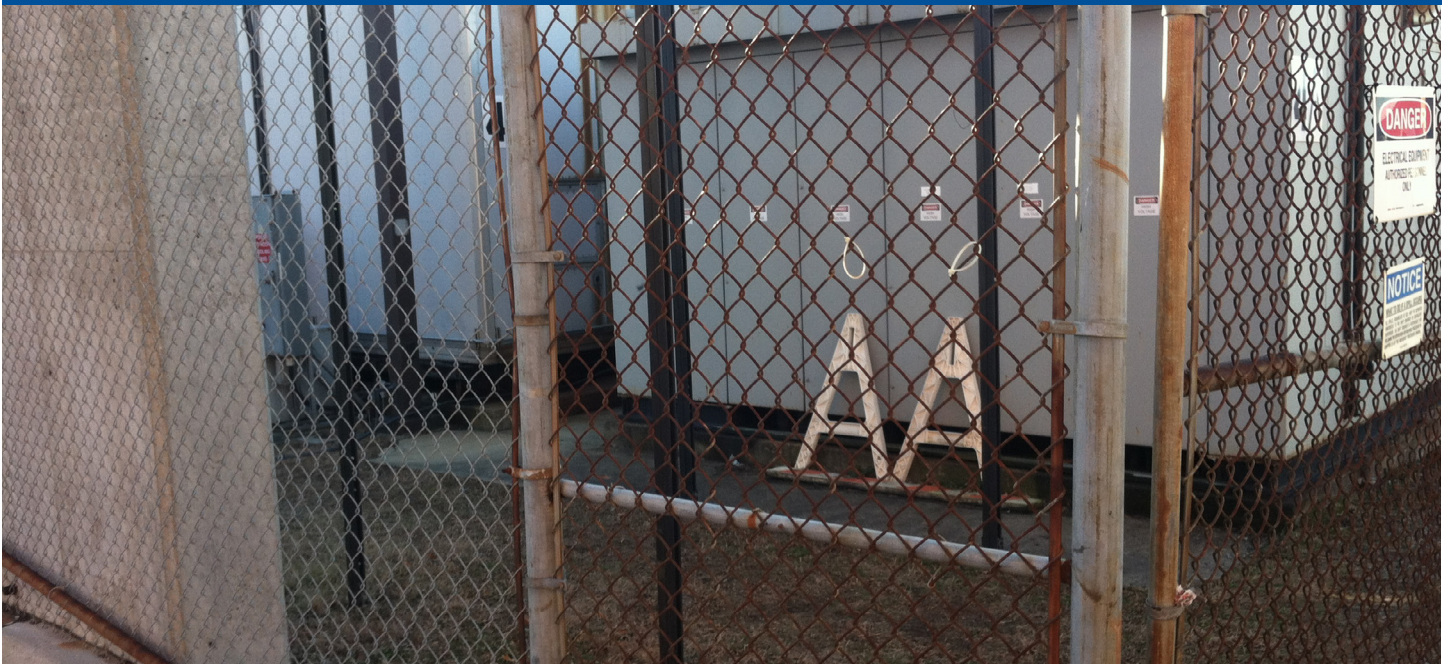
The Unit Substation adjacent to the Return Sludge Pump Station #3 would be flooded at grade level during the critical flood event.

The critical flood event would only result in half a foot of flooding near the Unit Substation; therefore, sandbagging around the Substation is recommended. This strategy is regularly employed at the Substation, already as staff know this area has the greatest potential for flooding. This option can be implemented as needed prior to large flood events. It is also affordable and provides an adequate level of protection for the Substation.

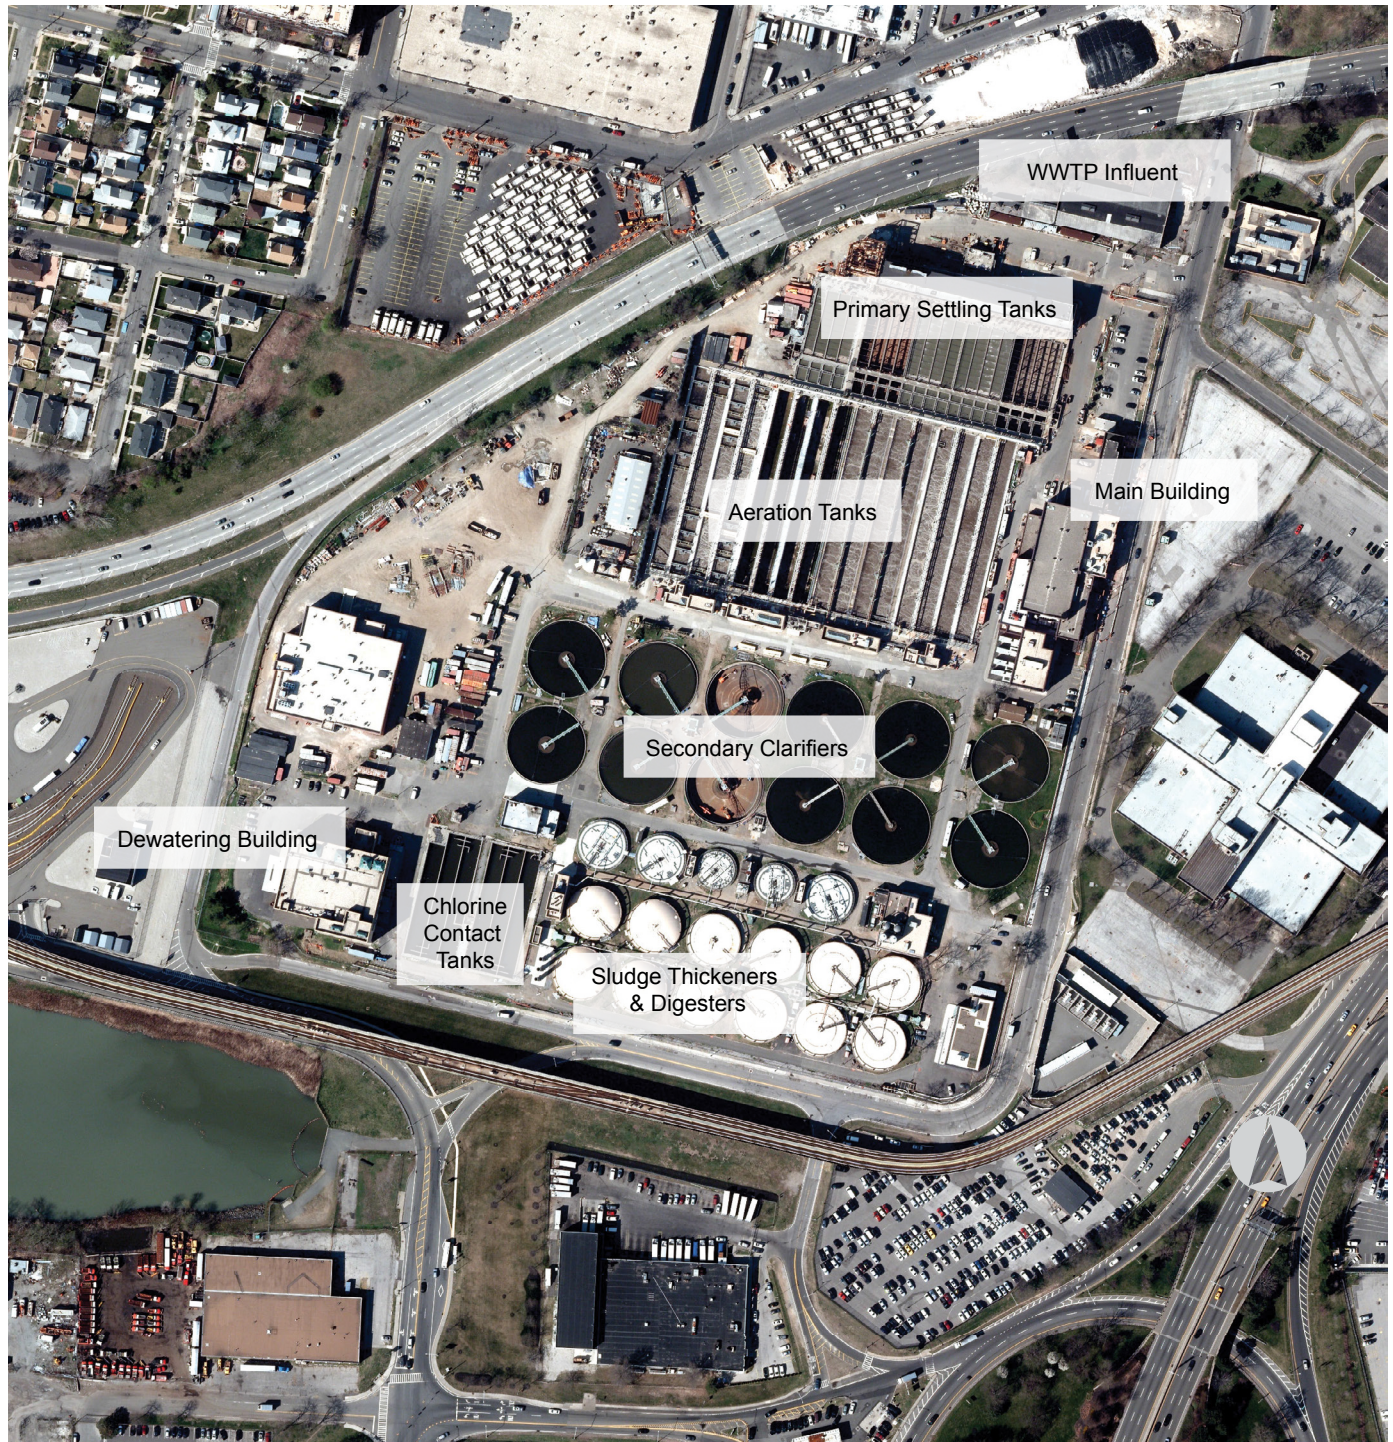
The Jamaica Wastewater Treatment Plant did not sustain any damage due to flooding during Hurricane Sandy.

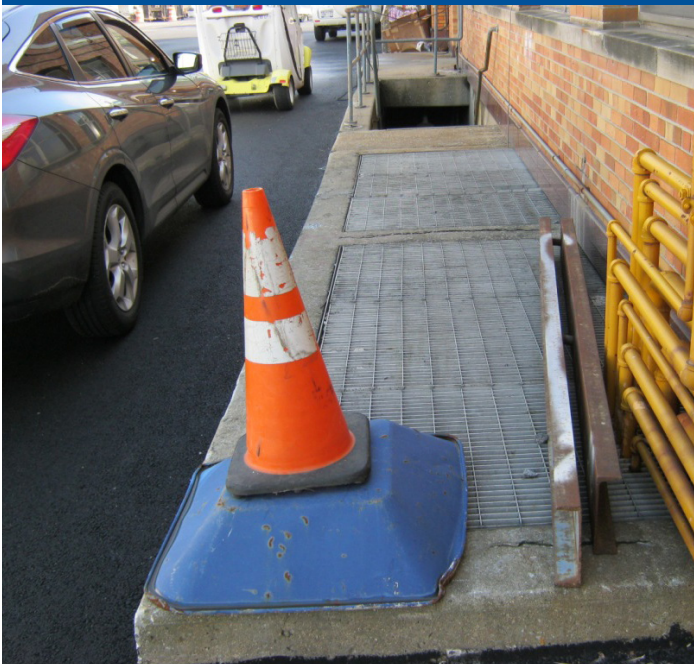
Basement access and floor grates on the perimeter of the Main Building

The Main Building contains several rooms that are susceptible to flooding under the critical flood event, such as the Main Pump Room, Old Facility Room, and Electrical Substation area. It is recommended to seal the building with water-tight doors and windows and flood-proof target pieces of equipment to provide adequate protection during the critical flood event and smaller storms.

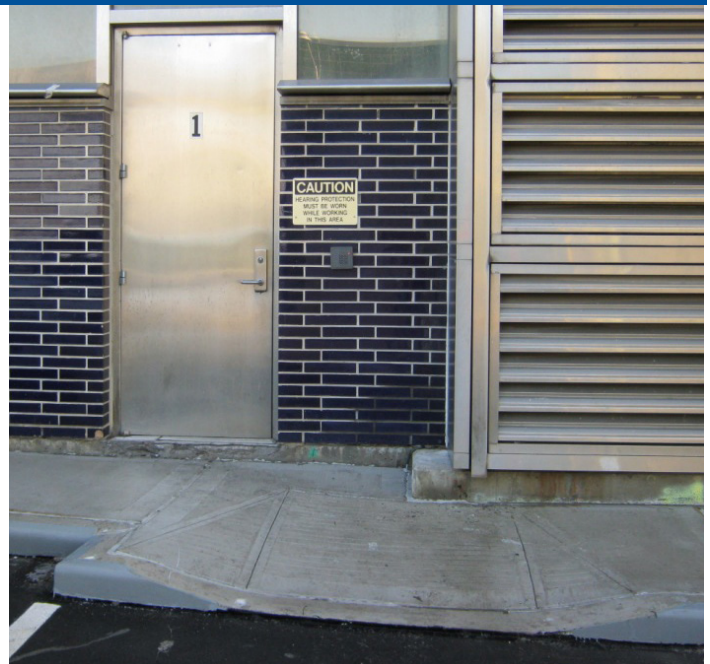
Low-lying louvers along-side the Main Building

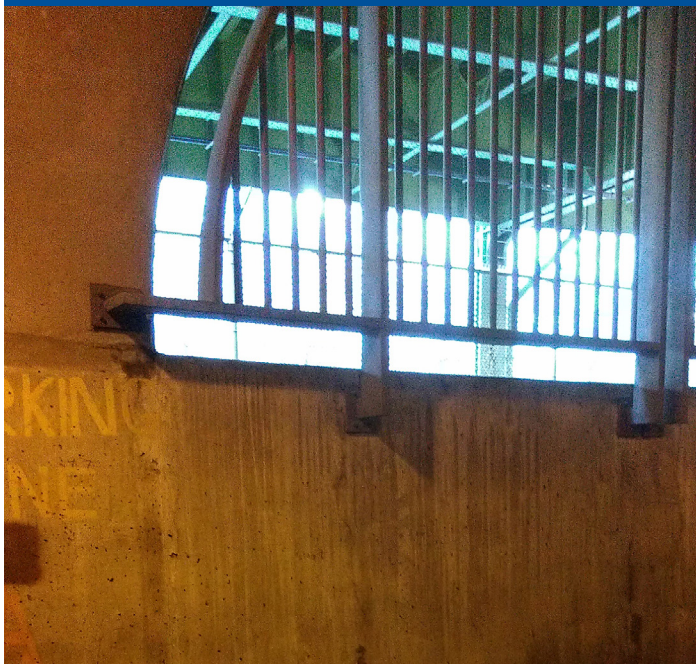
Arched windows around the perimeter of the ground level (EL 5) are considered pathways for flooding.

Since the first floor elevation (EL 5) at North River contains critical infrastructure, flood-proofing is recommended since it provides a high degree of protection. In areas of the first floor where not all infrastructure could be flood-proofed, sealing the openings to the building is recommended. Fortifying the manhole covers, driveway entrance, and arch openings along the perimeter of the building will greatly reduce the plant's risk and prevent floodwaters from entering the first floor, traveling throughout the plant, and damaging target pieces of equipment.

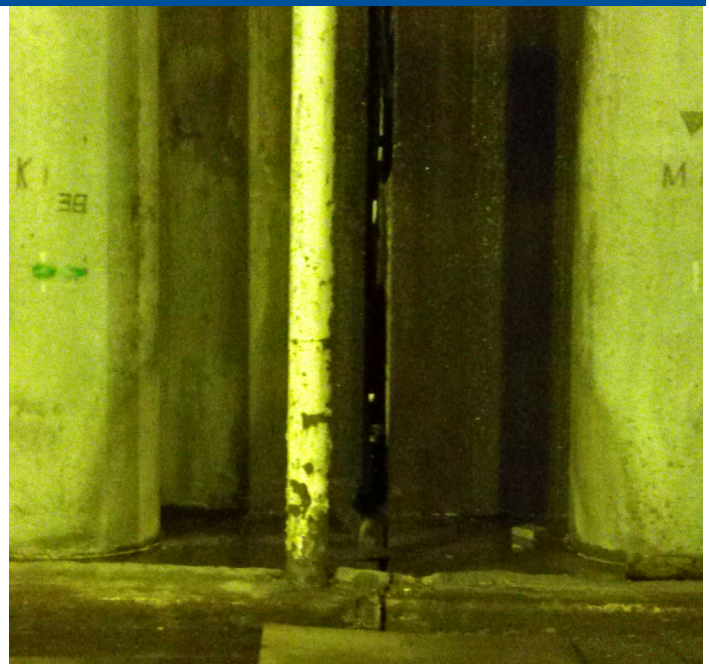
Expansion joints are flood pathways as experienced during Hurricane Sandy.

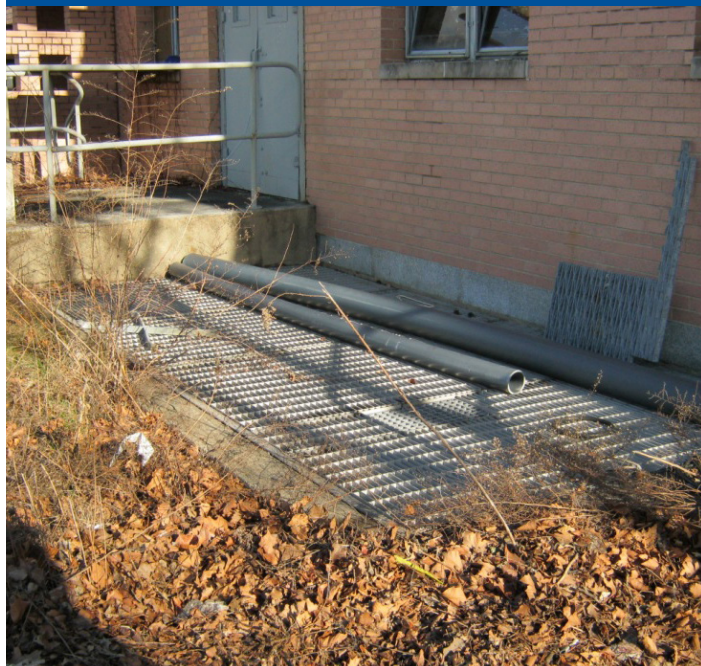
Floor grate outside of the Maintenance Building

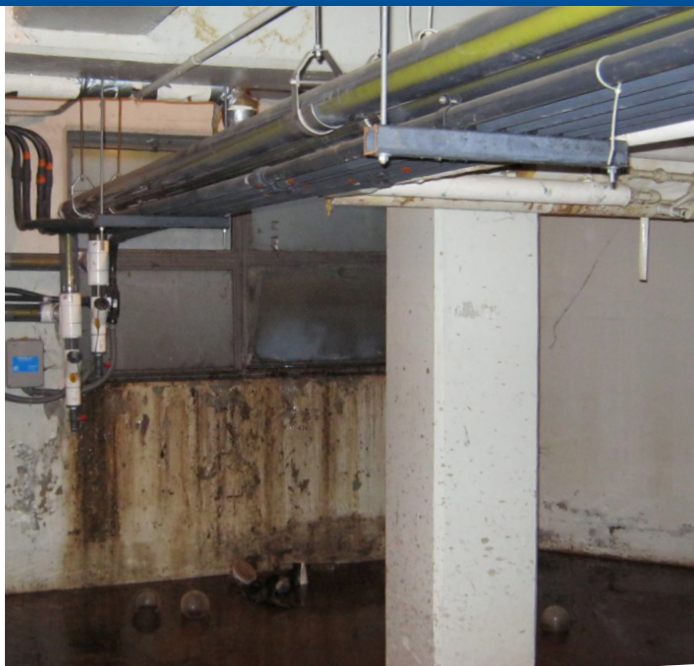
A window at the Sludge Storage Building was one of the main areaways for floodwater to enter during Hurricane Sandy.

In addition, Oakwood Beach is susceptible to flood damage from an interconnected tunnel system that has key at-risk flood pathways at the Sludge Storage Building. While flood-proofing and elevating equipment within the Sludge Storage Building would offer a high level of protection, constructing a static barrier around the area-ways and sealing the doorways and windows to prevent damage at the Main Building and Treatment Building is also recommended.

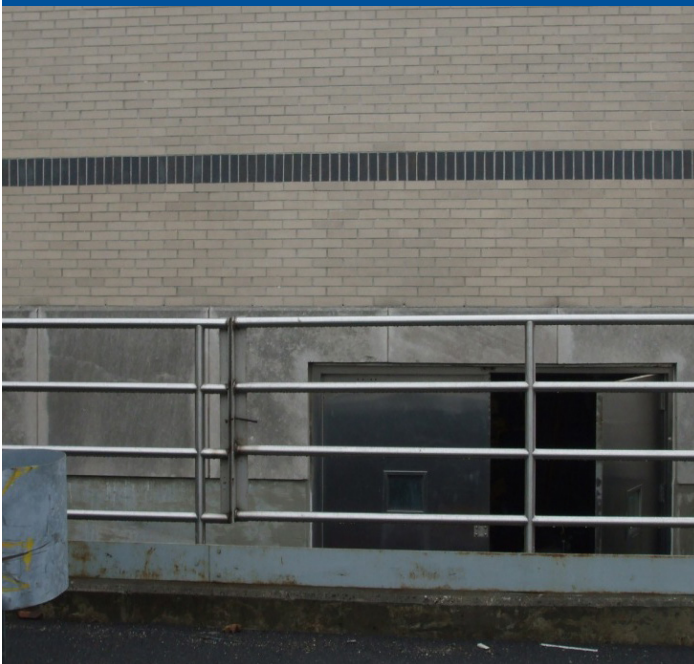
A pathway for flooding is around the perimeter of the Administration Building.

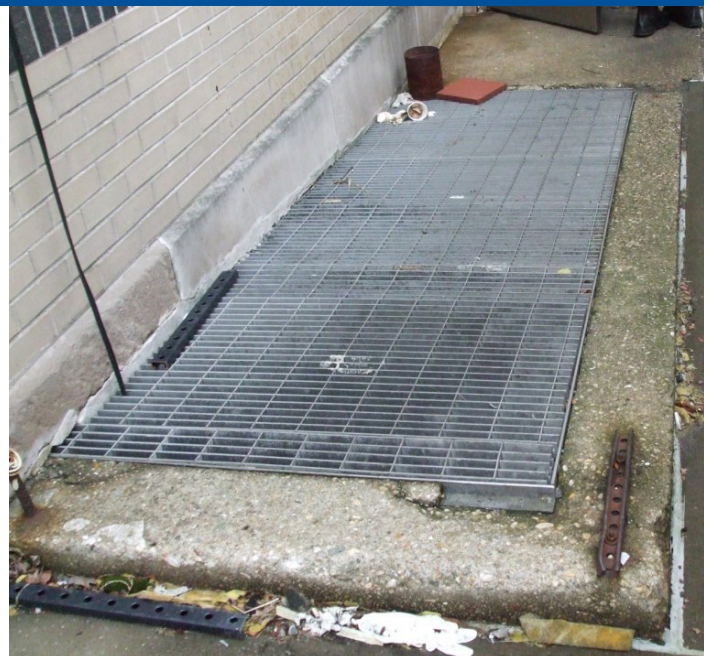
Floor grates near the Generator Room may allow floodwater to enter.

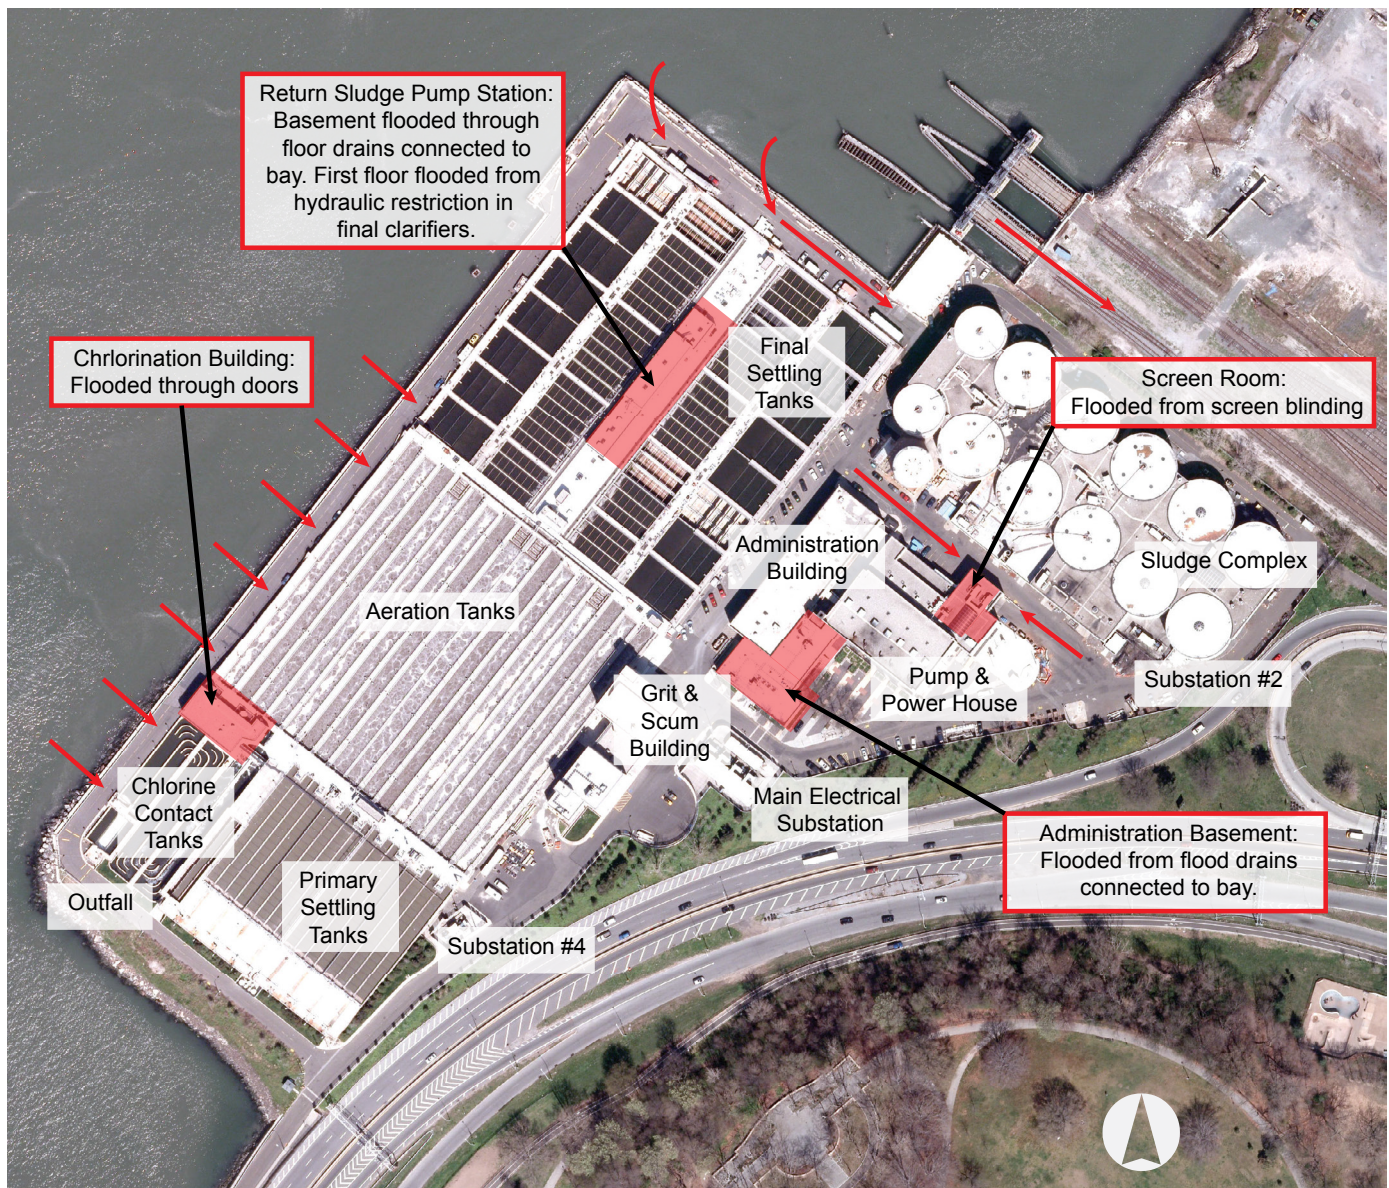
ing was flooded when sump pumps were unable to keep up with the rising water levels. Due to the high storm surge levels, both entrances to the plant were blocked which prevented staff from entering or exiting the site for two days after the storm.

Plant staff took precautions ahead of the storm which included sandbagging low-lying areas such as the Chlorination Building, Machine Shop, and Storage Room in the Administration Building. The plant lost power during the storm, but maintained normal wet weather operations using back-up generators. Plant staff successfully protected the Motor Control Centers located on the first floor of the disinfection facilities by opening the interior doorways to allow water to drain into the basement. The plant's ability to pump wastewater was uninterrupted during the storm event since the Pump and Blower Building and the plant's main pumping equipment were protected ahead of the storm.

Flood pathways and areas flooded during Hurricane Sandy are highlighted in red.

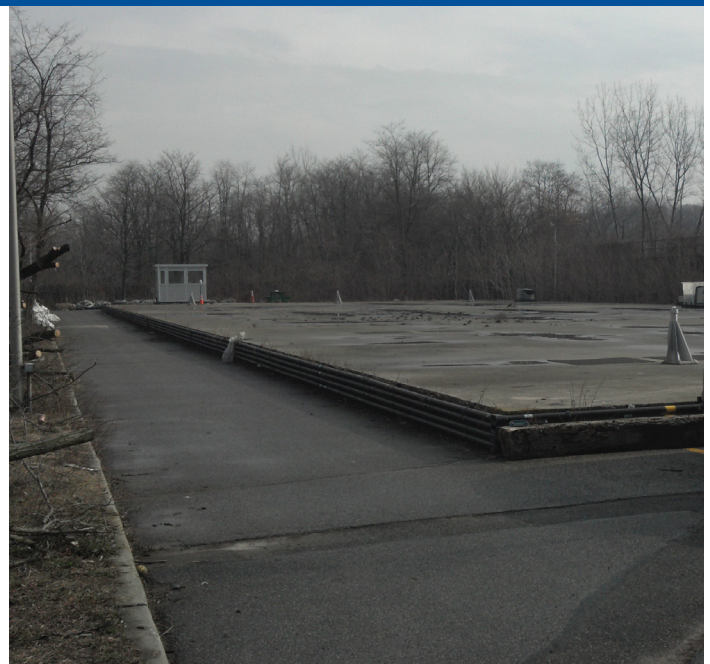
Chlorine Contact Tanks are potentially at risk of flooding during a large storm event.

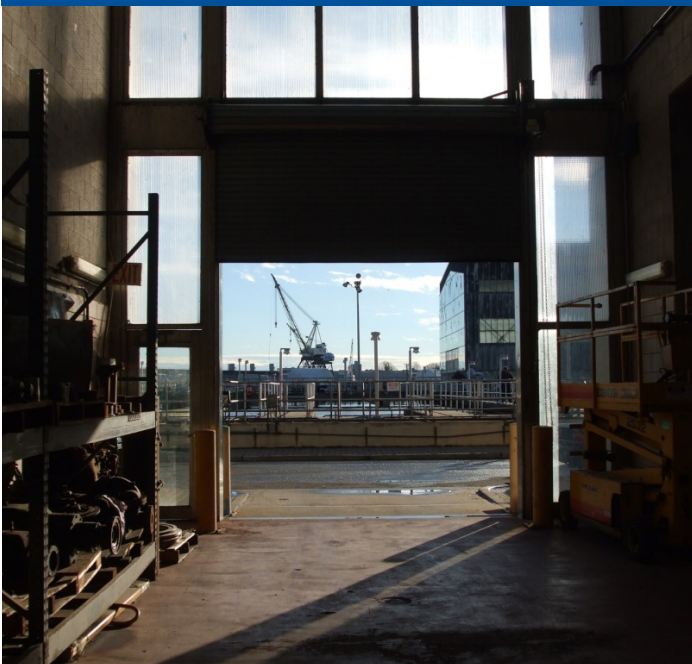
Rollup doors at the Main Building

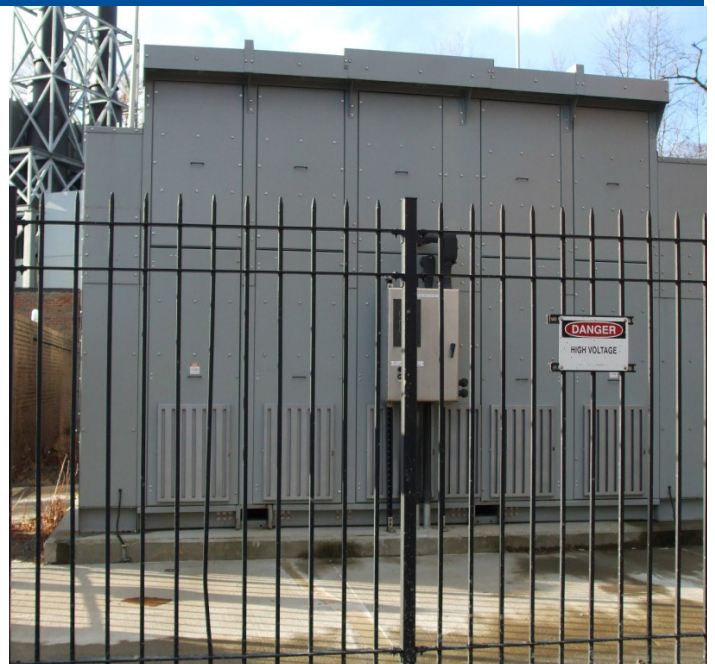
Fencing surrounding the outdoor Electrical Substation

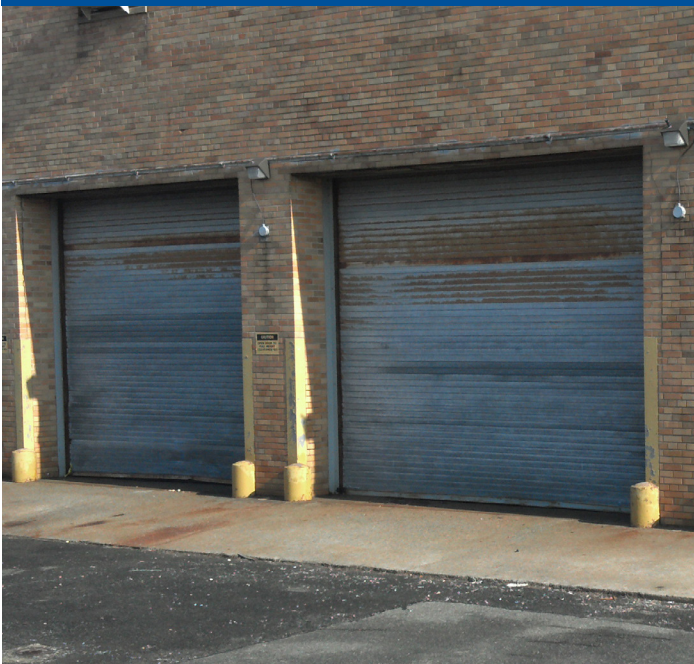
Rollup doors on the Sludge Storage Building adjacent to Jamaica Bay are potential pathways for flooding as experienced during Hurricane Sandy. The Sludge Storage Building is also an access point into the plant's interconnected tunnel system.

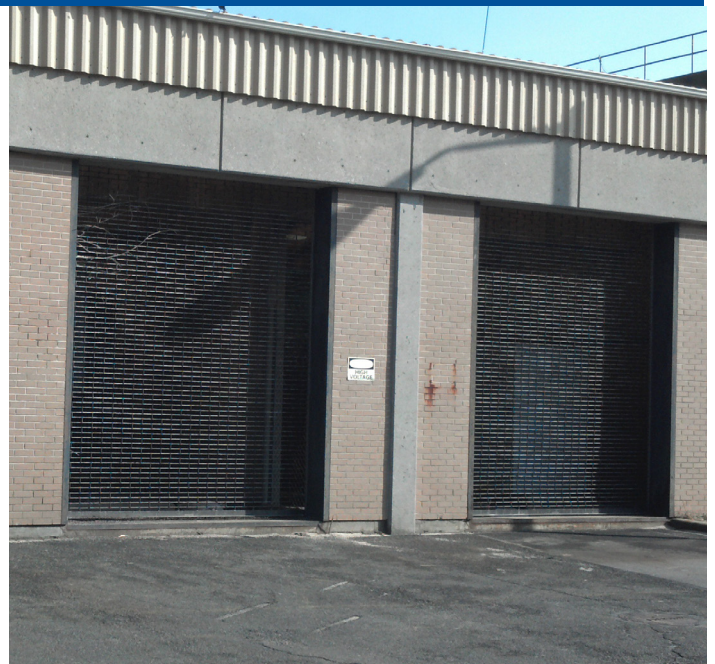
Rollup doors at the Electrical Substation Building

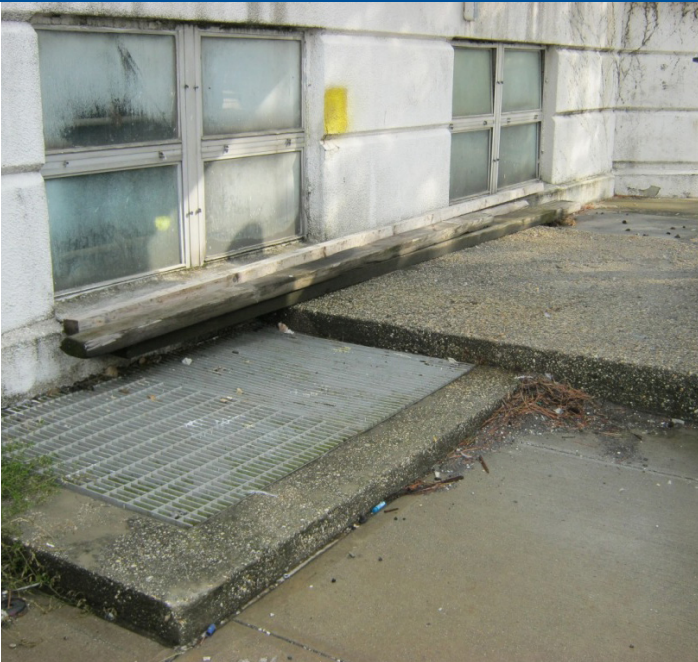
Grate and windows leading to the basement of the Sludge Thickener Building and tunnel system

The Chlorine Building, in particular, requires robust protection as it would experience several feet of flooding under the critical flood event and contains numerous pieces of equipment needed to disinfect wastewater. As such, waterproofing chemical feed pumps and sealing the building with water-tight windows and doors is recommended. Likewise, the Grit Building and Thickener Building are also key locations that require several protection measures, since they have thresholds below the critical flood which lead to the tunnel system.

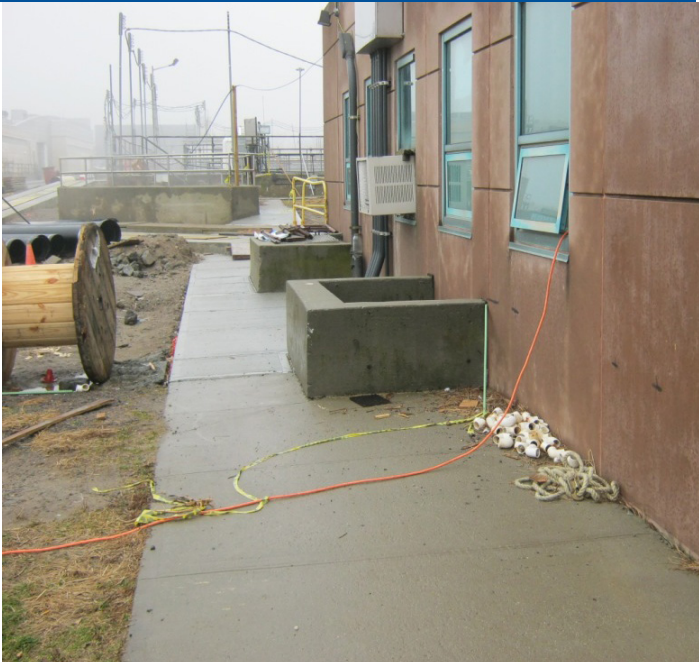
Basement access ways into the Chlorine Building

Tallman Island experienced minor flooding as a result of Hurricane Sandy. During the peak of the storm, floodwater submerged the sludge loading dock and inundated the roadway along the north end of the plant along the waterfront. Rising waters also encroached upon the central plant roadway, and approached the doorway of the Sludge Storage Building and some transformers mounted on pads next to the building; however, no damage was incurred. Floodwaters did enter the Chlorine Building through a few doors and basement access

ways. However, flooding was reduced by plant staff who took precautions ahead of the storm by placing temporary slide gates and sandbags coupled with concrete traffic barriers across flood pathways. In addition, the sump pumps within the Chlorine Building maintained operation during the flood and no equipment in the building was significantly affected. While the plant did not endure significant flood damage, the wooden boardwalk surrounding the plant was severely damaged in the areas where the storm surge overtopped the perimeter bulkhead.

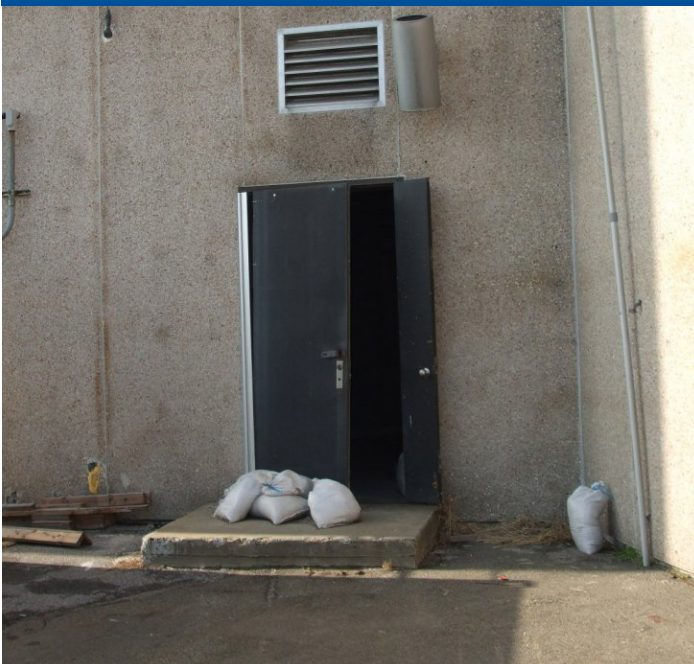
Access door leading to the equipment rooms in the Sludge Storage Tank Building

Since the plant is at a relatively high elevation, only one area, the Sludge Storage Tanks, may be flooded by up to 6 feet of water during the design flood event. However, since the Manhattan Grit Chamber is at a relatively low elevation it may be flooded by up to 8 feet during the critical flood event. These areas are listed in Table B and were found to be at risk in a 100-year flood with 30 inches of sea level rise.

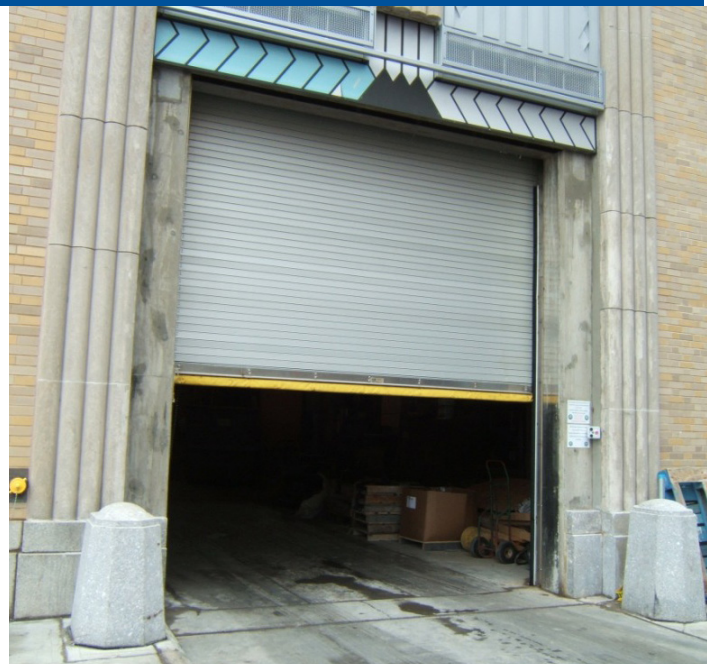
This rollup door at the Manhattan Grit Chamber was a pathway for flooding during Hurricane Sandy and may be flooded during the critical flood event.

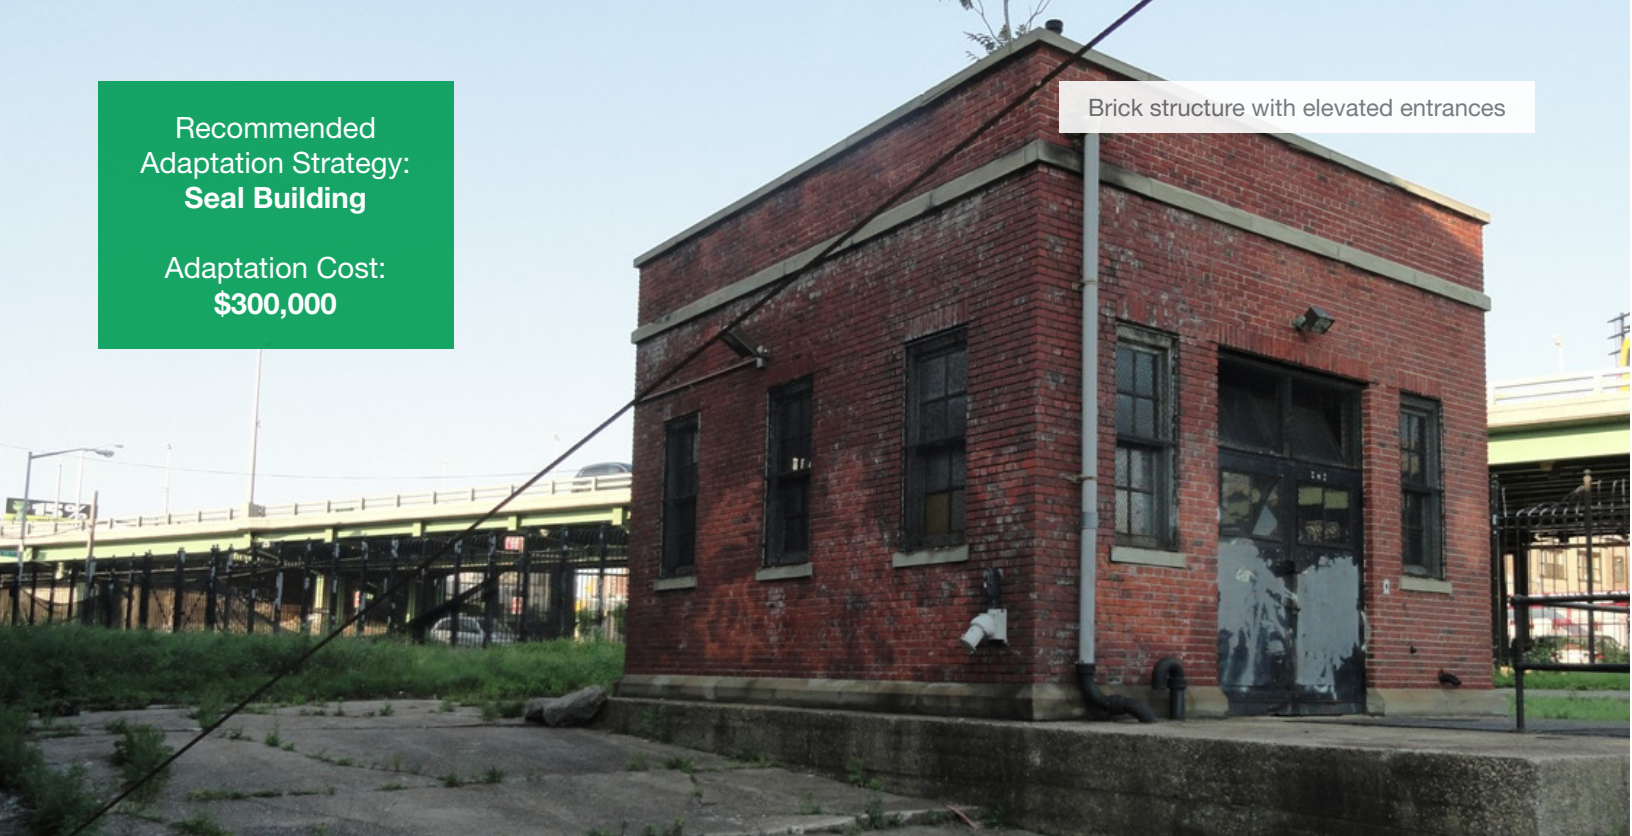
Brick structure with elevated entrances

Recommended  
Adaptation Strategy:  
**Seal Building**

Adaptation Cost:  
**\$300,000**

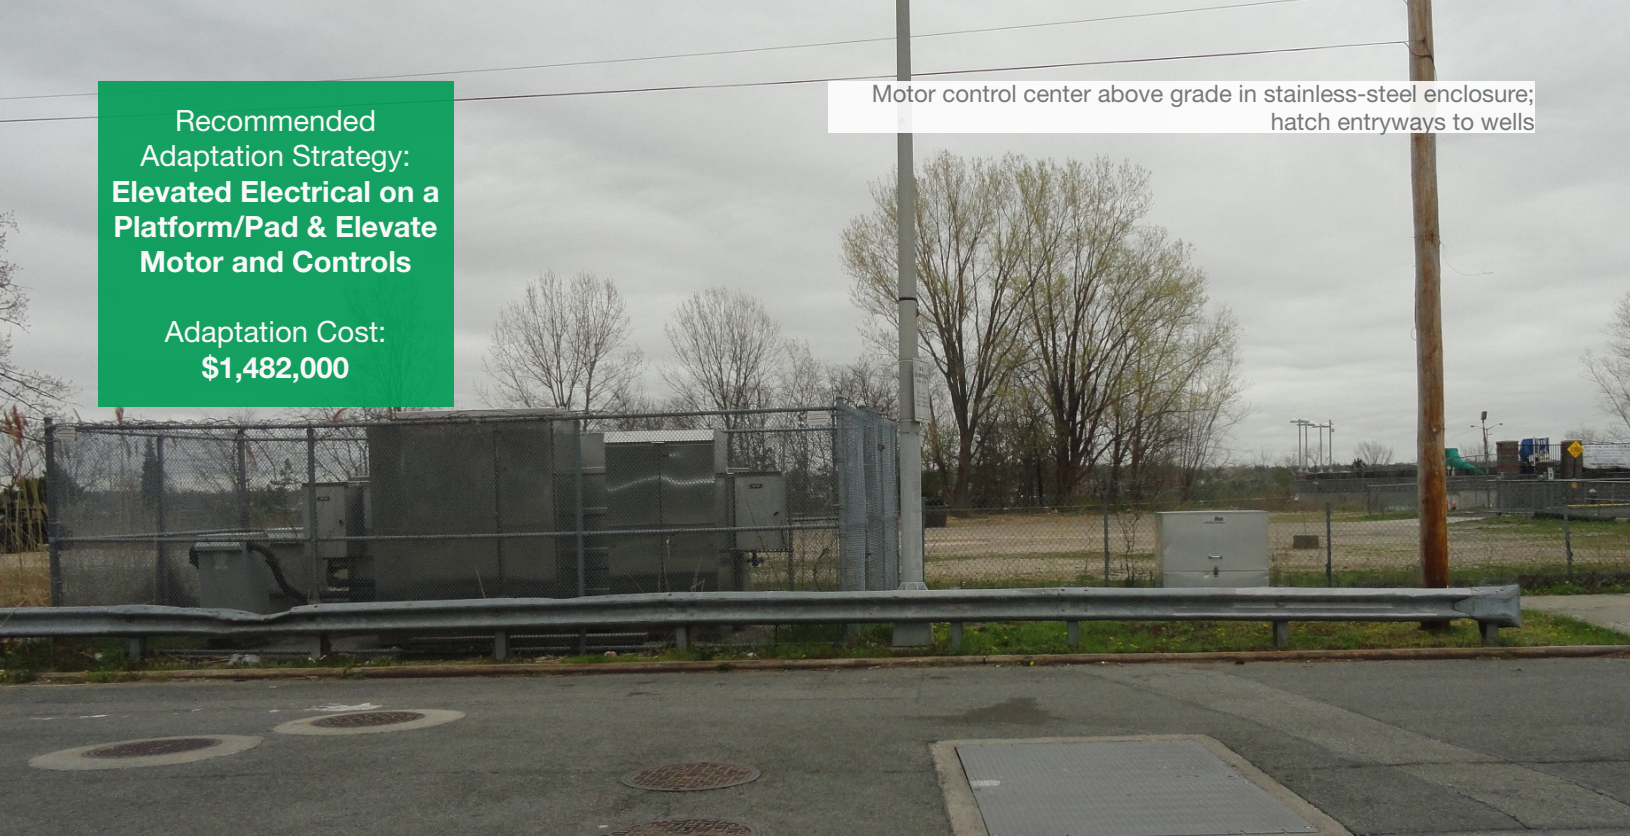
Motor control center above grade in stainless-steel enclosure;  
hatch entryways to wells

Adaptation Cost:  
**\$1,482,000**

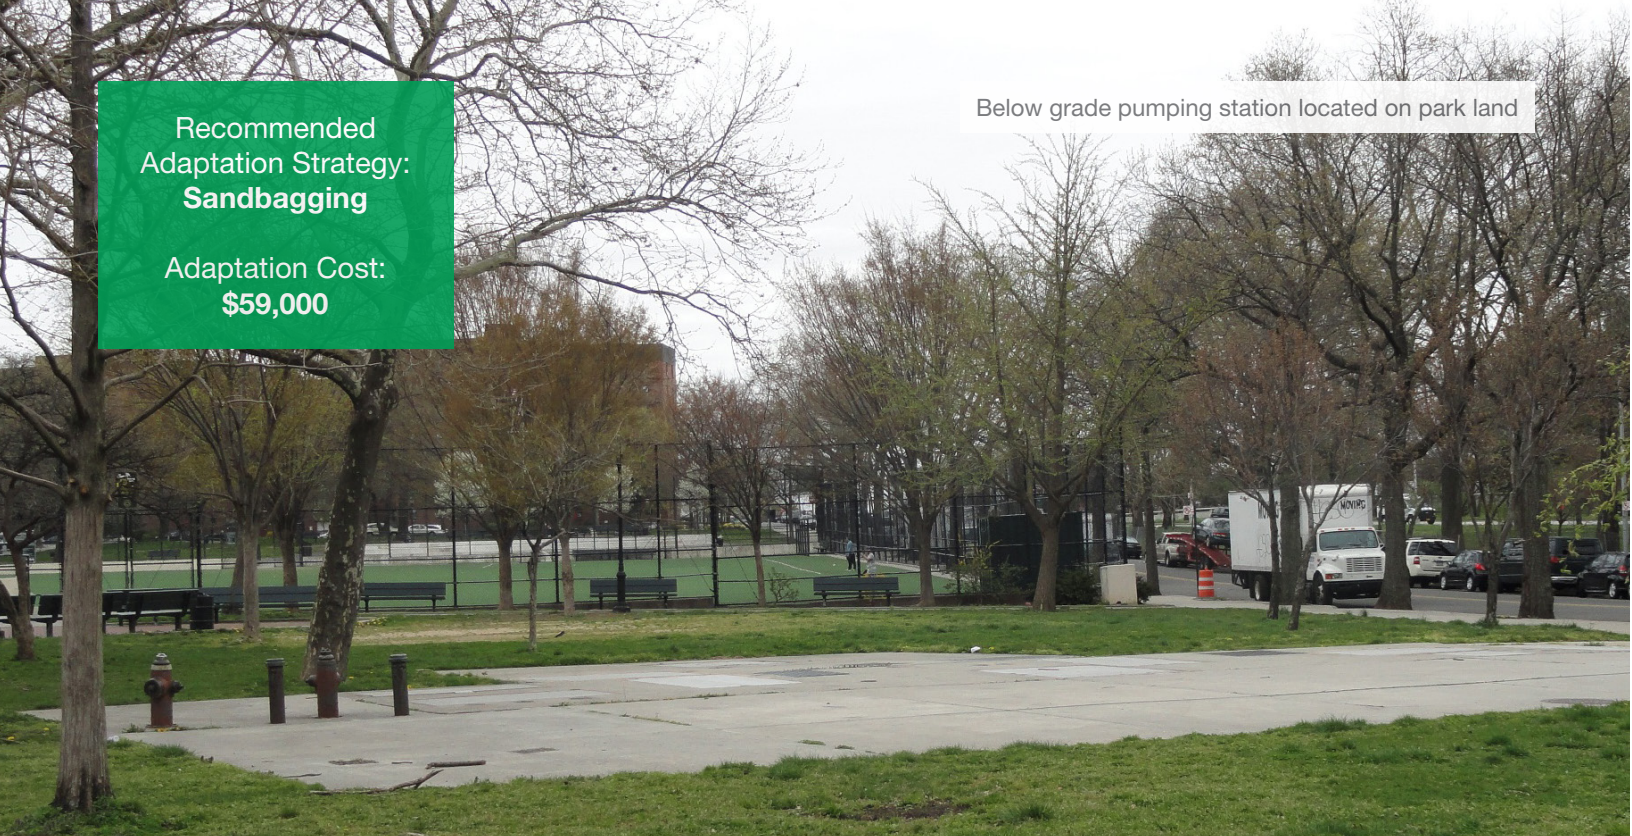
Below grade pumping station located on park land

The critical flood elevation would result in a flood depth of 1.6 feet above grade, and it would inundate the below grade station. This would damage electrical controls but would not affect the submersible pumps.

Recommended  
Adaptation Strategy:  
**Sandbagging**

The 37th Avenue pumping station requires adaptive measures to withstand the critical flood elevation. Potential strategies were evaluated against such factors as flood depth, equipment location, and space. Viable strategies were reviewed to identify the most cost-effective, resilient option. Due to the shallow flood depth and the station's location, in park land out of the way of vehicles and pedestrians, the recommended strategy is to place sandbags around potential water-entry points prior to flooding events. Residual risk is related to sandbags being stacked improperly or being disturbed by residents.
