# NYC WASTEWATER RESILIENCY PLAN

## CLIMATE RISK ASSESSMENT AND ADAPTATION STUDY

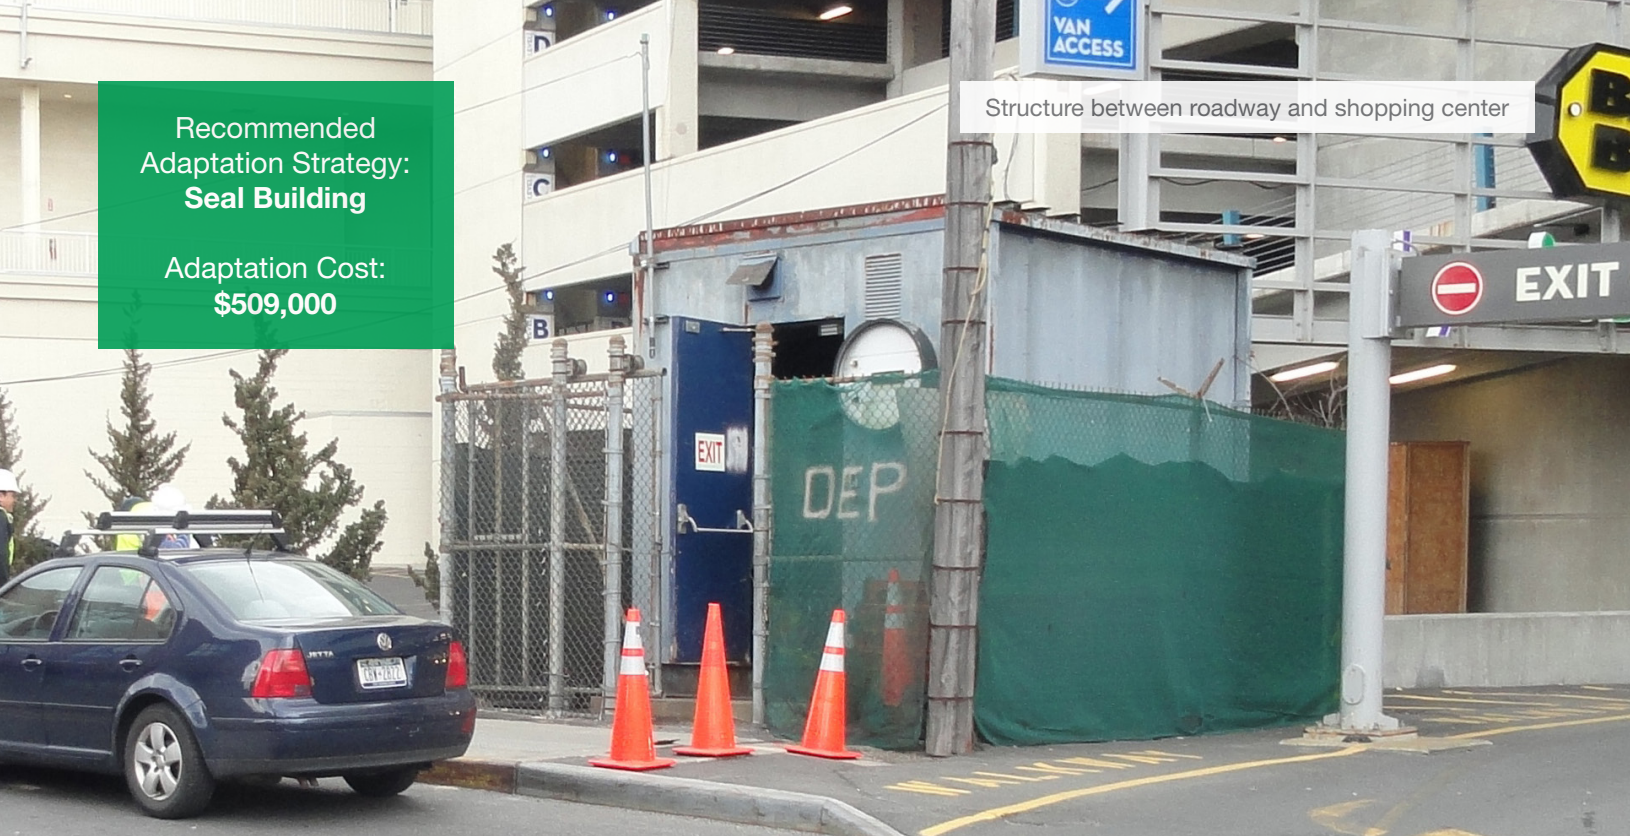
Structure between roadway and shopping center

This pumping station flooded during Hurricane Sandy. The control room flooded to a depth of approximately 3 inches, and the surrounding area was flooded to a depth of 2 to 3 feet. The station suffered damage to lighting and ventilation equipment, but the submersible pumps remained operating throughout the storm and were not damaged. There is no history of flooding aside from Hurricane Sandy.

The critical flood elevation would completely inundate the station, and the surrounding flood would be more than 6 feet above local grade. This would flood and damage the pump controls, a compressor, and the lighting panel. The submersible pumps should withstand flooding.

Recommended  
Adaptation Strategy:  
**Seal Building**

The 40th Road pumping station requires adaptive measures to withstand the critical flood elevation. Potential strategies were evaluated against such factors as flood depth, equipment location, and space. Pumps are submersible and do not require any modifications, but electrical controls, located in the existing above grade structure, are vulnerable to flood water. Property size and location limits the potential for a new, larger structure. Viable strategies include moving controls to the walls or roof of the existing structure as well as sealing the building; these strategies were reviewed to identify the most cost-effective, resilient option. The recommended strategy at 40th Road is to seal the existing building and add sluice gates to restrict inflows. Because water tight cases, doors, and building sealants are only rated up to a certain pressure, if flood depth is greater than expected the water pressure could exceed the rating and the building sealing could fail. Therefore, residual risk is related to a greater depth of flooding from larger storms or more extreme climate change and the potential for water pressure to exceed the rating of the sealing measures.

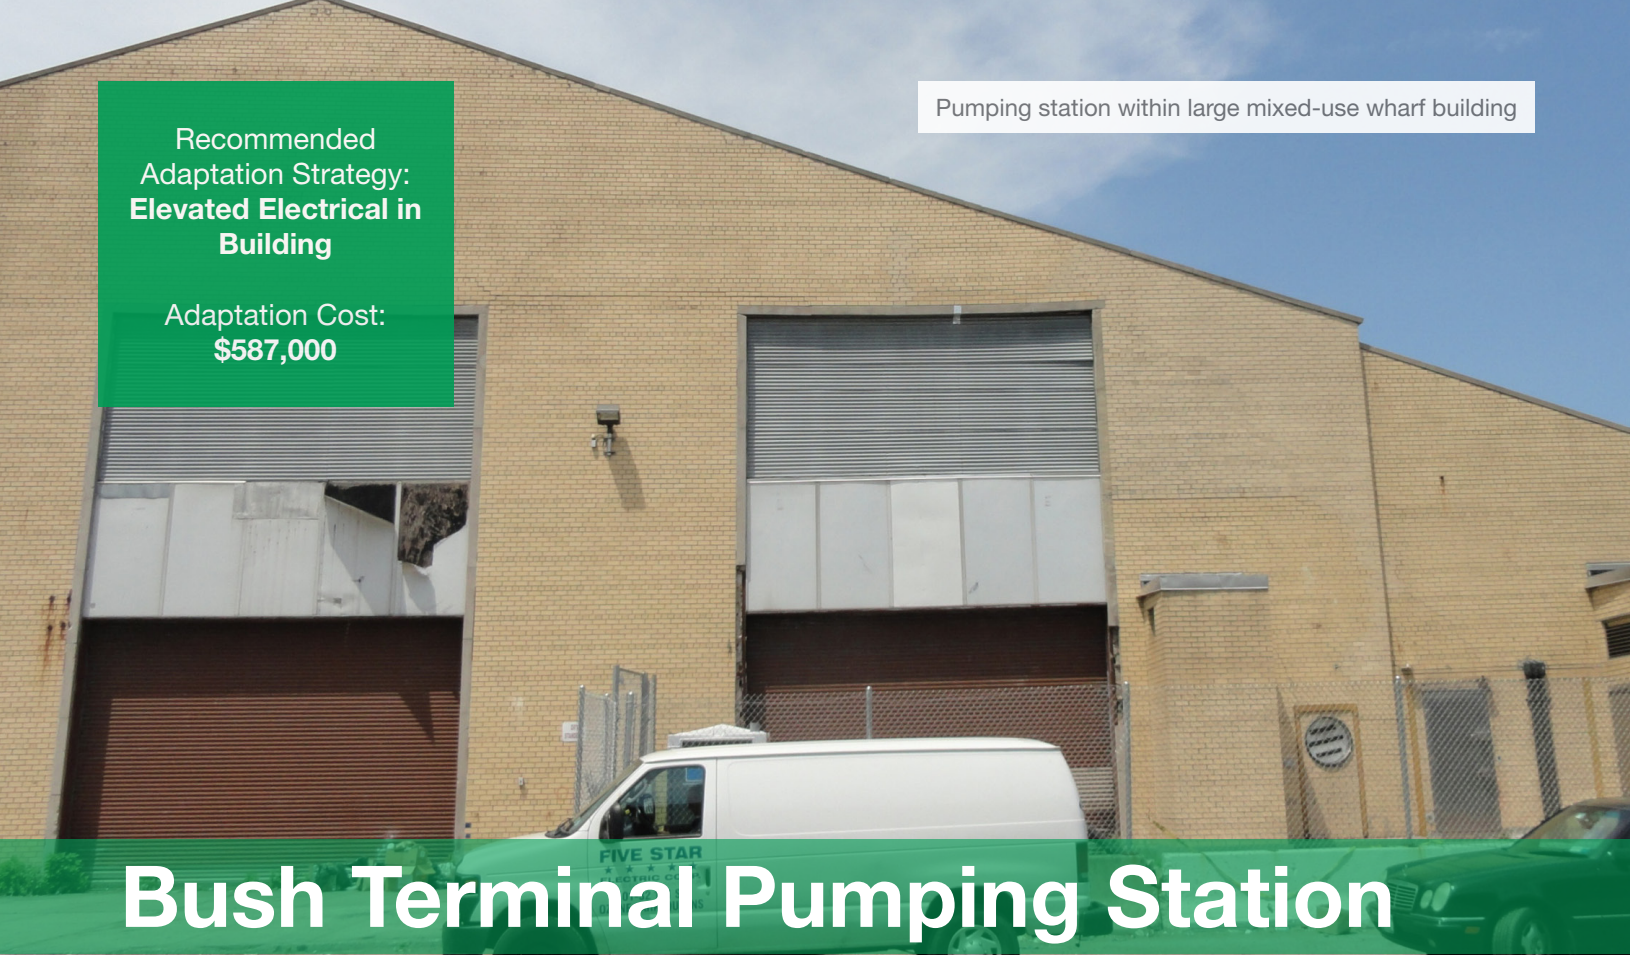
Pumping station within large mixed-use wharf building

Recommended  
Adaptation Strategy:  
**Elevated Electrical in  
Building**

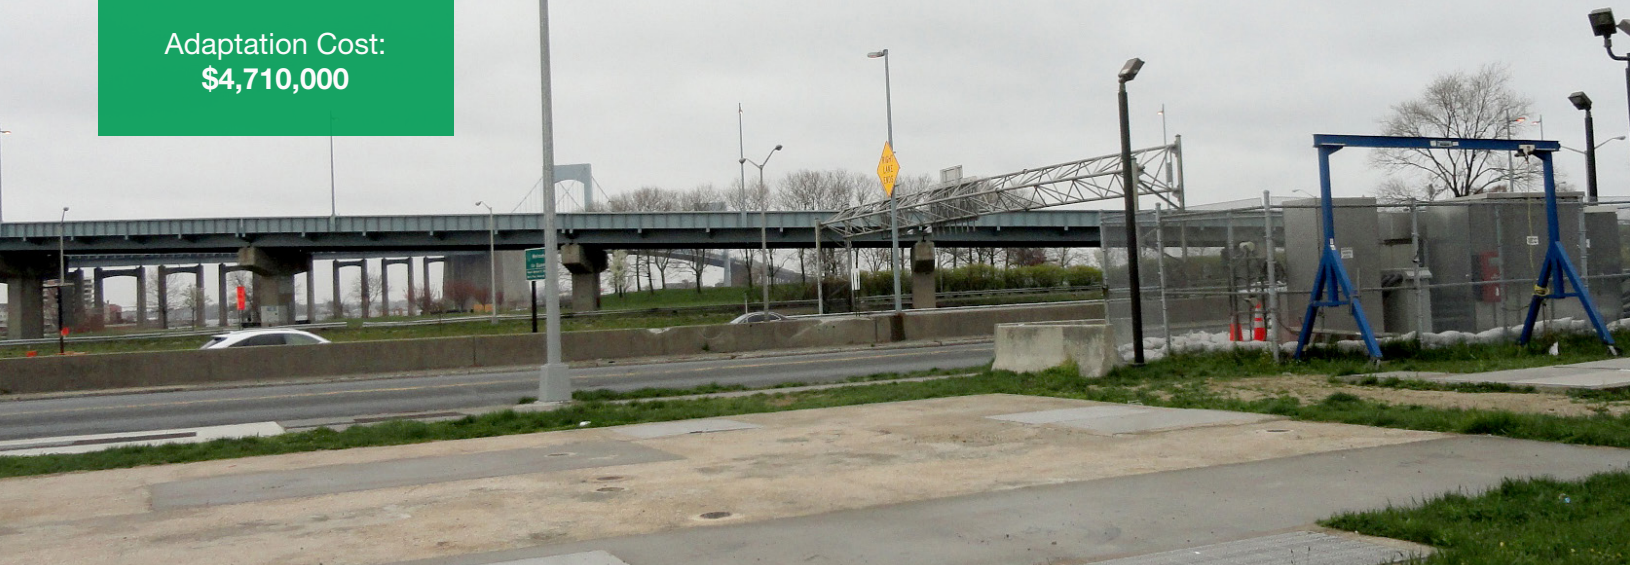
Motor control center above grade in stainless-steel enclosure;  
hatch entryways to wells

The Clearview pumping station is located in Queens along the Clearview Expressway service road, in a triangle of land that runs between the service road, the expressway, and an exit ramp from the expressway. The motor control center and other electrical components sit on a grade level concrete slab in stainless steel enclosures, and the wells are accessible through hatches.

that of the March 2013 FEMA Advisory Base Flood Elevation (ABFE) 100-year flood plus 30 inches of sea level rise (critical flood elevation). A visit to the pumping station to view its exterior revealed that the Motor Control Center (MCC) and other electrical controls, which were shown below grade in the drawings, had been moved to a slab above grade. DEP data also indicate that the pumps had been replaced with submersibles.

The critical flood elevation would be more than 3 feet above grade. This would flood and damage the grade-level motor control center and pump.

Recommended  
Adaptation Strategy:  
**Elevate Electrical on  
Platform/Pad**

Adaptation Cost:  
**\$634,000**

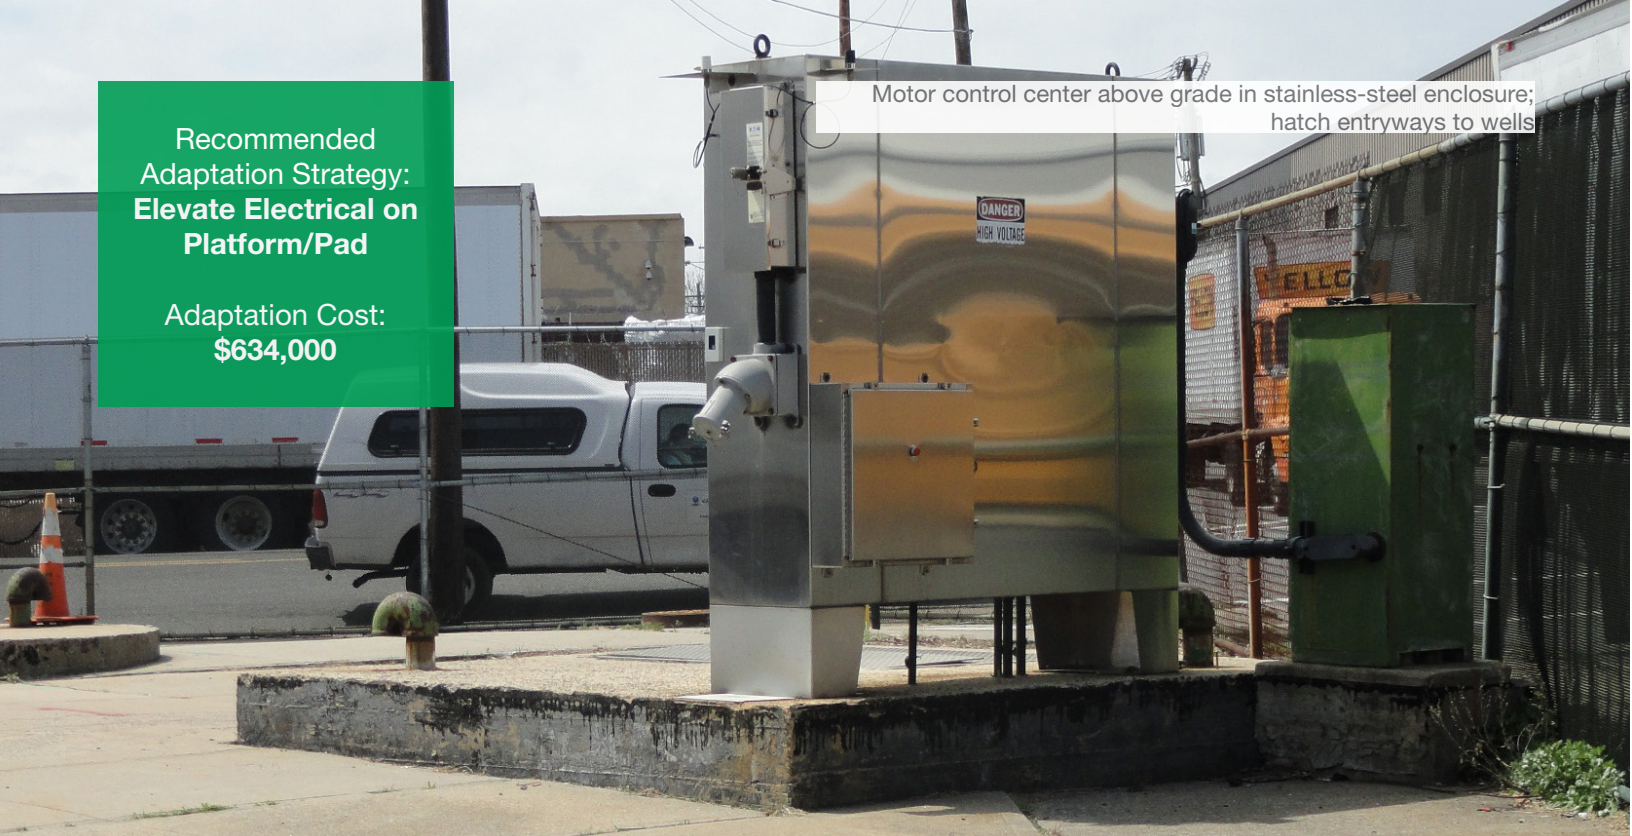
Base Flood Elevation (ABFE) 100- year flood plus 30 inches of sea level rise (critical flood elevation). A visit to the pumping station to view its exterior revealed that the electrical controls, which are shown below grade in the drawings, have been moved to a slab above grade. The critical flood elevation would be 5 feet above grade. Water would flood and damage the motor control center. The submersible pumps should withstand flooding.

The Commerce Avenue pumping station requires adaptive measures to withstand the critical flood elevation. Potential strategies were evaluated against such factors as flood depth, equipment location, and space. Viable strategies were reviewed to identify the most cost-effective, resilient option. Controls should be elevated to withstand the critical flood, and there is ample space to do so on the current lot. Because the station is located in an industrial area, a building is not necessary for aesthetic reasons. Components are currently exposed above grade, and there have been no known incidents of vandalism, so a building should not be necessary for security reasons, either. Therefore, the recommended strategy at Commerce Avenue is to elevate electrical controls onto a platform. Residual risk is related to a greater depth of flooding from larger storms or more extreme climate change.

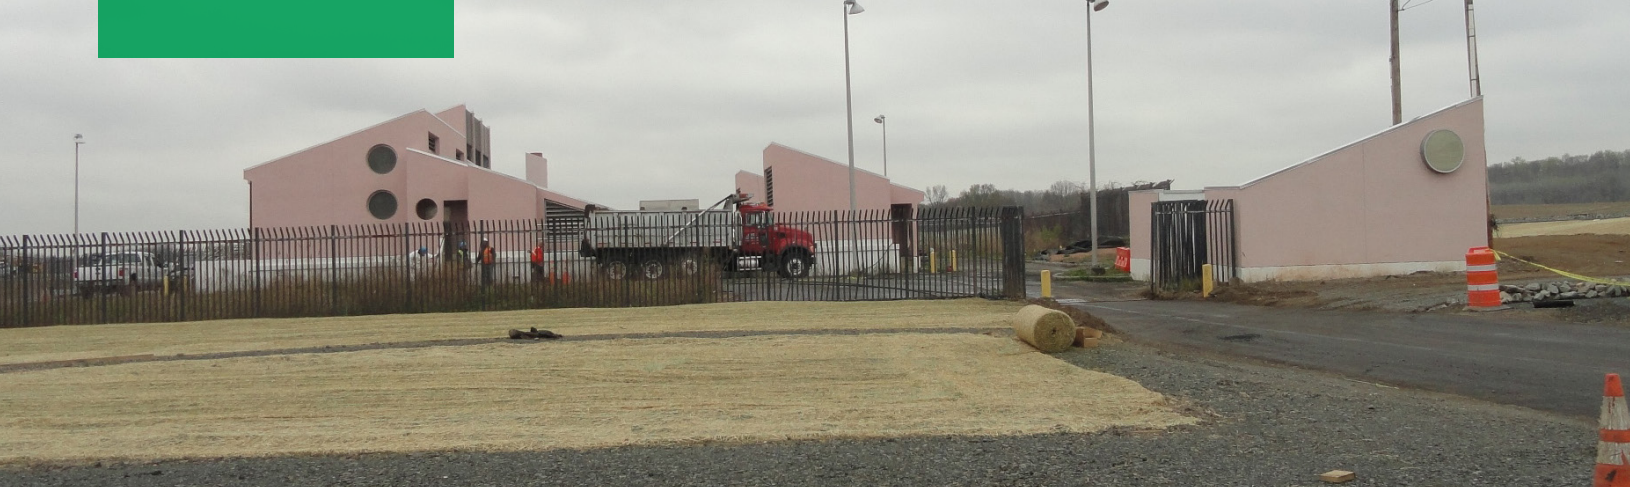
Large structure within Fresh Kills Landfill

The critical flood elevation would be just under 1 foot above local grade. Because electrical controls and non-submersible pumps are located below grade and below the flood elevation, they could be damaged if water enters the structure.

The Eltingville pumping station requires adaptive measures to withstand the critical flood elevation. Potential strategies were evaluated against such factors as flood depth, equipment location, and space. Viable strategies were reviewed to identify the most cost-effective, resilient option. Because there is a significant existing structure, the recommended strategy at Eltingville is to seal the building so that flood waters cannot enter; this is a less expensive option than those that involve moving electrical controls or motors. While this strategy will provide resilient protection, there is the potential for leaks, inflows to the wells, or unidentified flow paths. DEP will consider replacing the non-submersible pumps with submersibles as normal replacement is needed as part of regular maintenance. Because water tight cases, doors, and building sealants are only rated up to a certain pressure, if flood depth is greater than expected the water pressure could exceed the rating and the building sealing could fail. Therefore, residual risk is related to a greater depth of flooding from larger storms or more extreme climate change and the potential for water pressure to exceed the rating of the sealing measures.

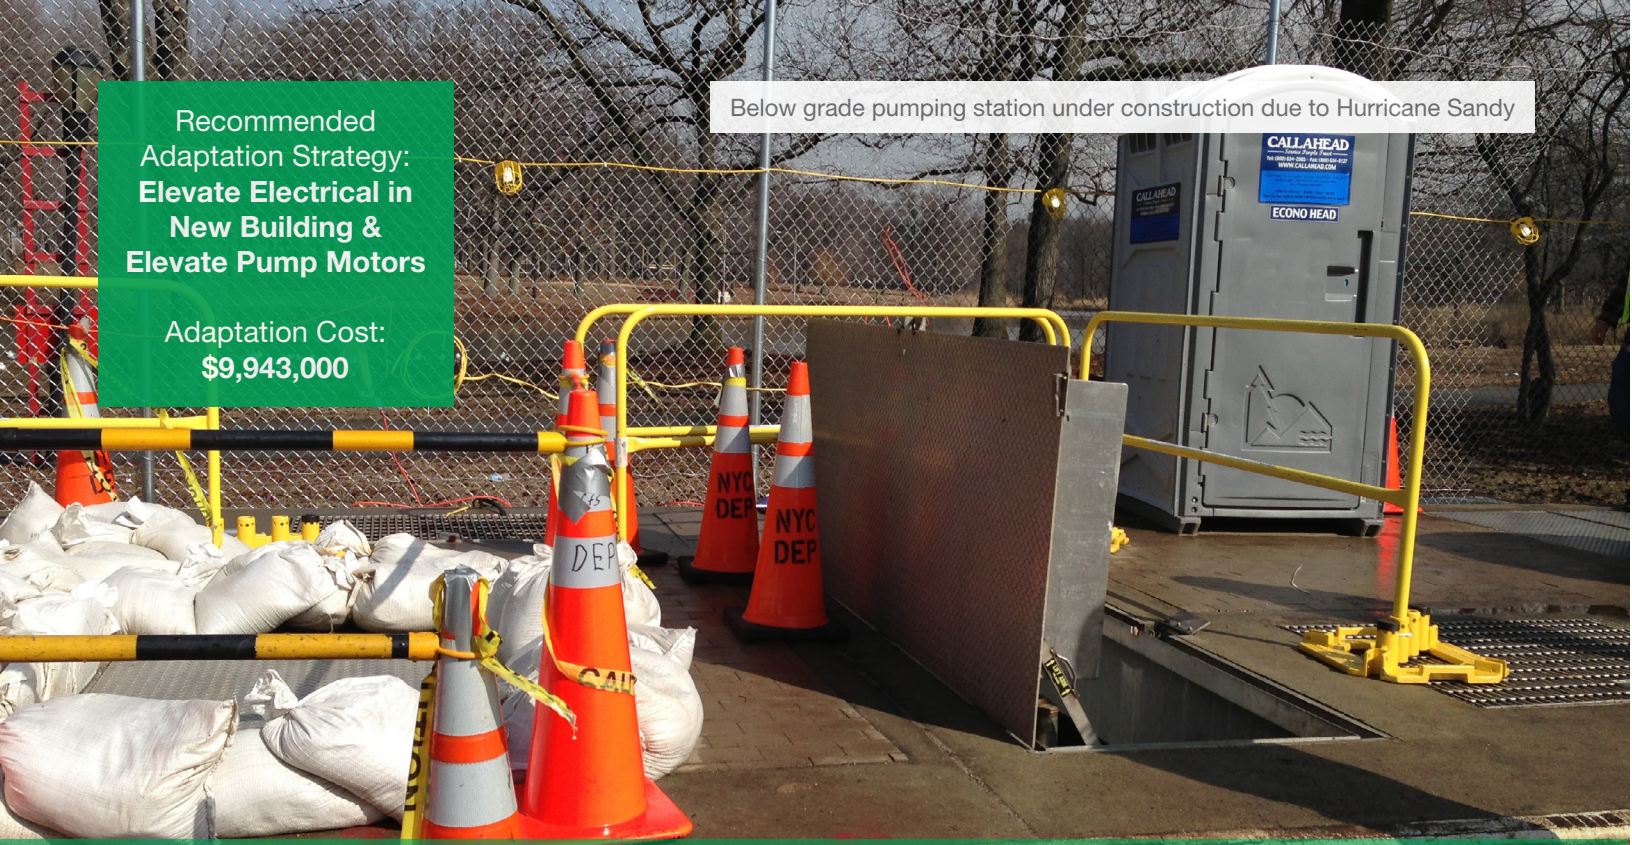
Rosedale pumping station was completely inundated by the storm surge during Hurricane Sandy, which damaged the electrical controls and non-submersible pump motors. DEP staff indicated there is also a history of flooding at this location due to smaller storms.

The critical flood elevation would inundate the area surrounding the facility with over 4 feet of water. This would damage electrical controls and the non-submersible pump motors. The Rosedale pumping station receives flow from another pumping station. Therefore loss of function at Rosedale increases the vulnerability of an additional pumping station.

**Recommended  
Adaptation Strategy:  
Elevate Electrical in  
New Building &  
Elevate Pump Motors**

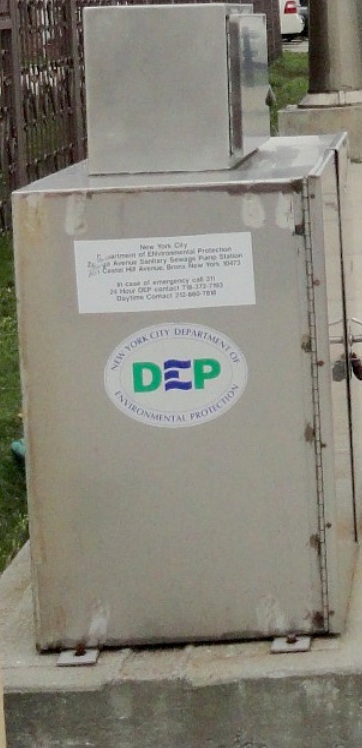
Controls and vent mounted atop slabs on sidewalk
