Angela M. De Lillo, P.E.
Deputy Commissioner
Bureau of Wastewater
Treatment

Re: Integrated Sentinel Monitoring Report Calendar Year 2023

INTEGRATED SENTINEL MONITORING REPORT CALENDAR YEAR 2023

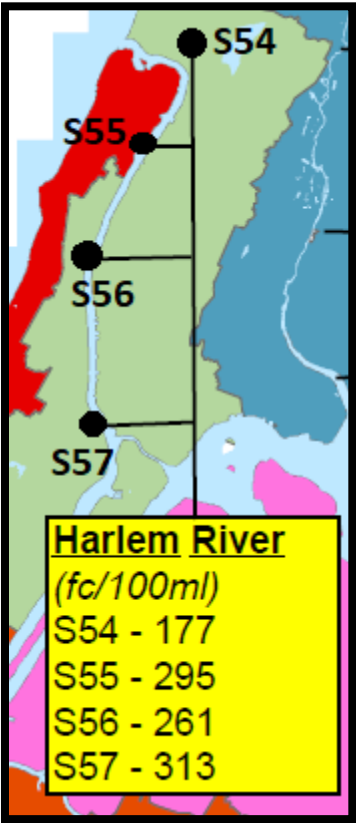
HARLEM RIVER

Sentinel monitoring station fecal coliform results from stations S54, S55, S56, and S57 exhibit an increasing trend from north to south. Abundant illegal mobile car wash activities were observed in the areas discharging wastewater to the outfalls to Harlem River. ERU along with NYPD has taken action against illegal mobile car washes throughout NYC. S55, S56 and S57 sentinel stations also have multiple CSO outfalls in the area and private outfalls. Some of the area near S57 is non-sewered.

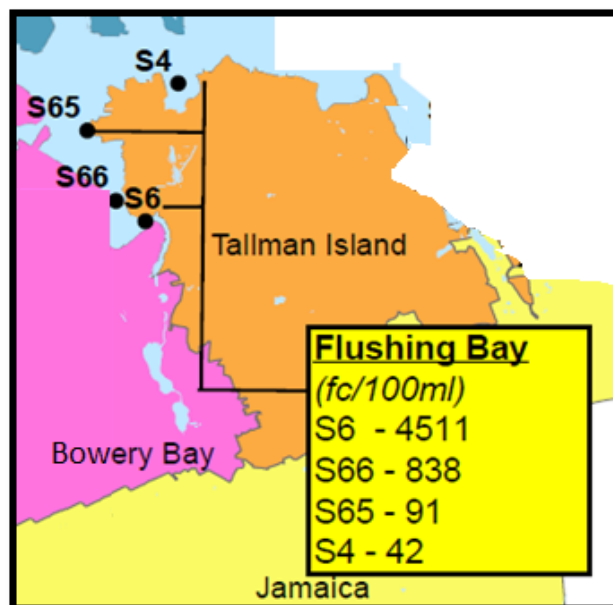
S66 and the lack of sewers in the sentinel station area

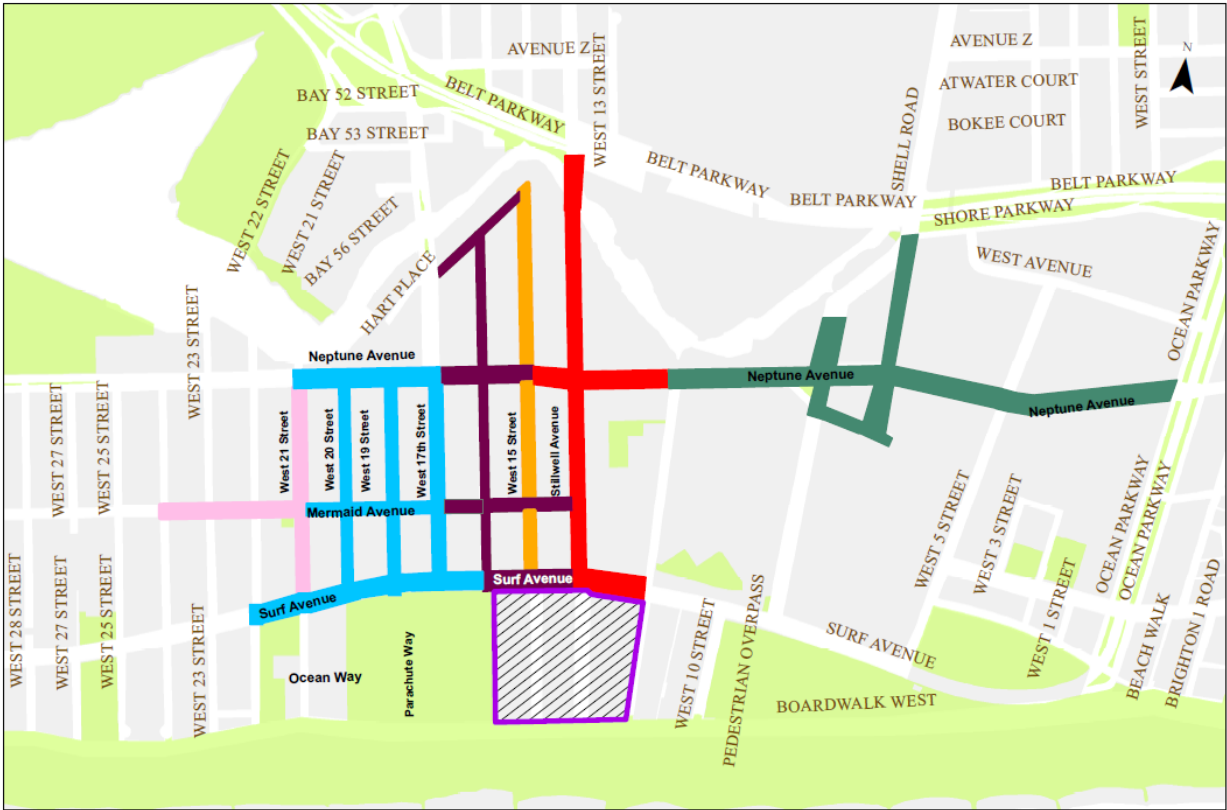
Construction phase diagram for Coney Island Creek storm outfalls

- Coney Island Creek contains sentinel stations S81 and S21 that both routinely have exceedance.
- Multiple cases at Coney Island Creek have been resolved by CMS personnel including the 2016 case involving the Beach Haven complex dumping 200,000 gallons/day of sanitary waste.
- Most recent case involving a broken sanitary sewer from NYCHA Gravesend causing 5,000 gallons of sewage to enter the storm sewer to CI-601 in April 2023.
- DDC is currently conducting design analysis on the replacement and/or extension of CI-601, CI-602 & CI-678 (under future capital project).

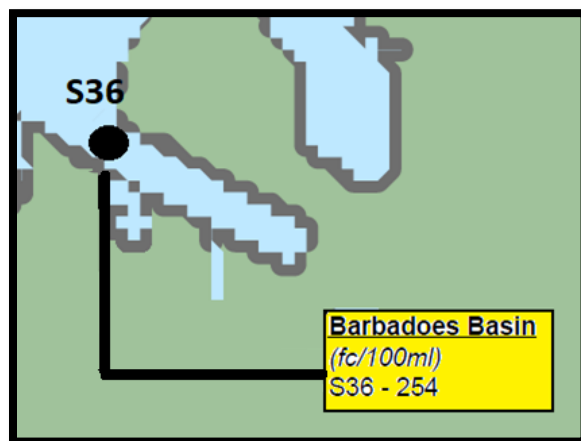
Sentinel monitoring station S36 exhibits exceedance in fecal coliform values as per baseline values. No active cases are present in the waterbody. Barbadoes Basin contains several businesses and industries in the area that are to be investigated by CMS personnel. The sewer maps are being changed to reflect new construction in the area.

S36 and the sewers in the sentinel station area. The sewer map requires changing.

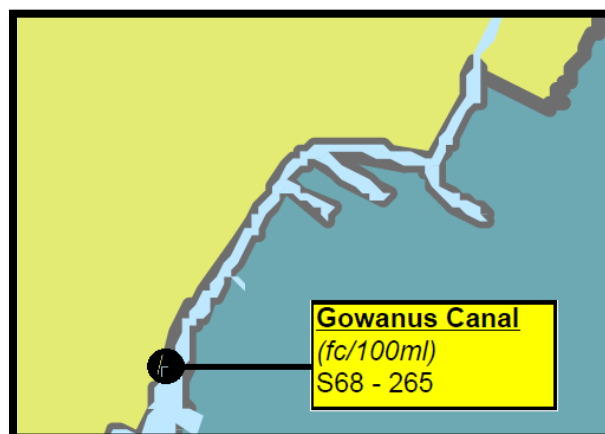
CMS joined with ERU personnel and the site construction superintendent of MEGA Contracting Group to conduct the investigation. What was observed to be wet weather discharge was seen at the location of MS4 outfall RH-605. As per the SWPPP investigator, the dewatering system that was permitted on the site was deactivated and removed shortly before the investigation as there was no further need for dewatering activities. CMS and ERU first conducted a dye test to verify that the manhole that was formerly used for dewatering the site into the canal was discharging to the EPA-permitted outfall to the west of the site; green dye was observed in the EPA-permitted outfall. The EPA permitted outfall and manholes are to remain on the site as a dewatering pump-out location for the building after construction is complete. A new GIS will be done to reflect current changes.

The sewers on Carroll Street are to be upgraded

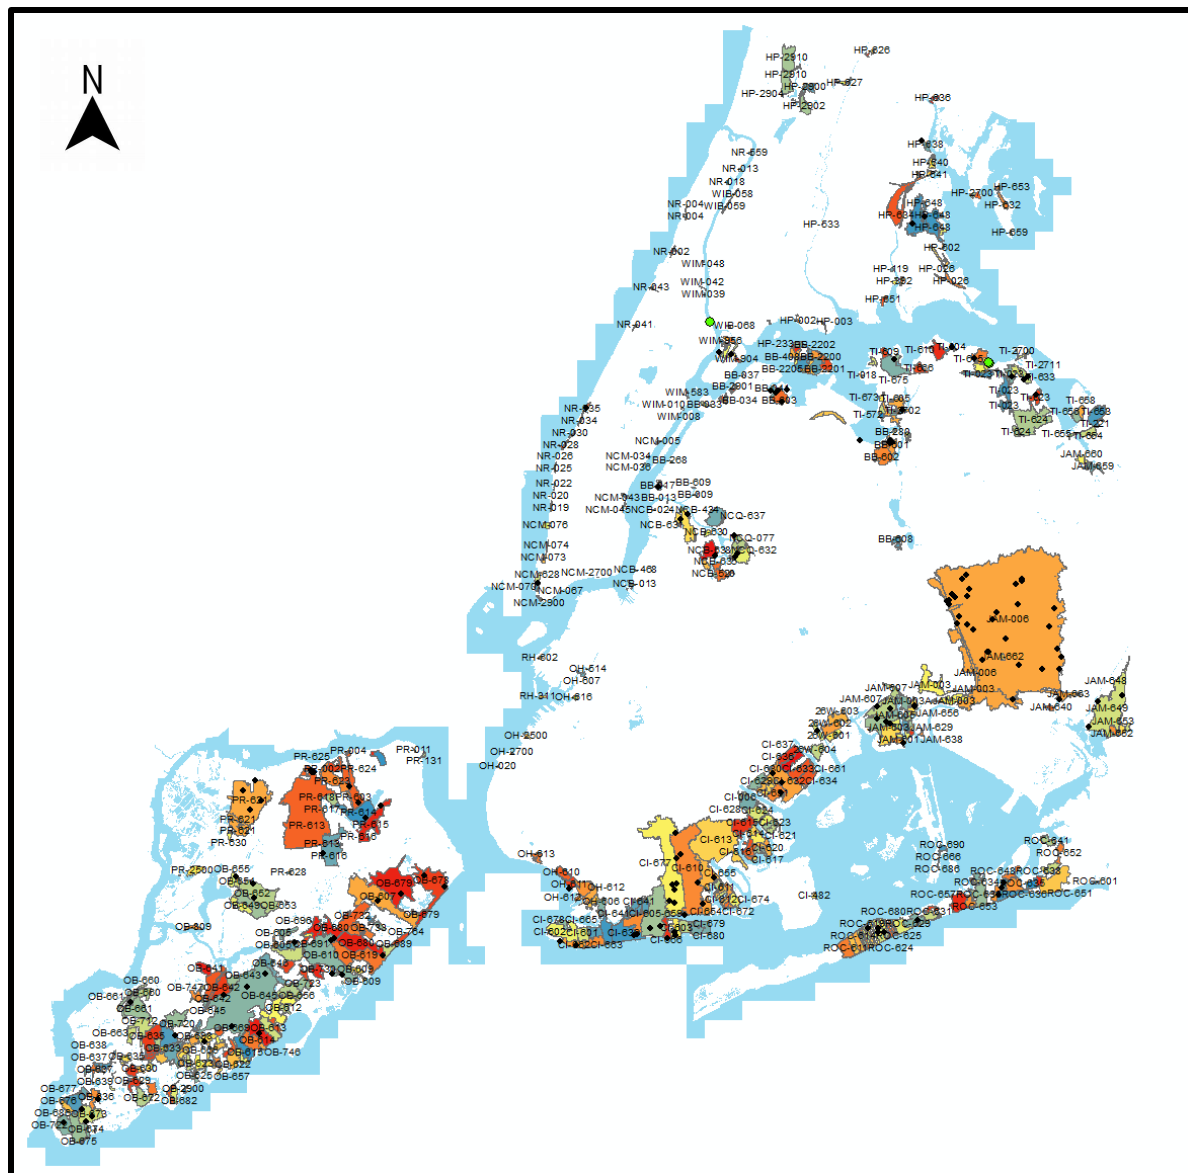
Figure 1. Map showing the MS4 and CSO drainage areas throughout New York City and the locations where illicit discharges to the MS4 or CSO were identified during 2023

Out of the 2129 unauthorized non-storm water discharge investigations, ERU completed inspections for discharge cases that lie within the NYC MS4. The list of discharges to the MS4 are shown below. Approximately 195 cases as listed in Table 2, were within one of the city's MS4 drainage areas, and 50 Commissioner's Orders were issued. A list of problem descriptions, the resolution of each case and the MS4 drainage area outfall to which each discharged are shown in pages 4-61. For most of the cases, the illicit discharge did not reach the waterway or was contained within catch basins. A map showing the locations for each case is presented in Figure 1.
