Re: Integrated Sentinel Monitoring Report Calendar Year 2024

INTEGRATED SENTINEL MONITORING REPORT CALENDAR YEAR 2024

NYC
Environmental
Protection

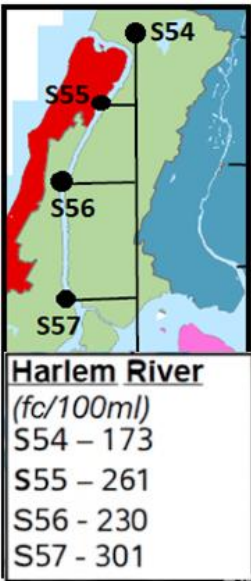
Sentinel monitoring station fecal coliform results from stations S54, S55, S56, and S57 exhibit an increasing trend from north to south. S55, S56 and S57 sentinel stations also have multiple CSO outfalls in the area and private outfalls. Some of the area near S57 is non-sewered. All fecal results are in compliance.

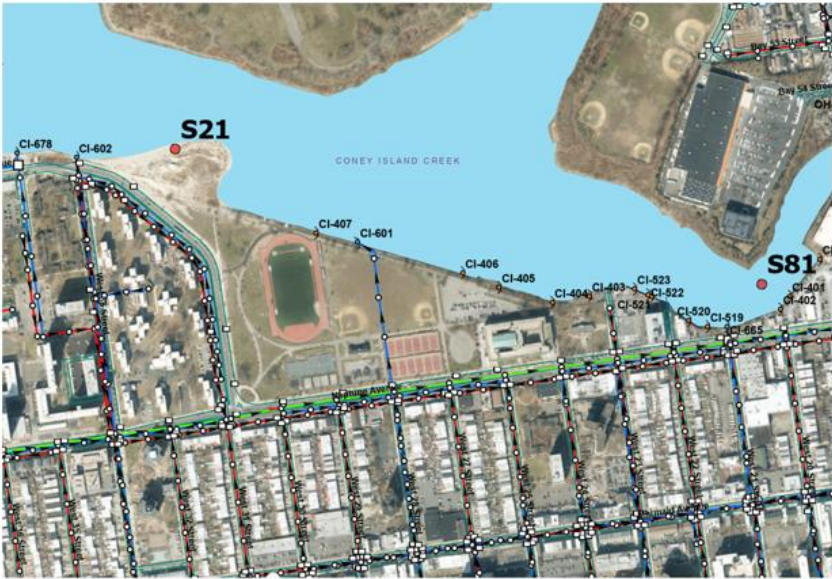
Coney Island Creek S21 & S81:

- Coney Island Creek contains sentinel stations S81 and S21 that both routinely have exceedance.
- Multiple cases at Coney Island Creek have been resolved by CMS personnel including the 2016 case involving the Beach Haven complex dumping 200,000 gallons/day of sanitary waste.
- Most recent case involving a broken sanitary sewer from NYCHA Gravesend causing 5,000 gallons of sewage to enter the storm sewer to CI-601 in April 2023.
- DDC is currently conducting design analysis on the replacement and/or extension of CI-601, CI-602 & CI-678 (under future capital project).

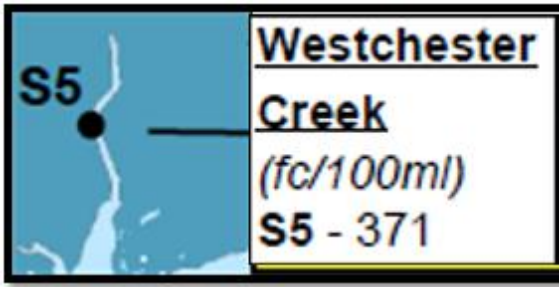
Westchester Creek (House Boats)

Sentinel monitoring station S5 exhibits exceedance in fecal coliform values as per baseline values. No active cases are present in the waterbody. Discharge from unidentified sources in Westchester County is believed to be the source of elevated fecal coliform levels in the area along with abundant houseboats with no sewer connections.

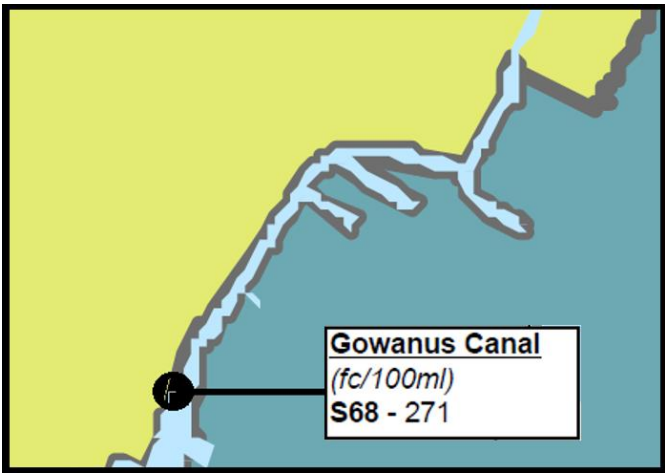
Sentinel monitoring station S68 exhibits exceedance in fecal coliform values as per baseline values. No active cases are present in Gowanus Canal. Heavy commercial and residential construction is underway in Gowanus Canal including the development of a combined sewer overflow tank by DEP at the head of the canal.

The sewers on Carroll Street are to be upgraded
