# **Soldiers & Sailors Monument Restoration**

## **Project M071-323M**

### **Public Design Commission Review**

October 2024

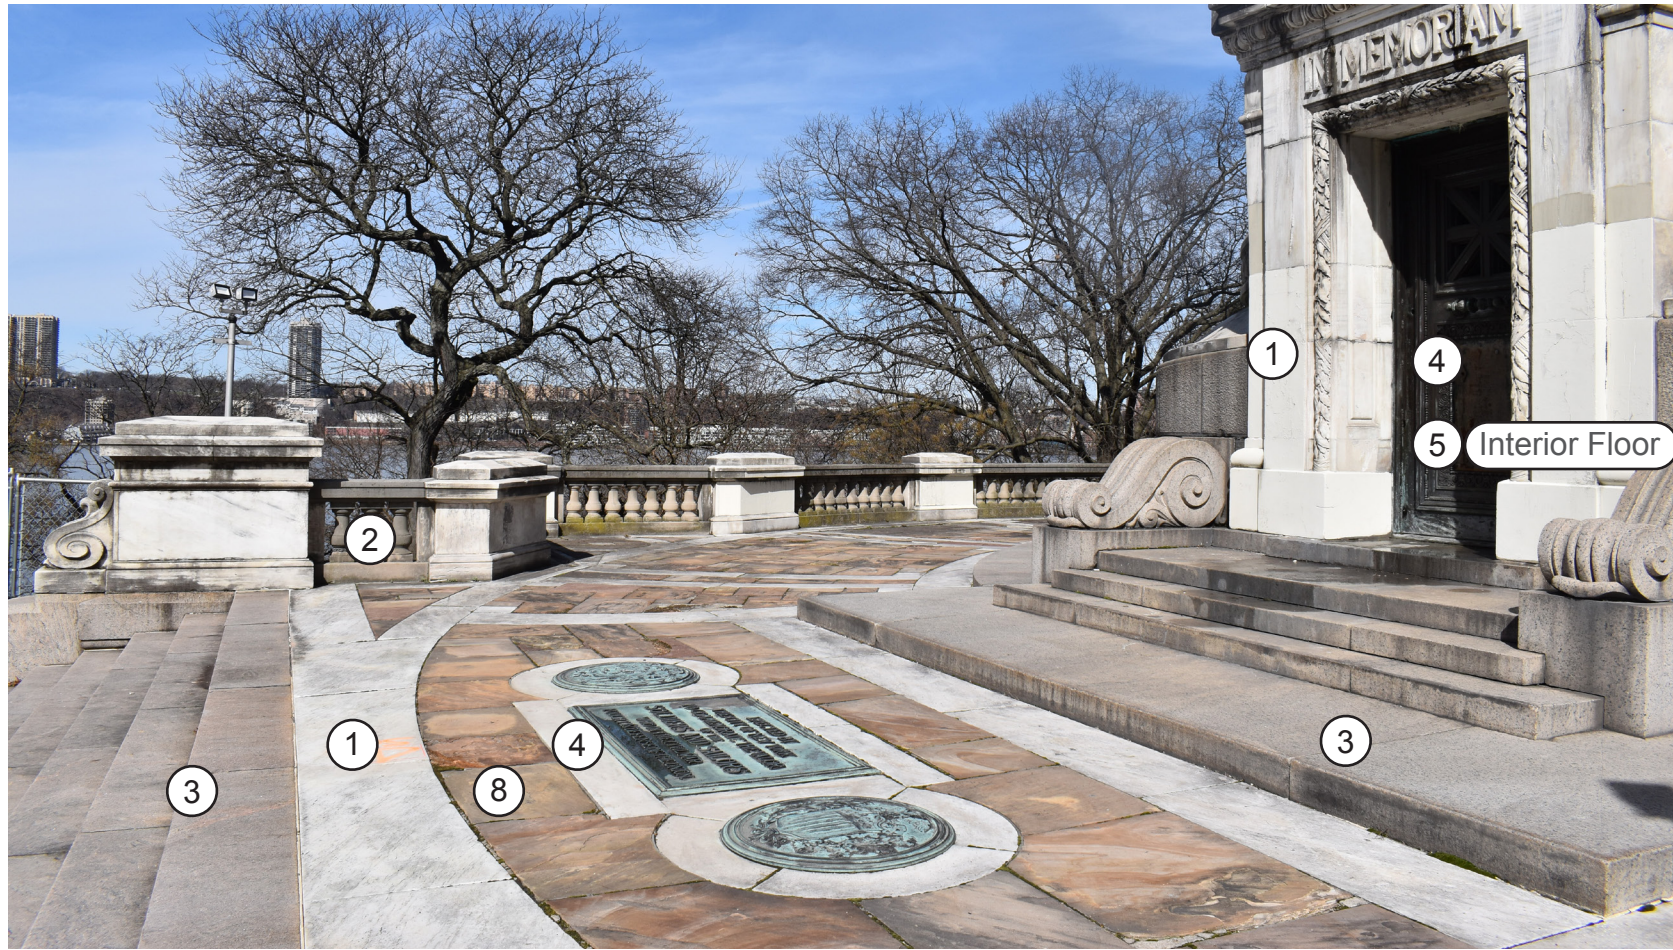
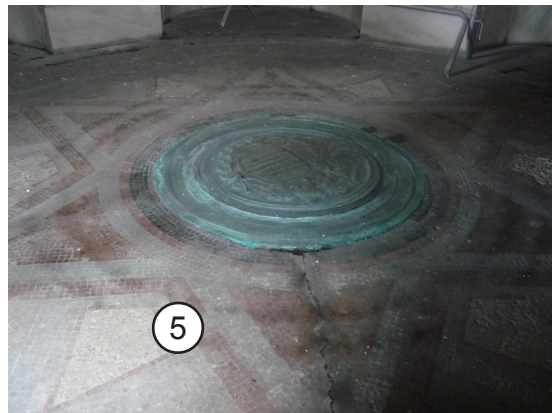
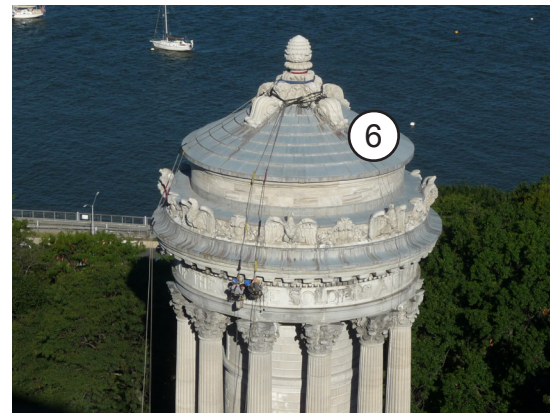
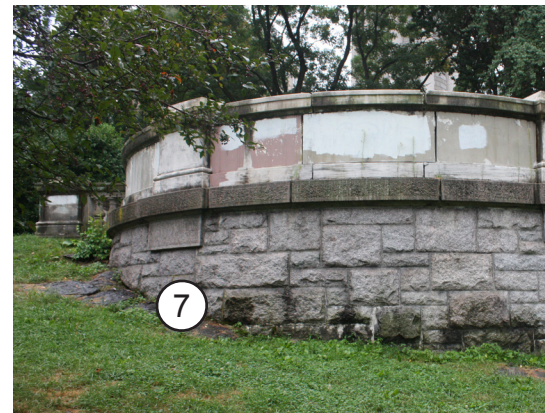
- 1 The existing marble, c. 1902, is to be restored.
- 2 The existing limestone balustrade, c. 1962, is to be restored.
- 3 The existing granite, c. 1902, is to be restored.
- 4 The existing bronze elements are to be preserved and maintained.
- 5 The existing mosaic tile floor finish of the monument interior to be restored.
- 6 The existing lead-coated copper roofing from 1960s to be replaced.
- 7 The existing Ashlar Foundation to be restored.
- 8 The existing crab orchard sandstone, c. 1962, is proposed to be replaced with custom brick pavers as per the original Stoughton & Stoughton design.

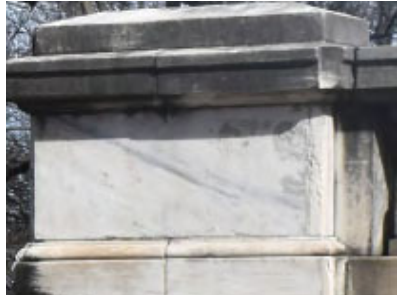
## 1 Danby Marble from Dorset, Vt

Preserved where possible. Missing or extremely deteriorated elements will be selectively patched or replaced to match the original configuration and marble.

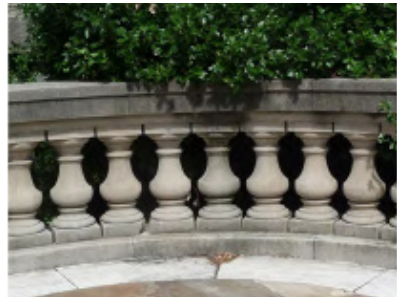
## 2 Indiana Limestone

Marble balustrades at the plazas were replaced with Indiana Limestone during the early 1960s restoration campaign. Limestone balustrade shall be preserved and restored where possible. Severely cracked units to be replaced with balusters salvaged from localized removal to accommodate the new ADA entrance to the site.

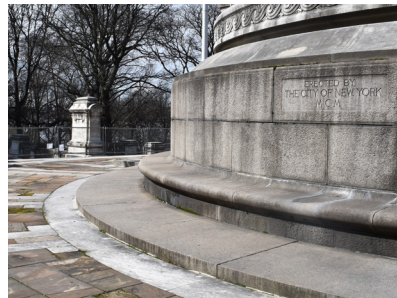
## 3 Granite

The Monument's granite steps and base were quarried from the Lacasse Quarry located in Derby, Vermont. Milford Pink Granite (MA) was used on the north approach stair. Where replacement is needed, a granite will be selected to match.

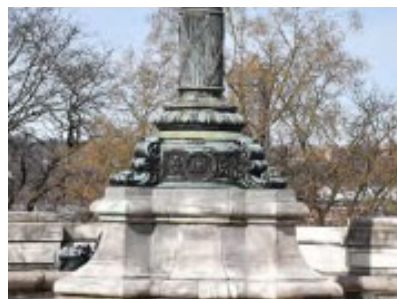
## 4 Bronze

Bronze is featured at the flag post, the tablets, the monument entrance door and the interior cover to the vault. On Monument Drum, Bronze is also used as a window grille screen detail. Bronze to be restored.

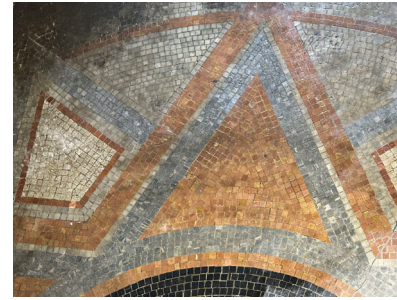
## 5 Mosaic Tile Floor

The floor finish of the Monument interior is comprised of patterned stone mosaic tesserae which has been damaged related to long-term water infiltration issues. The floor exhibits cracking and substantial loss and erosion of individual mosaic units. The damaged and missing stone tesserae are to be replaced in kind and set in compatible concrete setting bed.

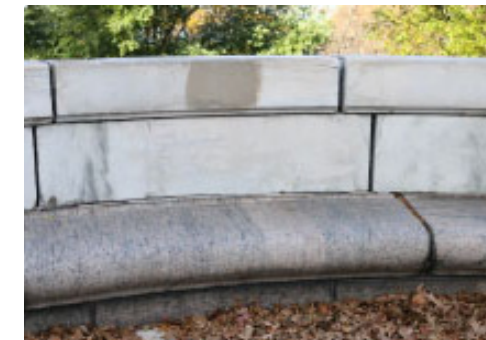
### Marble Cleaning

Microabrasion cleaning anticipated for most soiling types, incl. paint and heavy atmospheric soiling. Microbiological growth to be treated with D2 biocide. Limited use of pH neutral paint strippers and water washing is anticipated.

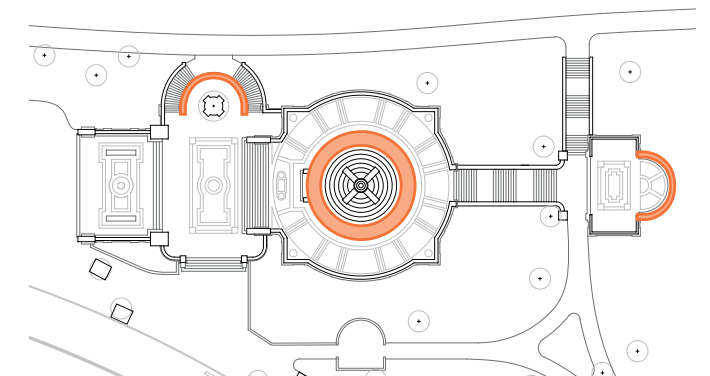
### Reset Displaced Marble

Remove, salvage and reset displaced marble at west flagpole surround and north Belvedere hemi-circular areas.

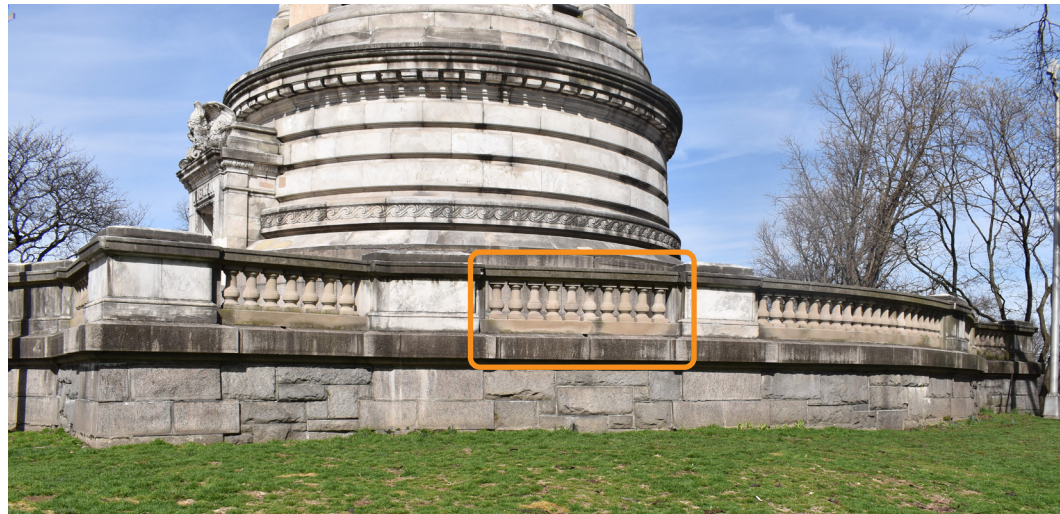
**Esplanade and Upper Plaza Limestone Units to be removed for new ADA entrance and to be Salvaged to Replace Damaged Elsewhere**

- Marble balustrades at the plazas were replaced with Indiana Limestone during the 1960s restoration campaign.
- Any balusters cracked horizontally through the neck or near the base will be replaced with matching balusters salvaged from openings created for the new ADA access points to the site.
- Remaining limestone balustrade is in overall good condition and shall be cleaned and preserved. Micro-abrasive cleaning is anticipated. All joints to be re-pointed with compatible mortar based on results of testing.

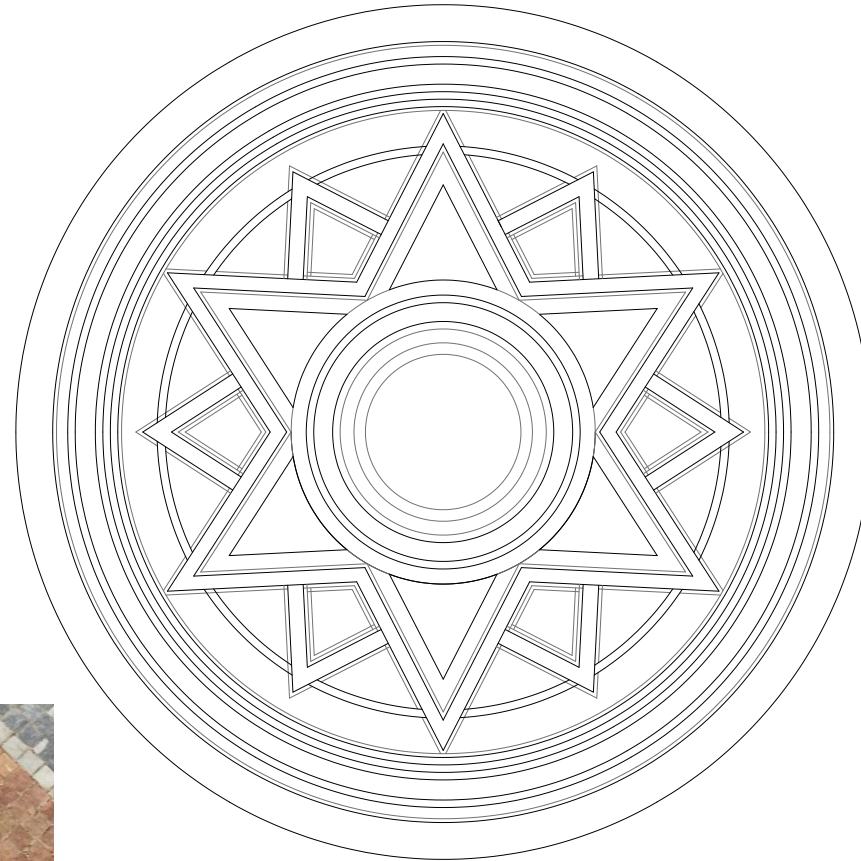
The floor finish of the Monument interior is comprised of patterned stone mosaic tesserae which has been damaged related to long-term water infiltration issues. The floor exhibits cracking and substantial loss and erosion of individual mosaic units. The damaged and missing stone tesserae are to be replaced in kind and set in compatible concrete setting bed.

Prior to replacement, Contractor shall submit samples for review and approval, to be followed by field mockups.

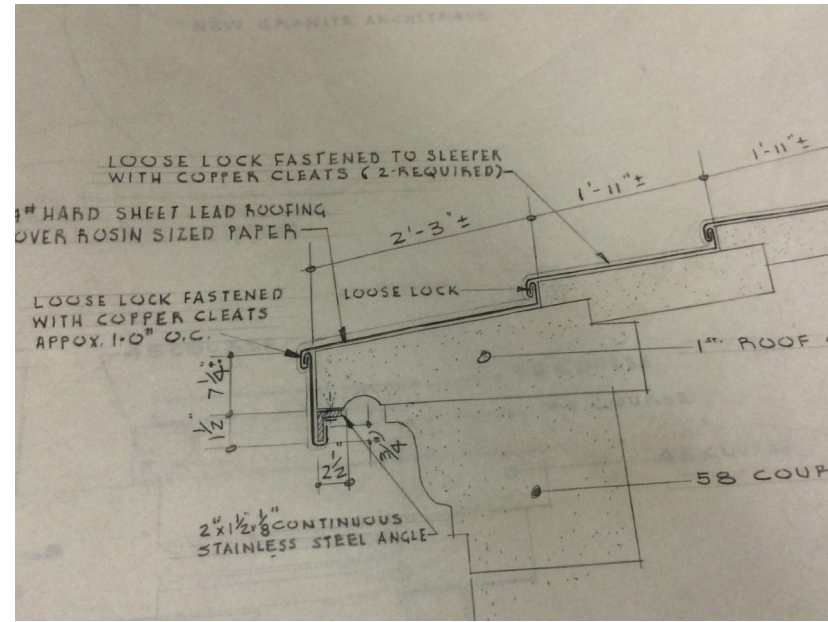
Repair Detail

- Loose and failed solder joints, typ.
- Corrosion pin holes and loss of surface material.
- Vandalism tears at base of Drum.

Remove and replace lead roofing assemblies in-kind. Base of drum (concealed from public view) to be treated with Kemper.

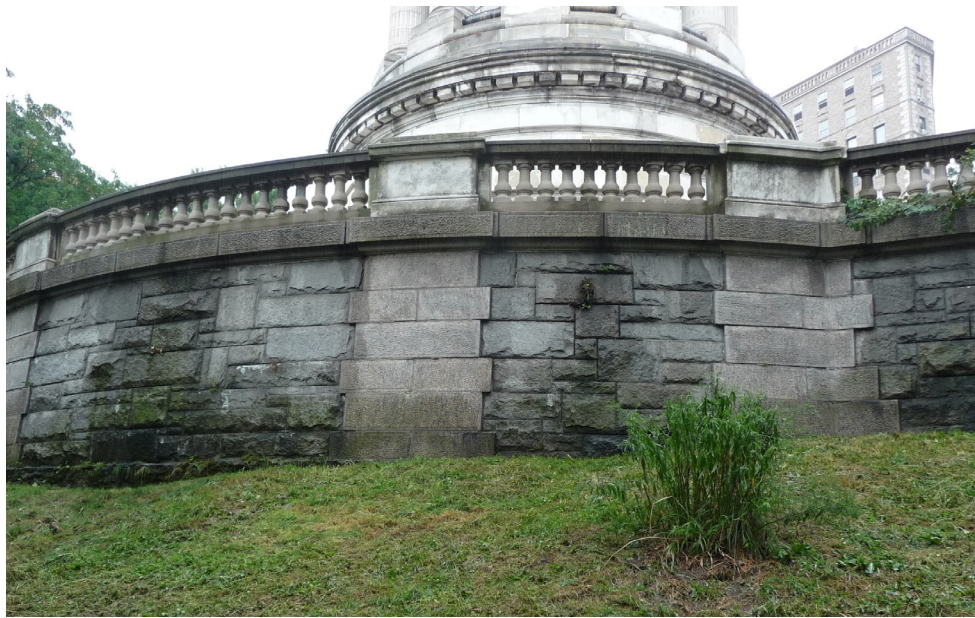
West Elevation

- Mortar joints are 100% deteriorated.
- Biological growth in joints is typical.
- Localized displacement

- Remove all biological growth from joints and face of stones.
- Repoint with compatible mortar based on testing.
- Reset loose and displaced stones.

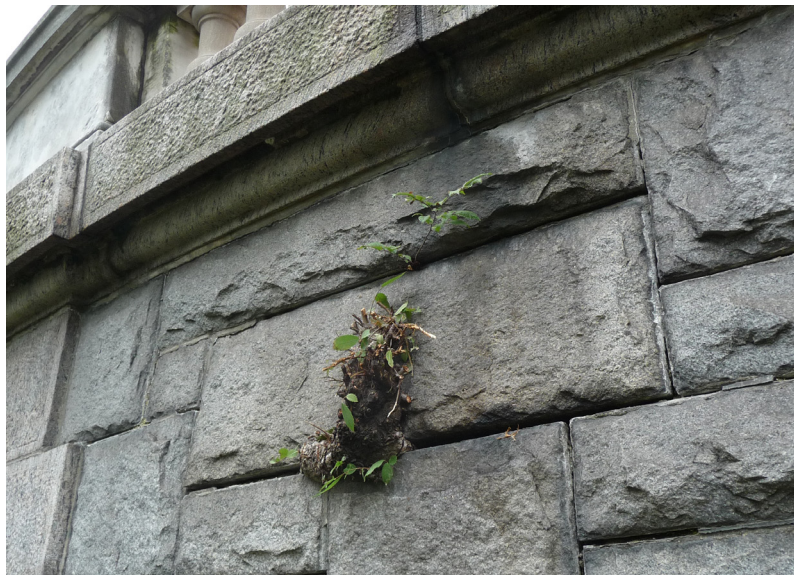
Biological Growth

The exposed ashlar foundation stone is locally quarried schist. Overall the stones themselves are in good condition. Deterioration relates to drainage and biological growth.

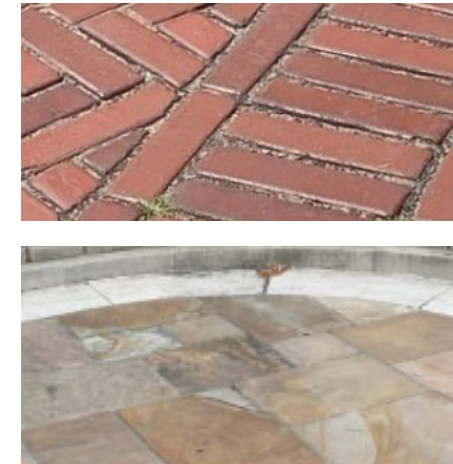
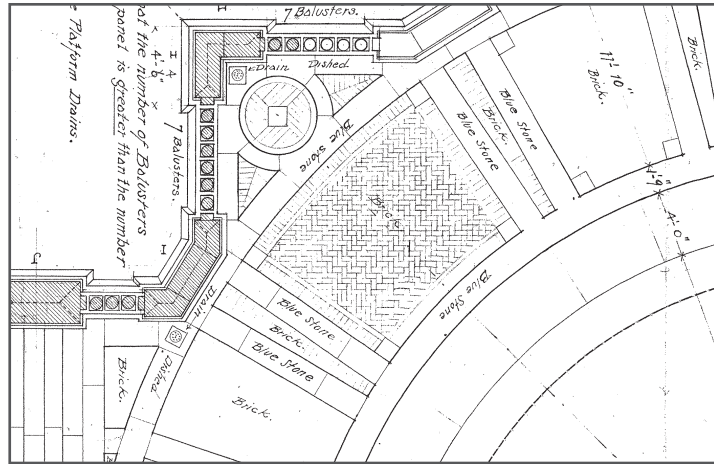
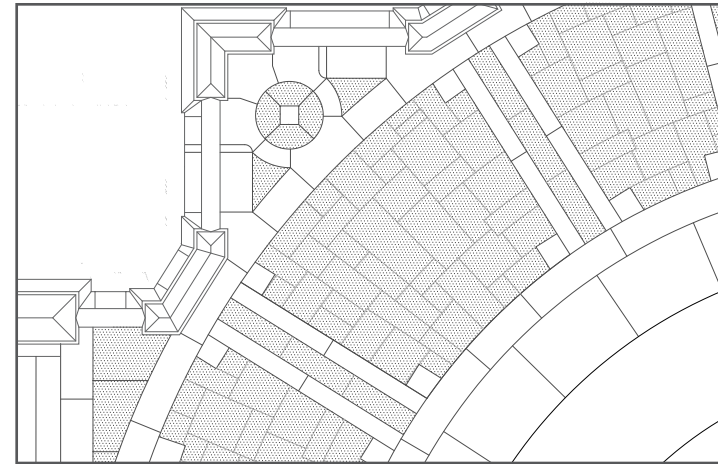
During the 1959-62 campaign, extensive work was conducted on the plazas. The original brick, previously replaced with concrete in the 1930s, was replaced with the existing brownish-colored Crab Orchard sandstone. The sandstone has not withstood the environmental conditions and is in overall poor condition. Surface loss, cracking and displacement is typical.

In coordination with necessary drainage and sub-surface upgrades, the deteriorated sandstone pavers shall be removed and replaced with new brick pavers, set within salvaged historic marble banding. The design of the brick pattern shall be based on information available from original design drawings and period photos before the 1930s.

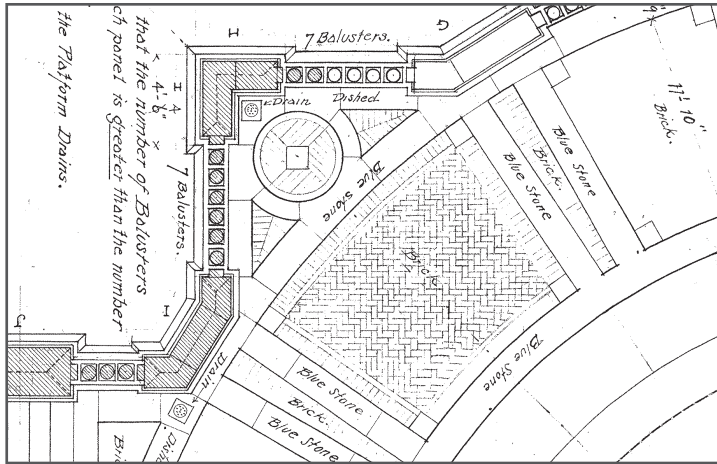
**1902**  
Terraces are completed in herringbone brick pavers.

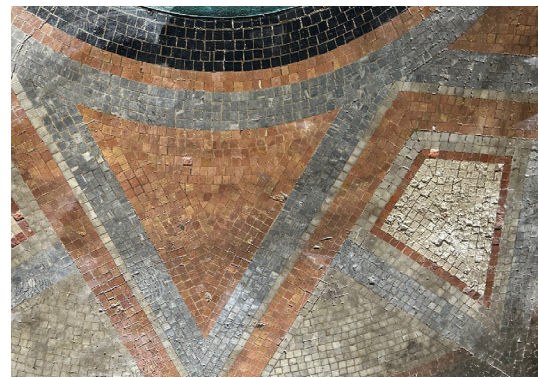
### Mosaic

The floor finish of the Monument interior is comprised of patterned stone mosaic tesserae. The damaged and missing units to be replaced in kind and set in compatible concrete setting bed.

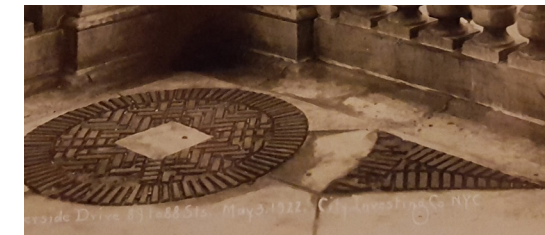
During the 1959—62 restoration campaign, extensive work was conducted on the plazas. Additionally, the deteriorated original brick paving, most of which had already been replaced with concrete (as shown in period photographs), was replaced with the brownish-colored Crab Orchard sandstone.

The design proposes a return to the Herringbone Red Brick Pavers.
