Re: NYSDEC Permit 2-6106-00002/00022 Ren 4 (Permit)  
Southwest Brooklyn Marine Transfer Station (MTS)  
New York City Department of Sanitation (DSNY)  
2025 Marine Inspection Report

# ROUTINE INSPECTION REPORT

## MARINE FENDER SYSTEM

### SOUTHWEST BROOKLYN MARINE TRANSFER STATION

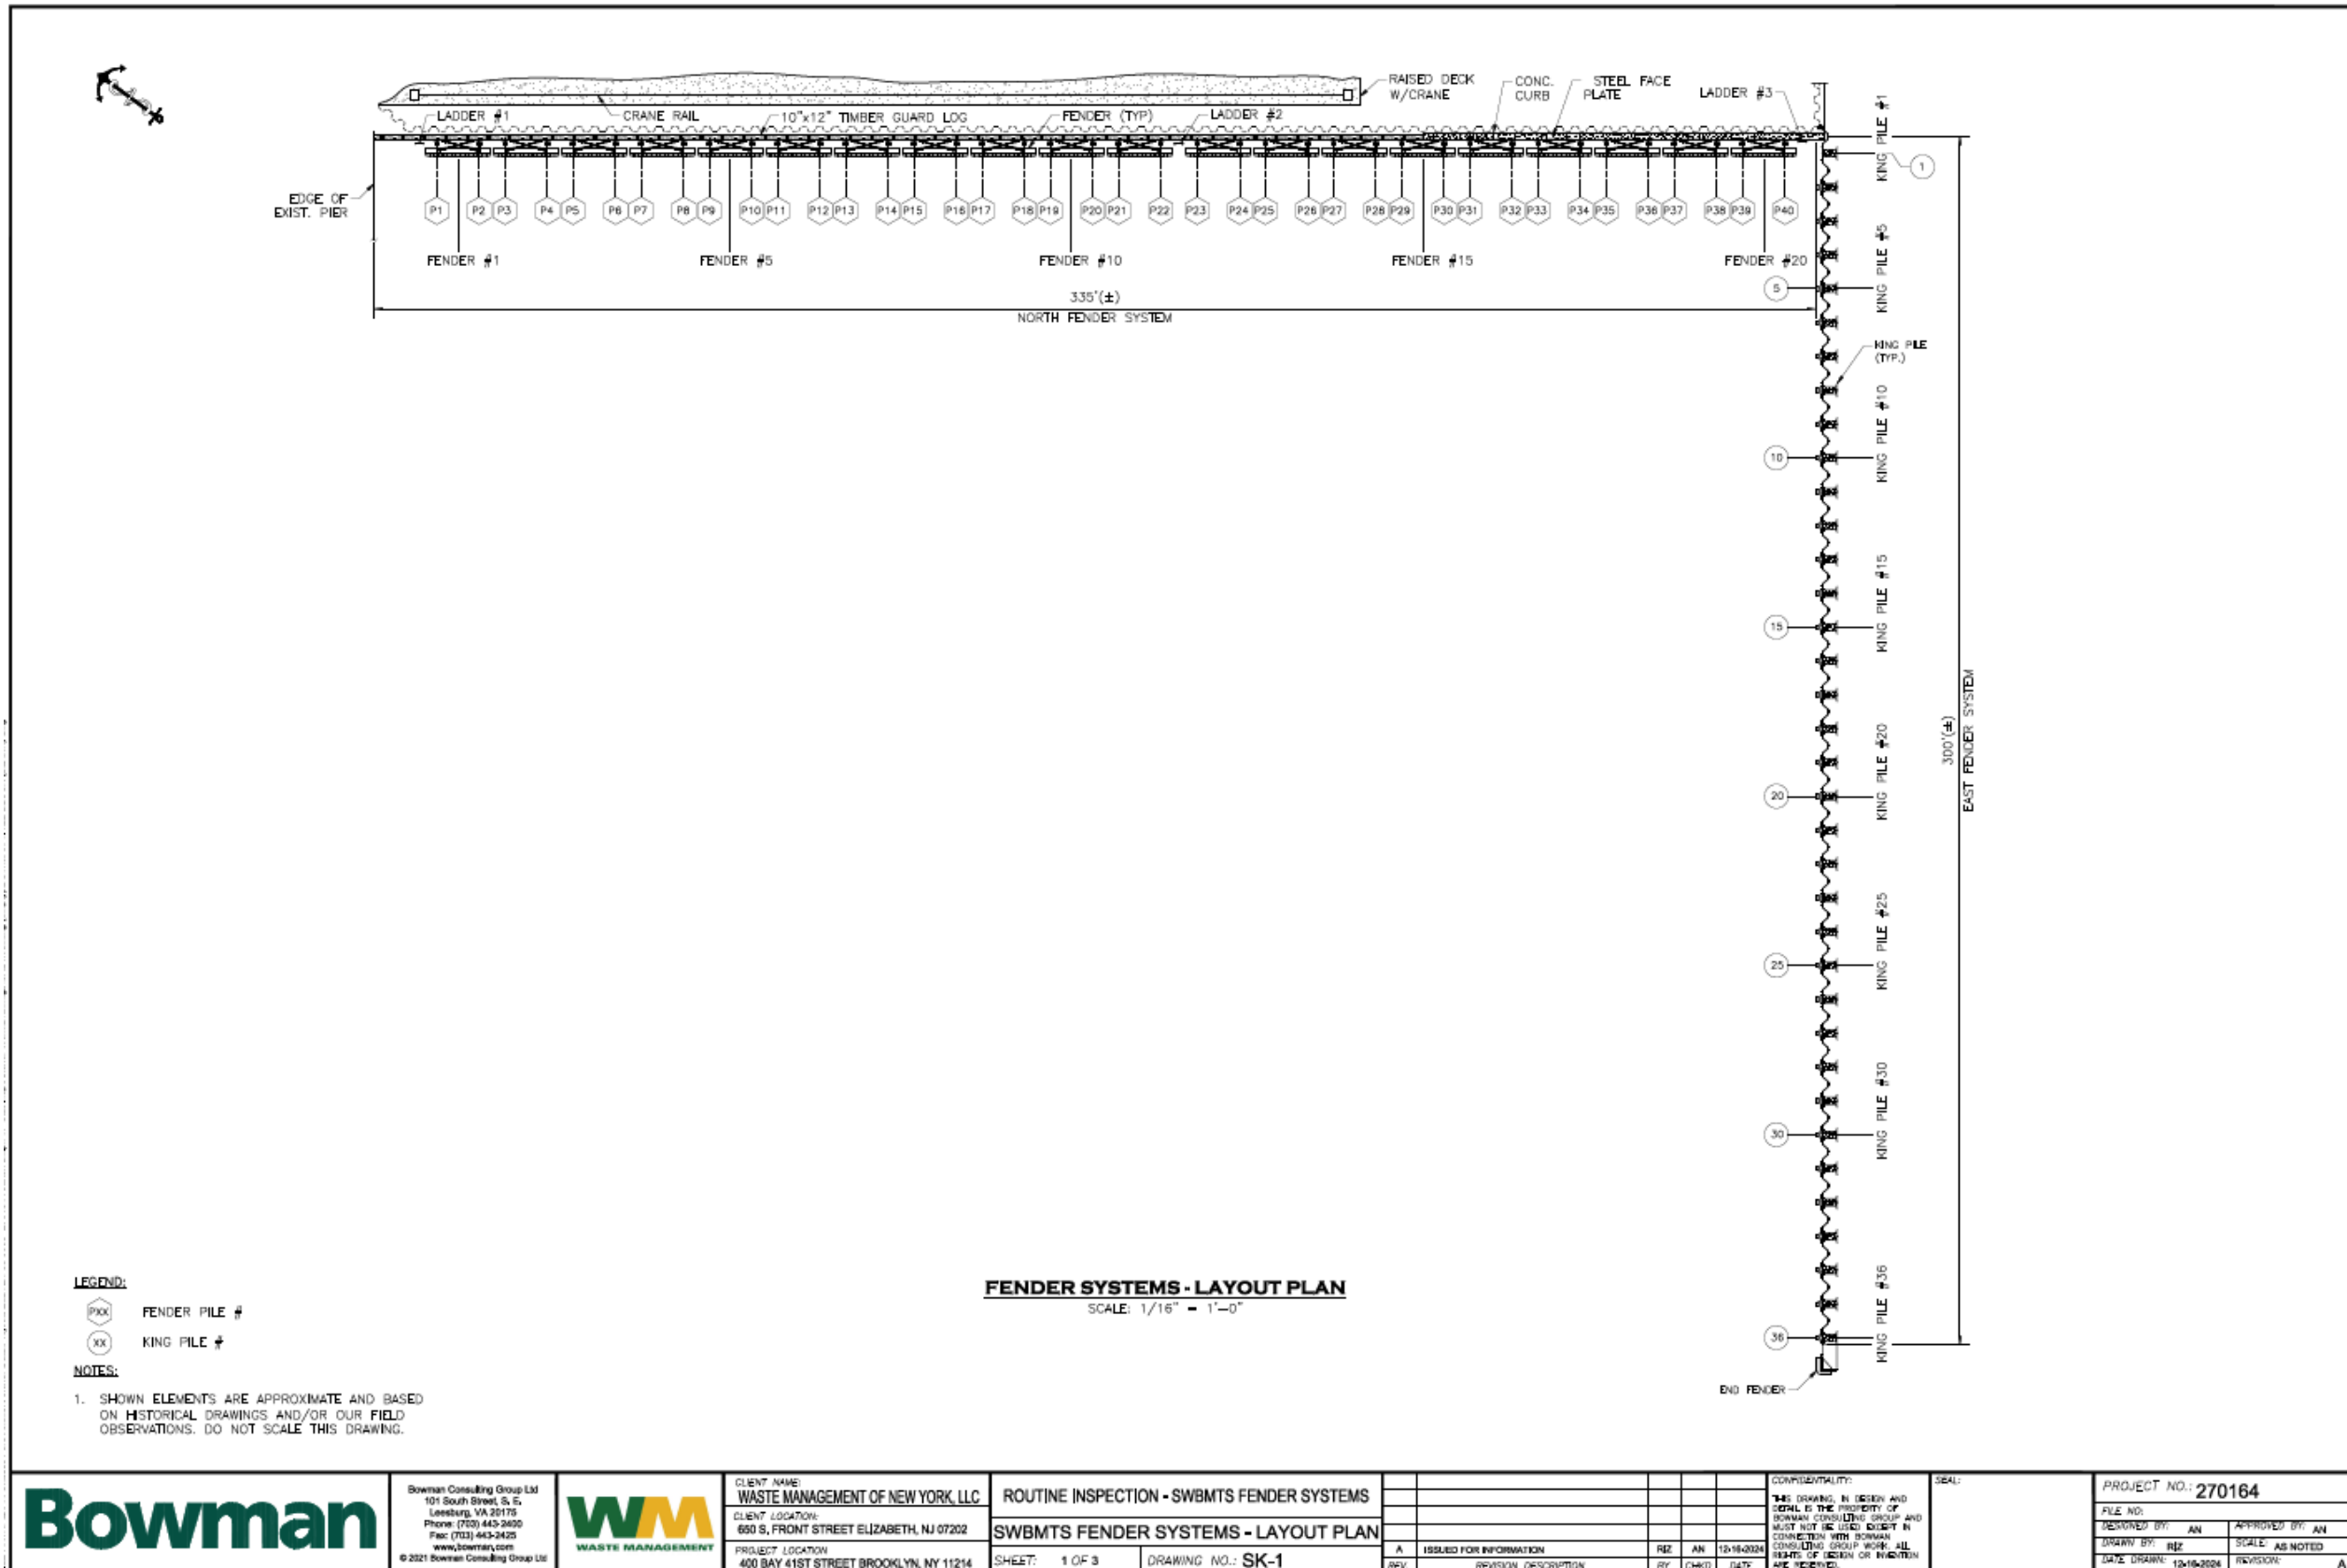
Figure 3 : General Layout of Fender Systems  
 Page 6 of 39

The North Fender System consists of 20 individual fender panels. In this report, and prior reports issued by Bowman, the westernmost fender panel is designated as "Fender #1" and the easternmost most fender panel is designated as "Fender #20" (see Figure 3). Each Fender Panel is constructed of a bolted frame, consisting of three horizontal members (Top, Middle, and Bottom Wales) of CTE coated W14 steel beams bolted to two vertically installed coal tar epoxy (CTE) coated HP12x84 steel "fender piles" that are driven into the seabed. The frame supports fifteen vertically mounted 10x12 timber fenders that are bolted to the outer face of the walers. Each panel is attached to and buffered from the bulkhead by two vertically oriented 300 mm x 1000 mm rubber arch fenders that are bolted to the inner flange of each fender pile. The inner flanges of each arch fender are bolted to a CTE coated mounting plate. The mounting plate is anchored to the concrete face of bulkhead using six galvanized threaded rods. The panels are also attached directly to the bulkhead via two galvanized shear chains along the top wale. Each chain is equipped with galvanized shackles and a chain tensioner.

The East Fender System extends 300 feet offshore from the eastern end of the wharf (see Figure 3). The East Fender System is free standing (not supported by an upland wharf). The system is composed of 36 pairs of CTE coated PSP900 steel "king" pilings that are installed directly adjacent to each other. The void between each installed pair is filled with concrete. Two vertically oriented 400 mm arch fenders are bolt-mounted to the west face of each king pile pair.

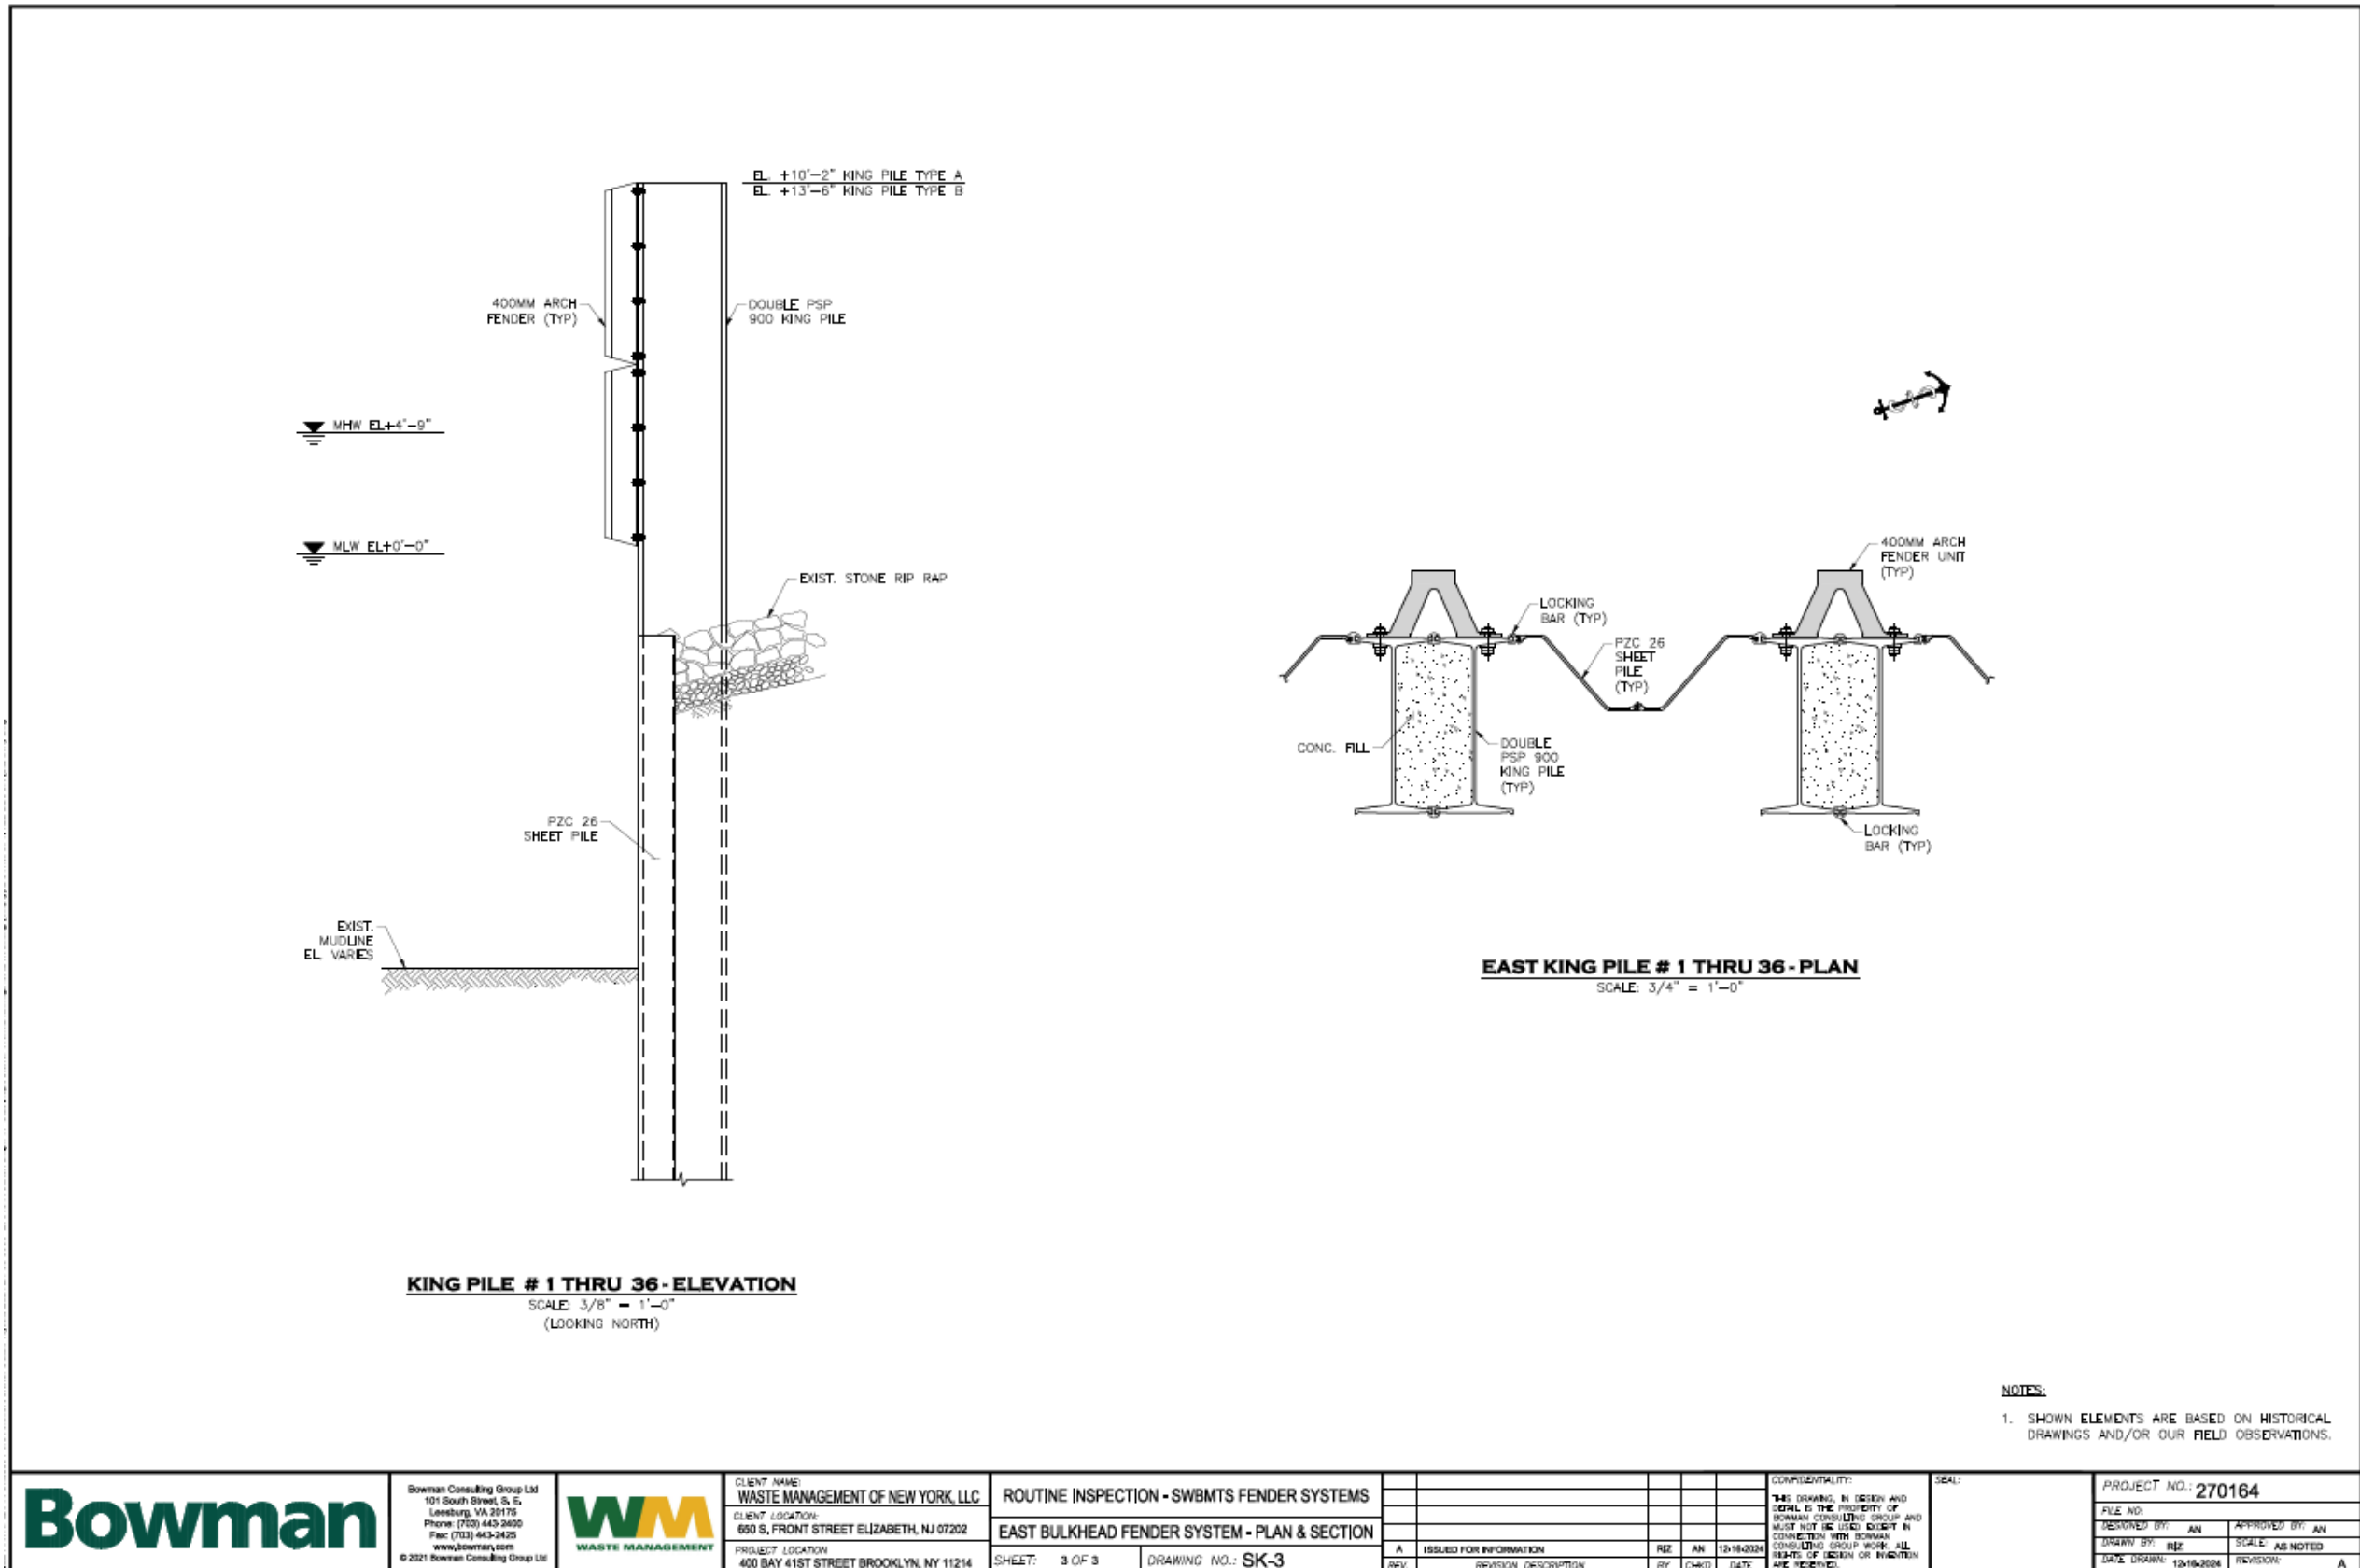
Figure 5 : East Fender Plan & Sections  
 Page 8 of 39

It is noted that the above-referenced descriptions are based upon design information provided to Bowman. In some instances, the actual construction varied from the design. Actual observed conditions are illustrated in Figures 4 and 5.
