**Public Notice Regarding Section 106 Review of
Proposed Supportive and Affordable Housing Project at 839 St. Marks Avenue, Brooklyn NY
Seeking Public Comment**

EXISTING CONDITIONS ASSESSMENT
for
839 ST. MARK'S AVENUE
CROWN HEIGHTS
BROOKLYN, NY 11213

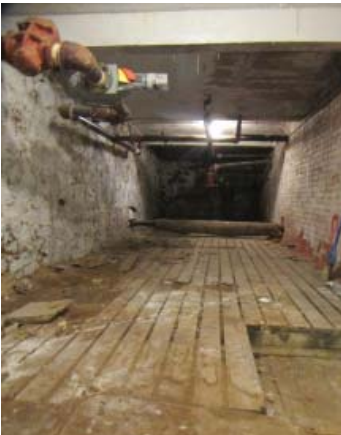
Fig. III-C-2 Room C01 Utilities Meter Room

EXISTING CONDITIONS ASSESSMENT INTERIOR								839 ST. MARK'S AVENUE
Location	Floors	Walls	Doors	Windows	Ceilings	Lighting	Heating & Ventilation	Miscellaneous
Basement								
C01 Utilities Meter Room	wood planks laid on top of earth; near back of room there is just plywood laid on top of earth.	Stone wall painted white at front and side walls of building; painted brick at remaining wall.	Wood panel/bead board door with sliding bolt.	(1) Opening on St. Mark's Avenue side with metal grate.	Painted, poured concrete with poured concrete encased beams.	(3) Fluorescent bulbs.		Mechanical equipment.
Existing Condition	<i>Poor Condition with several areas of missing/broken planks, exposing earth.</i>	<i>Poor Condition with stone walls cracking, having open joints, and delaminating and brick wall having open joints and coating is peeling.</i>	<i>Fair Condition with some areas of paint chipping.</i>	<i>Fair Condition.</i>	<i>Good Condition.</i>	<i>Fair Condition.</i>		<i>Good Condition.</i>

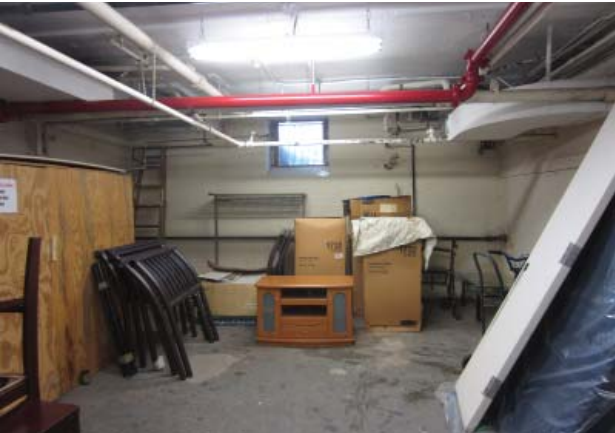
Fig. III-C-5 Room C02 Sprinkler Room

C02 Sprinkler Room	Poured concrete with painted blue/gray finish.	Painted white brick.	Painted metal set within brick archways.	(1) Aluminum, single pane, fixed window.	Painted white plaster.	Hanging fluorescent fixtures.		Exposed pipes on ceiling.
Existing Condition	<i>Fair Condition with various areas of paint splatters and needs cleaning. There are areas of cracking and deterioration.</i>	<i>Fair Condition with soiling along bottom and several areas where coating is peeling.</i>	<i>Fair Condition with some areas of paint chipping.</i>	<i>Good Condition.</i>	<i>Good Condition.</i>	<i>Good Condition.</i>		<i>Good Condition.</i>
C03 Boiler Room	Poured concrete with painted blue/gray finish. Opening in floor possibly for sump pump.	Painted white brick.	Painted metal set within brick archways.	Vent to exterior blocking window.	Metal paneled ceiling.	Hanging fluorescent fixtures.		Duct work, pipes, hot water heater and boiler, electrical panels on wall.

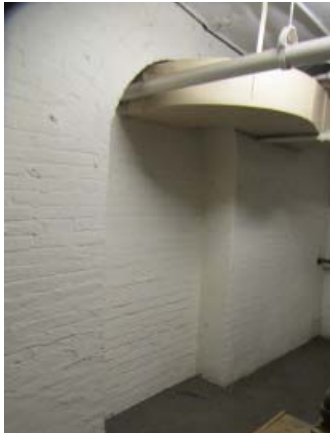
Fig. III-C-11 Room C03 Boiler Room arched opening infilled with brick

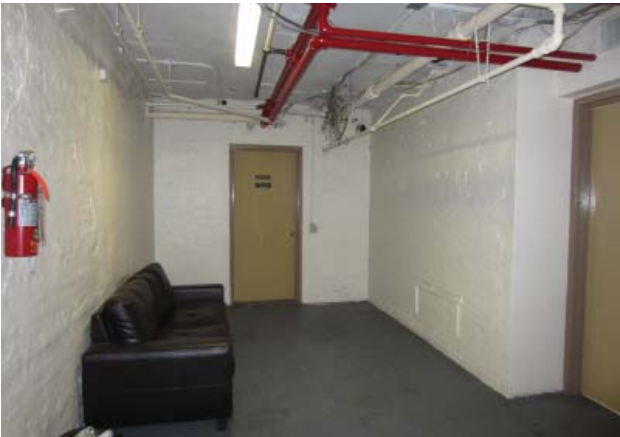
Fig. III-C-14 Room C05 Corridor

C05 Corridor	Poured concrete with painted blue/gray finish.	Painted white brick with some areas of plaster overtop of brick.	Painted metal.	N/A	Painted white plaster.	Hanging fluorescent fixtures.		N/A
Existing Condition	<i>Fair Condition with various areas of paint splatters and needs cleaning. There are areas of cracking and deterioration.</i>	<i>Fair Condition with soiling along bottom and several areas where coating is peeling. The plaster has detached in several areas exposing brick underneath.</i>	<i>Fair Condition with some areas of paint chipping.</i>	<i>N/A</i>	<i>Good Condition.</i>	<i>Good Condition.</i>		<i>N/A</i>

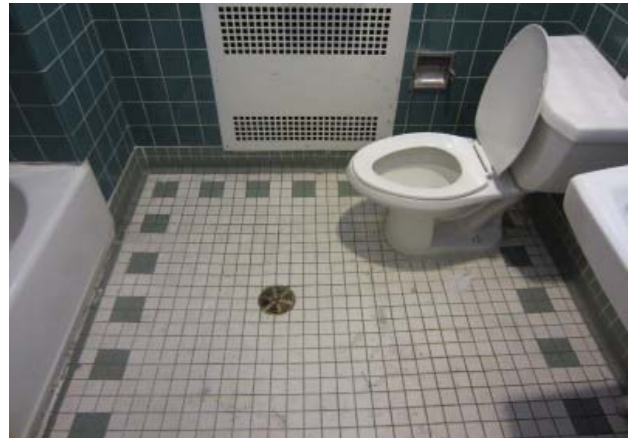
Fig. III-C-62 Room 204 Bathroom floor tiles

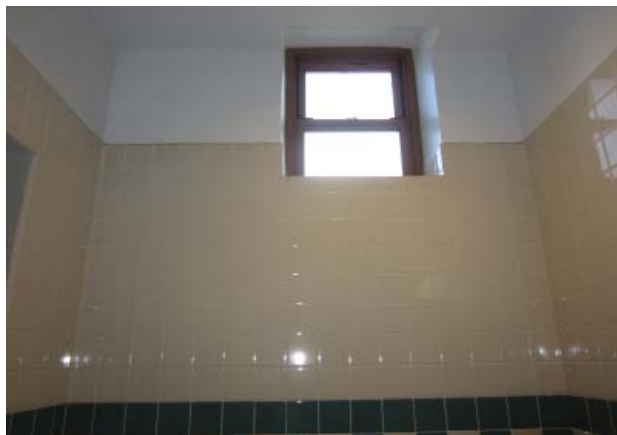
Fig. III-C-63 Room 204 Bathroom upper wall and window

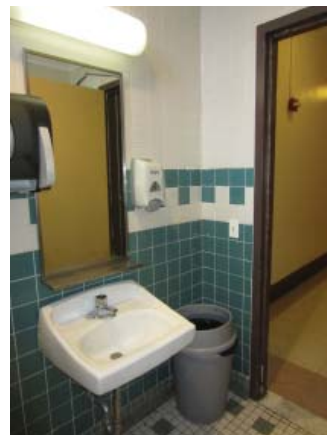
Fig. III-C-64 Room 204 Bathroom fixtures

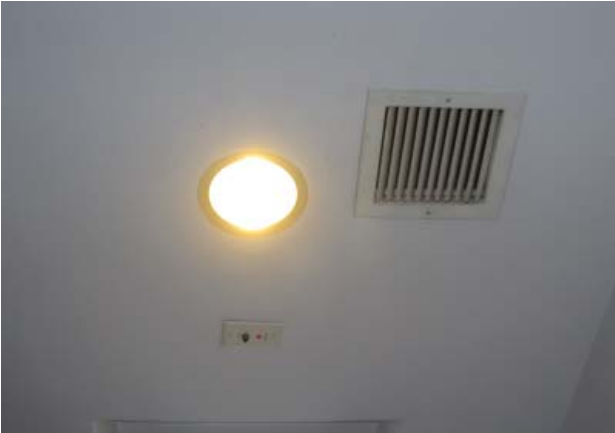
Fig. III-C-65 Room 204 Bathroom ceiling light and vent

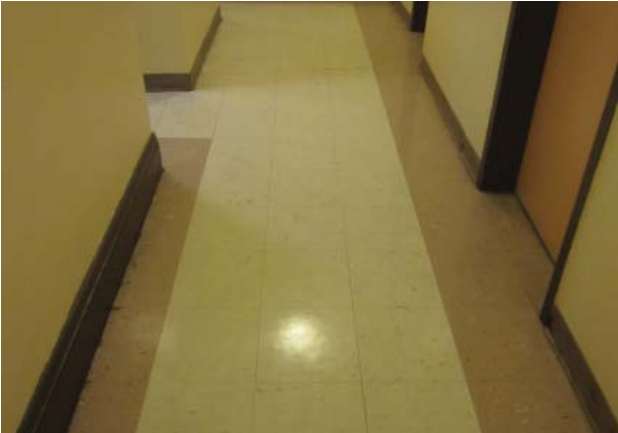
Fig. III-C-66 Room 205 Corridor floors

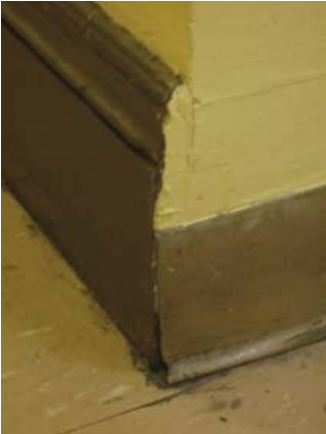
Fig. III-C-67 Room 205 Corridor baseboard

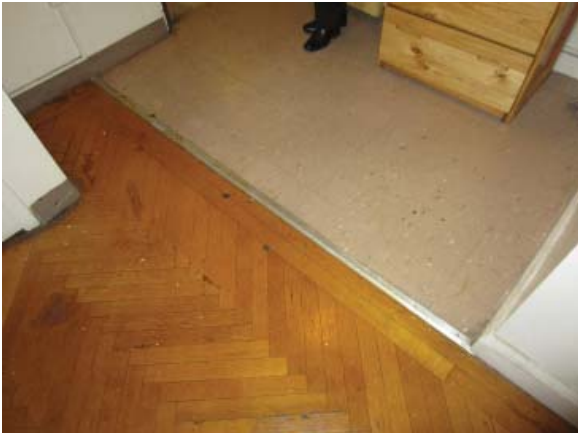
Fig. III-C-69 Room 206 Bedroom floors

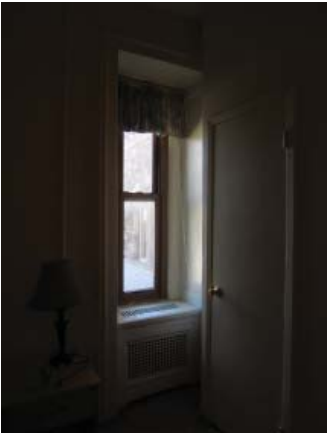
Fig. III-C-70 Room 206 Bedroom window

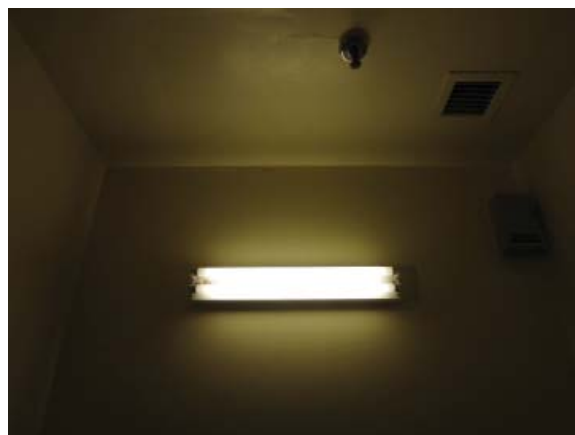
Fig. III-C-100 Room 217 Janitor's Closet ceiling and light fixture

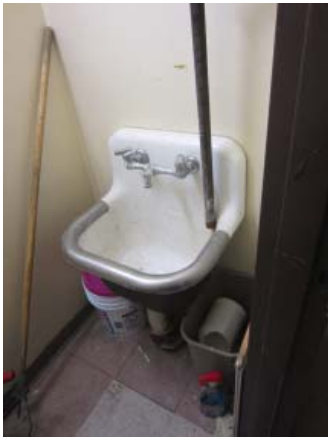
Fig. III-C-101 Room 217 Janitor's Closet utility sink

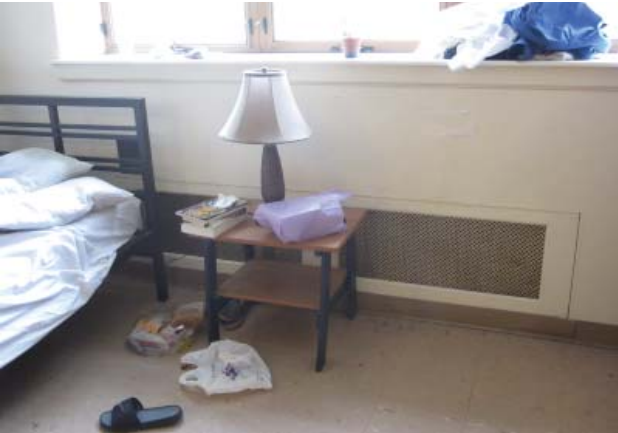
Fig. III-C-110 Room 301 Bedroom window vents

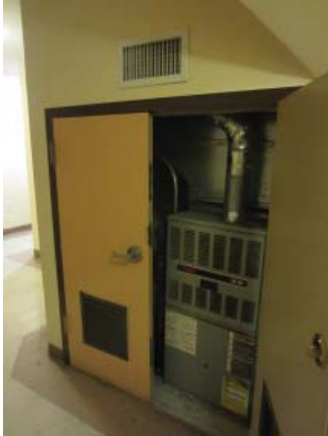
Fig. III-C-126 Room 305 Corridor mechanical room

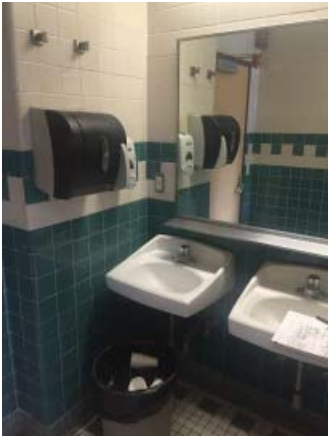
Fig. III-C-127 Room 306 Bathroom sinks

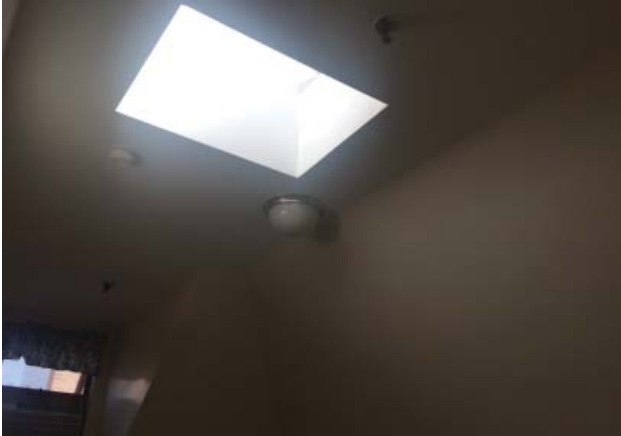
Fig. III-C-138 Room 308 Bedroom skylight

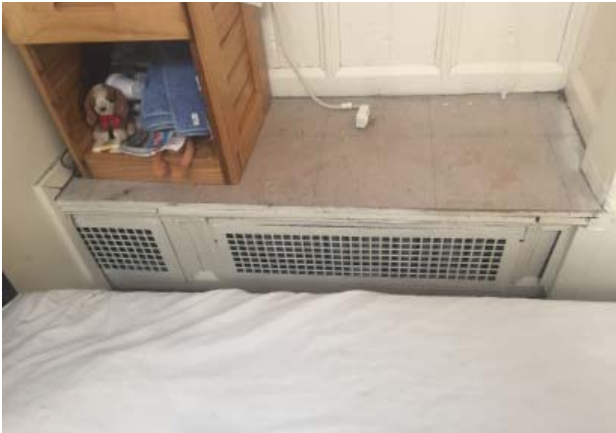
Fig. III-C-139 Room 308 Bedroom vent

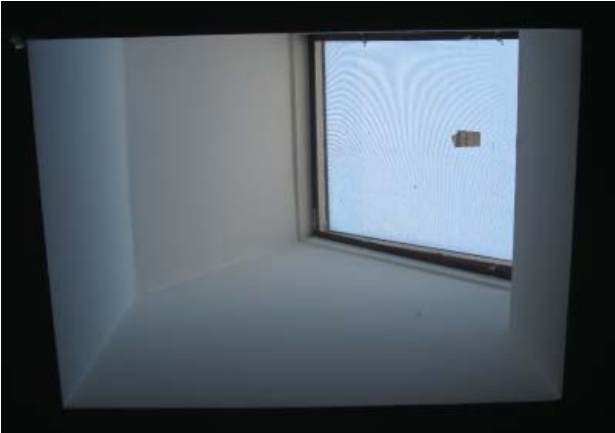
Fig. III-C-141 Room 309 Bedroom skylight

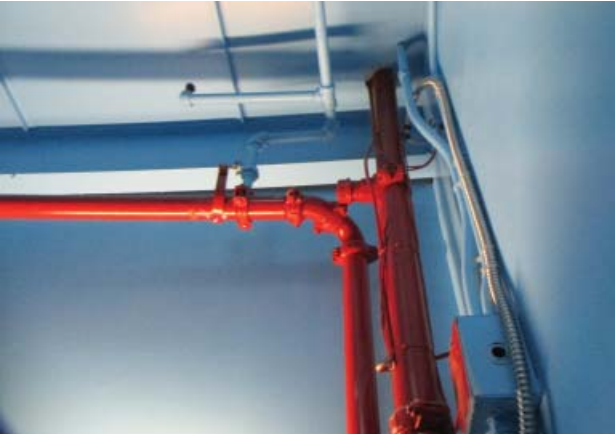
Fig. III-C-156 Stairwell B, Room 103 pipes

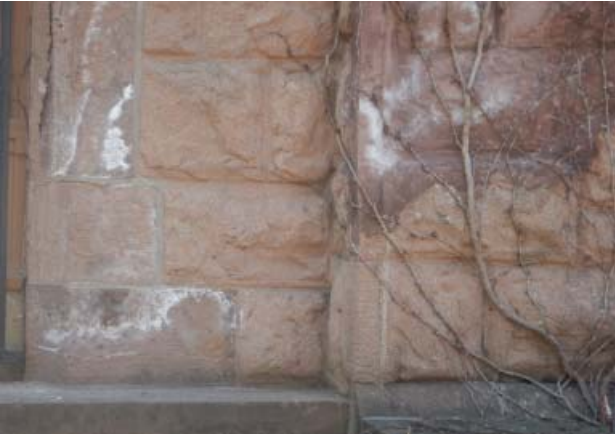
Fig. III-C-178 East Elevation detail of efflorescence

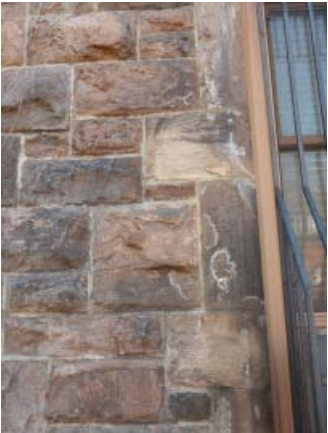
Fig. III-C-180 East Elevation detail of spalling masonry

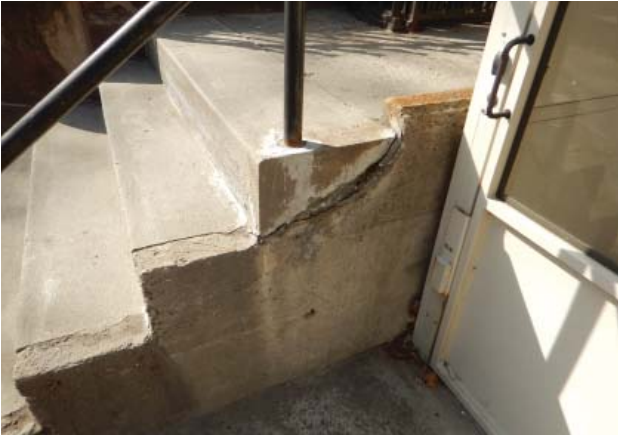
Fig. III-C-189 South Elevation detail of entry steps
